# **Peace River and Withlacoochee River Threats Assessments and Fish Assemblage Monitoring**

**Final Report July 1, 2015 – June 30, 2019**

Submitted to Florida State Wildlife Grants Program  
August 1, 2019  
PID: 98462501284

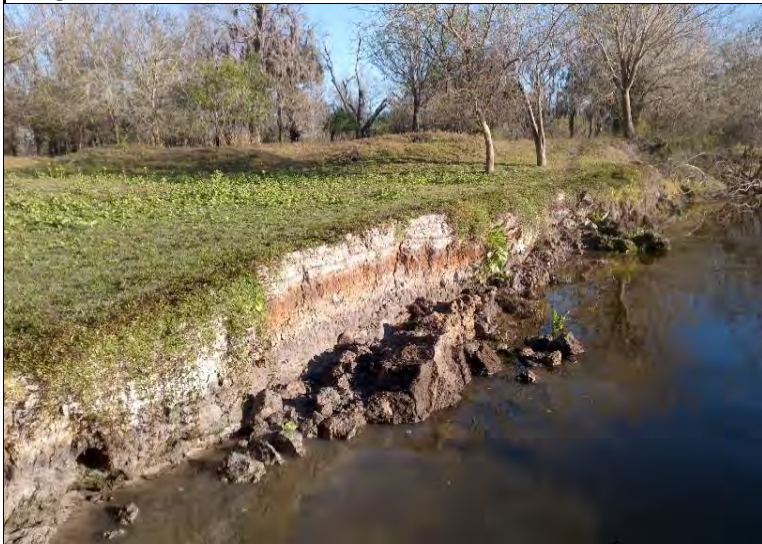
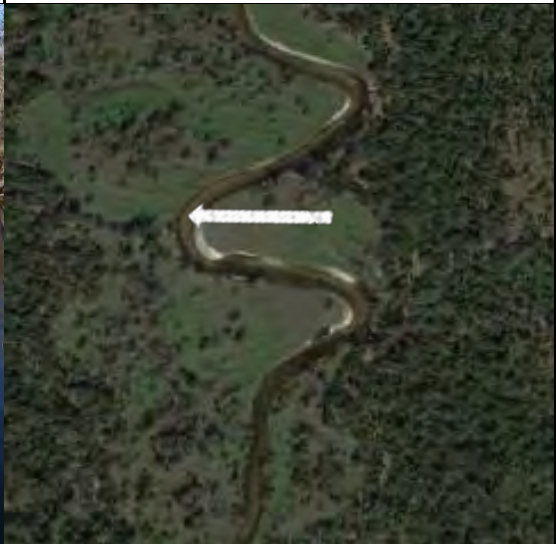
Peace River			Severity Scale: 7.0-Moderate
Watershed: Peace River Subwatershed: Peace River Branch Latitude: 27.38706 Longitude: -81.84448			County: Hardee Site Number: PI271 Reach Length: 120 ft. Landowner: Ben Hill Griffin Inc.

Pfankuch-Channel Stability:	Poor	1.5	
Channel Alteration:	None	0	
Bank Erosion:	Mass-wasting	1.5	
BEHI:	High (34.65)	1	
Local NPSP:	Obvious Sources	1.5	
Shoring Structures:	None	0	
Pipe Discharge:	None	0	
Water Odor:	Normal	0	
Fish Passage Barrier:	None	0	
RB: Riparian Buffer:	0 ft.	0.75	<b>Additional Site Features</b>
LB: Riparian Buffer:	0 ft.	0.75	Stream Channel Woody Material: Infrequent
RB: Floodplain Access:	Full	0	Impoundments: None
LB: Floodplain Access:	Full	0	Substrate Composition: Medium Sand
Severity Scale: 7.0			Bank Material: Sandy Clay
			Near Bank Stress: High
			RB Landuse: Pasture, Natural Forest
			LB Landuse: Pasture
Notes: Impaired - Aquatic Life Harvesting (mercury in fish tissue)

Restoration Option 1

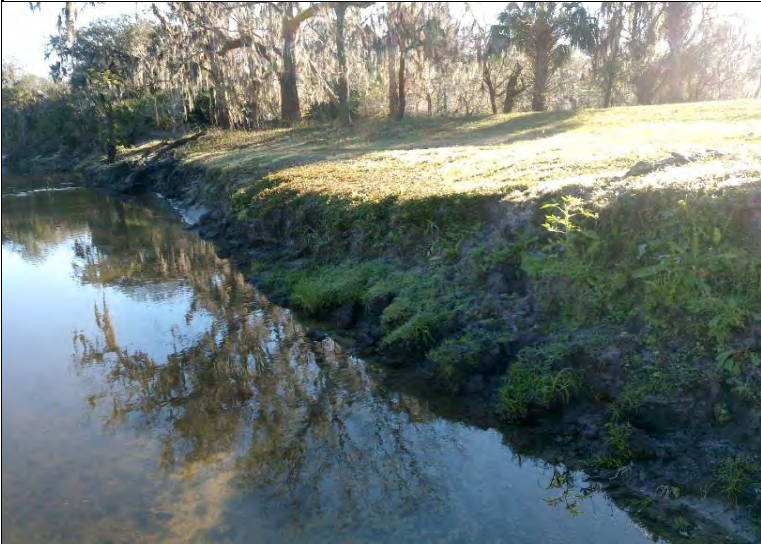
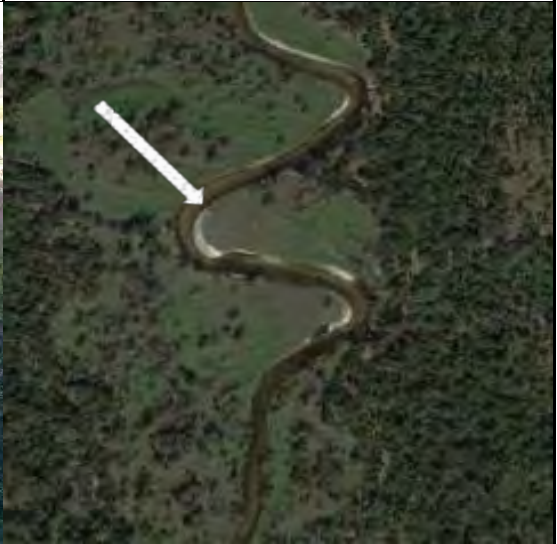
Peace River			Severity Scale: 6.0-Moderate
Watershed: Peace River Subwatershed: Peace River Branch Latitude: 27.38725 Longitude: -81.8442			County: Hardee Site Number: PI272 Reach Length: 215 ft. Landowner: Ben Hill Griffin Inc.

</div>
Pfankuch-Channel Stability:	Poor	1.5	
Channel Alteration:	None	0	
Bank Erosion:	Active	1	
BEHI:	Moderate (25.27)	0.5	
Local NPSP:	Obvious Sources	1.5	
Shoring Structures:	None	0	
Pipe Discharge:	None	0	
Water Odor:	Normal	0	
Fish Passage Barrier:	None	0	
RB: Riparian Buffer:	0 ft.	0.75	
LB: Riparian Buffer:	0 ft.	0.75	
RB: Floodplain Access:	Full	0	
LB: Floodplain Access:	Full	0	
<b>Severity Scale:</b>		<b>6.0</b>	<b>Additional Site Features</b>
			Stream Channel Woody Material: Infrequent
			Impoundments: None
			Substrate Composition: Medium Sand
			Bank Material: Sand
			Near Bank Stress: Moderate

RB Landuse: Pasture, Natural Forest
			LB Landuse: Pasture
Notes: Impaired - Aquatic Life Harvesting (mercury in fish tissue)			
Restoration Option 2 or 3

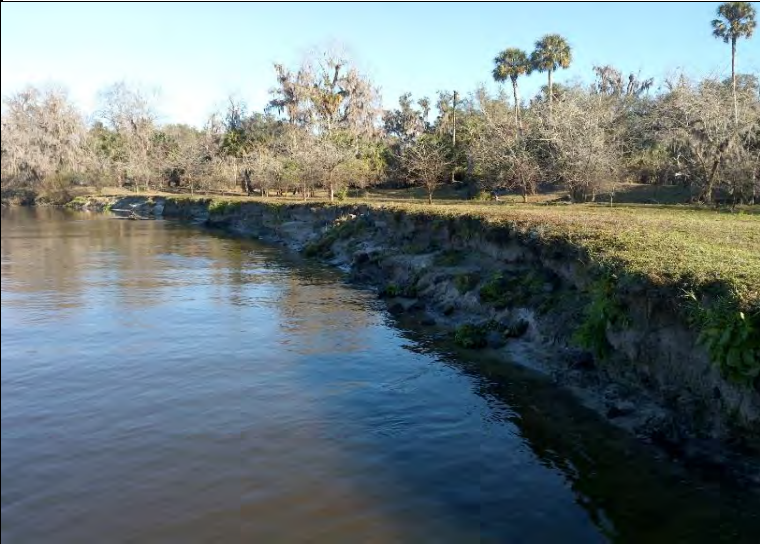
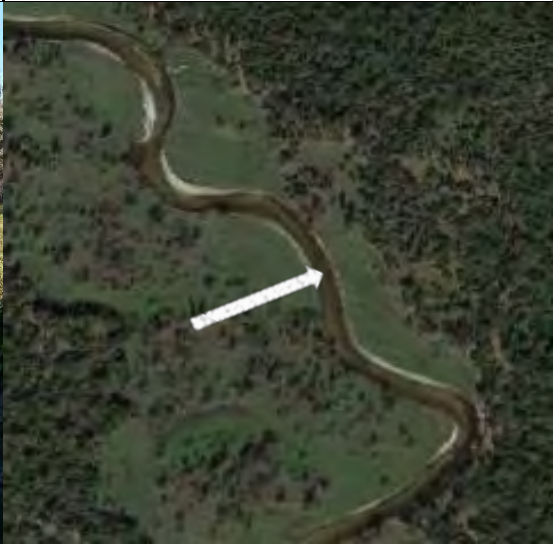
Peace River			Severity Scale: 6.75-Moderate
Watershed: Peace River Subwatershed: Peace River Branch Latitude: 27.38901 Longitude: -81.84394			County: Hardee Site Number: PI273 Reach Length: 590 ft. Landowner: Ben Hill Griffin Inc.

</div>
Pfankuch-Channel Stability:	Poor	1.5	
Channel Alteration:	None	0	
Bank Erosion:	Mass-wasting	1.5	
BEHI:	High (35.96)	1	
Local NPSP:	Obvious Sources	1.5	
Shoring Structures:	None	0	
Pipe Discharge:	None	0	
Water Odor:	Normal	0	
Fish Passage Barrier:	None	0	
RB: Riparian Buffer:	40 ft.	0.5	
LB: Riparian Buffer:	0 ft.	0.75	
RB: Floodplain Access:	Full	0	
LB: Floodplain Access:	Full	0	
Severity Scale:		6.75	<b>Additional Site Features</b> Stream Channel Woody Material: Infrequent Impoundments: None Substrate Composition: Medium Sand Bank Material: Sand Near Bank Stress: Moderate RB Landuse: Pasture, Natural Forest LB Landuse: Pasture

Notes: Impaired - Aquatic Life Harvesting (mercury in fish tissue)			
Restoration Option 1

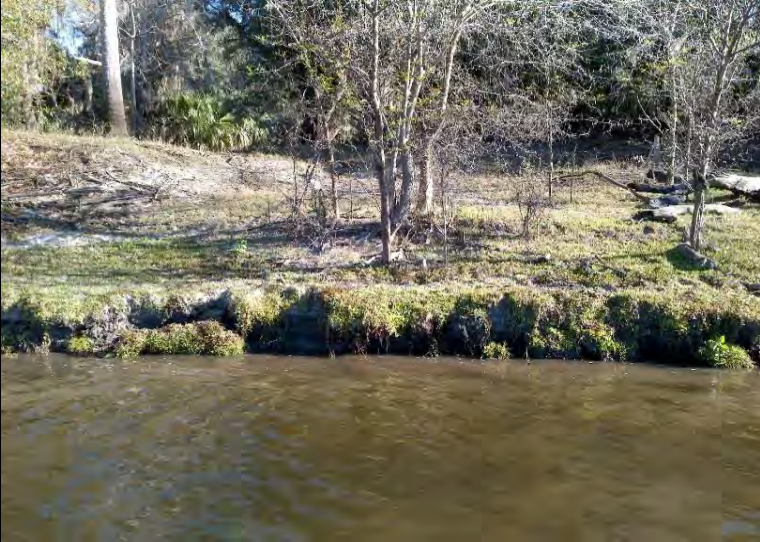
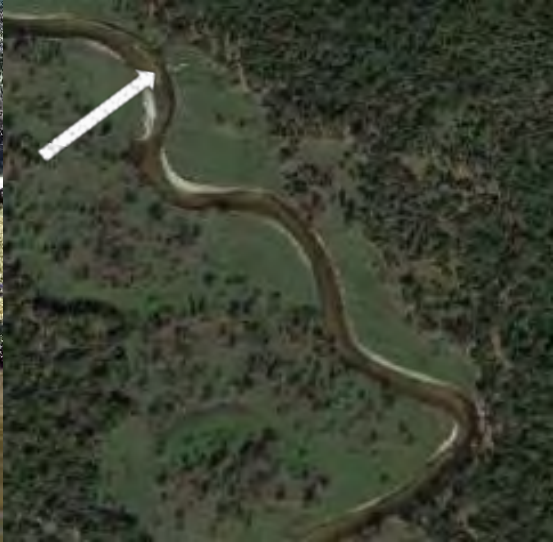
Peace River			Severity Scale: 6.25-Moderate
Watershed: Peace River Subwatershed: Peace River Branch Latitude: 27.39185 Longitude: -81.84601			County: Hardee Site Number: PI274 Reach Length: 174 ft. Landowner: Ben Hill Griffin Inc.

Risk Factor	Ranking	Score	
Pfankuch-Channel Stability:	Poor	1.5	
Channel Alteration:	None	0	
Bank Erosion:	Mass-wasting	1.5	
BEHI:	Moderate (28.81)	0.5	
Local NPSP:	Obvious Sources	1.5	
Shoring Structures:	None	0	
Pipe Discharge:	None	0	
Water Odor:	Normal	0	
Fish Passage Barrier:	None	0	
RB: Riparian Buffer:	0 ft.	0.75	
LB: Riparian Buffer:	40 ft.	0.5	
RB: Floodplain Access:	Full	0	
LB: Floodplain Access:	Full	0	
Severity Scale:		6.25	
Notes: Impaired - Aquatic Life Harvesting (mercury in fish tissue)			
Restoration Option 1

Additional Site Features
Stream Channel Woody Material: Moderate
Impoundments: None
Substrate Composition: Medium Sand
Bank Material: Sandy-clay
Near Bank Stress: High
RB Landuse: Pasture
LB Landuse: Natural Forest, Pasture

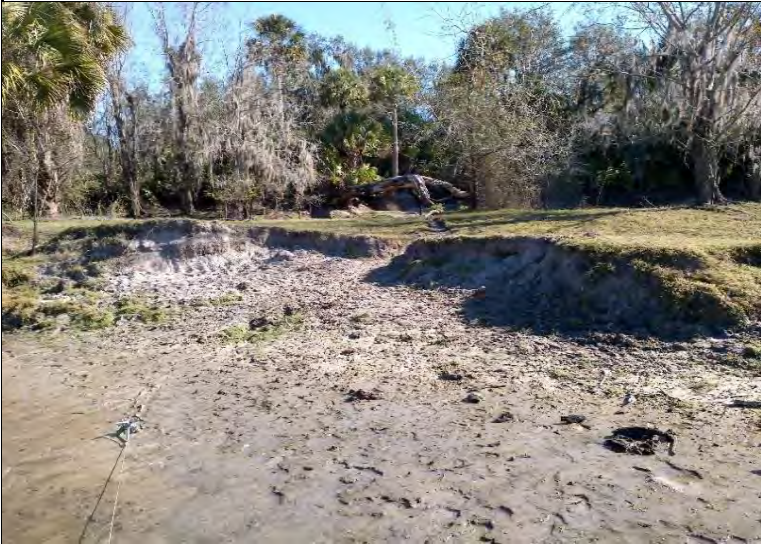
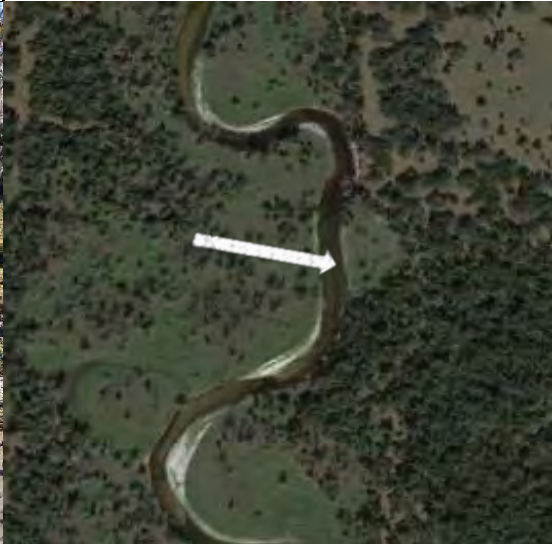
Peace River			Severity Scale: 6.0-Moderate
Watershed: Peace River Subwatershed: Peace River Branch Latitude: 27.39462 Longitude: -81.84632			County: Hardee Site Number: PI275 Reach Length: 257 ft. Landowner: Ben Hill Griffin Inc.

Pfankuch-Channel Stability:	Poor	1.5	
Channel Alteration:	None	0	
Bank Erosion:	Active	1	
BEHI:	Moderate (24.25)	0.5	
Local NPSP:	Obvious Sources	1.5	
Shoring Structures:	None	0	
Pipe Discharge:	None	0	
Water Odor:	Normal	0	
Fish Passage Barrier:	None	0	
RB: Riparian Buffer:	20 ft.	0.75	
LB: Riparian Buffer:	0 ft.	0.75	
RB: Floodplain Access:	Full	0	
LB: Floodplain Access:	Full	0	
<b>Severity Scale:</b>		<b>6.0</b>	
Notes: Impaired - Aquatic Life Harvesting (mercury in fish tissue)			<b>Additional Site Features</b>
			Stream Channel Woody Material: Infrequent
			Impoundments: None
			Substrate Composition: Medium Sand
			Bank Material: Sand

Near Bank Stress: Moderate
			RB Landuse: Pasture, Natural Forest
			LB Landuse: Pasture, Natural Forest
Restoration Option 2 or 3

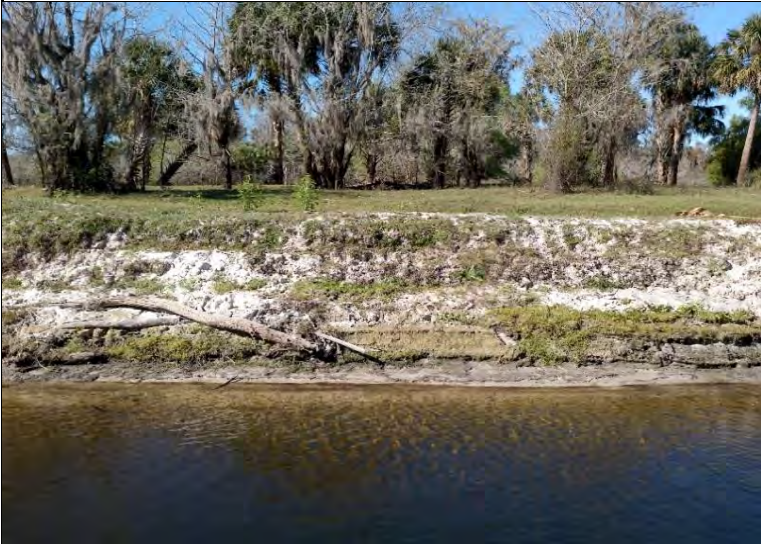
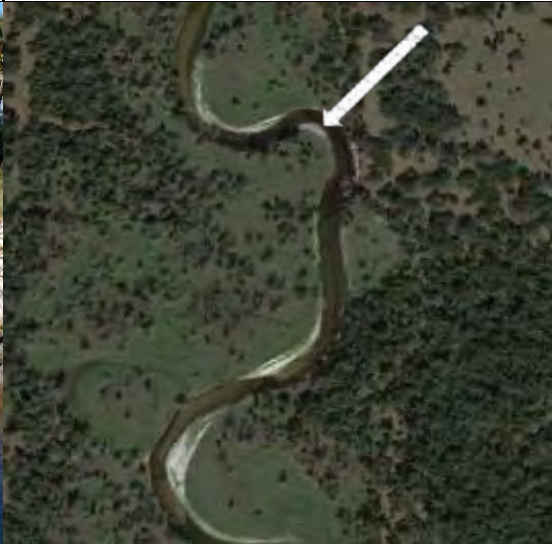
Peace River			Severity Scale: 6.0-Moderate
Watershed: Peace River Subwatershed: Peace River Branch Latitude: 27.39579 Longitude: -81.84644			County: Hardee Site Number: PI276 Reach Length: 134 ft. Landowner: Ben Hill Griffin Inc.

Pfankuch-Channel Stability:	Poor	1.5	
Channel Alteration:	None	0	
Bank Erosion:	Active	1	
BEHI:	Moderate (26.49)	0.5	
Local NPSP:	Obvious Sources	1.5	
Shoring Structures:	None	0	
Pipe Discharge:	None	0	
Water Odor:	Normal	0	
Fish Passage Barrier:	None	0	
RB: Riparian Buffer:	0 ft.	0.75	
LB: Riparian Buffer:	20 ft.	0.75	
RB: Floodplain Access:	Full	0	
LB: Floodplain Access:	Full	0	
<b>Severity Scale:</b>		<b>6.0</b>	<b>Additional Site Features</b>
			Stream Channel Woody Material: Numerous
			Impoundments: None
			Substrate Composition: Medium Sand
			Bank Material: Sand
			Near Bank Stress: Low
			RB Landuse: Pasture, Natural Forest
			LB Landuse: Pasture, Natural Forest

Notes: Impaired - Aquatic Life Harvesting (mercury in fish tissue)			
Restoration Option 2 or 3

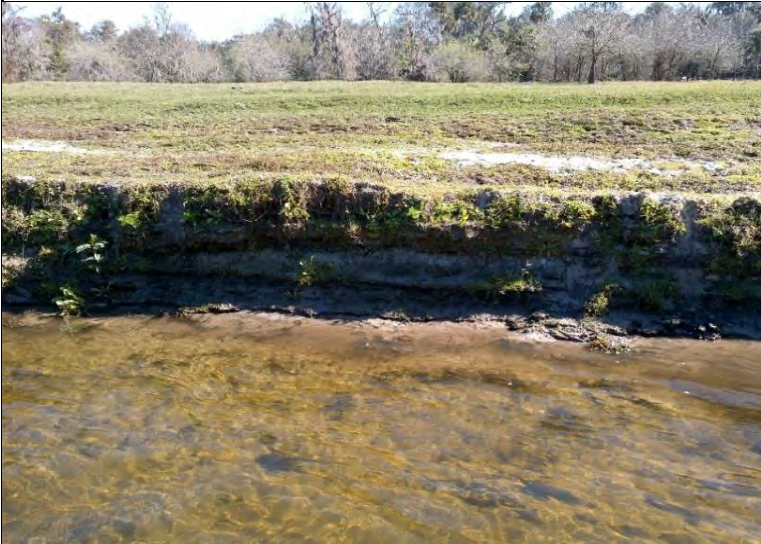
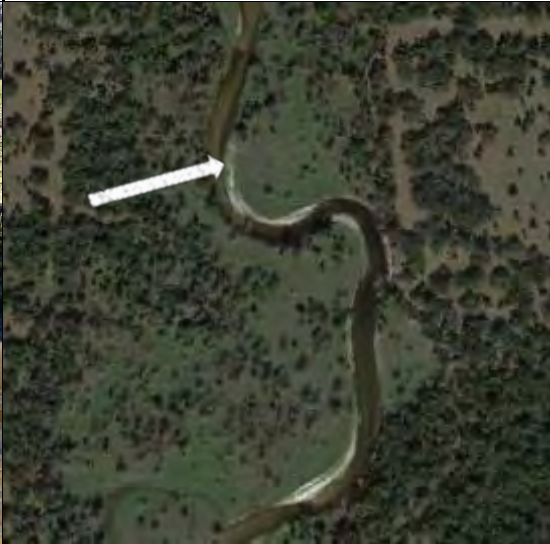
Peace River			Severity Scale: 5.75-Moderate
Watershed: Peace River Subwatershed: Peace River Branch Latitude: 27.39664 Longitude: -81.8479			County: Hardee Site Number: PI277 Reach Length: 97 ft. Landowner: Ben Hill Griffin Inc.

Pfankuch-Channel Stability:	Poor	1.5	
Channel Alteration:	None	0	
Bank Erosion:	Active	1	
BEHI:	Moderate (27.31)	0.5	
Local NPSP:	Obvious Sources	1.5	
Shoring Structures:	None	0	
Pipe Discharge:	None	0	
Water Odor:	Normal	0	
Fish Passage Barrier:	None	0	
RB: Riparian Buffer:	40 ft.	0.5	
LB: Riparian Buffer:	0 ft.	0.75	
RB: Floodplain Access:	Full	0	
LB: Floodplain Access:	Full	0	
<b>Severity Scale:</b>		<b>5.75</b>	<b>Additional Site Features</b>
			Stream Channel Woody Material: Moderate
			Impoundments: None
			Substrate Composition: Medium Sand
			Bank Material: Sand
			Near Bank Stress: Low
			RB Landuse: Pasture, Natural Forest
			LB Landuse: Pasture

Notes: Impaired - Aquatic Life Harvesting (mercury in fish tissue)			
Restoration Option 2 or 3

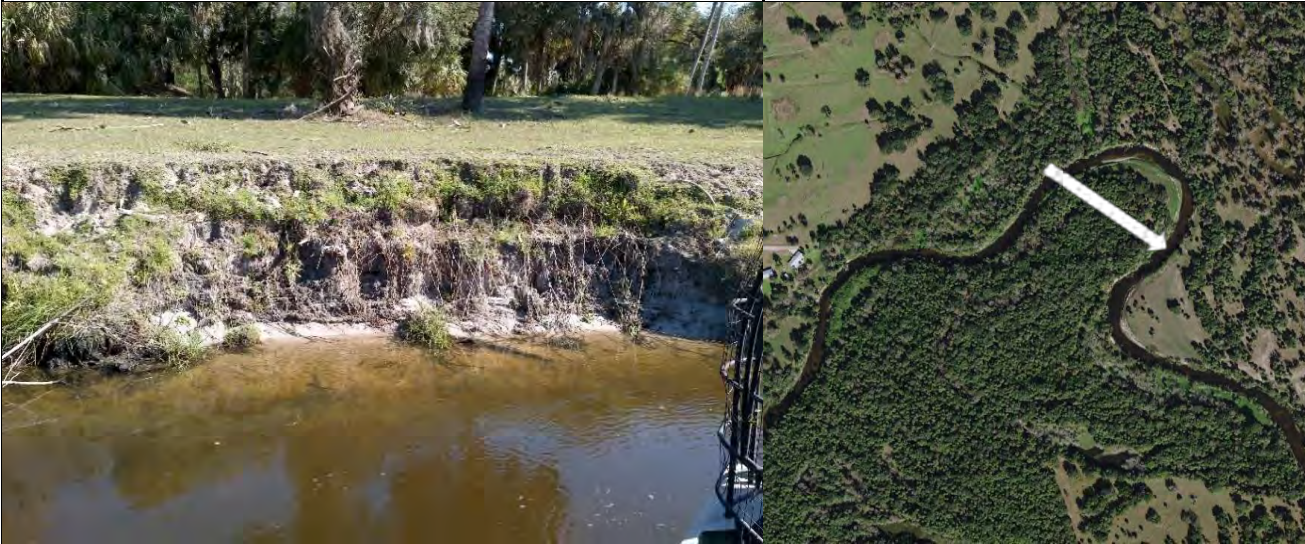
Peace River			Severity Scale: 5.75-Moderate
Watershed: Peace River Subwatershed: Peace River Branch Latitude: 27.49305 Longitude: -81.81644			County: Hardee Site Number: PI278 Reach Length: 62 ft. Landowner: M & R Cattle Co. LLC

Pfankuch-Channel Stability:	Poor	1.5	
Channel Alteration:	None	0	
Bank Erosion:	Active	1	
BEHI:	Moderate (23.00)	0.5	
Local NPSP:	Obvious Sources	1.5	
Shoring Structures:	None	0	
Pipe Discharge:	None	0	
Water Odor:	Normal	0	
Fish Passage Barrier:	None	0	
RB: Riparian Buffer:	0 ft.	0.75	
LB: Riparian Buffer:	40 ft.	0.5	
RB: Floodplain Access:	Full	0	
LB: Floodplain Access:	Full	0	
<b>Severity Scale:</b>		<b>5.75</b>	<b>Additional Site Features</b>
			Stream Channel Woody Material: Moderate
			Impoundments: None
			Substrate Composition: Medium Sand
			Bank Material: Sand
			Near Bank Stress: High
			RB Landuse: Pasture, Natural Forest
			LB Landuse: Natural Forest, Residential

Notes: Impaired - Aquatic Life Harvesting (mercury in fish tissue), Chlorophyll-A			
Restoration Option 1

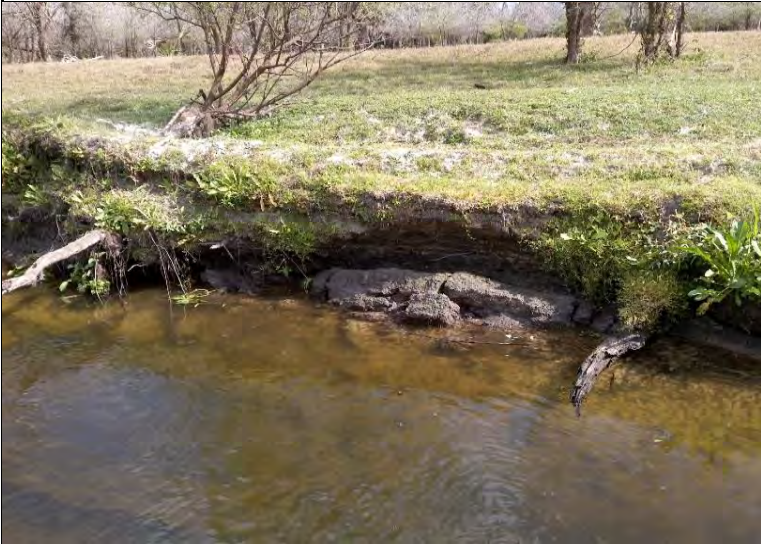
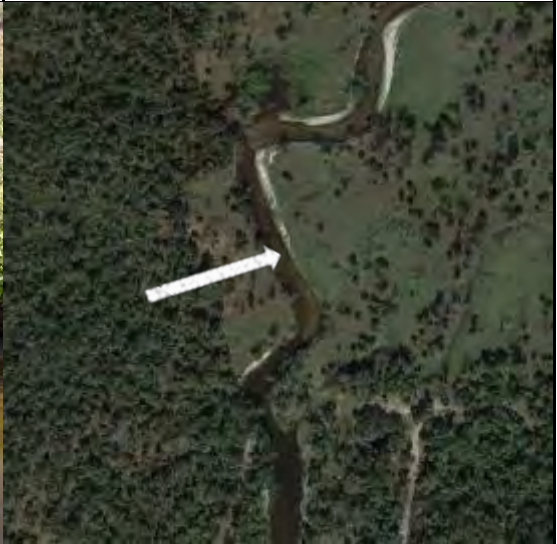
Peace River			Severity Scale: 5.75-Moderate
Watershed: Peace River Subwatershed: Peace River Branch Latitude: 27.42937 Longitude: -81.84982			County: Hardee Site Number: PI279 Reach Length: 325 ft. Landowner: Ben Hill Griffin Inc.

Risk Factor	Ranking	Score	
Pfankuch-Channel Stability:	Poor	1.5	
Channel Alteration:	None	0	
Bank Erosion:	Active	1	
BEHI:	Moderate (22.72)	0.5	
Local NPSP:	Obvious Sources	1.5	
Shoring Structures:	None	0	
Pipe Discharge:	None	0	
Water Odor:	Normal	0	
Fish Passage Barrier:	None	0	
RB: Riparian Buffer:	40 ft.	0.5	
LB: Riparian Buffer:	20 ft.	0.75	
RB: Floodplain Access:	Full	0	
LB: Floodplain Access:	Full	0	
<b>Severity Scale:</b>		<b>5.75</b>	
Notes: Impaired - Aquatic Life Harvesting (mercury in fish tissue)			
Restoration Option 1

Additional Site Features
Stream Channel Woody Material: Moderate
Impoundments: None
Substrate Composition: Medium Sand
Bank Material: Sand
Near Bank Stress: Moderate
RB Landuse: Pasture, Natural Forest
LB Landuse: Pasture, Natural Forest

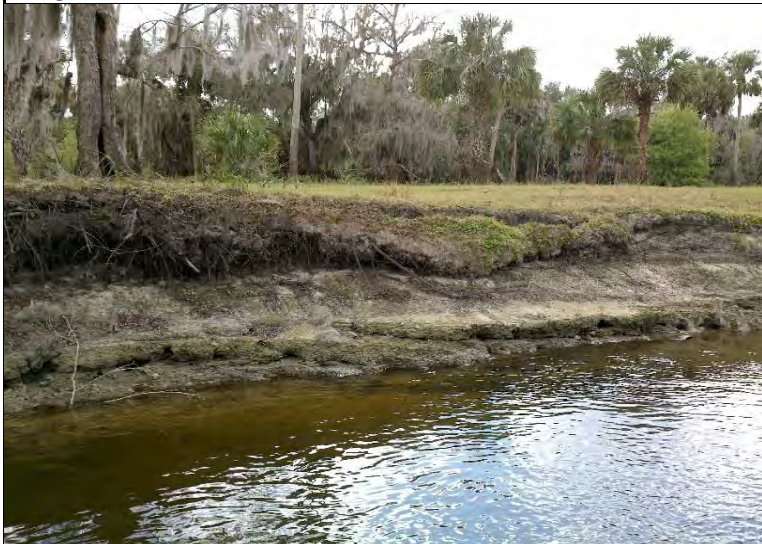
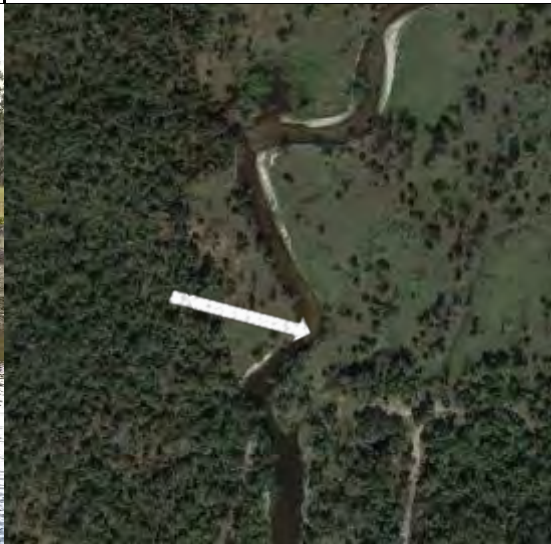
Peace River			Severity Scale: 5.0-Moderate
Watershed: Peace River Subwatershed: Peace River Branch Latitude: 27.42822 Longitude: -81.84991			County: Hardee Site Number: PI280 Reach Length: 165 ft. Landowner: Ben Hill Griffin Inc.

Pfankuch-Channel Stability:	Poor	1.5	
Channel Alteration:	None	0	
Bank Erosion:	Active	1	
BEHI:	Low (18.84)	0	
Local NPSP:	Obvious Sources	1.5	
Shoring Structures:	None	0	
Pipe Discharge:	None	0	
Water Odor:	Normal	0	
Fish Passage Barrier:	None	0	
RB: Riparian Buffer:	40 ft.	0.5	<b>Additional Site Features</b>
LB: Riparian Buffer:	40 ft.	0.5	Stream Channel Woody Material: Moderate
RB: Floodplain Access:	Full	0	Impoundments: None
LB: Floodplain Access:	Full	0	Substrate Composition: Medium Sand
<b>Severity Scale:</b>			Bank Material: Sand / Clay
<b>5.0</b>			Near Bank Stress: Moderate
			RB Landuse: Pasture, Natural Forest
			LB Landuse: Pasture, Natural Forest

Notes: Impaired - Aquatic Life Harvesting (mercury in fish tissue)			
Restoration Option 1

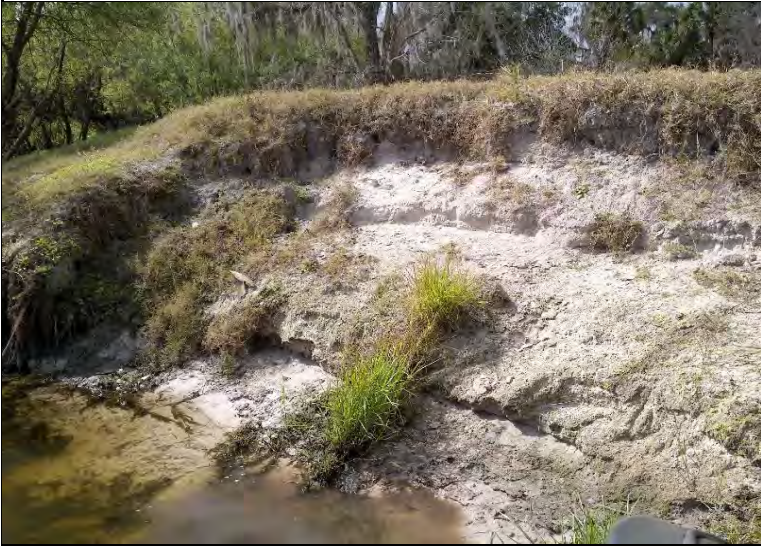
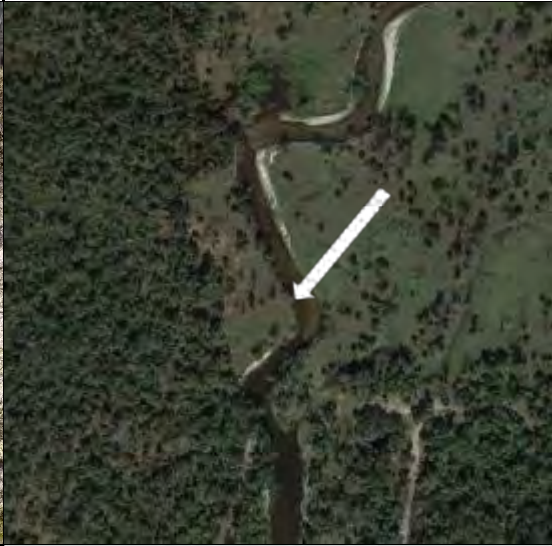
Peace River			Severity Scale: 6.25-Moderate
Watershed: Peace River Subwatershed: Peace River Branch Latitude: 27.42861 Longitude: -81.84974			County: Hardee Site Number: PI281 Reach Length: 16 ft. Landowner: Ben Hill Griffin Inc.

Risk Factor	Ranking	Score	
Pfankuch-Channel Stability:	Poor	1.5	
Channel Alteration:	None	0	
Bank Erosion:	Active	1	
BEHI:	High (37.76)	1	
Local NPSP:	Obvious Sources	1.5	
Shoring Structures:	None	0	
Pipe Discharge:	None	0	
Water Odor:	Normal	0	
Fish Passage Barrier:	None	0	
RB: Riparian Buffer:	0 ft.	0.75	
LB: Riparian Buffer:	40 ft.	0.5	
RB: Floodplain Access:	Full	0	
LB: Floodplain Access:	Full	0	
<b>Severity Scale:</b>		<b>6.25</b>	
Notes: Impaired - Aquatic Life Harvesting (mercury in fish tissue)			
Restoration Option 2 or 3

Additional Site Features	
Stream Channel Woody Material:	Moderate
Impoundments:	None
Substrate Composition:	Medium Sand
Bank Material:	Sand
Near Bank Stress:	Low
RB Landuse:	Pasture, Natural Forest
LB Landuse:	Pasture, Natural Forest

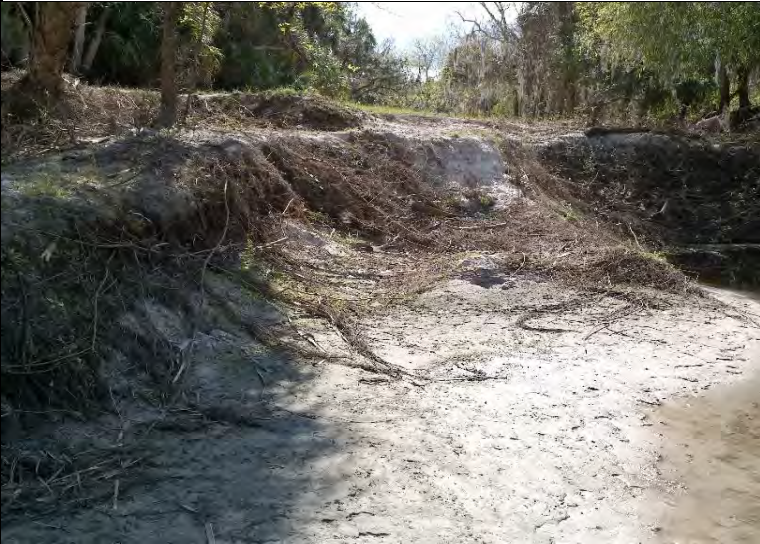
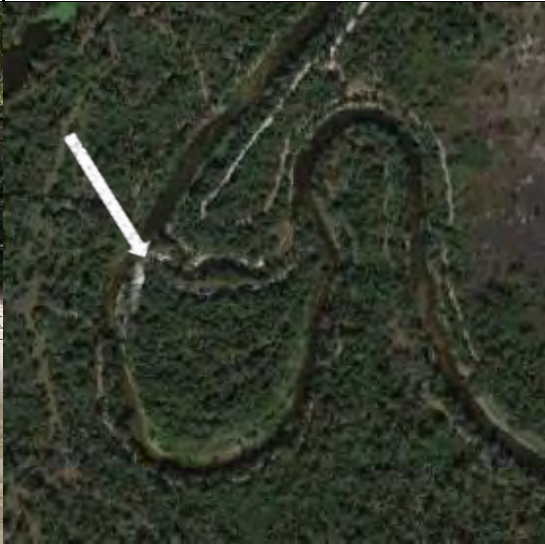
Peace River			Severity Scale: 3.5-Low
Watershed: Peace River Subwatershed: Peace River Branch Latitude: 27.42174 Longitude: -81.85343			County: Hardee Site Number: PI282 Reach Length: 85 ft. Landowner: Ben Hill Griffin Inc.

Risk Factor	Ranking	Score	
Pfankuch-Channel Stability:	Good	0	
Channel Alteration:	None	0	
Bank Erosion:	Active	1	
BEHI:	Moderate (26.30)	0.5	
Local NPSP:	Obvious Sources	1.5	
Shoring Structures:	None	0	
Pipe Discharge:	None	0	
Water Odor:	Normal	0	
Fish Passage Barrier:	None	0	
RB: Riparian Buffer:	100 ft.	0	
LB: Riparian Buffer:	40 ft.	0.5	
RB: Floodplain Access:	Full	0	
LB: Floodplain Access:	Full	0	
<b>Severity Scale:</b>		<b>3.5</b>	
Notes: Impaired - Aquatic Life Harvesting (mercury in fish tissue)			
Restoration Option 1, restoration should be done in conjunction with sites PI087, PI283-288

Additional Site Features	
Stream Channel Woody Material:	Infrequent
Impoundments:	None
Substrate Composition:	Medium Sand
Bank Material:	Sand
Near Bank Stress:	Low
RB Landuse:	Natural Forest
LB Landuse:	Pasture, Natural Forest

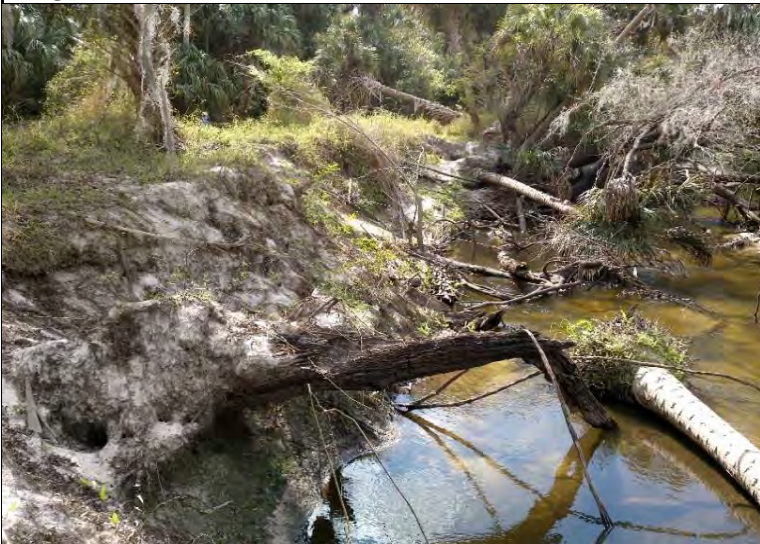
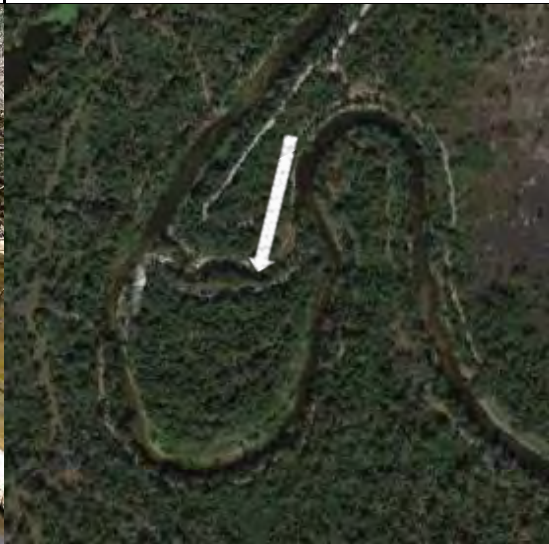
Peace River			Severity Scale: 3.5-Low	
Watershed: Peace River Subwatershed: Peace River Branch Latitude: 27.42171 Longitude: -81.85235			County: Hardee Site Number: PI284 Reach Length: 450 ft. Landowner: Ben Hill Griffin Inc.

Pfankuch-Channel Stability:	Good	0		
Channel Alteration:	None	0		
Bank Erosion:	Active	1		
BEHI:	Moderate (29.60)	0.5		
Local NPSP:	Obvious Sources	1.5		
Shoring Structures:	None	0		
Pipe Discharge:	None	0		
Water Odor:	Normal	0		
Fish Passage Barrier:	None	0		
RB: Riparian Buffer:	60 ft.	0.25		
LB: Riparian Buffer:	60 ft.	0.25		
RB: Floodplain Access:	Full	0		
LB: Floodplain Access:	Full	0		
Severity Scale:		3.5		
Notes: Impaired - Aquatic Life Harvesting (mercury in fish tissue)			Additional Site Features	
Restoration Option 1, restoration should be done in conjunction with sites PI087, PI282-288			Stream Channel Woody Material: Dominating

Impoundments: None	
			Substrate Composition: Medium Sand	
			Bank Material: Sand	
			Near Bank Stress: High	
			RB Landuse: Natural Forest, Pasture	
			LB Landuse: Natural Forest, Pasture

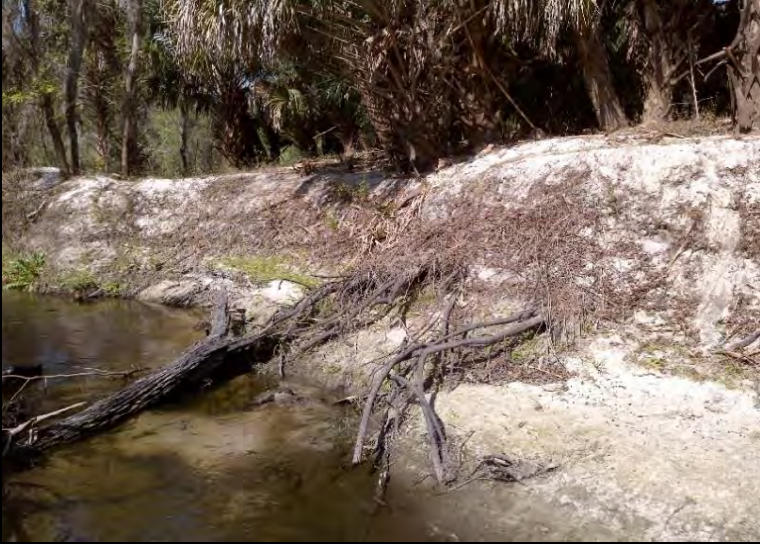
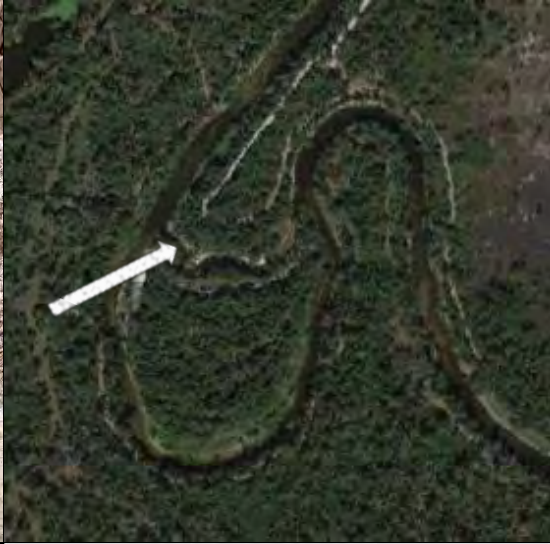
Peace River			Severity Scale: 3.0-Low
Watershed: Peace River Subwatershed: Peace River Branch Latitude: 27.42206 Longitude: -81.85304			County: Hardee Site Number: PI285 Reach Length: 120 ft. Landowner: Ben Hill Griffin Inc.

Pfankuch-Channel Stability:	Good	0	
Channel Alteration:	None	0	
Bank Erosion:	Active	1	
BEHI:	Moderate (22.53)	0.5	
Local NPSP:	Obvious Sources	1.5	
Shoring Structures:	None	0	
Pipe Discharge:	None	0	
Water Odor:	Normal	0	
Fish Passage Barrier:	None	0	
RB: Riparian Buffer:	100 ft.	0	
LB: Riparian Buffer:	100 ft.	0	
RB: Floodplain Access:	Full	0	
LB: Floodplain Access:	Full	0	
<b>Severity Scale:</b>		<b>3.0</b>	<b>Additional Site Features</b>
			Stream Channel Woody Material: Dominating
			Impoundments: None
			Substrate Composition: Medium Sand
			Bank Material: Sand
			Near Bank Stress: Low
			RB Landuse: Pasture, Natural Forest
			LB Landuse: Natural Forest, Pasture

Notes: Impaired - Aquatic Life Harvesting (mercury in fish tissue)			
Restoration Option 1, restoration should be done in conjunction with sites PI087, PI282-288

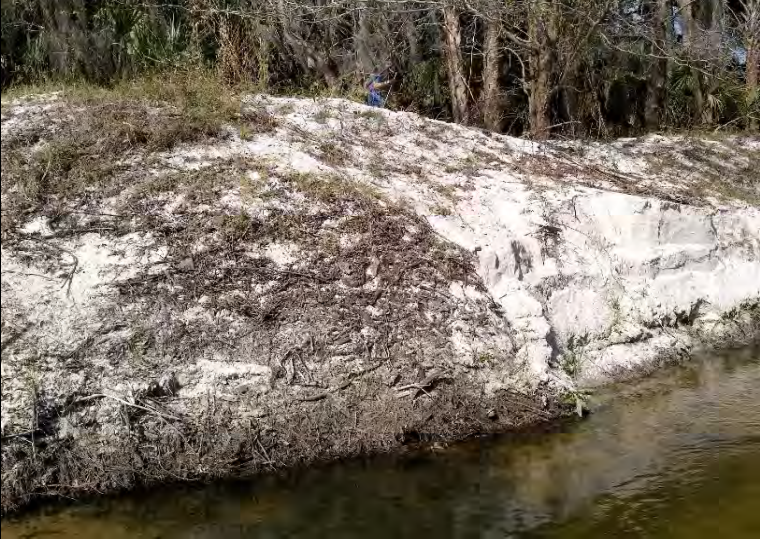
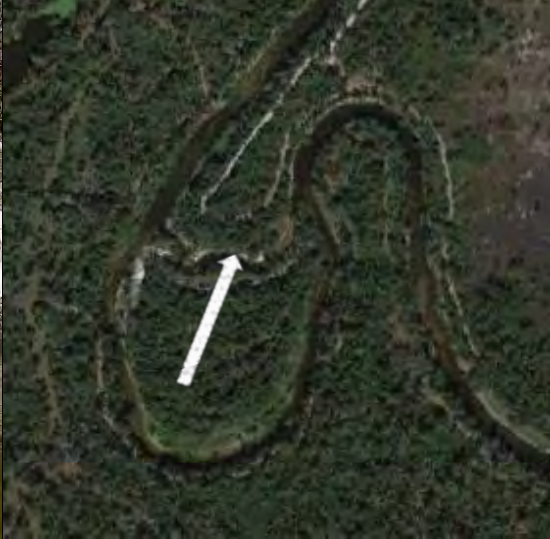
Peace River			Severity Scale: 4.25-Moderate
Watershed: Peace River Subwatershed: Peace River Branch Latitude: 27.42178 Longitude: -81.85225			County: Hardee Site Number: PI286 Reach Length: 170 ft. Landowner: Ben Hill Griffin Inc.

Risk Factor	Ranking	Score	
Pfankuch-Channel Stability:	Good	0	
Channel Alteration:	None	0	
Bank Erosion:	Active	1	
BEHI:	High (30.41)	1	
Local NPSP:	Obvious Sources	1.5	
Shoring Structures:	None	0	
Pipe Discharge:	None	0	
Water Odor:	Normal	0	
Fish Passage Barrier:	None	0	
RB: Riparian Buffer:	60 ft.	0.25	
LB: Riparian Buffer:	80 ft.	0.25	
RB: Floodplain Access:	Full	0	
LB: Floodplain Access:	Partial	0.25	
<b>Severity Scale:</b>		<b>4.25</b>	
Notes: Impaired - Aquatic Life Harvesting (mercury in fish tissue)			
Restoration Option 1, restoration should be done in conjunction with sites PI087, PI282-288

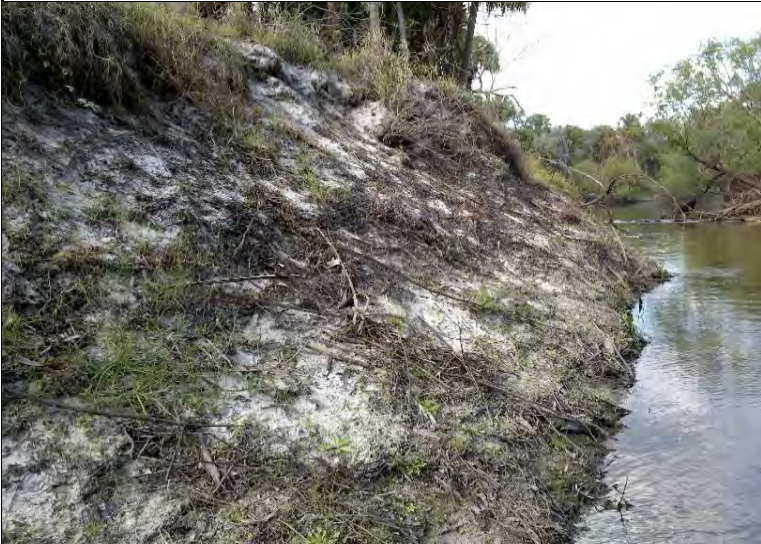
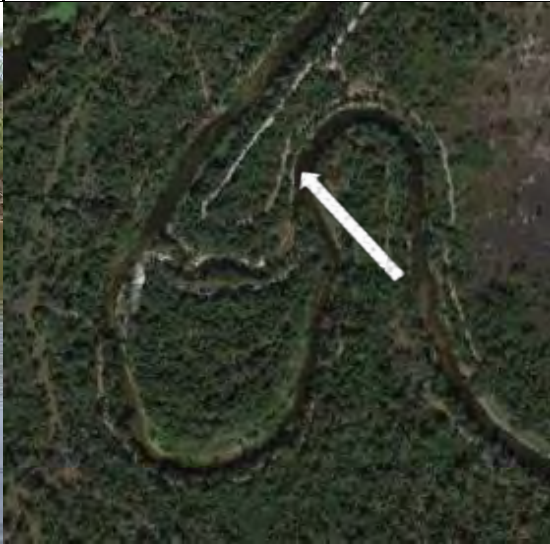
Peace River			Severity Scale: 4.5-Moderate
Watershed: Peace River Subwatershed: Peace River Branch Latitude: 27.42199 Longitude: -81.85188			County: Hardee Site Number: PI287 Reach Length: 335 ft. Landowner: Ben Hill Griffin Inc.

Risk Factor	Ranking	Score	
Pfankuch-Channel Stability:	Good	0	
Channel Alteration:	None	0	
Bank Erosion:	Active	1	
BEHI:	High (33.76)	1	
Local NPSP:	Obvious Sources	1.5	
Shoring Structures:	None	0	
Pipe Discharge:	None	0	
Water Odor:	Normal	0	
Fish Passage Barrier:	None	0	
RB: Riparian Buffer:	40 ft.	0.5	
LB: Riparian Buffer:	40 ft.	0.5	
RB: Floodplain Access:	Full	0	
LB: Floodplain Access:	Full	0	
<b>Severity Scale:</b>		<b>4.5</b>	
Notes: Impaired - Aquatic Life Harvesting (mercury in fish tissue)			
Restoration Option 1, restoration should be done in conjunction with sites PI087, PI282-288

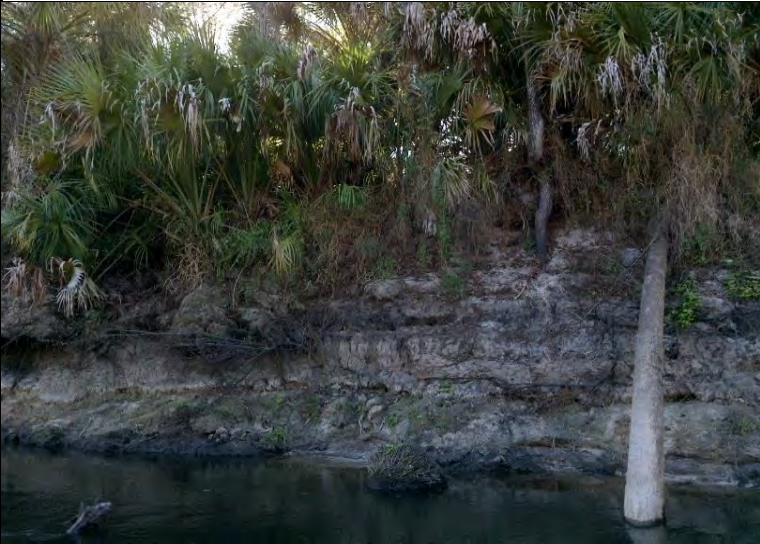
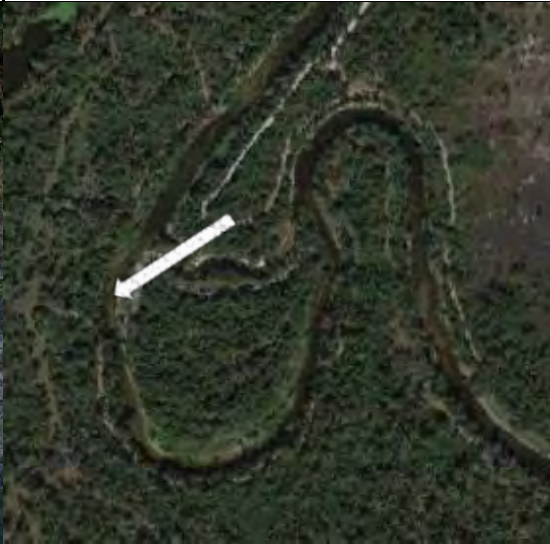
Peace River			Severity Scale: 4.5-Moderate
Watershed: Peace River Subwatershed: Peace River Branch Latitude: 27.42139 Longitude: -81.85374			County: Hardee Site Number: PI288 Reach Length: 160 ft. Landowner: Ben Hill Griffin Inc.

Pfankuch-Channel Stability:	Good	0	
Channel Alteration:	None	0	
Bank Erosion:	Mass-wasting	1.5	
BEHI:	Moderate (24.99)	0.5	
Local NPSP:	Obvious Sources	1.5	
Shoring Structures:	None	0	
Pipe Discharge:	None	0	
Water Odor:	Normal	0	
Fish Passage Barrier:	None	0	
RB: Riparian Buffer:	40 ft.	0.5	
LB: Riparian Buffer:	80 ft.	0.25	
RB: Floodplain Access:	Partial	0.25	
LB: Floodplain Access:	Full	0	
<b>Severity Scale:</b>		<b>4.5</b>	
Notes: Impaired - Aquatic Life Harvesting (mercury in fish tissue)			<b>Additional Site Features</b>
			Stream Channel Woody Material: Numerous
			Impoundments: None
			Substrate Composition: Medium Sand
			Bank Material: Sandy Clay

Near Bank Stress: Moderate
			RB Landuse: Natural Forest, Pasture
			LB Landuse: Natural Forest, Pasture
Restoration Option 1, restoration should be done in conjunction with sites PI087, PI282-288

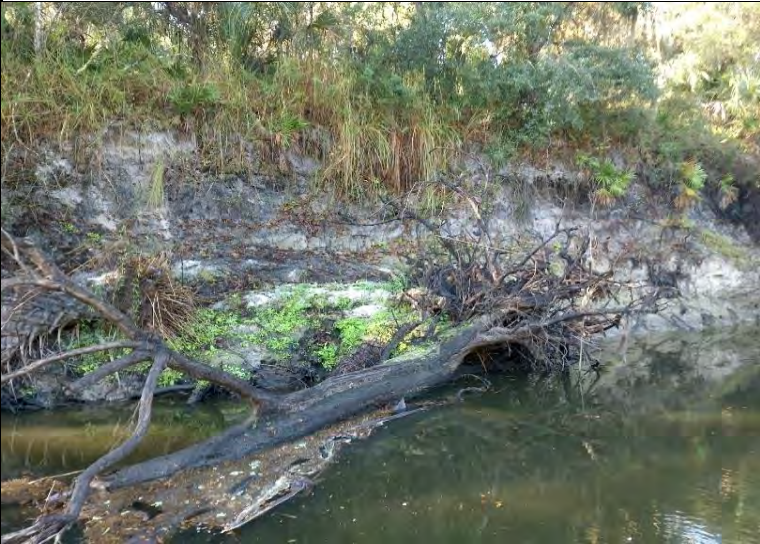
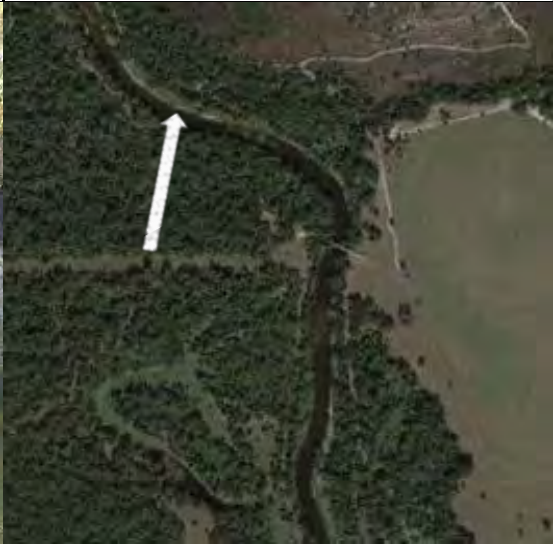
Peace River			Severity Scale: 4.5-Moderate
Watershed: Peace River Subwatershed: Peace River Branch Latitude: 27.41963 Longitude: -81.84834			County: Hardee Site Number: PI289 Reach Length: 250 ft. Landowner: Ben Hill Griffin Inc.

Risk Factor	Ranking	Score	
Pfankuch-Channel Stability:	Good	0	
Channel Alteration:	None	0	
Bank Erosion:	Active	1	
BEHI:	High (35.64)	1	
Local NPSP:	Obvious Sources	1.5	
Shoring Structures:	None	0	
Pipe Discharge:	None	0	
Water Odor:	Normal	0	
Fish Passage Barrier:	None	0	
RB: Riparian Buffer:	60 ft.	0.25	
LB: Riparian Buffer:	40 ft.	0.5	
RB: Floodplain Access:	Partial	0.25	
LB: Floodplain Access:	Full	0	
<b>Severity Scale:</b>		<b>4.5</b>	
Notes: Impaired - Aquatic Life Harvesting (mercury in fish tissue)			
Restoration Option 2

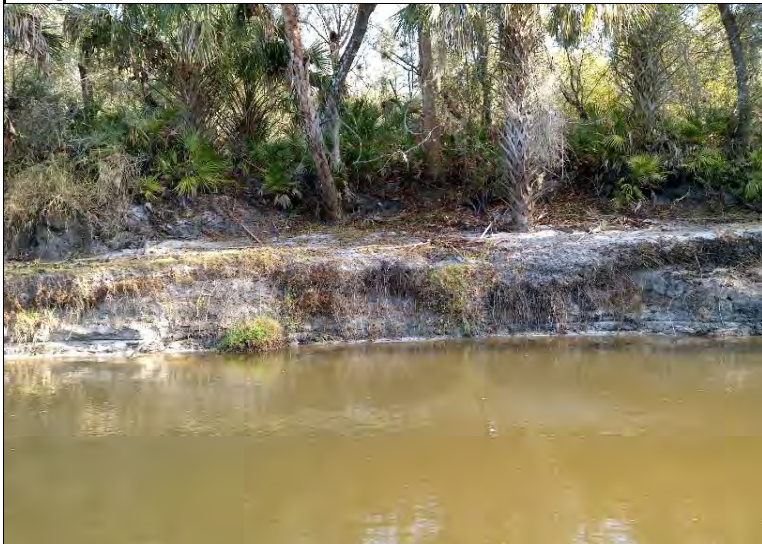
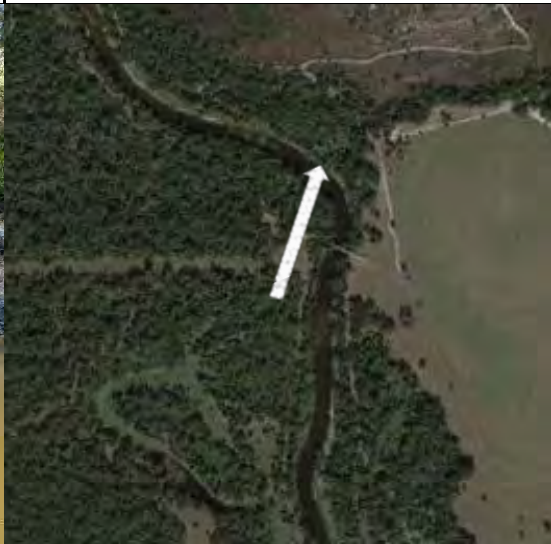
Peace River			Severity Scale: 4.0-Low	
Watershed: Peace River Subwatershed: Peace River Branch Latitude: 27.41915 Longitude: -81.84752			County: Hardee Site Number: PI290 Reach Length: 165 ft. Landowner: Ben Hill Griffin Inc.

Pfankuch-Channel Stability:	Good	0		
Channel Alteration:	None	0		
Bank Erosion:	Active	1		
BEHI:	High (31.66)	1		
Local NPSP:	Obvious Sources	1.5		
Shoring Structures:	None	0		
Pipe Discharge:	None	0		
Water Odor:	Normal	0		
Fish Passage Barrier:	None	0		
RB: Riparian Buffer:	60 ft.	0.25		
LB: Riparian Buffer:	60 ft.	0.25		
RB: Floodplain Access:	Full	0		
LB: Floodplain Access:	Full	0		
Severity Scale:		4.0	Additional Site Features	
			Stream Channel Woody Material: Infrequent	
			Impoundments: None	
			Substrate Composition: Medium Sand	
			Bank Material: Sand	
			Near Bank Stress: Very High	
			RB Landuse: Natural Forest, Pasture	
			LB Landuse: Pasture, Natural Forest

Notes: Impaired - Aquatic Life Harvesting (mercury in fish tissue)				
Restoration Option 1

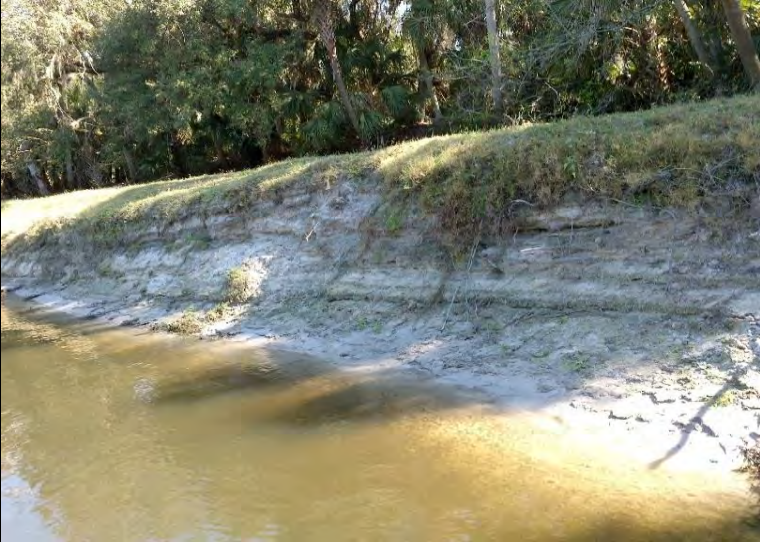
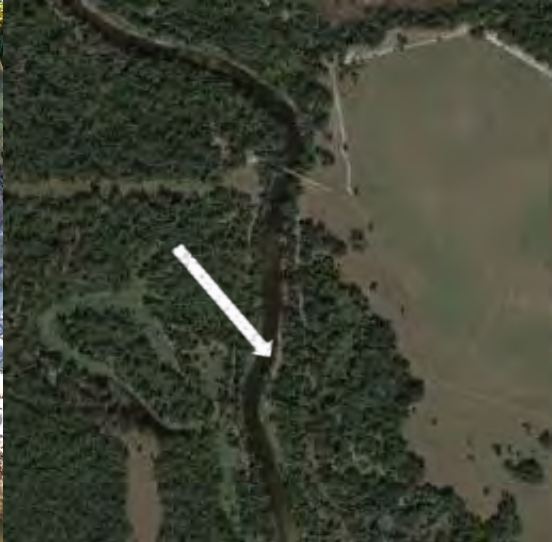
Peace River			Severity Scale: 4.25-Moderate
Watershed: Peace River Subwatershed: Peace River Branch Latitude: 27.41553 Longitude: -81.84734			County: Hardee Site Number: PI291 Reach Length: 95 ft. Landowner: Ben Hill Griffin Inc.

Pfankuch-Channel Stability:	Good	0	
Channel Alteration:	None	0	
Bank Erosion:	Active	1	
BEHI:	High (33.70)	1	
Local NPSP:	Obvious Sources	1.5	
Shoring Structures:	None	0	
Pipe Discharge:	None	0	
Water Odor:	Normal	0	
Fish Passage Barrier:	None	0	
RB: Riparian Buffer:	40 ft.	0.5	Additional Site Features
LB: Riparian Buffer:	60 ft.	0.25	
RB: Floodplain Access:	Full	0	
LB: Floodplain Access:	Full	0	
Severity Scale:		4.25	
Notes: Impaired - Aquatic Life Harvesting (mercury in fish tissue)			
Restoration Option 1

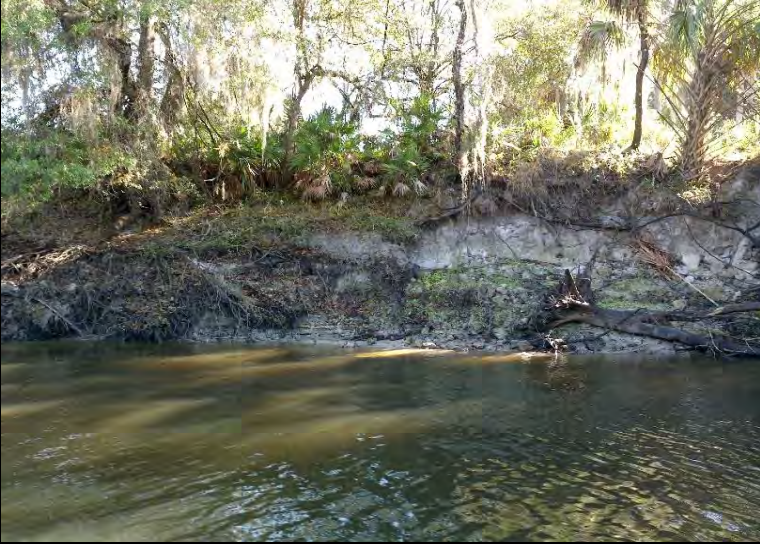
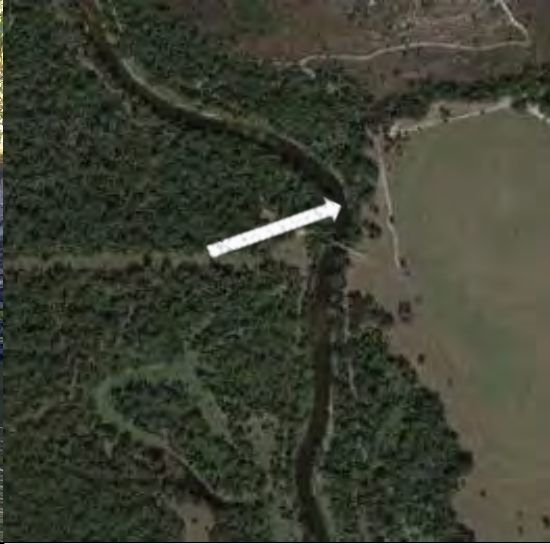
Peace River			Severity Scale: 4.75-Moderate
Watershed: Peace River Subwatershed: Peace River Branch Latitude: 27.41813 Longitude: -81.84702			County: Hardee Site Number: PI292 Reach Length: 170 ft. Landowner: Ben Hill Griffin Inc.

Risk Factor	Ranking	Score	
Pfankuch-Channel Stability:	Good	0	
Channel Alteration:	None	0	
Bank Erosion:	Mass-wasting	1.5	
BEHI:	High (34.02)	1	
Local NPSP:	Obvious Sources	1.5	
Shoring Structures:	None	0	
Pipe Discharge:	Not Present	0	
Water Odor:	Normal	0	
Fish Passage Barrier:	None	0	
RB: Riparian Buffer:	100 ft.	0	
LB: Riparian Buffer:	40 ft.	0.5	
RB: Floodplain Access:	Full	0	
LB: Floodplain Access:	Partial	0.25	
<b>Severity Scale:</b>		<b>4.75</b>	
Notes: Impaired - Aquatic Life Harvesting (mercury in fish tissue), private unpaved road crossing downstream of site, some woody debris build up on bridge pilings, no major issues with structure			
Restoration Option 1

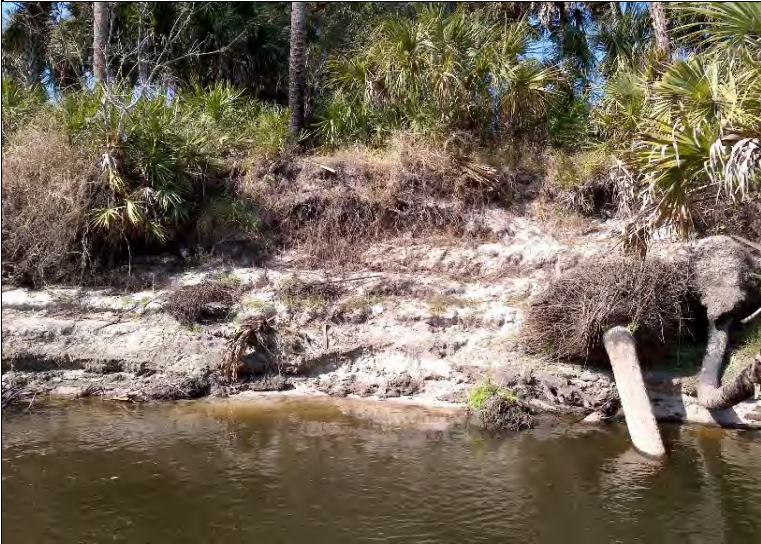
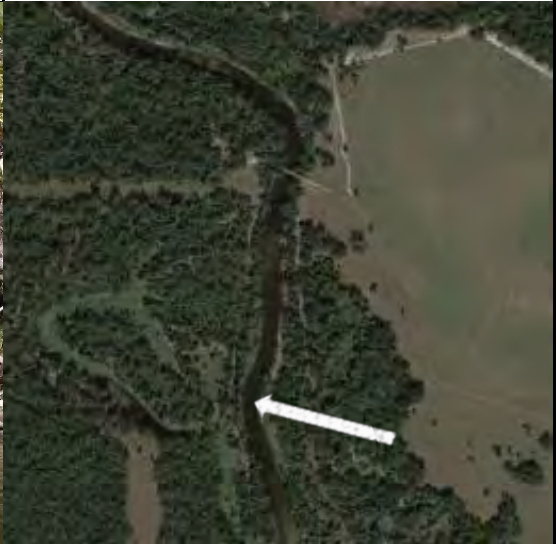
Peace River			Severity Scale: 4.0-Low
Watershed: Peace River Subwatershed: Peace River Branch Latitude: 27.41535 Longitude: -81.8476			County: Hardee Site Number: PI293 Reach Length: 125 ft. Landowner: Ben Hill Griffin Inc.

Risk Factor	Ranking	Score	
Pfankuch-Channel Stability:	Good	0	
Channel Alteration:	None	0	
Bank Erosion:	Active	1	
BEHI:	Moderate (29.98)	0.5	
Local NPSP:	Obvious Sources	1.5	
Shoring Structures:	None	0	
Pipe Discharge:	None	0	
Water Odor:	Normal	0	
Fish Passage Barrier:	None	0	
RB: Riparian Buffer:	40 ft.	0.5	
LB: Riparian Buffer:	60 ft.	0.25	
RB: Floodplain Access:	Partial	0.25	
LB: Floodplain Access:	Full	0	
<b>Severity Scale:</b>		<b>4.0</b>	
Notes: Impaired - Aquatic Life Harvesting (mercury in fish tissue)			
Restoration Option 1

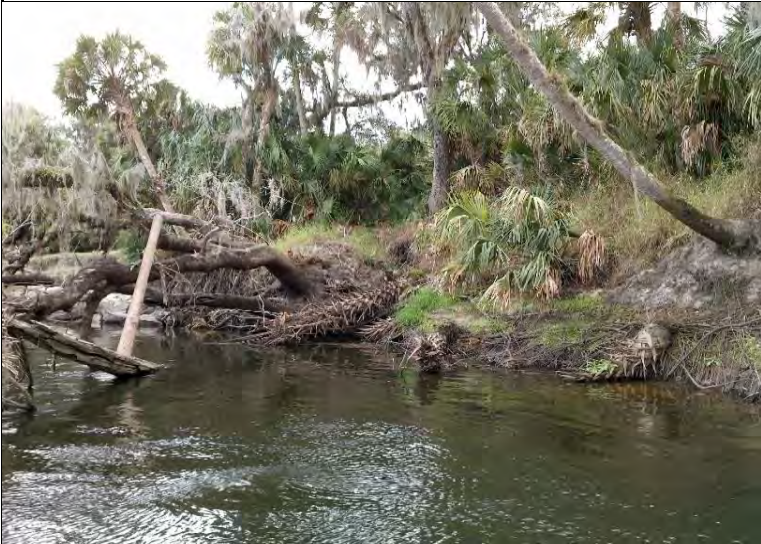
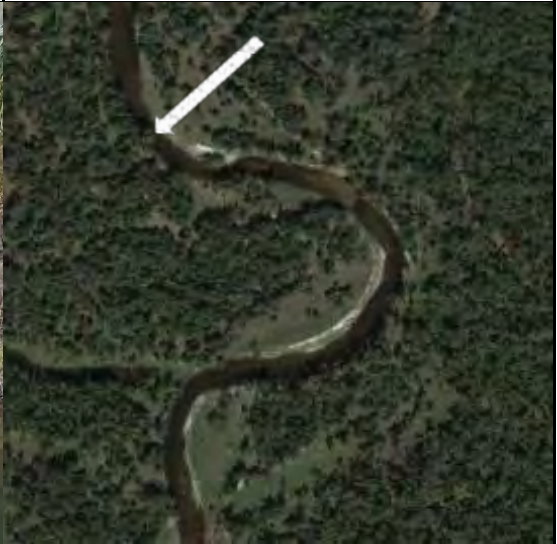
Peace River			Severity Scale: 6.25-Moderate
Watershed: Peace River Subwatershed: Peace River Branch Latitude: 27.4119 Longitude: -81.84659			County: Hardee Site Number: PI294 Reach Length: 240 ft. Landowner: Ben Hill Griffin Inc.

Pfankuch-Channel Stability:	Poor	1.5	
Channel Alteration:	None	0	
Bank Erosion:	Active	1	
BEHI:	High (30.35)	1	
Local NPSP:	Obvious Sources	1.5	
Shoring Structures:	None	0	
Pipe Discharge:	None	0	
Water Odor:	Normal	0	
Fish Passage Barrier:	None	0	
RB: Riparian Buffer:	40 ft.	0.5	Additional Site Features
LB: Riparian Buffer:	40 ft.	0.5	
RB: Floodplain Access:	Partial	0.25	
LB: Floodplain Access:	Full	0	
Severity Scale:		6.25	
Notes: Impaired - Aquatic Life Harvesting (mercury in fish tissue)			Stream Channel Woody Material: Numerous
Restoration Option 1, restoration should be done in conjunction with site PI296			Impoundments: None
			Substrate Composition: Medium Sand

Bank Material: Sand
			Near Bank Stress: High
			RB Landuse: Natural Forest, Pasture
			LB Landuse: Pasture, Natural Forest
