# **Peace River and Withlacoochee River Threats Assessments and Fish Assemblage Monitoring**

**Final Report July 1, 2015 – June 30, 2019**

Submitted to Florida State Wildlife Grants Program  
August 1, 2019  
PID: 98462501284

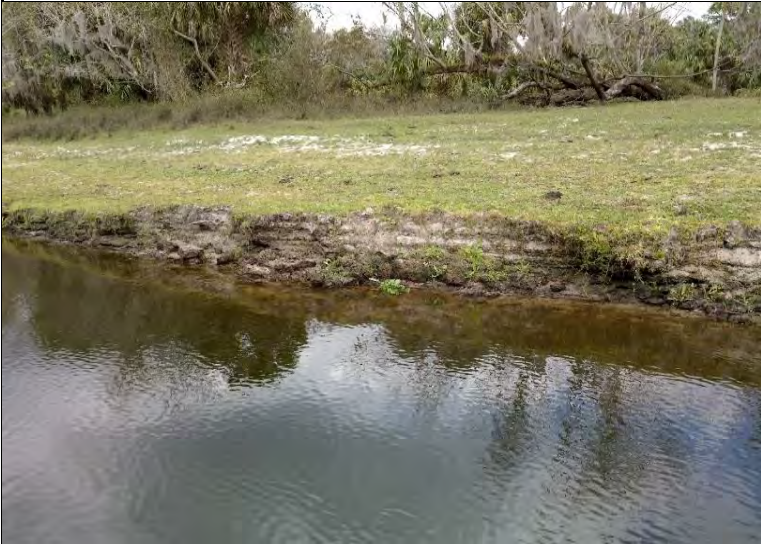
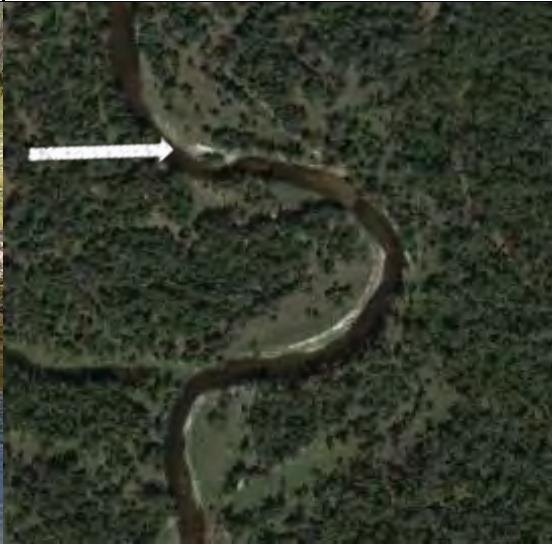
Peace River			Severity Scale: 5.75-Moderate
Watershed: Peace River Subwatershed: Peace River Branch Latitude: 27.41229 Longitude: -81.84668			County: Hardee Site Number: PI295 Reach Length: 105 ft. Landowner: Ben Hill Griffin Inc.

Pfankuch-Channel Stability:	Poor	1.5	
Channel Alteration:	None	0	
Bank Erosion:	Active	1	
BEHI:	Moderate (28.55)	0.5	
Local NPSP:	Obvious Sources	1.5	
Shoring Structures:	None	0	
Pipe Discharge:	None	0	
Water Odor:	Normal	0	
Fish Passage Barrier:	None	0	
RB: Riparian Buffer:	40 ft.	0.5	
LB: Riparian Buffer:	40 ft.	0.5	
RB: Floodplain Access:	Partial	0.25	
LB: Floodplain Access:	Full	0	
<b>Severity Scale:</b>		<b>5.75</b>	
Notes: Impaired - Aquatic Life Harvesting (mercury in fish tissue)			<b>Additional Site Features</b>
			Stream Channel Woody Material: Numerous
			Impoundments: None
			Substrate Composition: Medium Sand
			Bank Material: Sand

Near Bank Stress: Low
			RB Landuse: Natural Forest, Pasture
			LB Landuse: Pasture, Natural Forest
Restoration Option 2 or 3

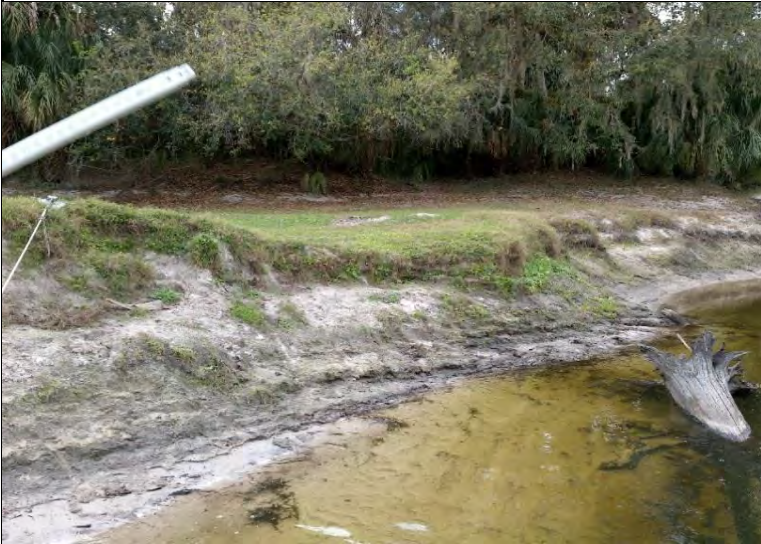
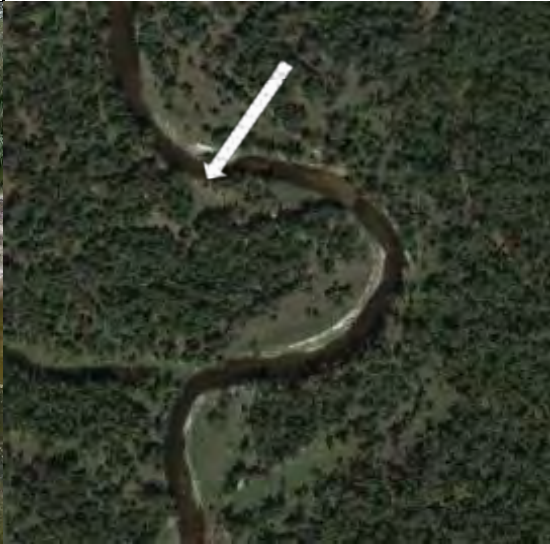
Peace River			Severity Scale: 5.75-Moderate
Watershed: Peace River Subwatershed: Peace River Branch Latitude: 27.41189 Longitude: -81.84596			County: Hardee Site Number: PI296 Reach Length: 220 ft. Landowner: Ben Hill Griffin Inc.

Risk Factor	Ranking	Score	
Pfankuch-Channel Stability:	Poor	1.5	
Channel Alteration:	None	0	
Bank Erosion:	Active	1	
BEHI:	Moderate (24.09)	0.5	
Local NPSP:	Obvious Sources	1.5	
Shoring Structures:	None	0	
Pipe Discharge:	None	0	
Water Odor:	Normal	0	
Fish Passage Barrier:	None	0	
RB: Riparian Buffer:	20 ft.	0.75	
LB: Riparian Buffer:	40 ft.	0.5	
RB: Floodplain Access:	Full	0	
LB: Floodplain Access:	Full	0	
<b>Severity Scale:</b>		<b>5.75</b>	
Notes: Impaired - Aquatic Life Harvesting (mercury in fish tissue)			
Restoration Option 1, restoration should be done in conjunction with site PI294

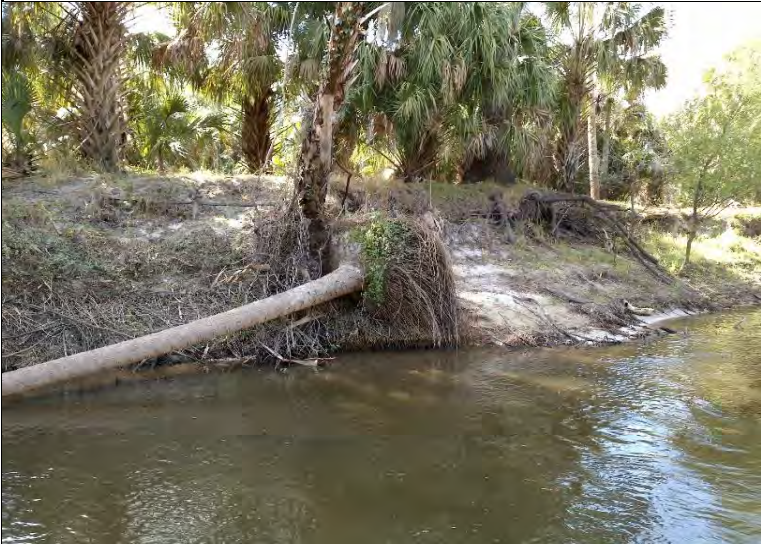
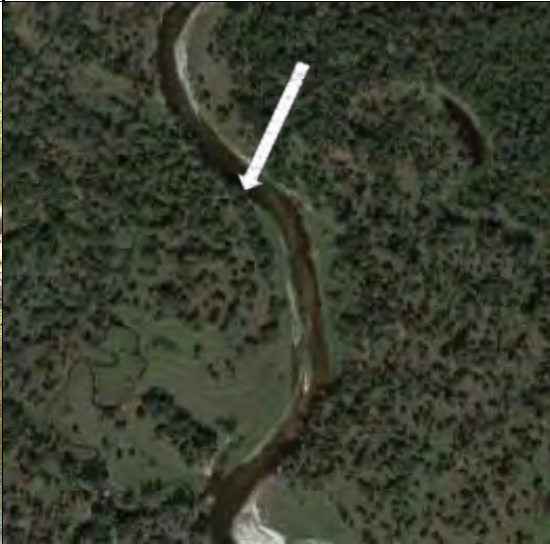
Peace River			Severity Scale: 5.75-Moderate
Watershed: Peace River Subwatershed: Peace River Branch Latitude: 27.40609 Longitude: -81.84827			County: Hardee Site Number: PI298 Reach Length: 100 ft. Landowner: Ben Hill Griffin Inc.

Risk Factor	Ranking	Score	
Pfankuch-Channel Stability:	Poor	1.5	
Channel Alteration:	None	0	
Bank Erosion:	Active	1	
BEHI:	Moderate (24.00)	0.5	
Local NPSP:	Obvious Sources	1.5	
Shoring Structures:	None	0	
Pipe Discharge:	None	0	
Water Odor:	Normal	0	
Fish Passage Barrier:	None	0	
RB: Riparian Buffer:	20 ft.	0.75	
LB: Riparian Buffer:	40 ft.	0.5	
RB: Floodplain Access:	Full	0	
LB: Floodplain Access:	Full	0	
<b>Severity Scale:</b>		<b>5.75</b>	
Notes: Impaired - Aquatic Life Harvesting (mercury in fish tissue)			
Restoration Option 2

Additional Site Features	
Stream Channel Woody Material:	Moderate
Impoundments:	None
Substrate Composition:	Medium Sand
Bank Material:	Sand
Near Bank Stress:	High
RB Landuse:	Pasture, Natural Forest
LB Landuse:	Pasture, Natural Forest

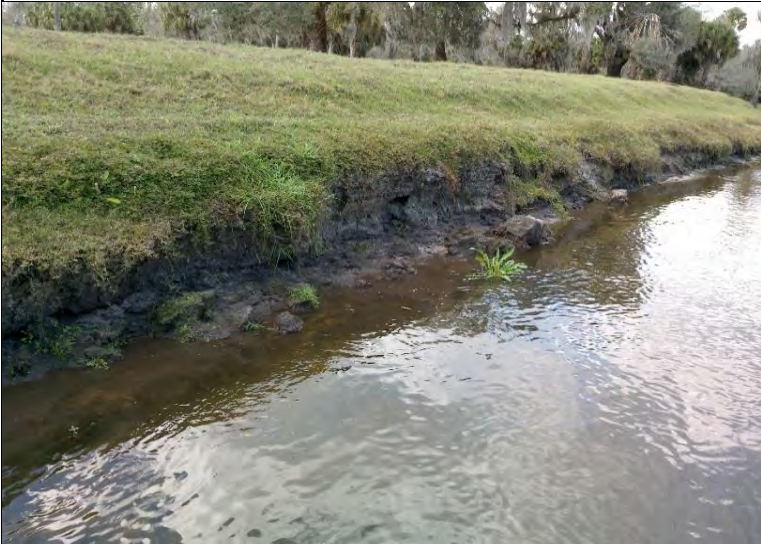
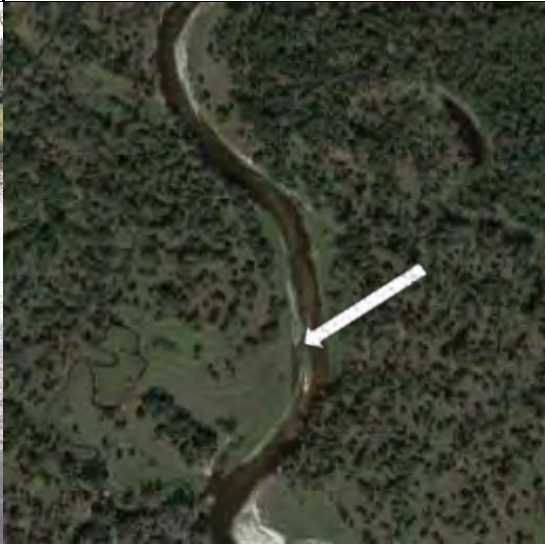
Peace River			Severity Scale: 6.0-Moderate
Watershed: Peace River Subwatershed: Peace River Branch Latitude: 27.40453 Longitude: -81.84779			County: Hardee Site Number: PI299 Reach Length: 205 ft. Landowner: Ben Hill Griffin Inc.

Risk Factor	Ranking	Score	
Pfankuch-Channel Stability:	Poor	1.5	
Channel Alteration:	None	0	
Bank Erosion:	Mass-wasting	1.5	
BEHI:	Low (19.41)	0	
Local NPSP:	Obvious Sources	1.5	
Shoring Structures:	None	0	
Pipe Discharge:	None	0	
Water Odor:	Normal	0	
Fish Passage Barrier:	None	0	
RB: Riparian Buffer:	0 ft.	0.75	
LB: Riparian Buffer:	40 ft.	0.5	
RB: Floodplain Access:	Full	0	
LB: Floodplain Access:	Partial	0.25	
<b>Severity Scale:</b>		<b>6.0</b>	
Notes: Impaired - Aquatic Life Harvesting (mercury in fish tissue)			
Restoration Option 2 or 3

Additional Site Features
Stream Channel Woody Material: Infrequent
Impoundments: None
Substrate Composition: Medium Sand
Bank Material: Sand / Clay
Near Bank Stress: High
RB Landuse: Pasture
LB Landuse: Pasture, Natural Forest

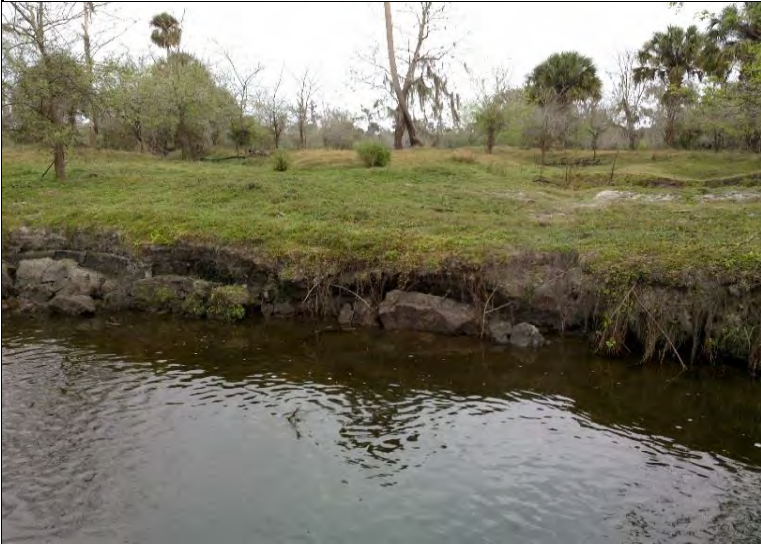
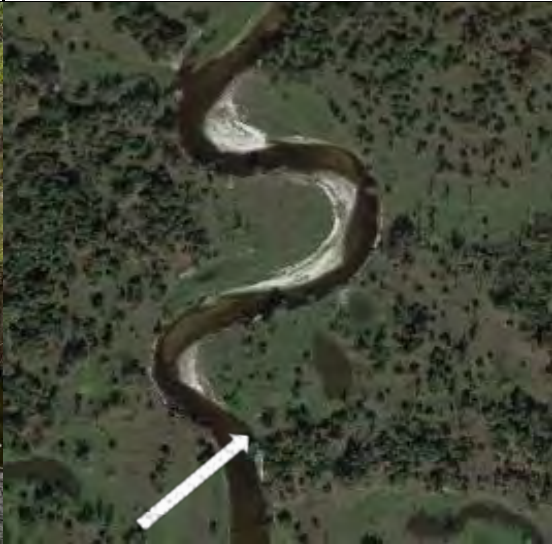
Peace River			Severity Scale: 6.5-Moderate
Watershed: Peace River Subwatershed: Peace River Branch Latitude: 27.40042 Longitude: -81.84801			County: Hardee Site Number: PI300 Reach Length: 235 ft. Landowner: Ben Hill Griffin Inc.

Risk Factor	Ranking	Score	
Pfankuch-Channel Stability:	Poor	1.5	
Channel Alteration:	None	0	
Bank Erosion:	Mass-wasting	1.5	
BEHI:	Moderate (19.72)	0.5	
Local NPSP:	Obvious Sources	1.5	
Shoring Structures:	None	0	
Pipe Discharge:	None	0	
Water Odor:	Normal	0	
Fish Passage Barrier:	None	0	
RB: Riparian Buffer:	0 ft.	0.75	
LB: Riparian Buffer:	20 ft.	0.75	
RB: Floodplain Access:	Full	0	
LB: Floodplain Access:	Full	0	
<b>Severity Scale:</b>		<b>6.5</b>

Additional Site Features
			Stream Channel Woody Material: Moderate
			Impoundments: None
			Substrate Composition: Medium Sand
			Bank Material: Sand / Clay
			Near Bank Stress: Low
			RB Landuse: Pasture, Natural Forest

LB Landuse: Pasture, Natural Forest
Notes: Impaired - Aquatic Life Harvesting (mercury in fish tissue)			
Restoration Option 1

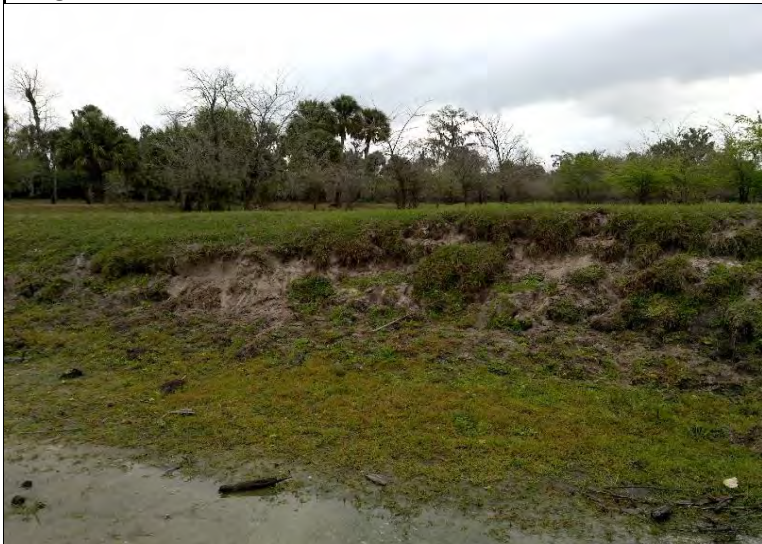
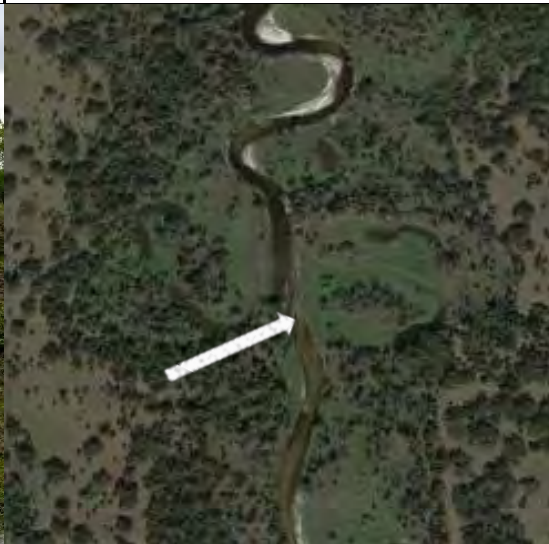
Peace River			Severity Scale: 6.0-Moderate			
Watershed: Peace River Subwatershed: Peace River Branch Latitude: 27.39897 Longitude: -81.8477			County: Hardee Site Number: PI301 Reach Length: 345 ft. Landowner: Ben Hill Griffin INC

<b>Additional Site Features</b> Stream Channel Woody Material: Infrequent Impoundments: None Substrate Composition: Medium Sand Bank Material: Medium Sand Near Bank Stress: Low RB Landuse: Pasture, Natural Forest LB Landuse: Pasture, Natural Forest			
Pfankuch-Channel Stability:	Poor	1.5				
Channel Alteration:	None	0				
Bank Erosion:	Active	1				
BEHI:	Moderate (24.93)	0.5				
Local NPSP:	Obvious Sources	1.5				
Shoring Structures:	None	0				
Pipe Discharge:	None	0				
Water Odor:	Normal	0				
Fish Passage Barrier:	None	0				
RB: Riparian Buffer:	0 ft.	0.75				
LB: Riparian Buffer:	0 ft.	0.75				
RB: Floodplain Access:	Full	0

LB: Floodplain Access:	Full	0				
Severity Scale:		6.0				
Notes: Impaired - Aquatic Life Harvesting (mercury in fish tissue)						
Restoration Option 2 or 3

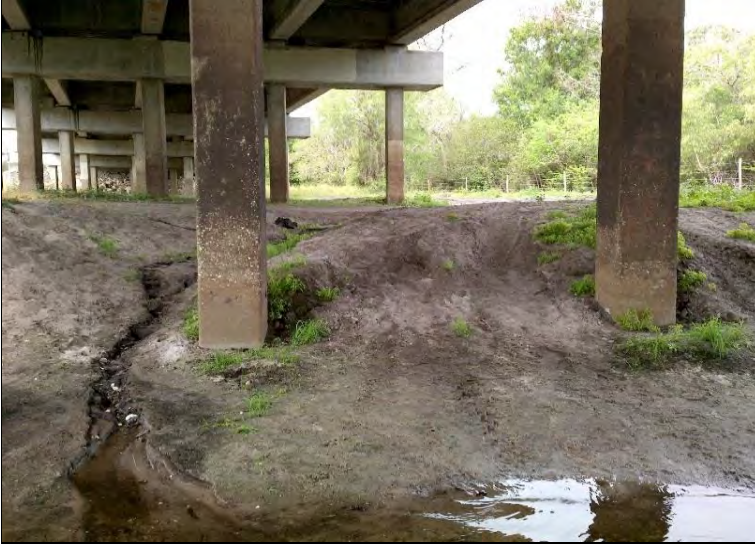
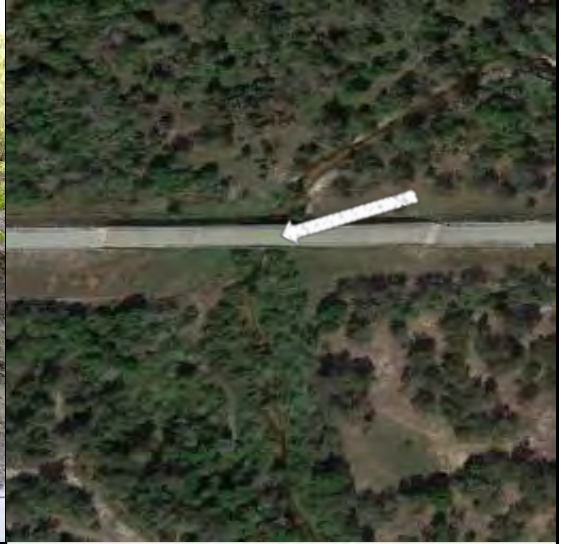
Landowner: CWP Properties LLC

Risk Factor	Ranking	Score
Pfankuch-Channel Stability:	Fair	1
Channel Alteration:	None	0
Bank Erosion:	Active	1
BEHI:	High (36.94)	1
Local NPSP:	Slight Potential	0.5
Shoring Structures:	None	0
Pipe Discharge:	None	0
Water Odor:	Normal	0
Fish Passage Barrier:	None	0
RB: Riparian Buffer:	0 ft.	0.75
LB: Riparian Buffer:	0 ft.	0.75
RB: Floodplain Access:	Partial	0.25
LB: Floodplain Access:	Partial	0.25
<b>Severity Scale:</b>	<b>5.5</b>

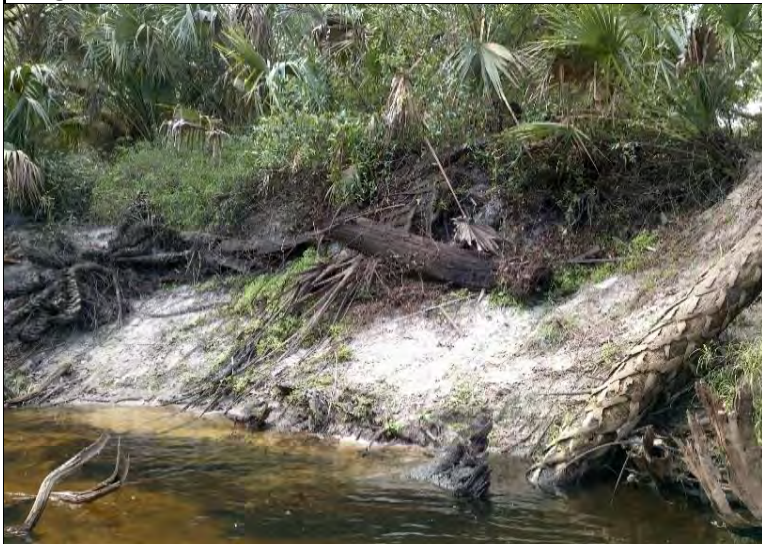
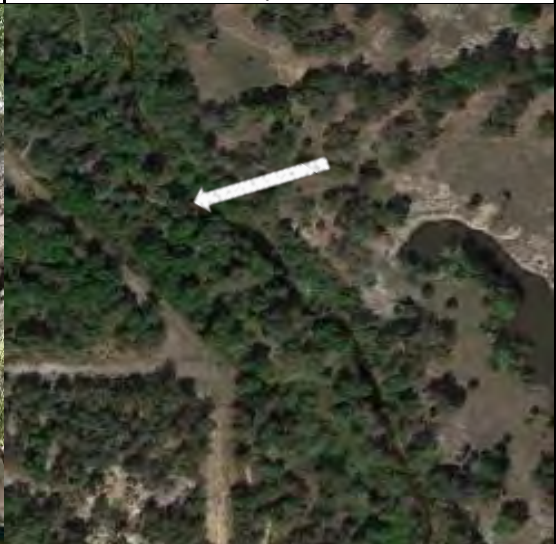
Horse Creek			Severity Scale: 4.0-Low	
Watershed: Peace River Subwatershed: Lower Horse Creek Latitude: 27.19765 Longitude: -81.98725			County: Desoto Site Number: PI303 Reach Length: 89 ft. Landowner: CWP Properties LLC

Pfankuch-Channel Stability:	Fair	1		
Channel Alteration:	None	0		
Bank Erosion:	Active	1		
BEHI:	High (31.12)	1		
Local NPSP:	No Evidence	0		
Shoring Structures:	None	0		
Pipe Discharge:	None	0		
Water Odor:	Normal	0		
Fish Passage Barrier:	None	0		
RB: Riparian Buffer:	10 ft.	0.75		
LB: Riparian Buffer:	100 ft.	0		
RB: Floodplain Access:	Partial	0.25		
LB: Floodplain Access:	Full	0		
Severity Scale:		4.0		
			Additional Site Features	
			Stream Channel Woody Material: Moderate	
			Impoundments: None	
			Substrate Composition: Medium Sand	
			Bank Material: Medium Sand	
			Near Bank Stress: Low	
			RB Landuse: Natural Forest, Recreation	
			LB Landuse: Natural Forest

Notes: Trail at top of bank 10' wide - grass; 303d: Impaired - Public Water Supply (DO & BOD)				
Restoration Option 1

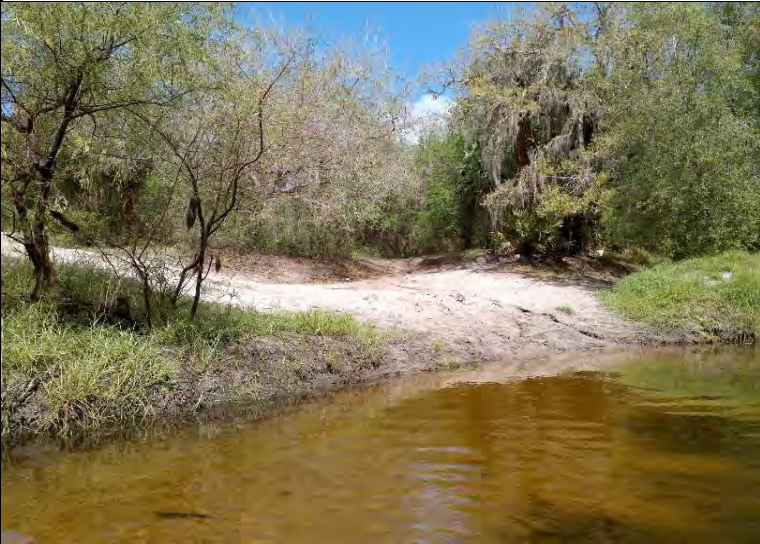
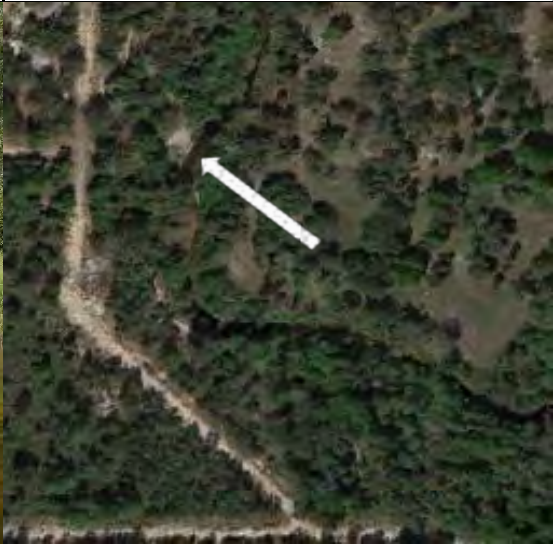
Horse Creek			Severity Scale: 3.5-Low
Watershed: Peace River Subwatershed: Lower Horse Creek Latitude: 27.1955 Longitude: -81.98689			County: Desoto Site Number: PI304 Reach Length: 50 ft. Landowner: CWP Properties LLC

Risk Factor	Ranking	Score	
Pfankuch-Channel Stability:	Fair	1	
Channel Alteration:	None	0	
Bank Erosion:	Active	1	
BEHI:	High (35.08)	1	
Local NPSP:	No Evidence	0	
Shoring Structures:	None	0	
Pipe Discharge:	None	0	
Water Odor:	Normal	0	
Fish Passage Barrier:	None	0	
RB: Riparian Buffer:	40 ft.	0.5	
LB: Riparian Buffer:	100 ft.	0	
RB: Floodplain Access:	Full	0	
LB: Floodplain Access:	Full	0	
<b>Severity Scale:</b>		<b>3.5</b>	
Notes: 4x4 trail next to top of bank; 303d: Impaired - Public Water Supply (DO & BOD)			
Restoration Option 2

Additional Site Features	
Stream Channel Woody Material:	Infrequent
Impoundments:	None
Substrate Composition:	Medium Sand
Bank Material:	Medium Sand
Near Bank Stress:	High
RB Landuse:	Recreational, Natural Forest
LB Landuse:	Natural Forest

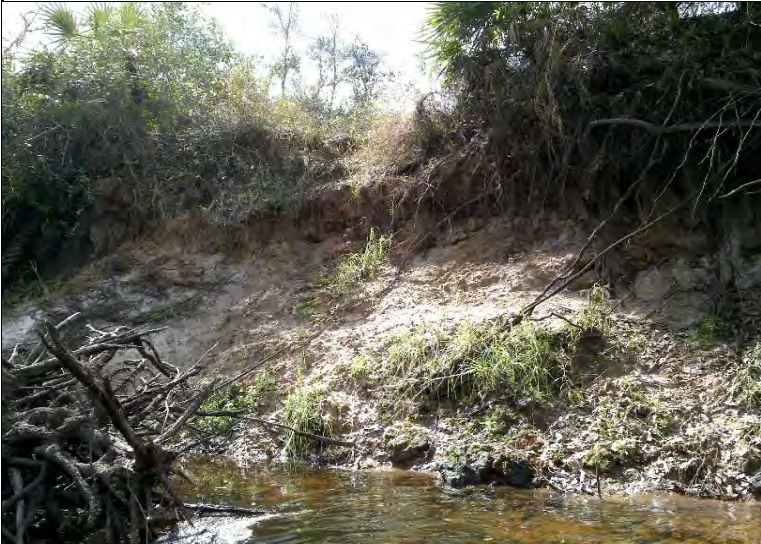
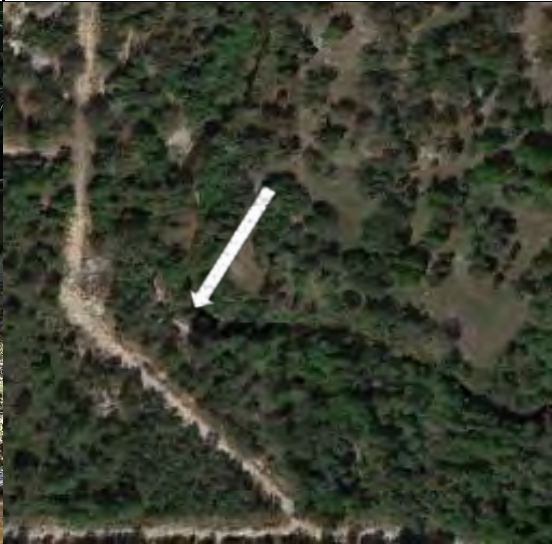
Horse Creek			Severity Scale: 3.5-Low
Watershed: Peace River Subwatershed: Lower Horse Creek Latitude: 27.19475 Longitude: -81.98682			County: Desoto Site Number: PI305 Reach Length: 100 ft. Landowner: CWP Properties LLC

Risk Factor	Ranking	Score	
Pfankuch-Channel Stability:	Fair	1	
Channel Alteration:	None	0	
Bank Erosion:	Active	1	
BEHI:	Moderate (23.49)	0.5	
Local NPSP:	No Evidence	0	
Shoring Structures:	None	0	
Pipe Discharge:	None	0	<b>Additional Site Features</b> Stream Channel Woody Material: Dominating Impoundments: None Substrate Composition: Medium Sand Bank Material: Sandy Clay Near Bank Stress: Low RB Landuse: Recreational, Natural Forest LB Landuse: Natural Forest
Water Odor:	Normal	0	
Fish Passage Barrier:	None	0	
RB: Riparian Buffer:	0 ft.	0.75	
LB: Riparian Buffer:	100 ft.	0	
RB: Floodplain Access:	Partial	0.25	
LB: Floodplain Access:	Full	0	
<b>Severity Scale:</b>		<b>3.5</b>

Notes: 303d: Impaired - Public Water Supply (DO & BOD)			
Restoration Option 1

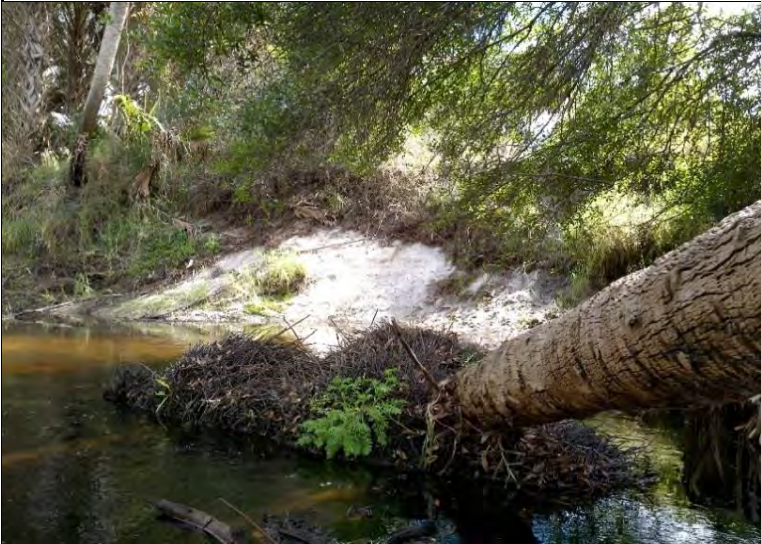
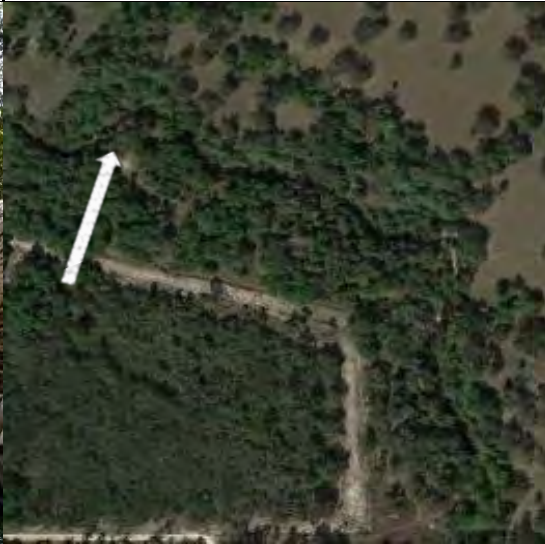
Horse Creek			Severity Scale: 3.25-Low
Watershed: Peace River Subwatershed: Lower Horse Creek Latitude: 27.19433 Longitude: -81.98509			County: Desoto Site Number: PI306 Reach Length: 64 ft. Landowner: CWP Properties LLC

Risk Factor	Ranking	Score	
Pfankuch-Channel Stability:	Fair	1	
Channel Alteration:	None	0	
Bank Erosion:	Active	1	
BEHI:	Moderate (29.26)	0.5	
Local NPSP:	No Evidence	0	
Shoring Structures:	None	0	
Pipe Discharge:	None	0	
Water Odor:	Normal	0	
Fish Passage Barrier:	None	0	
RB: Riparian Buffer:	0 ft.	0.75	
LB: Riparian Buffer:	100 ft.	0	
RB: Floodplain Access:	Full	0	
LB: Floodplain Access:	Full	0	
<b>Severity Scale:</b>		<b>3.25</b>	
Notes: 303d: Impaired - Public Water Supply (DO & BOD)			
Restoration Option 1

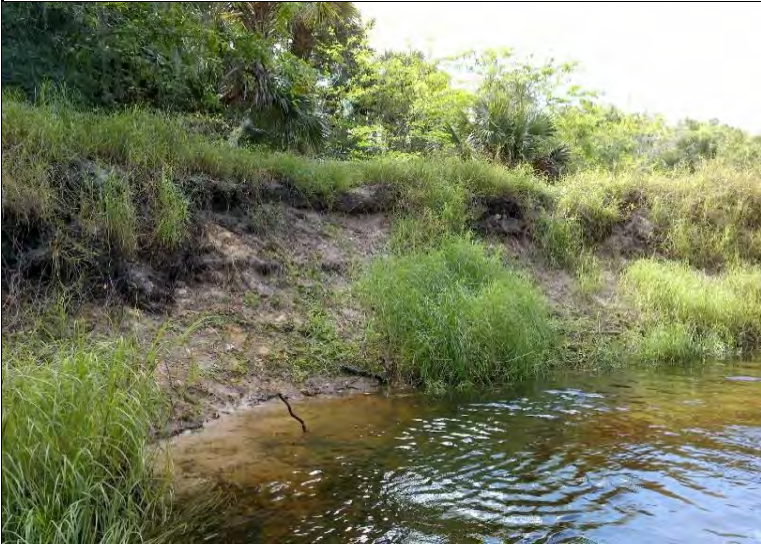
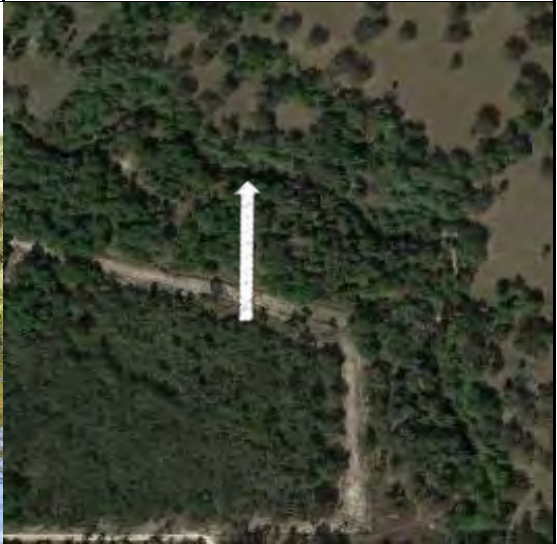
Horse Creek			Severity Scale: 3.0-Low
Watershed: Peace River Subwatershed: Lower Horse Creek Latitude: 27.19412 Longitude: -81.9842			County: Desoto Site Number: PI307 Reach Length: 33 ft. Landowner: CWP Properties LLC

Pfankuch-Channel Stability:	Fair	1	
Channel Alteration:	None	0	
Bank Erosion:	Active	1	
BEHI:	Moderate (25.18)	0.5	
Local NPSP:	No Evidence	0	
Shoring Structures:	None	0	
Pipe Discharge:	None	0	
Water Odor:	Normal	0	
Fish Passage Barrier:	None	0	
			Additional Site Features
RB: Riparian Buffer:	40 ft.	0.5	Stream Channel Woody Material: moderate
LB: Riparian Buffer:	100 ft.	0	Impoundments: None
RB: Floodplain Access:	Full	0	Substrate Composition: Medium Sand
LB: Floodplain Access:	Full	0	Bank Material: Medium Sand
			Near Bank Stress: High
			RB Landuse: Natural Forest
			LB Landuse: Natural Forest
<b>Severity Scale:</b>		<b>3.0</b>	
Notes: 303d: Impaired - Public Water Supply (DO & BOD)

Restoration Option 1

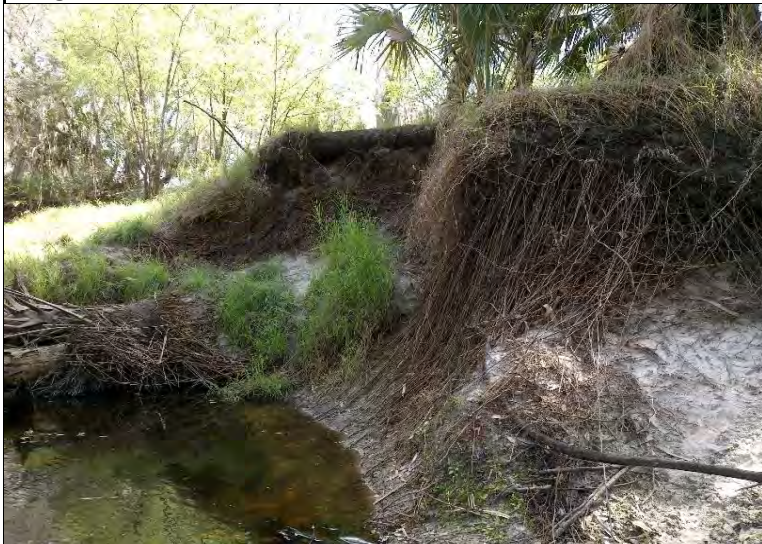
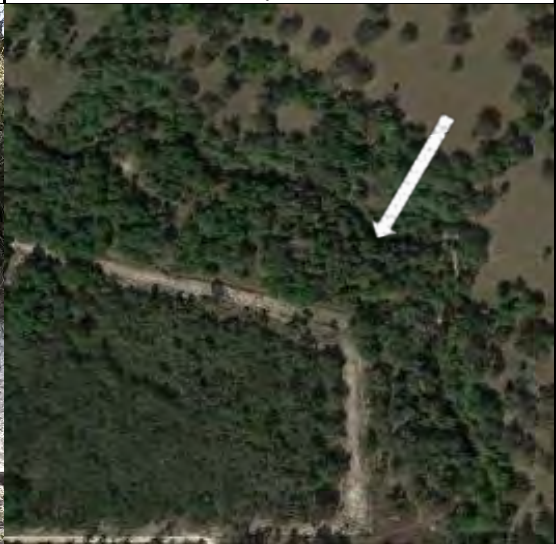
Horse Creek			Severity Scale: 2.75-Low	
Watershed: Peace River Subwatershed: Lower Horse Creek Latitude: 27.19376 Longitude: -81.98295			County: Desoto Site Number: PI308 Reach Length: 82 ft. Landowner: CWP Properties LLC

Pfankuch-Channel Stability:	Fair	1		
Channel Alteration:	None	0		
Bank Erosion:	Active	1		
BEHI:	Moderate (26.22)	0.5		
Local NPSP:	No Evidence	0		
Shoring Structures:	None	0		
Pipe Discharge:	None	0		
Water Odor:	Normal	0		
Fish Passage Barrier:	None	0		
			Additional Site Features	
RB: Riparian Buffer:	60 ft.	0.25	Stream Channel Woody Material: Extensive	
LB: Riparian Buffer:	100 ft.	0	Impoundments: None	
RB: Floodplain Access:	Full	0	Substrate Composition: Medium Sand	
LB: Floodplain Access:	Full	0	Bank Material: Medium Sand	
			Near Bank Stress: Low	
			RB Landuse: Natural Forest	
			LB Landuse: Natural Forest	
Notes: 303d: Impaired - Public Water Supply (DO & BOD)

Restoration Option 1

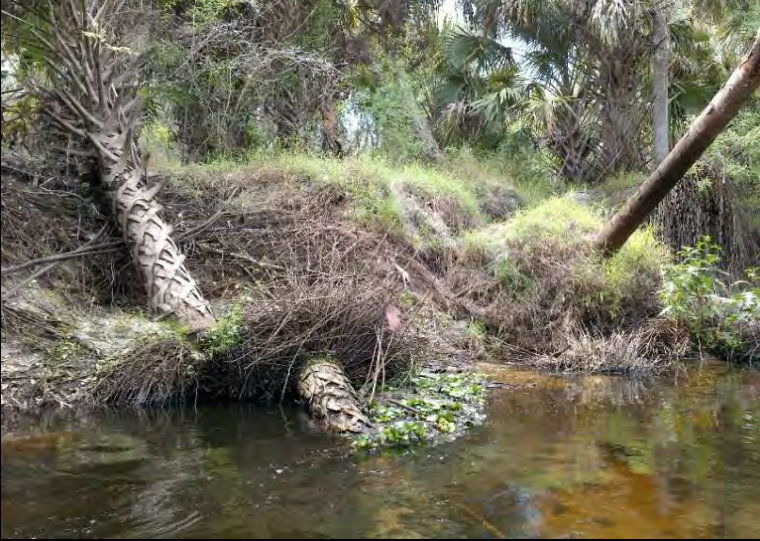
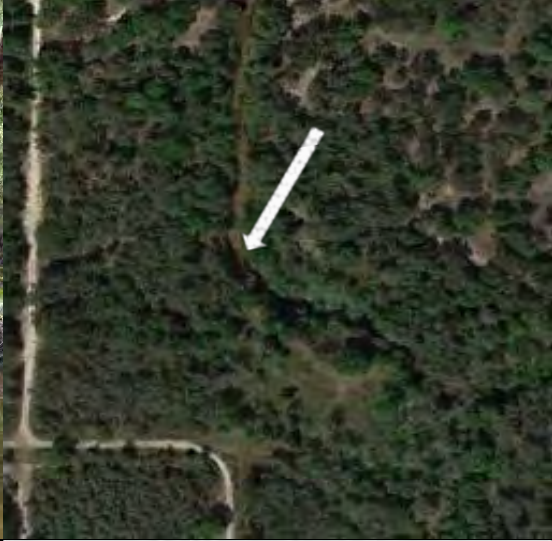
Horse Creek			Severity Scale: 2.5-Low
Watershed: Peace River Subwatershed: Lower Horse Creek Latitude: 27.18919 Longitude: -81.98335			County: Desoto Site Number: PI309 Reach Length: 75 ft. Landowner: Martha G Shunn

Risk Factor	Ranking	Score	
Pfankuch-Channel Stability:	Fair	1	
Channel Alteration:	None	0	
Bank Erosion:	Active	1	
BEHI:	Moderate (22.42)	0.5	
Local NPSP:	No Evidence	0	
Shoring Structures:	None	0	
Pipe Discharge:	None	0	<b>Additional Site Features</b> Stream Channel Woody Material: Numerous Impoundments: None Substrate Composition: Medium Sand Bank Material: Medium Sand Near Bank Stress: High RB Landuse: Natural Forest LB Landuse: Natural Forest
Water Odor:	Normal	0	
Fish Passage Barrier:	None	0	
RB: Riparian Buffer:	100 ft.	0	
LB: Riparian Buffer:	100 ft.	0	
RB: Floodplain Access:	Full	0	
LB: Floodplain Access:	Full	0	
<b>Severity Scale:</b>		<b>2.5</b>	
Notes: 303d: Impaired - Public Water Supply (DO & BOD)

Restoration Option 1

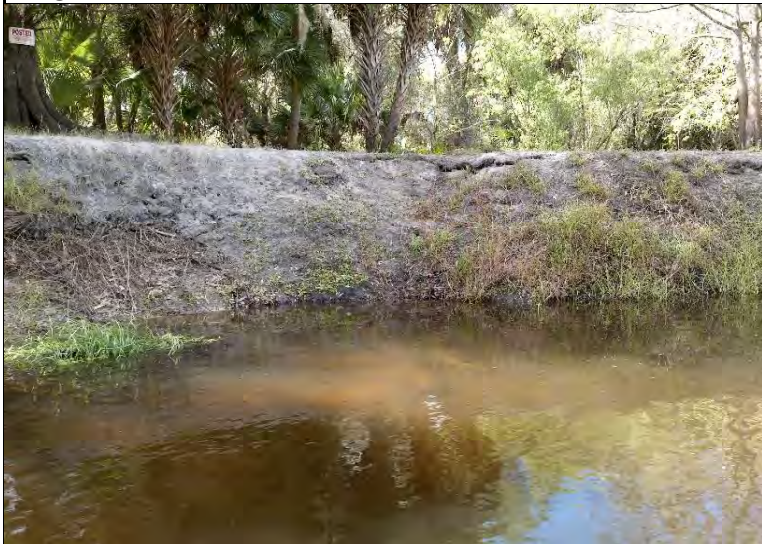
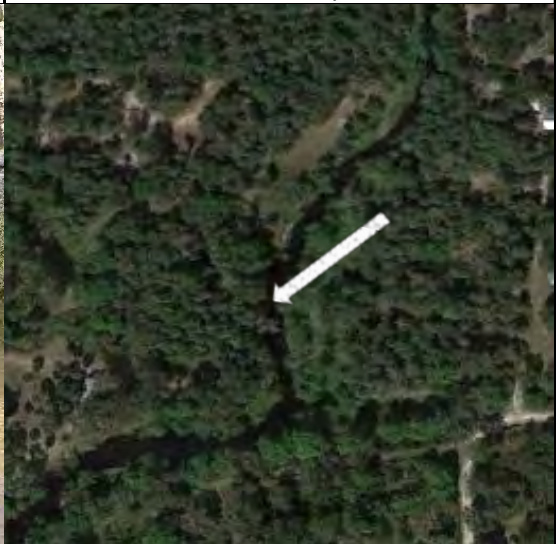
Horse Creek			Severity Scale: 3.25-Low	
Watershed: Peace River Subwatershed: Lower Horse Creek Latitude: 27.179 Longitude: -81.9821			County: Desoto Site Number: PI311 Reach Length: 65 ft. Landowner: Marie Ellen Drymon

Pfankuch-Channel Stability:	Fair	1		
Channel Alteration:	None	0		
Bank Erosion:	Active	1		
BEHI:	Moderate (22.06)	0.5		
Local NPSP:	No Evidence	0		
Shoring Structures:	None	0		
Pipe Discharge:	None	0		
Water Odor:	Normal	0		
Fish Passage Barrier:	None	0		
RB: Riparian Buffer:	0 ft.	0.75		
LB: Riparian Buffer:	100 ft.	0		
RB: Floodplain Access:	Full	0		
LB: Floodplain Access:	Full	0		
Severity Scale:		3.25	Additional Site Features	
			Stream Channel Woody Material: Moderate	
			Impoundments: None	
			Substrate Composition: Medium Sand	
			Bank Material: Medium Sand	
			Near Bank Stress: Moderate	
			RB Landuse: Recreational, Natural Forest	
			LB Landuse: Natural Forest

Notes: 303d: Impaired - Public Water Supply (DO & BOD)				
Restoration Option 2 or 3

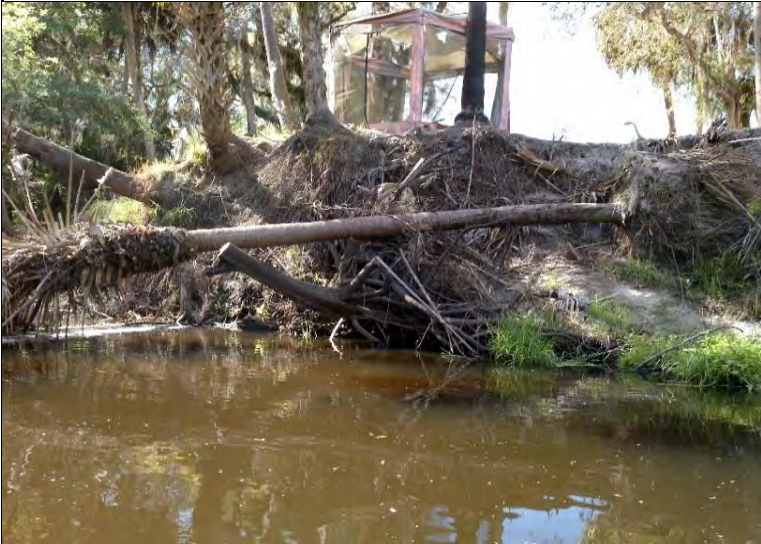
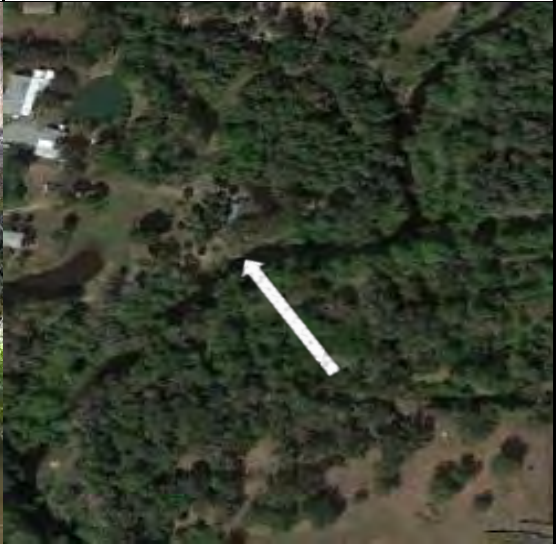
Horse Creek			Severity Scale: 6.0-Moderate
Watershed: Peace River Subwatershed: Lower Horse Creek Latitude: 27.17804 Longitude: -81.9829			County: Desoto Site Number: PI312 Reach Length: 90 ft. Landowner: Harry M Drymon III

Risk Factor	Ranking	Score	
Pfankuch-Channel Stability:	Fair	1	
Channel Alteration:	None	0	
Bank Erosion:	Active	1	
BEHI:	High (31.85)	1	
Local NPSP:	Slight Potential	0.5	
Shoring Structures:	Present	1.5	
Pipe Discharge:	None	0	<b>Additional Site Features</b> Stream Channel Woody Material: Moderate Impoundments: None Substrate Composition: Medium Sand Bank Material: Medium Sand Near Bank Stress: Moderate RB Landuse: Residential LB Landuse: Natural Forest
Water Odor:	Normal	0	
Fish Passage Barrier:	None	0	
RB: Riparian Buffer:	0 ft.	0.75	
LB: Riparian Buffer:	100 ft.	0	
RB: Floodplain Access:	Partial	0.25	
LB: Floodplain Access:	Full	0	
<b>Severity Scale:</b>		<b>6.0</b>	
Notes: 303d: Impaired - Public Water Supply (DO & BOD)

Restoration Option 1

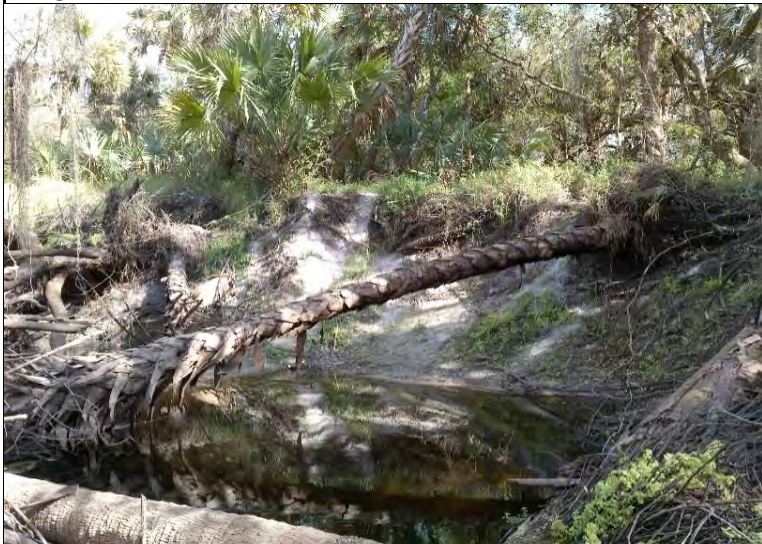
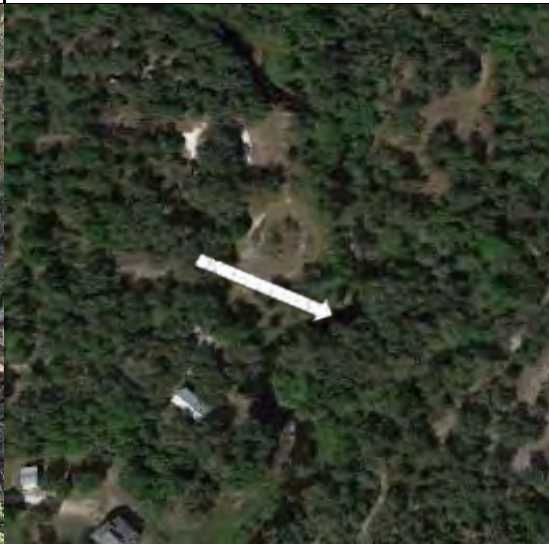
Horse Creek			Severity Scale: 3.25-Low																																														
Watershed: Peace River Subwatershed: Lower Horse Creek Latitude: 27.17357 Longitude: -81.98167			County: Desoto Site Number: PI313 Reach Length: 85 ft. Landowner: Brent A Garrod

Risk Factor	Ranking	Score	Pfankuch-Channel Stability:	Fair	1	Channel Alteration:	None	0	Bank Erosion:	Active	1	BEHI:	High (34.61)	1	Local NPSP:	No Evidence	0	Shoring Structures:	None	0	Pipe Discharge:	None	0	Water Odor:	Normal	0	Fish Passage Barrier:	None	0	RB: Riparian Buffer:	100 ft.	0	LB: Riparian Buffer:	100 ft.	0	RB: Floodplain Access:	Full	0	LB: Floodplain Access:	Partial	0.25	Severity Scale:		3.25

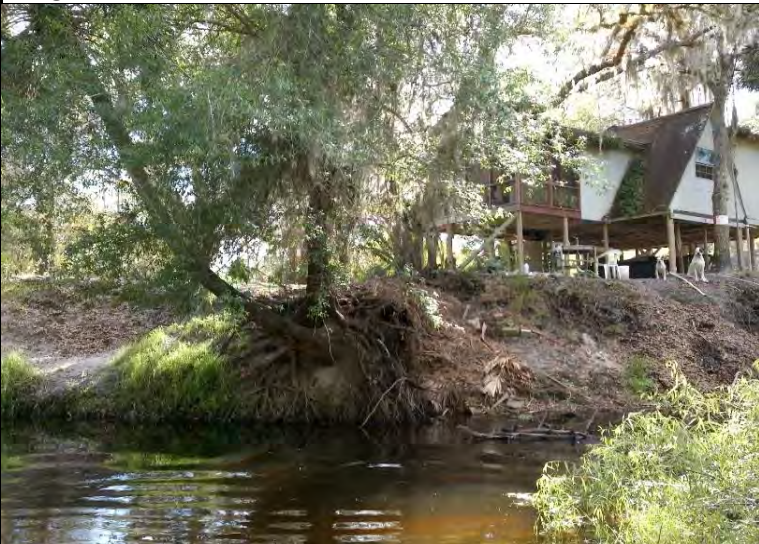
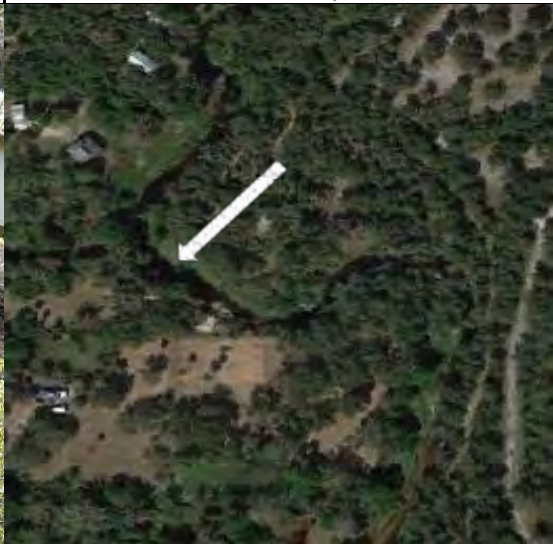
Horse Creek			Severity Scale: 6.0-Moderate	
Watershed: Peace River Subwatershed: Lower Horse Creek Latitude: 27.17176 Longitude: -81.98217			County: Desoto Site Number: PI314 Reach Length: 89 ft. Landowner: Marie Ellen Drymon

Pfankuch-Channel Stability:	Fair	1		
Channel Alteration:	None	0		
Bank Erosion:	Active	1		
BEHI:	High (36.82)	1		
Local NPSP:	Slight Potential	0.5		
Shoring Structures:	Present	1.5		
Pipe Discharge:	None	0		
Water Odor:	Normal	0		
Fish Passage Barrier:	None	0		
RB: Riparian Buffer:	0 ft.	0.75	<b>Additional Site Features</b>	
LB: Riparian Buffer:	100 ft.	0	Stream Channel Woody Material: Moderate	
RB: Floodplain Access:	Partial	0.25	Impoundments: None	
LB: Floodplain Access:	Full	0	Substrate Composition: Medium Sand	
<b>Severity Scale:</b>			Bank Material: Medium Sand	
			Near Bank Stress: Moderate	
			RB Landuse: Residential	
			LB Landuse: Natural Forest

Notes: 303d: Impaired - Public Water Supply (DO & BOD)				
Restoration Option 1

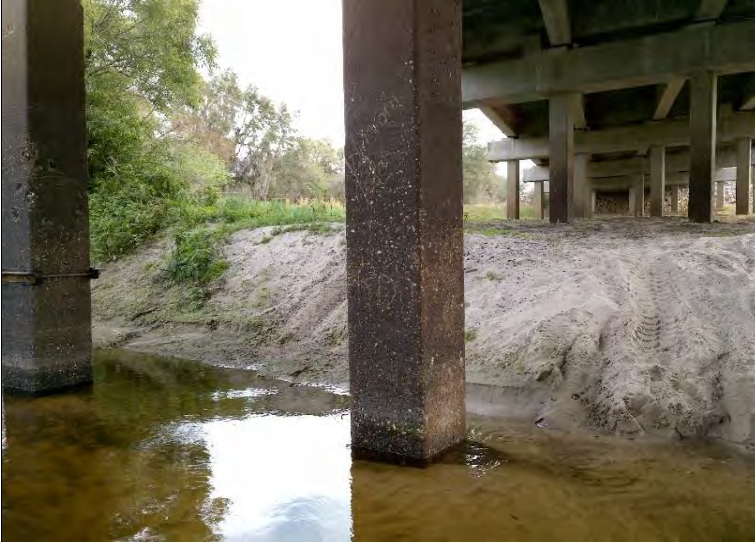
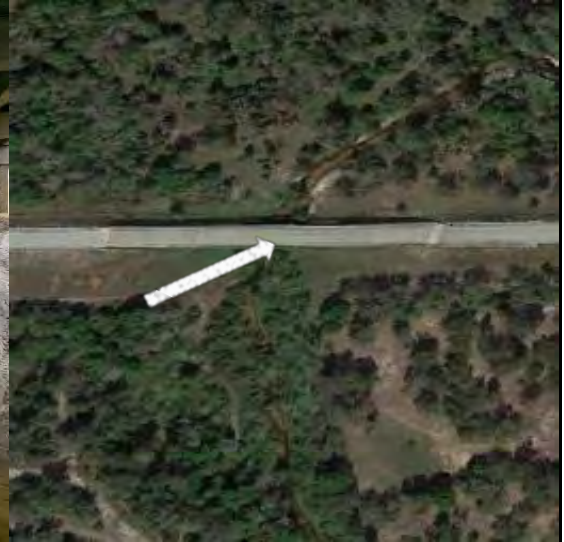
Severity Scale: 5.5-Moderate

Risk Factor	Ranking	Score
Pfankuch-Channel Stability:	Fair	1
Channel Alteration:	None	0
Bank Erosion:	Active	1
BEHI:	High (39.02)	1
Local NPSP:	Slight Potential	0.5
Shoring Structures:	None	0
Pipe Discharge:	None	0
Water Odor:	Normal	0
Fish Passage Barrier:	None	0
RB: Riparian Buffer:	0 ft.	0.75
LB: Riparian Buffer:	0 ft.	0.75
RB: Floodplain Access:	Partial	0.25
LB: Floodplain Access:	Partial	0.25
Severity Scale:		5.5

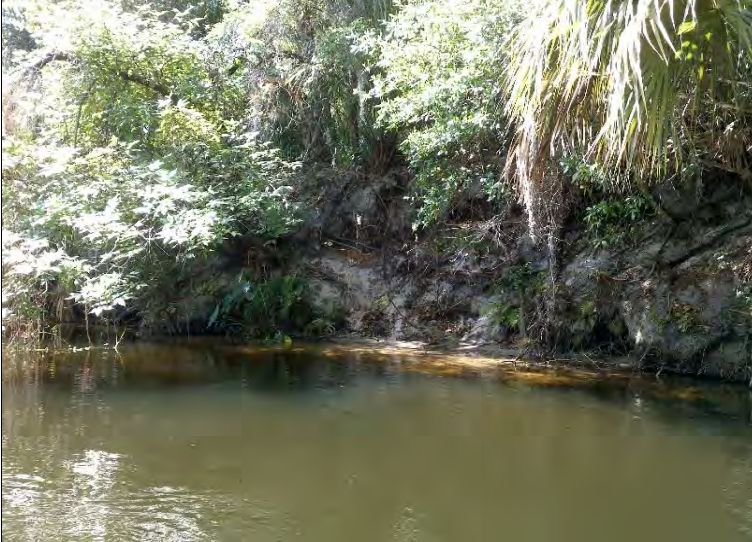
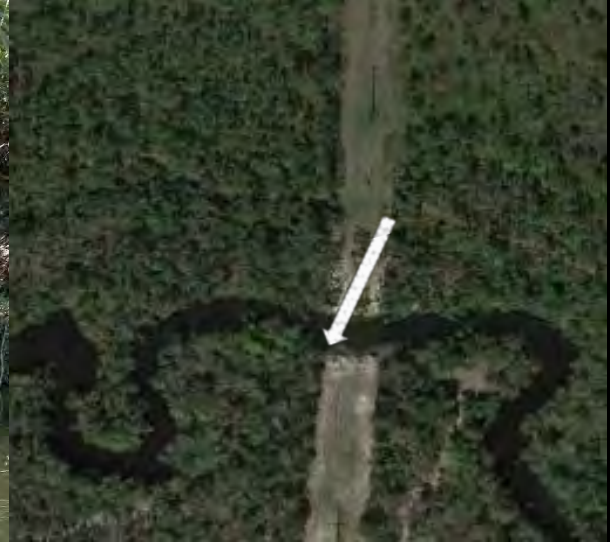
Risk Factor	Ranking	Score
Pfankuch-Channel Stability:	Good	0
Channel Alteration:	None	0
Bank Erosion:	Active	1
BEHI:	Moderate (29.54)	0.5
Local NPSP:	No Evidence	0
Shoring Structures:	None	0
Pipe Discharge:	None	0
Water Odor:	Normal	0
Fish Passage Barrier:	None	0
RB: Riparian Buffer:	100 ft.	0
LB: Riparian Buffer:	100 ft.	0
RB: Floodplain Access:	Full	0
LB: Floodplain Access:	Partial	0.25
<b>Severity Scale:</b>		<b>1.75</b>

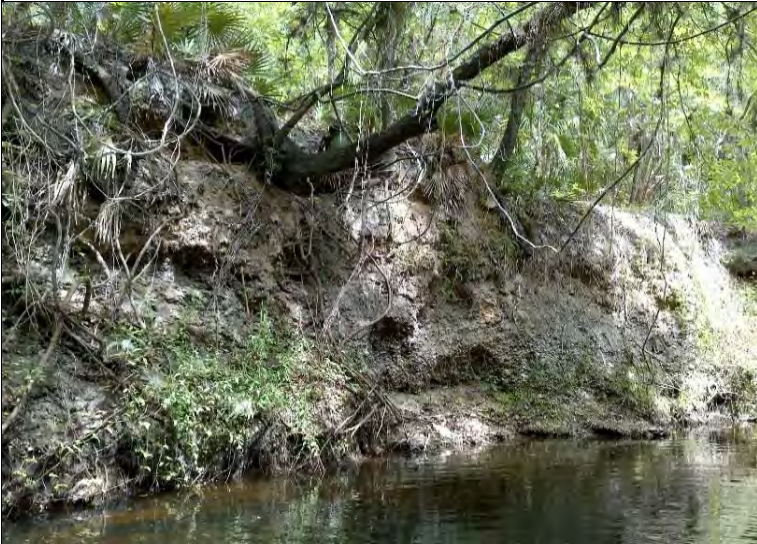
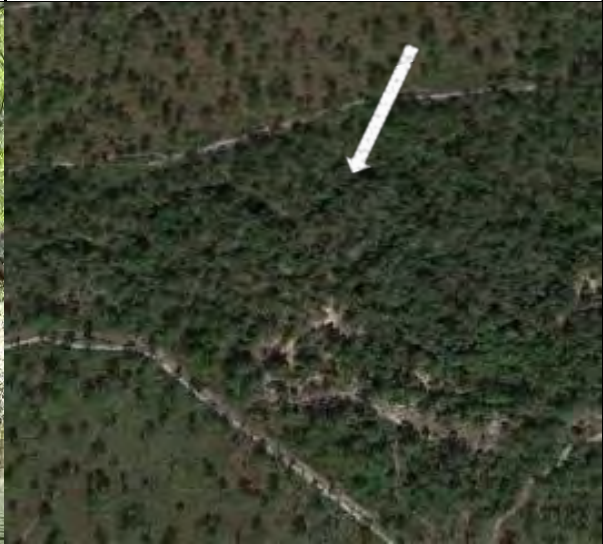
Shell Creek			Severity Scale: 2.25-Low																																														
Watershed: Peace River Subwatershed: Middle Shell Creek Latitude: 26.96905 Longitude: -81.84633			County: Charlotte Site Number: PI318 Reach Length: 55 ft. Landowner: Charlotte County

Risk Factor	Ranking	Score	Pfankuch-Channel Stability:	Good	0	Channel Alteration:	None	0	Bank Erosion:	Active	1	BEHI:	High (33.65)	1	Local NPSP:	No Evidence	0	Shoring Structures:	None	0	Pipe Discharge:	None	0	Water Odor:	Normal	0	Fish Passage Barrier:	None	0	RB: Riparian Buffer:	100 ft.	0	LB: Riparian Buffer:	100 ft.	0	RB: Floodplain Access:	Partial	0.25	LB: Floodplain Access:	Full	0	Severity Scale:		2.25

Risk Factor	Ranking	Score																																															
Pfankuch-Channel Stability:	Good	0																																															
Channel Alteration:	None	0																																															
Bank Erosion:	Active	1																																															
BEHI:	High (33.65)	1																																															
Local NPSP:	No Evidence	0																																															
Shoring Structures:	None	0																																															
Pipe Discharge:	None	0																																															
Water Odor:	Normal	0																																															
Fish Passage Barrier:	None	0																																															
RB: Riparian Buffer:	100 ft.	0																																															
LB: Riparian Buffer:	100 ft.	0																																															
RB: Floodplain Access:	Partial	0.25																																															
LB: Floodplain Access:	Full	0																																															
Severity Scale:		2.25																																															
			<b>Additional Site Features</b>																																														
			Stream Channel Woody Material: Mdoerate																																														
			Impoundments: None																																														
			Substrate Composition: Medium Sand																																														
			Bank Material: Sand																																														
			Near Bank Stress: High																																														
			RB Landuse: Natural Forest																																														
			LB Landuse: Natural Forest																																														
Notes: 303d: Impaired – Chloride, DO, Specific Conductivity and TDS																																																	
Restoration Option 2 or 3

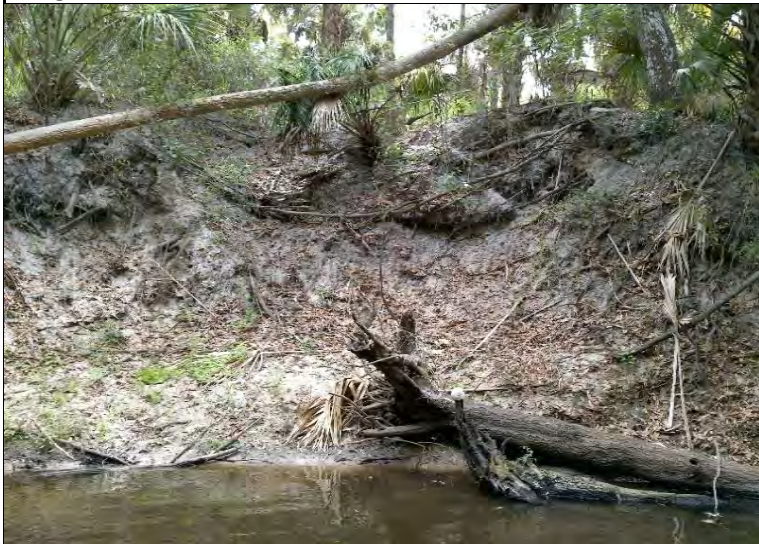
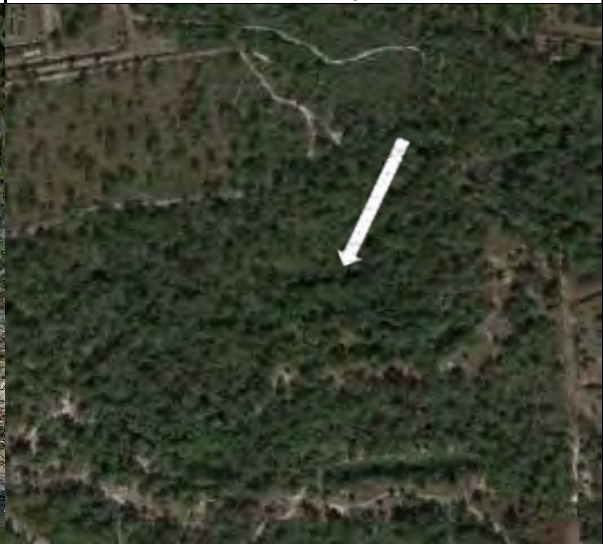
Shell Creek			Severity Scale: 2.25-Low																																															
Watershed: Peace River Subwatershed: Upper Shell Creek Latitude: 26.96946 Longitude: -81.84399			County: Charlotte Site Number: PI319 Reach Length: 50 ft. Landowner: Charlotte County

Risk Factor	Ranking	Score	Pfankuch-Channel Stability:	Good	0	Channel Alteration:	None	0	Bank Erosion:	Active	1	BEHI:	High (34.79)	1	Local NPSP:	No Evidence	0	Shoring Structures:	None	0	Pipe Discharge:	None	0	Water Odor:	Normal	0	Fish Passage Barrier:	None	0	RB: Riparian Buffer:	100 ft.	0	LB: Riparian Buffer:	100 ft.	0	RB: Floodplain Access:	Partial	0.25	LB: Floodplain Access:	Full	0	Severity Scale:		2.25

Risk Factor	Ranking	Score																																																
Pfankuch-Channel Stability:	Good	0																																																
Channel Alteration:	None	0																																																
Bank Erosion:	Active	1																																																
BEHI:	High (34.79)	1																																																
Local NPSP:	No Evidence	0																																																
Shoring Structures:	None	0																																																
Pipe Discharge:	None	0																																																
Water Odor:	Normal	0																																																
Fish Passage Barrier:	None	0																																																
RB: Riparian Buffer:	100 ft.	0																																																
LB: Riparian Buffer:	100 ft.	0																																																
RB: Floodplain Access:	Partial	0.25																																																
LB: Floodplain Access:	Full	0																																																
Severity Scale:		2.25																																																
			<b>Additional Site Features</b>																																															
			Stream Channel Woody Material: Moderate																																															
			Impoundments: None																																															
			Substrate Composition: Medium Sand																																															
			Bank Material: Sand																																															
			Near Bank Stress: Low																																															
			RB Landuse: Natural Forest																																															
			LB Landuse: Natural Forest																																															
Notes: 303d: Impaired – Chloride, DO, Specific Conductivity and TDS																																																		
Restoration Option 2 or 3
