# **Peace River and Withlacoochee River Threats Assessments and Fish Assemblage Monitoring**

**Final Report July 1, 2015 – June 30, 2019**

Submitted to Florida State Wildlife Grants Program  
August 1, 2019  
PID: 98462501284

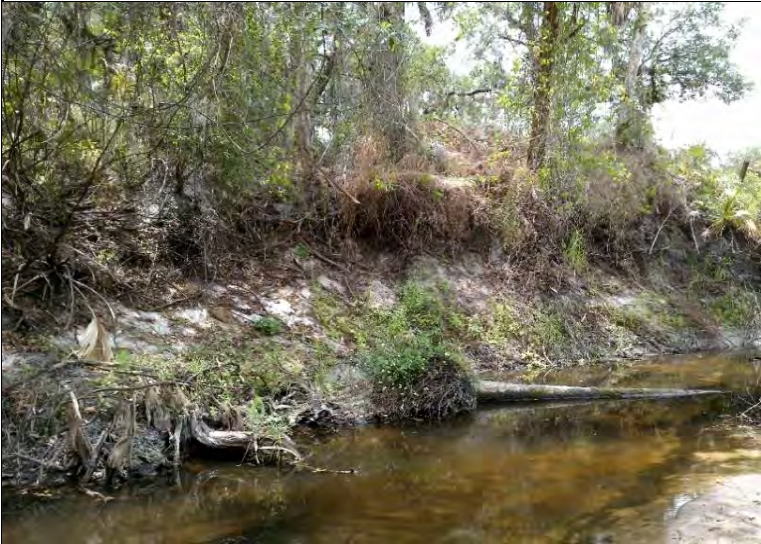
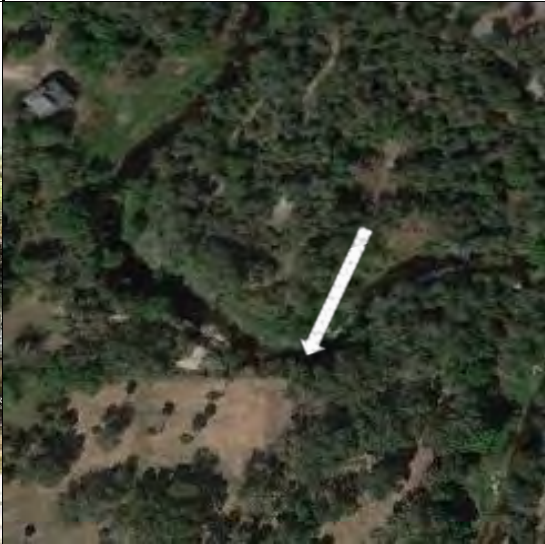
Horse Creek			Severity Scale: 4.5-Moderate
Watershed: Peace River Subwatershed: Lower Horse Creek Latitude: 27.17159 Longitude: -81.98177			County: Desoto Site Number: PI320 Reach Length: 121 ft. Landowner: Hector R Moran

Pfankuch-Channel Stability:	Fair	1	
Channel Alteration:	None	0	
Bank Erosion:	Active	1	
BEHI:	Moderate (27.62)	0.5	
Local NPSP:	Obvious Sources	1.5	
Shoring Structures:	None	0	
Pipe Discharge:	None	0	
Water Odor:	Normal	0	
Fish Passage Barrier:	None	0	
RB: Riparian Buffer:	60 ft.	0.25	
LB: Riparian Buffer:	100 ft.	0	
RB: Floodplain Access:	Partial	0.25	
LB: Floodplain Access:	Full	0	
<b>Severity Scale:</b>		<b>4.5</b>	<b>Additional Site Features</b>
			Stream Channel Woody Material: Extensive
			Impoundments: None
			Substrate Composition: Medium Sand
			Bank Material: Sand
			Near Bank Stress: High
			RB Landuse: Natural Forest, Pasture
			LB Landuse: Natural Forest

Notes: 303d: Impaired - Public Water Supply (DO & BOD)			
Restoration Option 1

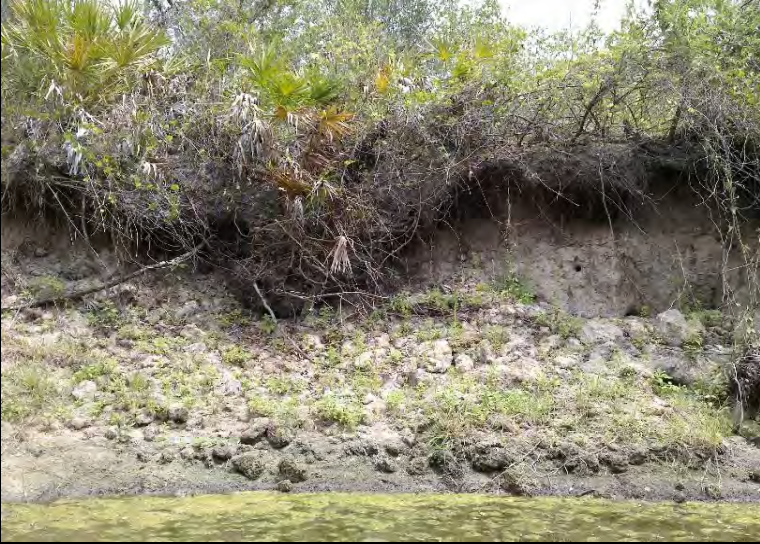
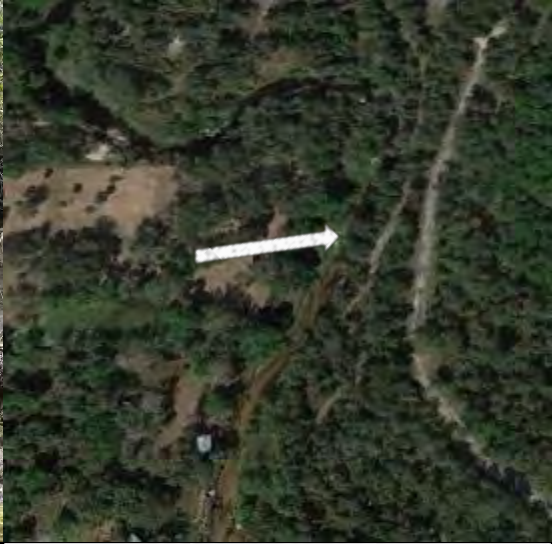
Horse Creek			Severity Scale: 4.0-Low	
Watershed: Peace River Subwatershed: Lower Horse Creek Latitude: 27.17174 Longitude: -81.98080			County: Desoto Site Number: PI321 Reach Length: 250 ft. Landowner: Brent A Garrod

Pfankuch-Channel Stability:	Fair	1		
Channel Alteration:	None	0		
Bank Erosion:	Mass-wasting	1.5		
BEHI:	High (34.97)	1		
Local NPSP:	No Evidence	0		
Shoring Structures:	None	0		
Pipe Discharge:	None	0		
Water Odor:	Normal	0		
Fish Passage Barrier:	None	0		
RB: Riparian Buffer:	100 ft.	0		
LB: Riparian Buffer:	40 ft.	0.5		
RB: Floodplain Access:	Full	0		
LB: Floodplain Access:	Full	0		
Severity Scale:		4.0	Additional Site Features	
Notes: 303d: Impaired - Public Water Supply (DO & BOD)  Restoration Option 1			Stream Channel Woody Material: Moderate	
			Impoundments: None	
			Substrate Composition: Medium Sand	
			Bank Material: Sand	
			Near Bank Stress: Low

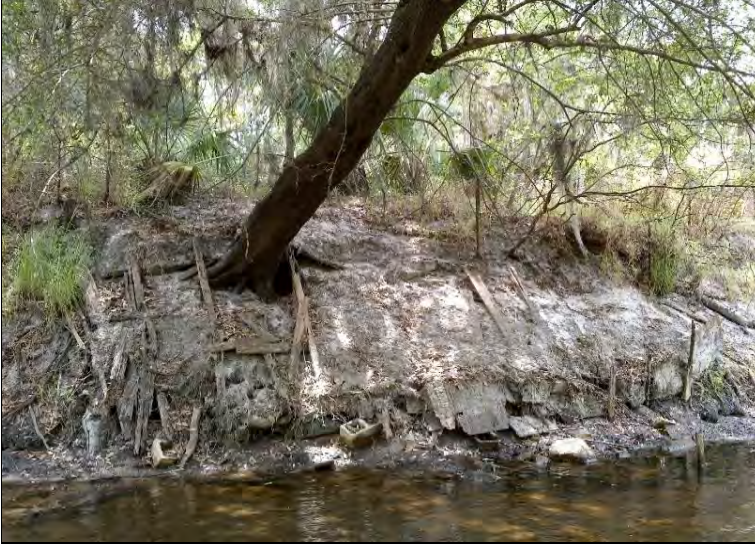
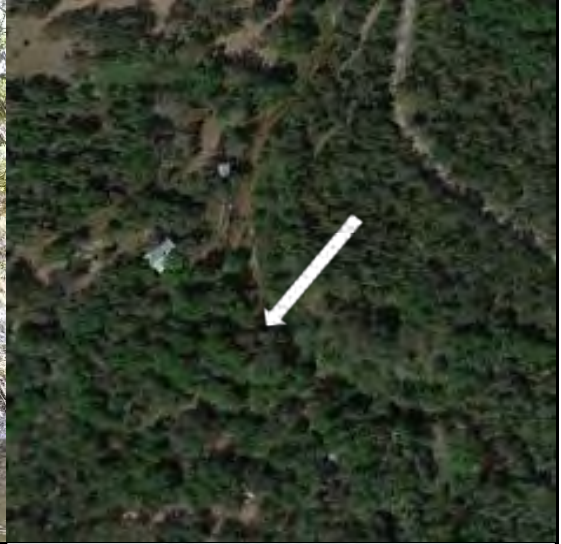
Risk Factor	Ranking	Score
Pfankuch-Channel Stability:	Fair	1
Channel Alteration:	None	0
Bank Erosion:	Active	1
BEHI:	Moderate (21.77)	0.5
Local NPSP:	Slight Potential	0.5
Shoring Structures:	Present	1.5
Pipe Discharge:	Present	1.5
Water Odor:	Normal	0
Fish Passage Barrier:	None	0
RB: Riparian Buffer:	0 ft.	0.75
LB: Riparian Buffer:	100 ft.	0
RB: Floodplain Access:	Full	0
LB: Floodplain Access:	Full	0
Severity Scale:		6.75

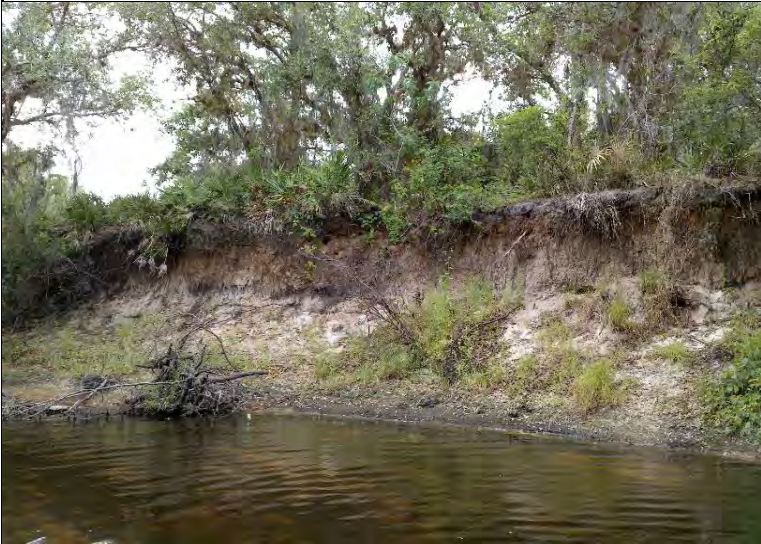
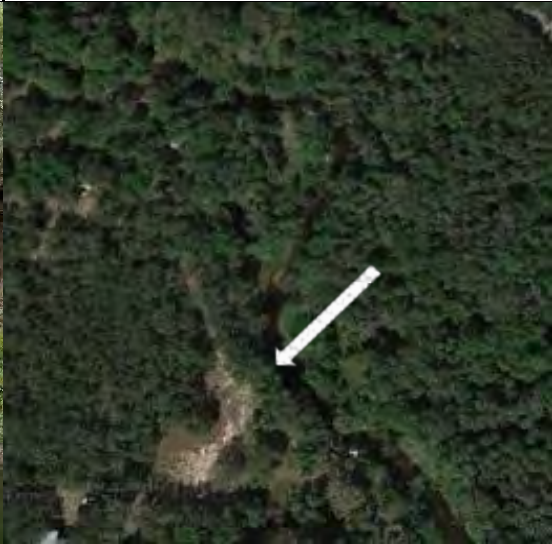
Horse Creek			Severity Scale: 5.0-Moderate
Watershed: Peace River Subwatershed: Lower Horse Creek Latitude: 27.16805 Longitude: -81.98046			County: Desoto Site Number: PI323 Reach Length: 200 ft. Landowner: Martin D and Susan E Raskie

Pfankuch-Channel Stability:	Fair	1	
Channel Alteration:	None	0	
Bank Erosion:	Active	1	
BEHI:	High (37.59)	1	
Local NPSP:	No Evidence	0	
Shoring Structures:	Present	1.5	
Pipe Discharge:	None	0	
Water Odor:	Normal	0	
Fish Passage Barrier:	None	0	
RB: Riparian Buffer:	60 ft.	0.25	Additional Site Features
LB: Riparian Buffer:	100 ft.	0	
RB: Floodplain Access:	Full	0	
LB: Floodplain Access:	Partial	0.25	
Severity Scale:		5.0	
Notes: 303d: Impaired - Public Water Supply (DO & BOD)			Stream Channel Woody Material: Moderate
Restoration Option 1			Impoundments: None
			Substrate Composition: Medium Sand
			Bank Material: Sand
			Near Bank Stress: Moderate

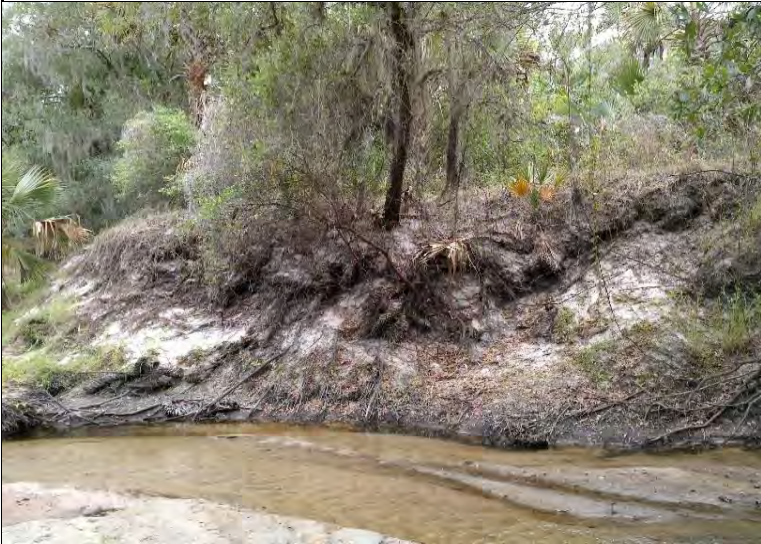
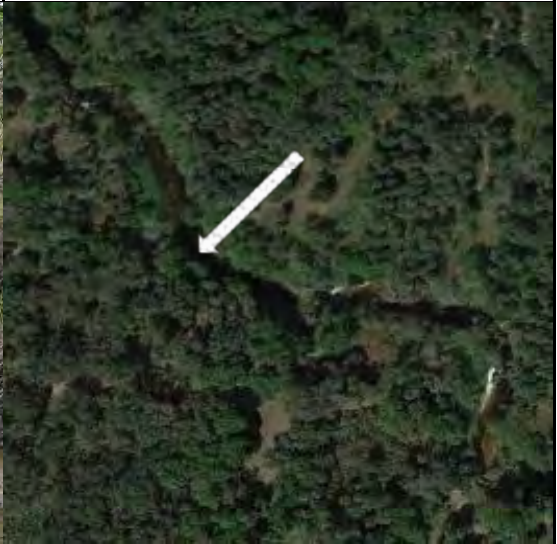
Horse Creek			Severity Scale: 2.75-Low
Watershed: Peace River Subwatershed: Lower Horse Creek Latitude: 27.16690 Longitude: -81.97968			County: Desoto Site Number: PI324 Reach Length: 150 ft. Landowner: Stephen John Krogel

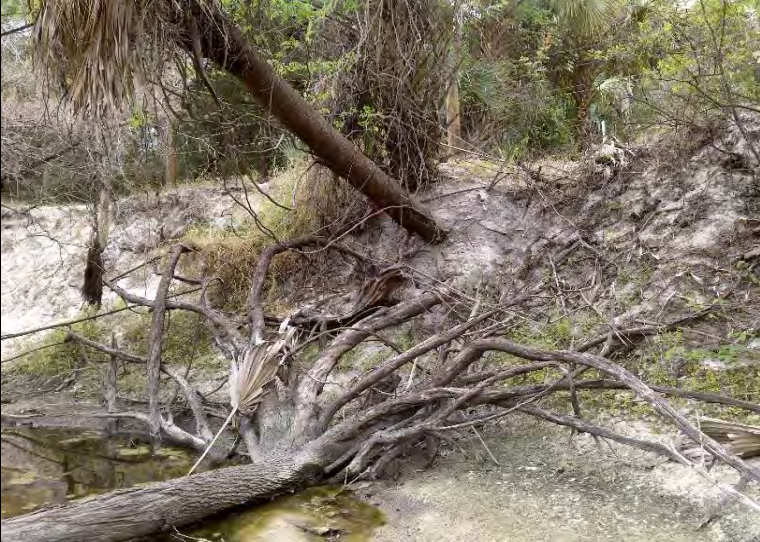
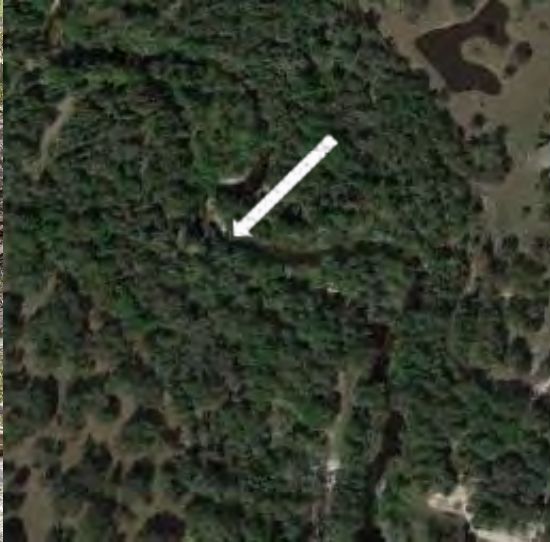
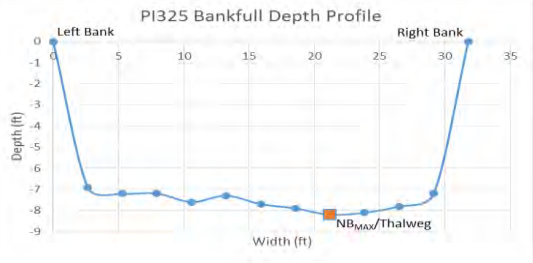
Horse Creek			Severity Scale: 4.75-Moderate
Watershed: Peace River Subwatershed: Lower Horse Creek Latitude: 27.16521 Longitude: -81.97775			County: Desoto Site Number: PI325 Reach Length: 158 ft. Landowner: Spanish Trail Land and Cattle

Pfankuch-Channel Stability:	Fair	1	
Channel Alteration:	None	0	
Bank Erosion:	Active	1	
BEHI:	Moderate (29.09)	0.5	
Local NPSP:	Obvious Sources	1.5	
Shoring Structures:	None	0	
Pipe Discharge:	None	0	
Water Odor:	Normal	0	
Fish Passage Barrier:	None	0	
RB: Riparian Buffer:	40 ft.	0.5	
LB: Riparian Buffer:	100 ft.	0	
RB: Floodplain Access:	Partial	0.25	
LB: Floodplain Access:	Full	0	
<b>Severity Scale:</b>		<b>4.75</b>	<b>Additional Site Features</b>
			Stream Channel Woody Material: Extensive
			Impoundments: None
			Substrate Composition: Medium Sand
			Bank Material: Sand
			Near Bank Stress: High
			RB Landuse: Pasture, Natural Forest

LB Landuse: Natural Forest
Notes: 303d: Impaired - Public Water Supply (DO & BOD)			
Restoration Option 1

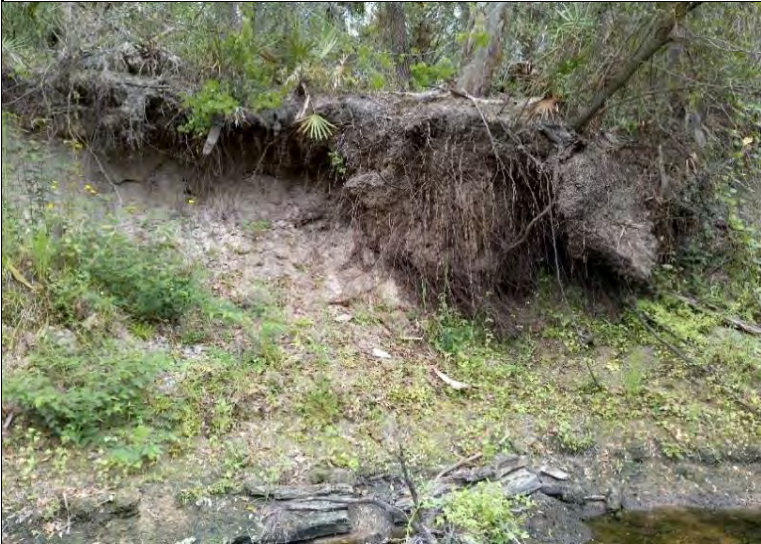
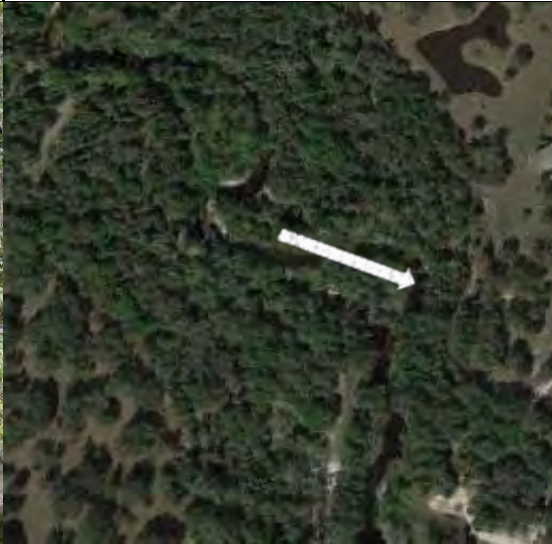
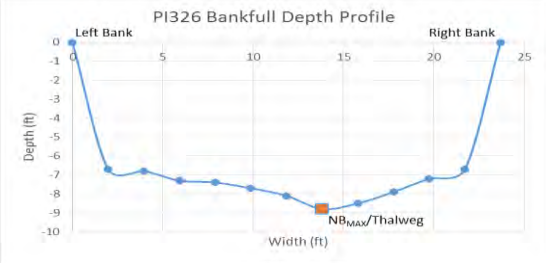
Horse Creek			Severity Scale: 3.25-Low
Watershed: Peace River Subwatershed: Lower Horse Creek Latitude: 27.16491 Longitude: -81.97659			County: Desoto Site Number: PI326 Reach Length: 160 ft. Landowner: Douglas M & Sandra D Page

Pfankuch-Channel Stability:	Fair	1	
Channel Alteration:	None	0	
Bank Erosion:	Active	1	
BEHI:	High (32.07)	1	
Local NPSP:	No Evidence	0	
Shoring Structures:	None	0	
Pipe Discharge:	None	0	
Water Odor:	Normal	0	
Fish Passage Barrier:	None	0	
RB: Riparian Buffer:	100 ft.	0	
LB: Riparian Buffer:	100 ft.	0	
RB: Floodplain Access:	Full	0	
LB: Floodplain Access:	Partial	0.25	
<b>Severity Scale:</b>		<b>3.25</b>	
Notes: 303d: Impaired - Public Water Supply (DO & BOD)			
Restoration Option 1

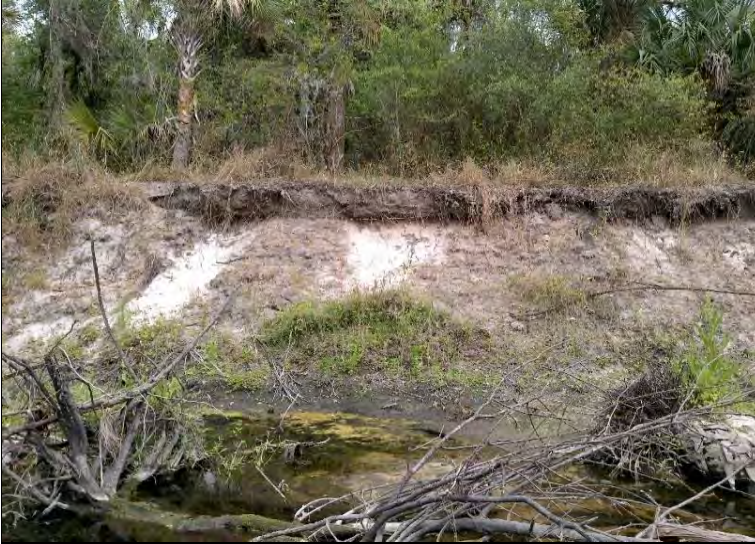
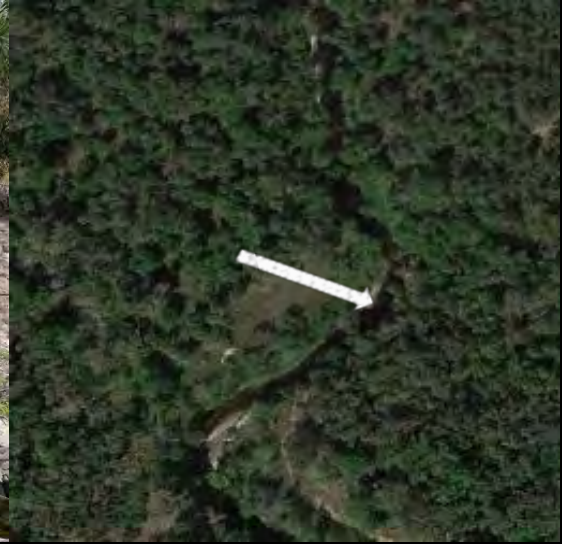
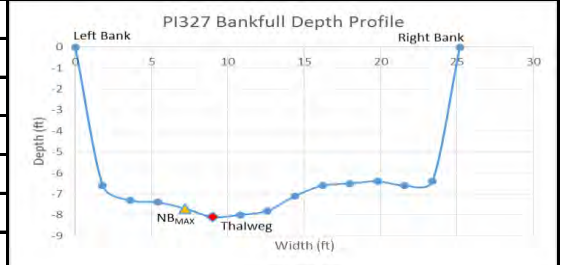
Risk Factor	Ranking	Score
Pfankuch-Channel Stability:	Fair	1
Channel Alteration:	None	0
Bank Erosion:	Active	1
BEHI:	High (34.40)	1
Local NPSP:	Obvious Sources	1.5
Shoring Structures:	None	0
Pipe Discharge:	None	0
Water Odor:	Normal	0
Fish Passage Barrier:	None	0
RB: Riparian Buffer:	100 ft.	0
LB: Riparian Buffer:	100 ft.	0
RB: Floodplain Access:	Full	0
LB: Floodplain Access:	Full	0
Severity Scale:		4.5

Restoration Option 1

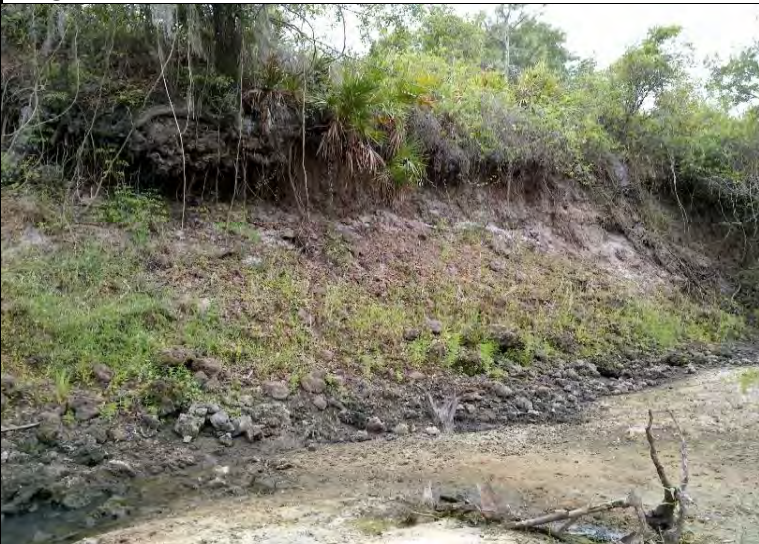
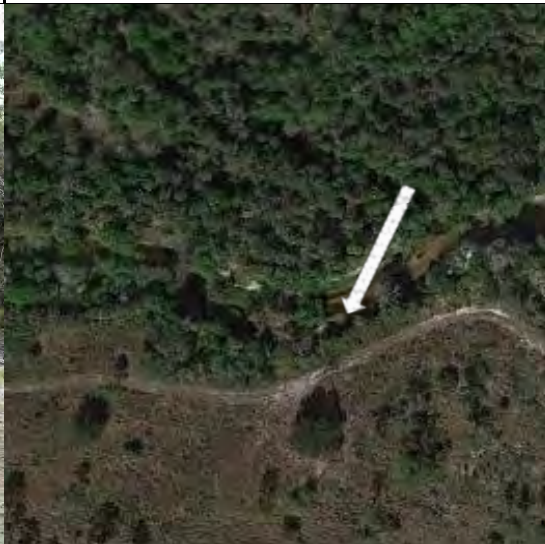
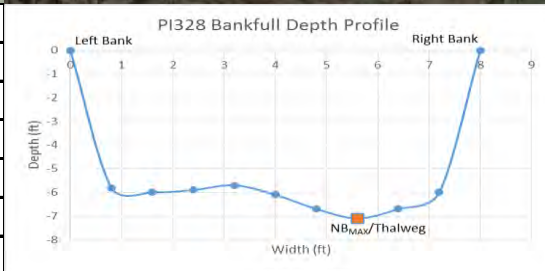
Horse Creek			Severity Scale: 5.0-Moderate	
Watershed: Peace River Subwatershed: Lower Horse Creek Latitude: 27.15953 Longitude: -81.97331			County: Desoto Site Number: PI328 Reach Length: 175 ft. Landowner: TIITF/State of Florida

Pfankuch-Channel Stability:	Fair	1		
Channel Alteration:	None	0		
Bank Erosion:	Active	1		
BEHI:	High (39.93)	1		
Local NPSP:	Obvious Sources	1.5		
Shoring Structures:	None	0		
Pipe Discharge:	None	0		
Water Odor:	Normal	0		
Fish Passage Barrier:	None	0		
RB: Riparian Buffer:	60 ft.	0.25	<b>Additional Site Features</b>	
LB: Riparian Buffer:	100 ft.	0	Stream Channel Woody Material: Moderate	
RB: Floodplain Access:	Full	0	Impoundments: None	
LB: Floodplain Access:	Partial	0.25	Substrate Composition: Medium Sand	
Severity Scale:		5.0	Bank Material: Sand	
Notes: 303d: Impaired - Public Water Supply (DO & BOD)			Near Bank Stress: High

RB Landuse: Natural Forest, Pasture	
			LB Landuse: Natural Forest	
Restoration Option 1

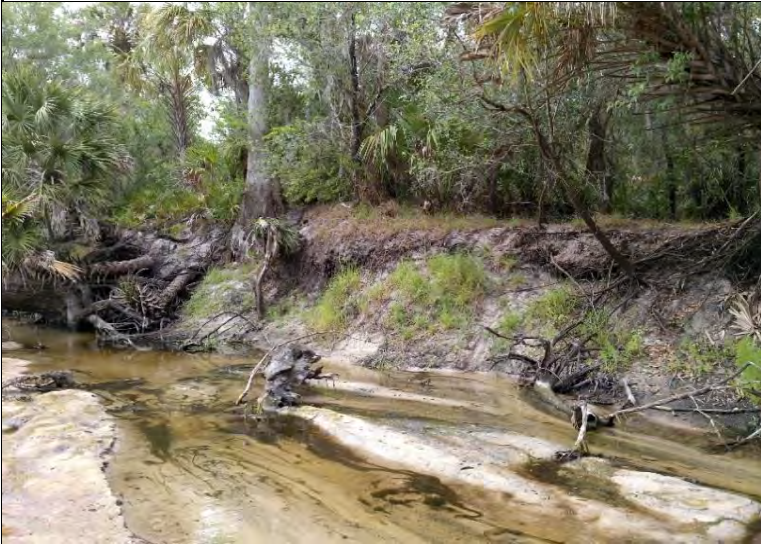
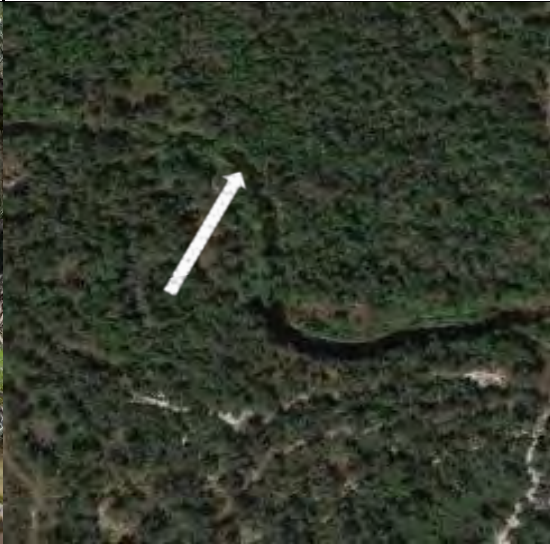
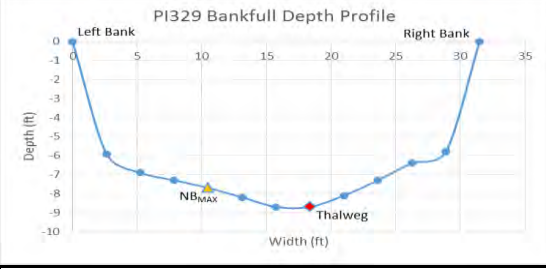
Horse Creek			Severity Scale: 3.25-Low
Watershed: Peace River Subwatershed: Lower Horse Creek Latitude: 27.16038 Longitude: -81.96816			County: Desoto Site Number: PI329 Reach Length: 190 ft. Landowner: TIITF/State of Florida

Pfankuch-Channel Stability:	Fair	1	
Channel Alteration:	None	0	
Bank Erosion:	Active	1	
BEHI:	High (31.93)	1	
Local NPSP:	No Evidence	0	
Shoring Structures:	None	0	
Pipe Discharge:	None	0	
Water Odor:	Normal	0	
Fish Passage Barrier:	None	0	
RB: Riparian Buffer:	100 ft.	0	
LB: Riparian Buffer:	100 ft.	0	
RB: Floodplain Access:	Full	0	
LB: Floodplain Access:	Partial	0.25	
<b>Severity Scale:</b>		<b>3.25</b>	
Notes: 303d: Impaired - Public Water Supply (DO & BOD)			<b>Additional Site Features</b>
			Stream Channel Woody Material: Numerous
			Impoundments: None
			Substrate Composition: Medium Sand
			Bank Material: Sand
			Near Bank Stress: Low

RB Landuse: Natural Forest
			LB Landuse: Natural Forest
Restoration Option 1

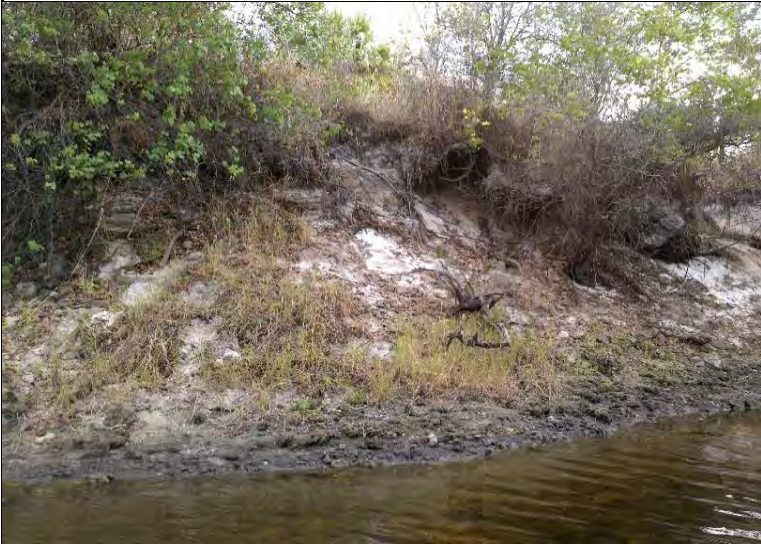
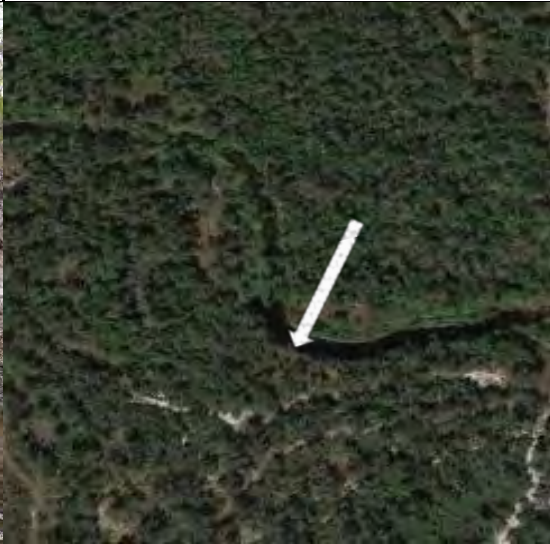
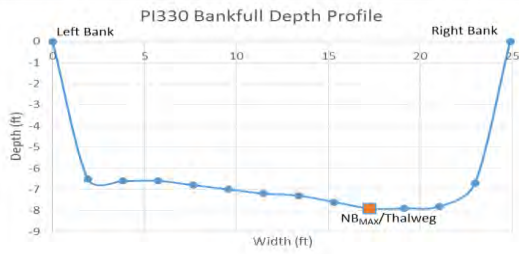
Horse Creek			Severity Scale: 4.25-Moderate
Watershed: Peace River Subwatershed: Lower Horse Creek Latitude: 27.15924 Longitude: -81.96779			County: Desoto Site Number: PI330 Reach Length: 315 ft. Landowner: TIITF/State of Florida

Pfankuch-Channel Stability:	Fair	1	
Channel Alteration:	None	0	
Bank Erosion:	Mass-wasting	1.5	
BEHI:	High (35.74)	1	
Local NPSP:	No Evidence	0	
Shoring Structures:	None	0	
Pipe Discharge:	None	0	
Water Odor:	Normal	0	
Fish Passage Barrier:	None	0	
RB: Riparian Buffer:	40 ft.	0.5	
LB: Riparian Buffer:	100 ft.	0	
RB: Floodplain Access:	Partial	0.25	
LB: Floodplain Access:	Full	0	
<b>Severity Scale:</b>		<b>4.25</b>	<b>Additional Site Features</b>
			Stream Channel Woody Material: Infrequent
			Impoundments: None
			Substrate Composition: Medium Sand
			Bank Material: Sand
			Near Bank Stress: High
			RB Landuse: Natural Forest
			LB Landuse: Natural Forest

Notes: 303d: Impaired - Public Water Supply (DO & BOD)			
Restoration Option 1

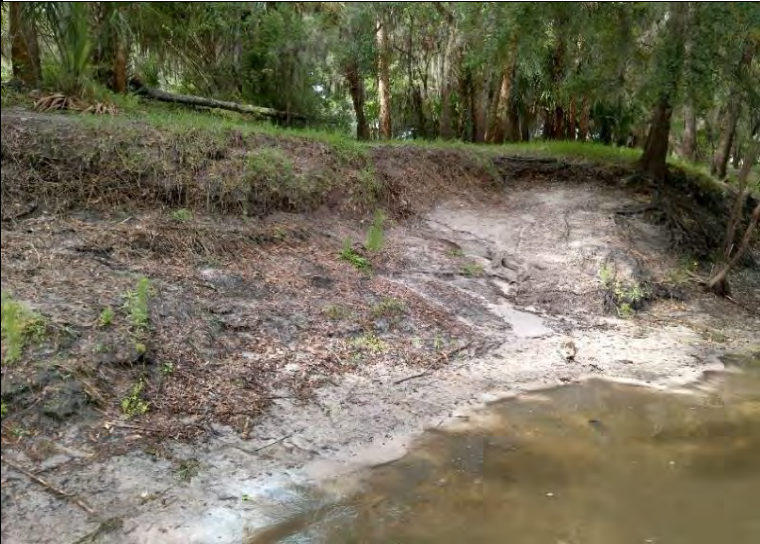
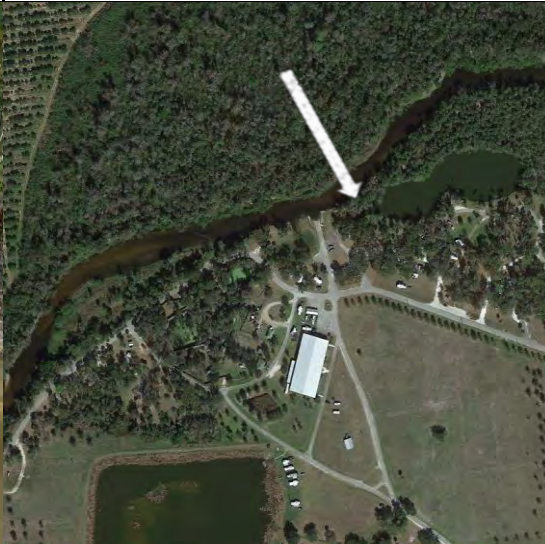
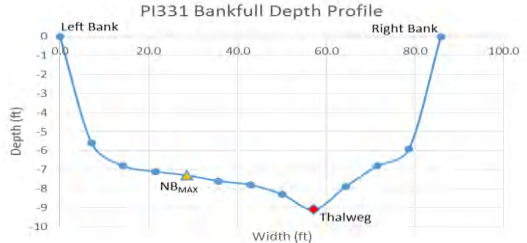
Peace River			Severity Scale: 3.25-Low
Watershed: Peace River Subwatershed: Troublesome Creek Latitude: 27.50454 Longitude: -81.80436			County: Hardee Site Number: PI331 Reach Length: 265 Landowner: Hardee County BCC

Pfankuch-Channel Stability:	Poor	1.5	
Channel Alteration:	None	0	
Bank Erosion:	Active	1	
BEHI:	Moderate (23.16)	0.5	
Local NPSP:	No Evidence	0	
Shoring Structures:	None	0	
Pipe Discharge:	None	0	
Water Odor:	Normal	0	
Fish Passage Barrier:	None	0	
RB: Riparian Buffer:	100 ft.	0	
LB: Riparian Buffer:	60 ft.	0.25	
RB: Floodplain Access:	Full	0	
LB: Floodplain Access:	Full	0	
<b>Severity Scale:</b>		<b>3.25</b>	
Notes: 303d: Impaired - Aquatic Life Harvesting (mercury in fish tissue), Chlorophyll-A			<b>Additional Site Features</b>
			Stream Channel Woody Material: Infrequent
			Impoundments: None
			Substrate Composition: Medium Sand
			Bank Material: Sand

Near Bank Stress: Low
			RB Landuse: Natural forest
			LB Landuse: Natural forest, Recreation
Restoration Option 1

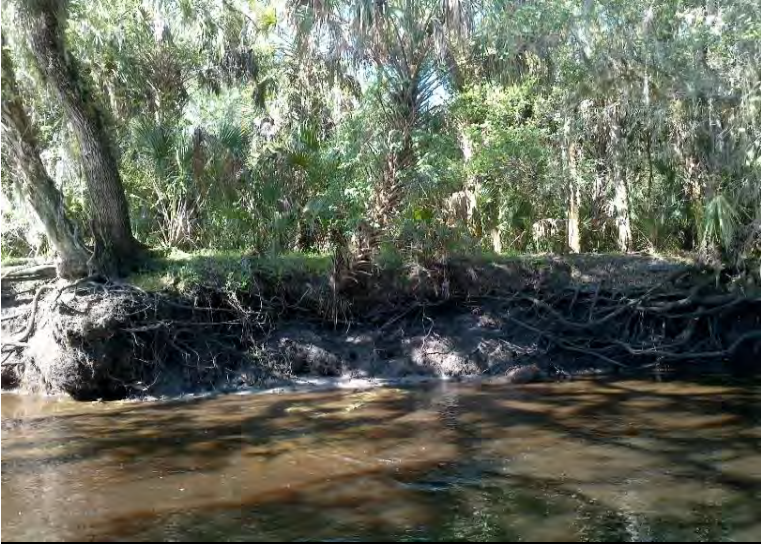
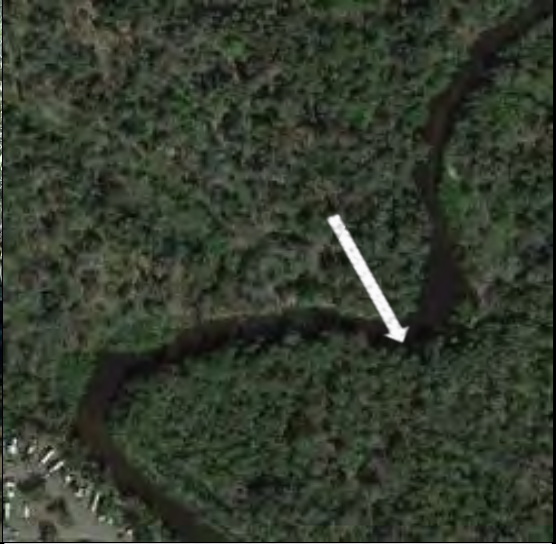
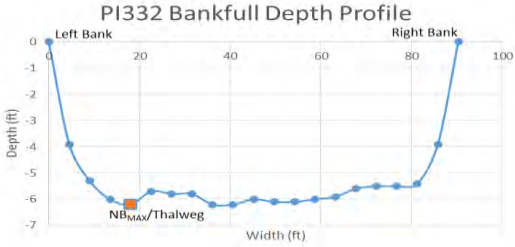
Peace River			Severity Scale: 1.25-Low
Watershed: Peace River Subwatershed: Troublesome Creek Latitude: 27.50903 Longitude: -81.79713			County: Hardee Site Number: PI332 Reach Length: 264 ft. Landowner: EIP Florida LLC

</div>
Pfankuch-Channel Stability:	Good	0	
Channel Alteration:	None	0	
Bank Erosion:	Active	1	
BEHI:	Low (13.76)	0	
Local NPSP:	No Evidence	0	
Shoring Structures:	None	0	
Pipe Discharge:	None	0	
Water Odor:	Normal	0	
Fish Passage Barrier:	None	0	
RB: Riparian Buffer:	100 ft.	0	
LB: Riparian Buffer:	100 ft.	0	
RB: Floodplain Access:	Full	0	
LB: Floodplain Access:	Partial	0.25	
<b>Severity Scale:</b>		<b>1.25</b>	<b>Additional Site Features</b>
			Stream Channel Woody Material: Moderate
			Impoundments: None
			Substrate Composition: Medium Sand
			Bank Material: Sandy Clay
			Near Bank Stress: High
			RB Landuse: Natural Forest

LB Landuse: Natural Forest
Notes: 303d: Impaired - Aquatic Life Harvesting (mercury in fish tissue), Chlorophyll-A			
Restoration Option 1

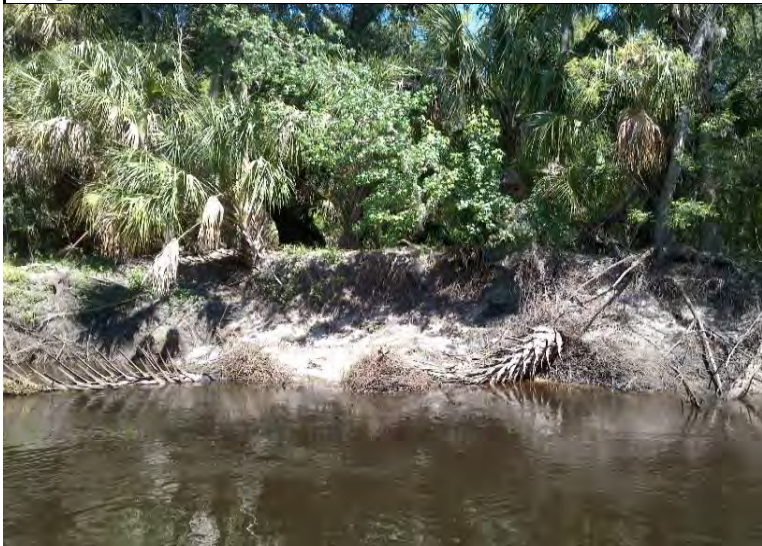
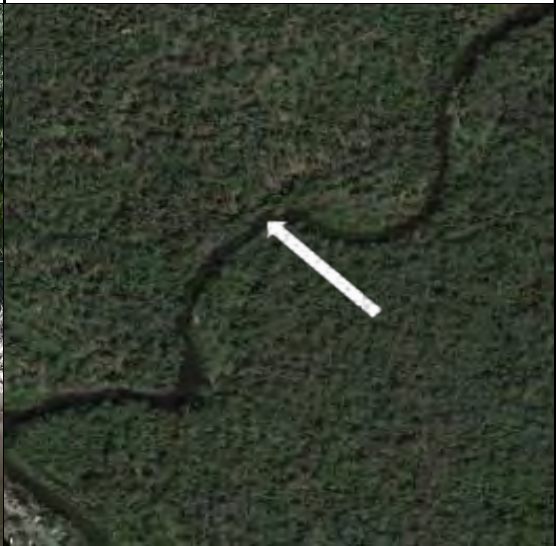
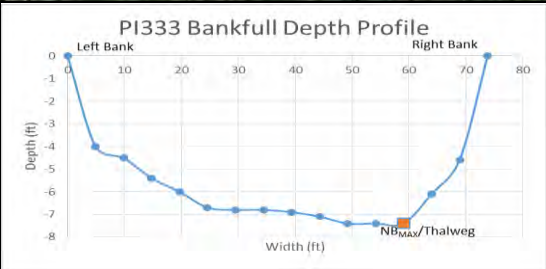
Peace River			Severity Scale: 1.75-Low	
Watershed: Peace River Subwatershed: Troublesome Creek Latitude: 27.51109 Longitude: -81.79532			County: Hardee Site Number: PI333 Reach Length: 138 ft. Landowner: EIP Florida LLC

Pfankuch-Channel Stability:	Good	0		
Channel Alteration:	None	0		
Bank Erosion:	Active	1		
BEHI:	Moderate (29.33)	0.5		
Local NPSP:	No evidence	0		
Shoring Structures:	None	0		
Pipe Discharge:	None	0		
Water Odor:	Normal	0		
Fish Passage Barrier:	None	0		
			Additional Site Features	
RB: Riparian Buffer:	100 ft.	0	Stream Channel Woody Material: Numerous	
LB: Riparian Buffer:	100 ft.	0	Impoundments: None	
RB: Floodplain Access:	Partial	0.25	Substrate Composition: Medium Sand	
LB: Floodplain Access:	Full	0	Bank Material: Sand	
			Near Bank Stress: High	
			RB Landuse: Natural Forest	
			LB Landuse: Natural Forest	
Notes: 303d: Impaired - Aquatic Life Harvesting (mercury in fish tissue), Chlorophyll-A

Restoration Option 1

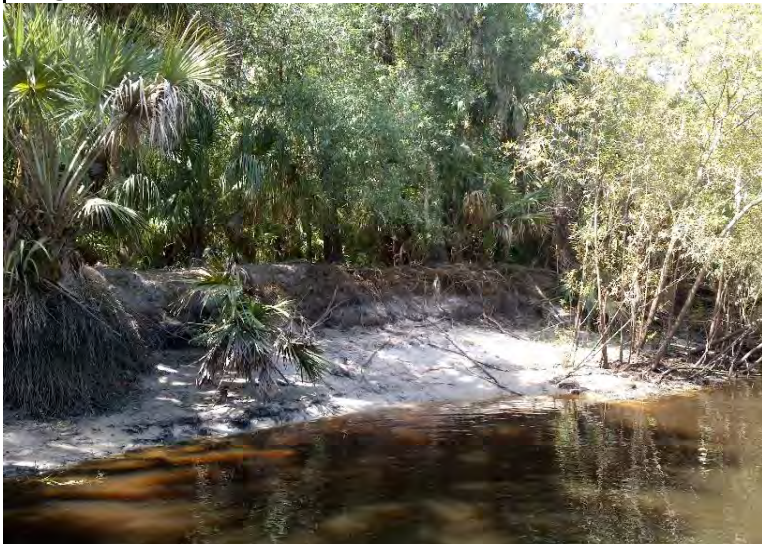
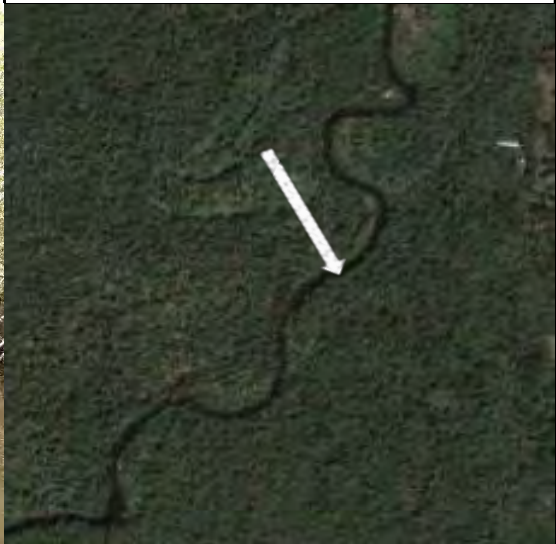
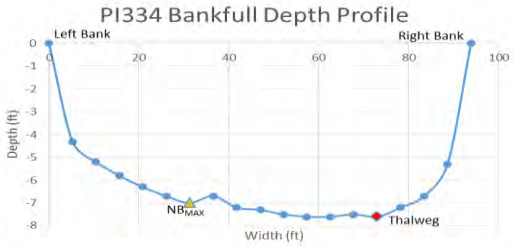
Peace River			Severity Scale: 2.25-Low	
Watershed: Peace River Subwatershed: Troublesome Creek Latitude: 27.51372 Longitude: -81.79198			County: Hardee Site Number: PI334 Reach Length: 114 ft. Landowner: EIP Florida LLC

Pfankuch-Channel Stability:	Good	0		
Channel Alteration:	None	0		
Bank Erosion:	Active	1		
BEHI:	High (30.74)	1		
Local NPSP:	No Evidence	0		
Shoring Structures:	None	0		
Pipe Discharge:	None	0		
Water Odor:	Normal	0		
Fish Passage Barrier:	None	0		
RB: Riparian Buffer:	100 ft.	0		
LB: Riparian Buffer:	100 ft.	0		
RB: Floodplain Access:	Full	0		
LB: Floodplain Access:	Partial	0.25		
Severity Scale:		2.25	Additional Site Features	
			Stream Channel Woody Material: Extensive	
			Impoundments: None	
			Substrate Composition: Medium Sand	
			Bank Material: Sand	
			Near Bank Stress: Low	
			RB Landuse: Natural Forest	
			LB Landuse: Natural Forest	
Notes: 303d: Impaired - Aquatic Life Harvesting (mercury in fish tissue), Chlorophyll-A

Restoration Option 2 or 3

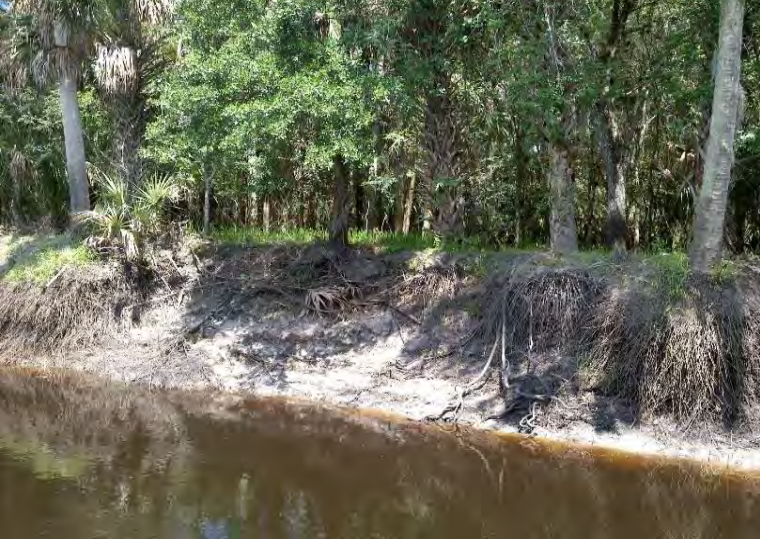
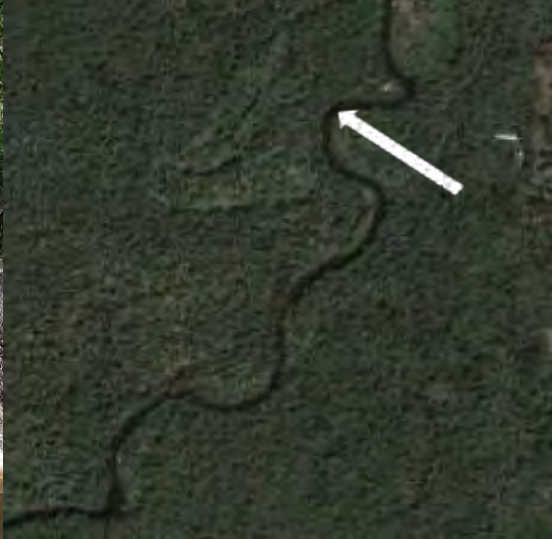
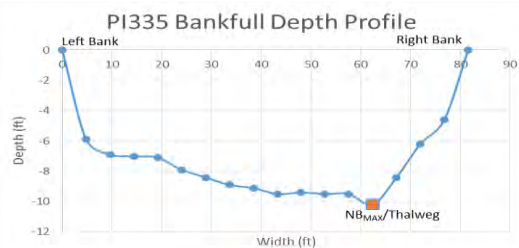
Peace River			Severity Scale: 1.5-Low
Watershed: Peace River Subwatershed: Thompson Branch Latitude: 27.51630 Longitude: -81.79236			County: Hardee Site Number: PI335 Reach Length: 185 ft. Landowner: EIP Florida LLC

Risk Factor	Ranking	Score	
Pfankuch-Channel Stability:	Good	0	
Channel Alteration:	None	0	
Bank Erosion:	Active	1	
BEHI:	Moderate (27.97)	0.5	
Local NPSP:	No Evidence	0	
Shoring Structures:	None	0	
Pipe Discharge:	None	0	
Water Odor:	Normal	0	
Fish Passage Barrier:	None	0	
RB: Riparian Buffer:	100 ft.	0	
LB: Riparian Buffer:	100 ft.	0	
RB: Floodplain Access:	Full	0	
LB: Floodplain Access:	Full	0	
Severity Scale:		1.5	
Notes: 303d: Impaired - Aquatic Life Harvesting (mercury in fish tissue), Chlorophyll-A			
Restoration Option 1

Additional Site Features
Stream Channel Woody Material: Numerous
Impoundments: None
Substrate Composition: Medium Sand
Bank Material: Sand
Near Bank Stress: High
RB Landuse: Natural Forest
LB Landuse: Natural Forest

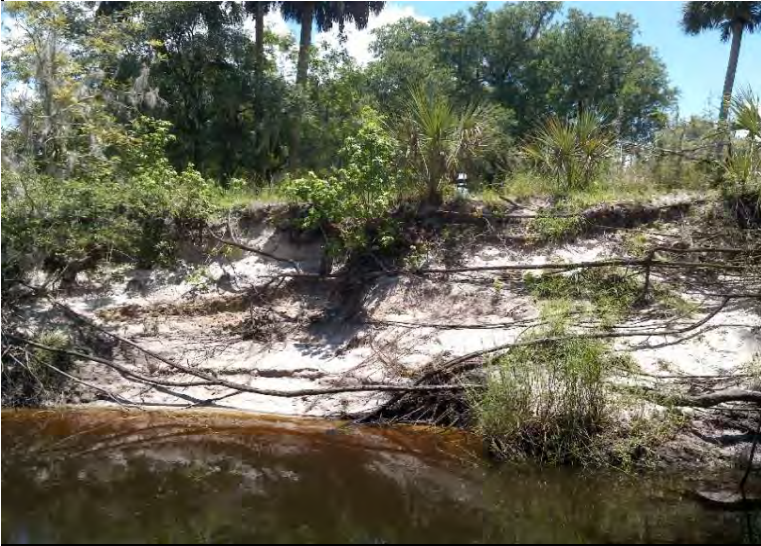
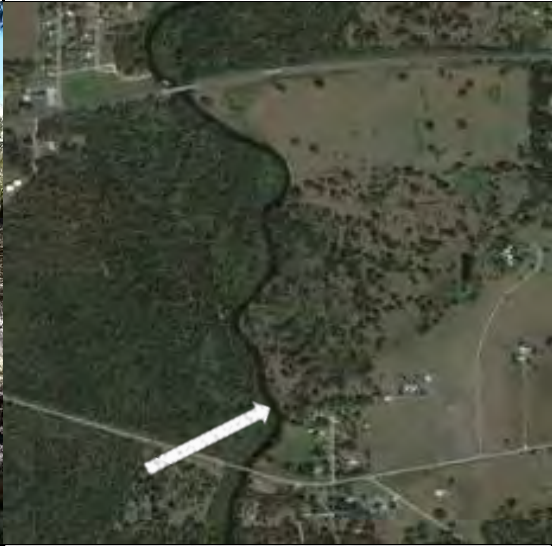
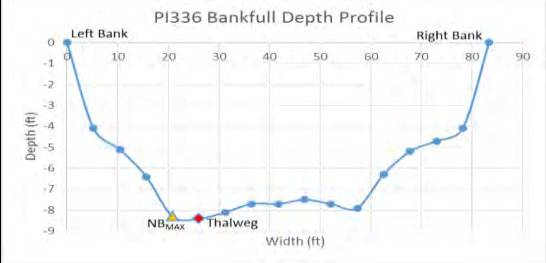
Peace River			Severity Scale: 4.5-Moderate
Watershed: Peace River Subwatershed: Thompson Branch Latitude: 27.54300 Longitude: -81.79153			County: Hardee Site Number: PI336 Reach Length: 101 ft. Landowner: Eason, J W Jr. and Betty Ann

Pfankuch-Channel Stability:	Good	0	
Channel Alteration:	None	0	
Bank Erosion:	Active	1	
BEHI:	High (37.16)	1	
Local NPSP:	Obvious Sources	1.5	
Shoring Structures:	None	0	
Pipe Discharge:	None	0	
Water Odor:	Normal	0	
Fish Passage Barrier:	None	0	
RB: Riparian Buffer:	100 ft.	0	
LB: Riparian Buffer:	0 ft.	0.75	
RB: Floodplain Access:	Full	0	
LB: Floodplain Access:	Partial	0.25	
<b>Severity Scale:</b>		<b>4.5</b>	
Notes: 303d: Impaired - Aquatic Life Harvesting (mercury in fish tissue), Chlorophyll-A			
Restoration Option 1

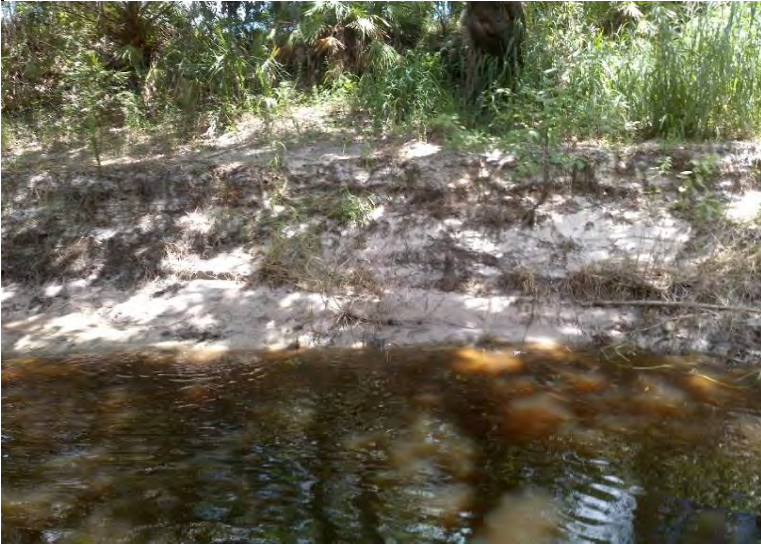
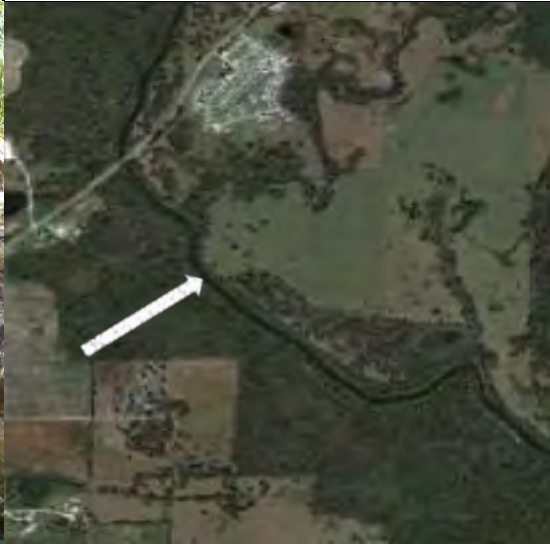
Peace River			Severity Scale: 4.0-Low
Watershed: Peace River Subwatershed: Thompson Branch Latitude: 27.57229 Longitude: -81.80223			County: Hardee Site Number: PI337 Reach Length: 85 ft. Landowner: Cynthia C. Parrish

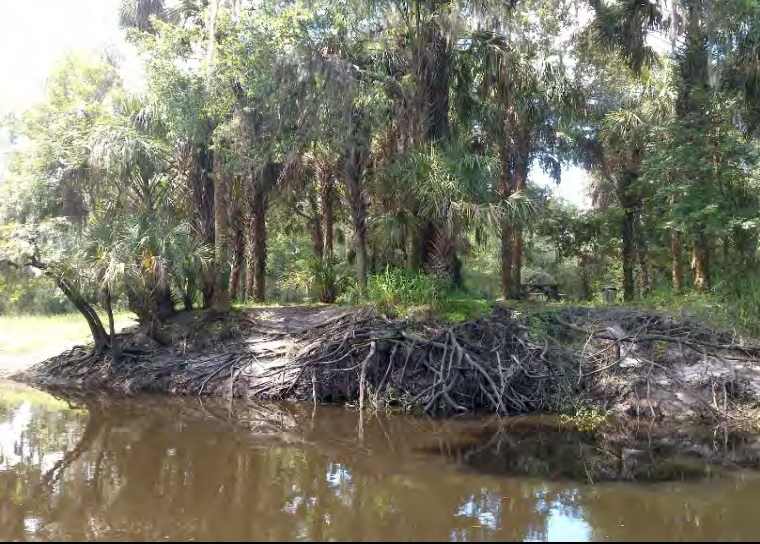
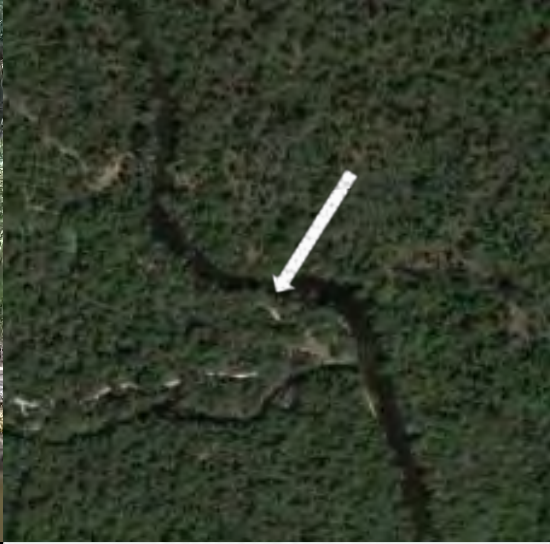
Peace River			Severity Scale: 2.5-Low
Watershed: Peace River Subwatershed: Thompson Branch Latitude: 27.61982 Longitude: -81.80216			County: Hardee Site Number: PI338 Reach Length: 169 ft. Landowner: TIITF/State of Florida

Risk Factor	Ranking	Score	
Pfankuch-Channel Stability:	Good	0	
Channel Alteration:	None	0	
Bank Erosion:	Active	1	
BEHI:	Moderate (25.18)	0.5	
Local NPSP:	No Evidence	0	
Shoring Structures:	None	0	
Pipe Discharge:	None	0	
Water Odor:	Normal	0	
Fish Passage Barrier:	None	0	
RB: Riparian Buffer:	40 ft.	0.5	
LB: Riparian Buffer:	100 ft.	0	
RB: Floodplain Access:	Partial	0.25	
LB: Floodplain Access:	Partial	0.25	
<b>Severity Scale:</b>		<b>2.5</b>	
Notes: 303d - Impaired: Aquatic Life Harvesting (mercury in fish tissue)			
Restoration Option 1

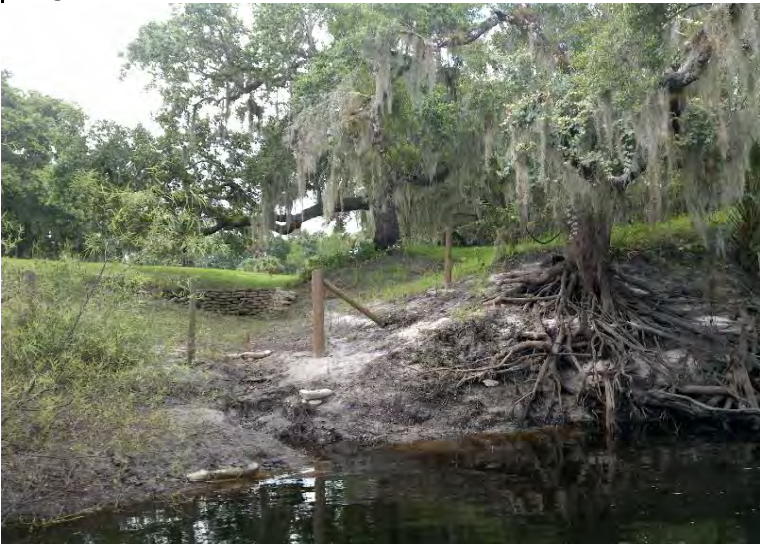
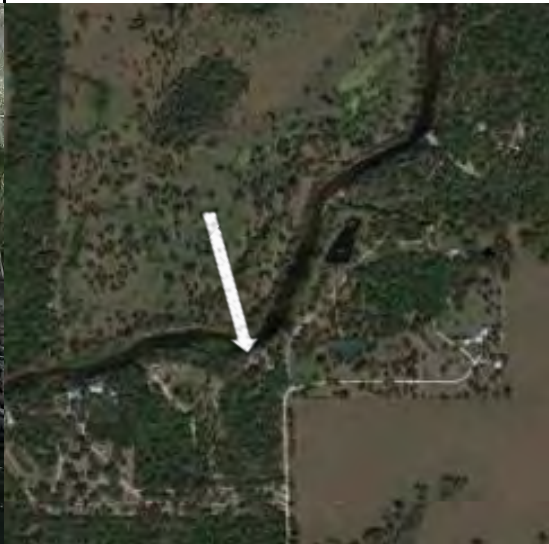
Peace River			Severity Scale: 3.75-Low	
Watershed: Peace River Subwatershed: McBride Branch Latitude: 27.29383 Longitude: -81.85000			County: Desoto Site Number: PI339 Reach Length: 290 ft. Landowner: PARAISO LLC

Pfankuch-Channel Stability:	Good	0		
Channel Alteration:	None	0		
Bank Erosion:	Active	1		
BEHI:	Low (15.29)	0		
Local NPSP:	Obvious Sources	1.5		
Shoring Structures:	None	0		
Pipe Discharge:	None	0		
Water Odor:	Normal	0		
Fish Passage Barrier:	None	0		
RB: Riparian Buffer:	60 ft.	0.25		
LB: Riparian Buffer:	10 ft.	0.75		
RB: Floodplain Access:	Full	0		
LB: Floodplain Access:	Partial	0.25		
Severity Scale:		3.75		
Notes: Little rock debris - trash; cattle or horse pasture; fenced out; 303d - Impaired: Aquatic Life Harvesting (fecal coliform, mercury in fish tissue)				
Restoration Option 1

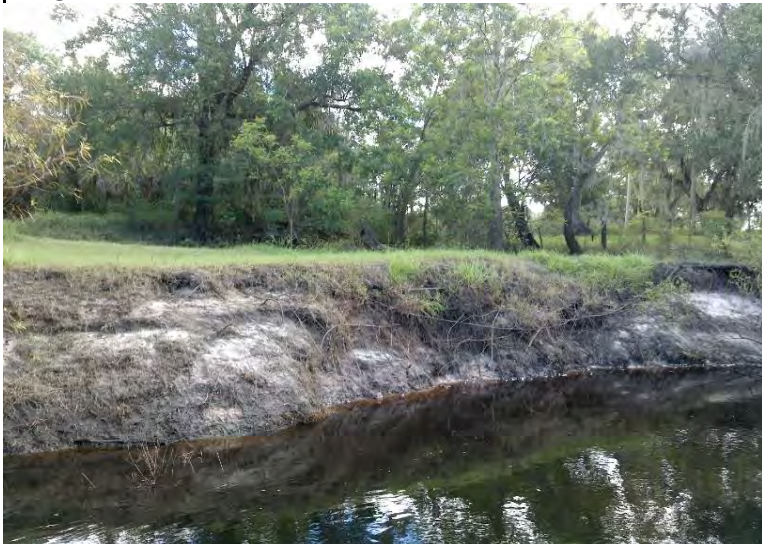
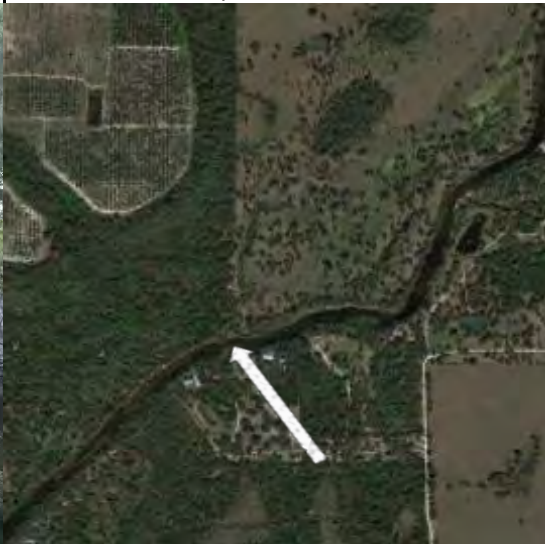
Peace River			Severity Scale: 3.25-Low	
Watershed: Peace River Subwatershed: McBride Branch Latitude: 27.29331 Longitude: -81.85373			County: Desoto Site Number: PI340 Reach Length: 282 ft. Landowner: Riverpeace Inc

Pfankuch-Channel Stability:	Good	0		
Channel Alteration:	None	0		
Bank Erosion:	Active	1		
BEHI:	Low (10.55)	0		
Local NPSP:	Obvious Sources	1.5		
Shoring Structures:	None	0		
Pipe Discharge:	None	0		
Water Odor:	Normal	0		
Fish Passage Barrier:	None	0		
RB: Riparian Buffer:	40 ft.	0.5	<b>Additional Site Features</b>	
LB: Riparian Buffer:	60 ft.	0.25	Stream Channel Woody Material: Numerous	
RB: Floodplain Access:	Full	0	Impoundments: None	
LB: Floodplain Access:	Full	0	Substrate Composition: Medium Sand	
Severity Scale:		3.25	Bank Material: Sandy Clay	
Notes: 303d - Impaired: Aquatic Life Harvesting (fecal coliform, mercury in fish tissue)			Near Bank Stress: High

Restoration Option 1			RB Landuse: Natural Forest, Pasture	
			LB Landuse: Natural Forest, Residential

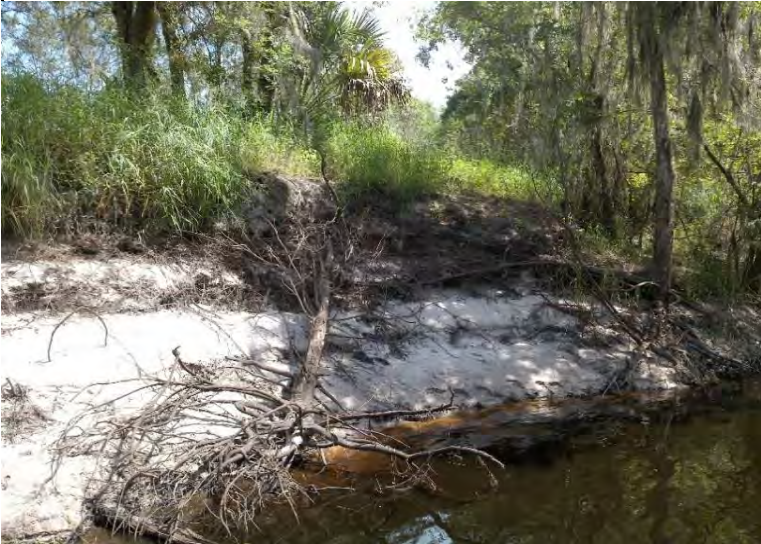
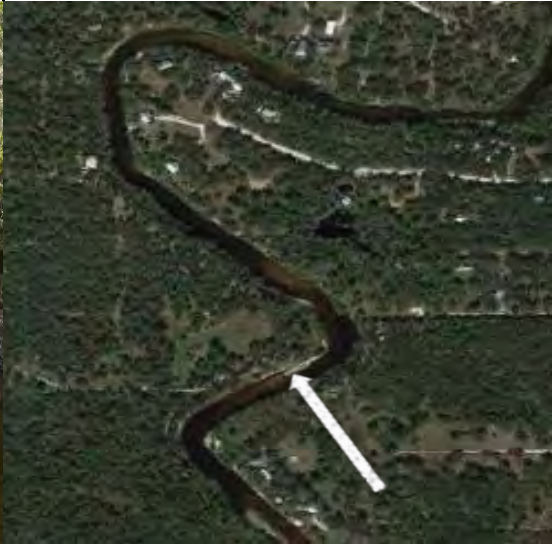
Peace River			Severity Scale: 3.5-Low
Watershed: Peace River Subwatershed: McBride Branch Latitude: 27.27829 Longitude: -81.85983			County: Desoto Site Number: PI341 Reach Length: 108 ft. Landowner: Anthony and Dorothy Werner

Risk Factor	Ranking	Score	
Pfankuch-Channel Stability:	Good	0	
Channel Alteration:	None	0	
Bank Erosion:	Active	1	
BEHI:	High (36.29)	1	
Local NPSP:	Slight Potential	0.5	
Shoring Structures:	None	0	
Pipe Discharge:	None	0	<b>Additional Site Features</b> Stream Channel Woody Material: Infrequent Impoundments: None Substrate Composition: Medium Sand Bank Material: Sand Near Bank Stress: Low RB Landuse: Residential LB Landuse: Natural Forest, Recreation
Water Odor:	Normal	0	
Fish Passage Barrier:	None	0	
RB: Riparian Buffer:	20 ft.	0.75	
LB: Riparian Buffer:	100 ft.	0	
RB: Floodplain Access:	Partial	0.25	
LB: Floodplain Access:	Full	0	
<b>Severity Scale:</b>		<b>3.5</b>

Notes: 303d - Impaired: Aquatic Life Harvesting (fecal coliform, mercury in fish tissue)			
Restoration Option 1
