# **Peace River and Withlacoochee River Threats Assessments and Fish Assemblage Monitoring**

**Final Report July 1, 2015 – June 30, 2019**

Submitted to Florida State Wildlife Grants Program  
August 1, 2019  
PID: 98462501284

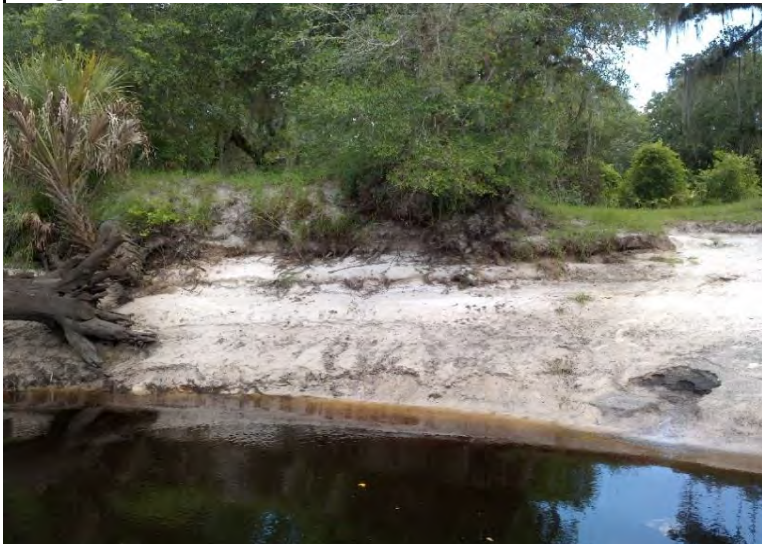
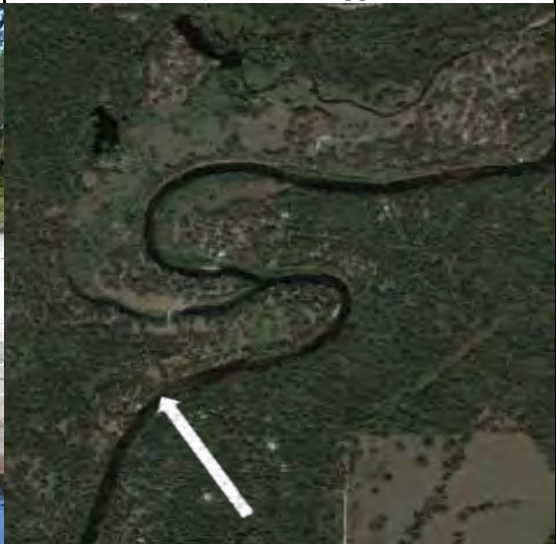
Peace River			Severity Scale: 4.0-Low	
Watershed: Peace River Subwatershed: McBride Branch Latitude: 27.26422 Longitude: -81.86738			County: Desoto Site Number: PI342 Reach Length: 80 ft. Landowner: Charlotte A Bragg

Pfankuch-Channel Stability:	Good	0		
Channel Alteration:	None	0		
Bank Erosion:	Active	1		
BEHI:	Very High (40.59)	1.5		
Local NPSP:	Slight Potential	0.5		
Shoring Structures:	None	0		
Pipe Discharge:	None	0		
Water Odor:	Normal	0		
Fish Passage Barrier:	None	0		
RB: Riparian Buffer:	20 ft.	0.75		
LB: Riparian Buffer:	100 ft.	0		
RB: Floodplain Access:	Partial	0.25		
LB: Floodplain Access:	Full	0		
Severity Scale:		4.0		
			Additional Site Features	
			Stream Channel Woody Material: Infrequent	
			Impoundments: None	
			Substrate Composition: Medium Sand	
			Bank Material: Sand	
			Near Bank Stress: Low	
			RB Landuse: Recreation, Natural Forest	
			LB Landuse: Natural Forest

Notes: Campsite; 303d - Impaired: Aquatic Life Harvesting (fecal coliform, mercury in fish tissue)				
Restoration Option 1

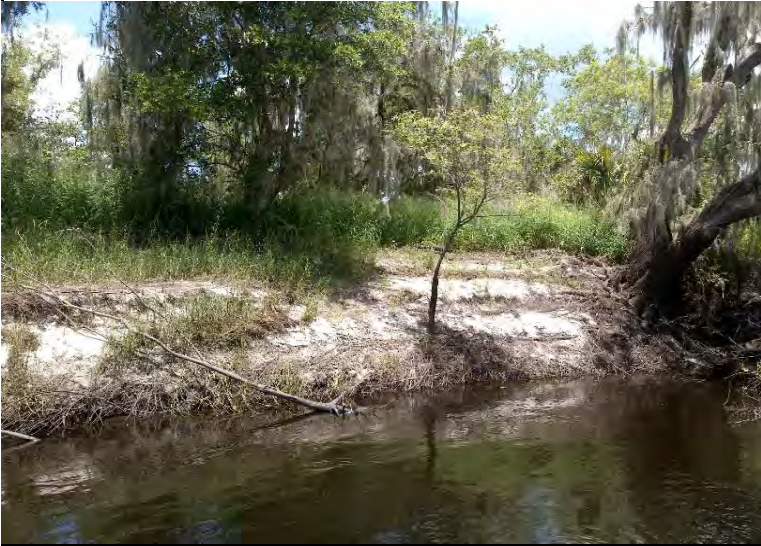
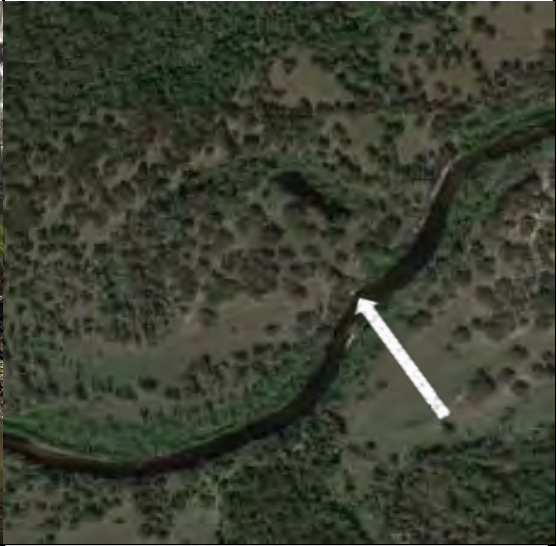
Peace River			Severity Scale: 4.25-Moderate
Watershed: Peace River Subwatershed: McBride Branch Latitude: 27.25359 Longitude: -81.87567			County: Desoto Site Number: PI343 Reach Length: Landowner: Constructora Limonar LLC

Risk Factor	Ranking	Score	
Pfankuch-Channel Stability:	Good	0	
Channel Alteration:	None	0	
Bank Erosion:	Active	1	
BEHI:	Moderate (26.23)	0.5	
Local NPSP:	Obvious Sources	1.5	
Shoring Structures:	None	0	
Pipe Discharge:	None	0	
Water Odor:	Normal	0	
Fish Passage Barrier:	None	0	
RB: Riparian Buffer:	40 ft.	0.5	
LB: Riparian Buffer:	40 ft.	0.5	
RB: Floodplain Access:	Partial	0.25	
LB: Floodplain Access:	Full	0	
<b>Severity Scale:</b>		<b>4.25</b>

Additional Site Features
			Stream Channel Woody Material: Moderate
			Impoundments: None
			Substrate Composition: Medium Sand
			Bank Material: Sand
			Near Bank Stress: Moderate
			RB Landuse: Pasture, Natural Forest
			LB Landuse: Pasture, Natural Forest

Notes: 303d: Impaired - Aquatic Life Harvesting (fecal coliform, mercury in fish tissue)			
Restoration Option 2 or 3

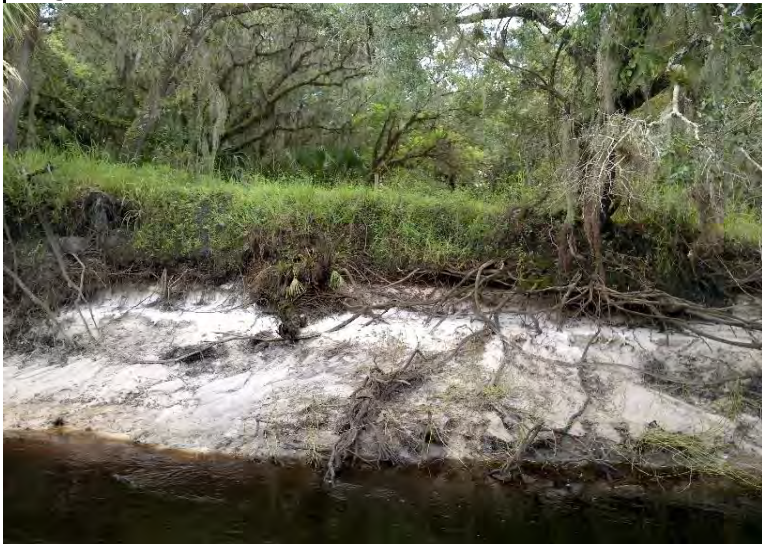
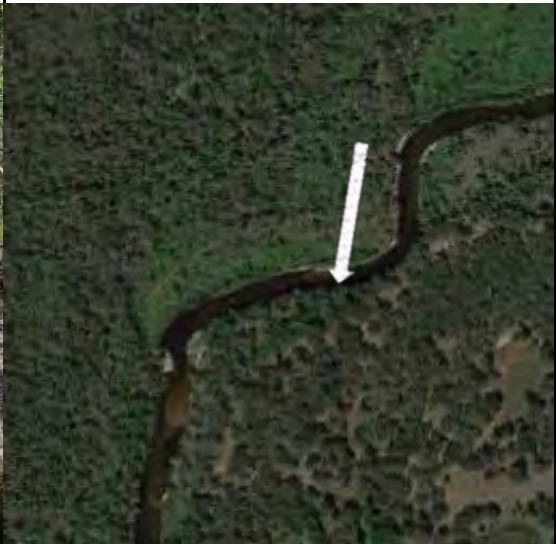
Peace River			Severity Scale: 3.75-Low	
Watershed: Peace River Subwatershed: McBride Branch Latitude: 27.24648 Longitude: -81.88428			County: Desoto Site Number: PI344 Reach Length: 612 ft. Landowner: Daniel E Lambert

Pfankuch-Channel Stability:	Good	0		
Channel Alteration:	None	0		
Bank Erosion:	Active	1		
BEHI:	Low (16.38)	0		
Local NPSP:	Obvious Sources	1.5		
Shoring Structures:	None	0		
Pipe Discharge:	None	0		
Water Odor:	Normal	0		
Fish Passage Barrier:	None	0		
RB: Riparian Buffer:	40 ft.	0.5		
LB: Riparian Buffer:	40 ft.	0.5		
RB: Floodplain Access:	Full	0		
LB: Floodplain Access:	Partial	0.25		
Severity Scale:		3.75	Additional Site Features	
			Stream Channel Woody Material: Infrequent	
			Impoundments: None	
			Substrate Composition: Medium Sand	
			Bank Material: Sand	
			Near Bank Stress: Moderate	
			RB Landuse: Natural Forest	
			LB Landuse: Natural Forest, Pasture

Notes: 303d - Impaired: Aquatic Life Harvesting (fecal coliform, mercury in fish tissue)				
Restoration Option 1

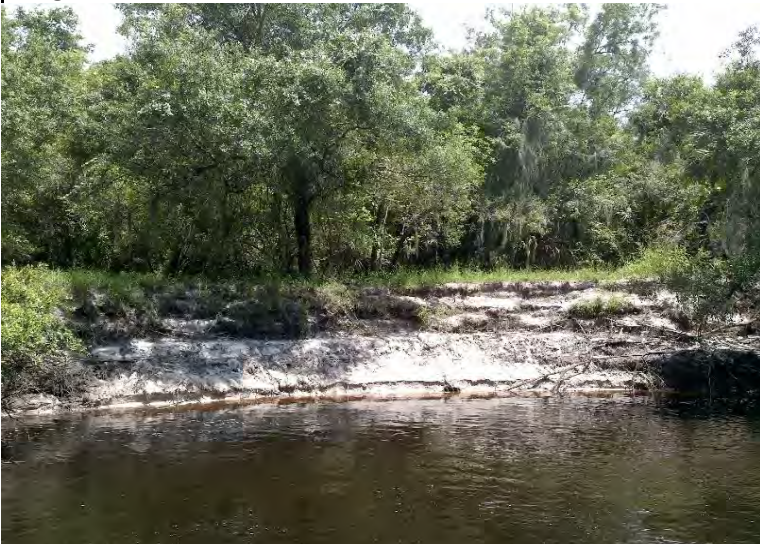
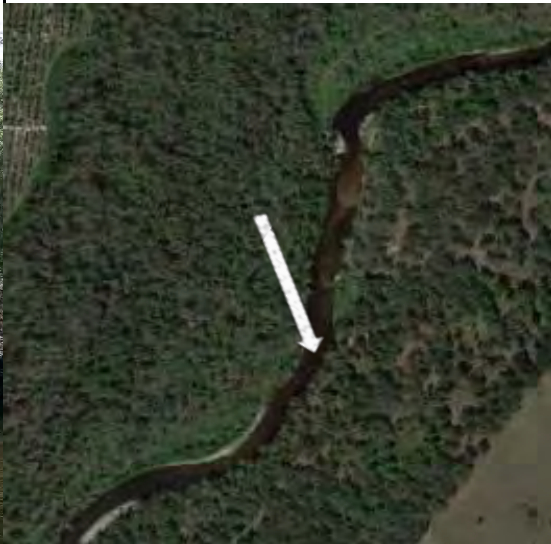
Peace River			Severity Scale: 2.75	
Watershed: Peace River Subwatershed: McBride Branch Latitude: 27.24312 Longitude: -81.88570			County: Desoto Site Number: PI345 Reach Length: 656 ft. Landowner: COLLINS CARY B TR &

Pfankuch-Channel Stability:	Good	0		
Channel Alteration:	None	0		
Bank Erosion:	Active	1		
BEHI:	Low (15.28)	0		
Local NPSP:	Obvious Sources	1.5		
Shoring Structures:	None	0		
Pipe Discharge:	None	0		
Water Odor:	Normal	0		
Fish Passage Barrier:	None	0		
RB: Riparian Buffer:	100 ft.	0		
LB: Riparian Buffer:	100 ft.	0		
RB: Floodplain Access:	Full	0		
LB: Floodplain Access:	Partial	0.25		
Severity Scale:		2.75	Additional Site Features	
			Stream Channel Woody Material: Infrequent	
			Impoundments: None	
			Substrate Composition: Medium Sand	
			Bank Material: Sandy Clay	
			Near Bank Stress: Moderate	
			RB Landuse: Natural Forest	
			LB Landuse: Natural Forest, Pasture

Notes: 303d - Impaired: Aquatic Life Harvesting (fecal coliform, mercury in fish tissue)				
Restoration Option 1

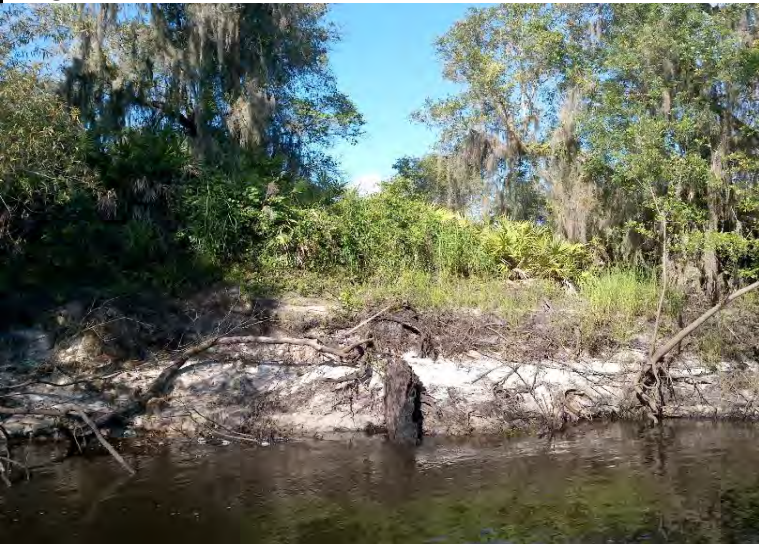
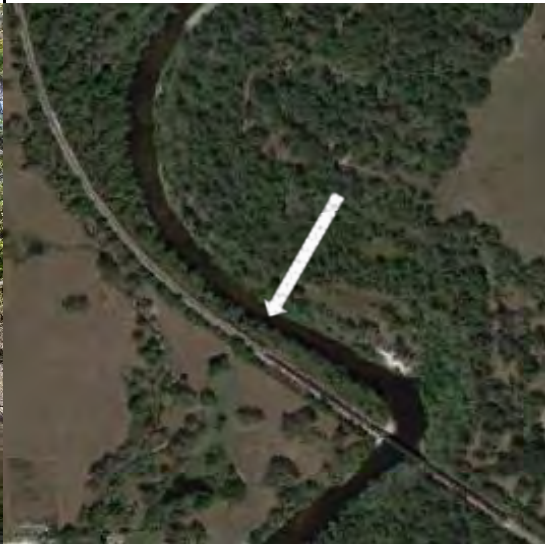
Peace River			Severity Scale: 2.25-Low	
Watershed: Peace River Subwatershed: McBride Branch Latitude: 27.23797 Longitude: -81.88751			County: Desoto Site Number: PI346 Reach Length: 322 ft. Landowner: Parker, John W. Sr. & Sue

Pfankuch-Channel Stability:	Good	0		
Channel Alteration:	None	0		
Bank Erosion:	Active	1		
BEHI:	Moderate (27.85)	0.5		
Local NPSP:	No Evidence	0		
Shoring Structures:	None	0		
Pipe Discharge:	None	0		
Water Odor:	Normal	0		
Fish Passage Barrier:	None	0		
RB: Riparian Buffer:	40 ft.	0.5		
LB: Riparian Buffer:	100 ft.	0		
RB: Floodplain Access:	Partial	0.25		
LB: Floodplain Access:	Full	0		
Severity Scale:		2.25		
			Additional Site Features	
			Stream Channel Woody Material: Numerous	
			Impoundments: None	
			Substrate Composition: Medium Sand	
			Bank Material: Sand	
			Near Bank Stress: Moderate	
			RB Landuse: Natural Forest, Transportation

LB Landuse: Natural Forest	
Notes: 303d - Impaired: Aquatic Life Harvesting (fecal coliform, mercury in fish tissue); Train track runs approx. 75 ft. from top of bank - cleared riparian vegetation				
Restoration Option 2 or 3

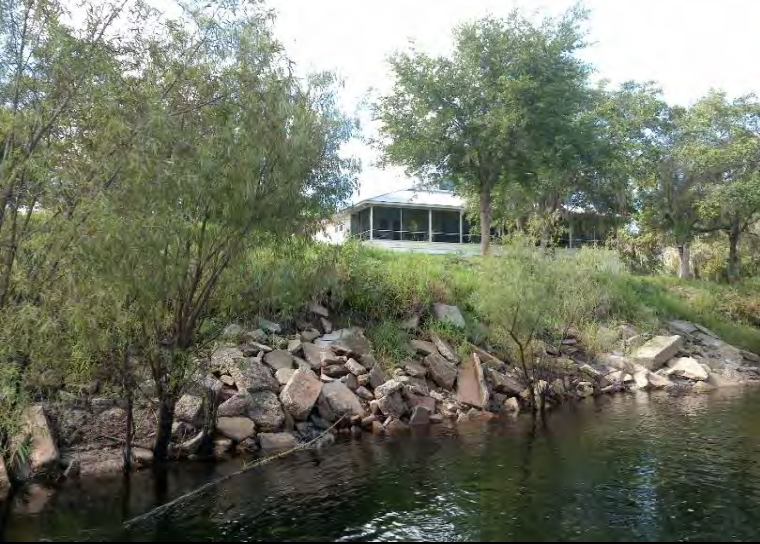
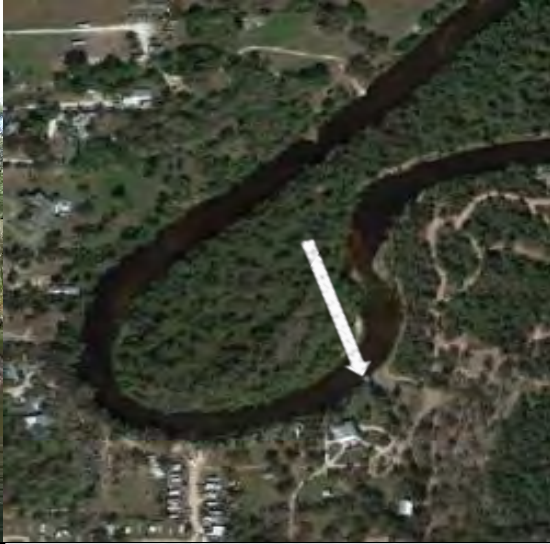
Peace River			Severity Scale: 5.0-Moderate
Watershed: Peace River Subwatershed: Johnson Lake - Peace River Latitude: 27.23198 Longitude: -81.88816			County: Desoto Site Number: PI347 Reach Length: 644 ft. Landowner: Four Marnan Inc.

Pfankuch-Channel Stability:	Good	0	
Channel Alteration:	None	0	
Bank Erosion:	Active	1	
BEHI:	High (39.31)	1	
Local NPSP:	Slight Potential	0.5	
Shoring Structures:	Present	1.5	
Pipe Discharge:	None	0	
Water Odor:	Normal	0	
Fish Passage Barrier:	None	0	
RB: Riparian Buffer:	0 ft.	0.75	
LB: Riparian Buffer:	100 ft.	0	
RB: Floodplain Access:	Partial	0.25	
LB: Floodplain Access:	Full	0	
Severity Scale:		5.0	
Notes: 303d - Impaired: Aquatic Life Harvesting (fecal coliform, mercury in fish tissue)			Additional Site Features
Restoration Option 1			Stream Channel Woody Material: Moderate
			Impoundments: None
			Substrate Composition: Medium Sand

Bank Material: Sand
			Near Bank Stress: Moderate
			RB Landuse: Residential, Natural Forest
			LB Landuse: Natural Forest

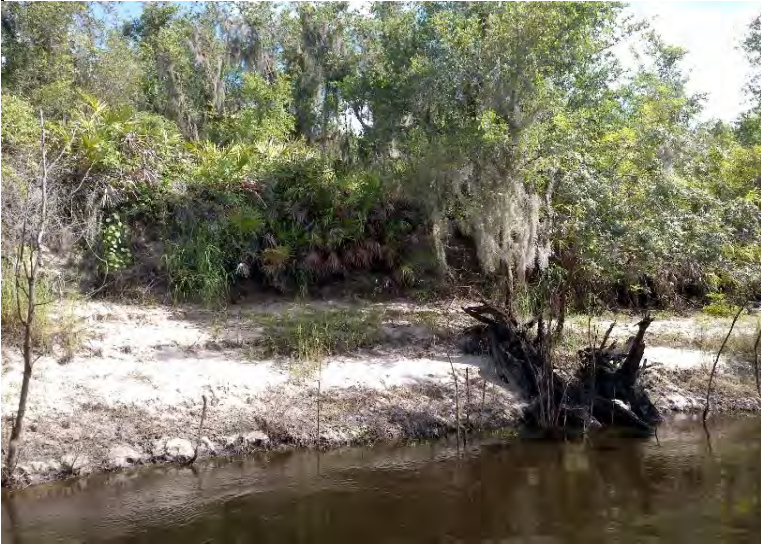
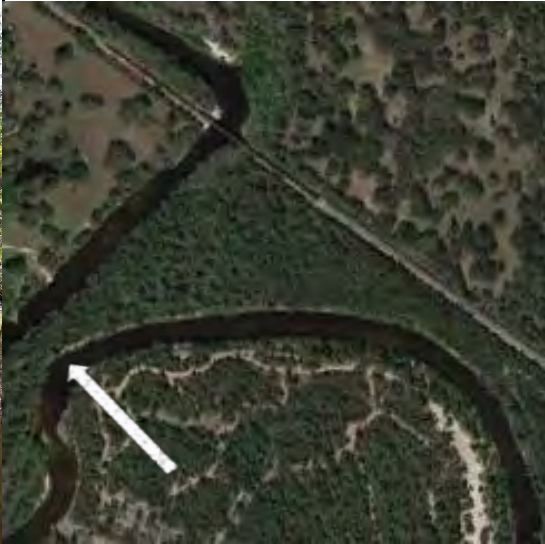
Peace River			Severity Scale: 2.5-Low
Watershed: Peace River Subwatershed: Johnson Lake - Peace River Latitude: 27.23411 Longitude: -81.88760			County: Desoto Site Number: PI348 Reach Length: 385 ft. Landowner: Neal Roy Jr. Estate

</div>
Pfankuch-Channel Stability:	Good	0	
Channel Alteration:	None	0	
Bank Erosion:	Active	1	
BEHI:	High (30.27)	1	
Local NPSP:	No Evidence	0	
Shoring Structures:	None	0	
Pipe Discharge:	None	0	
Water Odor:	Normal	0	
Fish Passage Barrier:	None	0	
RB: Riparian Buffer:	60 ft.	0.25	
LB: Riparian Buffer:	100 ft.	0	
RB: Floodplain Access:	Full	0	
LB: Floodplain Access:	Partial	0.25	
<b>Severity Scale:</b>		<b>2.5</b>	
			Additional Site Features
			Stream Channel Woody Material: Numerous
			Impoundments: None
			Substrate Composition: Medium Sand
			Bank Material: Sand
			Near Bank Stress: High
			RB Landuse: Natural Forest, Recreation

LB Landuse: Natural Forest
Notes: 303d - Impaired: Aquatic Life Harvesting (fecal coliform, mercury in fish tissue)			
Restoration Option 1

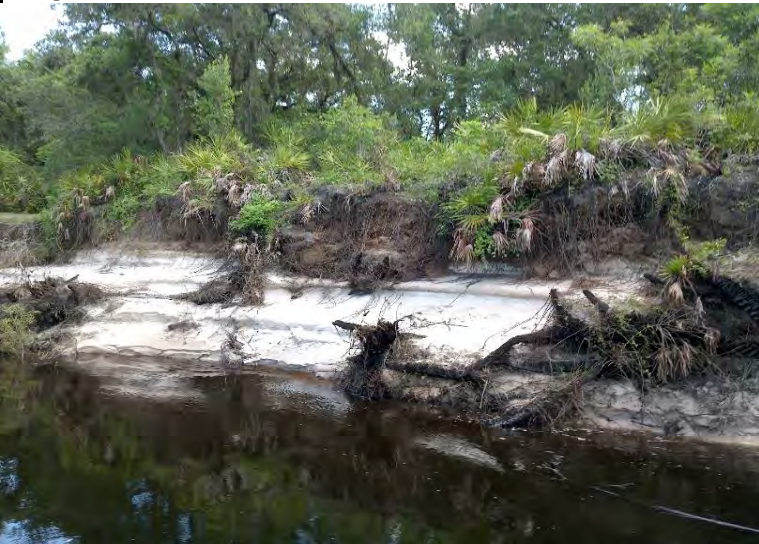
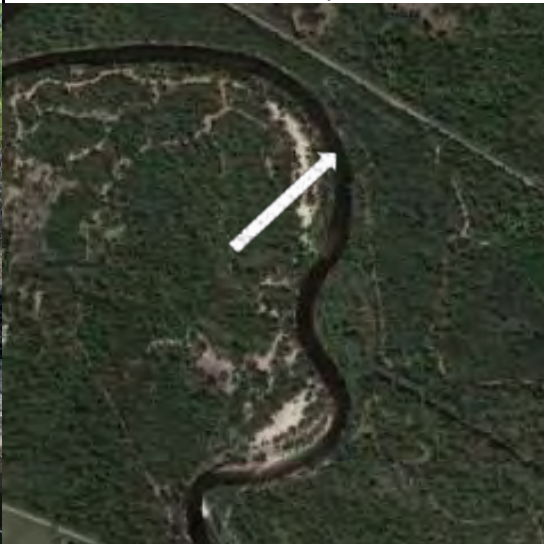
Peace River			Severity Scale: 3.25	
Watershed: Peace River Subwatershed: Johnson Lake - Peace River Latitude: 27.23021 Longitude: -81.88251			County: Desoto Site Number: PI349 Reach Length: 1,650 ft. Landowner: DeSoto County

Channel Alteration:	None	0		
Bank Erosion:	Mass-wasting	1.5		
BEHI:	High (35.27)	1		
Local NPSP:	No Evidence	0		
Shoring Structures:	None	0		
Pipe Discharge:	None	0		
Water Odor:	Normal	0		
Fish Passage Barrier:	None	0		
RB: Riparian Buffer:	40 ft.	0.5		
LB: Riparian Buffer:	100 ft.	0		
RB: Floodplain Access:	Full	0		
LB: Floodplain Access:	Partial	0.25		
Severity Scale:		3.25	Additional Site Features	
			Stream Channel Woody Material: Numerous	
			Impoundments: None	
			Substrate Composition: Medium Sand	
			Bank Material: Sand	
			Near Bank Stress: Moderate	
			RB Landuse: Recreation, Natural Forest

LB Landuse: Natural Forest	
Notes: 303d - Impaired: Aquatic Life Harvesting (fecal coliform, mercury in fish tissue);				
Long reach - some sections with good willows and cypress				
Restoration Option 1

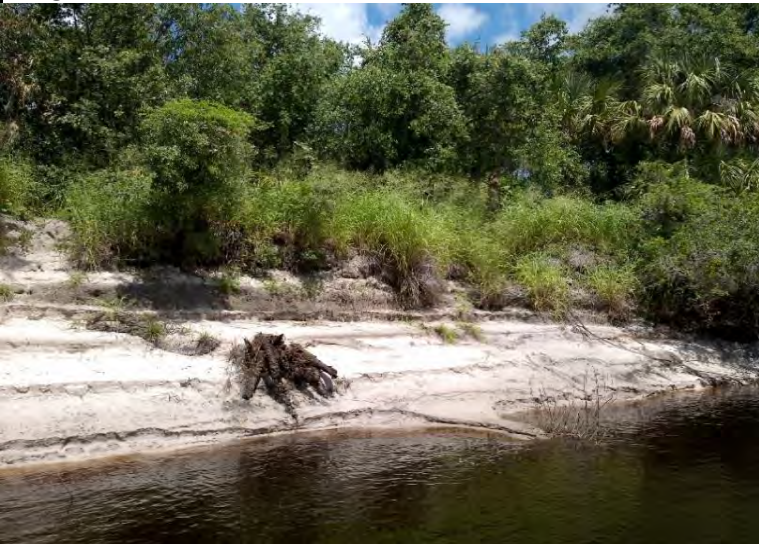
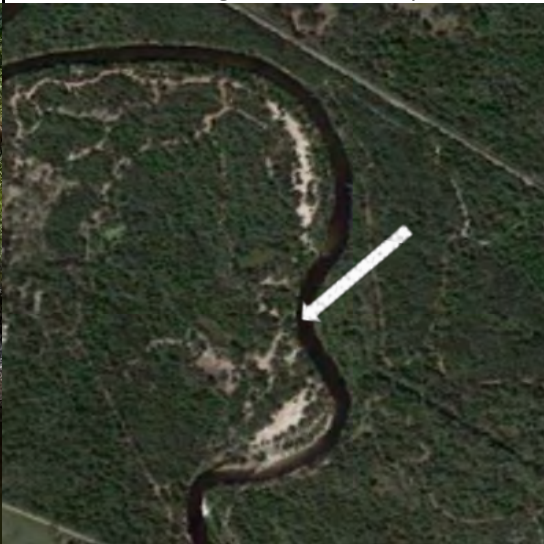
Peace River			Severity Scale: 3.25-Low	
Watershed: Peace River Subwatershed: Johnson Lake - Peace River Latitude: 27.22926 Longitude: -81.88292			County: Desoto Site Number: PI350 Reach Length: Landowner: George & Jonica Lempeneau

Pfankuch-Channel Stability:	Good	0		
Channel Alteration:	None	0		
Bank Erosion:	Active	1		
BEHI:	High (31.93)	1		
Local NPSP:	Slight Potential	0.5		
Shoring Structures:	None	0		
Pipe Discharge:	None	0		
Water Odor:	Normal	0		
Fish Passage Barrier:	None	0		
RB: Riparian Buffer:	40 ft.	0.5		
LB: Riparian Buffer:	100 ft.	0		
RB: Floodplain Access:	Full	0		
LB: Floodplain Access:	Partial	0.25		
Severity Scale:		3.25		
			Additional Site Features	
			Stream Channel Woody Material: None	
			Impoundments: None	
			Substrate Composition: Medium Sand	
			Bank Material: Sand	
			Near Bank Stress: Moderate	
			RB Landuse: Natural Forest, Pasture

LB Landuse: Natural Forest	
Notes: 303d - Impaired: Aquatic Life Harvesting (fecal coliform, mercury in fish tissue)				
Restoration Option 1

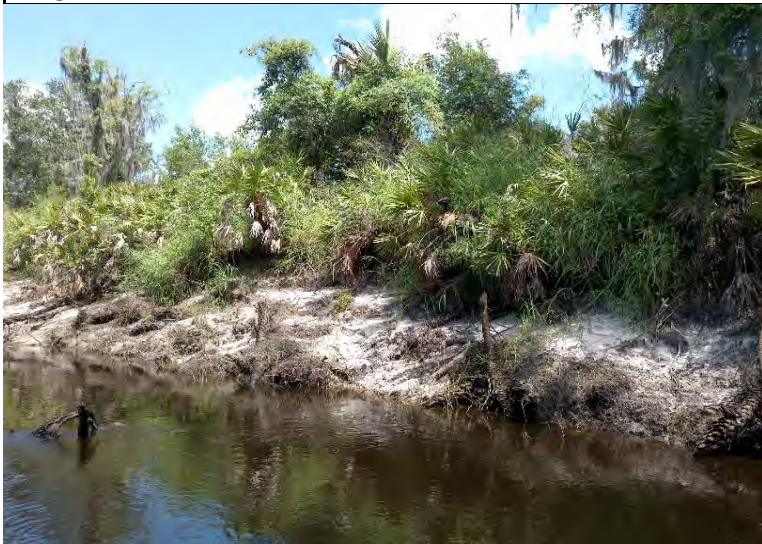
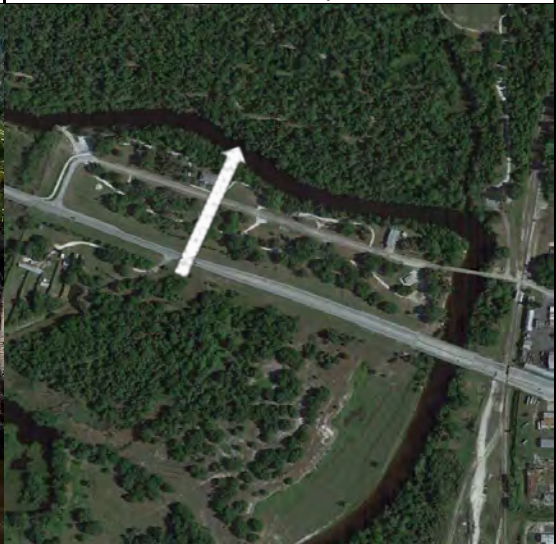
Peace River			Severity Scale: 4.0-Low	
Watershed: Peace River Subwatershed: Johnson Lake - Peace River Latitude: 27.22382 Longitude: -81.87945			County: Desoto Site Number: PI351 Reach Length: 355 ft. Landowner: Desoto County

Pfankuch-Channel Stability:	Poor	1.5		
Channel Alteration:	None	0		
Bank Erosion:	Active	1		
BEHI:	Moderate (28.91)	0.5		
Local NPSP:	No Evidence	0		
Shoring Structures:	None	0		
Pipe Discharge:	None	0		
Water Odor:	Normal	0		
Fish Passage Barrier:	None	0		
			Additional Site Features	
RB: Riparian Buffer:	40 ft.	0.5	Stream Channel Woody Material: Numerous	
LB: Riparian Buffer:	60 ft.	0.25	Impoundments: None	
RB: Floodplain Access:	Full	0	Substrate Composition: Medium Sand	
LB: Floodplain Access:	Partial	0.25	Bank Material: Sand	
			Near Bank Stress: High	
			RB Landuse: Natural Forest, Commercial	
			LB Landuse: Natural Forest, Recreation

<b>Severity Scale:</b>			<b>4.0</b>	
Notes: 303d - Impaired: Aquatic Life Harvesting (fecal coliform, mercury in fish tissue)				
Restoration Option 1

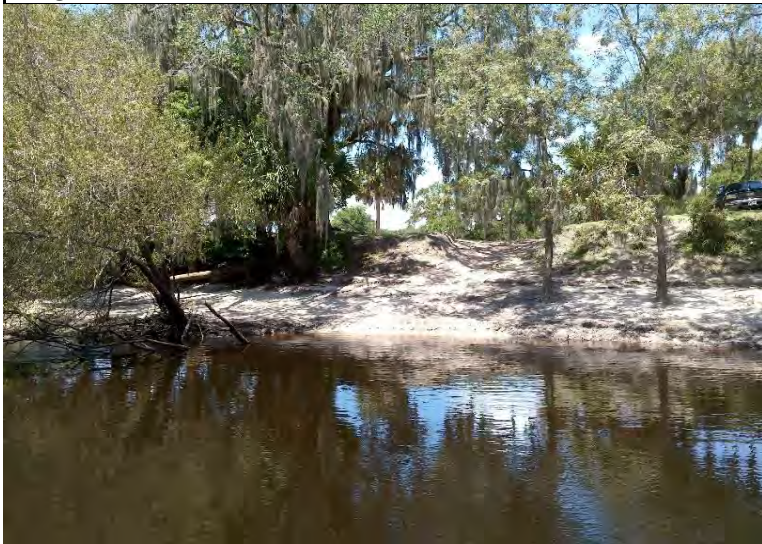
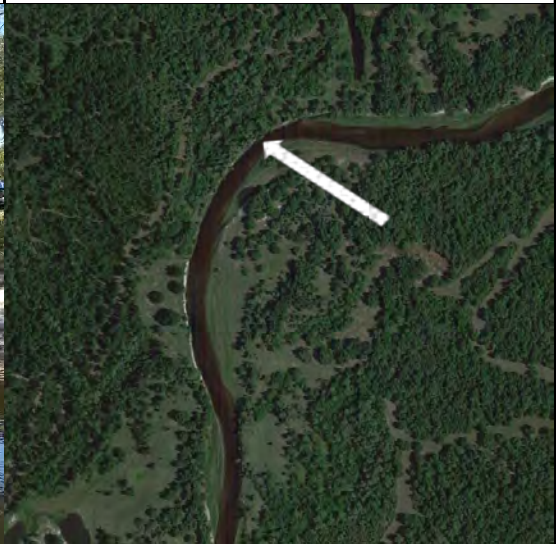
Peace River			Severity Scale: 5.0-Moderate	
Watershed: Peace River Subwatershed: Johnson Lake - Peace River Latitude: 27.21610 Longitude: -81.88634			County: Desoto Site Number: PI352 Reach Length: 510 ft. Landowner: Garner Grove and Cattle Co

Pfankuch-Channel Stability:	Poor	1.5		
Channel Alteration:	None	0		
Bank Erosion:	Active	1		
BEHI:	Moderate (25.08)	0.5		
Local NPSP:	Obvious Sources	1.5		
Shoring Structures:	None	0		
Pipe Discharge:	None	0		
Water Odor:	Normal	0		
Fish Passage Barrier:	None	0		
RB: Riparian Buffer:	60 ft.	0.25		
LB: Riparian Buffer:	70 ft.	0.25		
RB: Floodplain Access:	Full	0		
LB: Floodplain Access:	Full	0		
Severity Scale:		5.0	Additional Site Features	
			Stream Channel Woody Material: Numerous	
			Impoundments: None	
			Substrate Composition: Medium Sand	
			Bank Material: Sand	
			Near Bank Stress: High	
			RB Landuse: Natural Forest, Pasture

LB Landuse: Pasture, Natural Forest	
Notes: 303d - Impaired: Aquatic Life Harvesting (fecal coliform, mercury in fish tissue)				
Restoration Option 1

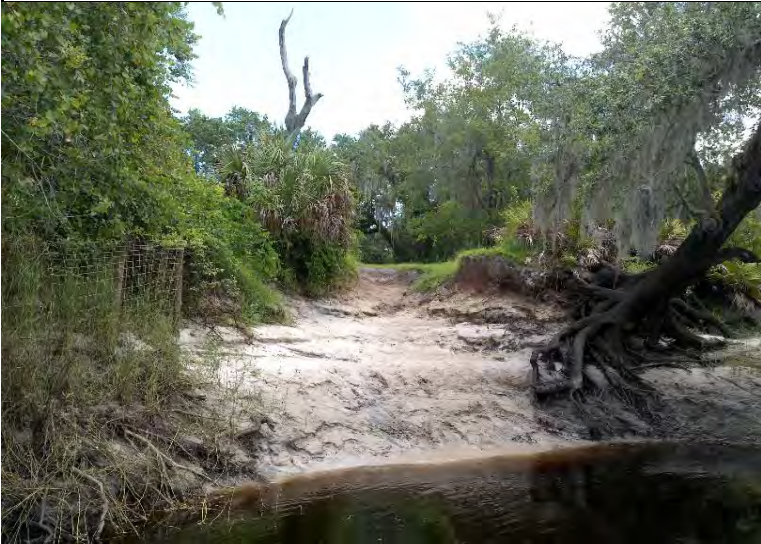
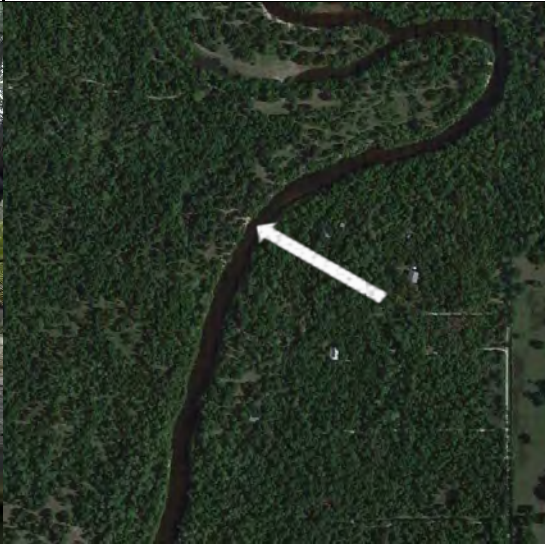
Peace River			Severity Scale: 2.25-Low
Watershed: Peace River Subwatershed: McBride Branch Latitude: 27.21837 Longitude: -81.87807			County: Desoto Site Number: PI353 Reach Length: 128 ft. Landowner: Garner Grove & Cattle Co Inc

Risk Factor	Ranking	Score	
Pfankuch-Channel Stability:	Good	0	
Channel Alteration:	None	0	
Bank Erosion:	Active	1	
BEHI:	High (31.84)	1	
Local NPSP:	No Evidence	0	
Shoring Structures:	None	0	
Pipe Discharge:	None	0	
Water Odor:	Normal	0	
Fish Passage Barrier:	None	0	
RB: Riparian Buffer:	100 ft.	0	
LB: Riparian Buffer:	100 ft.	0	
RB: Floodplain Access:	Full	0	
LB: Floodplain Access:	Partial	0.25	
<b>Severity Scale:</b>		<b>2.25</b>

Additional Site Features
			Stream Channel Woody Material: Moderate
			Impoundments: None
			Substrate Composition: Medium Sand
			Bank Material: Sand
			Near Bank Stress: Low
			RB Landuse: Natural Forest
			LB Landuse: Natural Forest

Notes: 303d - Impaired: Aquatic Life Harvesting (fecal coliform, mercury in fish tissue); just downstream of PI342 - used same data.			
Restoration Option 2 or 3

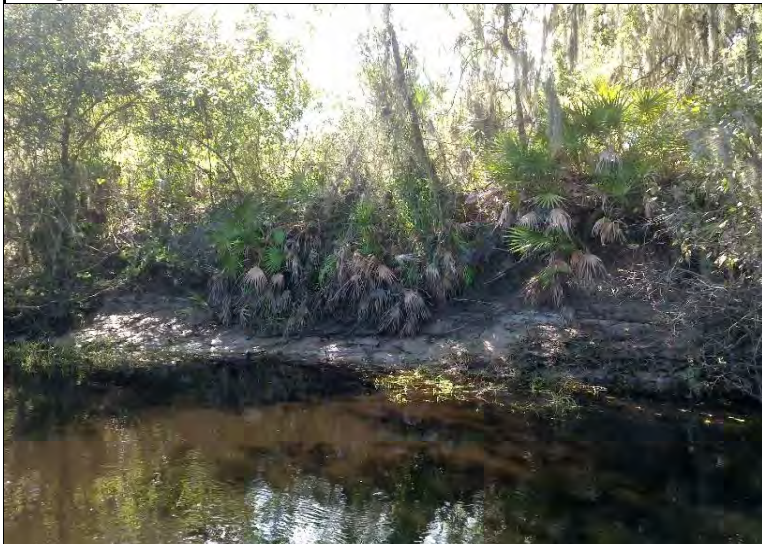
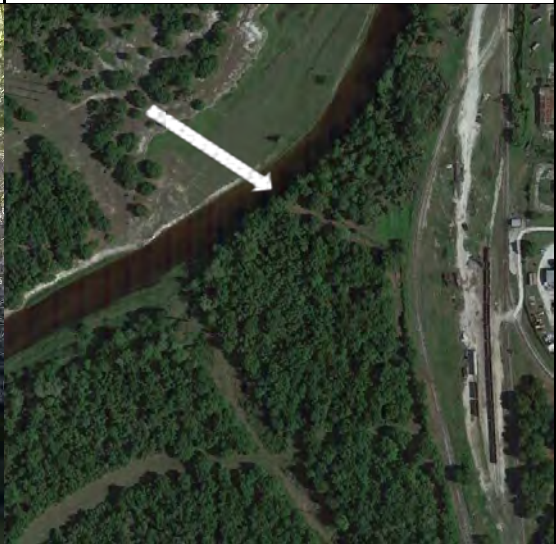
Peace River			Severity Scale: 3.75-Low	
Watershed: Peace River Subwatershed: Johnson Lake - Peace River Latitude: 27.21837 Longitude: -81.87807			County: Desoto Site Number: PI354 Reach Length: 128 ft. Landowner: Susie Robertson

Pfankuch-Channel Stability:	Poor	1.5		
Channel Alteration:	None	0		
Bank Erosion:	Active	1		
BEHI:	High (31.84)	1		
Local NPSP:	No Evidence	0		
Shoring Structures:	None	0		
Pipe Discharge:	None	0		
Water Odor:	Normal	0		
Fish Passage Barrier:	None	0		
RB: Riparian Buffer:	100 ft.	0	<b>Additional Site Features</b> Stream Channel Woody Material: Moderate Impoundments: None Substrate Composition: Medium Sand Bank Material: Sand Near Bank Stress: High RB Landuse: Natural Forest LB Landuse: Natural Forest	
LB: Riparian Buffer:	100 ft.	0		
RB: Floodplain Access:	Full	0		
LB: Floodplain Access:	Partial	0.25		
<b>Severity Scale:</b>		<b>3.75</b>

Notes: 303d: Impaired - Aquatic Life Harvesting (fecal coliform, mercury in fish tissue)				
Restoration Option 1

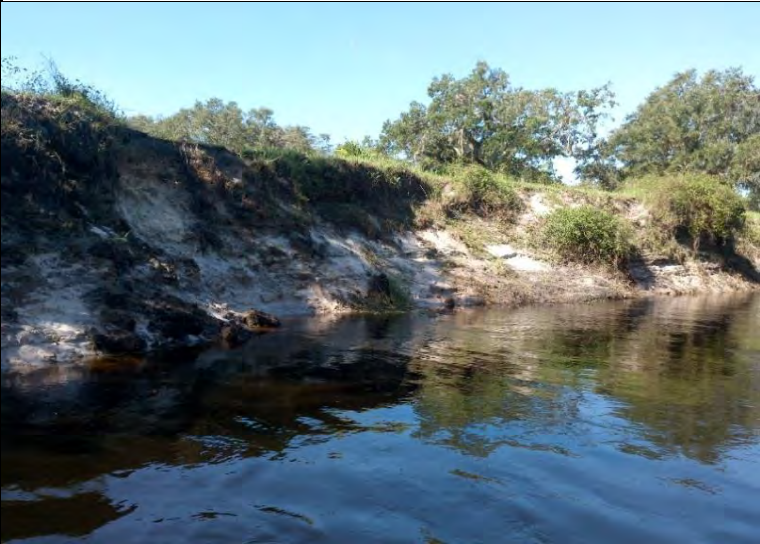
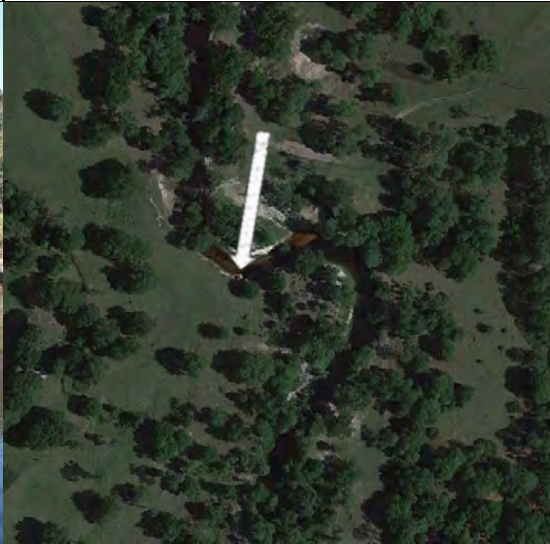
Horse Creek			Severity Scale: 7.25-Moderate
Watershed: Peace River Subwatershed: Lower Horse Creek Latitude: 27.22602 Longitude: -81.99317			County: Desoto Site Number: PI355 Reach Length: 180 ft. Landowner: VHC Management Co.

Risk Factor	Ranking	Score	
Pfankuch-Channel Stability:	Poor	1.5	
Channel Alteration:	None	0	
Bank Erosion:	Mass-wasting	1.5	
BEHI:	High (38.65)	1	
Local NPSP:	Obvious Sources	1.5	
Shoring Structures:	None	0	
Pipe Discharge:	None	0	
Water Odor:	Normal	0	
Fish Passage Barrier:	None	0	
RB: Riparian Buffer:	0 ft.	0.75	
LB: Riparian Buffer:	20 ft.	0.75	
RB: Floodplain Access:	Partial	0.25	
LB: Floodplain Access:	Full	0	
<b>Severity Scale:</b>		<b>7.25</b>	
Notes: Cattle fence present but not preventing cattle from accessing stream; 303d: Impaired - Public Water Supply (BOD & DO)			
Restoration Option 1

Additional Site Features	
Stream Channel Woody Material:	Infrequent
Impoundments:	None
Substrate Composition:	Medium Sand
Bank Material:	Sand
Near Bank Stress:	High
RB Landuse:	Pasture
LB Landuse:	Pasture

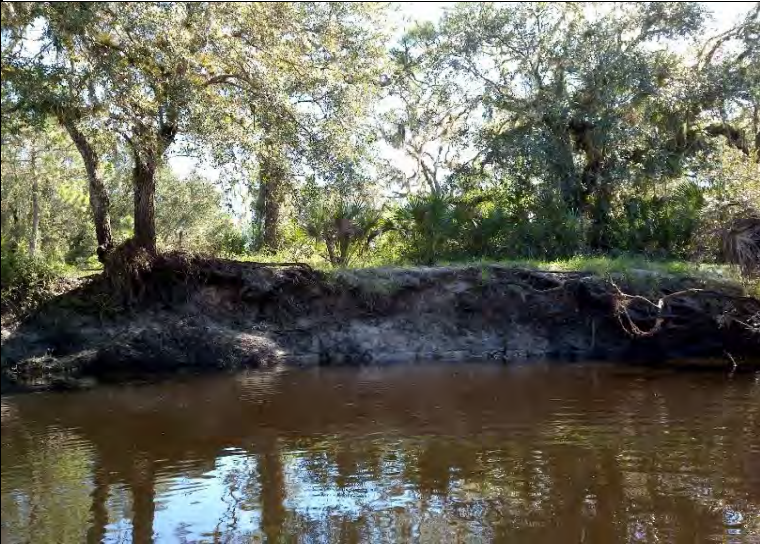
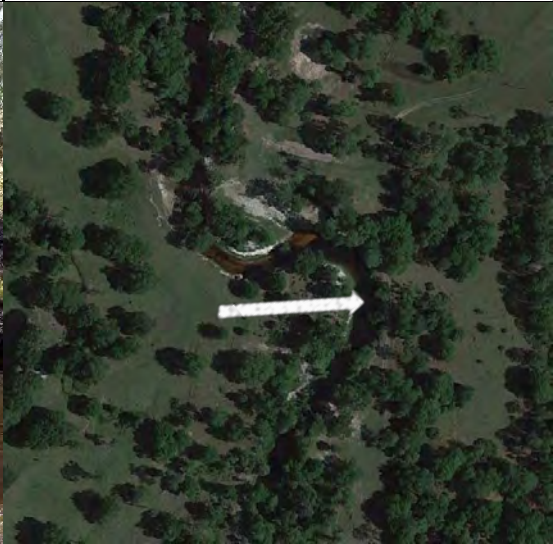
Horse Creek			Severity Scale: 6.0-Moderate
Watershed: Peace River Subwatershed: Lower Horse Creek Latitude: 27.22587 Longitude: -81.99220			County: Desoto Site Number: PI356 Reach Length: 136 ft. Landowner: VHC Management Co.

Risk Factor	Ranking	Score	
Pfankuch-Channel Stability:	Poor	1.5	
Channel Alteration:	None	0	
Bank Erosion:	Active	1	
BEHI:	High (32.16)	1	
Local NPSP:	Obvious Sources	1.5	
Shoring Structures:	None	0	
Pipe Discharge:	None	0	<b>Additional Site Features</b> Stream Channel Woody Material: Numerous Impoundments: None Substrate Composition: Medium Sand Bank Material: Sand Near Bank Stress: Moderate RB Landuse: Pasture, Natural Forest LB Landuse: Pasture, Natural Forest
Water Odor:	Normal	0	
Fish Passage Barrier:	None	0	
RB: Riparian Buffer:	60 ft.	0.25	
LB: Riparian Buffer:	0 ft.	0.75	
RB: Floodplain Access:	Full	0	
LB: Floodplain Access:	Full	0	
<b>Severity Scale:</b>		<b>6.0</b>

Notes: Farm road near bank; 303d: Impaired - Public Water Supply (BOD & DO)			
Restoration Option 1

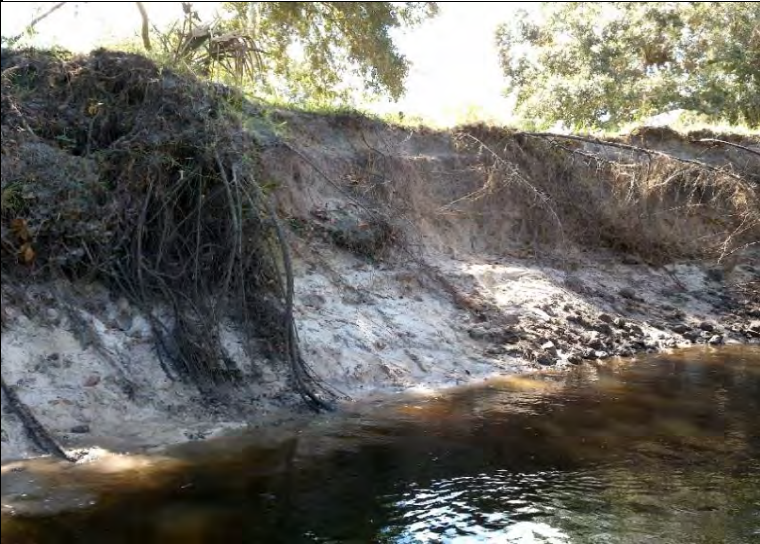
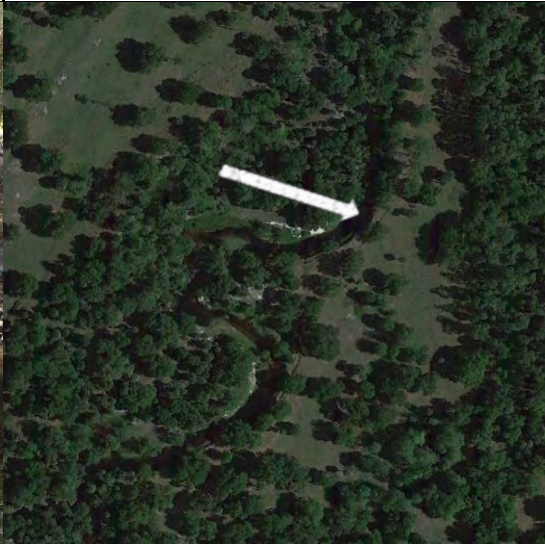
Horse Creek			Severity Scale: 6.5-Moderate
Watershed: PI357 Subwatershed: Lower Horse Creek Latitude: 27.22359 Longitude: -81.99275			County: Desoto Site Number: PI357 Reach Length: 193 ft. Landowner: VHC Management Co.

Risk Factor	Ranking	Score	
Pfankuch-Channel Stability:	Poor	1.5	
Channel Alteration:	None	0	
Bank Erosion:	Mass-wasting	1.5	
BEHI:	High (34.08)	1	
Local NPSP:	Obvious Sources	1.5	
Shoring Structures:	None	0	
Pipe Discharge:	None	0	
Water Odor:	Normal	0	
Fish Passage Barrier:	None	0	
RB: Riparian Buffer:	60 ft.	0.25	
LB: Riparian Buffer:	0 ft.	0.75	
RB: Floodplain Access:	Full	0	
LB: Floodplain Access:	Full	0	
<b>Severity Scale:</b>		<b>6.5</b>	
Notes: Fence present but cattle able to access creek; 303d: Impaired - Public Water Supply (BOD & DO)			
Restoration Option 1

Additional Site Features
Stream Channel Woody Material: Extensive
Impoundments: None
Substrate Composition: Medium Sand
Bank Material: Sandy Clay
Near Bank Stress: Moderate
RB Landuse: Pasture, Natural Forest
LB Landuse: Pasture

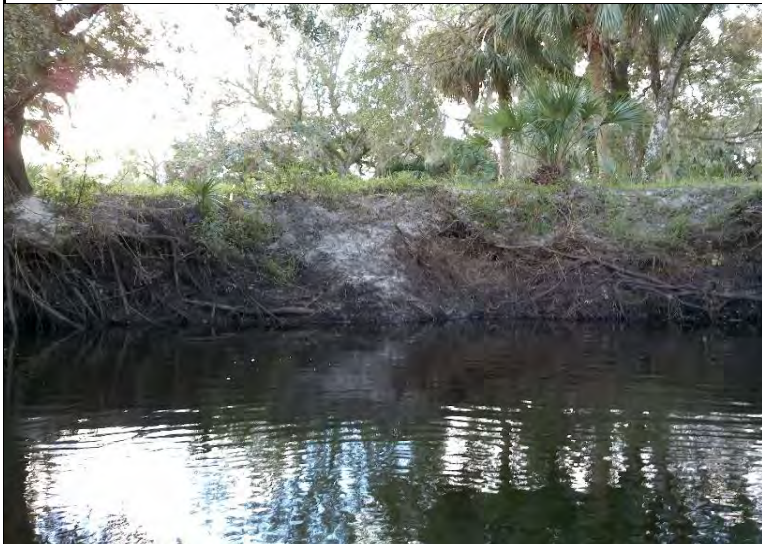
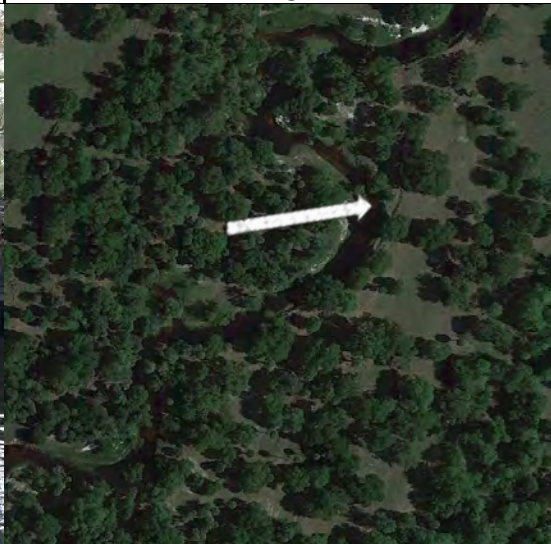
Horse Creek			Severity Scale: 5.5-Moderate
Watershed: Peace River Subwatershed: Lower Horse Creek Latitude: 27.22258 Longitude: -81.99321			County: Desoto Site Number: PI358 Reach Length: 215 ft. Landowner: VHC Management Co.

Pfankuch-Channel Stability:	Poor	1.5	
Channel Alteration:	None	0	
Bank Erosion:	Active	1	
BEHI:	Moderate (24.42)	0.5	
Local NPSP:	Obvious Sources	1.5	
Shoring Structures:	None	0	
Pipe Discharge:	None	0	
Water Odor:	Normal	0	
Fish Passage Barrier:	None	0	
RB: Riparian Buffer:	100 ft.	0	
LB: Riparian Buffer:	0 ft.	0.75	
RB: Floodplain Access:	Full	0	
LB: Floodplain Access:	Partial	0.25	
Severity Scale:		5.5	
Notes: Cattle fence near bank; 303d: Impaired - Public Water Supply (BOD & DO)			
Restoration Option 1

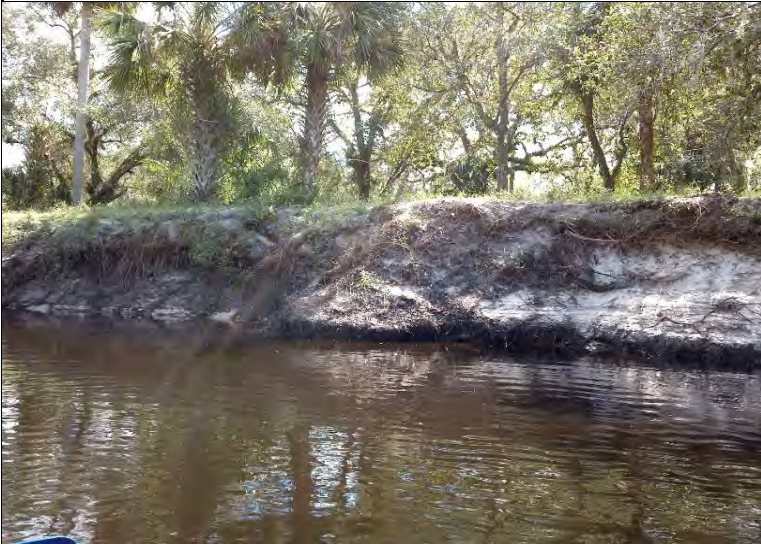
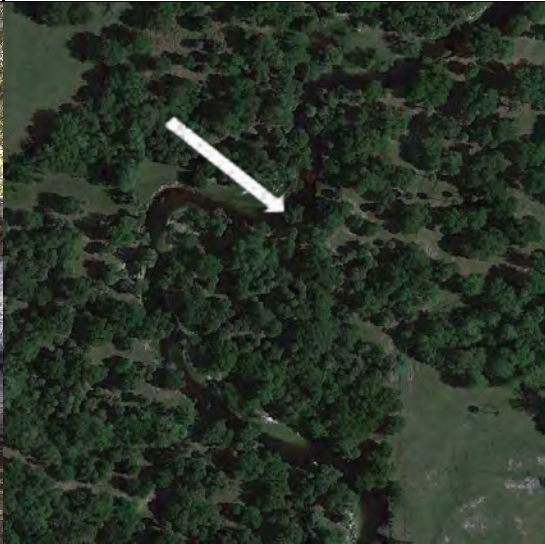
Horse Creek			Severity Scale: 5.5-Moderate
Watershed: Peace River Subwatershed: Lower Horse Creek Latitude: 27.22135 Longitude: -81.99448			County: Desoto Site Number: PI359 Reach Length: 55 ft. Landowner: VHC Management Co.

Risk Factor	Ranking	Score	
Pfankuch-Channel Stability:	Poor	1.5	
Channel Alteration:	None	0	
Bank Erosion:	Active	1	
BEHI:	High (30.45)	1	
Local NPSP:	Obvious Sources	1.5	
Shoring Structures:	None	0	
Pipe Discharge:	None	0	
Water Odor:	Normal	0	
Fish Passage Barrier:	None	0	
RB: Riparian Buffer:	40 ft.	0.5	
LB: Riparian Buffer:	100 ft.	0	
RB: Floodplain Access:	Full	0	
LB: Floodplain Access:	Full	0	
<b>Severity Scale:</b>		<b>5.5</b>	
Notes: 303d: Impaired - Public Water Supply (BOD & DO)			
Restoration Option 1

Additional Site Features
Stream Channel Woody Material: Numerous
Impoundments: None
Substrate Composition: Medium Sand
Bank Material: Sand
Near Bank Stress: Moderate
RB Landuse: Natural Forest, Pasture
LB Landuse: Natural Forest

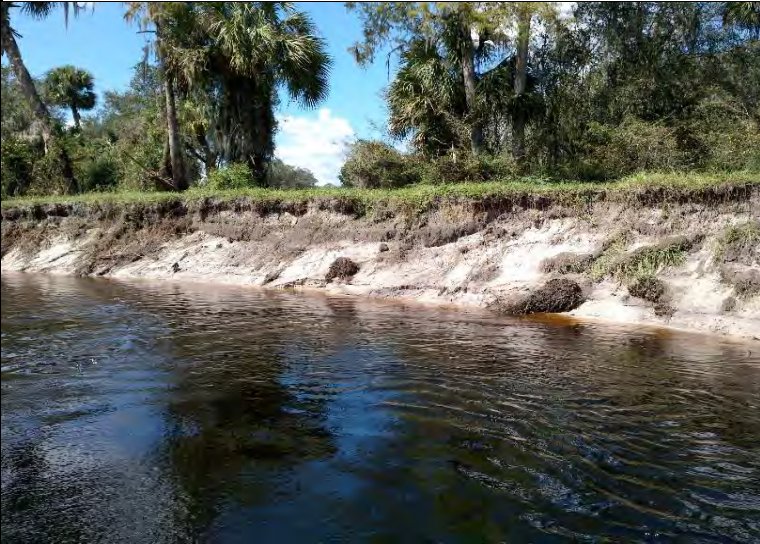
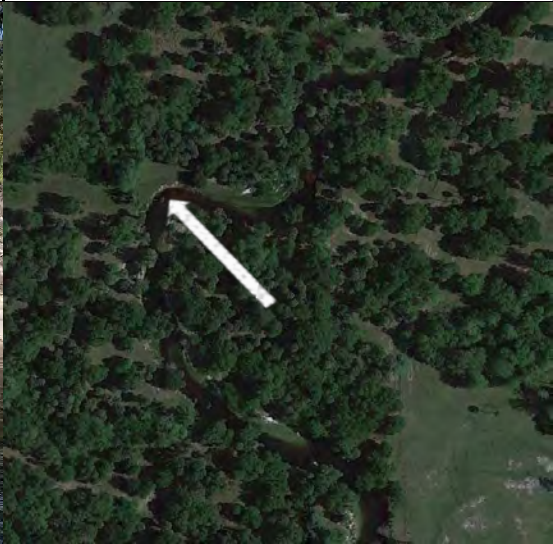
Horse Creek			Severity Scale: 6.75-Moderate
Watershed: Peace River Subwatershed: Lower Horse Creek Latitude: 27.22148 Longitude: -81.99496			County: Desoto Site Number: PI360 Reach Length: 131 ft. Landowner: VHC Management Co.

Risk Factor	Ranking	Score	
Pfankuch-Channel Stability:	Poor	1.5	
Channel Alteration:	None	0	
Bank Erosion:	Mass-wasting	1.5	
BEHI:	Very High (39.97)	1.5	
Local NPSP:	Obvious Sources	1.5	
Shoring Structures:	None	0	
Pipe Discharge:	None	0	
Water Odor:	Normal	0	
Fish Passage Barrier:	None	0	
RB: Riparian Buffer:	0 ft.	0.75	
LB: Riparian Buffer:	100 ft.	0	
RB: Floodplain Access:	Full	0	
LB: Floodplain Access:	Full	0	
<b>Severity Scale:</b>		<b>6.75</b>	
Notes: 303d: Impaired - Public Water Supply (BOD & DO)			
Restoration Option 1

Additional Site Features
Stream Channel Woody Material: Moderate
Impoundments: None
Substrate Composition: Medium Sand
Bank Material: Sand
Near Bank Stress: Low
RB Landuse: Pasture
LB Landuse: Natural Forest

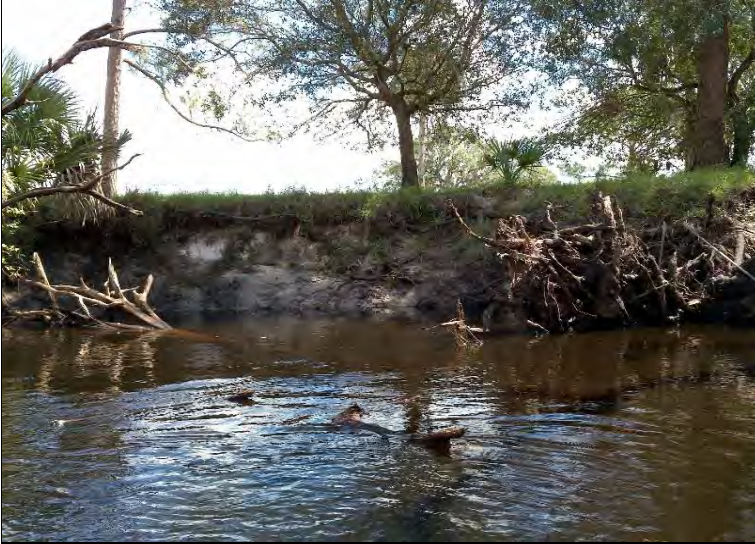
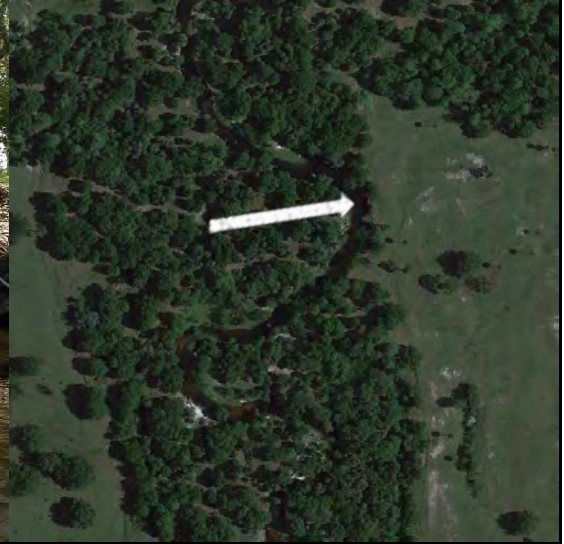
Risk Factor	Ranking	Score
Pfankuch-Channel Stability:	Poor	1.5
Channel Alteration:	None	0
Bank Erosion:	Active	1
BEHI:	High (33.52)	1
Local NPSP:	Obvious Sources	1.5
Shoring Structures:	None	0
Pipe Discharge:	None	0
Water Odor:	Normal	0
Fish Passage Barrier:	None	0
RB: Riparian Buffer:	100 ft.	0
LB: Riparian Buffer:	0 ft.	0.75
RB: Floodplain Access:	Full	0
LB: Floodplain Access:	Full	0
Severity Scale:		5.75

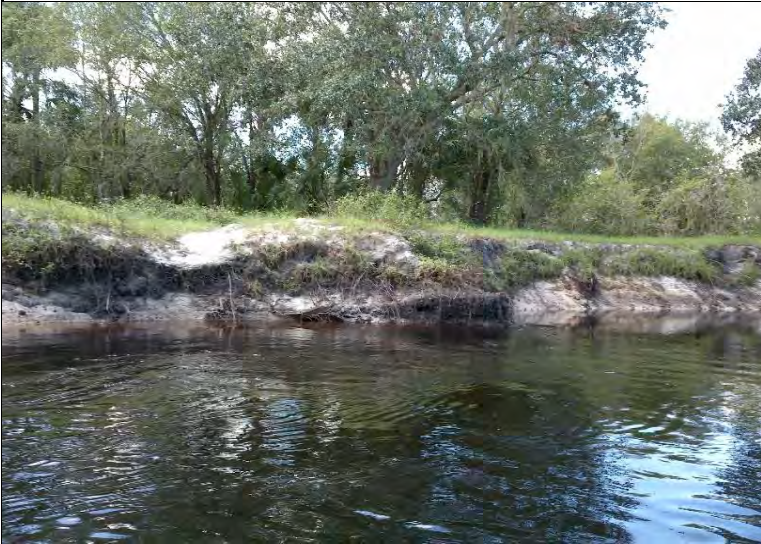
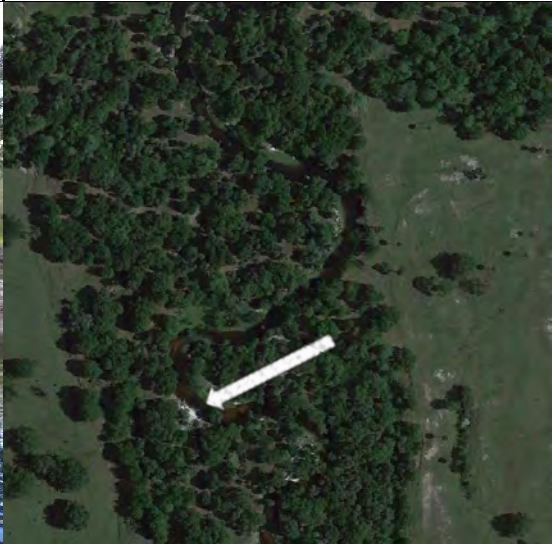
Horse Creek			Severity Scale: 6.25-Moderate
Watershed: Peace River Subwatershed: Lower Horse Creek Latitude: 27.21886 Longitude: -81.99551			County: Desoto Site Number: PI362 Reach Length: 200 ft. Landowner: VHC Management Co.

Risk Factor	Ranking	Score	
Pfankuch-Channel Stability:	Poor	1.5	
Channel Alteration:	None	0	
Bank Erosion:	Mass-wasting	1.5	
BEHI:	High (37.40)	1	
Local NPSP:	Obvious Sources	1.5	
Shoring Structures:	None	0	
Pipe Discharge:	None	0	
Water Odor:	Normal	0	<b>Additional Site Features</b>
Fish Passage Barrier:	None	0	Stream Channel Woody Material: Moderate
RB: Riparian Buffer:	40 ft.	0.5	Impoundments: None
LB: Riparian Buffer:	80 ft.	0.25	Substrate Composition: Medium Sand
RB: Floodplain Access:	Full	0	Bank Material: Sand
LB: Floodplain Access:	Full	0	Near Bank Stress: High
			RB Landuse: Natural Forest, Pasture
			LB Landuse: Natural Forest, Pasture
<b>Severity Scale:</b>		<b>6.25</b>

Notes: 303d: Impaired - Public Water Supply (BOD & DO)			
Restoration Option 1

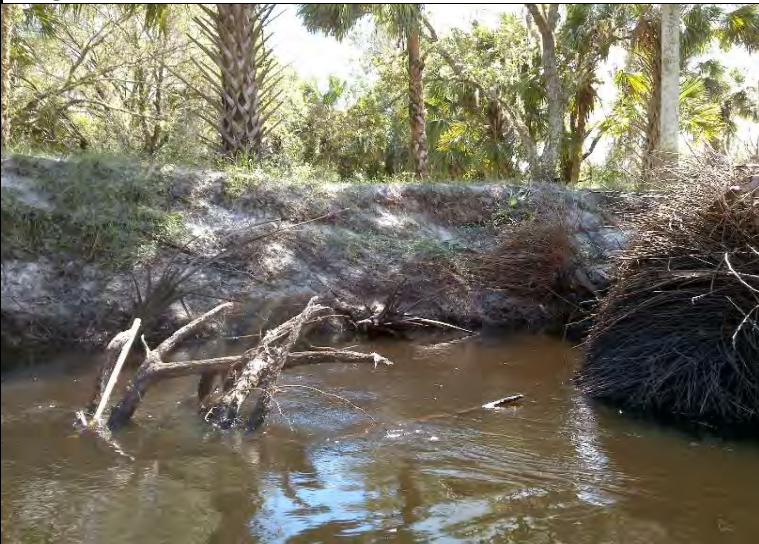
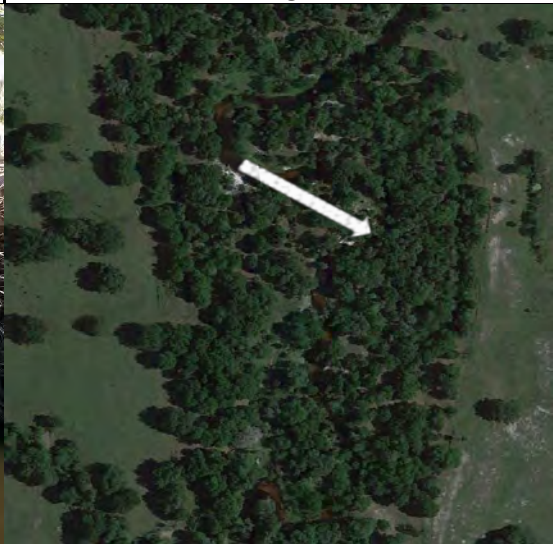
Horse Creek			Severity Scale: 5.5-Moderate	
Watershed: Peace River Subwatershed: Lower Horse Creek Latitude: 27.21812 Longitude: -81.99457			County: Desoto Site Number: PI363 Reach Length: 37 ft. Landowner: VHC Management Co.

Pfankuch-Channel Stability:	Poor	1.5		
Channel Alteration:	None	0		
Bank Erosion:	Active	1		
BEHI:	Moderate (26.47)	0.5		
Local NPSP:	Obvious Sources	1.5		
Shoring Structures:	None	0		
Pipe Discharge:	None	0		
Water Odor:	Normal	0		
Fish Passage Barrier:	None	0		
RB: Riparian Buffer:	40 ft.	0.5	<b>Additional Site Features</b> Stream Channel Woody Material: Extensive Impoundments: None Substrate Composition: Medium Sand Bank Material: Sand Near Bank Stress: High RB Landuse: Natural Forest, Pasture LB Landuse: Natural Forest, Pasture	
LB: Riparian Buffer:	40 ft.	0.5		
RB: Floodplain Access:	Full	0		
LB: Floodplain Access:	Full	0		
<b>Severity Scale:</b>		<b>5.5</b>

Notes: 303d: Impaired - Public Water Supply (BOD & DO)				
Restoration Option 1
