# **Peace River and Withlacoochee River Threats Assessments and Fish Assemblage Monitoring**

**Final Report July 1, 2015 – June 30, 2019**

Submitted to Florida State Wildlife Grants Program  
August 1, 2019  
PID: 98462501284

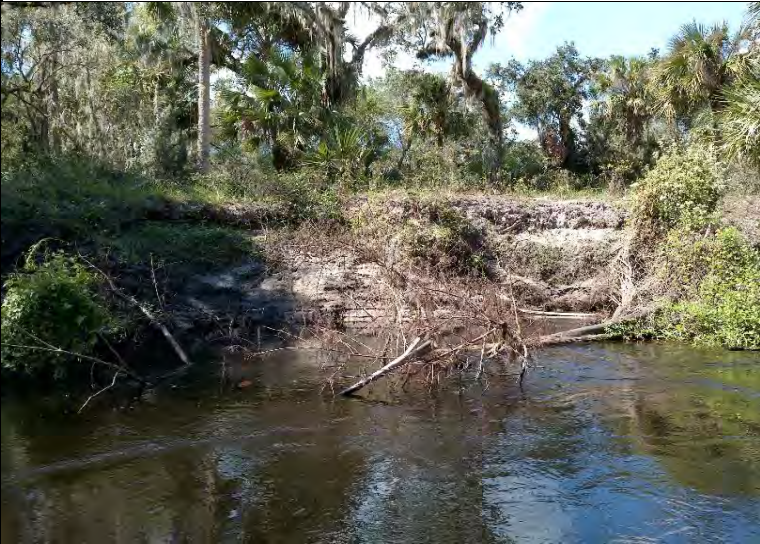
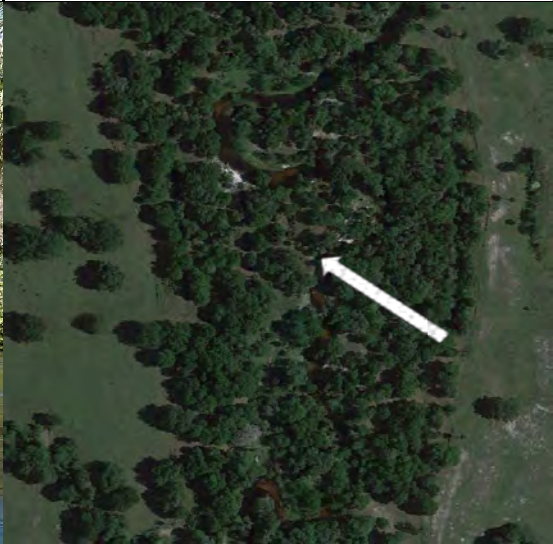
Horse Creek			Severity Scale: 5.5-Moderate
Watershed: Peace River Subwatershed: Lower Horse Creek Latitude: 27.21802 Longitude: -81.99496			County: Desoto Site Number: PI364 Reach Length: 22 ft. Landowner: VHC Management Co.

Pfankuch-Channel Stability:	Poor	1.5	
Channel Alteration:	None	0	
Bank Erosion:	Active	1	
BEHI:	Moderate (26.22)	0.5	
Local NPSP:	Obvious Sources	1.5	
Shoring Structures:	None	0	
Pipe Discharge:	None	0	
Water Odor:	Normal	0	
Fish Passage Barrier:	None	0	
RB: Riparian Buffer:	40 ft.	0.5	
LB: Riparian Buffer:	40 ft.	0.5	
RB: Floodplain Access:	Full	0	
LB: Floodplain Access:	Full	0	
<b>Severity Scale:</b>		<b>5.5</b>	<b>Additional Site Features</b>
			Stream Channel Woody Material: Numerous
			Impoundments: None
			Substrate Composition: Medium Sand
			Bank Material: Sand
			Near Bank Stress: High
			RB Landuse: Natural Forest, Pasture
			LB Landuse: Natural Forest, Pasture

Notes: 303d: Impaired - Public Water Supply (BOD & DO)			
Restoration Option 1

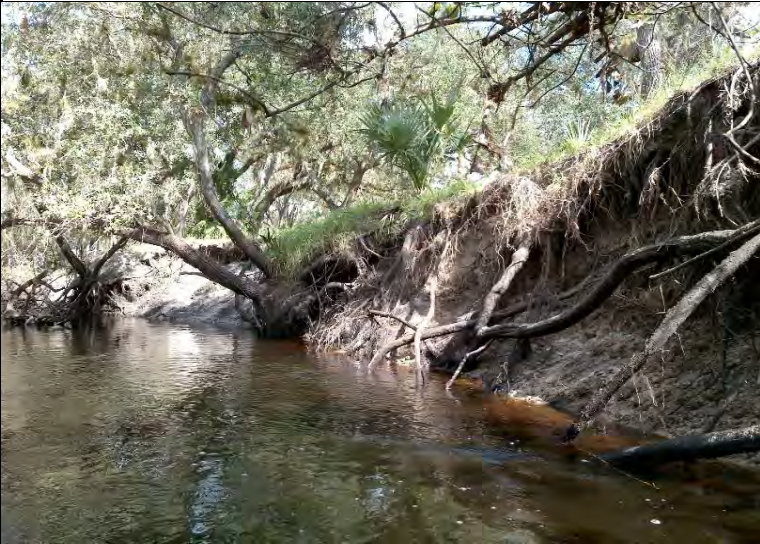
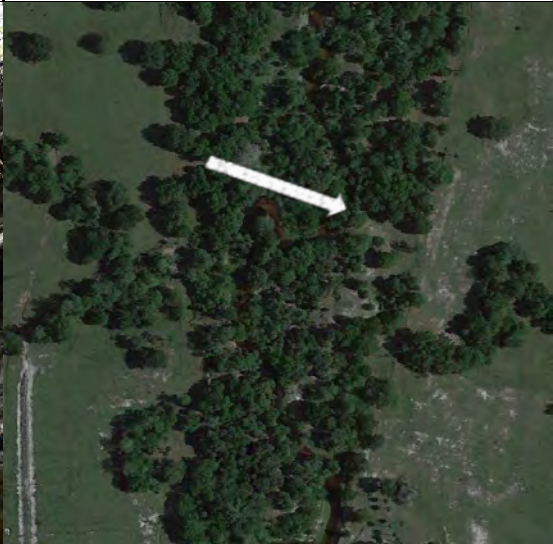
Horse Creek			Severity Scale: 6.0-Moderate	
Watershed: Peace River Subwatershed: Lower Horse Creek Latitude: 27.21653 Longitude: -81.99493			County: Desoto Site Number: PI365 Reach Length: 90 ft. Landowner: VHC Management Co.

Risk Factor	Ranking	Score		
Pfankuch-Channel Stability:	Poor	1.5		
Channel Alteration:	None	0		
Bank Erosion:	Mass-wasting	1.5		
BEHI:	High (31.62)	1		
Local NPSP:	Obvious Sources	1.5		
Shoring Structures:	None	0		
Pipe Discharge:	None	0		
Water Odor:	Normal	0		
Fish Passage Barrier:	None	0		
RB: Riparian Buffer:	100 ft.	0		
LB: Riparian Buffer:	40 ft.	0.5		
RB: Floodplain Access:	Full	0		
LB: Floodplain Access:	Full	0		
Severity Scale:		6.0		
Notes: 303d: Impaired - Public Water Supply (BOD & DO)				
Restoration Option 1

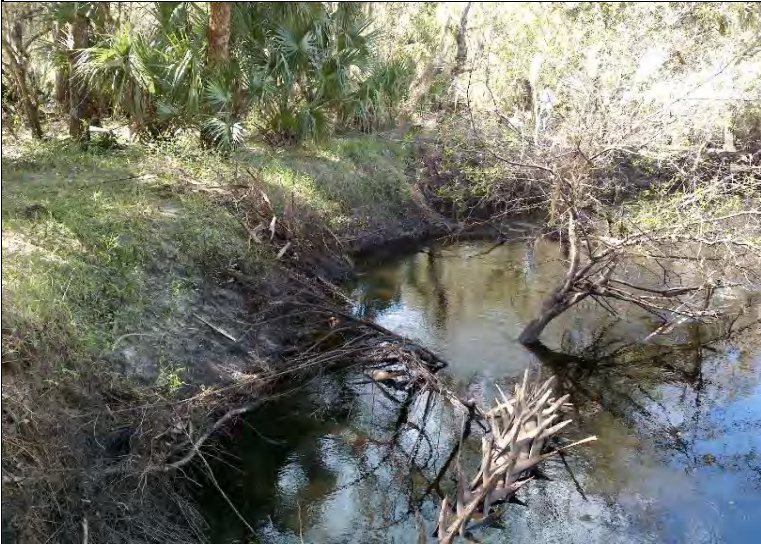
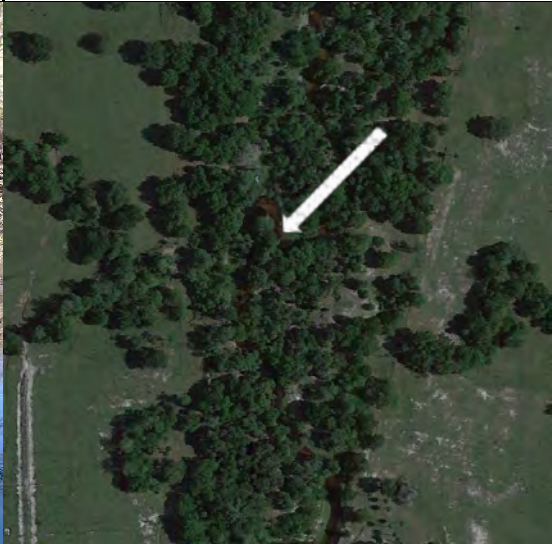
Horse Creek			Severity Scale: 5.5-Moderate
Watershed: Peace River Subwatershed: Lower Horse Creek Latitude: 27.21620 Longitude: -81.99537			County: Desoto Site Number: PI366 Reach Length: 100 ft. Landowner: VHC Management Co.

Pfankuch-Channel Stability:	Poor	1.5	
Channel Alteration:	None	0	
Bank Erosion:	Active	1	
BEHI:	Moderate (26.98)	0.5	
Local NPSP:	Obvious Sources	1.5	
Shoring Structures:	None	0	
Pipe Discharge:	None	0	
Water Odor:	Normal	0	
Fish Passage Barrier:	None	0	
RB: Riparian Buffer:	40 ft.	0.5	
LB: Riparian Buffer:	40 ft.	0.5	
RB: Floodplain Access:	Full	0	
LB: Floodplain Access:	Full	0	
<b>Severity Scale:</b>		<b>5.5</b>	<b>Additional Site Features</b>
			Stream Channel Woody Material: Extensive
			Impoundments: None
			Substrate Composition: Medium Sand
			Bank Material: Sand
			Near Bank Stress: Moderate
			RB Landuse: Natural Forest, Pasture
			LB Landuse: Natural Forest, Pasture

Notes: 303d: Impaired - Public Water Supply (BOD & DO)			
Restoration Option 1

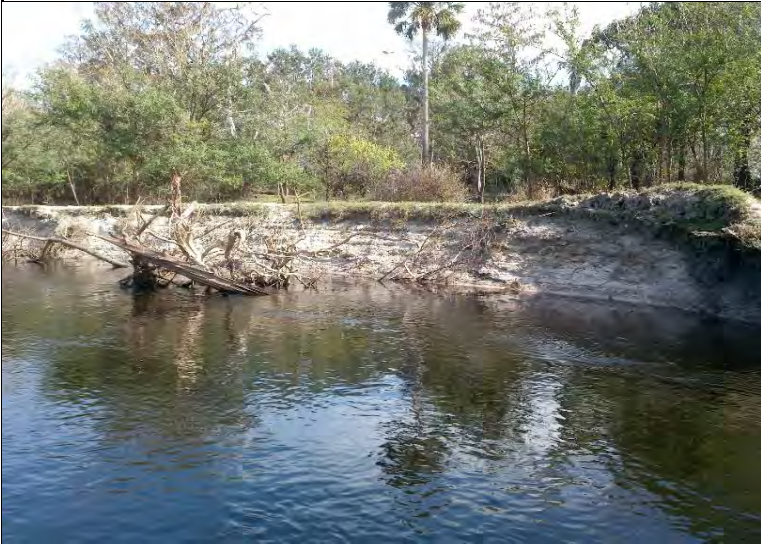
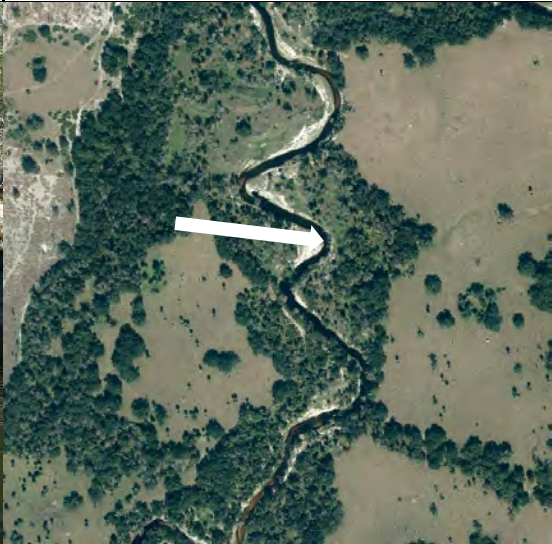
Charlie Creek			Severity Scale: 6.5-Moderate
Watershed: Peace River Subwatershed: Lower Charlie Creek Latitude: 27.37002 Longitude: -81.81011			County: Hardee Site Number: PI367 Reach Length: 250 ft. Landowner: Ben Hill Griffin Inc.

Risk Factor	Ranking	Score	
Pfankuch-Channel Stability:	Poor	1.5	
Channel Alteration:	None	0	
Bank Erosion:	Active	1	
BEHI:	High (37.98)	1	
Local NPSP:	Obvious Sources	1.5	
Shoring Structures:	None	0	
Pipe Discharge:	None	0	
Water Odor:	Normal	0	
Fish Passage Barrier:	None	0	
RB: Riparian Buffer:	0 ft.	0.75	
LB: Riparian Buffer:	0 ft.	0.75	
RB: Floodplain Access:	Full	0	
LB: Floodplain Access:	Full	0	
Severity Scale:		6.5	
303d: Impaired - Fecal Coliform			
Restoration Option 1

Additional Site Features
Stream Channel Woody Material: Numerous
Impoundments: None
Substrate Composition: Medium Sand
Bank Material: Sand
Near Bank Stress: High
RB Landuse: Pasture
LB Landuse: Pasture, Natural Forest

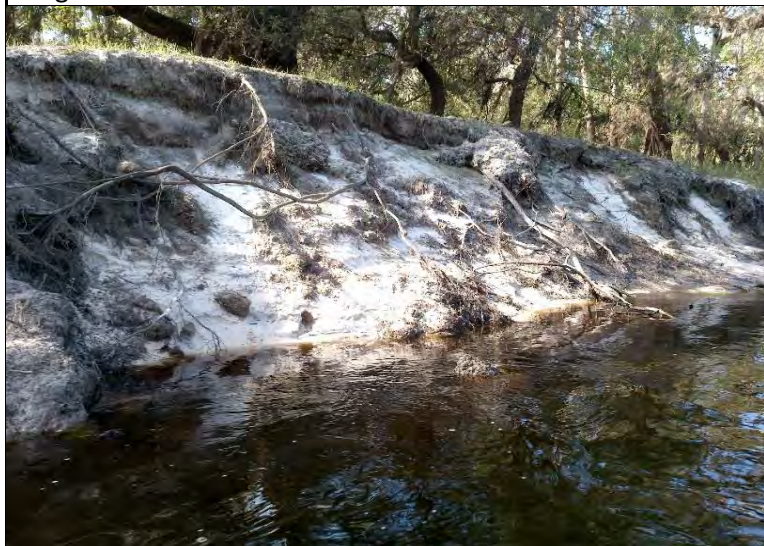
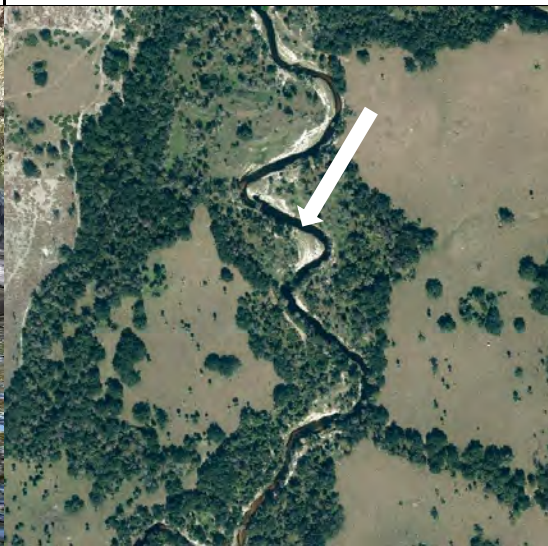
Risk Factor	Ranking	Score
Pfankuch-Channel Stability:	Poor	1.5
Channel Alteration:	None	0
Bank Erosion:	Active	1
BEHI:	High (34.45)	1
Local NPSP:	Obvious Sources	1.5
Shoring Structures:	None	0
Pipe Discharge:	None	0
Water Odor:	Normal	0
Fish Passage Barrier:	None	0
RB: Riparian Buffer:	40 ft.	0.5
LB: Riparian Buffer:	10 ft.	0.75
RB: Floodplain Access:	Full	0
LB: Floodplain Access:	Full	0
Severity Scale:		6.25

Additional Site Features
Stream Channel Woody Material: Infrequent
Impoundments: None
Substrate Composition: Medium Sand
Bank Material: Sand
Near Bank Stress: High
RB Landuse: Pasture, Natural Forest
LB Landuse: Pasture

303d: Impaired - Fecal Coliform

Restoration Option 1, restore along with PI369

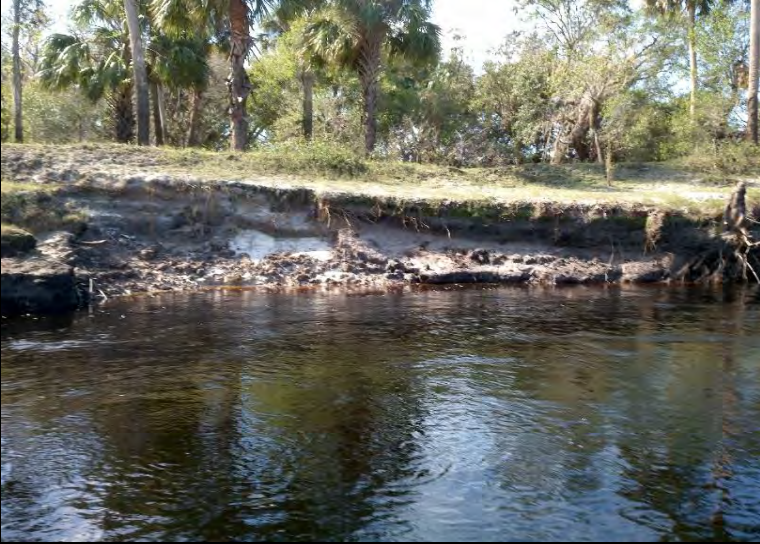
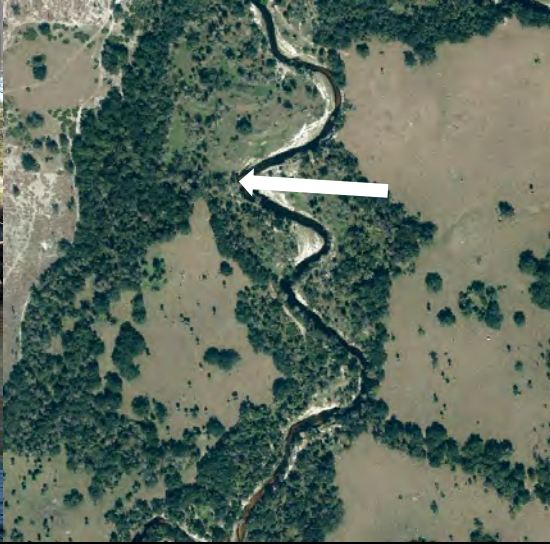
Charlie Creek			Severity Scale: 6.25-Moderate
Watershed: Peace River Subwatershed: Lower Charlie Creek Latitude: 27.37024 Longitude: -81.81100			County: Hardee Site Number: PI369 Reach Length: 165 ft. Landowner: Ben Hill Griffin Inc.

Risk Factor	Ranking	Score	
Pfankuch-Channel Stability:	Poor	1.5	
Channel Alteration:	None	0	
Bank Erosion:	Mass-wasting	1.5	
BEHI:	Moderate (26.35)	0.5	
Local NPSP:	Obvious Sources	1.5	
Shoring Structures:	None	0	
Pipe Discharge:	None	0	
Water Odor:	Normal	0	
Fish Passage Barrier:	None	0	
RB: Riparian Buffer:	40 ft.	0.5	
LB: Riparian Buffer:	0 ft.	0.75	
RB: Floodplain Access:	Full	0	
LB: Floodplain Access:	Full	0	
<b>Severity Scale:</b>		<b>6.25</b>	
303d: Impaired - Fecal Coliform			
Restoration Option 1, restore along with PI368

Additional Site Features
Stream Channel Woody Material: Numerous
Impoundments: None
Substrate Composition: Medium Sand
Bank Material: Clay
Near Bank Stress: High
RB Landuse: Pasture, Natural Forest
LB Landuse: Pasture

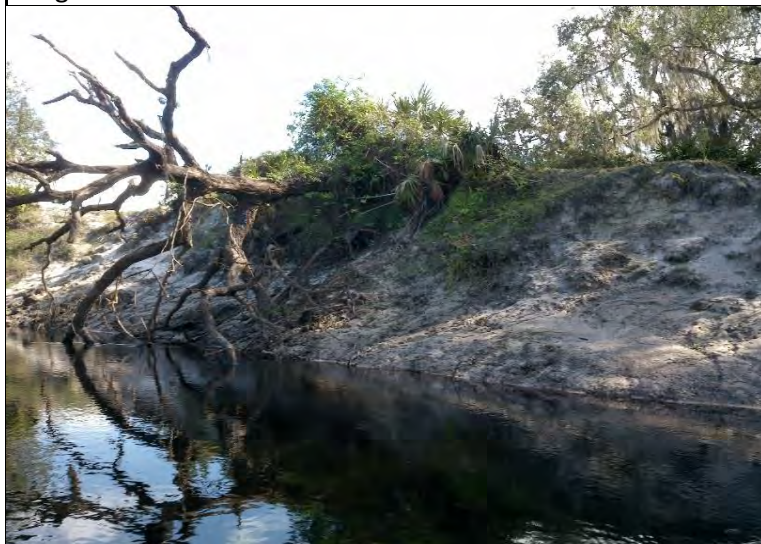
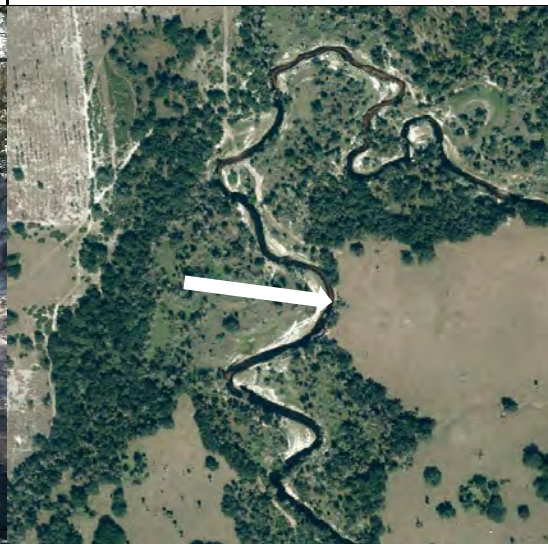
Risk Factor	Ranking	Score
Pfankuch-Channel Stability:	Poor	1.5
Channel Alteration:	None	0
Bank Erosion:	Active	1
BEHI:	Very High (40.35)	1.5
Local NPSP:	Obvious Sources	1.5
Shoring Structures:	None	0
Pipe Discharge:	None	0
Water Odor:	Normal	0
Fish Passage Barrier:	None	0
RB: Riparian Buffer:	0 ft.	0.75
LB: Riparian Buffer:	0 ft.	0.75
RB: Floodplain Access:	Full	0
LB: Floodplain Access:	Partial	0.25
Severity Scale:		7.25

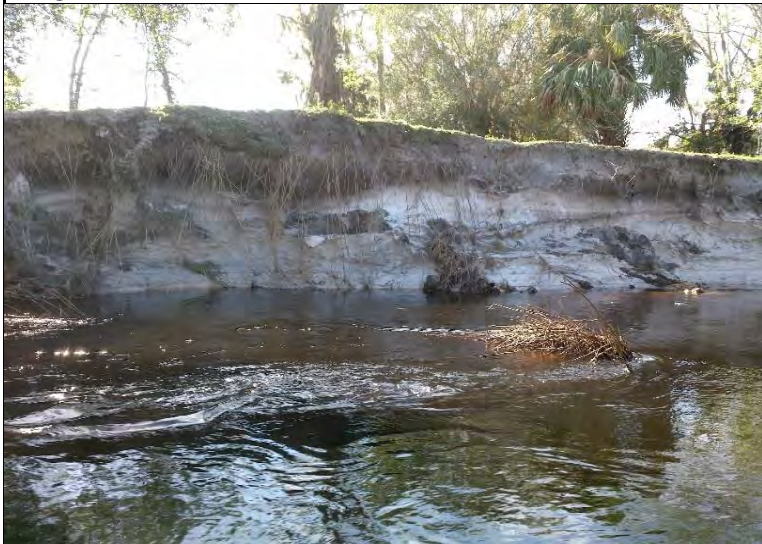
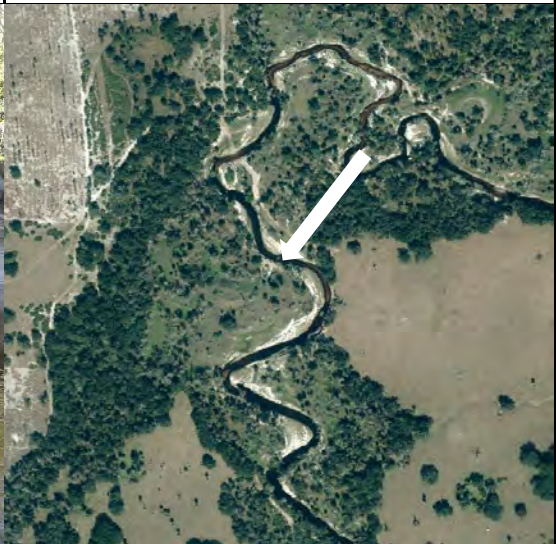
Charlie Creek			Severity Scale: 7.0-Moderate	
Watershed: Peace River Subwatershed: Lower Charlie Creek Latitude: 27.37210 Longitude: -81.81020			County: Hardee Site Number: PI371 Reach Length: 250 ft. Landowner: Ben Hill Griffin Inc.

Pfankuch-Channel Stability:	Poor	1.5		
Channel Alteration:	None	0		
Bank Erosion:	Mass-wasting	1.5		
BEHI:	High (37.35)	1		
Local NPSP:	Obvious Sources	1.5		
Shoring Structures:	None	0		
Pipe Discharge:	None	0		
Water Odor:	Normal	0		
Fish Passage Barrier:	None	0		
RB: Riparian Buffer:	0 ft.	0.75	<b>Additional Site Features</b> Stream Channel Woody Material: Moderate Impoundments: None Substrate Composition: Medium Sand Bank Material: Sand Near Bank Stress: High RB Landuse: Pasture LB Landuse: Pasture	
LB: Riparian Buffer:	0 ft.	0.75		
RB: Floodplain Access:	Full	0		
LB: Floodplain Access:	Full	0		
Severity Scale:		7.0		
303d: Impaired - Fecal Coliform

Restoration Option 1

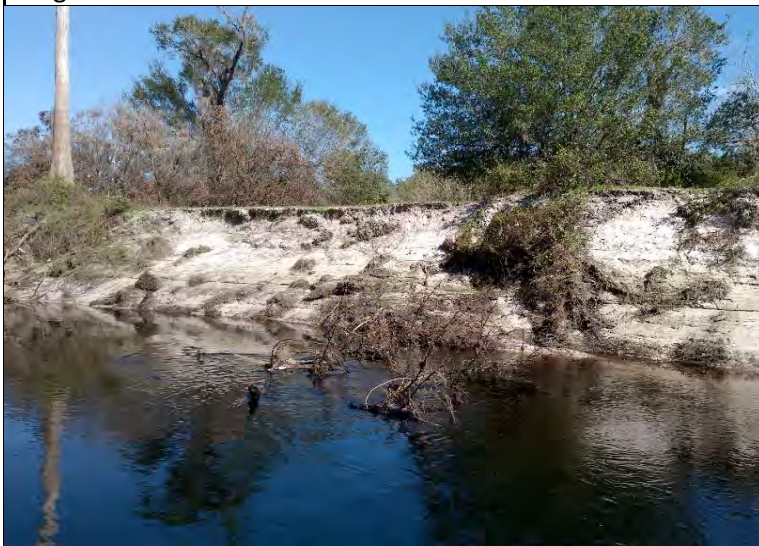
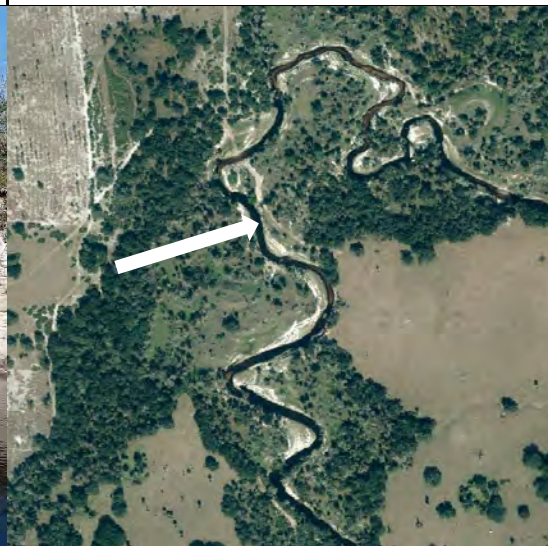
Risk Factor	Ranking	Score
Pfankuch-Channel Stability:	Poor	1.5
Channel Alteration:	None	0
Bank Erosion:	Mass-wasting	1.5
BEHI:	High (29.72)	1
Local NPSP:	Obvious Sources	1.5
Shoring Structures:	None	0
Pipe Discharge:	None	0
Water Odor:	Normal	0
Fish Passage Barrier:	None	0
RB: Riparian Buffer:	40 ft.	0.5
LB: Riparian Buffer:	0 ft.	0.75
RB: Floodplain Access:	Full	0
LB: Floodplain Access:	Full	0
<b>Severity Scale:</b>		<b>6.75</b>

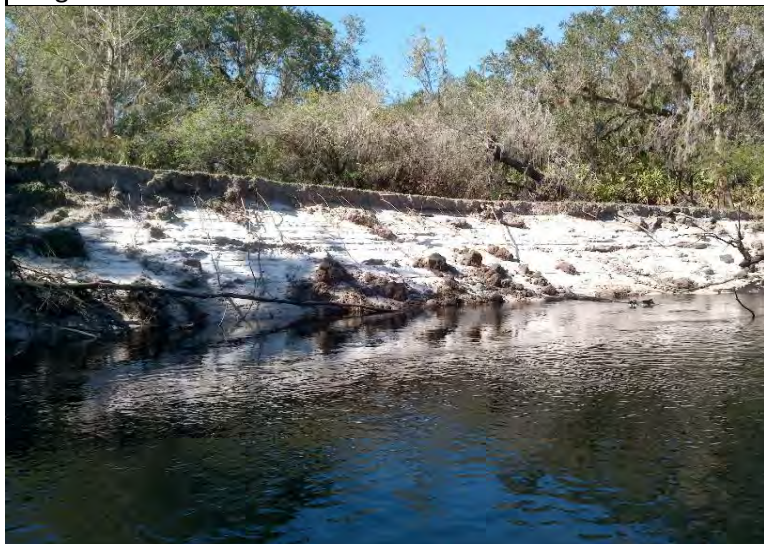
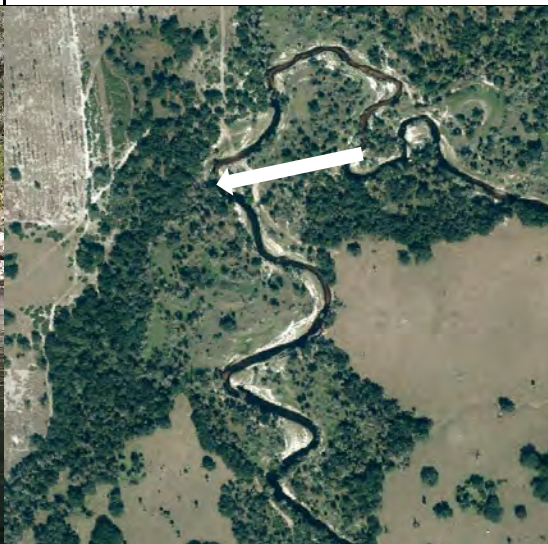
Risk Factor	Ranking	Score
Pfankuch-Channel Stability:	Poor	1.5
Channel Alteration:	None	0
Bank Erosion:	Mass-wasting	1.5
BEHI:	High (34.76)	1
Local NPSP:	Obvious Sources	1.5
Shoring Structures:	None	0
Pipe Discharge:	None	0
Water Odor:	Normal	0
Fish Passage Barrier:	None	0
RB: Riparian Buffer:	0 ft.	0.75
LB: Riparian Buffer:	40 ft.	0.5
RB: Floodplain Access:	Full	0
LB: Floodplain Access:	Full	0
Severity Scale:		6.75

Additional Site Features
Stream Channel Woody Material: Extensive
Impoundments: None
Substrate Composition: Medium Sand
Bank Material: Sand
Near Bank Stress: Moderate
RB Landuse: Pasture, Natural Forest
LB Landuse: Pasture, Natural Forest

303d: Impaired - Fecal Coliform

Restoration Option 1

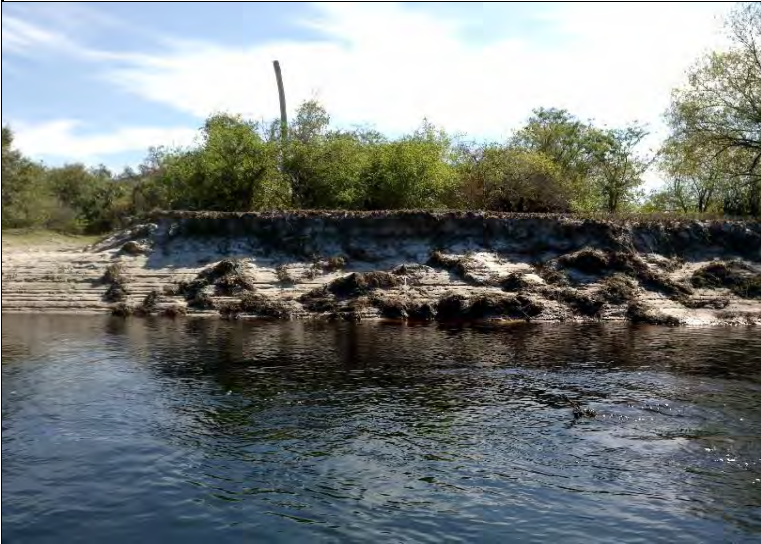
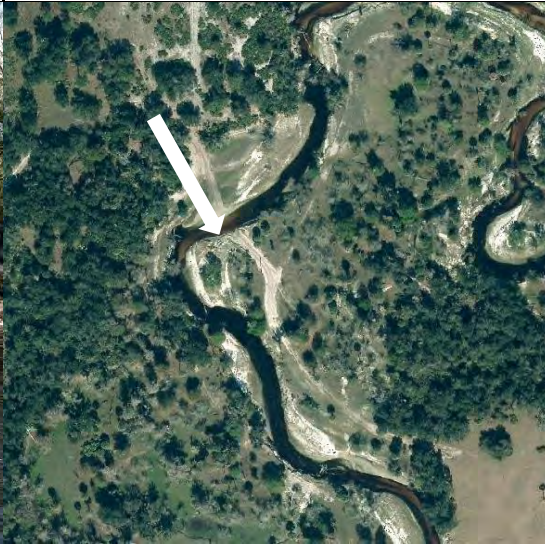
Charlie Creek			Severity Scale: 6.5-Moderate
Watershed: Peace River Subwatershed: Lower Charlie Creek Latitude: 27.37350 Longitude: -81.81121			County: Hardee Site Number: PI374 Reach Length: 95 ft. Landowner: Ben Hill Griffin Inc.

Pfankuch-Channel Stability:	Poor	1.5	
Channel Alteration:	None	0	
Bank Erosion:	Mass-wasting	1.5	
BEHI:	High (36.09)	1	
Local NPSP:	Obvious Sources	1.5	
Shoring Structures:	None	0	
Pipe Discharge:	None	0	
Water Odor:	Normal	0	
Fish Passage Barrier:	None	0	
RB: Riparian Buffer:	60 ft.	0.25	
LB: Riparian Buffer:	0 ft.	0.75	
RB: Floodplain Access:	Full	0	
LB: Floodplain Access:	Full	0	
<b>Severity Scale:</b>		<b>6.5</b>	<b>Additional Site Features</b>
			Stream Channel Woody Material: Infrequent
			Impoundments: None
			Substrate Composition: Medium Sand
			Bank Material: Sand
			Near Bank Stress: High
			RB Landuse: Natural Forest, Pasture

LB Landuse: Pasture, Natural Forest
Notes: Tractor/cattle crossing; 303d: Impaired - Fecal Coliform			
Restoration Option 1

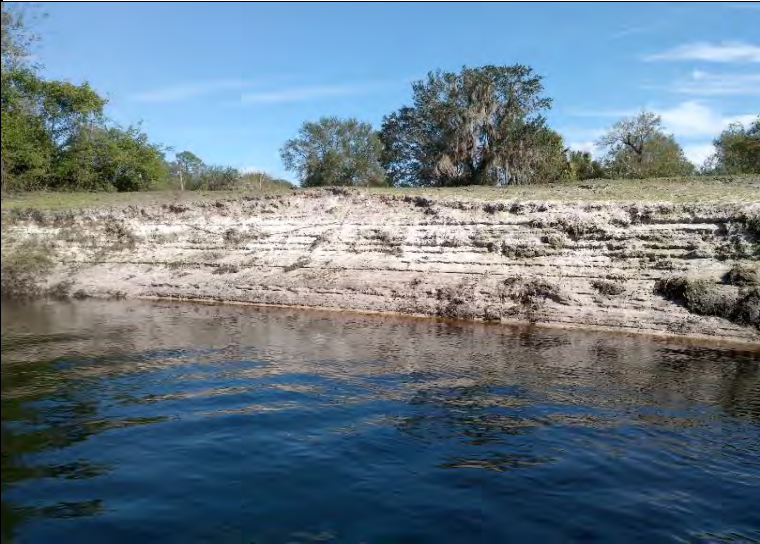
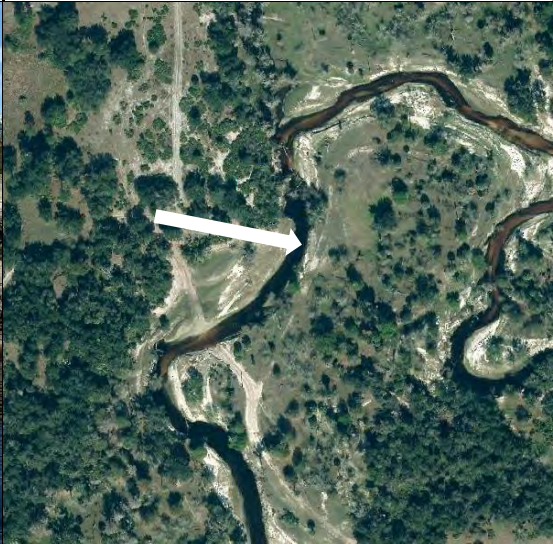
Charlie Creek			Severity Scale: 6.5-Moderate
Watershed: Peace River Subwatershed: Lower Charlie Creek Latitude: 27.37406 Longitude: -81.81055			County: Hardee Site Number: PI375 Reach Length: 45 ft. Landowner: Ben Hill Griffin Inc.

Pfankuch-Channel Stability:	Poor	1.5	
Channel Alteration:	None	0	
Bank Erosion:	Active	1	
BEHI:	High (37.29)	1	
Local NPSP:	Obvious Sources	1.5	
Shoring Structures:	None	0	
Pipe Discharge:	None	0	
Water Odor:	Normal	0	
Fish Passage Barrier:	None	0	
RB: Riparian Buffer:	0 ft.	0.75	
LB: Riparian Buffer:	0 ft.	0.75	
RB: Floodplain Access:	Full	0	
LB: Floodplain Access:	Full	0	
Severity Scale:		6.5	Additional Site Features
			Stream Channel Woody Material: Infrequent
			Impoundments: None
			Substrate Composition: Medium Sand
			Bank Material: Sand
			Near Bank Stress: High
			RB Landuse: Pasture
			LB Landuse: Pasture
303d: Impaired - Fecal Coliform

Restoration Option 1

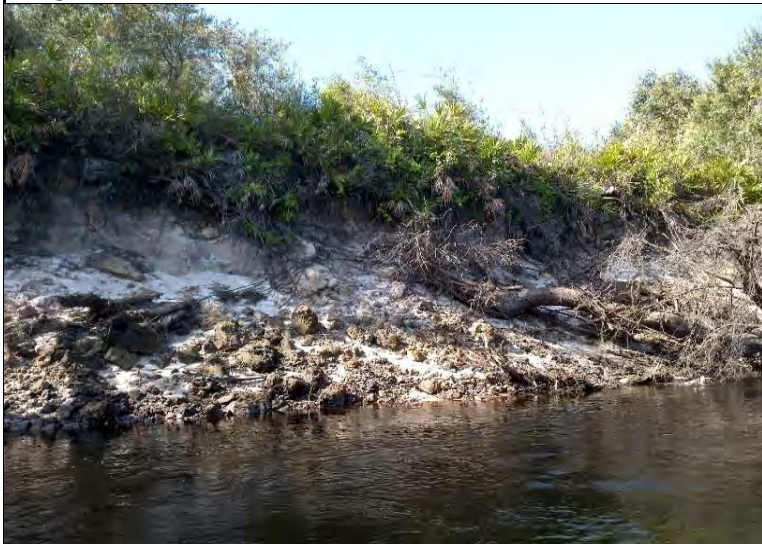
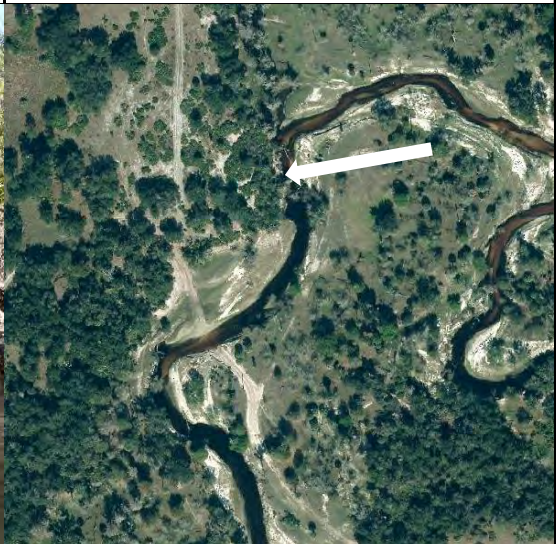
Charlie Creek			Severity Scale: 6.5-Moderate	
Watershed: Peace River Subwatershed: Lower Charlie Creek Latitude: 27.37435 Longitude: -81.81062			County: Hardee Site Number: PI376 Reach Length: 130 ft. Landowner: Ben Hill Griffin Inc.

Pfankuch-Channel Stability:	Poor	1.5		
Channel Alteration:	None	0		
Bank Erosion:	Mass-wasting	1.5		
BEHI:	Moderate (26.57)	0.5		
Local NPSP:	Obvious Sources	1.5		
Shoring Structures:	None	0		
Pipe Discharge:	None	0		
Water Odor:	Normal	0		
Fish Passage Barrier:	None	0		
RB: Riparian Buffer:	40 ft.	0.5	<b>Additional Site Features</b> Stream Channel Woody Material: Numerous Impoundments: None Substrate Composition: Medium Sand Bank Material: Sandstone + Clay Near Bank Stress: Low RB Landuse: Pasture, Natural Forest, Farm Rd LB Landuse: Pasture, Natural forest	
LB: Riparian Buffer:	20 ft.	0.75		
RB: Floodplain Access:	Partial	0.25

LB: Floodplain Access:	Full	0		
<b>Severity Scale:</b>		<b>6.5</b>		
303d: Impaired - Fecal Coliform				
Restoration Option 1

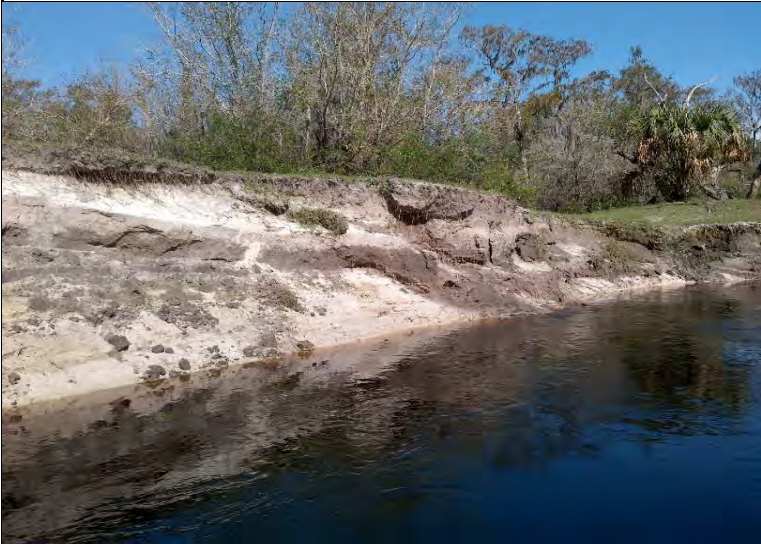
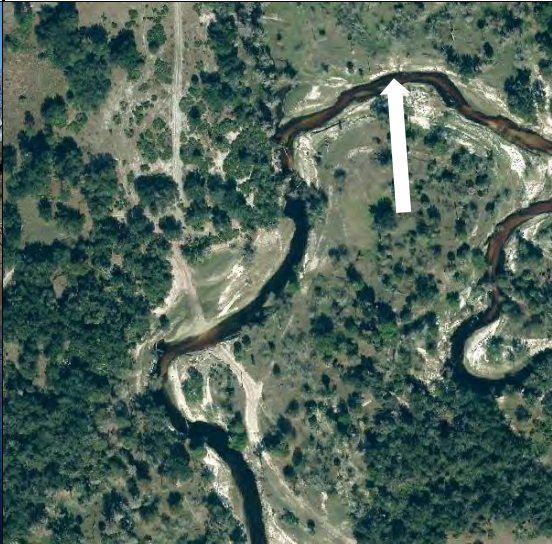
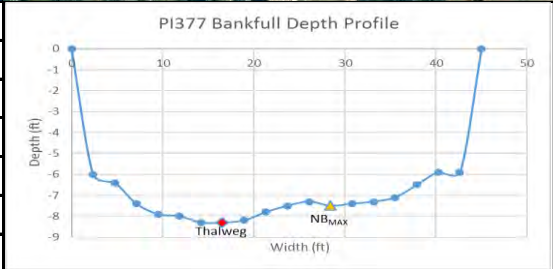
Charlie Creek			Severity Scale: 6.5-Moderate
Watershed: Peace River Subwatershed: Lower Charlie Creek Latitude: 27.37501 Longitude: -81.81022			County: Hardee Site Number: PI377 Reach Length: 190 ft. Landowner: Ben Hill Griffin Inc.

Risk Factor	Ranking	Score	
Pfankuch-Channel Stability:	Poor	1.5	
Channel Alteration:	None	0	
Bank Erosion:	Active	1	
BEHI:	High (39.26)	1	
Local NPSP:	Obvious Sources	1.5	
Shoring Structures:	None	0	
Pipe Discharge:	None	0	
Water Odor:	Normal	0	
Fish Passage Barrier:	None	0	
RB: Riparian Buffer:	20 ft.	0.75	
LB: Riparian Buffer:	0 ft.	0.75	
RB: Floodplain Access:	Full	0	
LB: Floodplain Access:	Full	0	
<b>Severity Scale:</b>		<b>6.5</b>	
303d: Impaired - Fecal Coliform			
Restoration Option 1

Additional Site Features
Stream Channel Woody Material: Infrequent
Impoundments: None
Substrate Composition: Medium Sand
Bank Material: Sand
Near Bank Stress: Low
RB Landuse: Pasture, Natural Forest
LB Landuse: Pasture, Natural Forest

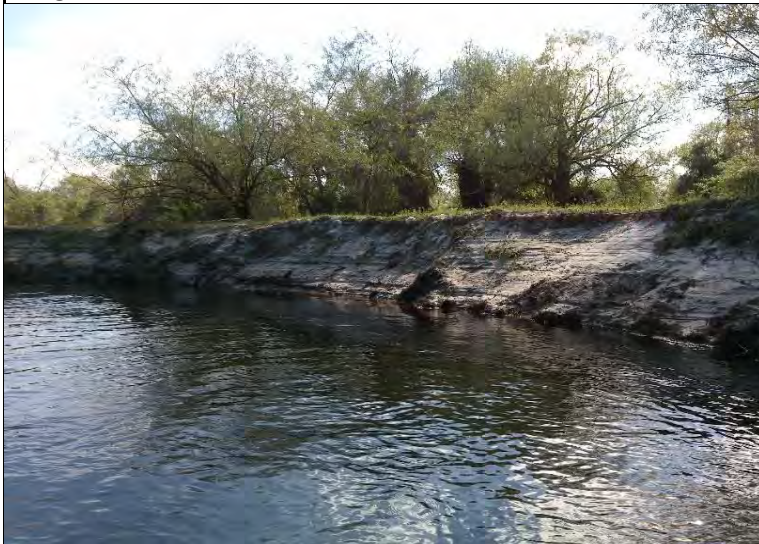
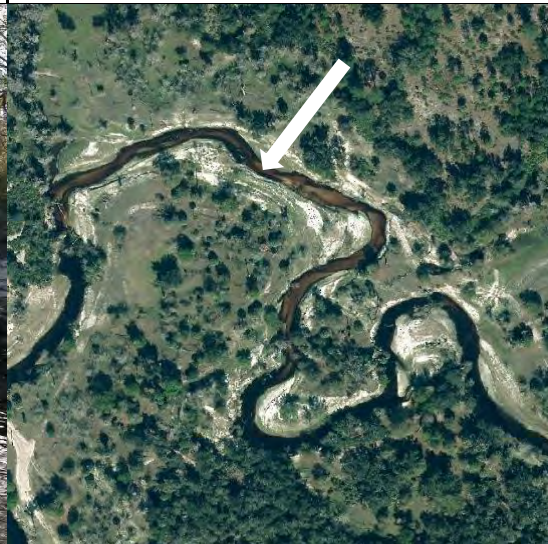
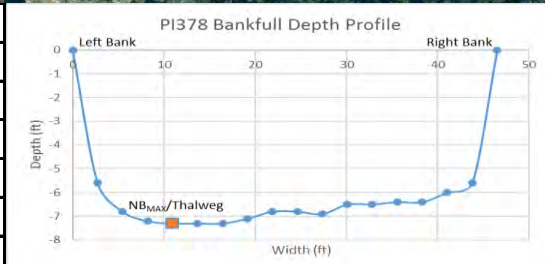
Risk Factor	Ranking	Score
Pfankuch-Channel Stability:	Poor	1.5
Channel Alteration:	None	0
Bank Erosion:	Active	1
BEHI:	High (34.04)	1
Local NPSP:	Obvious Sources	1.5
Shoring Structures:	None	0
Pipe Discharge:	None	0
Water Odor:	Normal	0
Fish Passage Barrier:	None	0
RB: Riparian Buffer:	20 ft.	0.75
LB: Riparian Buffer:	0 ft.	0.75
RB: Floodplain Access:	Full	0
LB: Floodplain Access:	Full	0
Severity Scale:		6.5

Stream Channel Woody Material: Infrequent
Impoundments: None
Substrate Composition: Medium Sand
Bank Material: Sand
Near Bank Stress: High
RB Landuse: Pasture, Natural Forest
LB Landuse: Pasture, Natural forest

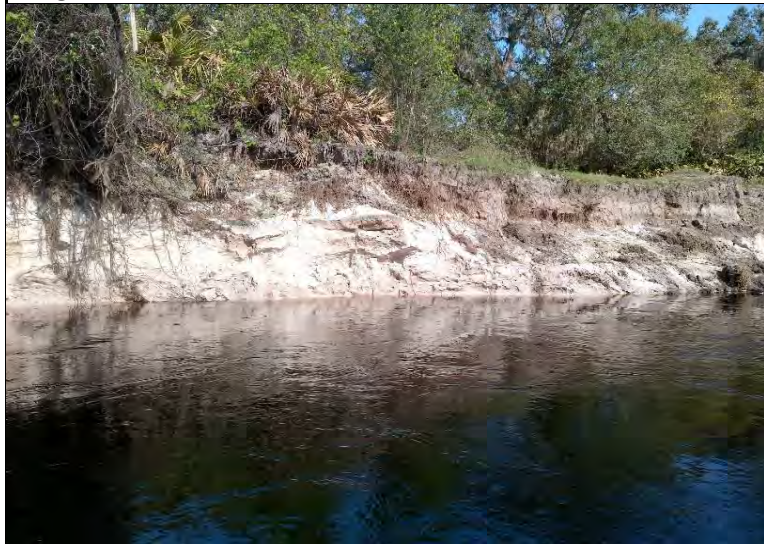
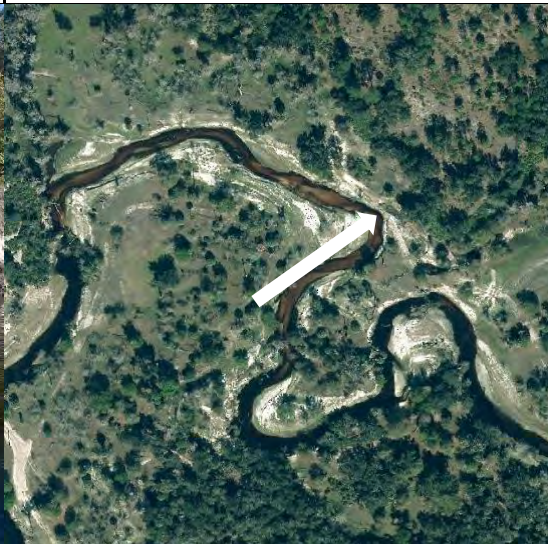
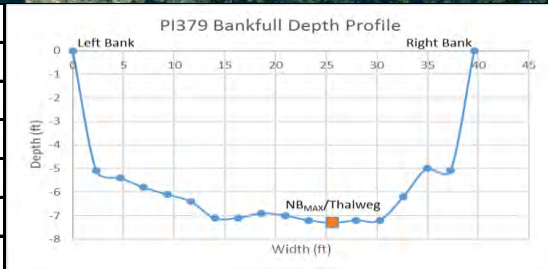
Risk Factor	Ranking	Score
Pfankuch-Channel Stability:	Poor	1.5
Channel Alteration:	None	0
Bank Erosion:	Active	1
BEHI:	High (36.31)	1
Local NPSP:	Obvious Sources	1.5
Shoring Structures:	None	0
Pipe Discharge:	None	0
Water Odor:	Normal	0
Fish Passage Barrier:	None	0
RB: Riparian Buffer:	20 ft.	0.75
LB: Riparian Buffer:	0 ft.	0.75
RB: Floodplain Access:	Full	0
LB: Floodplain Access:	Full	0
Severity Scale:		6.5

Additional Site Features
Stream Channel Woody Material: Infrequent
Impoundments: None
Substrate Composition: Medium Sand
Bank Material: Sand
Near Bank Stress: Moderate
RB Landuse: Pasture, Natural Forest
LB Landuse: Pasture, Natural Forest

303d: Impaired - Fecal Coliform

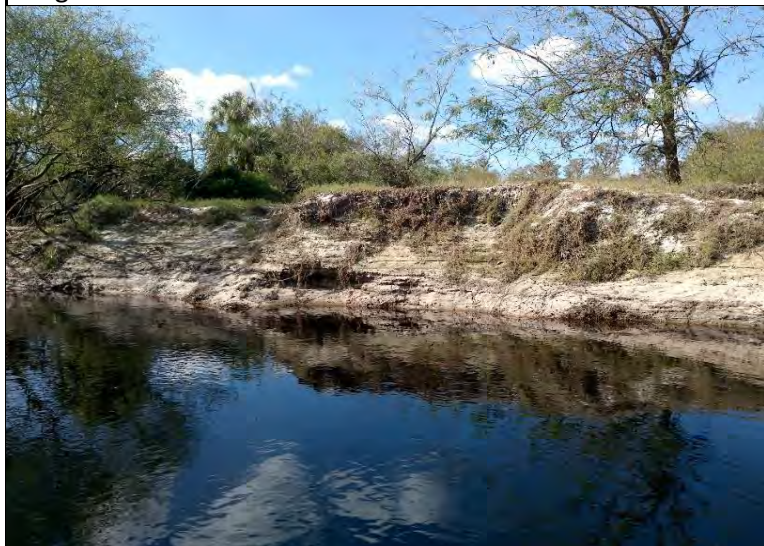
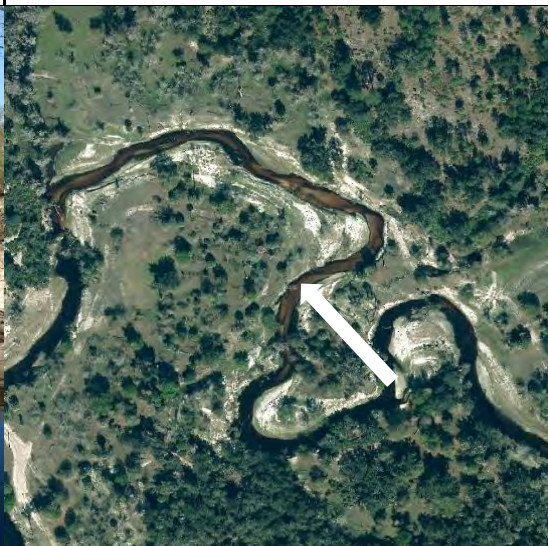
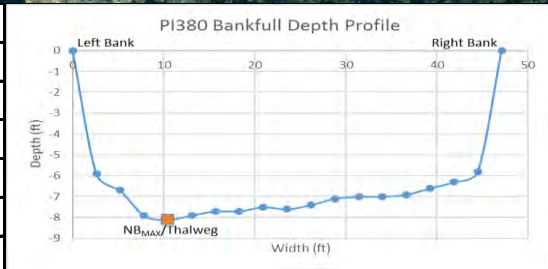
County: Hardee  
Site Number: PI380  
Reach Length: 160 ft.  
Landowner: Ben Hill Griffin Inc.

Risk Factor	Ranking	Score
Pfankuch-Channel Stability:	Poor	1.5
Channel Alteration:	None	0
Bank Erosion:	Active	1
BEHI:	High (36.17)	1
Local NPSP:	Obvious Sources	1.5
Shoring Structures:	None	0
Pipe Discharge:	None	0
Water Odor:	Normal	0
Fish Passage Barrier:	None	0
RB: Riparian Buffer:	40 ft.	0.5
LB: Riparian Buffer:	40 ft.	0.5
RB: Floodplain Access:	Full	0
LB: Floodplain Access:	Full	0
Severity Scale:		6.0

Additional Site Features
Stream Channel Woody Material: Moderate
Impoundments: None
Substrate Composition: Medium Sand
Bank Material: Sand
Near Bank Stress: High
RB Landuse: Natural Forest, Pasture
LB Landuse: Natural Forest, Pasture

303d: Impaired - Fecal Coliform

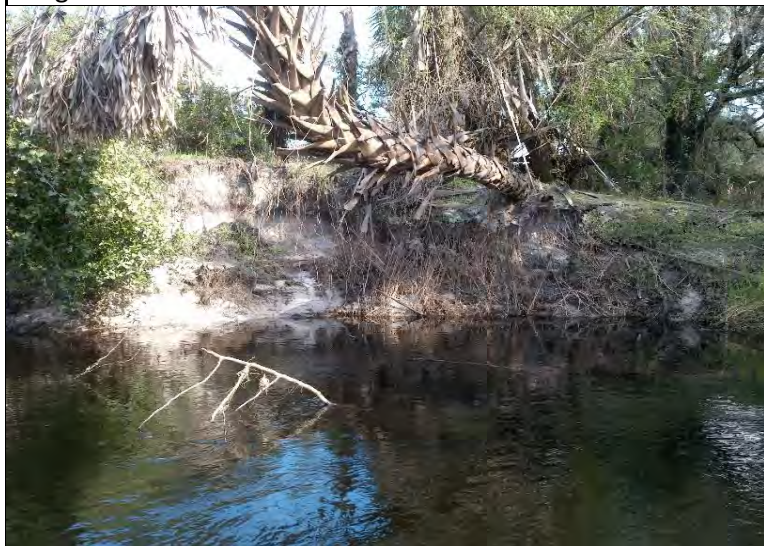
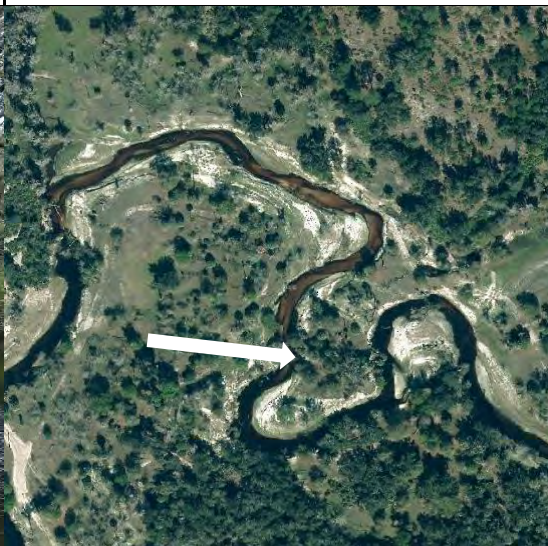
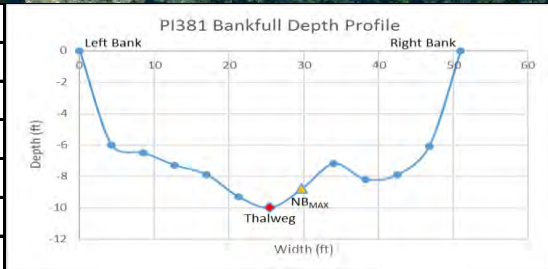
Risk Factor	Ranking	Score
Pfankuch-Channel Stability:	Poor	1.5
Channel Alteration:	None	0
Bank Erosion:	Mass-wasting	1.5
BEHI:	High (33.71)	1
Local NPSP:	Obvious Sources	1.5
Shoring Structures:	None	0
Pipe Discharge:	None	0
Water Odor:	Normal	0
Fish Passage Barrier:	None	0
RB: Riparian Buffer:	40 ft.	0.5
LB: Riparian Buffer:	40 ft.	0.5
RB: Floodplain Access:	Full	0
LB: Floodplain Access:	Full	0
Severity Scale:		6.5

Additional Site Features
Stream Channel Woody Material: extensive
Impoundments: None
Substrate Composition: Meedium Sand
Bank Material: Sand
Near Bank Stress: Moderate
RB Landuse: Natural Forest, Pasture
LB Landuse: Pasture, Natural Forest

303d: Impaired - Fecal Coliform

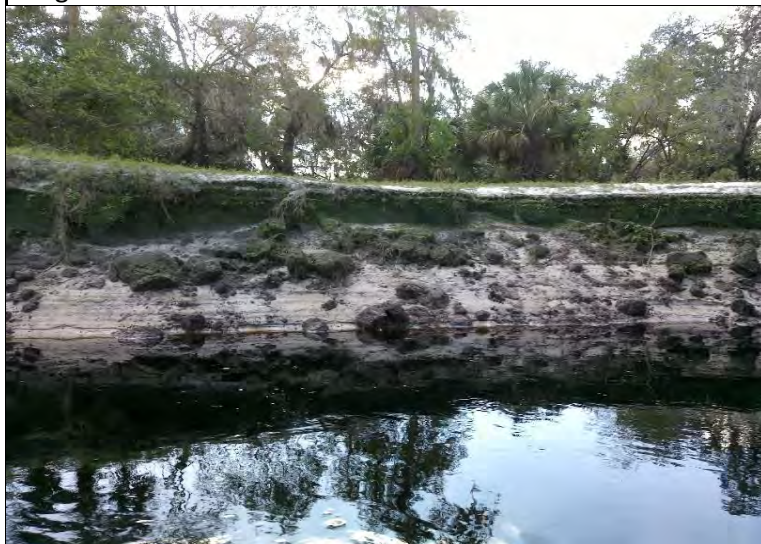
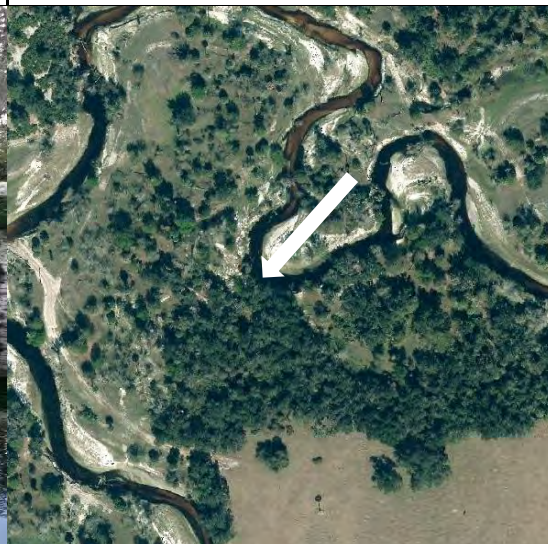
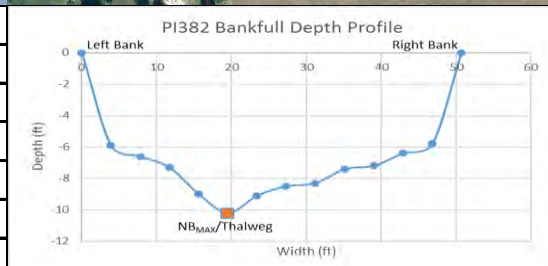
Risk Factor	Ranking	Score
Pfankuch-Channel Stability:	Poor	1.5
Channel Alteration:	None	0
Bank Erosion:	Mass-wasting	1.5
BEHI:	Moderate (28.04)	0.5
Local NPSP:	Obvious Sources	1.5
Shoring Structures:	None	0
Pipe Discharge:	None	0
Water Odor:	Normal	0
Fish Passage Barrier:	None	0
RB: Riparian Buffer:	20 ft.	0.75
LB: Riparian Buffer:	0 ft.	0.75
RB: Floodplain Access:	Full	0
LB: Floodplain Access:	Full	0
Severity Scale:		6.5

Stream Channel Woody Material: Infrequent

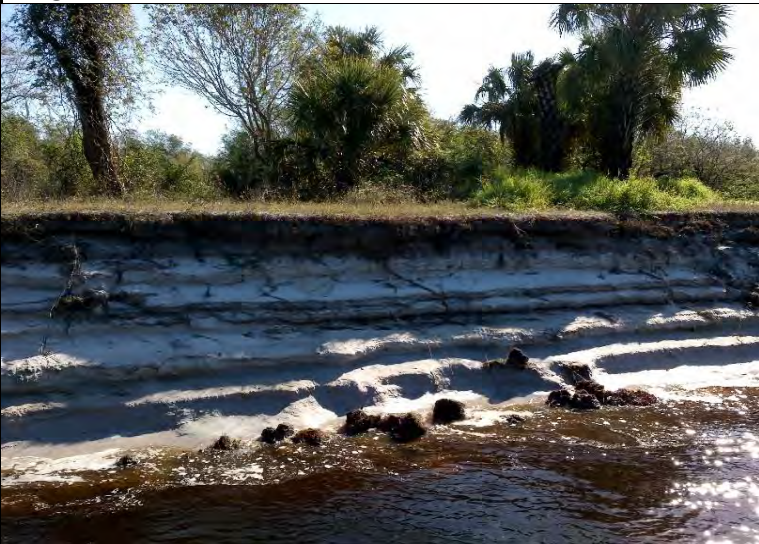
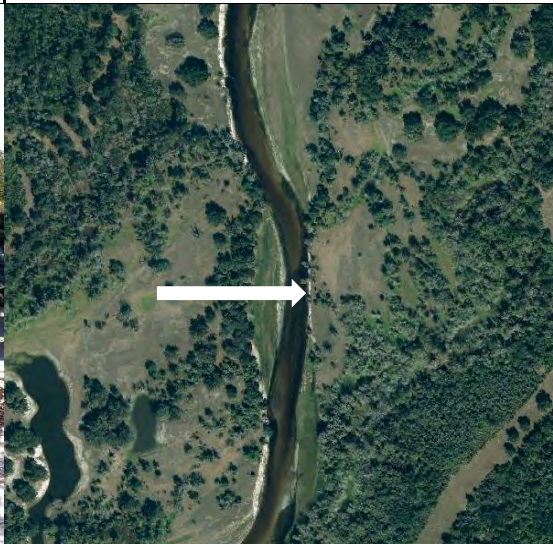
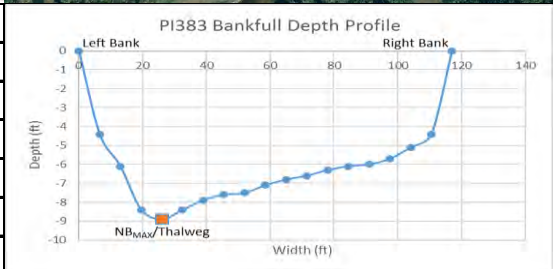
Peace River			Severity Scale: 6.5-Moderate	
Watershed: Peace River Subwatershed: Johnson Lake Latitude: 27.21186 Longitude: -81.88622			County: Desoto Site Number: PI383 Reach Length: 345 ft. Landowner: Garner Grove & Cattle Co

Pfankuch-Channel Stability:	Poor	1.5		
Channel Alteration:	None	0		
Bank Erosion:	Mass-wasting	1.5		
BEHI:	High (38.70)	1		
Local NPSP:	Obvious Sources	1.5		
Shoring Structures:	None	0		
Pipe Discharge:	None	0		
Water Odor:	Normal	0		
Fish Passage Barrier:	None	0		
RB: Riparian Buffer:	60 ft.	0.25		
LB: Riparian Buffer:	0 ft.	0.75		
RB: Floodplain Access:	Full	0		
LB: Floodplain Access:	Full	0		
Severity Scale:		6.5	Additional Site Features	
			Stream Channel Woody Material: Moderate	
			Impoundments: None	
			Substrate Composition: Medium Sand	
			Bank Material: Sand	
			Near Bank Stress: High	
			RB Landuse: Natural Forest, Pasture	
			LB Landuse: Pasture, Natural Forest

Notes: 303d: Impaired - Aquatic Life Harvesting (fecal coliform, mercury in fish tissue)				
Restoration Option 1

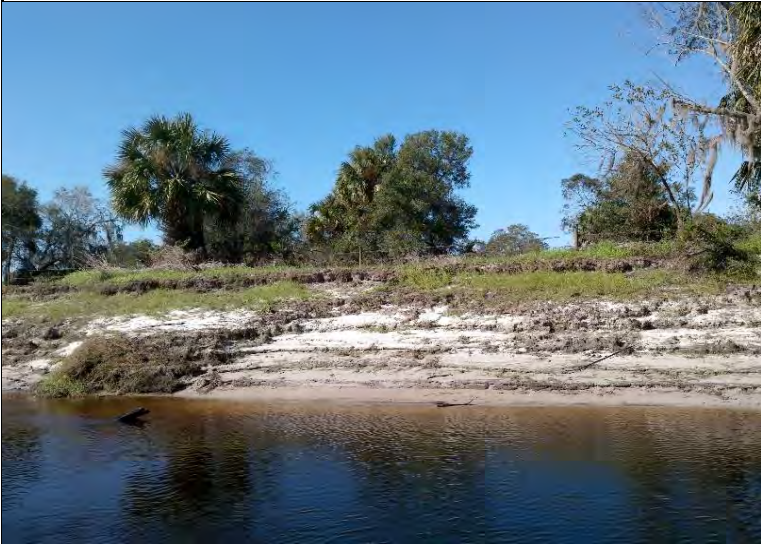
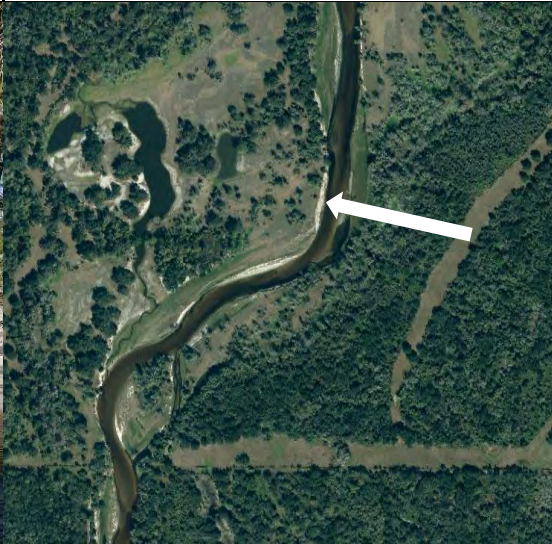
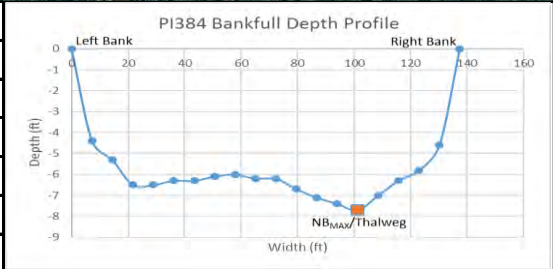
Peace River			Severity Scale: 6.0-Moderate
Watershed: Peace River Subwatershed: Johnson Lake Latitude: 27.21015 Longitude: -81.88668			County: Desoto Site Number: PI384 Reach Length: 475 ft. Landowner: Garner Grove & Cattle Co

Risk Factor	Ranking	Score	
Pfankuch-Channel Stability:	Poor	1.5	
Channel Alteration:	None	0	
Bank Erosion:	Active	1	
BEHI:	High (31.52)	1	
Local NPSP:	Obvious Sources	1.5	
Shoring Structures:	None	0	
Pipe Discharge:	None	0	
Water Odor:	Normal	0	
Fish Passage Barrier:	None	0	
RB: Riparian Buffer:	40 ft.	0.5	
LB: Riparian Buffer:	60 ft.	0.25	
RB: Floodplain Access:	Partial	0.25	
LB: Floodplain Access:	Full	0	
<b>Severity Scale:</b>		<b>6.0</b>	
Notes: 303d: Impaired - Aquatic Life Harvesting (fecal coliform, mercury in fish tissue)			
Restoration Option 2 or 3

Additional Site Features
Stream Channel Woody Material: Moderate
Impoundments: None
Substrate Composition: Medium Sand
Bank Material: Sand
Near Bank Stress: High
RB Landuse: Pasture, Natural Forest
LB Landuse: Natural Forest, Pasture

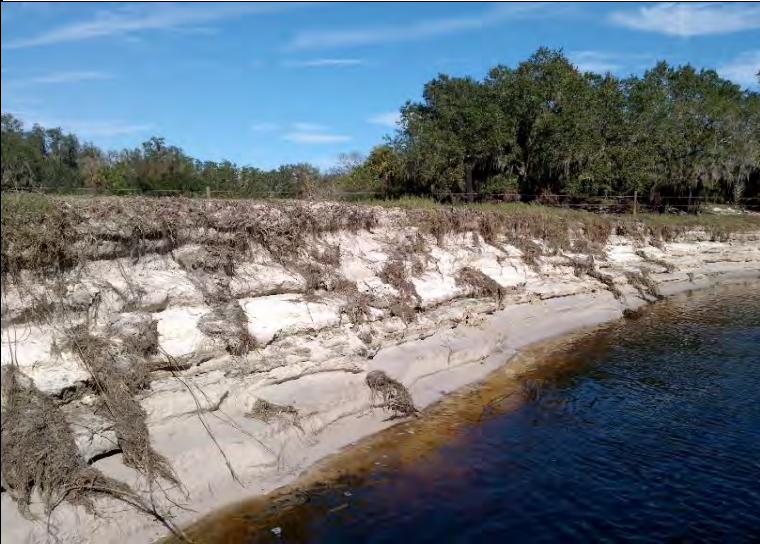
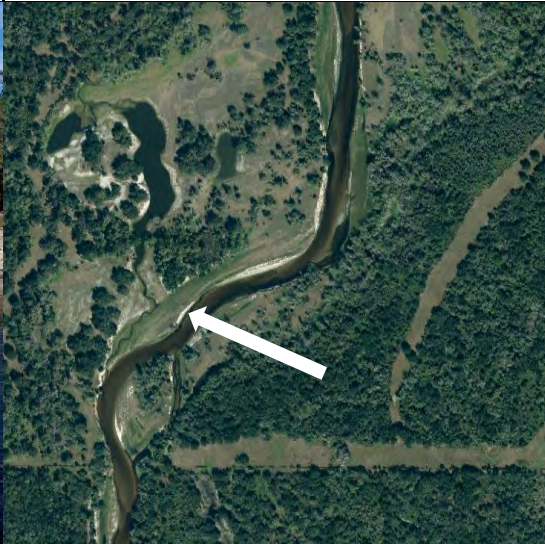
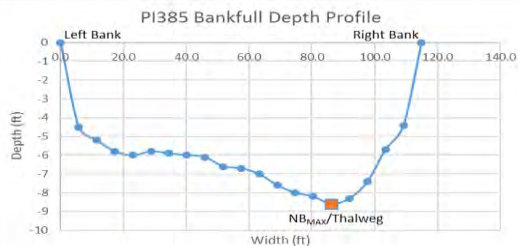
Peace River			Severity Scale: 7.25-Moderate
Watershed: Peace River Subwatershed: Johnson Lake Latitude: 27.20726 Longitude: -81.88878			County: Desoto Site Number: PI385 Reach Length: 200 ft. Landowner: Garner Grove & Cattle Co

Risk Factor	Ranking	Score	
Pfankuch-Channel Stability:	Poor	1.5	
Channel Alteration:	None	0	
Bank Erosion:	Mass-wasting	1.5	
BEHI:	Very High (41.95)	1.5	
Local NPSP:	Obvious Sources	1.5	
Shoring Structures:	None	0	
Pipe Discharge:	None	0	
Water Odor:	Normal	0	<b>Additional Site Features</b>
Fish Passage Barrier:	None	0	Stream Channel Woody Material: Infrequent
RB: Riparian Buffer:	0 ft.	0.75	Impoundments: None
LB: Riparian Buffer:	40 ft.	0.5	Substrate Composition: Medium Sand
RB: Floodplain Access:	Full	0	Bank Material: Sand
LB: Floodplain Access:	Full	0	Near Bank Stress: High
			RB Landuse: Pasture, Natural Forest
	<b>Severity Scale:</b>	<b>7.25</b>	LB Landuse: Pasture, Natural Forest

Notes: 303d: Impaired - Aquatic Life Harvesting (fecal coliform, mercury in fish tissue)			
Restoration Option 1, restoration should be done in conjunction with sites PI386 and PI055.
