# **Peace River and Withlacoochee River Threats Assessments and Fish Assemblage Monitoring**

**Final Report July 1, 2015 – June 30, 2019**

Submitted to Florida State Wildlife Grants Program  
August 1, 2019  
PID: 98462501284

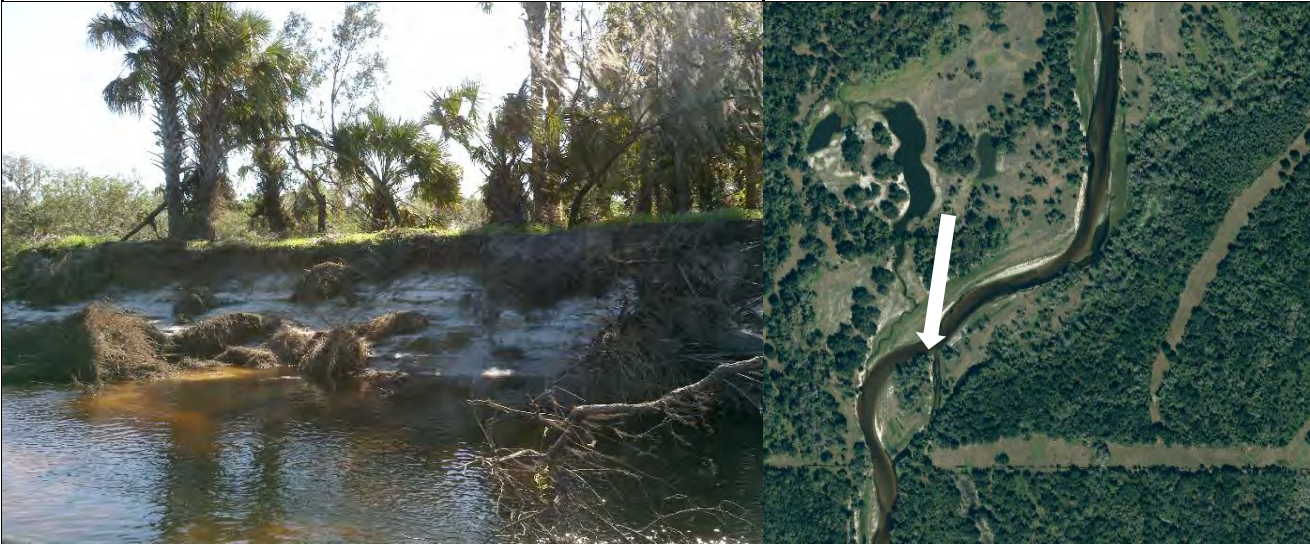
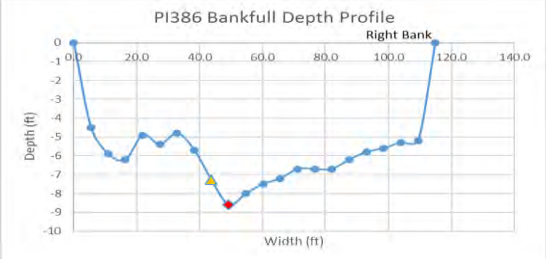
Peace River			Severity Scale: 6.5-Moderate
Watershed: Peace River Subwatershed: Johnson Lake Latitude: 27.20687 Longitude: -81.88928			County: Desoto Site Number: PI386 Reach Length: 245 ft. Landowner: Garner Grove & Cattle Co

Pfankuch-Channel Stability:	Poor	1.5	
Channel Alteration:	None	0	
Bank Erosion:	Active	1	
BEHI:	High (37.72)	1	
Local NPSP:	Obvious Sources	1.5	
Shoring Structures:	None	0	
Pipe Discharge:	None	0	
Water Odor:	Normal	0	
Fish Passage Barrier:	None	0	
RB: Riparian Buffer:	0 ft.	0.75	
LB: Riparian Buffer:	40 ft.	0.5	
RB: Floodplain Access:	Full	0	
LB: Floodplain Access:	Partial	0.25	
<b>Severity Scale:</b>		<b>6.5</b>	
			Additional Site Features
			Stream Channel Woody Material: Extensive
			Impoundments: None
			Substrate Composition: Medium Sand
			Bank Material: Sand
			Near Bank Stress: Moderate
			RB Landuse: Pasture, Natural Forest
			LB Landuse: Pasture, Natural Forest

Notes: 303d: Impaired - Aquatic Life Harvesting (fecal coliform, mercury in fish tissue)			
Restoration Option 2, restoration should be done in conjunction with sites PI385 and PI055.

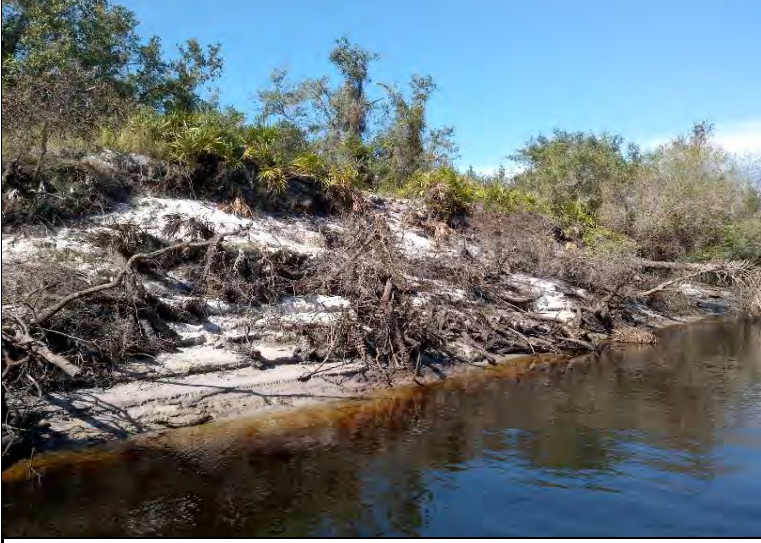
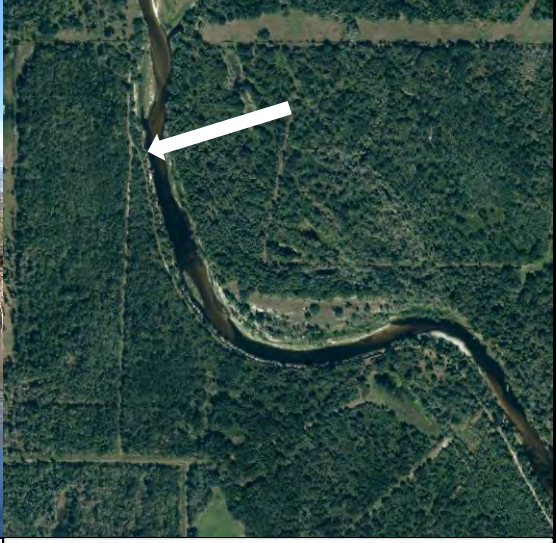
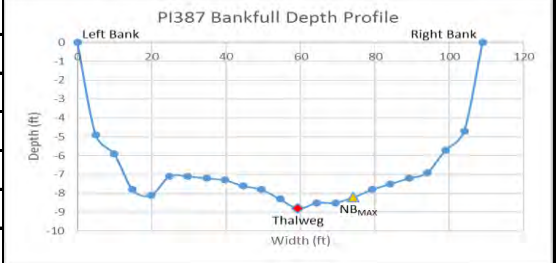
Peace River			Severity Scale: 6.5-Moderate
Watershed: Peace River Subwatershed: Johnson Lake Latitude: 27.20307 Longitude: -81.88953			County: Desoto Site Number: PI387 Reach Length: 315 ft. Landowner: GERACI D D TR

Risk Factor	Ranking	Score	
Pfankuch-Channel Stability:	Poor	1.5	
Channel Alteration:	None	0	
Bank Erosion:	Active	1	
BEHI:	Very High (43.07)	1.5	
Local NPSP:	Obvious Sources	1.5	
Shoring Structures:	None	0	
Pipe Discharge:	None	0	
Water Odor:	Normal	0	
Fish Passage Barrier:	None	0	
RB: Riparian Buffer:	40 ft.	0.5	
LB: Riparian Buffer:	80 ft.	0.25	
RB: Floodplain Access:	Partial	0.25	
LB: Floodplain Access:	Full	0	
<b>Severity Scale:</b>		<b>6.5</b>	
Notes: 303d: Impaired - Aquatic Life Harvesting (fecal coliform, mercury in fish tissue)			
Restoration Option 1

Additional Site Features
Stream Channel Woody Material: Numerous
Impoundments: None
Substrate Composition: Medium Sand
Bank Material: Sand
Near Bank Stress: Moderate
RB Landuse: Natural Forest, Pasture
LB Landuse: Natural Forest

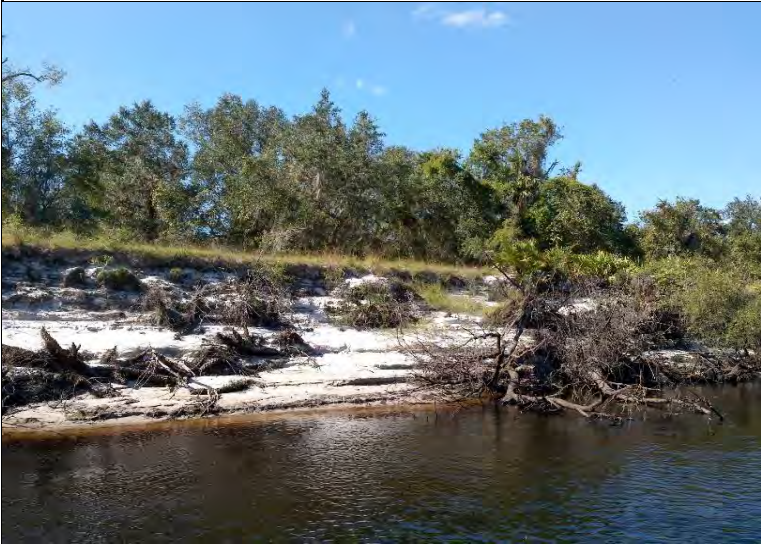
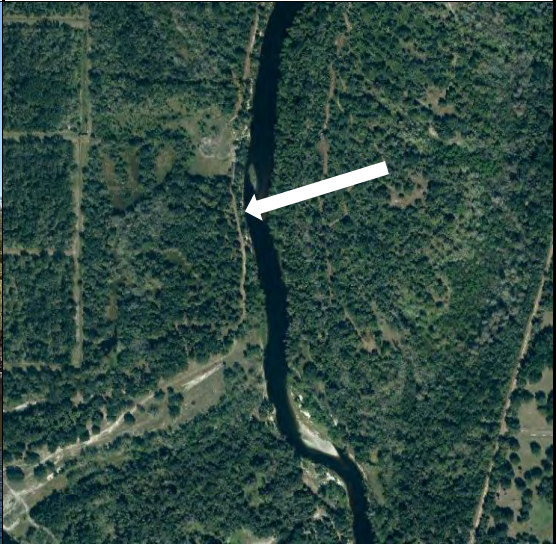
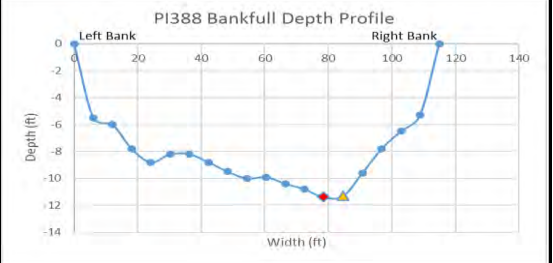
Peace River			Severity Scale: 5.75-Moderate
Watershed: Peace River Subwatershed: Johnson Lake Latitude: 27.18323 Longitude: -81.88690			County: Desoto Site Number: PI388 Reach Length: 160 ft. Landowner: GERACI D D TR

Risk Factor	Ranking	Score	
Pfankuch-Channel Stability:	Poor	1.5	
Channel Alteration:	None	0	
Bank Erosion:	Active	1	
BEHI:	High (37.93)	1	
Local NPSP:	Obvious Sources	1.5	
Shoring Structures:	None	0	
Pipe Discharge:	None	0	
Water Odor:	Normal	0	
Fish Passage Barrier:	None	0	
RB: Riparian Buffer:	40 ft.	0.5	
LB: Riparian Buffer:	100 ft.	0	
RB: Floodplain Access:	Partial	0.25	
LB: Floodplain Access:	Full	0	
<b>Severity Scale:</b>		<b>5.75</b>	
Notes: 303d: Impaired - Aquatic Life Harvesting (fecal coliform, mercury in fish tissue)			
Restoration Option 1

Additional Site Features	
Stream Channel Woody Material:	Numerous
Impoundments:	None
Substrate Composition:	Medium Sand
Bank Material:	Sand
Near Bank Stress:	High
RB Landuse:	Pasture, Natural Forest
LB Landuse:	Natural Forest, Pasture

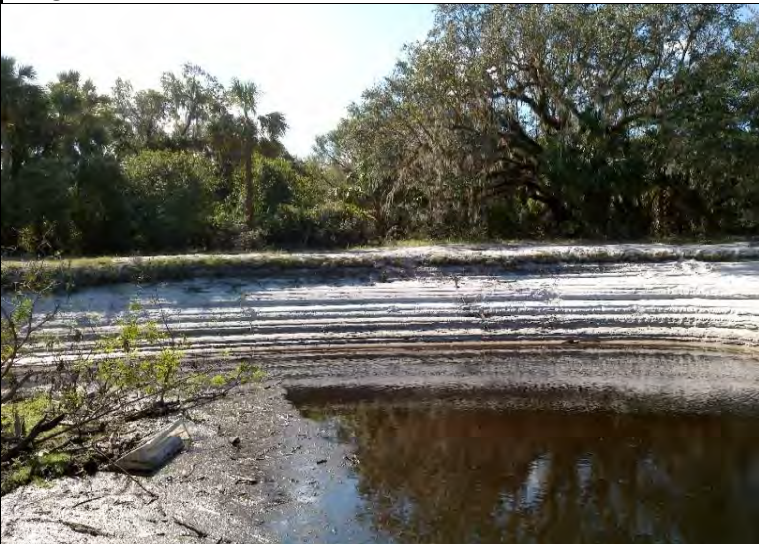
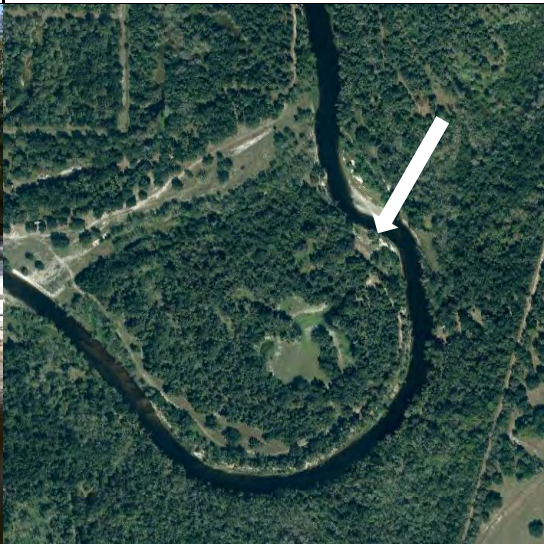
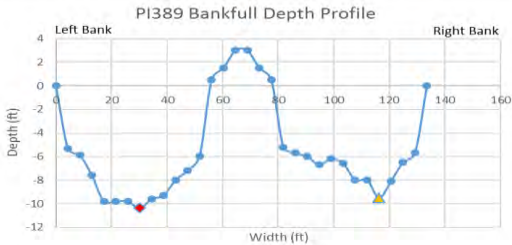
Peace River			Severity Scale: 6.5-Moderate	
Watershed: Peace River Subwatershed: Johnson Lake Latitude: 27.17935 Longitude: -81.88579			County: Desoto Site Number: PI389 Reach Length: 180 ft. Landowner: GERACI D D TR

Risk Factor	Ranking	Score	PI389 Bankfull Depth Profile	
Pfankuch-Channel Stability:	Poor	1.5

Channel Alteration:	None	0		
Bank Erosion:	Active	1		
BEHI:	Very High (41.94)	1.5		
Local NPSP:	Obvious Sources	1.5		
Shoring Structures:	None	0		
Pipe Discharge:	None	0		
Water Odor:	Normal	0		
Fish Passage Barrier:	None	0	Additional Site Features	
RB: Riparian Buffer:	40 ft.	0.5	Stream Channel Woody Material: Numerous	
LB: Riparian Buffer:	60 ft.	0.25	Impoundments: Woody Material Jams	
RB: Floodplain Access:	Partial	0.25	Substrate Composition: Medium Sand	
LB: Floodplain Access:	Full	0	Bank Material: Sand	
Severity Scale:		6.5	Near Bank Stress: Low	
			RB Landuse: Pasture, Natural Forest

LB Landuse: Natural Forest, Pasture	
Notes: Island; 303d: Impaired - Aquatic Life Harvesting (fecal coliform, mercury in fish tissue)				
Restoration Option 1

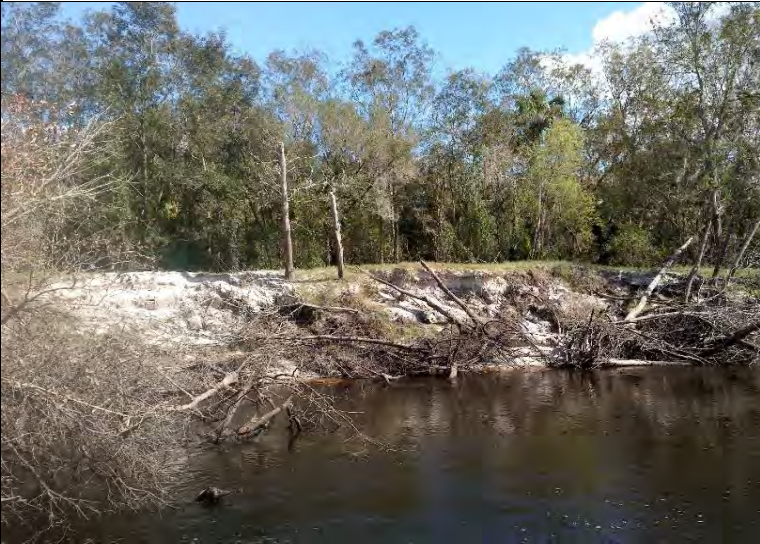
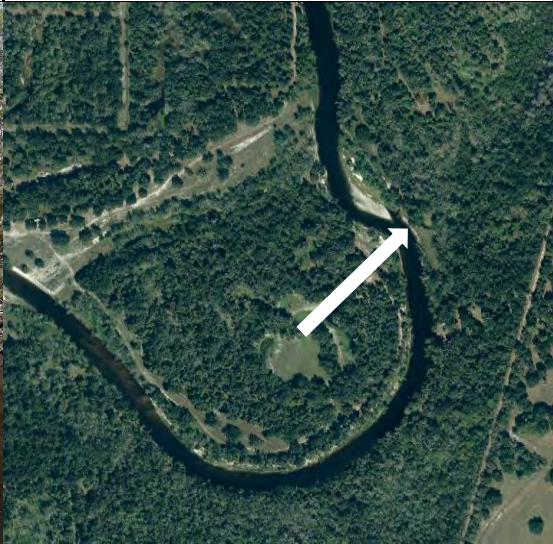
Peace River			Severity Scale: 5.75-Moderate
Watershed: Peace River Subwatershed: Johnson Lake Latitude: 27.17918 Longitude: -81.88514			County: Desoto Site Number: PI390 Reach Length: 210 ft. Landowner: PULLING JOHN A JR

Risk Factor	Ranking	Score	
Pfankuch-Channel Stability:	Poor	1.5	
Channel Alteration:	None	0	
Bank Erosion:	Active	1	
BEHI:	High (35.89)	1	
Local NPSP:	Obvious Sources	1.5	
Shoring Structures:	None	0	
Pipe Discharge:	None	0	<b>Additional Site Features</b> Stream Channel Woody Material: Extensive Impoundments: None Substrate Composition: Medium Sand Bank Material: Sand Near Bank Stress: High RB Landuse: Natural Forest, Pasture LB Landuse: Pasture, Natural Forest
Water Odor:	Normal	0	
Fish Passage Barrier:	None	0	
RB: Riparian Buffer:	100 ft.	0	
LB: Riparian Buffer:	0 ft.	0.75	
RB: Floodplain Access:	Full	0	
LB: Floodplain Access:	Full	0	
<b>Severity Scale:</b>		<b>5.75</b>

Notes: 303d: Impaired - Aquatic Life Harvesting (fecal coliform, mercury in fish tissue)			
Restoration Option 1

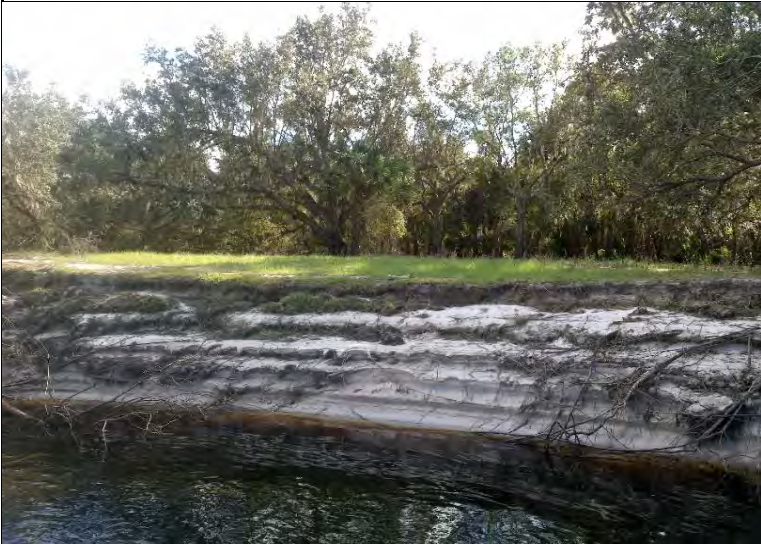
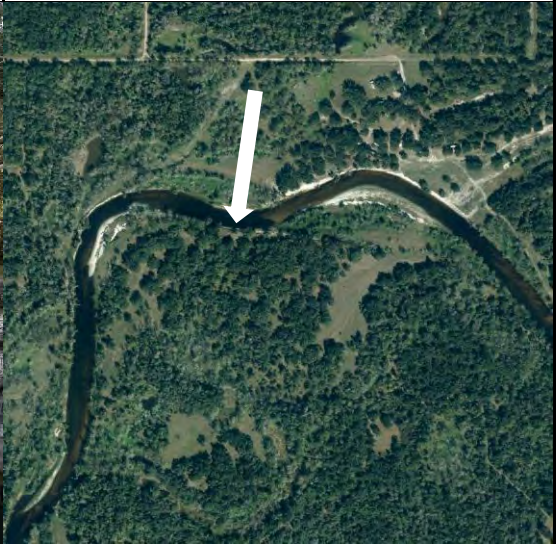
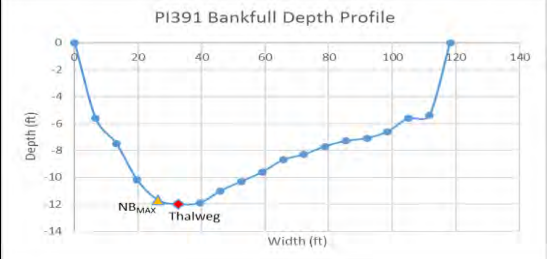
Peace River			Severity Scale: 5.0-Moderate
Watershed: Peace River Subwatershed: Johnson Lake Latitude: 27.17879 Longitude: -81.89433			County: Desoto Site Number: PI391 Reach Length: 210 ft. Landowner: GERACI D D TR

Pfankuch-Channel Stability:	Poor	1.5	
Channel Alteration:	None	0	
Bank Erosion:	Active	1	
BEHI:	Moderate (27.21)	0.5	
Local NPSP:	Obvious Sources	1.5	
Shoring Structures:	None	0	
Pipe Discharge:	None	0	
Water Odor:	Normal	0	
Fish Passage Barrier:	None	0	
RB: Riparian Buffer:	100 ft.	0	
LB: Riparian Buffer:	40 ft.	0.5	
RB: Floodplain Access:	Full	0	
LB: Floodplain Access:	Full	0	
<b>Severity Scale:</b>		<b>5.0</b>	<b>Additional Site Features</b> Stream Channel Woody Material: Numerous Impoundments: None Substrate Composition: Medium Sand Bank Material: Sand Near Bank Stress: High RB Landuse: Pasture, Natural Forest LB Landuse: Pasture, Natural Forest

Notes: 303d: Impaired - Aquatic Life Harvesting (fecal coliform, mercury in fish tissue)			
Restoration Option 1

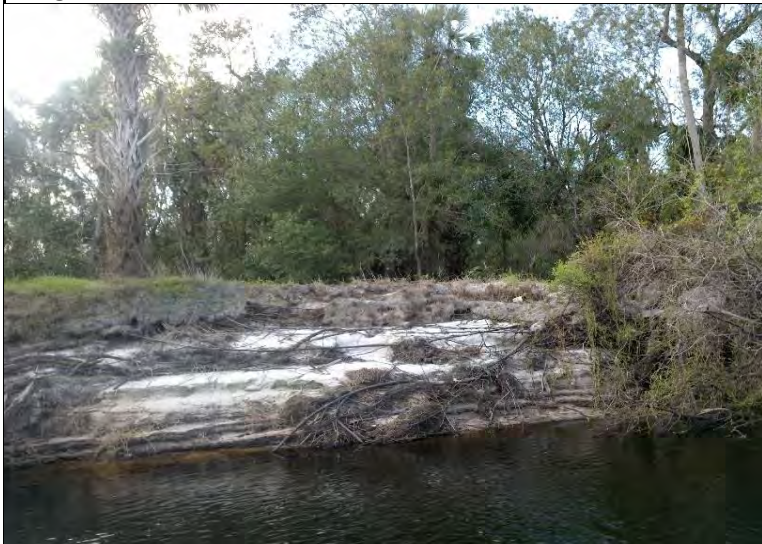
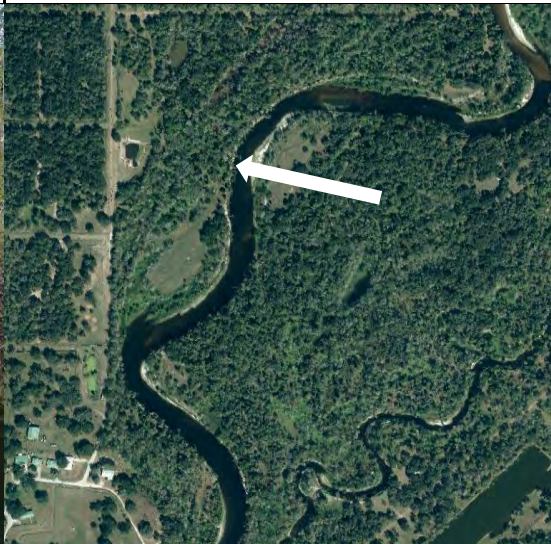
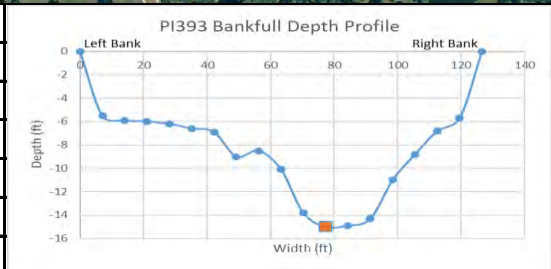
Peace River			Severity Scale: 5.5-Moderate	
Watershed: Peace River Subwatershed: Johnson Lake Latitude: 27.16909 Longitude: -81.90128			County: Desoto Site Number: PI393 Reach Length: 90 ft. Landowner: GERACI D D TR

Pfankuch-Channel Stability:	Poor	1.5		
Channel Alteration:	None	0		
Bank Erosion:	Active	1		
BEHI:	High (31.01)	1		
Local NPSP:	Obvious Sources	1.5		
Shoring Structures:	None	0		
Pipe Discharge:	None	0		
Water Odor:	Normal	0		
Fish Passage Barrier:	None	0		
RB: Riparian Buffer:	40 ft.	0.5	<b>Additional Site Features</b> Stream Channel Woody Material: Extensive Impoundments: None Substrate Composition: Medium Sand Bank Material: Sand Near Bank Stress: Moderate RB Landuse: Natural Forest, Pasture LB Landuse: Natural Forest, Pasture	
LB: Riparian Buffer:	100 ft.	0		
RB: Floodplain Access:	Full	0		
LB: Floodplain Access:	Full	0		
Severity Scale:		5.5

Notes: 303d: Impaired - Aquatic Life Harvesting (mercury in fish tissue)				
Restoration Option 1

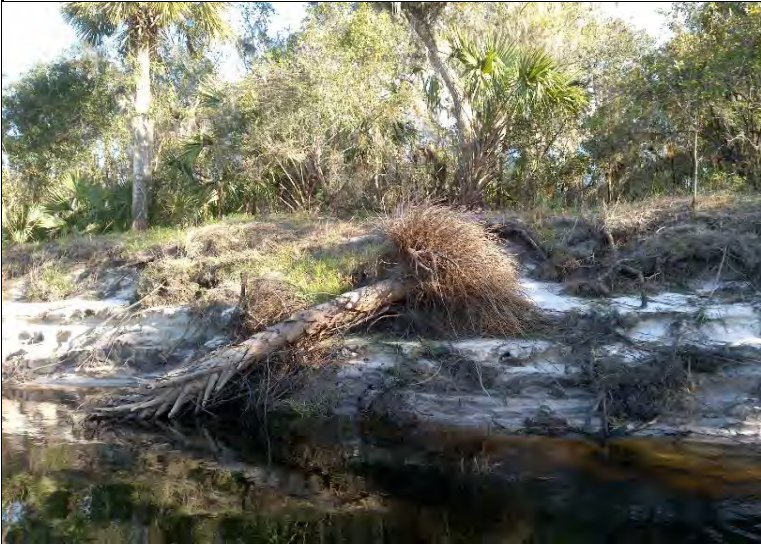
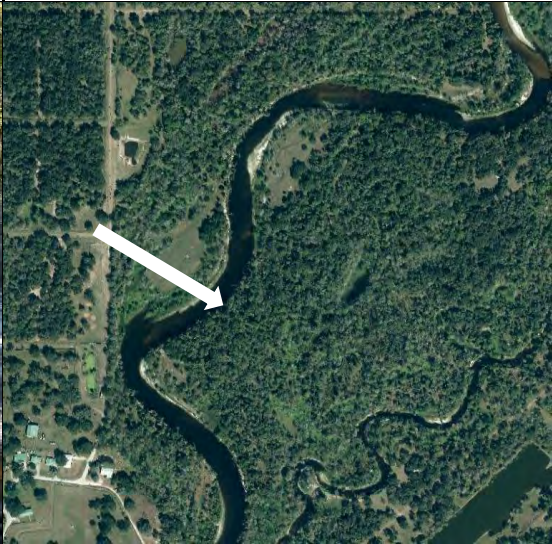
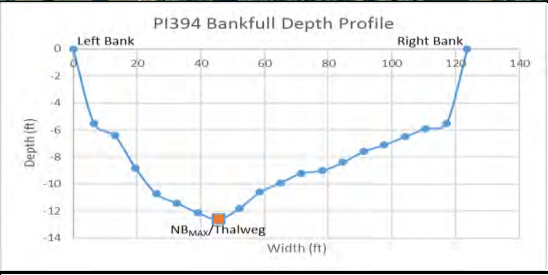
Peace River			Severity Scale: 5.25-Moderate
Watershed: Peace River Subwatershed: Johnson Lake Latitude: 27.16624 Longitude: -81.90263			County: Desoto Site Number: PI394 Reach Length: 700 ft. Landowner: GERACI D D TR

Pfankuch-Channel Stability:	Poor	1.5	
Channel Alteration:	None	0	
Bank Erosion:	Active	1	
BEHI:	High (30.31)	1	
Local NPSP:	Obvious Sources	1.5	
Shoring Structures:	None	0	
Pipe Discharge:	None	0	
Water Odor:	Normal	0	
Fish Passage Barrier:	None	0	
RB: Riparian Buffer:	100 ft.	0	
LB: Riparian Buffer:	100 ft.	0	
RB: Floodplain Access:	Full	0	
LB: Floodplain Access:	Partial	0.25	
<b>Severity Scale:</b>		<b>5.25</b>	Additional Site Features
			Stream Channel Woody Material: Numerous
			Impoundments: None
			Substrate Composition: Medium Sand
			Bank Material: Sand
			Near Bank Stress: Moderate
			RB Landuse: Natural Forest, Pasture
			LB Landuse: Natural Forest

Notes: 303d: Impaired - Aquatic Life Harvesting (mercury in fish tissue)			
Restoration Option 1

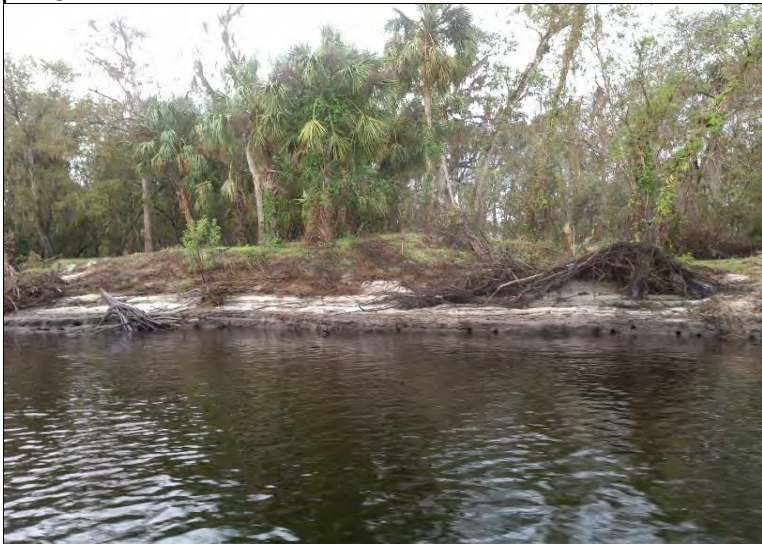
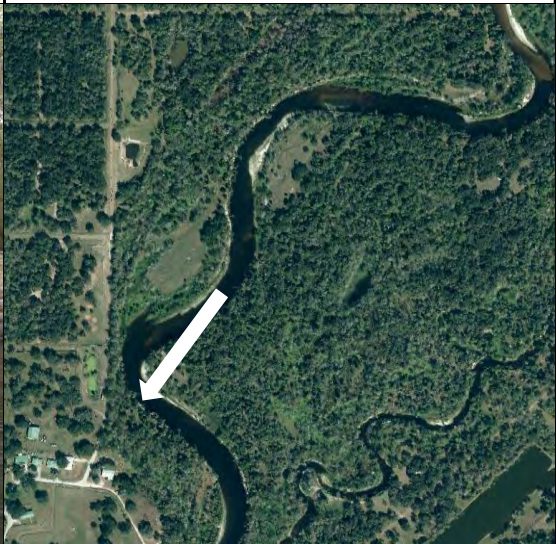
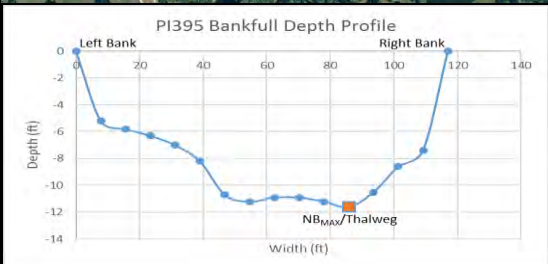
Peace River			Severity Scale: 2.75-Low	
Watershed: Peace River Subwatershed: Johnson Lake Latitude: 27.16504 Longitude: -81.90207			County: Desoto Site Number: PI395 Reach Length: 450 ft. Landowner: PEACE RIVER CHARTERS LLC

Pfankuch-Channel Stability:	Poor	1.5		
Channel Alteration:	None	0		
Bank Erosion:	Active	1		
BEHI:	Low (13.15)	0		
Local NPSP:	No Evidence	0		
Shoring Structures:	None	0		
Pipe Discharge:	None	0		
Water Odor:	Normal	0		
Fish Passage Barrier:	None	0		
RB: Riparian Buffer:	60 ft.	0.25	<b>Additional Site Features</b>	
LB: Riparian Buffer:	100 ft.	0	Stream Channel Woody Material: Numerous	
RB: Floodplain Access:	Full	0	Impoundments: None	
LB: Floodplain Access:	Full	0	Substrate Composition: Medium Sand	
Severity Scale: 2.75			Bank Material: Clay	
			Near Bank Stress: High	
			RB Landuse: Natural Forest, Pasture	
			LB Landuse: Natural Forest

Notes: 303d: Impaired - Aquatic Life Harvesting (mercury in fish tissue)				
Restoration Option 1

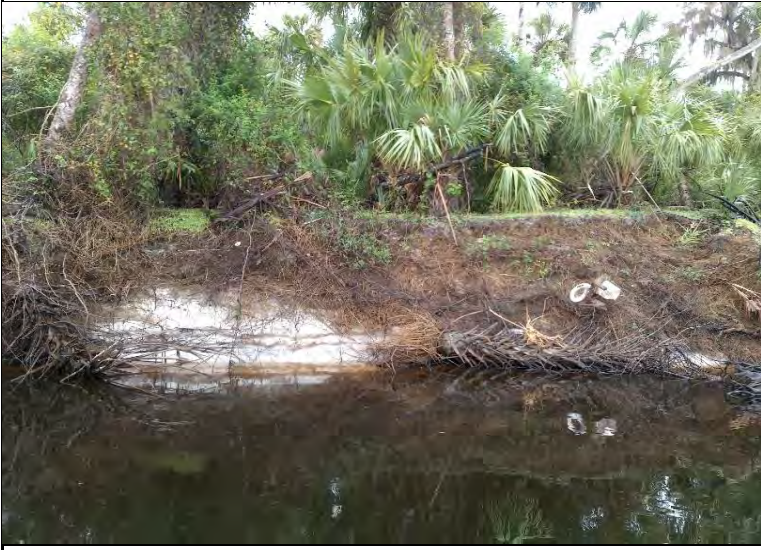
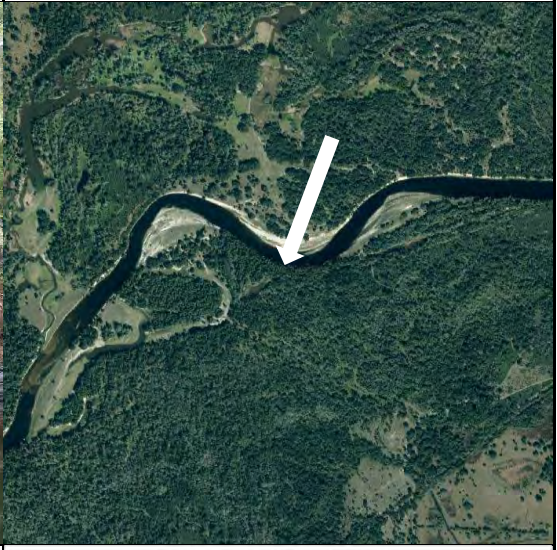
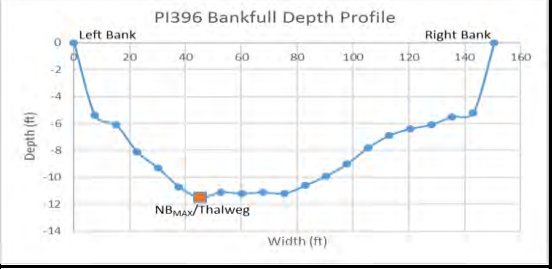
Peace River			Severity Scale: 3.25-Low
Watershed: Peace River Subwatershed: Johnson Lake Latitude: 27.1550 Longitude: -81.92175			County: Desoto Site Number: PI396 Reach Length: 780 ft. Landowner: ROBERTSON SUSIE TR

Pfankuch-Channel Stability:	Poor	1.5	
Channel Alteration:	None	0	
Bank Erosion:	Active	1	
BEHI:	Moderate (24.01)	0.5	
Local NPSP:	No Evidence	0	
Shoring Structures:	None	0	
Pipe Discharge:	None	0	
Water Odor:	Normal	0	
Fish Passage Barrier:	None	0	
RB: Riparian Buffer:	100 ft.	0	
LB: Riparian Buffer:	100 ft.	0	
RB: Floodplain Access:	Full	0	
LB: Floodplain Access:	Partial	0.25	
<b>Severity Scale:</b>		<b>3.25</b>	
Notes: 303d: Impaired - Aquatic Life Harvesting (mercury in fish tissue)			
Restoration Option 1

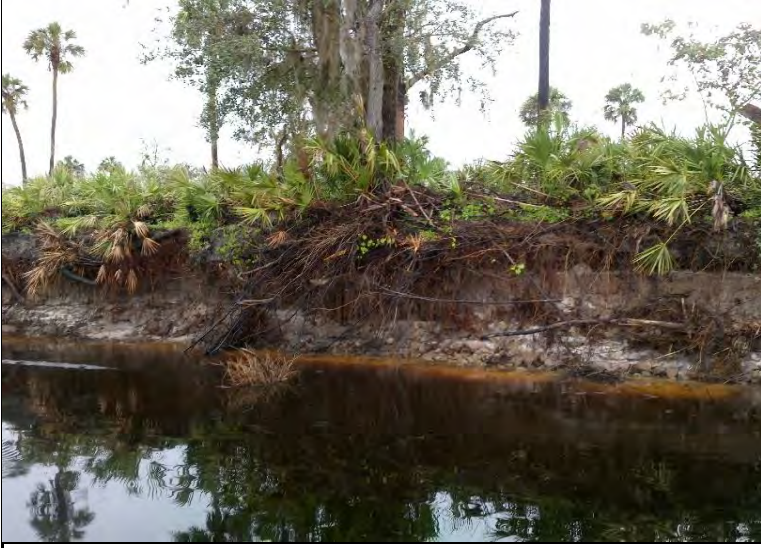
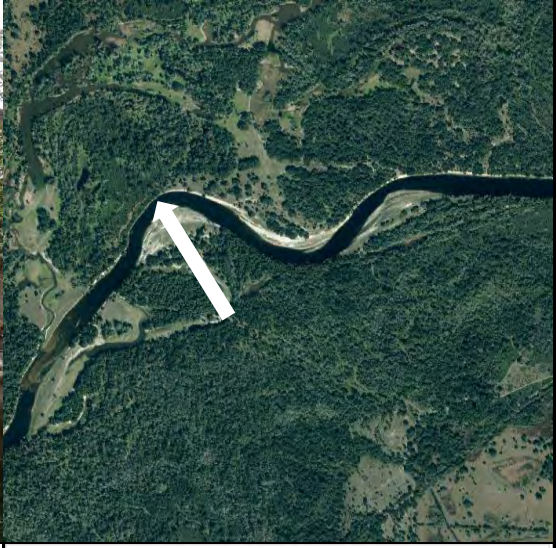
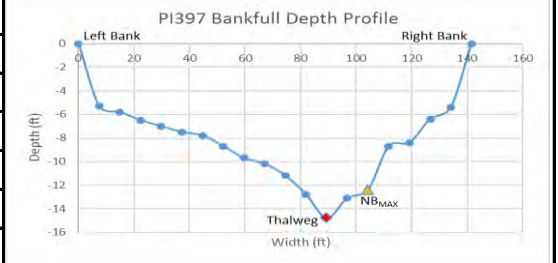
Peace River			Severity Scale: 4.25-Moderate
Watershed: Peace River Subwatershed: Johnson Lake Latitude: 27.15582 Longitude: -81.92352			County: Desoto Site Number: PI397 Reach Length: 600 ft. Landowner: ROBERTSON FAMILY LLC

Risk Factor	Ranking	Score	
Pfankuch-Channel Stability:	Poor	1.5	
Channel Alteration:	None	0	
Bank Erosion:	Mass-wasting	1.5	
BEHI:	High (37.04)	1	
Local NPSP:	No Evidence	0	
Shoring Structures:	None	0	
Pipe Discharge:	None	0	
Water Odor:	Normal	0	
Fish Passage Barrier:	None	0	
RB: Riparian Buffer:	70 ft.	0.25	
LB: Riparian Buffer:	100 ft.	0	
RB: Floodplain Access:	Full	0	
LB: Floodplain Access:	Full	0	
Severity Scale:		4.25	
Notes: 303d: Impaired - Aquatic Life Harvesting (mercury in fish tissue)			
Restoration Option 1

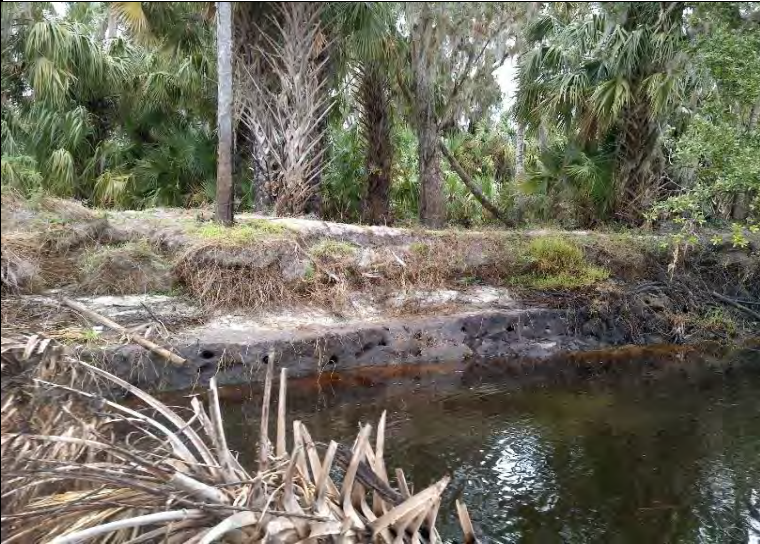
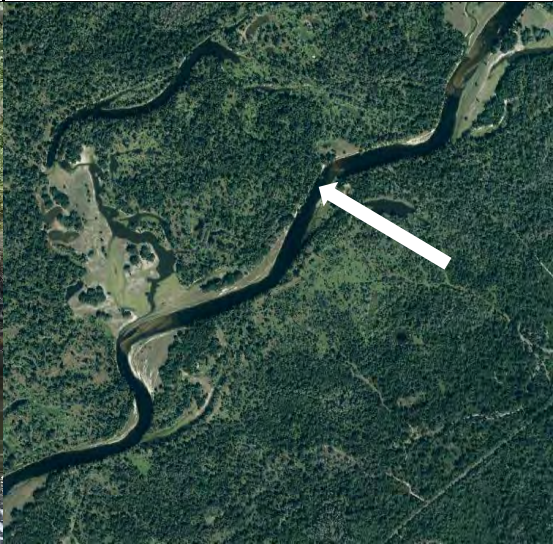
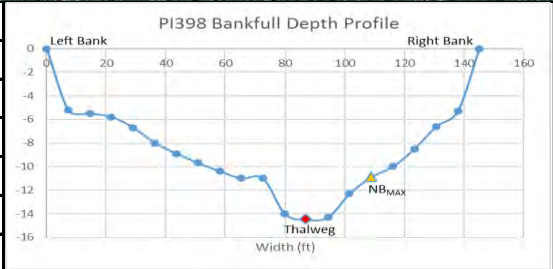
Peace River			Severity Scale: 4.25-Moderate
Watershed: Peace River Subwatershed: Johnson Lake Latitude: 27.14689 Longitude: -81.93165			County: Desoto Site Number: PI398 Reach Length: 575 ft. Landowner: JOHNSON HOMESTEAD LLC

Risk Factor	Ranking	Score	
Pfankuch-Channel Stability:	Poor	1.5	
Channel Alteration:	None	0	
Bank Erosion:	Active	1	
BEHI:	Low (10.69)	0	
Local NPSP:	Obvious Sources	1.5	
Shoring Structures:	None	0	
Pipe Discharge:	None	0	<b>Additional Site Features</b> Stream Channel Woody Material: Numerous Impoundments: None Substrate Composition: Medium Sand Bank Material: Clay Near Bank Stress: Moderate RB Landuse: Natural Forest, Pasture LB Landuse: Natural Forest, Pasture
Water Odor:	Normal	0	
Fish Passage Barrier:	None	0	
RB: Riparian Buffer:	60 ft.	0.25	
LB: Riparian Buffer:	100 ft.	0	
RB: Floodplain Access:	Full	0	
LB: Floodplain Access:	Full	0	
<b>Severity Scale:</b>		<b>4.25</b>

Notes: 303d: Impaired - Aquatic Life Harvesting (mercury in fish tissue)			
Restoration Option 1

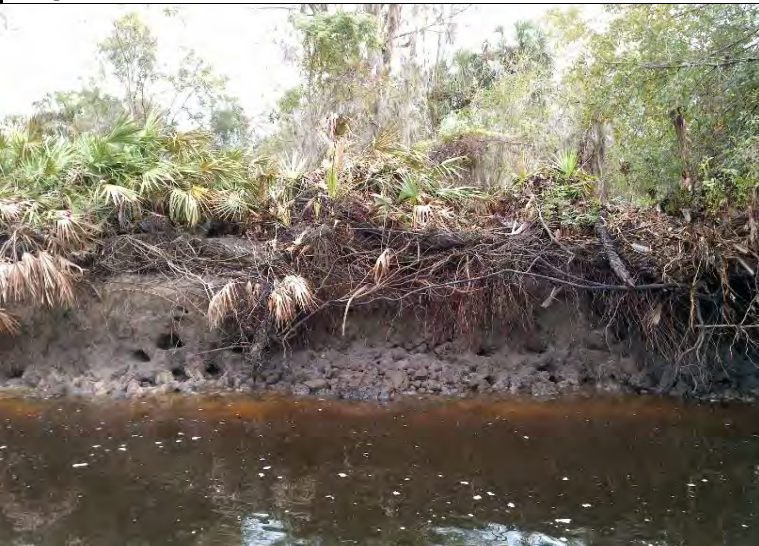
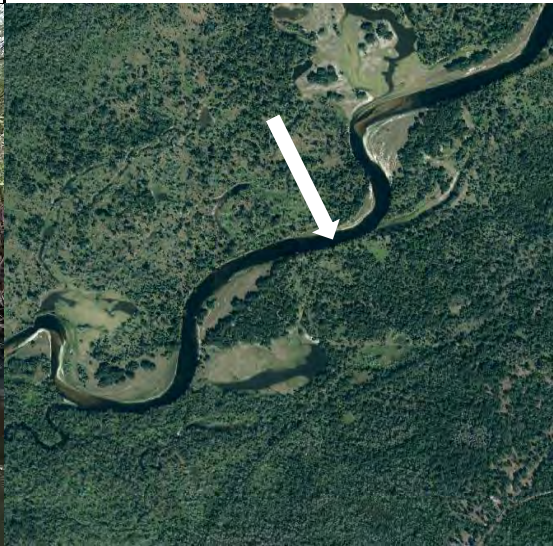
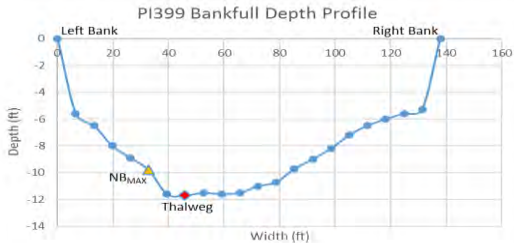
Peace River			Severity Scale: 4.5-Moderate	
Watershed: Peace River Subwatershed: Johnson Lake Latitude: 27.14033 Longitude: -81.93670			County: Desoto Site Number: PI399 Reach Length: 550 ft. Landowner: ROBERTSON SUSIE TR

Pfankuch-Channel Stability:	Poor	1.5		
Channel Alteration:	None	0		
Bank Erosion:	Active	1		
BEHI:	Low (12.95)	0		
Local NPSP:	Obvious Sources	1.5		
Shoring Structures:	None	0		
Pipe Discharge:	None	0		
Water Odor:	Normal	0		
Fish Passage Barrier:	None	0		
RB: Riparian Buffer:	60 ft.	0.25		
LB: Riparian Buffer:	60 ft.	0.25		
RB: Floodplain Access:	Full	0		
LB: Floodplain Access:	Full	0		
Severity Scale:		4.5	Additional Site Features	
			Stream Channel Woody Material: Moderate	
			Impoundments: None	
			Substrate Composition: Medium Sand	
			Bank Material: Clay	
			Near Bank Stress: High	
			RB Landuse: Natural Forest, Pasture	
			LB Landuse: Natural Forest

Notes: 303d: Impaired - Aquatic Life Harvesting (mercury in fish tissue)				
Restoration Option 1

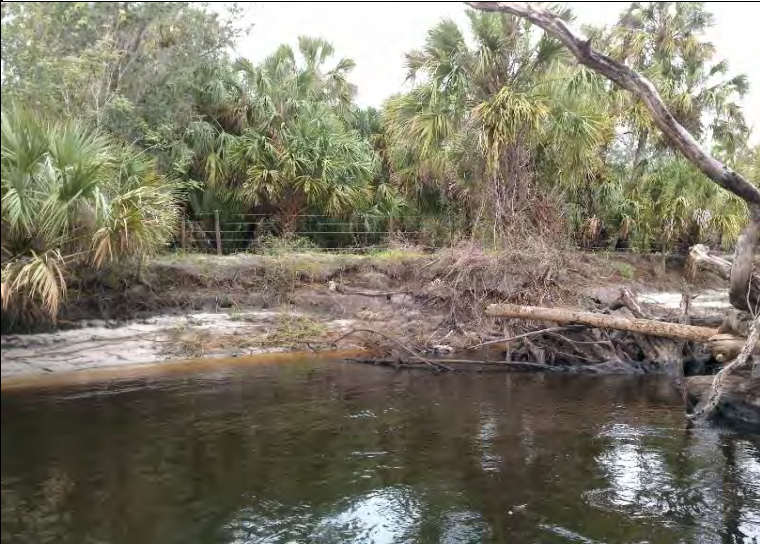
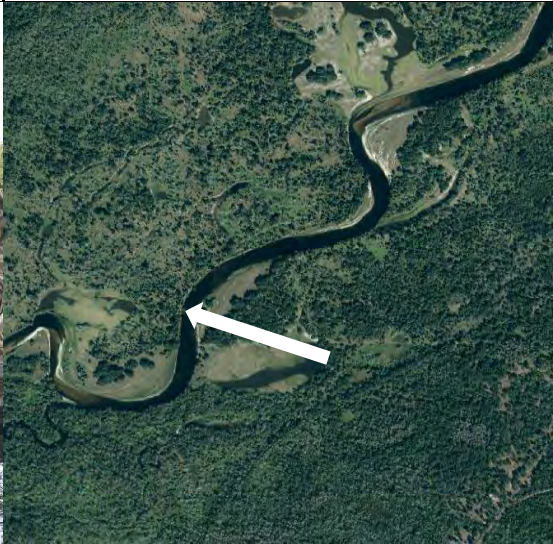
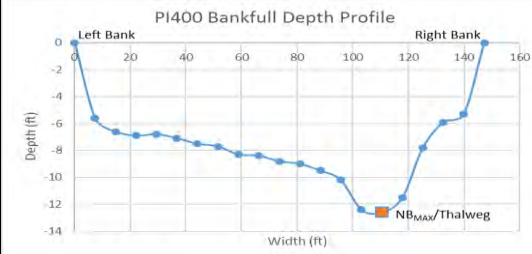
Peace River			Severity Scale: 5.5-Moderate
Watershed: Peace River Subwatershed: Lettuce Lake Latitude: 27.13781 Longitude: -81.94142			County: Desoto Site Number: PI400 Reach Length: 130 ft. Landowner: HAU II LLC

Risk Factor	Ranking	Score	
Pfankuch-Channel Stability:	Poor	1.5	
Channel Alteration:	None	0	
Bank Erosion:	Active	1	
BEHI:	Moderate (21.95)	0.5	
Local NPSP:	Obvious Sources	1.5	
Shoring Structures:	None	0	
Pipe Discharge:	None	0	
Water Odor:	Normal	0	
Fish Passage Barrier:	None	0	
RB: Riparian Buffer:	40 ft.	0.5	
LB: Riparian Buffer:	40 ft.	0.5	
RB: Floodplain Access:	Full	0	
LB: Floodplain Access:	Full	0	
<b>Severity Scale:</b>		<b>5.5</b>	
Notes: 303d: Impaired - Aquatic Life Harvesting (mercury in fish tissue)			
Restoration Option 1

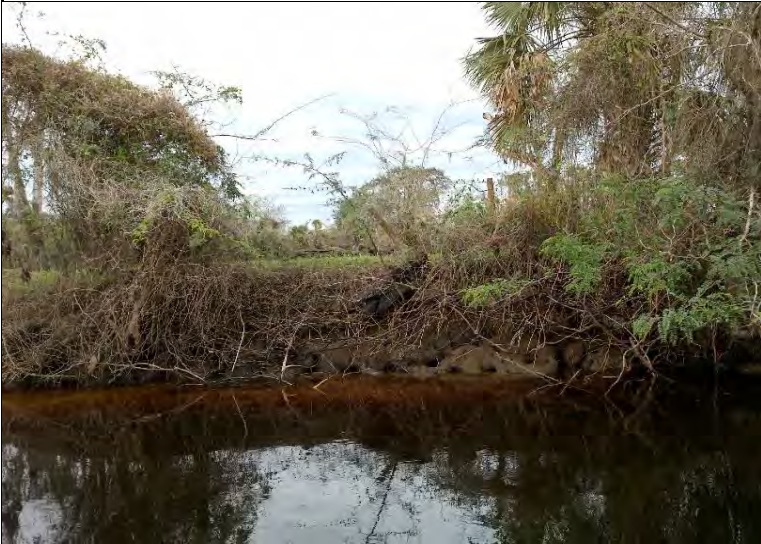
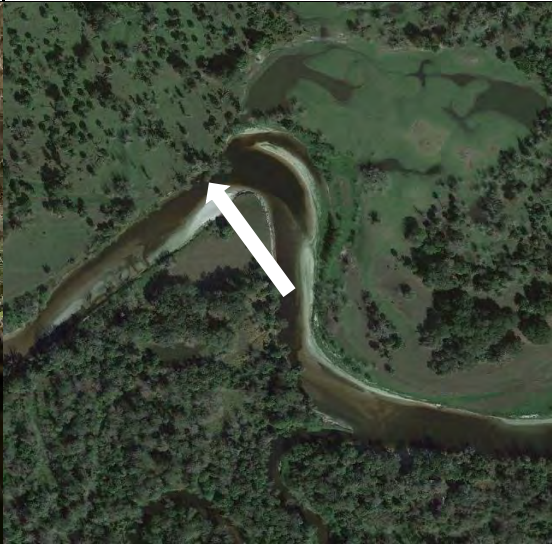
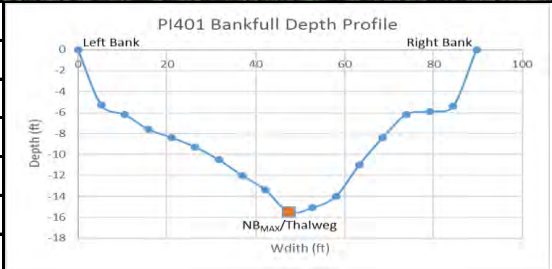
Peace River			Severity Scale: 5.75-Moderate
Watershed: Peace River Subwatershed: Lettuce Lake Latitude: 27.13738 Longitude: -81.94576			County: Desoto Site Number: PI401 Reach Length: 115 ft. Landowner: HAU II LLC

Risk Factor	Ranking	Score	
Pfankuch-Channel Stability:	Poor	1.5	
Channel Alteration:	None	0	
Bank Erosion:	Mass-wasting	1.5	
BEHI:	Moderate (21.75)	0.5	
Local NPSP:	Obvious Sources	1.5	
Shoring Structures:	None	0	
Pipe Discharge:	None	0	
Water Odor:	Normal	0	
Fish Passage Barrier:	None	0	
RB: Riparian Buffer:	20 ft.	0.75	
LB: Riparian Buffer:	100 ft.	0	
RB: Floodplain Access:	Full	0	
LB: Floodplain Access:	Full	0	
Severity Scale:		5.75	
Notes: 303d: Impaired - Aquatic Life Harvesting (mercury in fish tissue)			
Restoration Option 1

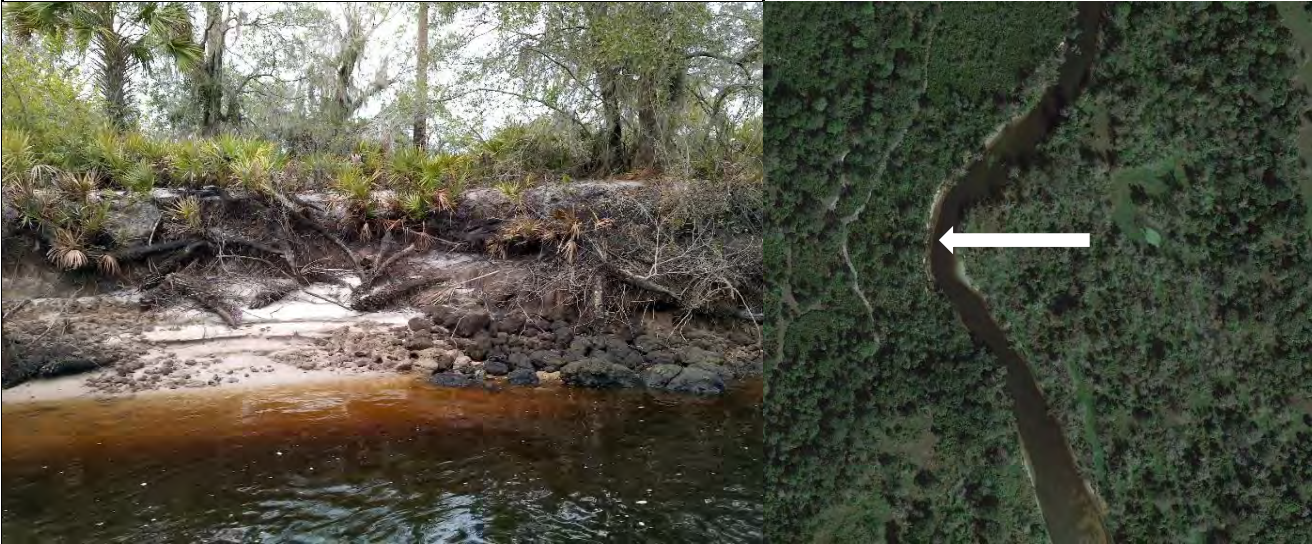
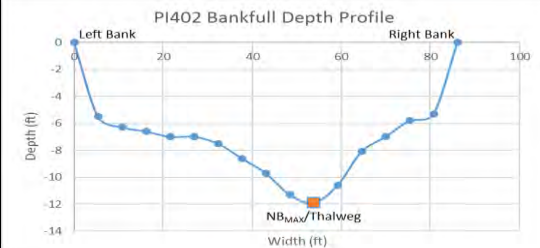
Peace River			Severity Scale: 2.75-Low
Watershed: Peace River Subwatershed: Lettuce Lake Latitude: 27.13329 Longitude: -81.95090			County: Desoto Site Number: PI402 Reach Length: 370 ft. Landowner: HAU II LLC

Pfankuch-Channel Stability:	Poor	1.5	
Channel Alteration:	None	0	
Bank Erosion:	Active	1	
BEHI:	Low (16.33)	0	
Local NPSP:	No Evidence	0	
Shoring Structures:	None	0	
Pipe Discharge:	None	0	
Water Odor:	Normal	0	
Fish Passage Barrier:	None	0	
RB: Riparian Buffer:	100 ft.	0	
LB: Riparian Buffer:	100 ft.	0	
RB: Floodplain Access:	Partial	0.25	
LB: Floodplain Access:	Full	0	
<b>Severity Scale:</b>		<b>2.75</b>	
Notes: 303d: Impaired - Aquatic Life Harvesting (mercury in fish tissue)			<b>Additional Site Features</b>
			Stream Channel Woody Material: Moderate
			Impoundments: None
			Substrate Composition: Medium Sand
			Bank Material: Clay
			Near Bank Stress: Moderate

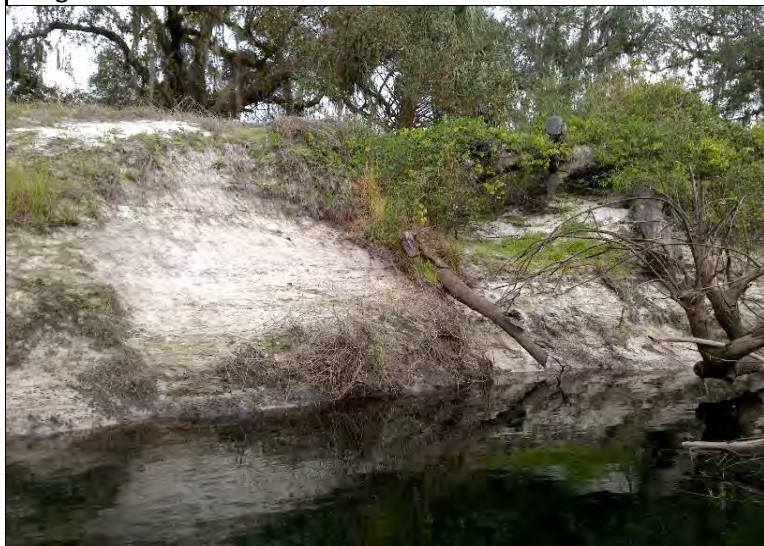
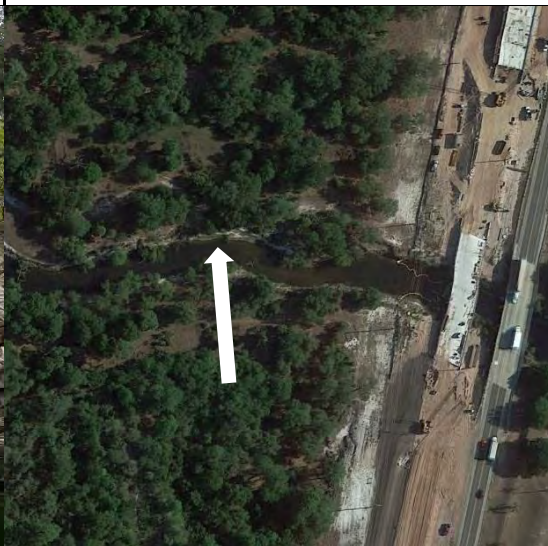
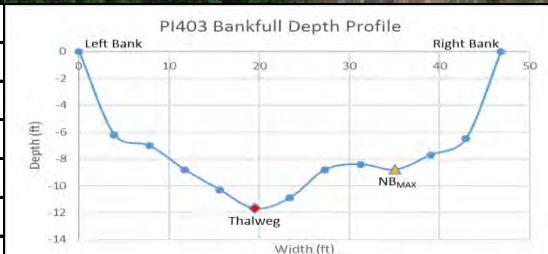
Risk Factor	Ranking	Score
Pfankuch-Channel Stability:	Poor	1.5
Channel Alteration:	None	0
Bank Erosion:	Active	1
BEHI:	High (33.32)	1
Local NPSP:	Obvious Sources	1.5
Shoring Structures:	None	0
Pipe Discharge:	None	0
Water Odor:	Normal	0
Fish Passage Barrier:	None	0
RB: Riparian Buffer:	40 ft.	0.5
LB: Riparian Buffer:	40 ft.	0.5
RB: Floodplain Access:	Partial	0.25
LB: Floodplain Access:	Full	0
<b>Severity Scale:</b>		<b>6.25</b>

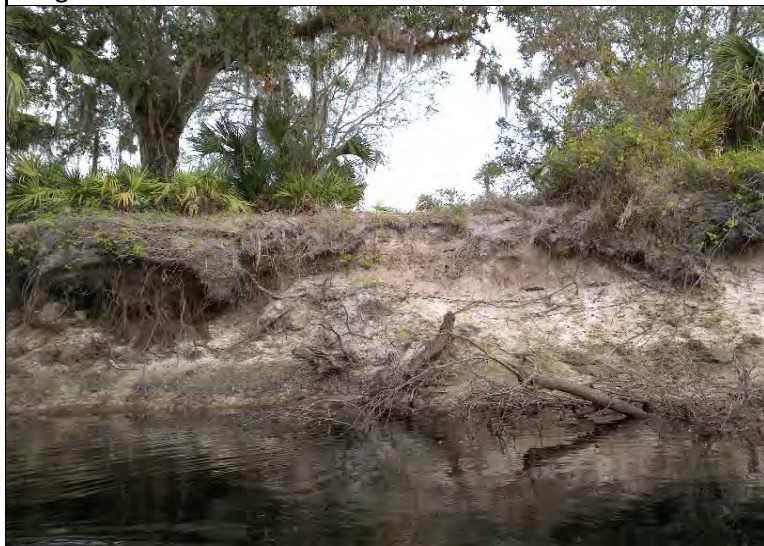
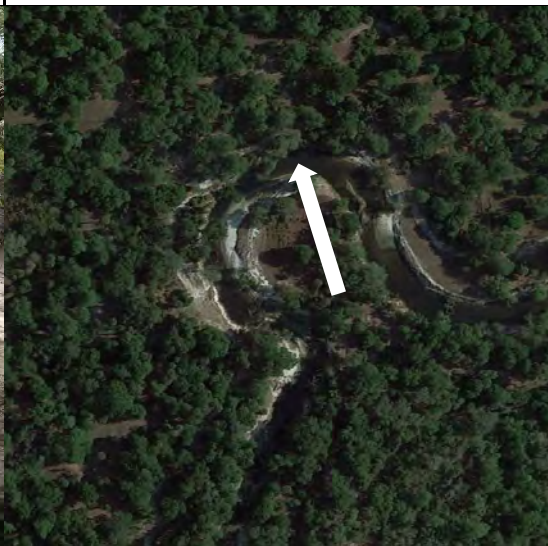
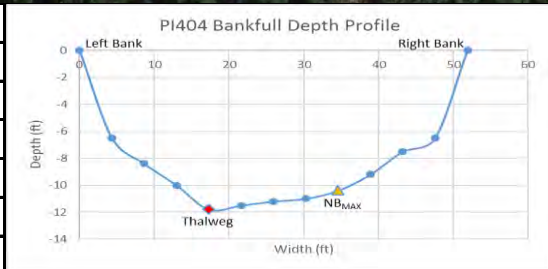
Risk Factor	Ranking	Score
Pfankuch-Channel Stability:	Poor	1.5
Channel Alteration:	None	0
Bank Erosion:	Active	1
BEHI:	High (31.35)	1
Local NPSP:	Obvious Sources	1.5
Shoring Structures:	None	0
Pipe Discharge:	None	0
Water Odor:	Normal	0
Fish Passage Barrier:	None	0
RB: Riparian Buffer:	40 ft.	0.5
LB: Riparian Buffer:	20 ft.	0.75
RB: Floodplain Access:	Partial	0.25
LB: Floodplain Access:	Full	0
Severity Scale:		6.5

Notes: 303d: Impaired - Fecal Coliform

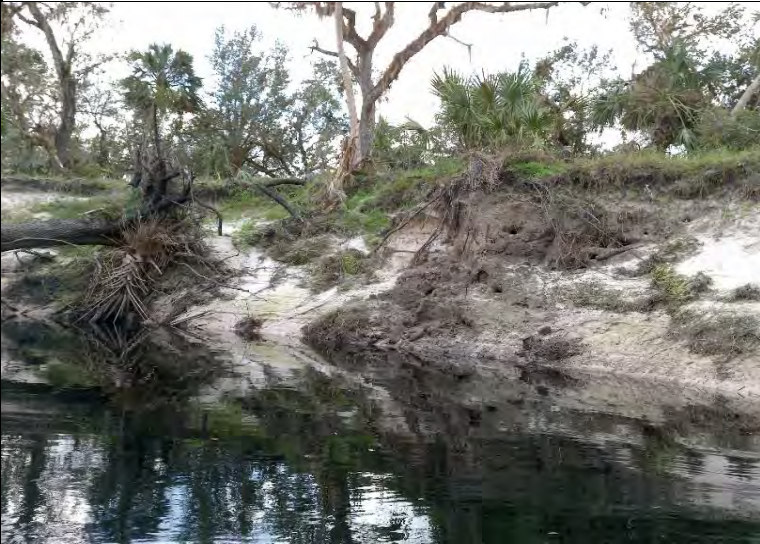
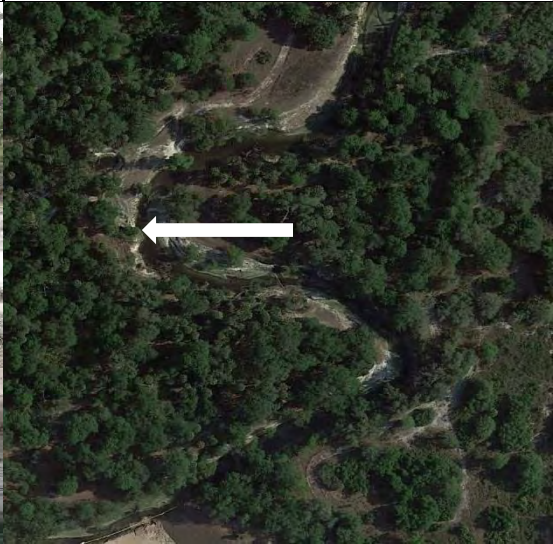
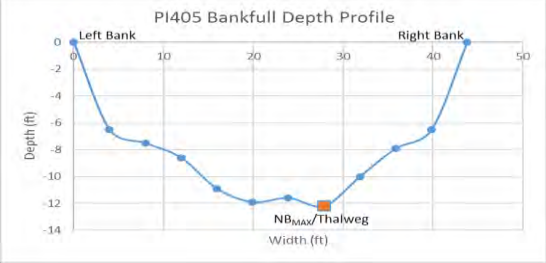
Charlie Creek			Severity Scale: 6.25-Moderate
Watershed: Peace River Subwatershed: Lower Charlie Creek Latitude: 27.37329 Longitude: -81.80103			County: Hardee Site Number: PI405 Reach Length: 350 ft. Landowner: Ben Hill Griffin Inc.

Pfankuch-Channel Stability:	Poor	1.5	
Channel Alteration:	None	0	
Bank Erosion:	Active	1	
BEHI:	High (35.97)	1	
Local NPSP:	Obvious Sources	1.5	
Shoring Structures:	None	0	
Pipe Discharge:	None	0	
Water Odor:	Normal	0	
Fish Passage Barrier:	None	0	
RB: Riparian Buffer:	40 ft.	0.5	Additional Site Features
LB: Riparian Buffer:	40 ft.	0.5	
RB: Floodplain Access:	Partial	0.25	
LB: Floodplain Access:	Full	0	
Severity Scale:		6.25	
Notes: 303d: Impaired - Fecal Coliform			Stream Channel Woody Material: Numerous
Restoration Option 1			Impoundments: None
			Substrate Composition: Medium Sand
			Bank Material: Sand
			Near Bank Stress: Moderate

RB Landuse: Natural Forest, Pasture
			LB Landuse: Pasture, Natural Forest

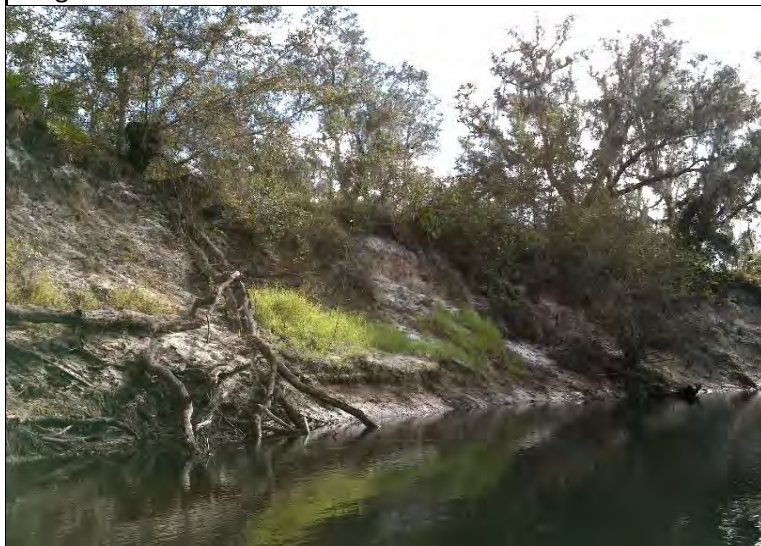
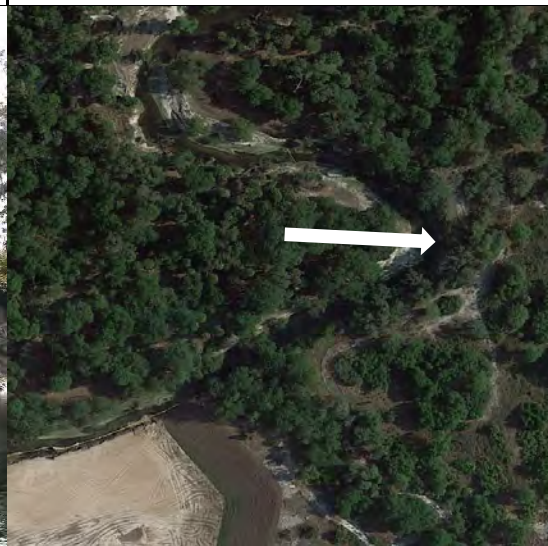
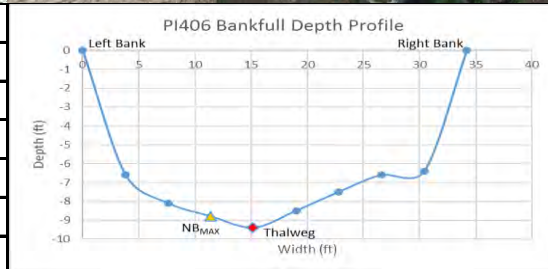
Reach Length: 400 ft.

Risk Factor	Ranking	Score
Pfankuch-Channel Stability:	Poor	1.5
Channel Alteration:	None	0
Bank Erosion:	Active	1
BEHI:	Moderate (28.92)	0.5
Local NPSP:	Obvious Sources	1.5
Shoring Structures:	None	0
Pipe Discharge:	None	0
Water Odor:	Normal	0
Fish Passage Barrier:	None	0
RB: Riparian Buffer:	60 ft.	0.25
LB: Riparian Buffer:	60 ft.	0.25
RB: Floodplain Access:	Partial	0.25
LB: Floodplain Access:	Partial	0.25
Severity Scale:		5.5
