# **Peace River and Withlacoochee River Threats Assessments and Fish Assemblage Monitoring**

**Final Report July 1, 2015 – June 30, 2019**

Submitted to Florida State Wildlife Grants Program  
August 1, 2019  
PID: 98462501284

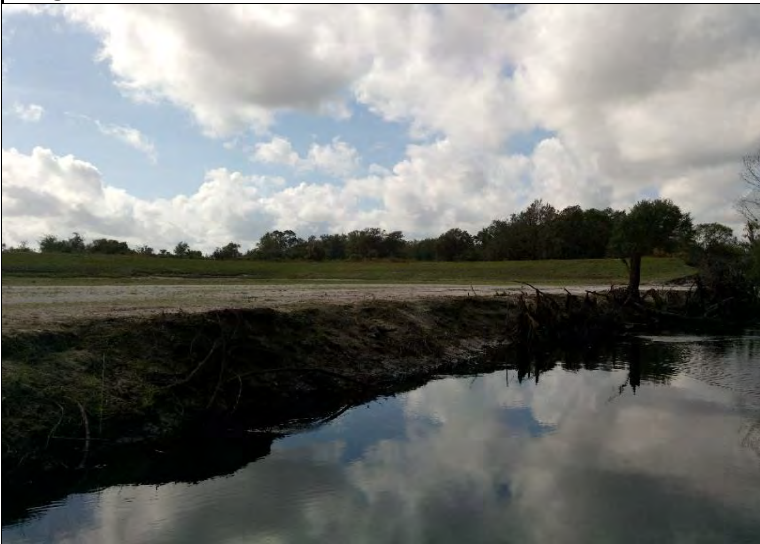
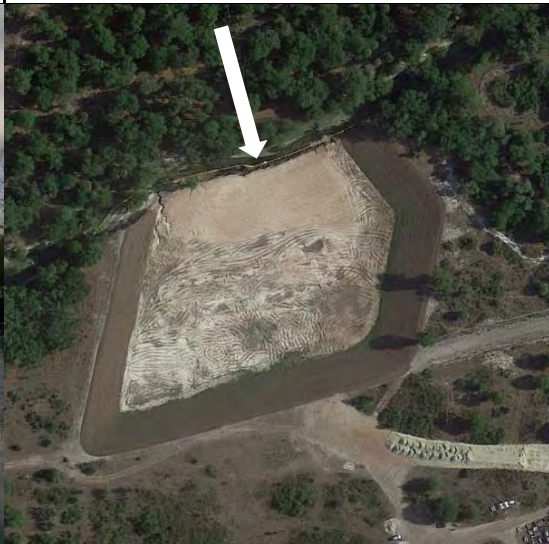
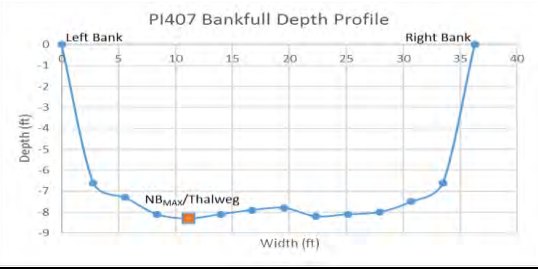
Charlie Creek			Severity Scale: 5.0-Moderate	
Watershed: Peace River Subwatershed: Lower Charlie Creek Latitude: 27.37171 Longitude: -81.80099			County: Hardee Site Number: PI408 Reach Length: 420 ft. Landowner: Ben Hill Griffin Inc.

Pfankuch-Channel Stability:	Poor	1.5		
Channel Alteration:	None	0		
Bank Erosion:	Active	1		
BEHI:	Very Low (7.69)	0		
Local NPSP:	Obvious Sources	1.5		
Shoring Structures:	None	0		
Pipe Discharge:	None	0		
Water Odor:	Normal	0		
Fish Passage Barrier:	None	0		
RB: Riparian Buffer:	60 ft.	0.25		
LB: Riparian Buffer:	0 ft.	0.75		
RB: Floodplain Access:	Full	0		
LB: Floodplain Access:	Full	0		
Severity Scale:		5.0	Additional Site Features	
			Stream Channel Woody Material: Moderate	
			Impoundments: None	
			Substrate Composition: Medium Sand	
			Bank Material: Sandy Clay	
			Near Bank Stress: High	
			RB Landuse: Natural Forest, Pasture

LB Landuse: Commercial	
Notes: 303d: Impaired - Fecal Coliform; Land adjacent to bank has been cleared and excavated by DOT to create wetland habitat, but is producing high runoff since it was not stabilized.				
Restoration Option 1

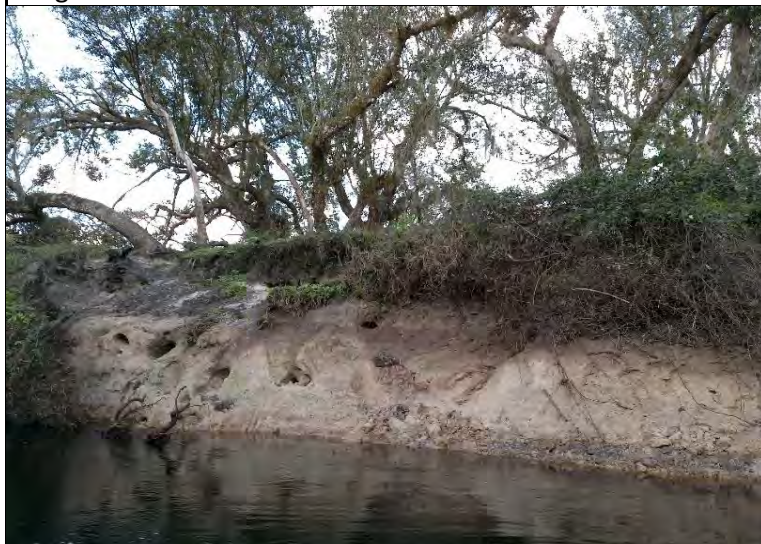
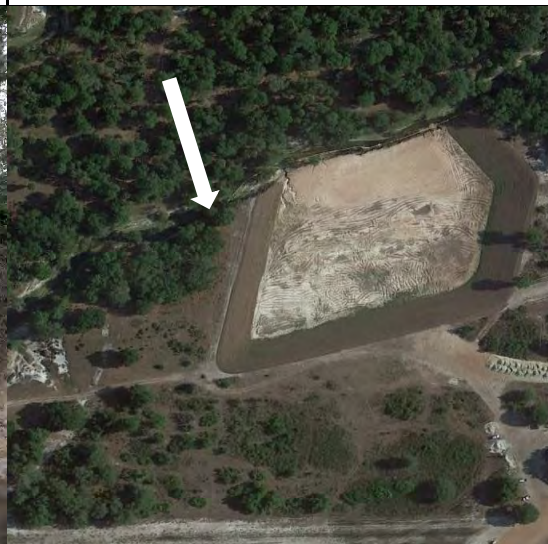
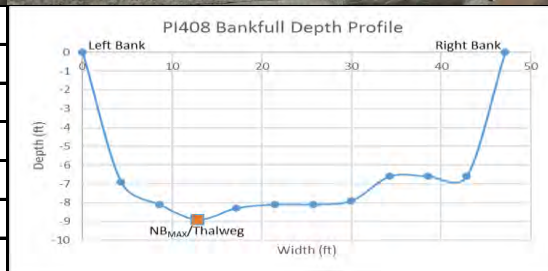
Reach Length: 250 ft.

Risk Factor	Ranking	Score
Pfankuch-Channel Stability:	Poor	1.5
Channel Alteration:	None	0
Bank Erosion:	Active	1
BEHI:	Moderate (23.80)	0.5
Local NPSP:	Obvious Sources	1.5
Shoring Structures:	None	0
Pipe Discharge:	None	0
Water Odor:	Normal	0
Fish Passage Barrier:	None	0
RB: Riparian Buffer:	40 ft.	0.5
LB: Riparian Buffer:	40 ft.	0.5
RB: Floodplain Access:	Full	0
LB: Floodplain Access:	Partial	0.25
<b>Severity Scale:</b>		<b>5.75</b>

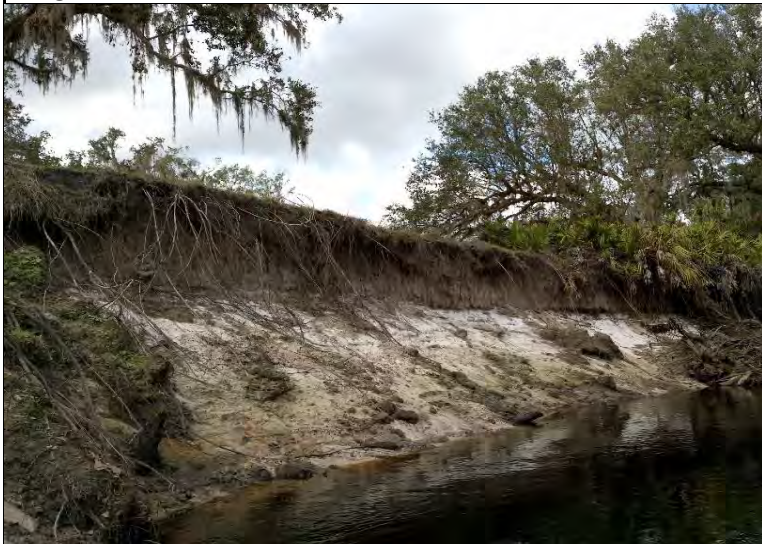
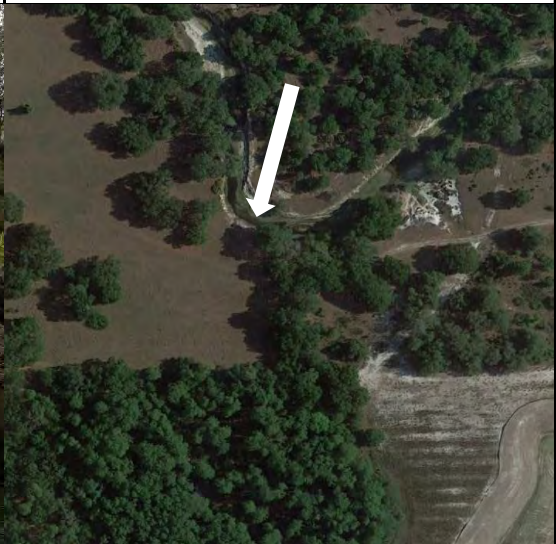
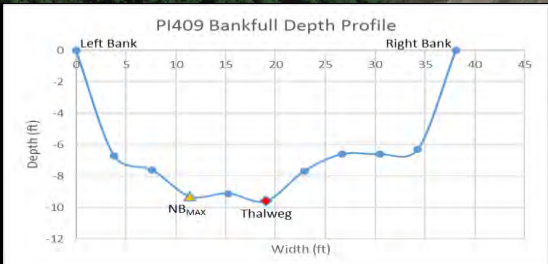
Charlie Creek			Severity Scale: 7.0-Moderate	
Watershed: Peace River Subwatershed: Lower Charlie Creek Latitude: -27.37016 Longitude: -81.80403			County: Hardee Site Number: PI409 Reach Length: 500 ft. Landowner: Ben Hill Griffin Inc.

Pfankuch-Channel Stability:	Poor	1.5		
Channel Alteration:	None	0		
Bank Erosion:	Mass-wasting	1.5		
BEHI:	Very High (41.30)	1.5		
Local NPSP:	Obvious Sources	1.5		
Shoring Structures:	None	0		
Pipe Discharge:	None	0		
Water Odor:	Normal	0		
Fish Passage Barrier:	None	0		
RB: Riparian Buffer:	60 ft.	0.25	<b>Additional Site Features</b>	
LB: Riparian Buffer:	0 ft.	0.75	Stream Channel Woody Material: Numerous	
RB: Floodplain Access:	Full	0	Impoundments: None	
LB: Floodplain Access:	Full	0	Substrate Composition: Medium Sand	
Severity Scale:		7.0	Bank Material: Sand	
			Near Bank Stress: Moderate	
			RB Landuse: Natural Forest, Pasture

LB Landuse: Pasture, Natural Forest	
Notes: 303d: Impaired - Fecal Coliform				
Restoration Option 1

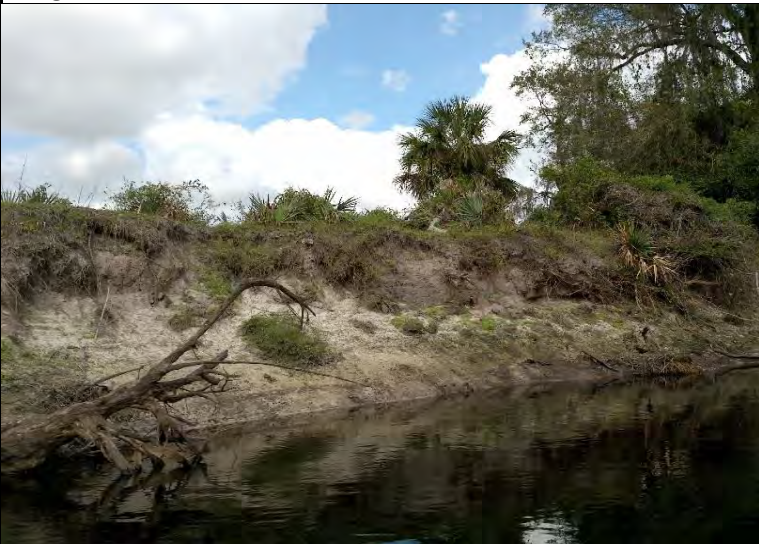
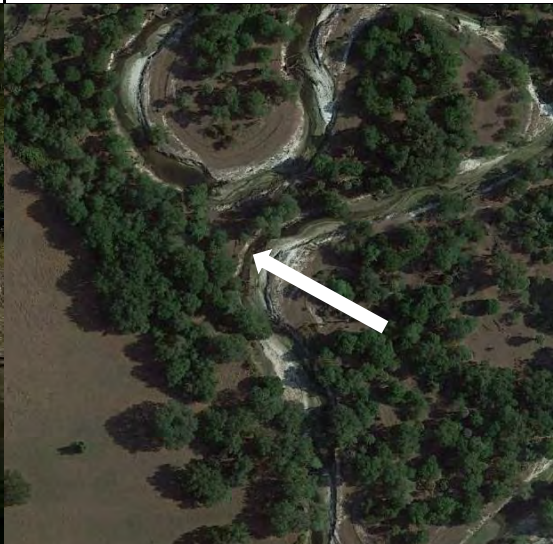
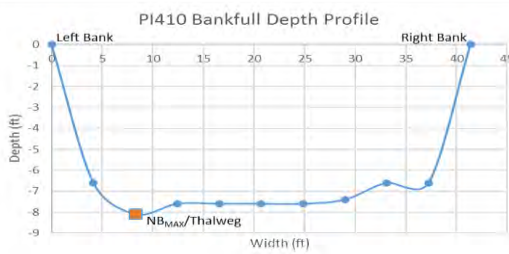
Charlie Creek			Severity Scale: 5.5-Moderate	
Watershed: Peace River Subwatershed: Lower Charlie Creek Latitude: 27.37150 Longitude: -81.80498			County: Hardee Site Number: PI410 Reach Length: 210 ft. Landowner: Ben Hill Griffin Inc.

Pfankuch-Channel Stability:	Poor	1.5		
Channel Alteration:	None	0		
Bank Erosion:	Active	1		
BEHI:	Moderate (26.64)	0.5		
Local NPSP:	Obvious Sources	1.5		
Shoring Structures:	None	0		
Pipe Discharge:	None	0		
Water Odor:	Normal	0		
Fish Passage Barrier:	None	0		
RB: Riparian Buffer:	40 ft.	0.5	<b>Additional Site Features</b> Stream Channel Woody Material: Extensive Impoundments: None Substrate Composition: Medium Sand Bank Material: Sand Near Bank Stress: High RB Landuse: Natural Forest, Pasture LB Landuse: Natural Forest, Pasture	
LB: Riparian Buffer:	40 ft.	0.5		
RB: Floodplain Access:	Full	0		
LB: Floodplain Access:	Full	0

Severity Scale:		5.5		
Notes: 303d: Impaired - Fecal Coliform				
Restoration Option 1

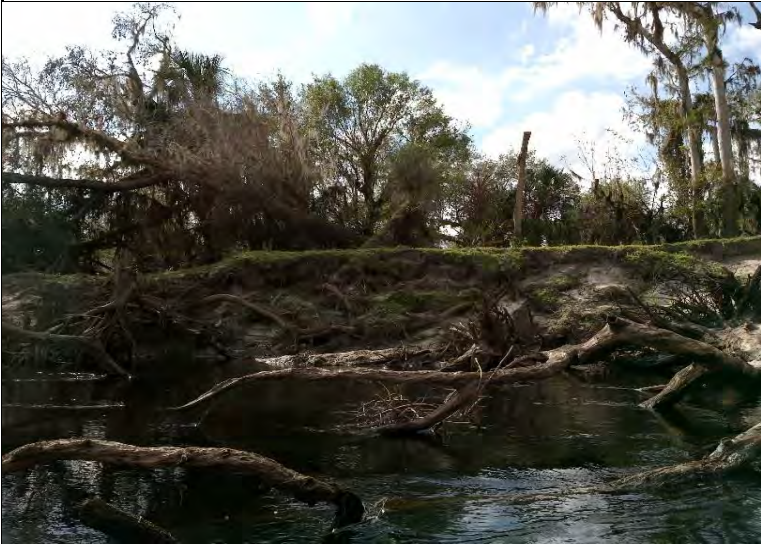
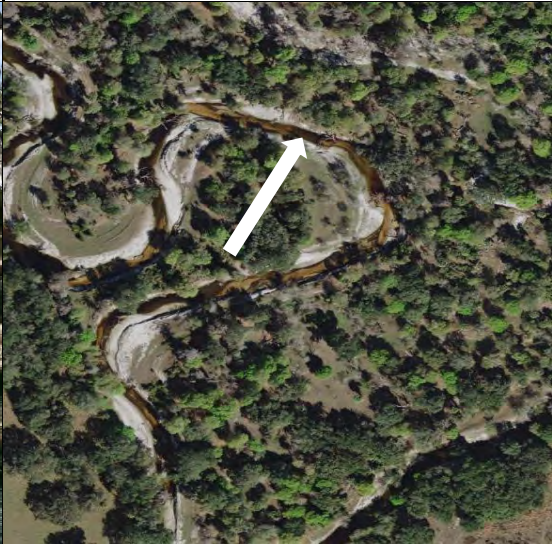
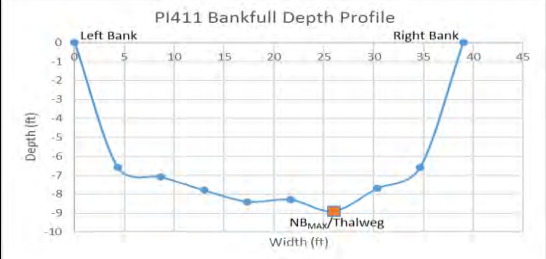
Charlie Creek			Severity Scale: 6.0-Moderate
Watershed: Peace River Subwatershed: Lower Charlie Creek Latitude: 27.37194 Longitude: -81.80422			County: Hardee Site Number: PI411 Reach Length: 1,120 ft. Landowner: Ben Hill Griffin Inc.

Pfankuch-Channel Stability:	Poor	1.5	
Channel Alteration:	None	0	
Bank Erosion:	Active	1	
BEHI:	High (34.36)	1	
Local NPSP:	Obvious Sources	1.5	
Shoring Structures:	None	0	
Pipe Discharge:	None	0	
Water Odor:	Normal	0	
Fish Passage Barrier:	None	0	
RB: Riparian Buffer:	40 ft.	0.5	
LB: Riparian Buffer:	40 ft.	0.5	
RB: Floodplain Access:	Full	0	
LB: Floodplain Access:	Full	0	
<b>Severity Scale:</b>		<b>6.0</b>	
Notes: 303d: Impaired - Fecal Coliform			<b>Additional Site Features</b>
			Stream Channel Woody Material: Extensive
			Impoundments: None
			Substrate Composition: Medium Sand
			Bank Material: Sand
			Near Bank Stress: High
			RB Landuse: Natural Forest, Pasture

LB Landuse: Pasture, Natural Forest
Restoration Option 1

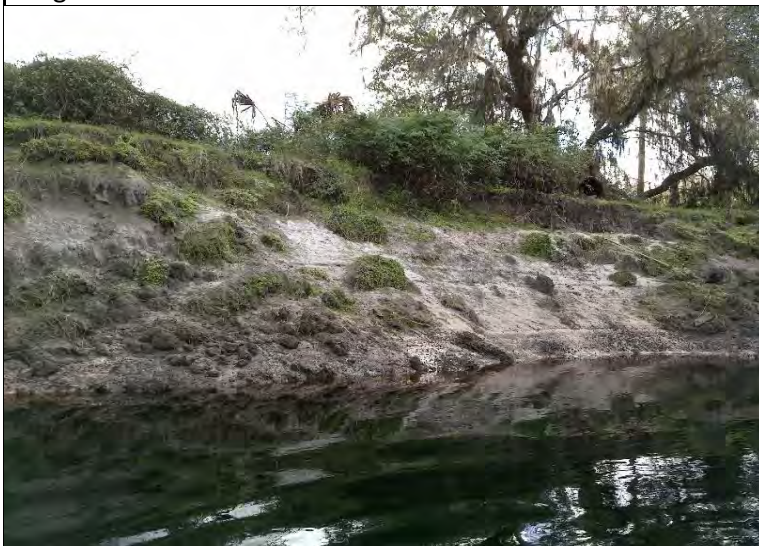
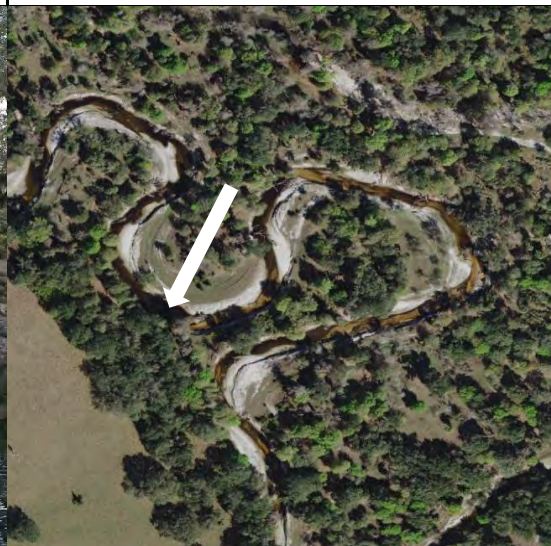
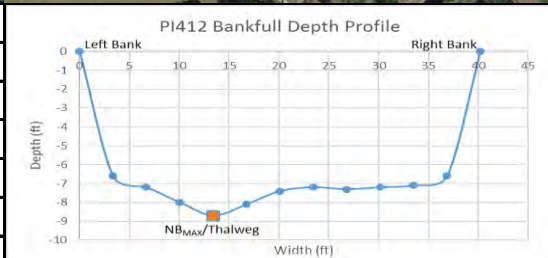
Reach Length: 680 ft.

Risk Factor	Ranking	Score
Pfankuch-Channel Stability:	Poor	1.5
Channel Alteration:	None	0
Bank Erosion:	Mass-wasting	1.5
BEHI:	High (37.42)	1
Local NPSP:	Obvious Sources	1.5
Shoring Structures:	None	0
Pipe Discharge:	None	0
Water Odor:	Normal	0
Fish Passage Barrier:	None	0
RB: Riparian Buffer:	20 ft.	0.75
LB: Riparian Buffer:	40 ft.	0.5
RB: Floodplain Access:	Full	0
LB: Floodplain Access:	Full	0
<b>Severity Scale:</b>		<b>6.75</b>

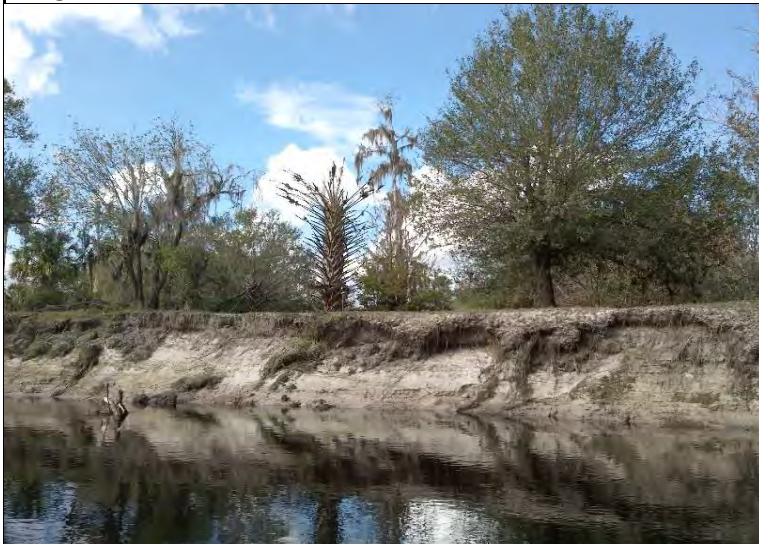
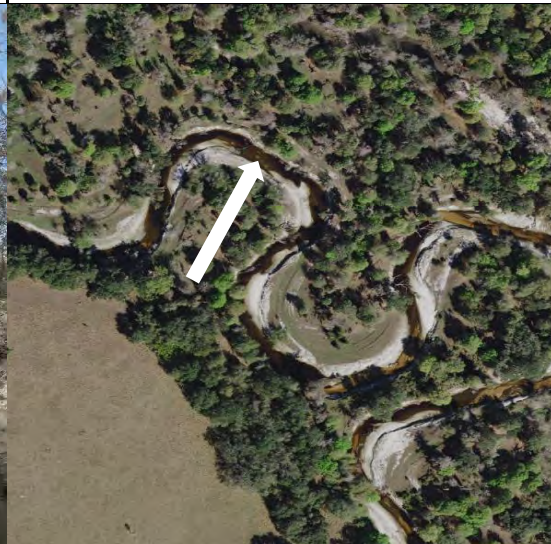
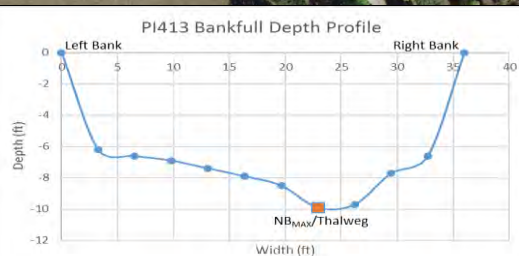
Reach Length: 530 ft.

Risk Factor	Ranking	Score
Pfankuch-Channel Stability:	Poor	1.5
Channel Alteration:	None	0
Bank Erosion:	Active	1
BEHI:	High (33.54)	1
Local NPSP:	Obvious Sources	1.5
Shoring Structures:	None	0
Pipe Discharge:	None	0
Water Odor:	Normal	0
Fish Passage Barrier:	None	0
RB: Riparian Buffer:	20 ft.	0.75
LB: Riparian Buffer:	40 ft.	0.5
RB: Floodplain Access:	Full	0
LB: Floodplain Access:	Full	0
Severity Scale:		6.25

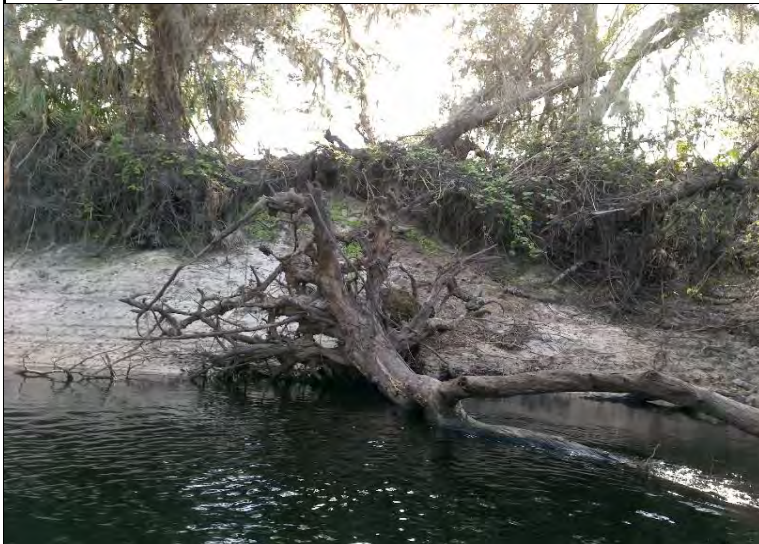
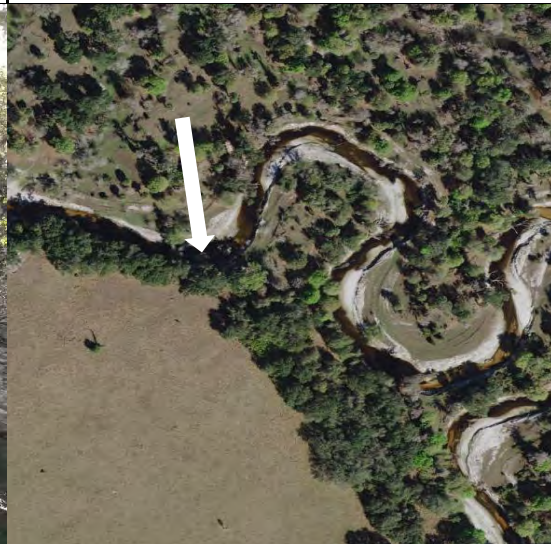
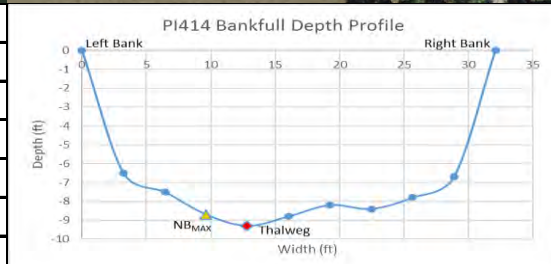
Reach Length: 370 ft.

Risk Factor	Ranking	Score
Pfankuch-Channel Stability:	Poor	1.5
Channel Alteration:	None	0
Bank Erosion:	Mass-wasting	1.5
BEHI:	High (35.50)	1
Local NPSP:	Obvious Sources	1.5
Shoring Structures:	None	0
Pipe Discharge:	None	0
Water Odor:	Normal	0
Fish Passage Barrier:	None	0
RB: Riparian Buffer:	40 ft.	0.5
LB: Riparian Buffer:	40 ft.	0.5
RB: Floodplain Access:	Full	0
LB: Floodplain Access:	Partial	0.25
<b>Severity Scale:</b>		<b>6.75</b>

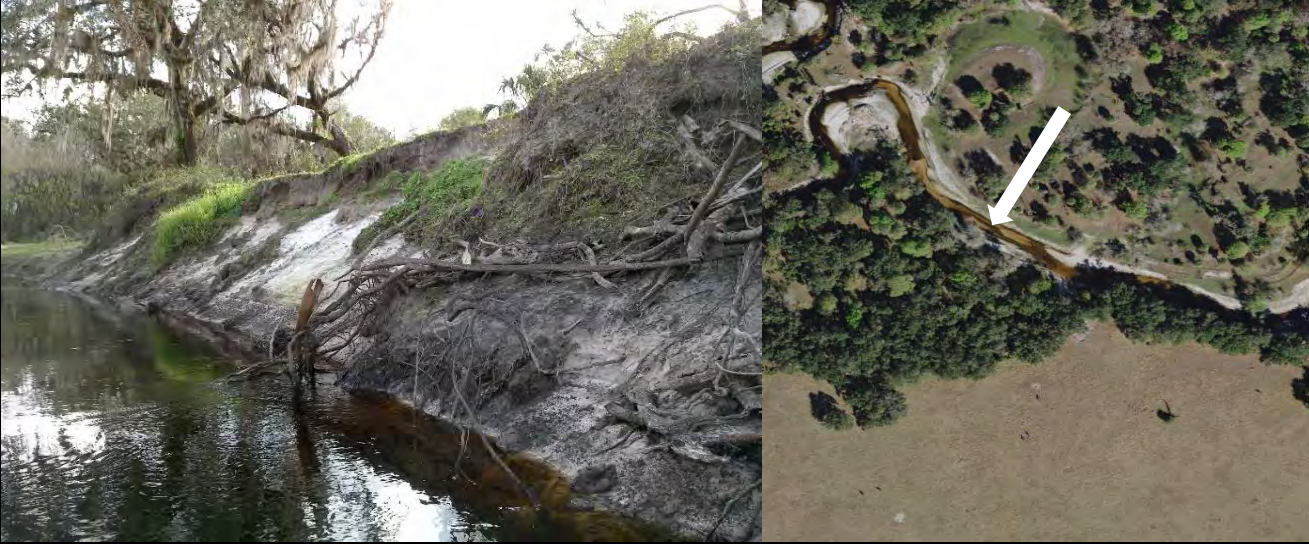
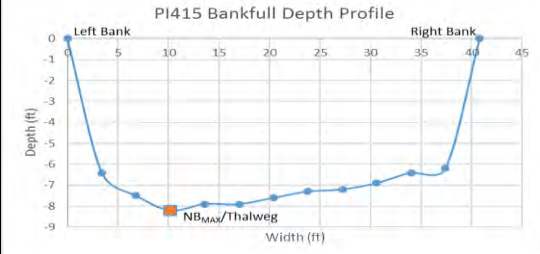
Charlie Creek			Severity Scale: 6.5-Moderate
Watershed: Peace River Subwatershed: Lower Charlie Creek Latitude: 27.37299 Longitude: -81.80750			County: Hardee Site Number: PI415 Reach Length: 465 ft. Landowner: Ben Hill Griffin Inc.

Pfankuch-Channel Stability:	Poor	1.5	
Channel Alteration:	None	0	
Bank Erosion:	Active	1	
BEHI:	High (31.79)	1	
Local NPSP:	Obvious Sources	1.5	
Shoring Structures:	None	0	
Pipe Discharge:	None	0	
Water Odor:	Normal	0	
Fish Passage Barrier:	None	0	
RB: Riparian Buffer:	20 ft.	0.75	
LB: Riparian Buffer:	20 ft.	0.75	
RB: Floodplain Access:	Full	0	
LB: Floodplain Access:	Full	0	
<b>Severity Scale:</b>		<b>6.5</b>	Additional Site Features
			Stream Channel Woody Material: Moderate
			Impoundments: None
			Substrate Composition: Medium Sand
			Bank Material: Sand
			Near Bank Stress: High
			RB Landuse: Pasture, Natural Forest
			LB Landuse: Pasture, Natural Forest

Notes: 303d: Impaired - Fecal Coliform; Middle section of reach not as bad as upper/lower reach			
- greater root depth and surface protection in middle.			
Restoration Option 1

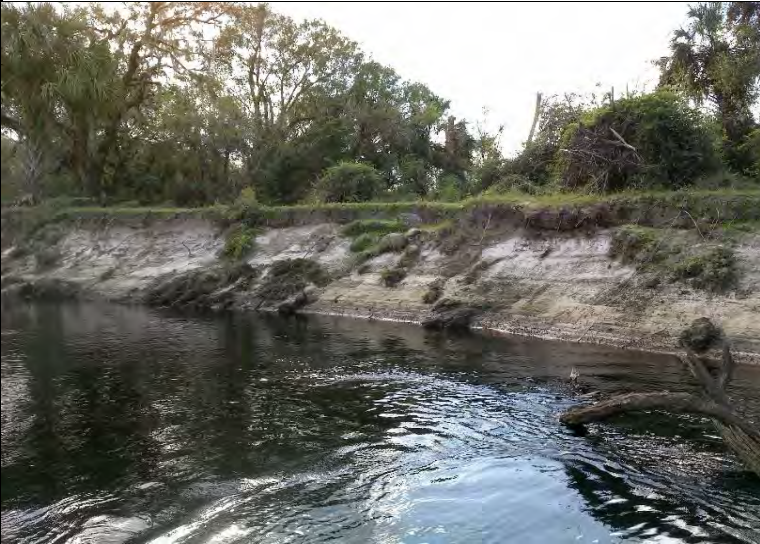
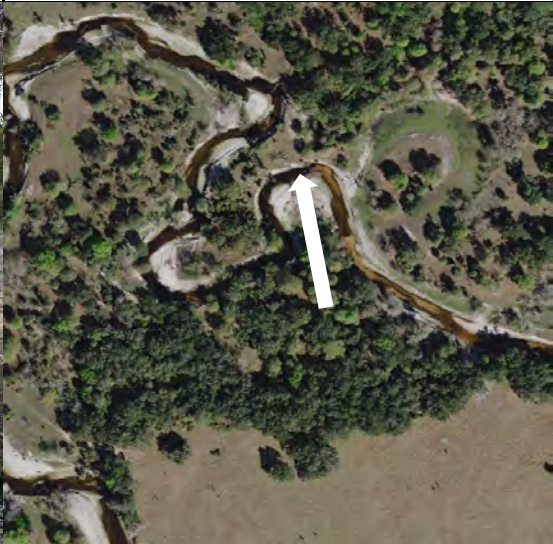
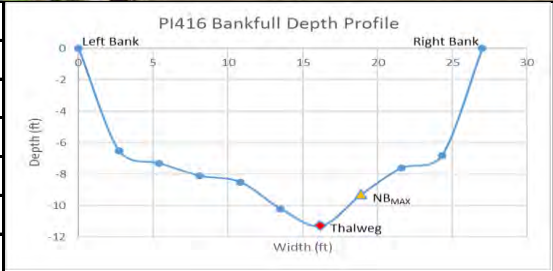
Charlie Creek			Severity Scale: 7.0-Moderate	
Watershed: Peace River Subwatershed: Lower Charlie Creek Latitude: 27.37402 Longitude: -81.80852			County: Hardee Site Number: PI416 Reach Length: 310 ft. Landowner: Ben Hill Griffin Inc.

Risk Factor	Ranking	Score		
Pfankuch-Channel Stability:	Poor	1.5		
Channel Alteration:	None	0		
Bank Erosion:	Mass-wasting	1.5		
BEHI:	High (38.95)	1		
Local NPSP:	Obvious Sources	1.5		
Shoring Structures:	None	0		
Pipe Discharge:	None	0		
Water Odor:	Normal	0		
Fish Passage Barrier:	None	0		
RB: Riparian Buffer:	0 ft.	0.75		
LB: Riparian Buffer:	0 ft.	0.75		
RB: Floodplain Access:	Full	0		
LB: Floodplain Access:	Full	0		
Severity Scale:		7.0		
Notes: 303d: Impaired - Fecal Coliform				
Restoration Option 1

Additional Site Features	
Stream Channel Woody Material: Moderate	
Impoundments: Woody Material Jams	
Substrate Composition: Medium Sand	
Bank Material: Sand	
Near Bank Stress: Moderate	
RB Landuse: Pasture, Natural Forest	
LB Landuse: Pasture, Natural Forest

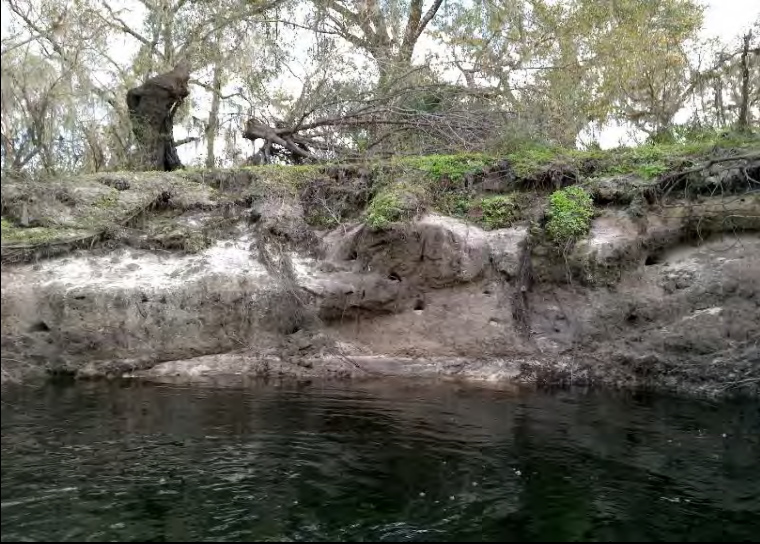
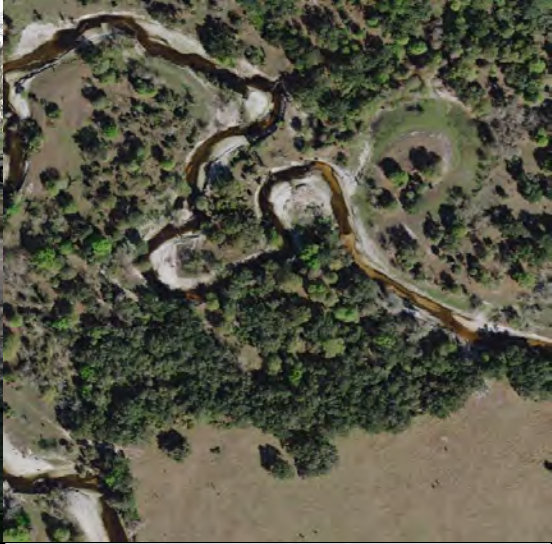
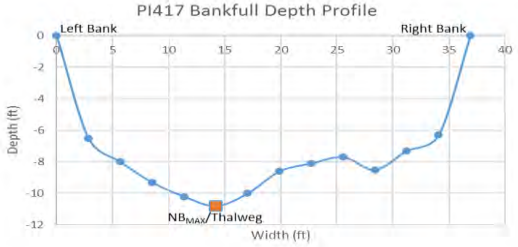
Charlie Creek			Severity Scale: 5.5-Moderate
Watershed: Peace River Subwatershed: Lower Charlie Creek Latitude: 27.37353 Longitude: -81.80897			County: Hardee Site Number: PI417 Reach Length: 65 ft. Landowner: Ben Hill Griffin Inc.

Pfankuch-Channel Stability:	Poor	1.5	
Channel Alteration:	None	0	
Bank Erosion:	Active	1	
BEHI:	Moderate (20.28)	0.5	
Local NPSP:	Obvious Sources	1.5	
Shoring Structures:	None	0	
Pipe Discharge:	None	0	
Water Odor:	Normal	0	
Fish Passage Barrier:	None	0	
RB: Riparian Buffer:	40 ft.	0.5	
LB: Riparian Buffer:	40 ft.	0.5	
RB: Floodplain Access:	Full	0	
LB: Floodplain Access:	Full	0	
<b>Severity Scale:</b>		<b>5.5</b>	
Notes: 303d: Impaired - Fecal Coliform			<b>Additional Site Features</b>
			Stream Channel Woody Material: Moderate
			Impoundments: None
			Substrate Composition: Medium Sand
			Bank Material: Clay
			Near Bank Stress: Moderate

RB Landuse: Pasture, Natural Forest
			LB Landuse: Pasture, Natural Forest
Restoration Option 1

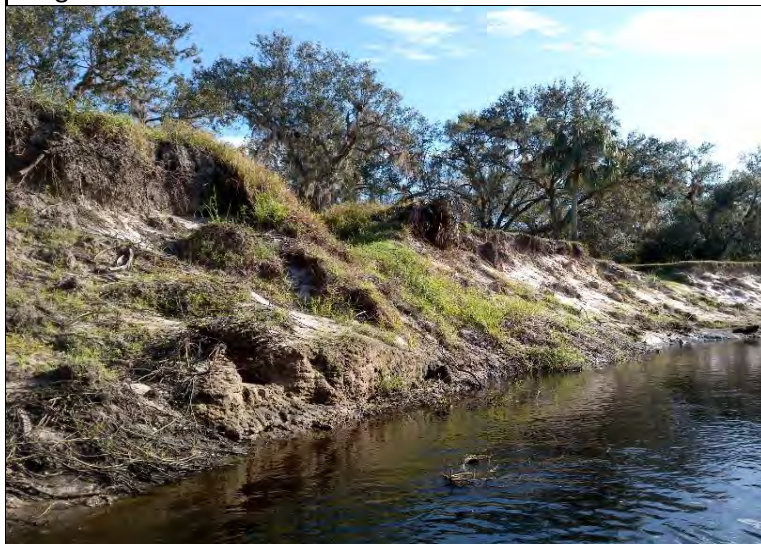
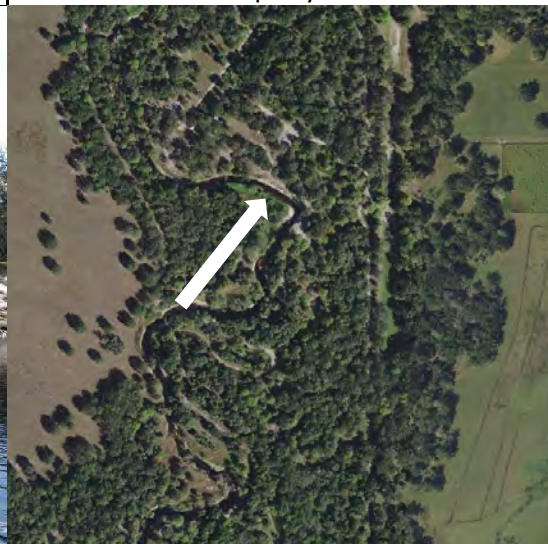
Reach Length: 360 ft.

Risk Factor	Ranking	Score
Pfankuch-Channel Stability:	Fair	1
Channel Alteration:	None	0
Bank Erosion:	Mass-wasting	1.5
BEHI:	Very High (39.83)	1.5
Local NPSP:	Obvious Sources	1.5
Shoring Structures:	Present	1.5
Pipe Discharge:	None	0
Water Odor:	Normal	0
Fish Passage Barrier:	None	0
RB: Riparian Buffer:	60 ft.	0.25
LB: Riparian Buffer:	40 ft.	0.5
RB: Floodplain Access:	Full	0
LB: Floodplain Access:	Partial	0.25
<b>Severity Scale:</b>		<b>8.0</b>

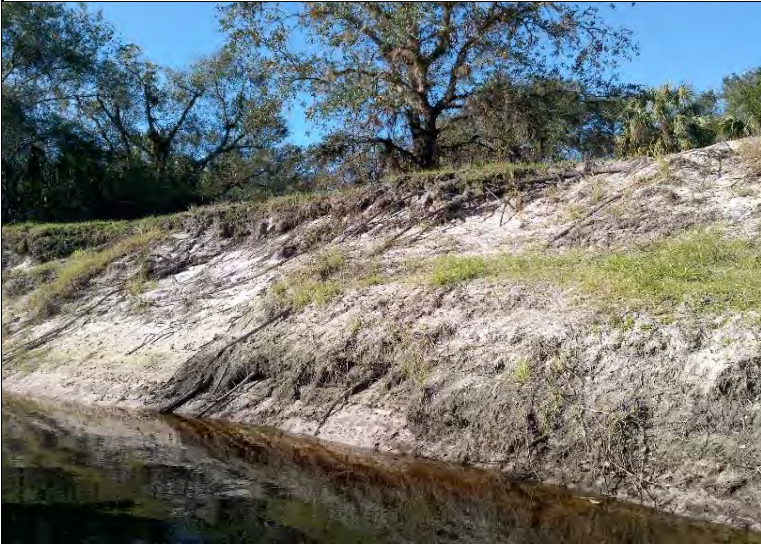
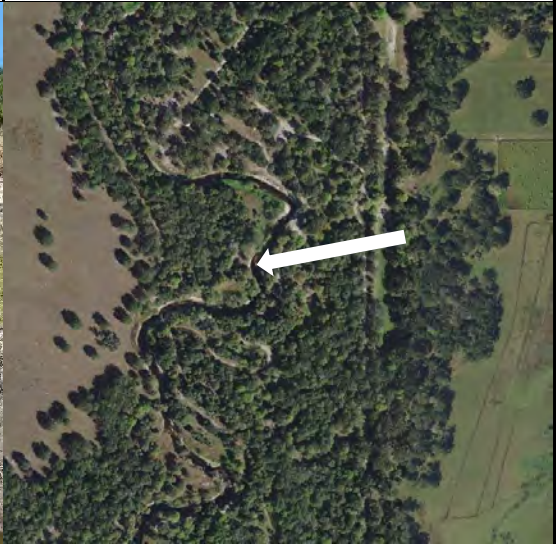
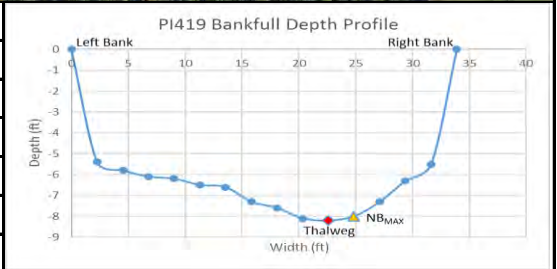
Charlie Creek			Severity Scale: 5.5-Moderate
Watershed: Peace River Subwatershed: Lower Charlie Creek Latitude: 27.40536 Longitude: -81.74487			County: Hardee Site Number: PI419 Reach Length: 100 ft. Landowner: WHITE MARSH LLC

Risk Factor	Ranking	Score	
Pfankuch-Channel Stability:	Fair	1	
Channel Alteration:	None	0	
Bank Erosion:	Active	1	
BEHI:	High (35.22)	1	
Local NPSP:	Obvious Sources	1.5	
Shoring Structures:	None	0	
Pipe Discharge:	None	0	
Water Odor:	Normal	0	
Fish Passage Barrier:	None	0	
RB: Riparian Buffer:	40 ft.	0.5	
LB: Riparian Buffer:	60 ft.	0.25	
RB: Floodplain Access:	Full	0	
LB: Floodplain Access:	Partial	0.25	
<b>Severity Scale:</b>		<b>5.5</b>	
Notes: 303d: Impaired - Fecal Coliform			
Restoration Option 1

Additional Site Features	
Stream Channel Woody Material:	Moderate
Impoundments:	None
Substrate Composition:	Medium Sand
Bank Material:	Sand
Near Bank Stress:	High
RB Landuse:	Pasture, Natural Forest
LB Landuse:	Pasture, Natural Forest

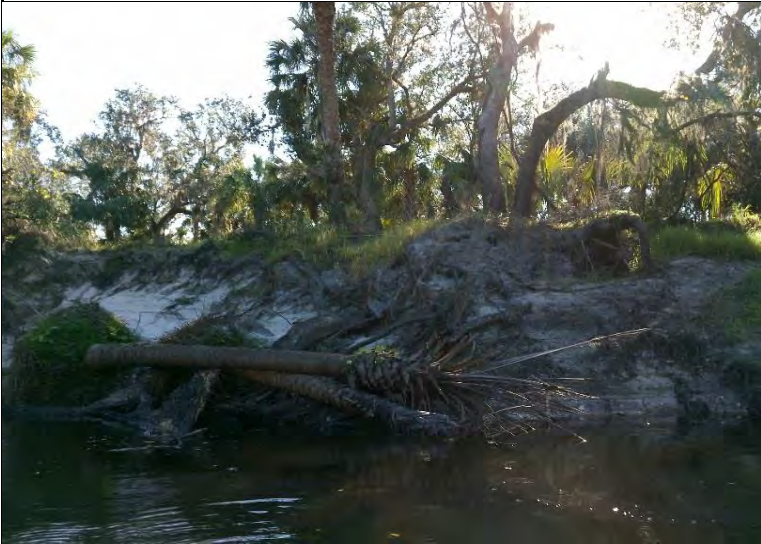
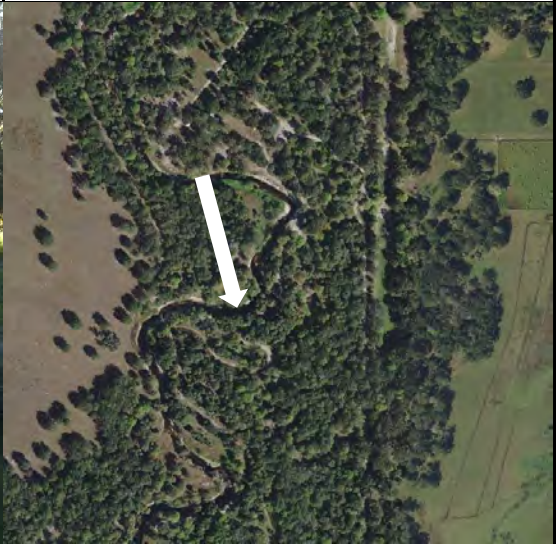
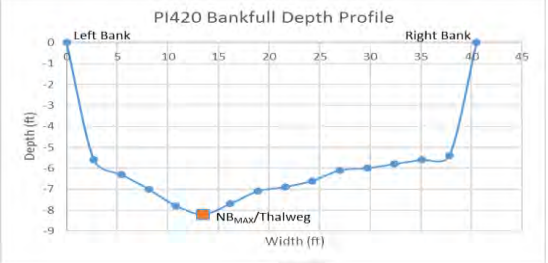
Charlie Creek			Severity Scale: 4.75-Moderate
Watershed: Peace River Subwatershed: Lower Charlie Creek Latitude: 27.40471 Longitude: -81.74500			County: Hardee Site Number: PI420 Reach Length: 215 ft. Landowner: The Property LLC

Pfankuch-Channel Stability:	Fair	1	
Channel Alteration:	None	0	
Bank Erosion:	Active	1	
BEHI:	Moderate (26.28)	0.5	
Local NPSP:	Obvious Sources	1.5	
Shoring Structures:	None	0	
Pipe Discharge:	None	0	
Water Odor:	Normal	0	
Fish Passage Barrier:	None	0	
RB: Riparian Buffer:	60 ft.	0.25	
LB: Riparian Buffer:	60 ft.	0.25	
RB: Floodplain Access:	Full	0	
LB: Floodplain Access:	Partial	0.25	
<b>Severity Scale:</b>		<b>4.75</b>	
Notes: 303d: Impaired - Fecal Coliform			<b>Additional Site Features</b>
			Stream Channel Woody Material: Extensive
			Impoundments: None
			Substrate Composition: Medium Sand
			Bank Material: Sand
			Near Bank Stress: High

RB Landuse: Natural Forest, Pasture
			LB Landuse: Natural Forest, Pasture
Restoration Option 1

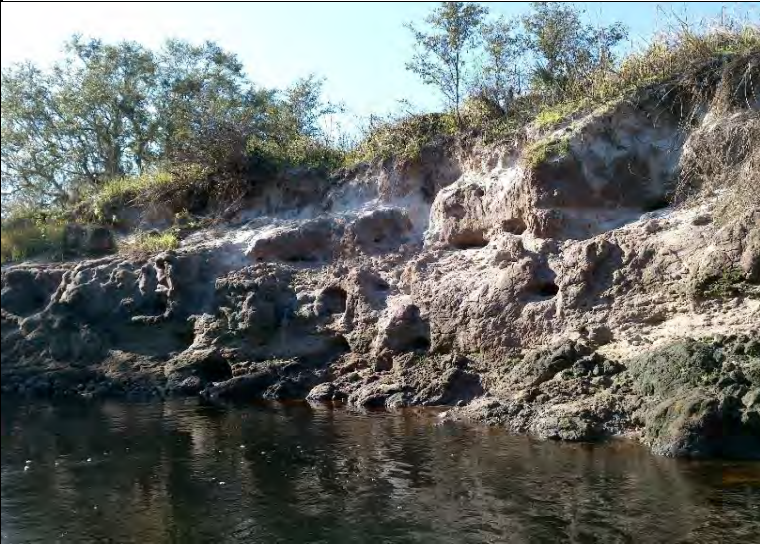
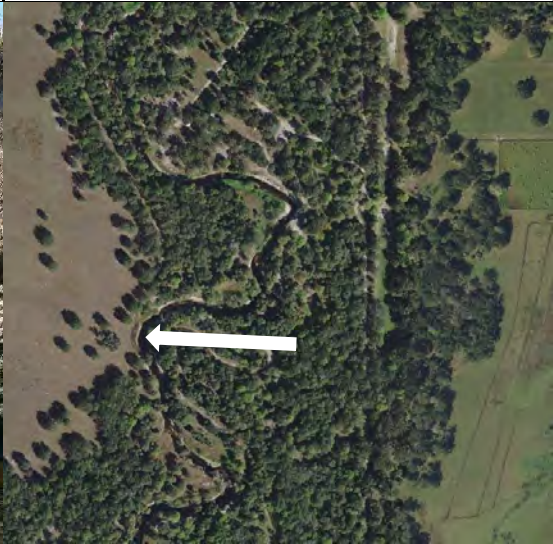
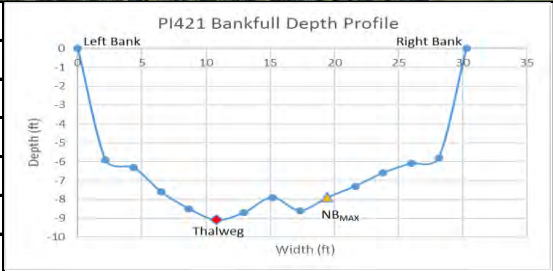
Peace River			Severity Scale: 6.0-Moderate
Watershed: Peace River Subwatershed: Lower Charlie Creek Latitude: 27.40448 Longitude: -81.74642			County: Hardee Site Number: PI421 Reach Length: 140 ft. Landowner: WHITE MARSH LLC

Risk Factor	Ranking	Score	
Pfankuch-Channel Stability:	Fair	1	
Channel Alteration:	None	0	
Bank Erosion:	Active	1	
BEHI:	High (30.36)	1	
Local NPSP:	Obvious Sources	1.5	
Shoring Structures:	None	0	
Pipe Discharge:	None	0	
Water Odor:	Normal	0	
Fish Passage Barrier:	None	0	
RB: Riparian Buffer:	0 ft.	0.75	
LB: Riparian Buffer:	40 ft.	0.5	
RB: Floodplain Access:	Partial	0.25	
LB: Floodplain Access:	Full	0	
Severity Scale:		6.0	
Notes: 303d: Impaired - Fecal Coliform			
Restoration Option 1

Additional Site Features
Stream Channel Woody Material: Moderate
Impoundments: None
Substrate Composition: Medium Sand
Bank Material: Sandstone
Near Bank Stress: Low
RB Landuse: Pasture
LB Landuse: Pasture, Natural Forest

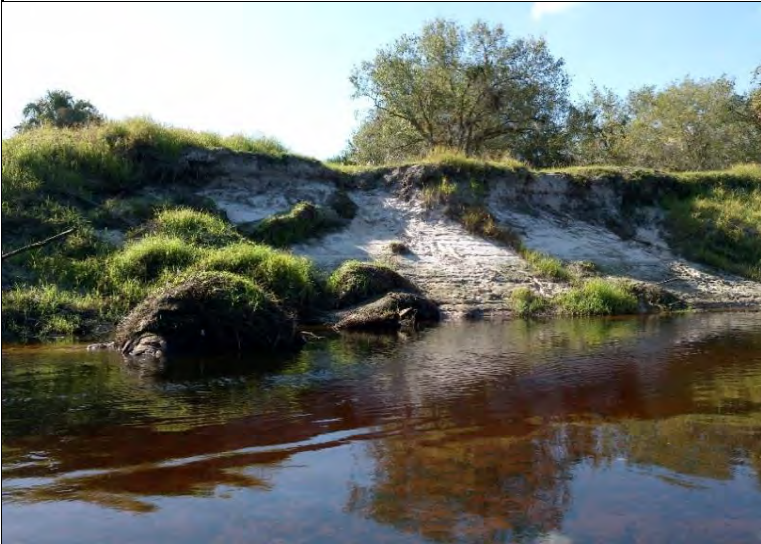
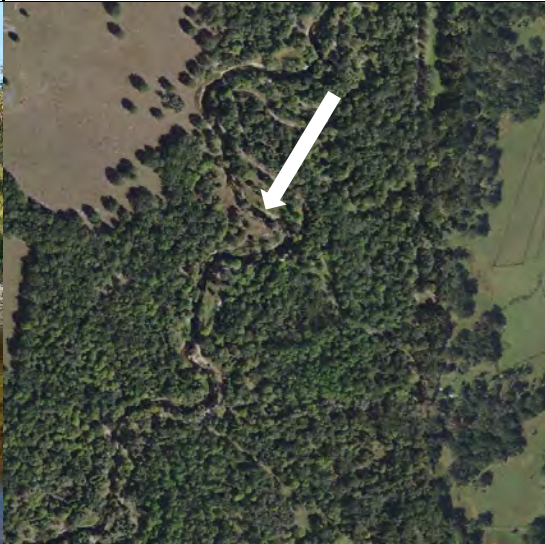
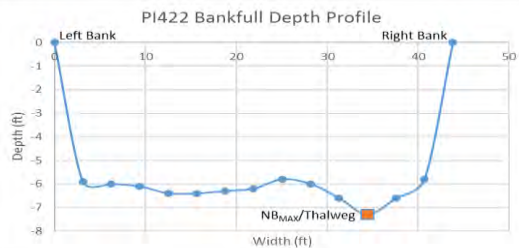
Charlie Creek			Severity Scale: 6.75-Moderate
Watershed: Peace River Subwatershed: Lower Charlie Creek Latitude: 27.40272 Longitude: -81.74577			County: Hardee Site Number: PI422 Reach Length: 120 ft. Landowner: WHITE MARSH LLC

Risk Factor	Ranking	Score	
Pfankuch-Channel Stability:	Fair	1	
Channel Alteration:	None	0	
Bank Erosion:	Active	1	
BEHI:	Very High (40.57)	1.5	
Local NPSP:	Obvious Sources	1.5	
Shoring Structures:	None	0	
Pipe Discharge:	None	0	
Water Odor:	Normal	0	
Fish Passage Barrier:	None	0	
RB: Riparian Buffer:	0 ft.	0.75	
LB: Riparian Buffer:	0 ft.	0.75	
RB: Floodplain Access:	Partial	0.25	
LB: Floodplain Access:	Full	0	
<b>Severity Scale:</b>		<b>6.75</b>	
Notes: 303d: Impaired - Fecal Coliform			
Restoration Option 1

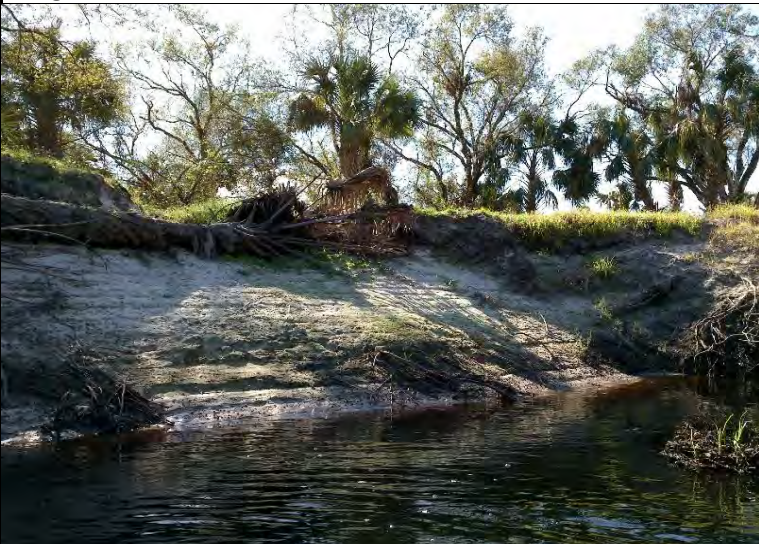
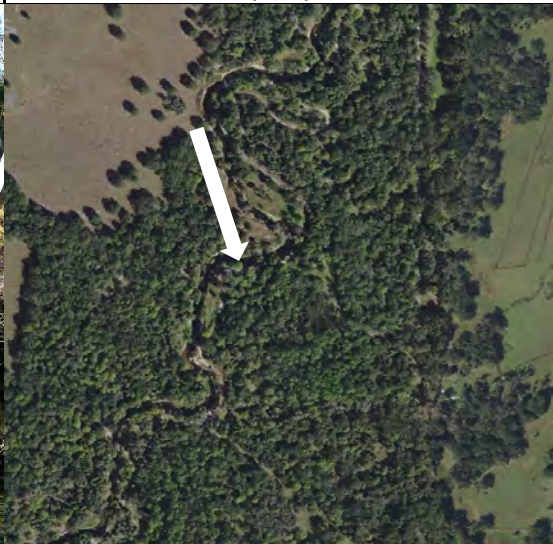
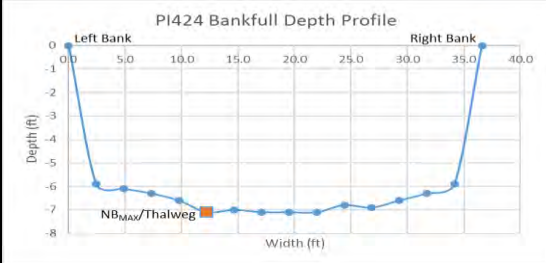
Charlie Creek			Severity Scale: 6.0-Moderate		
Watershed: Peace River Subwatershed: Lower Charlie Creek Latitude: 27.40217 Longitude: -81.74583			County: Hardee Site Number: PI424 Reach Length: 65 ft. Landowner: The Property LLC

Pfankuch-Channel Stability:	Fair	1			
Channel Alteration:	None	0			
Bank Erosion:	Active	1			
BEHI:	High (32.95)	1			
Local NPSP:	Obvious Sources	1.5			
Shoring Structures:	None	0			
Pipe Discharge:	None	0			
Water Odor:	Normal	0			
Fish Passage Barrier:	None	0			
RB: Riparian Buffer:	0 ft.	0.75	<b>Additional Site Features</b> Stream Channel Woody Material: Moderate Impoundments: None Substrate Composition: Medium Sand Bank Material: Sand Near Bank Stress: High RB Landuse: Pasture, Natural Forest LB Landuse: Pasture, Natural Forest		
LB: Riparian Buffer:	40 ft.	0.5			
RB: Floodplain Access:	Full	0			
LB: Floodplain Access:	Partial	0.25

Severity Scale:		6.0			
Notes: 303d: Impaired - Fecal Coliform					
Restoration Option 1

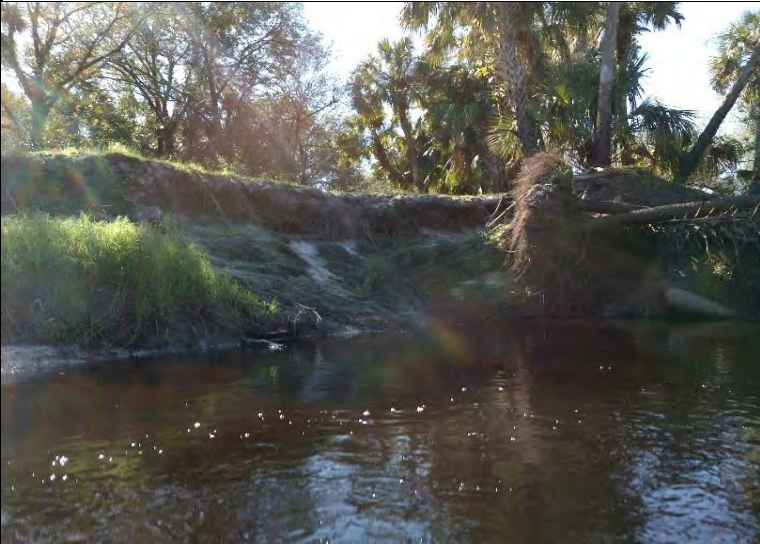
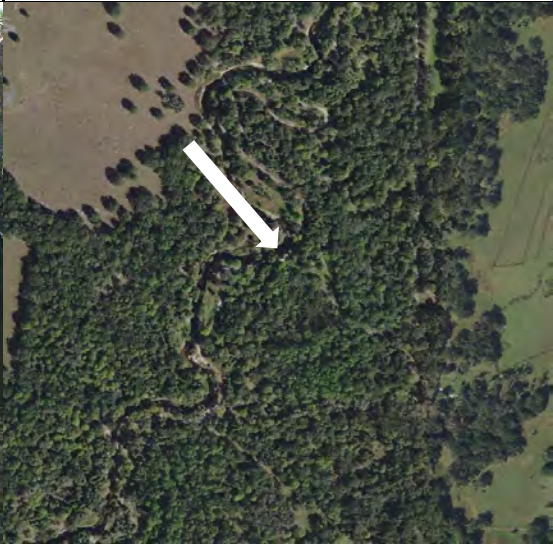
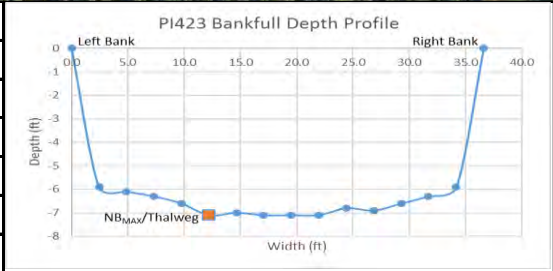
Charlie Creek			Severity Scale: 6.0-Moderate
Watershed: Peace River Subwatershed: Lower Charlie Creek Latitude: 27.40257 Longitude: -81.74524			County: Hardee Site Number: PI423 Reach Length: 160 ft. Landowner: The Property LLC

Risk Factor	Ranking	Score	
Pfankuch-Channel Stability:	Fair	1	
Channel Alteration:	None	0	
Bank Erosion:	Active	1	
BEHI:	High (32.95)	1	
Local NPSP:	Obvious Sources	1.5	
Shoring Structures:	None	0	
Pipe Discharge:	None	0	
Water Odor:	Normal	0	
Fish Passage Barrier:	None	0	
RB: Riparian Buffer:	0 ft.	0.75	
LB: Riparian Buffer:	40 ft.	0.5	
RB: Floodplain Access:	Full	0	
LB: Floodplain Access:	Partial	0.25	
Severity Scale:		6.0	
Notes: 303d: Impaired - Fecal Coliform			
Restoration Option 1

Additional Site Features
Stream Channel Woody Material: Moderate
Impoundments: None
Substrate Composition: Medium Sand
Bank Material: Sand
Near Bank Stress: High
RB Landuse: Pasture, Natural Forest
LB Landuse: Pasture, Natural Forest

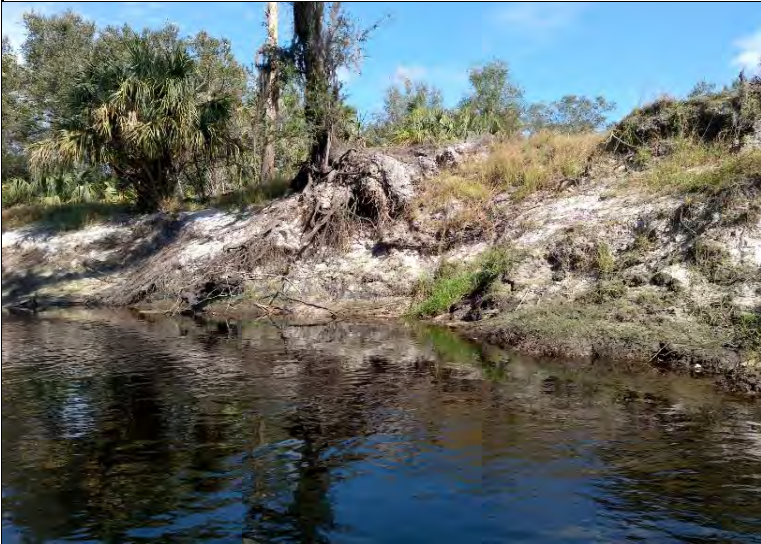
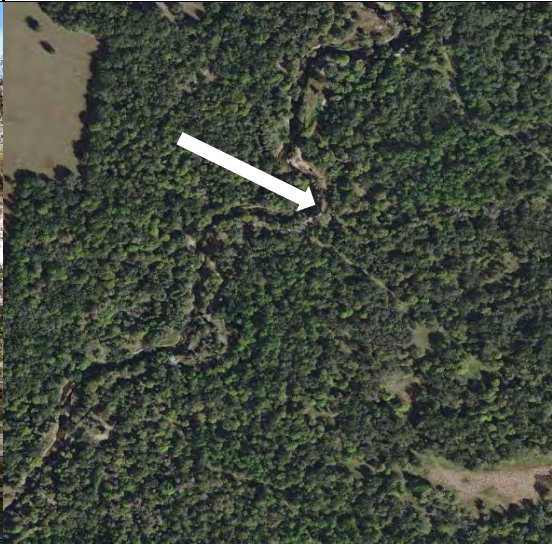
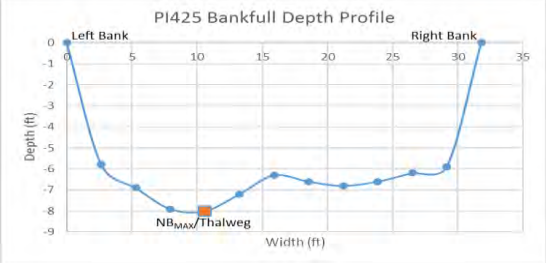
Charlie Creek			Severity Scale: 6.25-Moderate
Watershed: Peace River Subwatershed: Lower Charlie Creek Latitude: 27.40076 Longitude: -81.74656			County: Hardee Site Number: PI425 Reach Length: 330 ft. Landowner: The Property LLC

Pfankuch-Channel Stability:	Fair	1	
Channel Alteration:	None	0	
Bank Erosion:	Mass-wasting	1.5	
BEHI:	High (34.83)	1	
Local NPSP:	Obvious Sources	1.5	
Shoring Structures:	None	0	
Pipe Discharge:	None	0	
Water Odor:	Normal	0	
Fish Passage Barrier:	None	0	
RB: Riparian Buffer:	60 ft.	0.25	
LB: Riparian Buffer:	0 ft.	0.75	
RB: Floodplain Access:	Full	0	
LB: Floodplain Access:	Partial	0.25	
<b>Severity Scale:</b>		<b>6.25</b>	
Notes: 303d: Impaired - Fecal Coliform			<b>Additional Site Features</b>
			Stream Channel Woody Material: Moderate
			Impoundments: None
			Substrate Composition: Medium sand
			Bank Material: Sand
			Near Bank Stress: High

RB Landuse: Natural Forest, Pasture
			LB Landuse: Natural Forest, Pasture
Restoration Option 1

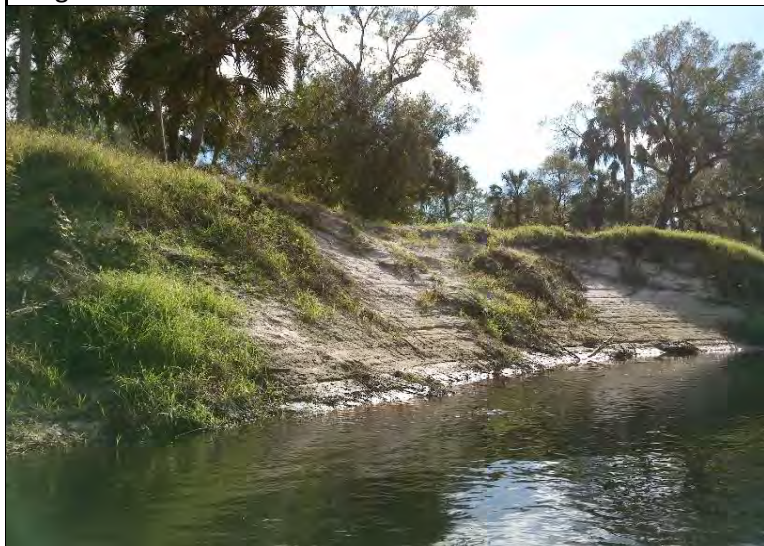
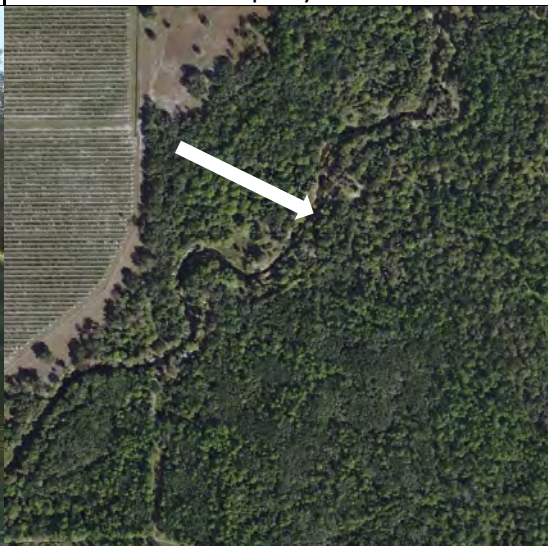
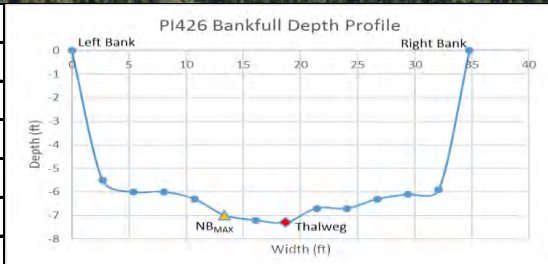
Risk Factor	Ranking	Score
Pfankuch-Channel Stability:	Fair	1
Channel Alteration:	None	0
Bank Erosion:	Active	1
BEHI:	High (34.16)	1
Local NPSP:	Obvious Sources	1.5
Shoring Structures:	None	0
Pipe Discharge:	None	0
Water Odor:	Normal	0
Fish Passage Barrier:	None	0
RB: Riparian Buffer:	40 ft.	0.5
LB: Riparian Buffer:	40 ft.	0.5
RB: Floodplain Access:	Full	0
LB: Floodplain Access:	Partial	0.25
<b>Severity Scale:</b>		<b>5.75</b>

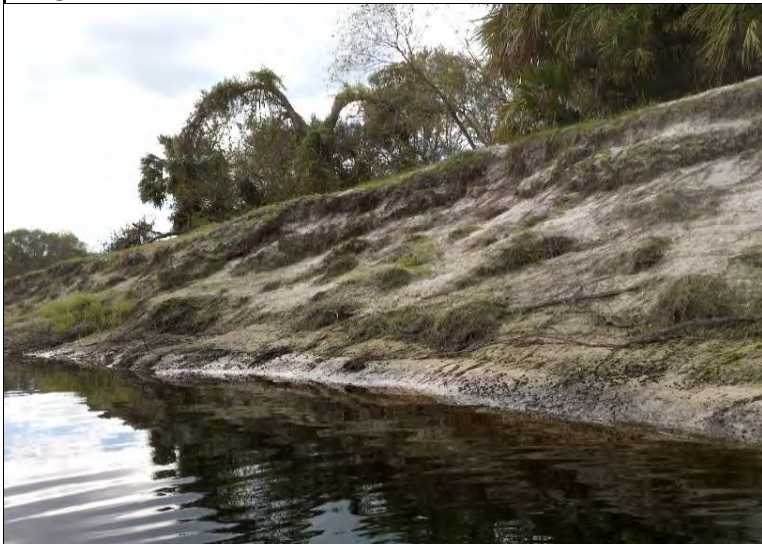
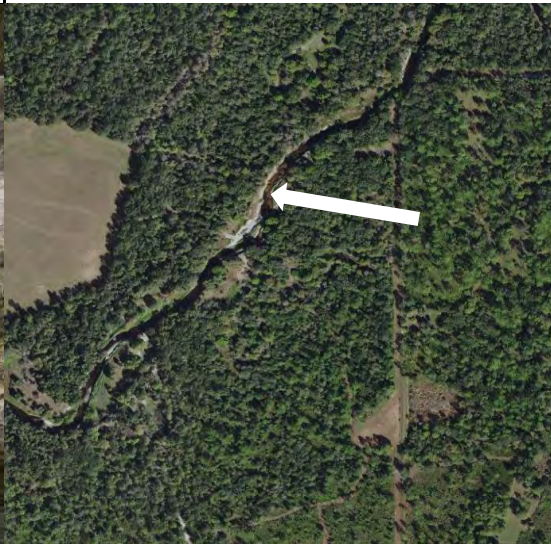
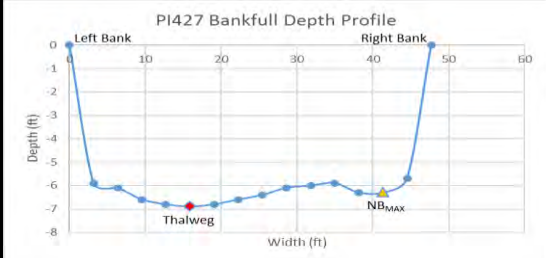
Charlie Creek			Severity Scale: 5.25-Moderate	
Watershed: Peace River Subwatershed: Lower Charlie Creek Latitude: 27.38950 Longitude: -81.76151			County: Hardee Site Number: PI427 Reach Length: 130 ft. Landowner: WHITE MARSH LLC

Pfankuch-Channel Stability:	Fair	1		
Channel Alteration:	None	0		
Bank Erosion:	Active	1		
BEHI:	High (39.21)	1		
Local NPSP:	Obvious Sources	1.5		
Shoring Structures:	None	0		
Pipe Discharge:	None	0		
Water Odor:	Normal	0		
Fish Passage Barrier:	None	0		
RB: Riparian Buffer:	100 ft.	0	<b>Additional Site Features</b> Stream Channel Woody Material: Infrequent Impoundments: None Substrate Composition: Medium sand Bank Material: Sand Near Bank Stress: High RB Landuse: Natural Forest, Pasture LB Landuse: Natural Forest	
LB: Riparian Buffer:	40 ft.	0.5		
RB: Floodplain Access:	Partial	0.25		
LB: Floodplain Access:	Full	0		
<b>Severity Scale:</b>		<b>5.25</b>

Notes: 303d: Impaired - Fecal Coliform				
Restoration Option 1
