# **Peace River and Withlacoochee River Threats Assessments and Fish Assemblage Monitoring**

**Final Report July 1, 2015 – June 30, 2019**

Submitted to Florida State Wildlife Grants Program  
August 1, 2019  
PID: 98462501284

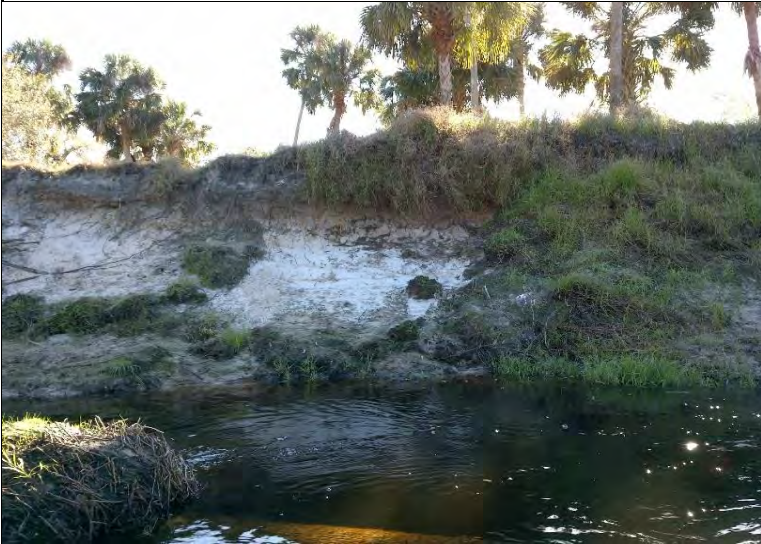
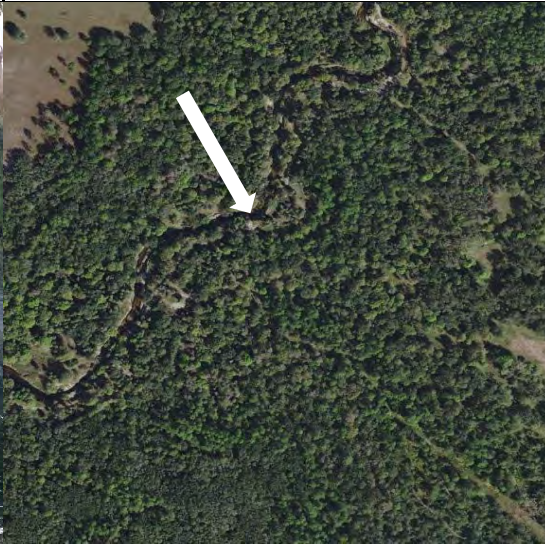
Charlie Creek			Severity Scale: 6.0-Moderate
Watershed: Peace River Subwatershed: Lower Charlie Creek Latitude: 27.39864 Longitude: -81.74778			County: Hardee Site Number: PI428 Reach Length: 95 ft. Landowner: The Property LLC

<b>Risk Factor</b>	<b>Ranking</b>	<b>Score</b>	<b>*Depth Profile Not Recorded*</b>
Pfankuch-Channel Stability:	Fair	1	
Channel Alteration:	None	0	
Bank Erosion:	Active	1	
BEHI:	High (36.05)	1	
Local NPSP:	Obvious Sources	1.5	
Shoring Structures:	None	0	
Pipe Discharge:	None	0	<b>Additional Site Features</b>
Water Odor:	Normal	0	Stream Channel Woody Material: Moderate
Fish Passage Barrier:	None	0	Impoundments: None
RB: Riparian Buffer:	40 ft.	0.5	Substrate Composition: Medium Sand
LB: Riparian Buffer:	0 ft.	0.75	Bank Material: Sand
RB: Floodplain Access:	Full	0	Near Bank Stress: Low (1.12)
LB: Floodplain Access:	Partial	0.25	RB Landuse: Natural Forest, Pasture
<b>Severity Scale:</b>		<b>6.0</b>	LB Landuse: Pasture, Natural Forest

Notes: 303d: Impaired - Fecal Coliform			
Restoration Option 1

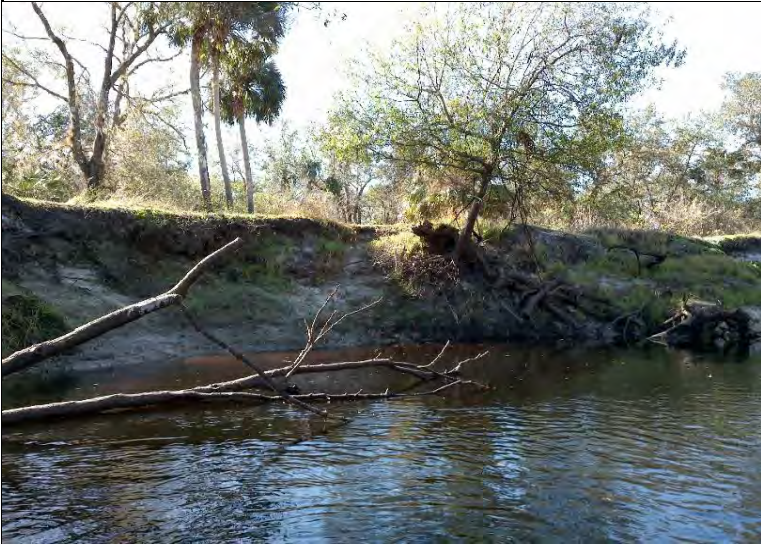
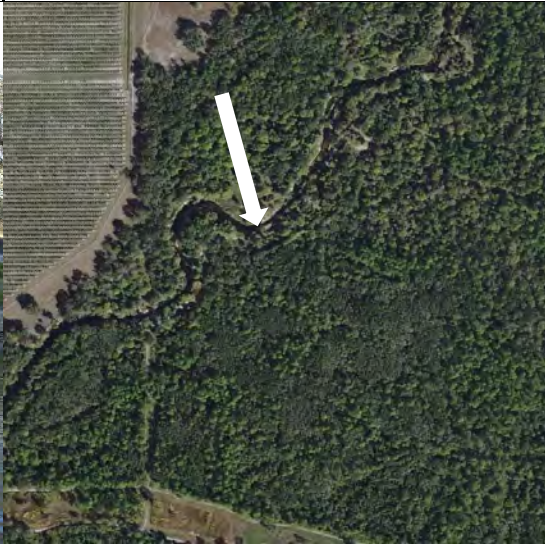
Charlie Creek			Severity Scale: 5.5-Moderate	
Watershed: Peace River Subwatershed: Lower Charlie Creek Latitude: 27.39668 Longitude: -81.74976			County: Hardee Site Number: PI429 Reach Length: 330 ft. Landowner: The Property LLC

<b>Risk Factor</b>	<b>Ranking</b>	<b>Score</b>	<b>*Bank Profile Not Recorded*</b>	
Pfankuch-Channel Stability:	Fair	1		
Channel Alteration:	None	0		
Bank Erosion:	Active	1		
BEHI:	Moderate (29.48)	0.5		
Local NPSP:	Obvious Sources	1.5		
Shoring Structures:	None	0	<b>Additional Site Features</b>	
Pipe Discharge:	None	0		
Water Odor:	Normal	0		Stream Channel Woody Material: Numerous
Fish Passage Barrier:	None	0		Impoundments: None
RB: Riparian Buffer:	40 ft.	0.5		Substrate Composition: Medium Sand
LB: Riparian Buffer:	0 ft.	0.75		Bank Material: Sand
RB: Floodplain Access:	Full	0		Near Bank Stress: Low (1.19)
LB: Floodplain Access:	Partial	0.25		RB Landuse: Pasture, Natural Forest

<b>Severity Scale:</b>		<b>5.5</b>		LB Landuse: Pasture, Natural Forest
Notes: 303d: Impaired - Fecal Coliform				
Restoration Option 1

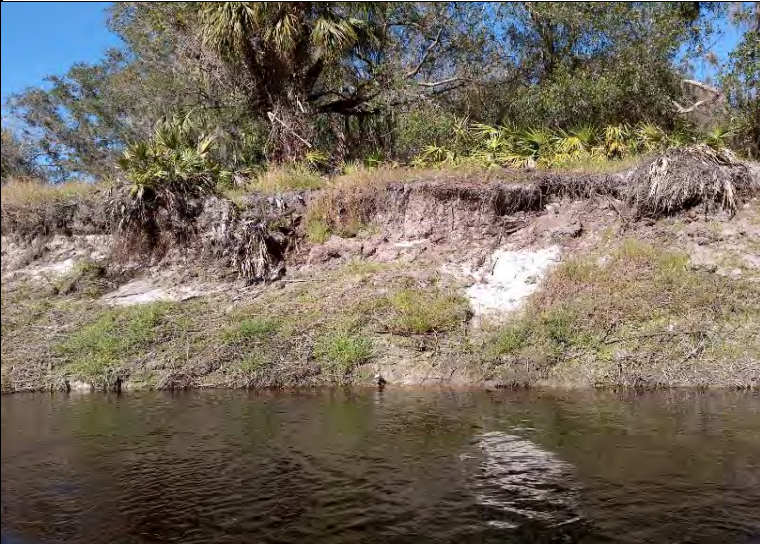
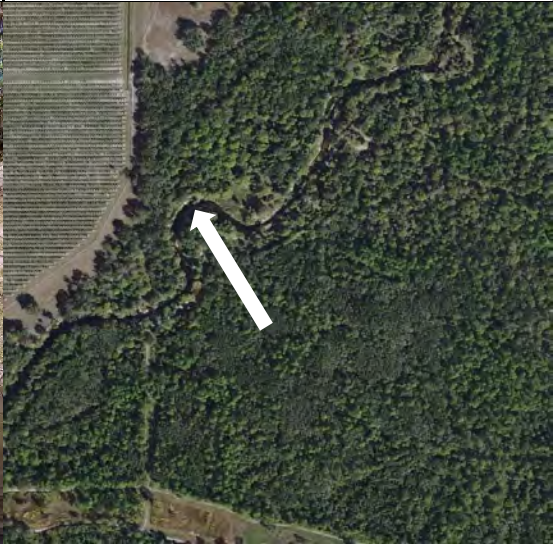
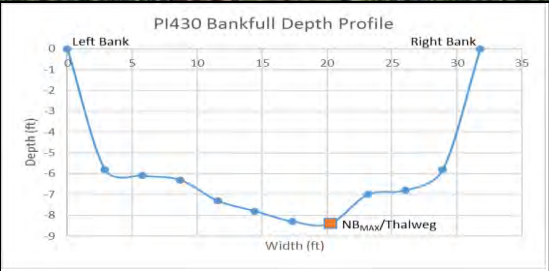
Charlie Creek			Severity Scale: 5.5-Moderate
Watershed: Peace River Subwatershed: Lower Charlie Creek Latitude: 27.39671 Longitude: -81.75104			County: Hardee Site Number: PI430 Reach Length: 140 ft. Landowner: WHITE MARSH LLC

Risk Factor	Ranking	Score	
Pfankuch-Channel Stability:	Fair	1	
Channel Alteration:	None	0	
Bank Erosion:	Active	1	
BEHI:	High (30.13)	1	
Local NPSP:	Obvious Sources	1.5	
Shoring Structures:	None	0	
Pipe Discharge:	None	0	<b>Additional Site Features</b> Stream Channel Woody Material: Numerous Impoundments: None Substrate Composition: Medium Sand Bank Material: Sand Near Bank Stress: Moderate RB Landuse: Natural Forest, Pasture LB Landuse: Pasture, Natural Forest
Water Odor:	Normal	0	
Fish Passage Barrier:	None	0	
RB: Riparian Buffer:	40 ft.	0.5	
LB: Riparian Buffer:	60 ft.	0.25	
RB: Floodplain Access:	Partial	0.25	
LB: Floodplain Access:	Full	0	
<b>Severity Scale:</b>		<b>5.5</b>

Notes: 303d: Impaired - Fecal Coliform			
Restoration Option 1

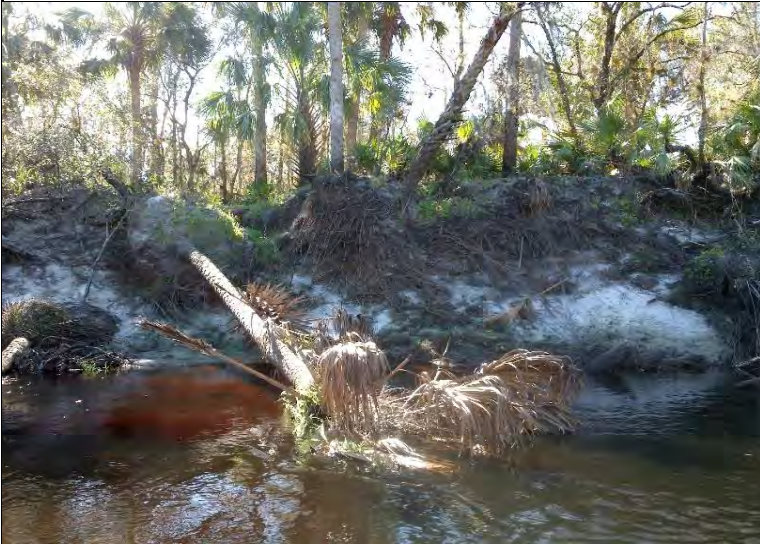
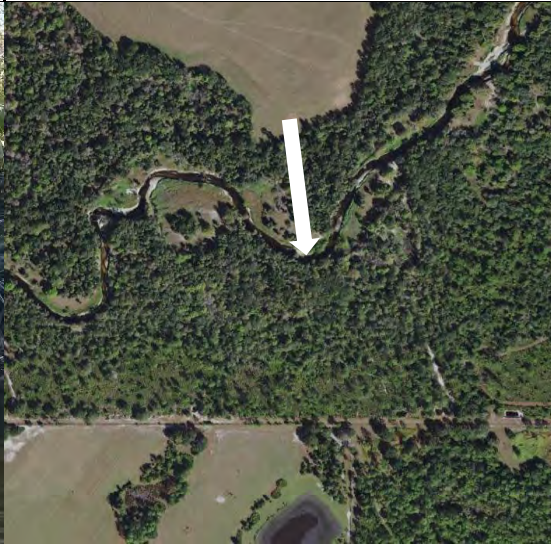
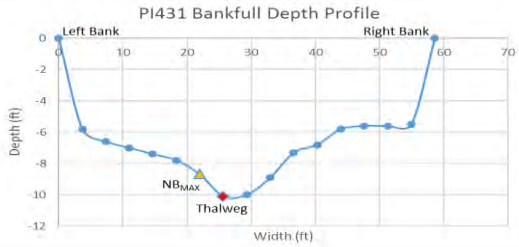
Charlie Creek			Severity Scale: 4.0-Low	
Watershed: Peace River Subwatershed: Lower Charlie Creek Latitude: 27.38609 Longitude: -81.76437			County: Hardee Site Number: PI431 Reach Length: 200 ft. Landowner: WHITE MARSH LLC

Pfankuch-Channel Stability:	Fair	1		
Channel Alteration:	None	0		
Bank Erosion:	Active	1		
BEHI:	High (37.97)	1		
Local NPSP:	Slight Potential	0.5		
Shoring Structures:	None	0		
Pipe Discharge:	None	0		
Water Odor:	Normal	0		
Fish Passage Barrier:	None	0		
RB: Riparian Buffer:	60 ft.	0.25		
LB: Riparian Buffer:	100 ft.	0		
RB: Floodplain Access:	Full	0		
LB: Floodplain Access:	Partial	0.25		
Severity Scale:		4.0	Additional Site Features	
			Stream Channel Woody Material: Extensive	
			Impoundments: None	
			Substrate Composition: Medium Sand	
			Bank Material: Sand	
			Near Bank Stress: Moderate	
			RB Landuse: Natural Forest, Pasture	
			LB Landuse: Natural Forest

Notes: 303d: Impaired - Fecal Coliform				
Restoration Option 1

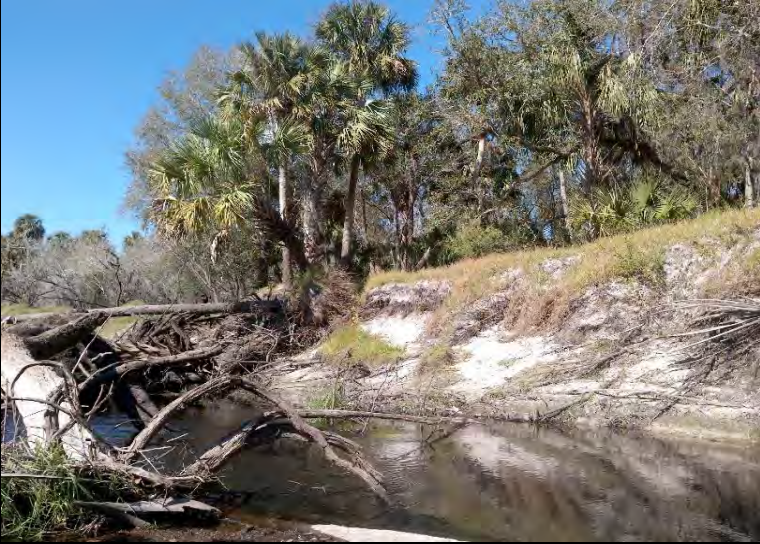
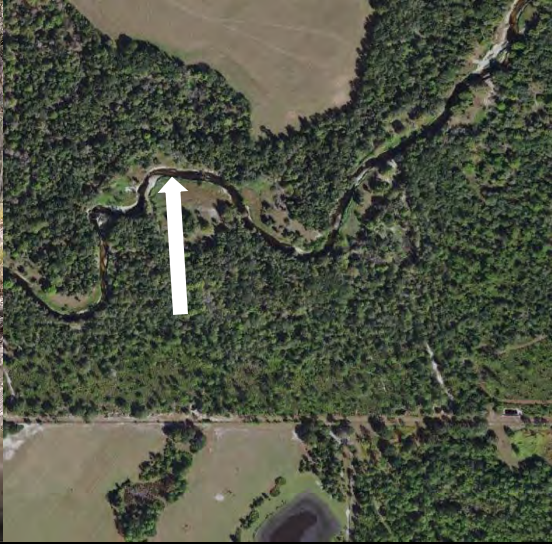
Charlie Creek			Severity Scale: 3.75-Low
Watershed: Peace River Subwatershed: Lower Charlie Creek Latitude: 27.38725 Longitude: -81.76551			County: Hardee Site Number: PI432 Reach Length: 400 ft. Landowner: WHITE MARSH LLC

<b>Risk Factor</b>	<b>Ranking</b>	<b>Score</b>	<b>*Depth Profile Not Recorded*</b>
Pfankuch-Channel Stability:	Fair	1	
Channel Alteration:	None	0	
Bank Erosion:	Active	1	
BEHI:	High (36.25)	1	
Local NPSP:	No Evidence	0	
Shoring Structures:	None	0	
Pipe Discharge:	None	0	<b>Additional Site Features</b>
Water Odor:	Normal	0	Stream Channel Woody Material: Infrequent
Fish Passage Barrier:	None	0	Impoundments: None
RB: Riparian Buffer:	0 ft.	0.75	Substrate Composition: Medium Sand
LB: Riparian Buffer:	100 ft.	0	Bank Material: Sand
RB: Floodplain Access:	Full	0	Near Bank Stress: Very Low (0.94)
LB: Floodplain Access:	Full	0	RB Landuse: Pasture, Natural Forest
<b>Severity Scale:</b>		<b>3.75</b>	LB Landuse: Natural Forest

Notes: 303d: Impaired - Fecal Coliform			
Restoration Option 1

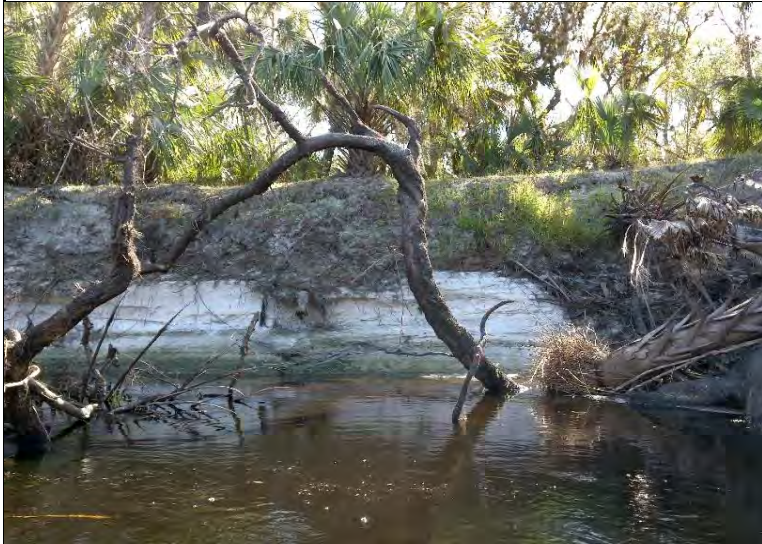
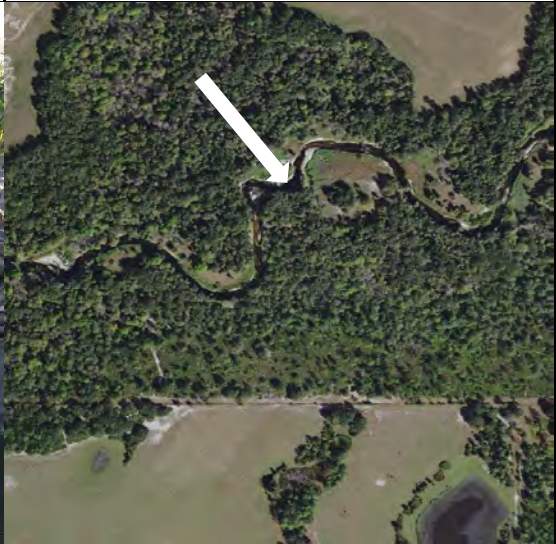
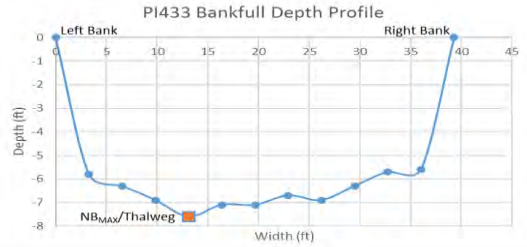
Charlie Creek			Severity Scale: 3.5-Low	
Watershed: Peace River Subwatershed: Lower Charlie Creek Latitude: 27.38675 Longitude: -81.76667			County: Hardee Site Number: PI433 Reach Length: 105 ft. Landowner: WHITE MARSH LLC

Pfankuch-Channel Stability:	Fair	1		
Channel Alteration:	None	0		
Bank Erosion:	Active	1		
BEHI:	High (35.50)	1		
Local NPSP:	No Evidence	0		
Shoring Structures:	None	0		
Pipe Discharge:	None	0		
Water Odor:	Normal	0		
Fish Passage Barrier:	None	0		
RB: Riparian Buffer:	100 ft.	0		
LB: Riparian Buffer:	60 ft.	0.25		
RB: Floodplain Access:	Full	0		
LB: Floodplain Access:	Partial	0.25		
Severity Scale:		3.5		
Notes: 303d: Impaired - Fecal Coliform			Additional Site Features	
Restoration Option 1			Stream Channel Woody Material: Extensive	
			Impoundments: None	
			Substrate Composition: Medium Sand	
			Bank Material: Sand	
			Near Bank Stress: High

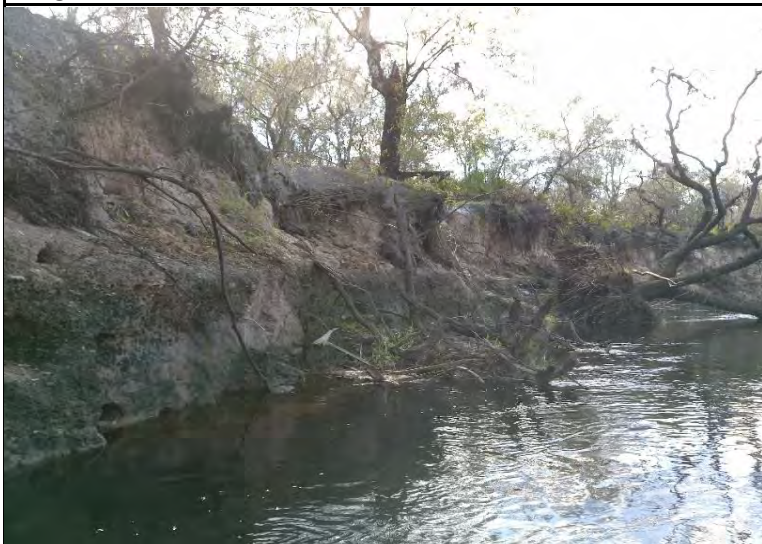
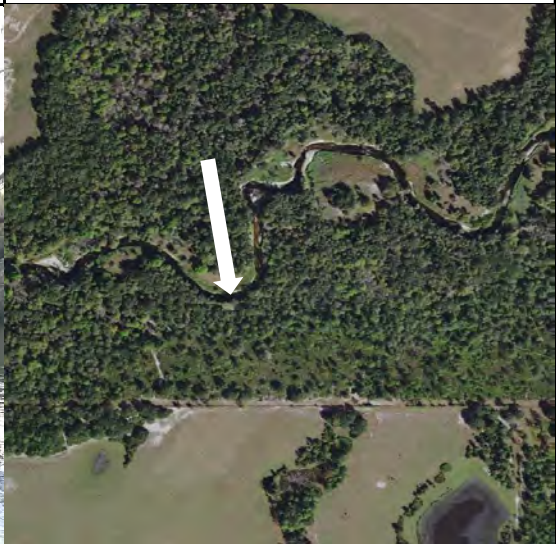
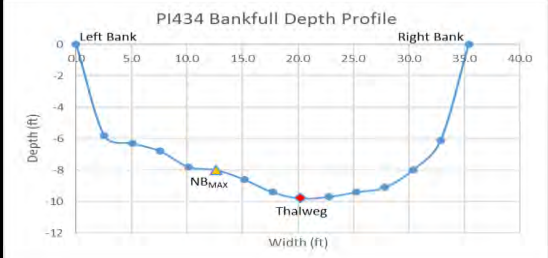
Charlie Creek			Severity Scale: 3.25-Low	
Watershed: Peace River Subwatershed: Lower Charlie Creek Latitude: 27.38553 Longitude: -81.76711			County: Hardee Site Number: PI434 Reach Length: 500 ft. Landowner: WHITE MARSH LLC

Pfankuch-Channel Stability:	Fair	1		
Channel Alteration:	None	0		
Bank Erosion:	Mass-wasting	1.5		
BEHI:	Moderate (25.69)	0.5		
Local NPSP:	No Evidence	0		
Shoring Structures:	None	0		
Pipe Discharge:	None	0		
Water Odor:	Normal	0		
Fish Passage Barrier:	None	0		
RB: Riparian Buffer:	100 ft.	0		
LB: Riparian Buffer:	100 ft.	0		
RB: Floodplain Access:	Full	0		
LB: Floodplain Access:	Partial	0.25		
Severity Scale:		3.25	Additional Site Features	
			Stream Channel Woody Material: Extensive	
			Impoundments: None	
			Substrate Composition: Medium Sand	
			Bank Material: Sandy Clay	
			Near Bank Stress: Low	
			RB Landuse: Natural Forest	
			LB Landuse: Natural Forest

Notes: 303d: Impaired - Fecal Coliform				
Restoration Option 1

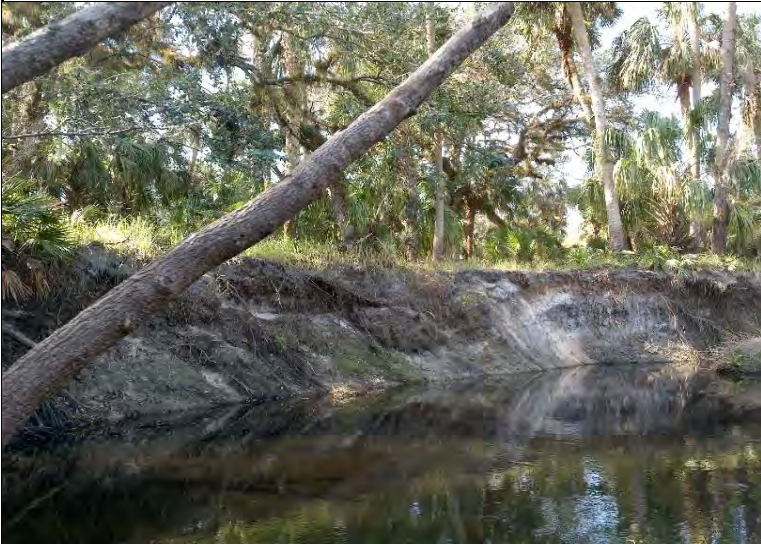
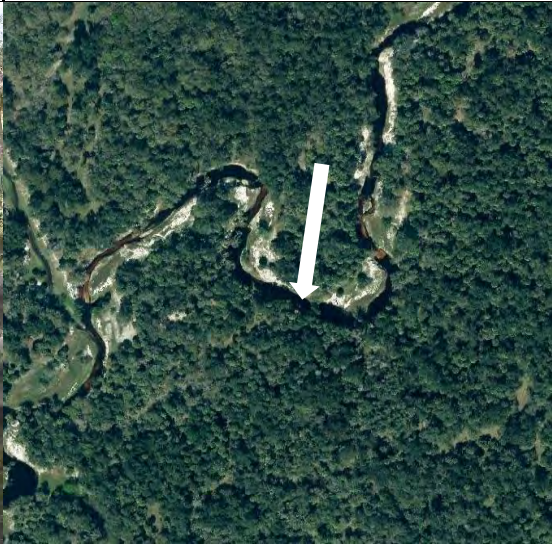
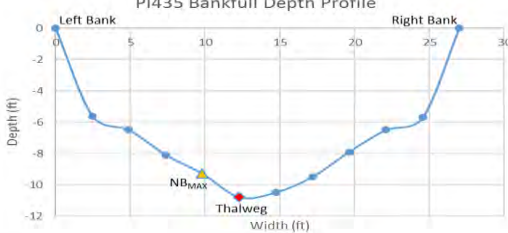
Charlie Creek			Severity Scale: 2.5-Low
Watershed: Peace River Subwatershed: Middle Charlie Creek Latitude: 27.43836 Longitude: -81.72526			County: Hardee Site Number: PI435 Reach Length: 620 ft. Landowner: DH Ranch Inc.

</div>
Pfankuch-Channel Stability:	Fair	1	
Channel Alteration:	None	0	
Bank Erosion:	Active	1	
BEHI:	Moderate (24.87)	0.5	
Local NPSP:	No Evidence	0	
Shoring Structures:	None	0	
Pipe Discharge:	None	0	
Water Odor:	Normal	0	
Fish Passage Barrier:	None	0	
RB: Riparian Buffer:	100 ft.	0	
LB: Riparian Buffer:	100 ft.	0	
RB: Floodplain Access:	Full	0	
LB: Floodplain Access:	Full	0	
<b>Severity Scale:</b>		<b>2.5</b>	Additional Site Features
			Stream Channel Woody Material: Numerous
			Impoundments: None
			Substrate Composition: Medium Sand
			Bank Material: Sand
			Near Bank Stress: Moderate
			RB Landuse: Natural Forest

LB Landuse: Natural Forest
Notes: Good riparian; 303d: NA			
Restoration Option 1

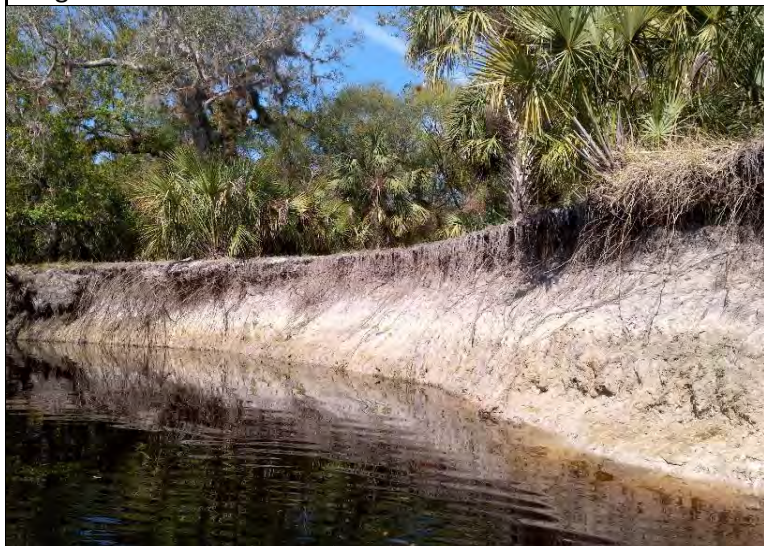
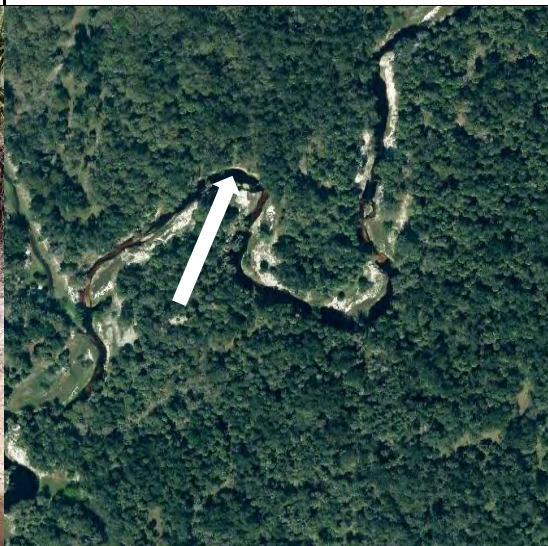
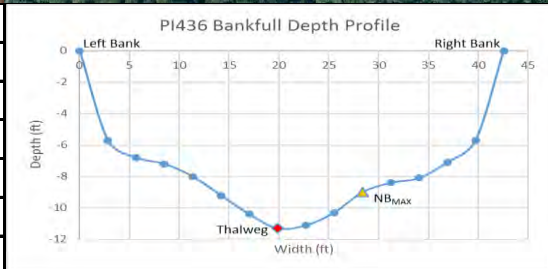
Risk Factor	Ranking	Score
Pfankuch-Channel Stability:	Fair	1
Channel Alteration:	None	0
Bank Erosion:	Active	1
BEHI:	Moderate (22.96)	0.5
Local NPSP:	No Evidence	0
Shoring Structures:	None	0
Pipe Discharge:	None	0
Water Odor:	Normal	0
Fish Passage Barrier:	None	0
RB: Riparian Buffer:	100 ft.	0
LB: Riparian Buffer:	100 ft.	0
RB: Floodplain Access:	Full	0
LB: Floodplain Access:	Full	0
Severity Scale:		2.5

Additional Site Features
Stream Channel Woody Material: Moderate
Impoundments: None
Substrate Composition: Medium Sand
Bank Material: Sandy Clay
Near Bank Stress: Low
RB Landuse: Natural Forest
LB Landuse: Natural Forest

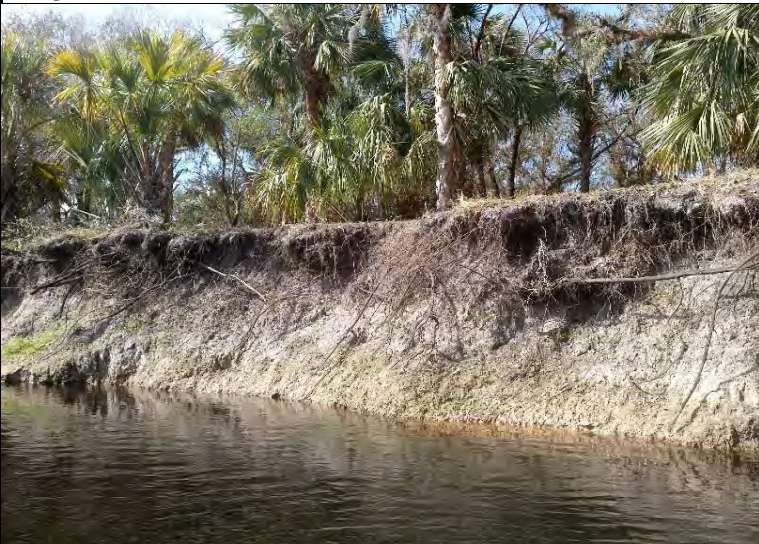
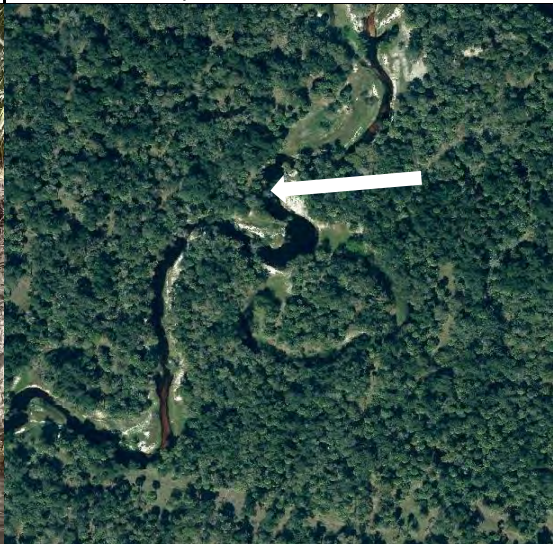
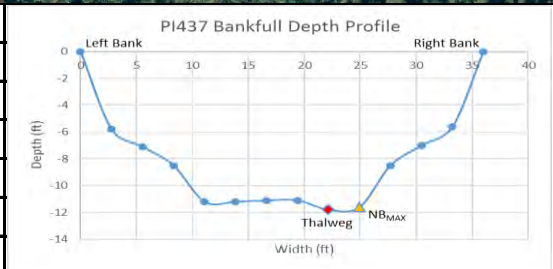
Charlie Creek			Severity Scale: 3.75-Low	
Watershed: Peace River Subwatershed: Middle Charlie Creek Latitude: 27.43743 Longitude: -81.72792			County: Hardee Site Number: PI437 Reach Length: 105 ft. Landowner: Square D Ranch LTD LLP

Pfankuch-Channel Stability:	Fair	1		
Channel Alteration:	None	0		
Bank Erosion:	Active	1		
BEHI:	Moderate (22.77)	0.5		
Local NPSP:	Moderate Potential	1		
Shoring Structures:	None	0		
Pipe Discharge:	None	0		
Water Odor:	Normal	0		
Fish Passage Barrier:	None	0		
RB: Riparian Buffer:	100 ft.	0	<b>Additional Site Features</b>	
LB: Riparian Buffer:	100 ft.	0	Stream Channel Woody Material: Numerous	
RB: Floodplain Access:	Partial	0.25	Impoundments: None	
LB: Floodplain Access:	Full	0	Substrate Composition: Medium Sand	
Severity Scale: 3.75			Bank Material: Sandy Clay	
			Near Bank Stress: Moderate	
			RB Landuse: Natural Forest	
			LB Landuse: Natural Forest

Notes: Cattle fencing approx. 100 ft. from stream; 303d: NA				
Restoration Option 1

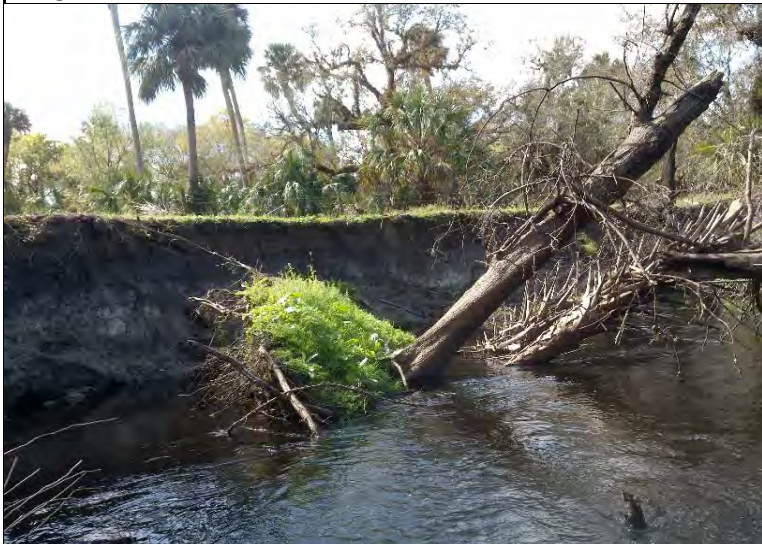
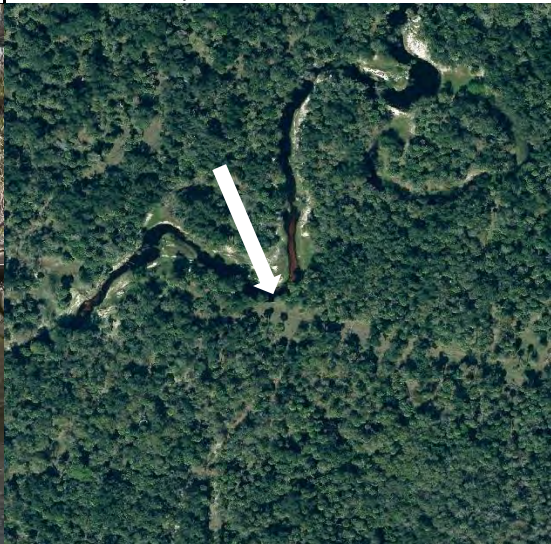
Charlie Creek			Severity Scale: 3.75-Low																																														
Watershed: Peace River Subwatershed: Middle Charlie Creek Latitude: 27.43576 Longitude: -81.72855			County: Hardee Site Number: PI438 Reach Length: 270 ft. Landowner: Square D Ranch LTD LLP

<table><tr><th>Risk Factor</th><th>Ranking</th><th>Score</th></tr><tr><td>Pfankuch-Channel Stability:</td><td>Fair</td><td>1</td></tr></table>

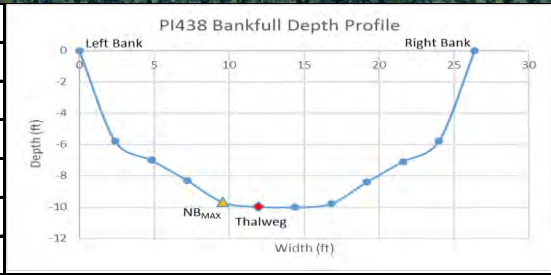
Risk Factor	Ranking	Score	Pfankuch-Channel Stability:	Fair	1	Channel Alteration:	None	0	Bank Erosion:	Active	1	BEHI:	Moderate (19.57)	0.5	Local NPSP:	Slight Potential	0.5	Shoring Structures:	None	0	Pipe Discharge:	None	0	Water Odor:	Normal	0	Fish Passage Barrier:	None	0	RB: Riparian Buffer:	100 ft.	0	LB: Riparian Buffer:	40 ft.	0.5	RB: Floodplain Access:	Full	0	LB: Floodplain Access:	Partial	0.25	Severity Scale:		3.75

Risk Factor	Ranking	Score																																															
Pfankuch-Channel Stability:	Fair	1																																															
Channel Alteration:	None	0																																															
Bank Erosion:	Active	1																																															
BEHI:	Moderate (19.57)	0.5																																															
Local NPSP:	Slight Potential	0.5																																															
Shoring Structures:	None	0																																															
Pipe Discharge:	None	0																																															
Water Odor:	Normal	0																																															
Fish Passage Barrier:	None	0																																															
RB: Riparian Buffer:	100 ft.	0																																															
LB: Riparian Buffer:	40 ft.	0.5																																															
RB: Floodplain Access:	Full	0																																															
LB: Floodplain Access:	Partial	0.25																																															
Severity Scale:		3.75																																															
			<b>Additional Site Features</b>																																														
			Stream Channel Woody Material: Dominating																																														
			Impoundments: None																																														
			Substrate Composition: Medium Sand																																														
			Bank Material: Sandy Clay																																														
			Near Bank Stress: Moderate																																														
			RB Landuse: Natural Forest																																														
			LB Landuse: Natural Forest, Pasture																																														
Notes: 303d: NA																																																	
Restoration Option 1

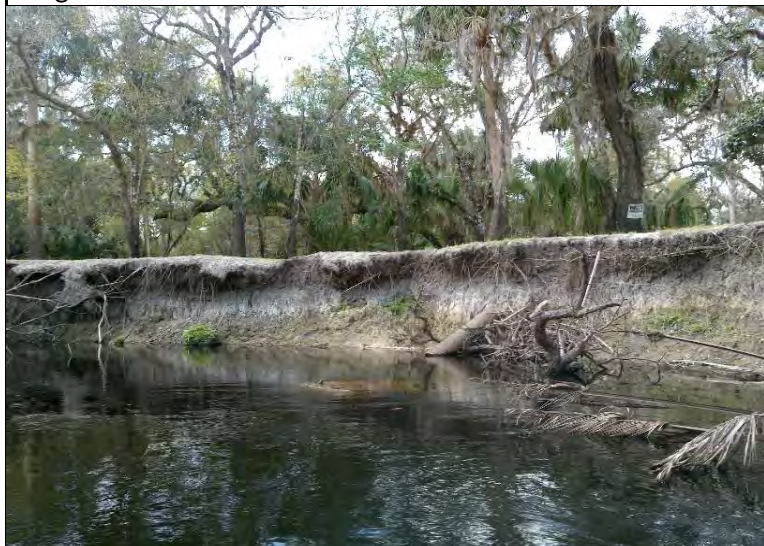
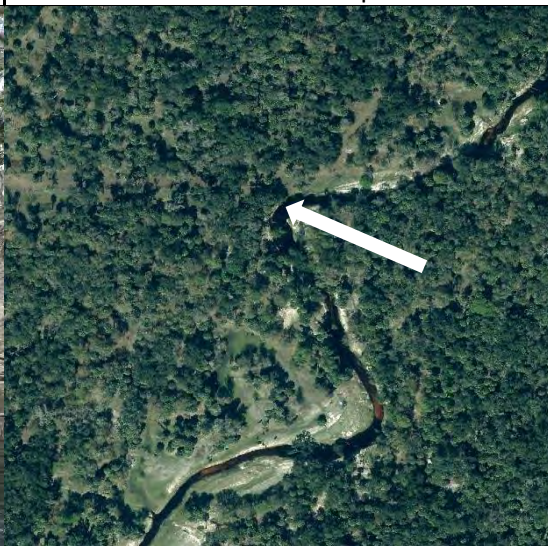
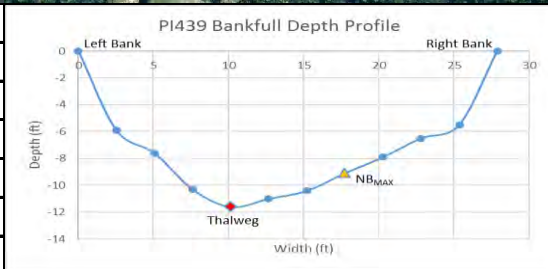
Risk Factor	Ranking	Score
Pfankuch-Channel Stability:	Fair	1
Channel Alteration:	None	0
Bank Erosion:	Active	1
BEHI:	Low (19.20)	0
Local NPSP:	Obvious Sources	1.5
Shoring Structures:	None	0
Pipe Discharge:	None	0
Water Odor:	Normal	0
Fish Passage Barrier:	None	0
RB: Riparian Buffer:	40 ft.	0.5
LB: Riparian Buffer:	80 ft.	0.25
RB: Floodplain Access:	Full	0
LB: Floodplain Access:	Full	0
Severity Scale:		4.25

Additional Site Features
Stream Channel Woody Material: Moderate
Impoundments: None
Substrate Composition: Medium Sand
Bank Material: Sandy Clay
Near Bank Stress: Low
RB Landuse: Natural Forest, Pasture
LB Landuse: Natural Forest

Notes: 303d: NA; \*Square C Ranch LTD LLP also owns small portion of site

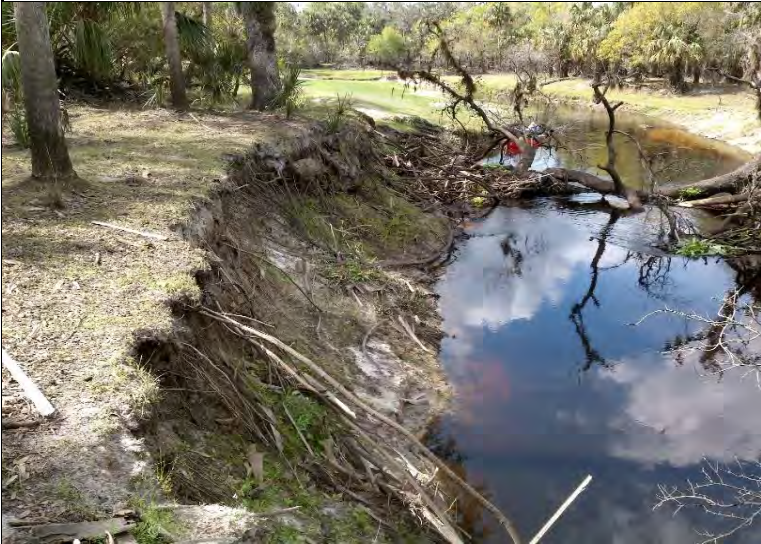
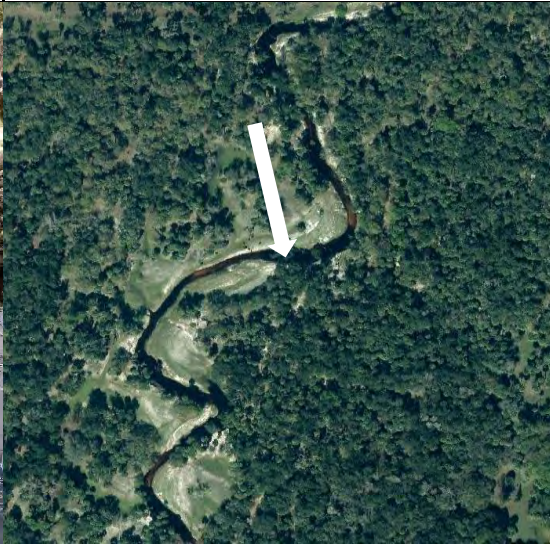
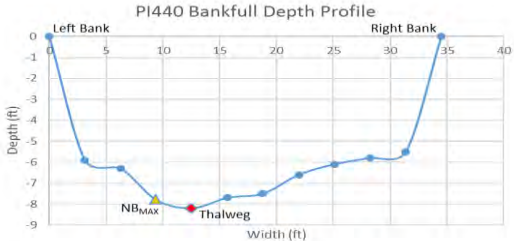
Charlie Creek			Severity Scale: 4.0-Low
Watershed: Peace River Subwatershed: Middle Charlie Creek Latitude: 27.43353 Longitude: -81.73100			County: Hardee Site Number: PI440 Reach Length: 120 ft. Landowner: J.A.M. Farms Corporation

Pfankuch-Channel Stability:	Fair	1	
Channel Alteration:	None	0	
Bank Erosion:	Active	1	
BEHI:	Low (14.47)	0	
Local NPSP:	Obvious Sources	1.5	
Shoring Structures:	None	0	
Pipe Discharge:	None	0	
Water Odor:	Normal	0	
Fish Passage Barrier:	None	0	
RB: Riparian Buffer:	100 ft.	0	
LB: Riparian Buffer:	40 ft.	0.5	
RB: Floodplain Access:	Full	0	
LB: Floodplain Access:	Full	0	
<b>Severity Scale:</b>		<b>4.0</b>	
Notes: 303d: NA			<b>Additional Site Features</b>
			Stream Channel Woody Material: Extensive
			Impoundments: None
			Substrate Composition: Medium Sand
			Bank Material: Sandy Clay
			Near Bank Stress: Moderate
			RB Landuse: Natural Forest

LB Landuse: Natural Forest, Pasture
Restoration Option 1

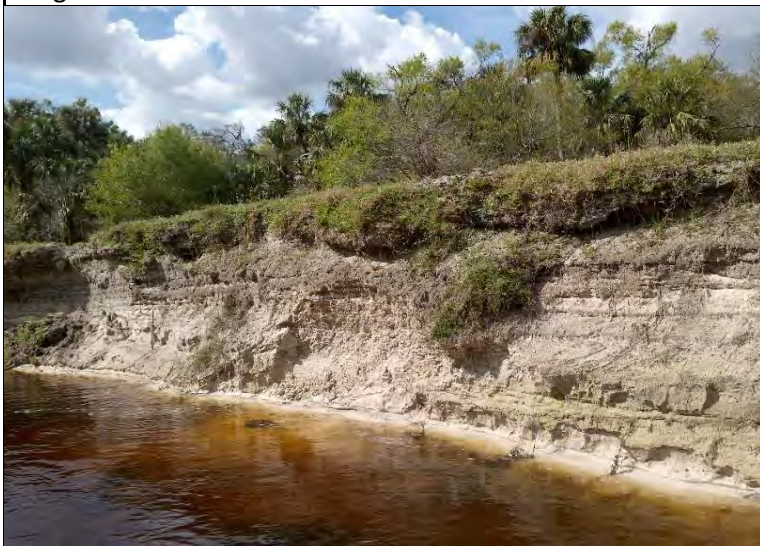
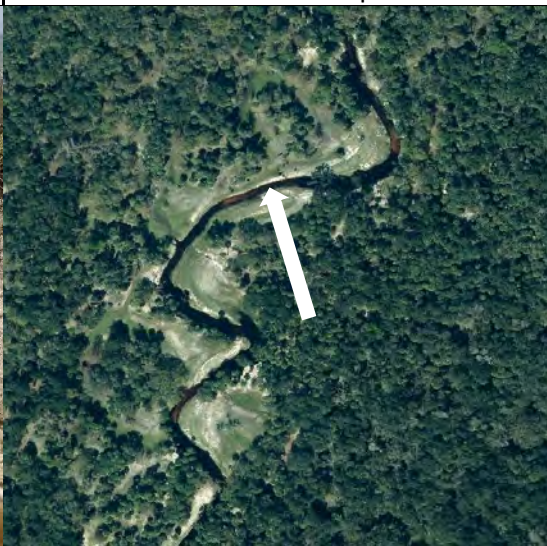
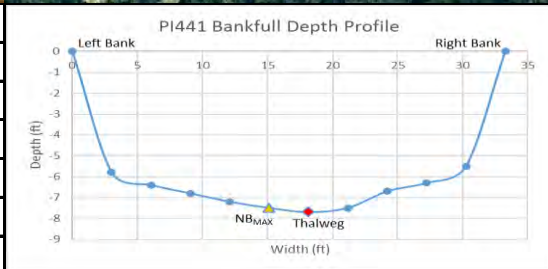
Risk Factor	Ranking	Score
Pfankuch-Channel Stability:	Fair	1
Channel Alteration:	None	0
Bank Erosion:	Active	1
BEHI:	Very High (40.89)	1.5
Local NPSP:	Moderate Potential	1
Shoring Structures:	None	0
Pipe Discharge:	None	0
Water Odor:	Normal	0
Fish Passage Barrier:	None	0
RB: Riparian Buffer:	40 ft.	0.5
LB: Riparian Buffer:	80 ft.	0.25
RB: Floodplain Access:	Full	0
LB: Floodplain Access:	Full	0
Severity Scale:		5.25

Additional Site Features	
Stream Channel Woody Material:	Infrequent
Impoundments:	None
Substrate Composition:	Medium Sand
Bank Material:	Sand
Near Bank Stress:	Low
RB Landuse:	Natural Forest, Pasture
LB Landuse:	Natural Forest, Pasture

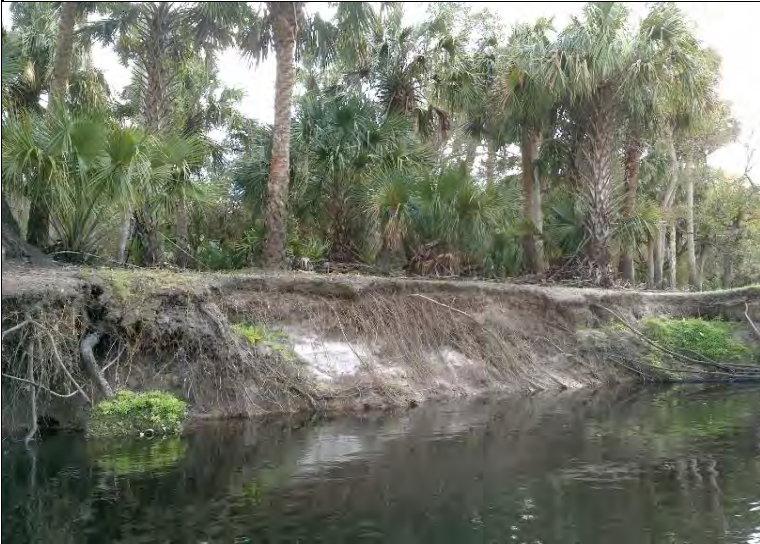
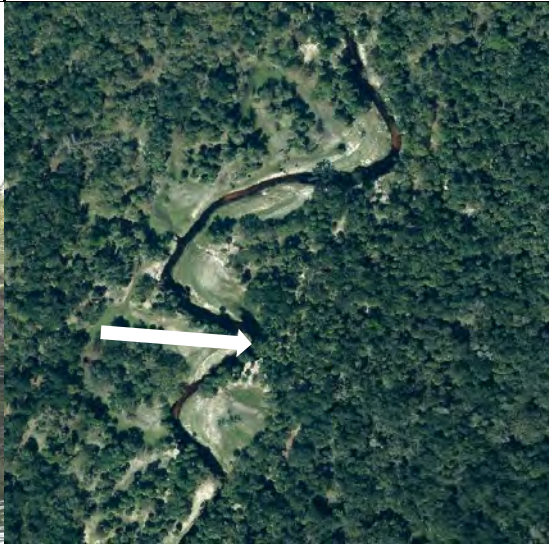
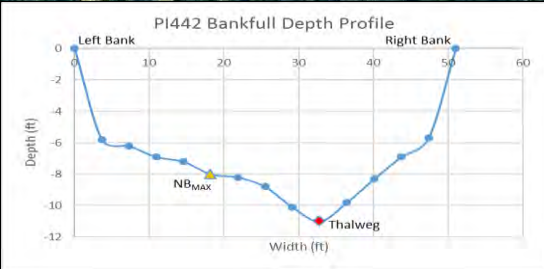
Charlie Creek			Severity Scale: 3.5-Low	
Watershed: Peace River Subwatershed: Middle Charlie Creek Latitude: 27.43253 Longitude: -81.73128			County: Hardee Site Number: PI442 Reach Length: 135 ft. Landowner: J.A.M. Farms Corporation

Pfankuch-Channel Stability:	Fair	1		
Channel Alteration:	None	0		
Bank Erosion:	Active	1		
BEHI:	Low (18.58)	0		
Local NPSP:	Moderate Potential	1		
Shoring Structures:	None	0		
Pipe Discharge:	None	0		
Water Odor:	Normal	0		
Fish Passage Barrier:	None	0		
RB: Riparian Buffer:	40 ft.	0.5		
LB: Riparian Buffer:	100 ft.	0		
RB: Floodplain Access:	Full	0		
LB: Floodplain Access:	Full	0		
Severity Scale:		3.5	Additional Site Features	
Notes: 303d: NA			Stream Channel Woody Material: Infrequent	
			Impoundments: None	
			Substrate Composition: Medium Sand	
			Bank Material: Sandy Clay	
			Near Bank Stress: Low	
Restoration Option 1			RB Landuse: Natural Forest, Pasture

LB Landuse: Natural Forest, Pasture

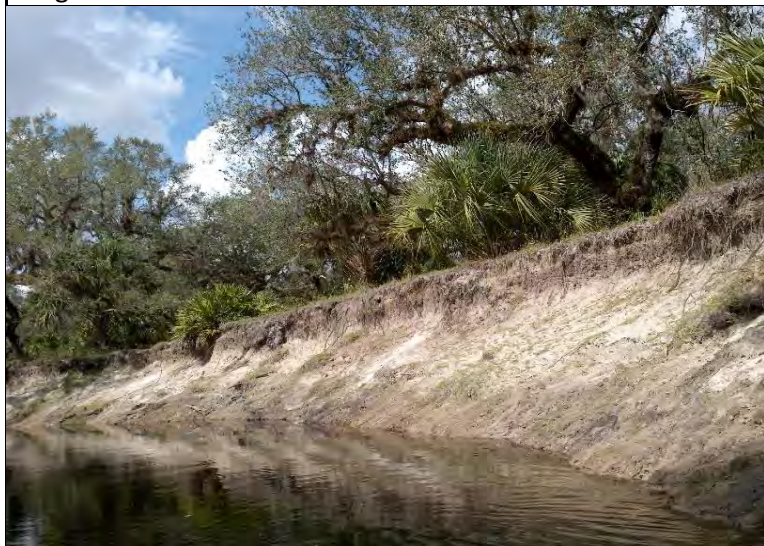
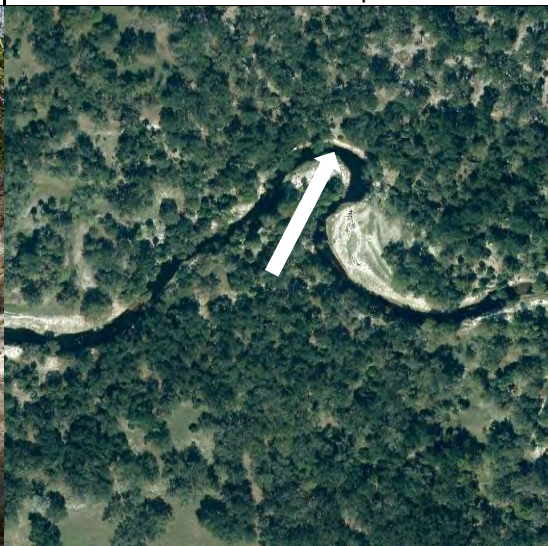
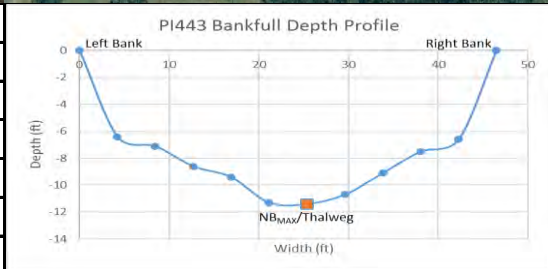
Risk Factor	Ranking	Score
Pfankuch-Channel Stability:	Fair	1
Channel Alteration:	None	0
Bank Erosion:	Active	1
BEHI:	Very High (39.70)	1.5
Local NPSP:	Slight Potential	0.5
Shoring Structures:	None	0
Pipe Discharge:	None	0
Water Odor:	Normal	0
Fish Passage Barrier:	None	0
RB: Riparian Buffer:	100 ft.	0
LB: Riparian Buffer:	100 ft.	0
RB: Floodplain Access:	Partial	0.25
LB: Floodplain Access:	Full	0
Severity Scale:		4.25

Additional Site Features
Stream Channel Woody Material: Moderate
Impoundments: None
Substrate Composition: Medium Sand
Bank Material: Sand
Near Bank Stress: Low
RB Landuse: Natural Forest
LB Landuse: Natural Forest

Notes: 303d: Impaired - Fecal Coliform

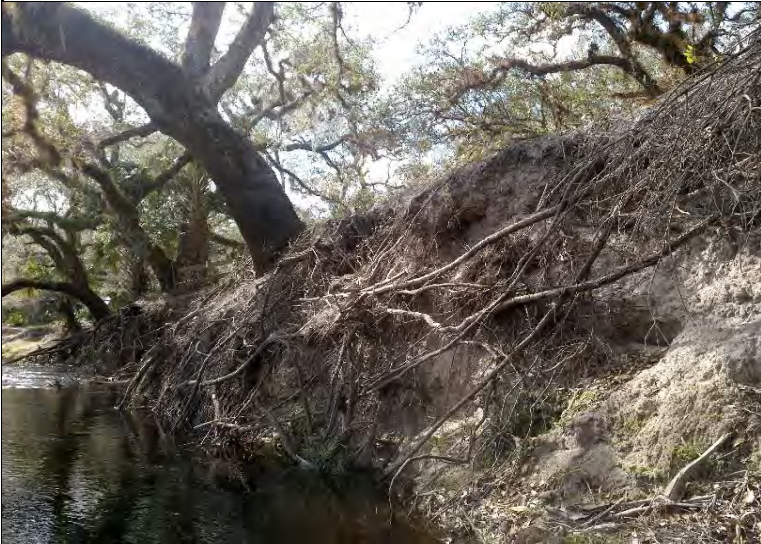
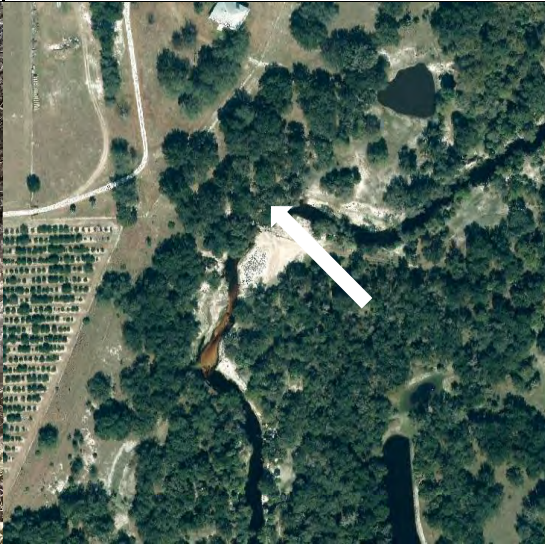
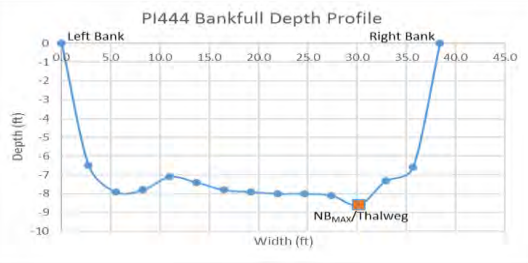
Charlie Creek			Severity Scale: 5.5-Moderate
Watershed: Peace River Subwatershed: Lower Charlie Creek Latitude: 27.42789 Longitude: -81.74169			County: Hardee Site Number: PI444 Reach Length: 235 ft. Landowner: J.A.M. Farms Corporation

Pfankuch-Channel Stability:	Fair	1	
Channel Alteration:	None	0	
Bank Erosion:	Active	1	
BEHI:	High (29.67)	1	
Local NPSP:	Moderate Potential	1	
Shoring Structures:	None	0	
Pipe Discharge:	None	0	
Water Odor:	Normal	0	
Fish Passage Barrier:	None	0	
RB: Riparian Buffer:	20 ft.	0.75	
LB: Riparian Buffer:	0 ft.	0.75	
RB: Floodplain Access:	Full	0	
LB: Floodplain Access:	Full	0	
<b>Severity Scale:</b>		<b>5.5</b>	<b>Additional Site Features</b>
			Stream Channel Woody Material: Moderate
			Impoundments: None
			Substrate Composition: Medium Sand
			Bank Material: Sand
			Near Bank Stress: High
			RB Landuse: Pasture, Natural Forest
			LB Landuse: Pasture

Notes: 303d: Impaired - Fecal Coliform			
Restoration Option 1

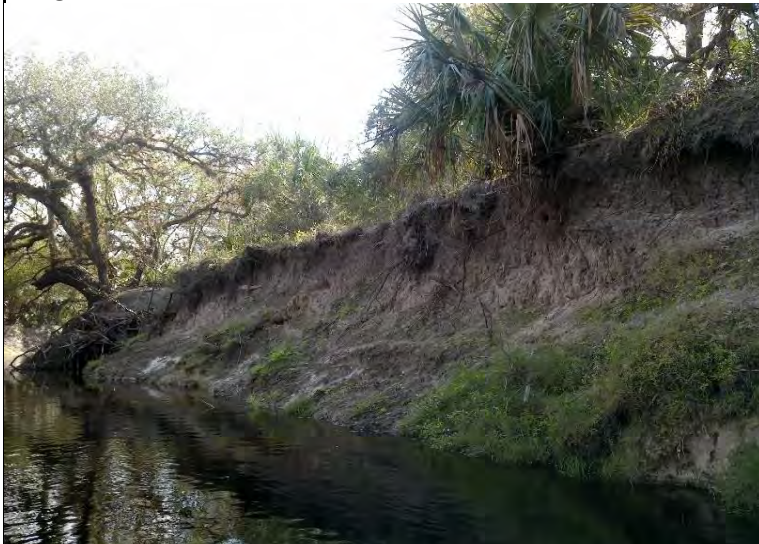
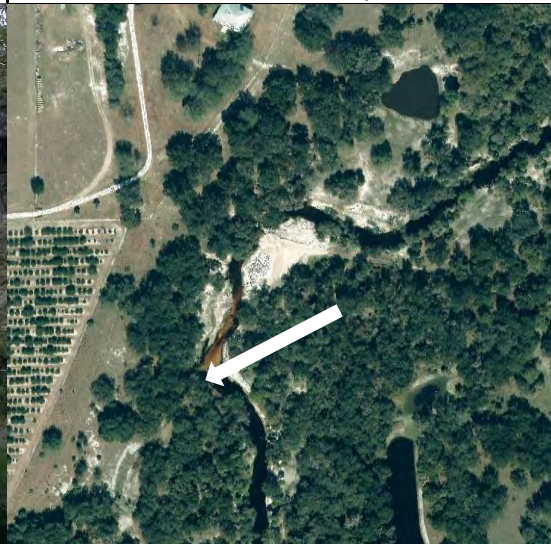
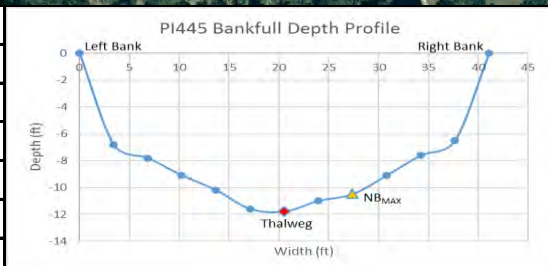
Risk Factor	Ranking	Score
Pfankuch-Channel Stability:	Fair	1
Channel Alteration:	None	0
Bank Erosion:	Active	1
BEHI:	Moderate (23.70)	0.5
Local NPSP:	Obvious Sources	1.5
Shoring Structures:	None	0
Pipe Discharge:	None	0
Water Odor:	Normal	0
Fish Passage Barrier:	None	0
RB: Riparian Buffer:	100 ft.	0
LB: Riparian Buffer:	100 ft.	0
RB: Floodplain Access:	Partial	0.25
LB: Floodplain Access:	Full	0
<b>Severity Scale:</b>		<b>4.25</b>

Stream Channel Woody Material: Infrequent
Impoundments: None
Substrate Composition: Medium Sand
Bank Material: Sandy Clay
Near Bank Stress: Moderate
RB Landuse: Natural Forest
LB Landuse: Natural Forest

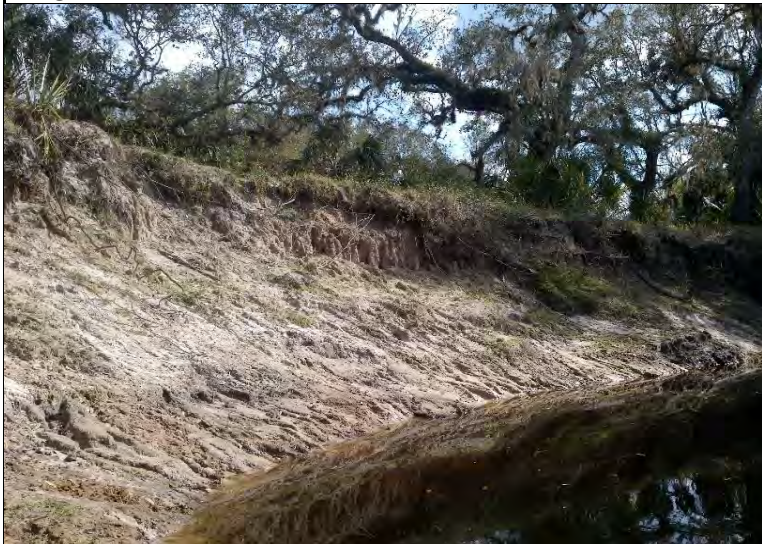
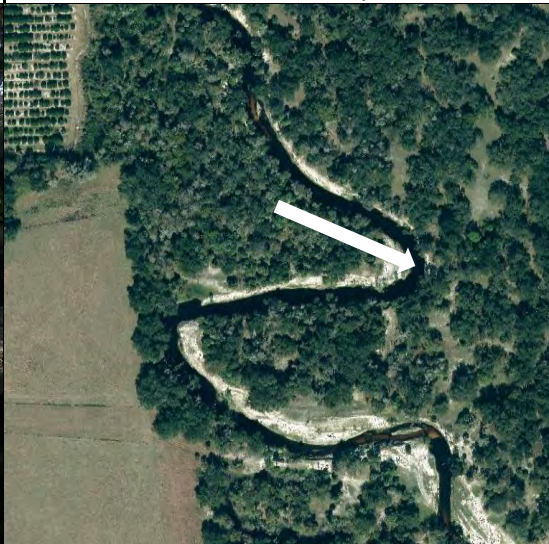
Charlie Creek			Severity Scale: 3.0-Low	
Watershed: Peace River Subwatershed: Lower Charlie Creek Latitude: 27.42270 Longitude: -81.74210			County: Hardee Site Number: PI447 Reach Length: 326 ft. Landowner: J.A.M. Farms Corporation

Pfankuch-Channel Stability:	Fair	1		
Channel Alteration:	None	0		
Bank Erosion:	Active	1		
BEHI:	Low (16.96)	0		
Local NPSP:	Moderate Potential	0.5		
Shoring Structures:	None	0		
Pipe Discharge:	None	0		
Water Odor:	Normal	0		
Fish Passage Barrier:	None	0		
RB: Riparian Buffer:	100 ft.	0	<b>Additional Site Features</b> Stream Channel Woody Material: Moderate Impoundments: None Substrate Composition: Medium Sand Bank Material: Sandy Clay Near Bank Stress: Moderate RB Landuse: Natural Forest, Pasture LB Landuse: Natural Forest	
LB: Riparian Buffer:	60 ft.	0.25		
RB: Floodplain Access:	Full	0		
LB: Floodplain Access:	Partial	0.25

<b>Severity Scale:</b>		<b>3.0</b>		
Notes: 303d: Impaired - Fecal Coliform				
Restoration Option 1

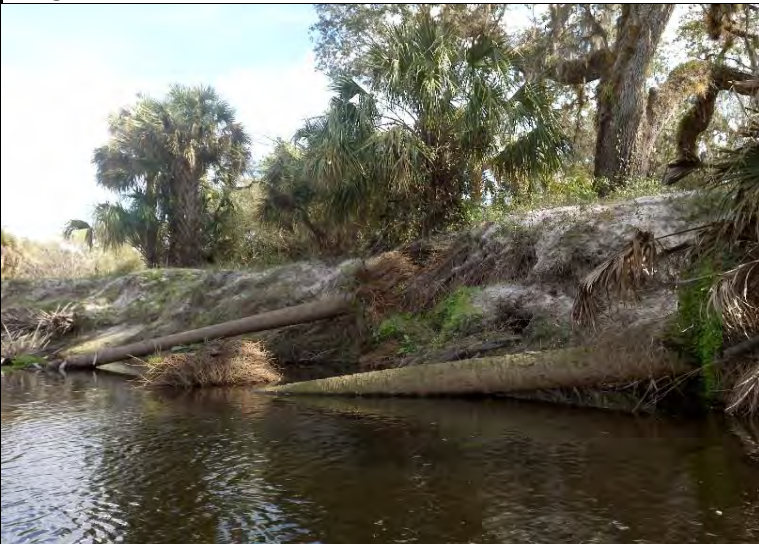
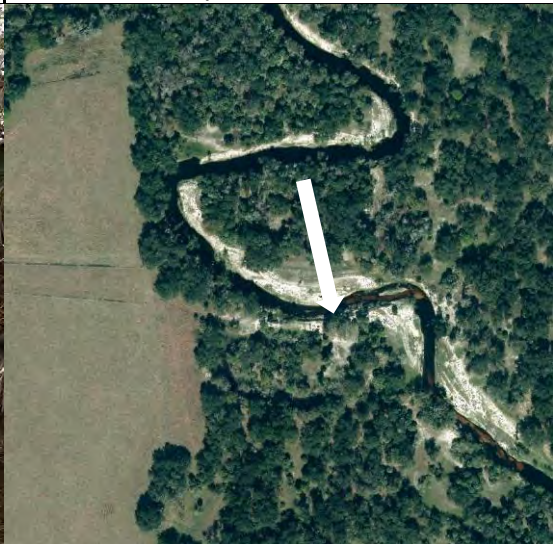
Charlie Creek			Severity Scale: 4.0-Low	
Watershed: Peace River Subwatershed: Lower Charlie Creek Latitude: 27.42119 Longitude: -81.74285			County: Hardee Site Number: PI448 Reach Length: 200 ft. Landowner: Kelly W. James

Pfankuch-Channel Stability:	Fair	1		
Channel Alteration:	None	0		
Bank Erosion:	Active	1		
BEHI:	Moderate (28.10)	0.5		
Local NPSP:	Moderate Potential	1		
Shoring Structures:	None	0		
Pipe Discharge:	None	0		
Water Odor:	Normal	0		
Fish Passage Barrier:	None	0		
RB: Riparian Buffer:	40 ft.	0.5	<b>Additional Site Features</b> Stream Channel Woody Material: Numerous Impoundments: None Substrate Composition: Medium Sand Bank Material: Sand Near Bank Stress: Low RB Landuse: Natural Forest, Pasture LB Landuse: Natural Forest	
LB: Riparian Buffer:	100 ft.	0		
RB: Floodplain Access:	Full	0		
LB: Floodplain Access:	Full	0		
<b>Severity Scale:</b>		<b>4.0</b>

Notes: 303d: Impaired - Fecal Coliform				
Restoration Option 1
