# **Peace River and Withlacoochee River Threats Assessments and Fish Assemblage Monitoring**

**Final Report July 1, 2015 – June 30, 2019**

Submitted to Florida State Wildlife Grants Program  
August 1, 2019  
PID: 98462501284

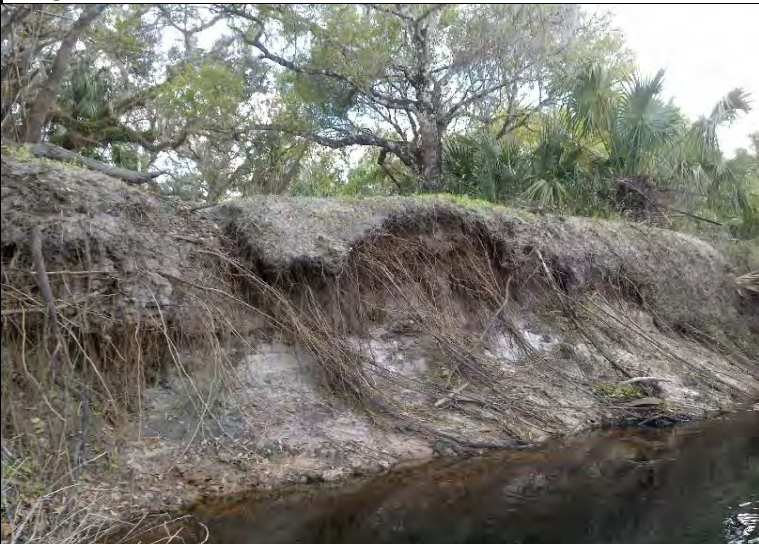
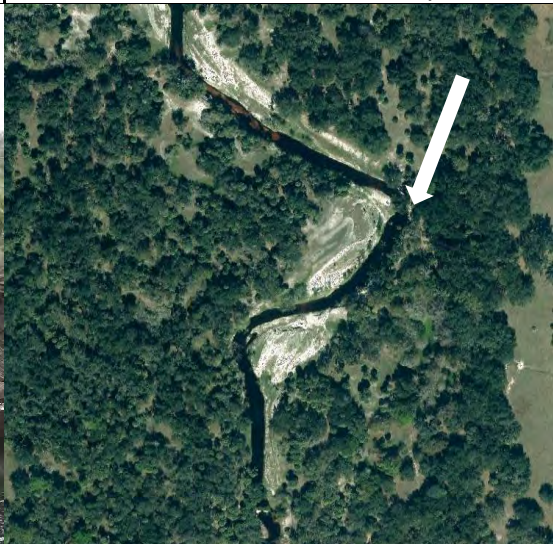
Charlie Creek			Severity Scale: 3.5-Low	
Watershed: Peace River Subwatershed: Lower Charlie Creek Latitude: 27.41973 Longitude: -81.74029			County: Hardee Site Number: PI449 Reach Length: 230 ft. Landowner: Southern Sisters Family LTD

Pfankuch-Channel Stability:	Fair	1		
Channel Alteration:	None	0		
Bank Erosion:	Active	1		
BEHI:	Low (13.89)	0		
Local NPSP:	Moderate Potential	1		
Shoring Structures:	None	0		
Pipe Discharge:	None	0		
Water Odor:	Normal	0		
Fish Passage Barrier:	None	0		
RB: Riparian Buffer:	100 ft.	0	<b>Additional Site Features</b> Stream Channel Woody Material: Moderate Impoundments: None Substrate Composition: Medium Sand Bank Material: Sandy Clay Near Bank Stress: Low RB Landuse: Natural Forest LB Landuse: Natural Forest, Pasture	
LB: Riparian Buffer:	40 ft.	0.5		
RB: Floodplain Access:	Full	0		
LB: Floodplain Access:	Full	0		
Severity Scale:		3.5

Notes: 303d: Impaired - Fecal Coliform				
Restoration Option 1

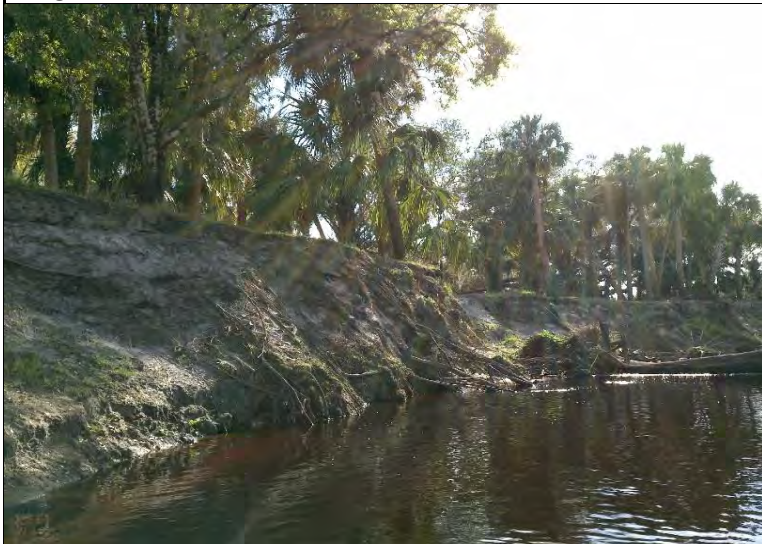
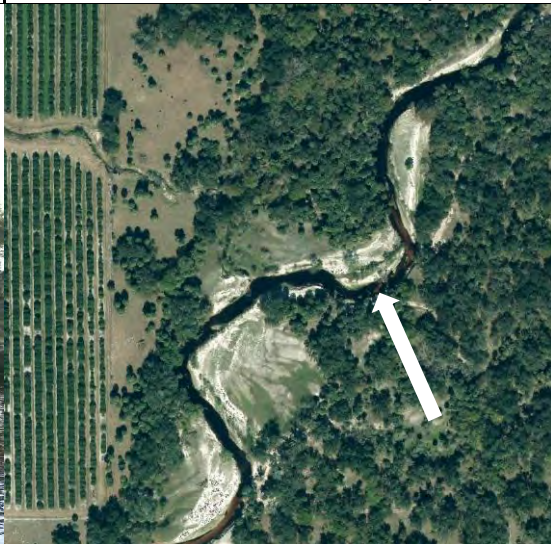
Charlie Creek			Severity Scale: 4.5-Moderate	
Watershed: Peace River Subwatershed: Lower Charlie Creek Latitude: 27.41544 Longitude: -81.74217			County: Hardee Site Number: PI450 Reach Length: 380 ft. Landowner: Southern Sisters Family LTD

Pfankuch-Channel Stability:	Fair	1		
Channel Alteration:	None	0		
Bank Erosion:	Active	1		
BEHI:	Low (17.91)	0		
Local NPSP:	Obvious Sources	1.5		
Shoring Structures:	None	0		
Pipe Discharge:	None	0		
Water Odor:	Normal	0		
Fish Passage Barrier:	None	0		
RB: Riparian Buffer:	100 ft.	0		
LB: Riparian Buffer:	0 ft.	0.75		
RB: Floodplain Access:	Full	0		
LB: Floodplain Access:	Partial	0.25		
Severity Scale:		4.5	<b>Additional Site Features</b> Stream Channel Woody Material: Extensive Impoundments: None Substrate Composition: Medium Sand Bank Material: Sandy Clay Near Bank Stress: High RB Landuse: Natural Forest LB Landuse: Pasture, Natural Forest

Notes: 303d: Impaired - Fecal Coliform				
Restoration Option 1

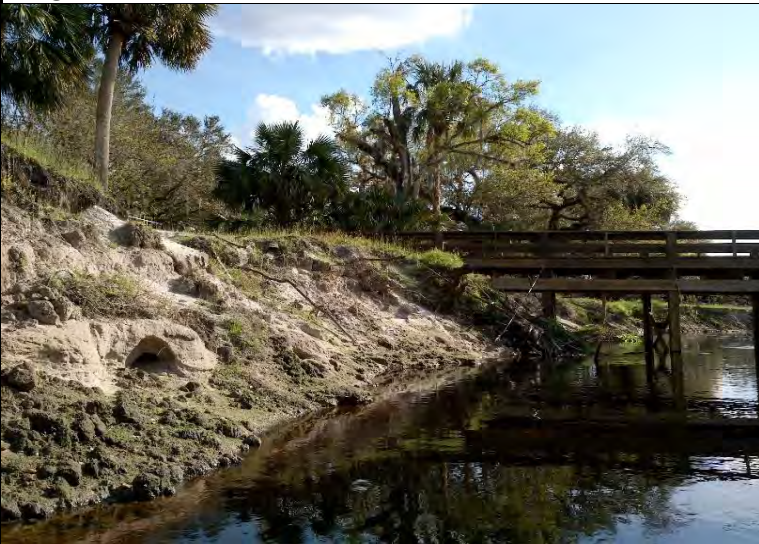
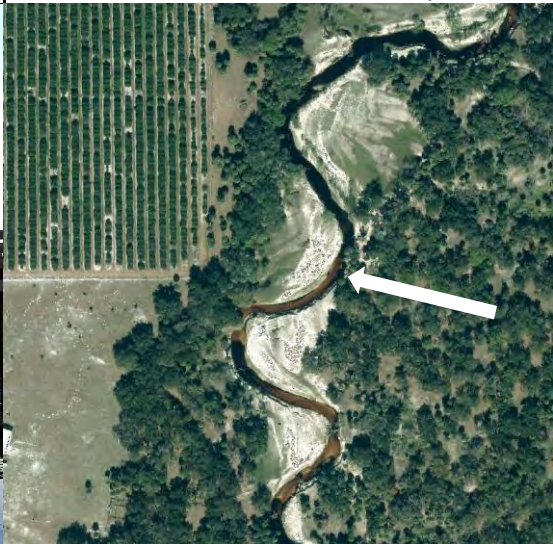
Charlie Creek			Severity Scale: 5.75-Moderate	
Watershed: Peace River Subwatershed: Lower Charlie Creek Latitude: 27.41380 Longitude: -81.74340			County: Hardee Site Number: PI451 Reach Length: 340 ft. Landowner: Southern Sisters Family LTD

Pfankuch-Channel Stability:	Fair	1		
Channel Alteration:	None	0		
Bank Erosion:	Active	1		
BEHI:	High (31.17)	1		
Local NPSP:	Obvious Sources	1.5		
Shoring Structures:	None	0		
Pipe Discharge:	None	0		
Water Odor:	Normal	0		
Fish Passage Barrier:	None	0		
RB: Riparian Buffer:	40 ft.	0.5		
LB: Riparian Buffer:	20 ft.	0.75		
RB: Floodplain Access:	Full	0		
LB: Floodplain Access:	Full	0		
Severity Scale:		5.75		
Notes: Cattle fence and wooden bridge across river; 303d: Impaired - Fecal Coliform			Additional Site Features	
			Stream Channel Woody Material: Infrequent	
			Impoundments: None	
			Substrate Composition: Medium Sand

Bank Material: Sand	
			Near Bank Stress: High	
			RB Landuse: Pasture, Agriculture, Nat. Forest	
			LB Landuse: Pasture, Nat. Forest, Recreation	
Restoration Option 1

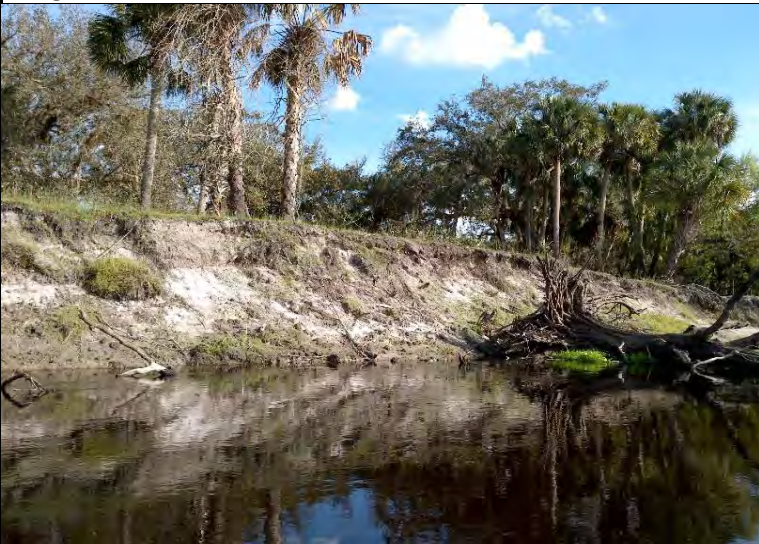
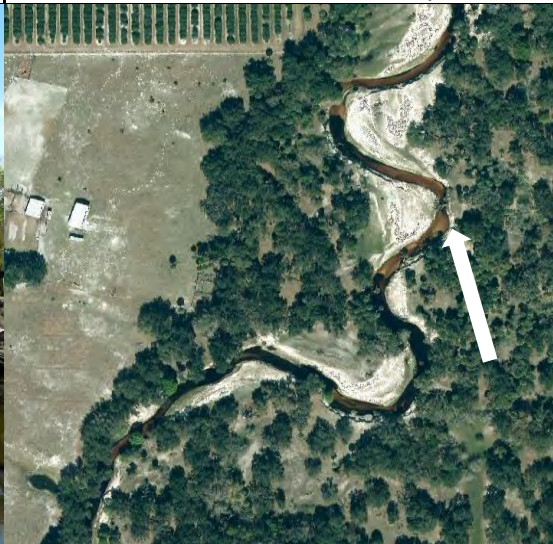
Charlie Creek			Severity Scale: 6.0-Moderate	
Watershed: Peace River Subwatershed: Lower Charlie Creek Latitude: 27.41253 Longitude: -81.74377			County: Hardee Site Number: PI452 Reach Length: 325 ft. Landowner: Southern Sisters Family LTD

Pfankuch-Channel Stability:	Fair	1		
Channel Alteration:	None	0		
Bank Erosion:	Active	1		
BEHI:	High (32.03)	1		
Local NPSP:	Obvious Sources	1.5		
Shoring Structures:	None	0		
Pipe Discharge:	None	0		
Water Odor:	Normal	0		
Fish Passage Barrier:	None	0		
RB: Riparian Buffer:	0 ft.	0.75	<b>Additional Site Features</b>	
LB: Riparian Buffer:	0 ft.	0.75	Stream Channel Woody Material: Numerous	
RB: Floodplain Access:	Full	0	Impoundments: None	
LB: Floodplain Access:	Full	0	Substrate Composition: Medium Sand	
Severity Scale:		6.0	Bank Material: Sand	
			Near Bank Stress: High	
			RB Landuse: Pasture, Natural Forest	
			LB Landuse: Natural Forest, Pasture

303d: Impaired - Fecal Coliform				
Restoration Option 1

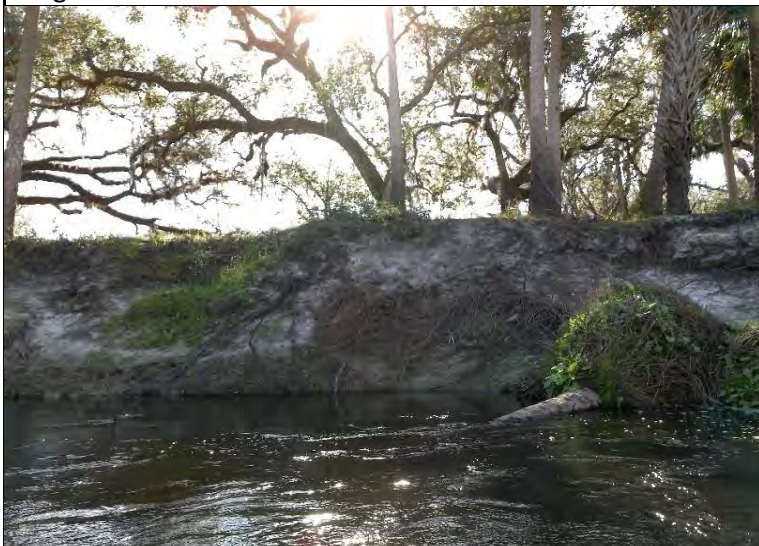
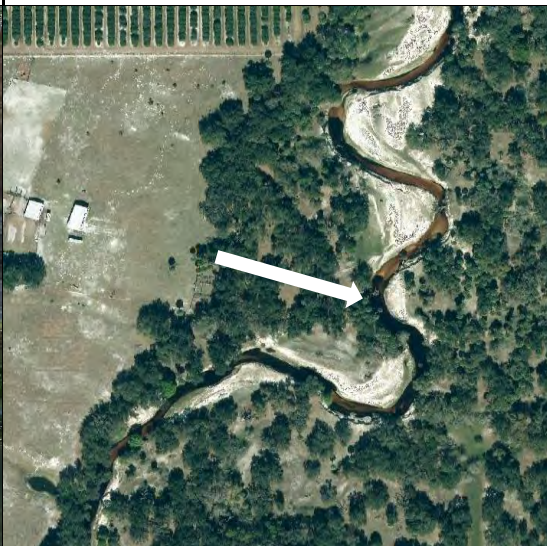
Risk Factor	Ranking	Score
Pfankuch-Channel Stability:	Fair	1
Channel Alteration:	None	0
Bank Erosion:	Active	1
BEHI:	High (35.77)	1
Local NPSP:	Obvious Sources	1.5
Shoring Structures:	None	0
Pipe Discharge:	None	0
Water Odor:	Normal	0
Fish Passage Barrier:	None	0
RB: Riparian Buffer:	40 ft.	0.5
LB: Riparian Buffer:	40 ft.	0.5
RB: Floodplain Access:	Partial	0.25
LB: Floodplain Access:	Full	0
<b>Severity Scale:</b>		<b>5.75</b>

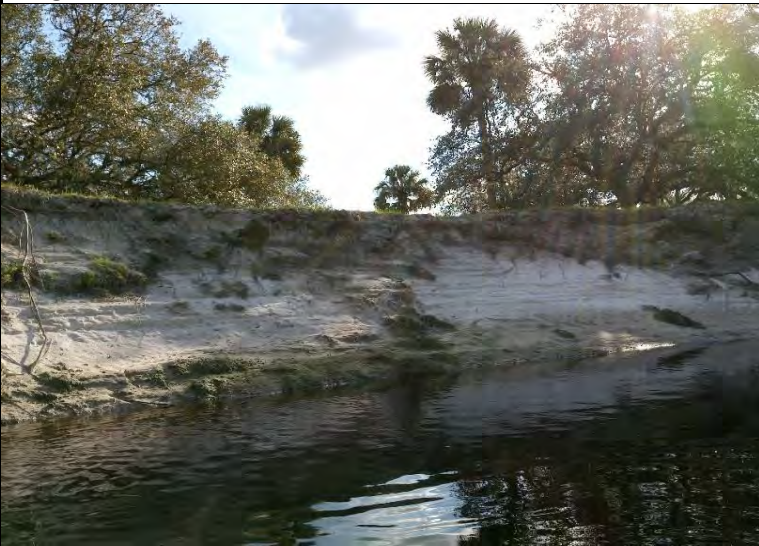
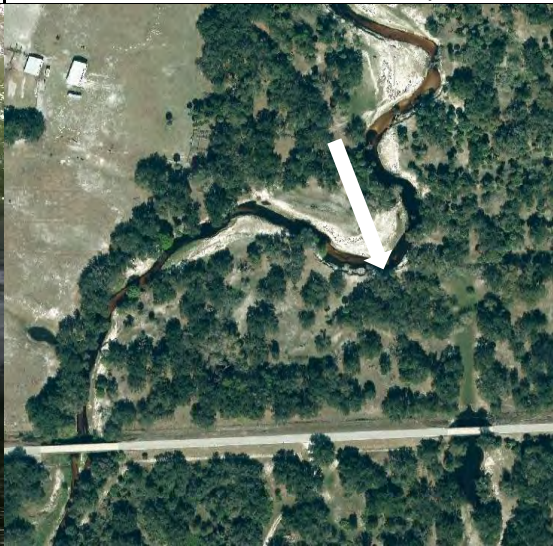
Charlie Creek			Severity Scale: 6.25-Moderate
Watershed: Peace River Subwatershed: Lower Charlie Creek Latitude: 27.41069 Longitude: -81.74362			County: Hardee Site Number: PI454 Reach Length: 280 ft. Landowner: Southern Sisters Family LTD

Pfankuch-Channel Stability:	Fair	1	
Channel Alteration:	None	0	
Bank Erosion:	Active	1	
BEHI:	High (38.52)	1	
Local NPSP:	Obvious Sources	1.5	
Shoring Structures:	None	0	
Pipe Discharge:	None	0	
Water Odor:	Normal	0	
Fish Passage Barrier:	None	0	
RB: Riparian Buffer:	0 ft.	0.75	<b>Additional Site Features</b>
LB: Riparian Buffer:	0 ft.	0.75	Stream Channel Woody Material: Infrequent
RB: Floodplain Access:	Full	0	Impoundments: None
LB: Floodplain Access:	Partial	0.25	Substrate Composition: Medium Sand
<b>Severity Scale:</b>			Bank Material: Sand
			Near Bank Stress: Moderate
			RB Landuse: Pasture
			LB Landuse: Natural Forest, Pasture

303d: Impaired - Fecal Coliform			
Restoration Option 1

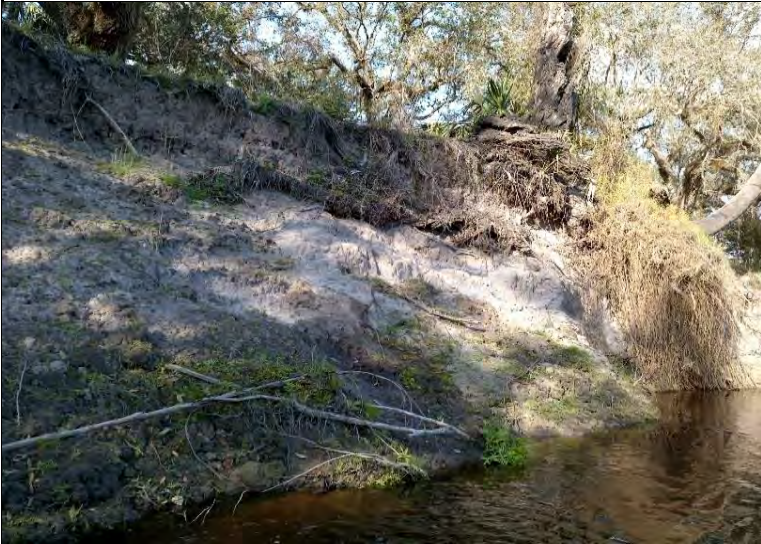
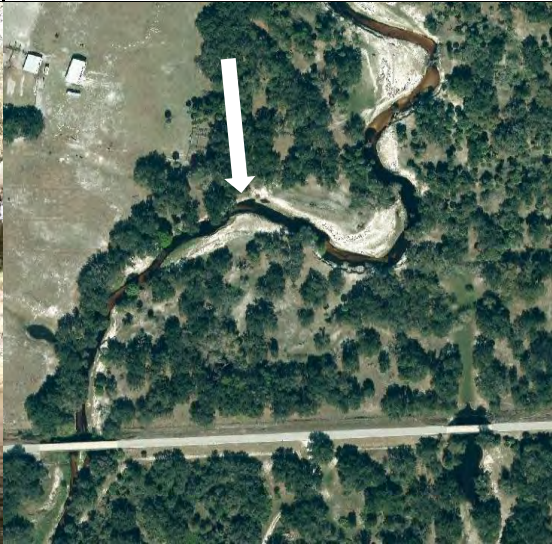
Charlie Creek			Severity Scale: 6.0-Moderate
Watershed: Peace River Subwatershed: Lower Charlie Creek Latitude: 27.41122 Longitude: -81.74474			County: Hardee Site Number: PI455 Reach Length: 135 ft. Landowner: Donna & James H Webb Jr

Pfankuch-Channel Stability:	Fair	1	
Channel Alteration:	None	0	
Bank Erosion:	Active	1	
BEHI:	High (36.76)	1	
Local NPSP:	Obvious Sources	1.5	
Shoring Structures:	None	0	
Pipe Discharge:	None	0	
Water Odor:	Normal	0	
Fish Passage Barrier:	None	0	
RB: Riparian Buffer:	40 ft.	0.5	
LB: Riparian Buffer:	0 ft.	0.75	
RB: Floodplain Access:	Partial	0.25	
LB: Floodplain Access:	Full	0	
<b>Severity Scale:</b>		<b>6.0</b>	<b>Additional Site Features</b>
			Stream Channel Woody Material: Infrequent
			Impoundments: None
			Substrate Composition: Medium Sand
			Bank Material: Sand
			Near Bank Stress: High
			RB Landuse: Natural Forest, Pasture

LB Landuse: Pasture
303d: Impaired - Fecal Coliform			
Restoration Option 1

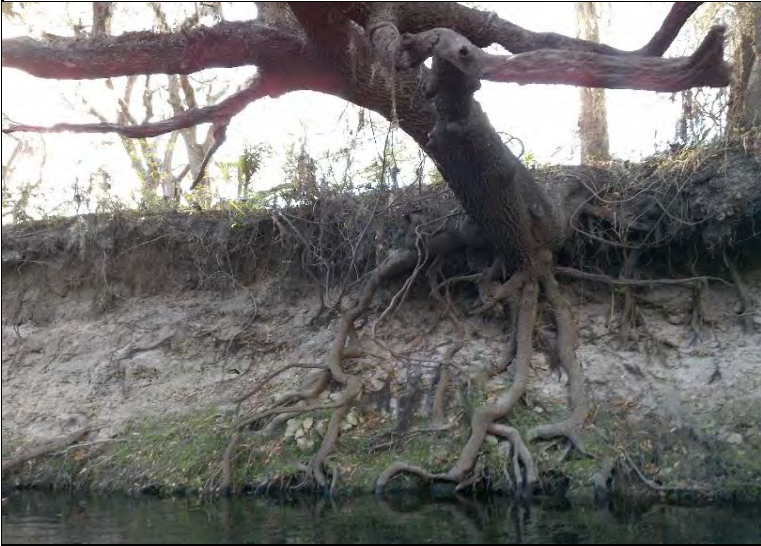
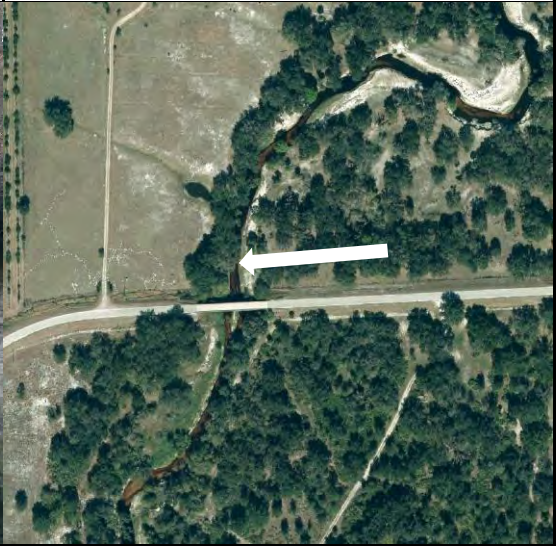
Charlie Creek			Severity Scale: 6.25-Moderate
Watershed: Peace River Subwatershed: Lower Charlie Creek Latitude: 27.41040 Longitude: -81.74588			County: Hardee Site Number: PI456 Reach Length: 155 ft. Landowner: Donna & James H Webb Jr

Risk Factor	Ranking	Score	
Pfankuch-Channel Stability:	Fair	1	
Channel Alteration:	None	0	
Bank Erosion:	Active	1	
BEHI:	High (39.27)	1	
Local NPSP:	Obvious Sources	1.5	
Shoring Structures:	None	0	
Pipe Discharge:	None	0	
Water Odor:	Normal	0	
Fish Passage Barrier:	None	0	
RB: Riparian Buffer:	20 ft.	0.75	
LB: Riparian Buffer:	0 ft.	0.75	
RB: Floodplain Access:	Partial	0.25	
LB: Floodplain Access:	Full	0	
<b>Severity Scale:</b>		<b>6.25</b>	
303d: Impaired - Fecal Coliform			
Restoration Option 1

Additional Site Features
Stream Channel Woody Material: Infrequent
Impoundments: None
Substrate Composition: Medium Sand
Bank Material: Sandy Clay
Near Bank Stress: Moderate
RB Landuse: Pasture, Natural Forest
LB Landuse: Pasture

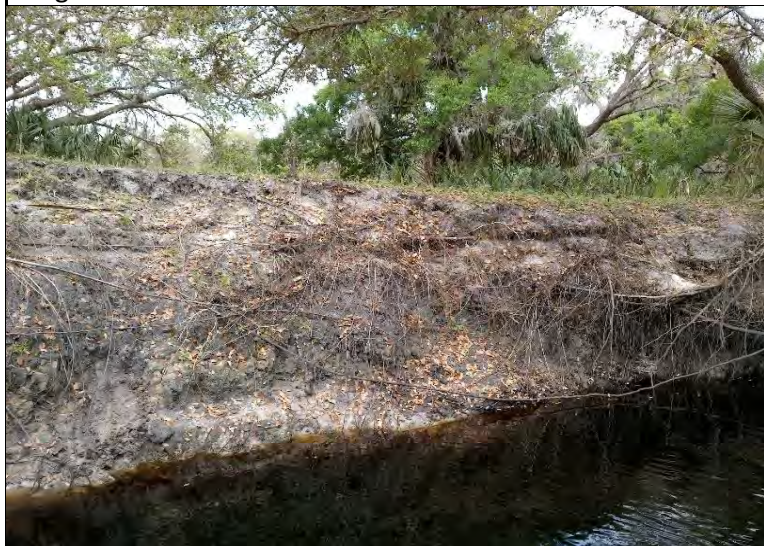
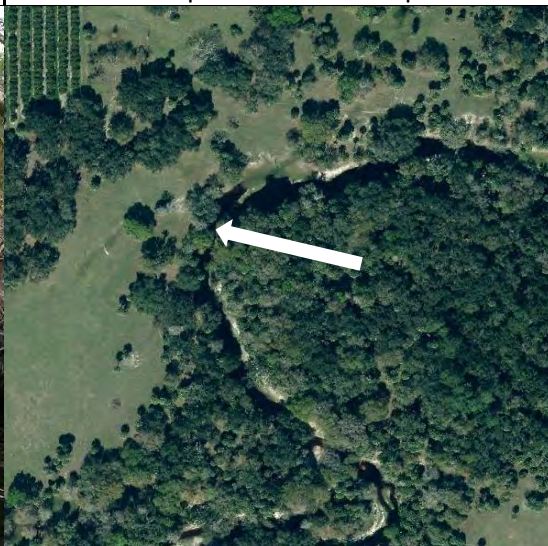
Risk Factor	Ranking	Score
Pfankuch-Channel Stability:	Fair	1
Channel Alteration:	None	0
Bank Erosion:	Active	1
BEHI:	Low (12.60)	0
Local NPSP:	Obvious Sources	1.5
Shoring Structures:	None	0
Pipe Discharge:	None	0
Water Odor:	Normal	0
Fish Passage Barrier:	None	0
RB: Riparian Buffer:	40 ft.	0.5
LB: Riparian Buffer:	100 ft.	0
RB: Floodplain Access:	Full	0
LB: Floodplain Access:	Full	0
Severity Scale:		4.0

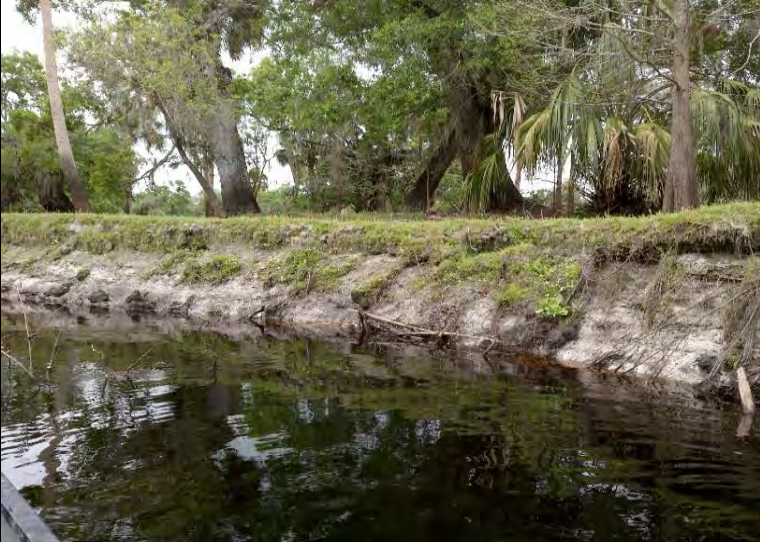
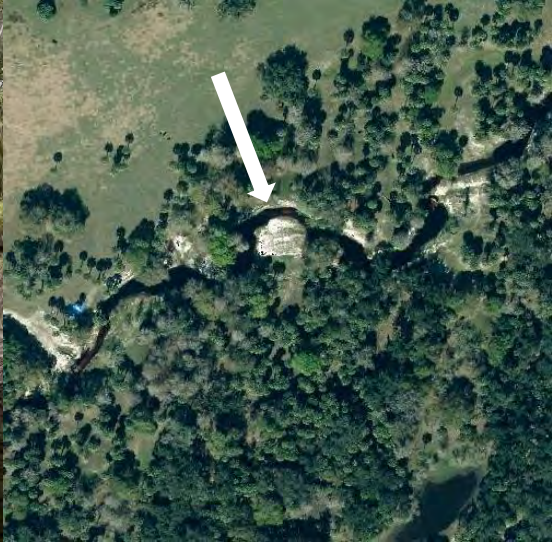
Charlie Creek			Severity Scale: 4.5-Moderate
Watershed: Peace River Subwatershed: Middle Charlie Creek Latitude: 27.45229 Longitude: -81.68897			County: Hardee Site Number: PI458 Reach Length: 125 ft. Landowner: Robertson Farms LLC

Pfankuch-Channel Stability:	Fair	1	
Channel Alteration:	None	0	
Bank Erosion:	Active	1	
BEHI:	Moderate (28.36)	0.5	
Local NPSP:	Obvious Sources	1.5	
Shoring Structures:	None	0	
Pipe Discharge:	None	0	
Water Odor:	Normal	0	
Fish Passage Barrier:	None	0	
RB: Riparian Buffer:	40 ft.	0.5	
LB: Riparian Buffer:	100 ft.	0	
RB: Floodplain Access:	Full	0	
LB: Floodplain Access:	Full	0	
<b>Severity Scale:</b>		<b>4.5</b>	
Notes: 303d: NA			<b>Additional Site Features</b>
			Stream Channel Woody Material: Moderate
			Impoundments: None
			Substrate Composition: Medium Sand
			Bank Material: Sand
			Near Bank Stress: Moderate
			RB Landuse: Pasture, Natural Forest

LB Landuse: Natural Forest
Restoration Option 1

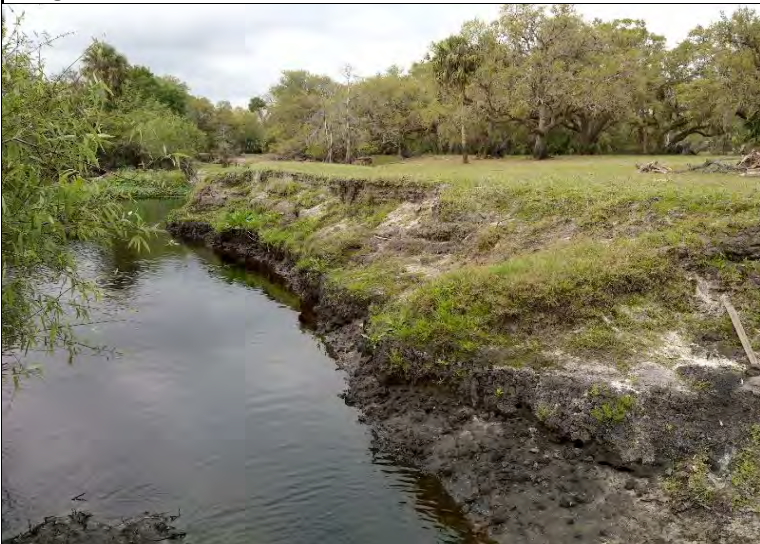
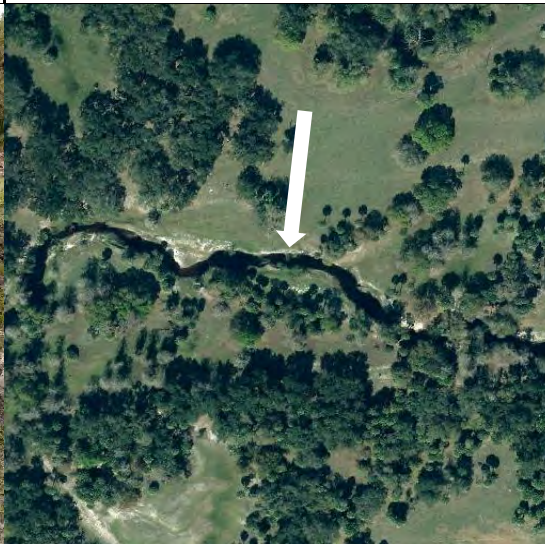
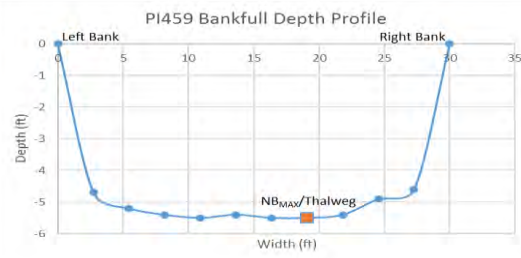
Charlie Creek			Severity Scale: 5.0-Moderate			
Watershed: Peace River Subwatershed: Middle Charlie Creek Latitude: 27.45139 Longitude: -81.69266			County: Hardee Site Number: PI459 Reach Length: 150 ft. Landowner: Robertson Farms LLC

Pfankuch-Channel Stability:	Fair	1				
Channel Alteration:	None	0				
Bank Erosion:	Active	1				
BEHI:	Moderate (20.88)	0.5				
Local NPSP:	Obvious Sources	1.5				
Shoring Structures:	None	0				
Pipe Discharge:	None	0				
Water Odor:	Normal	0				
Fish Passage Barrier:	None	0				
RB: Riparian Buffer:	0 ft.	0.75	<b>Additional Site Features</b> Stream Channel Woody Material: Infrequent Impoundments: None Substrate Composition: Medium Sand Bank Material: Sandy Clay Near Bank Stress: Moderate RB Landuse: Pasture, Natural Forest LB Landuse: Natural Forest, Pasture			
LB: Riparian Buffer:	60 ft.	0.25				
RB: Floodplain Access:	Full	0

LB: Floodplain Access:	Full	0				
<b>Severity Scale:</b>		<b>5.0</b>				
Notes: 303d: NA						
Restoration Option 1

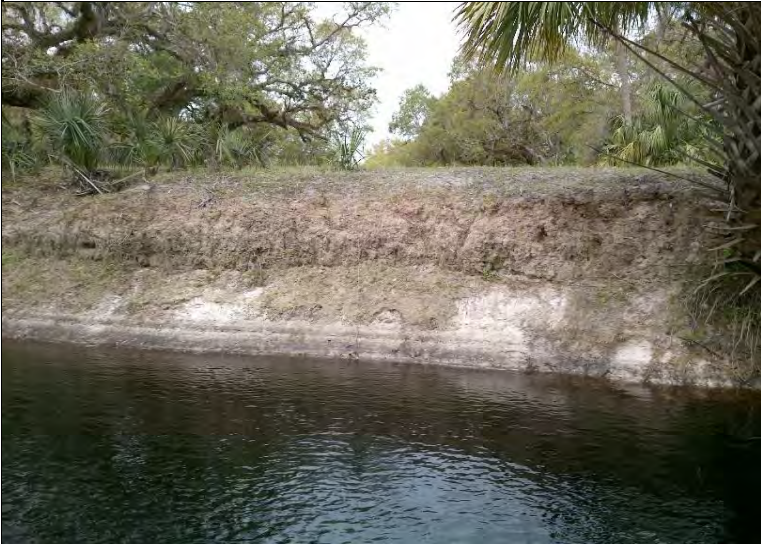
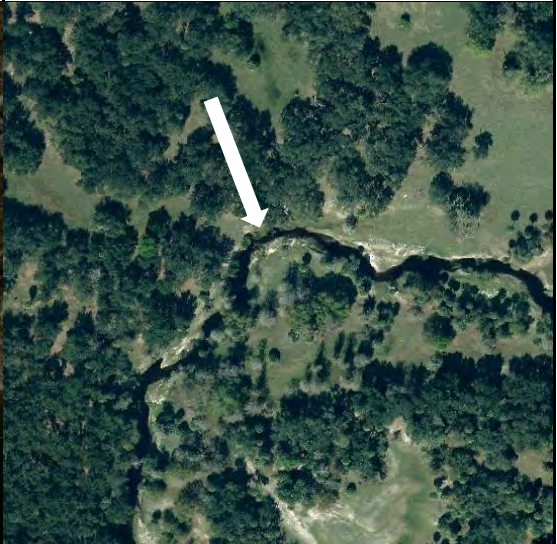
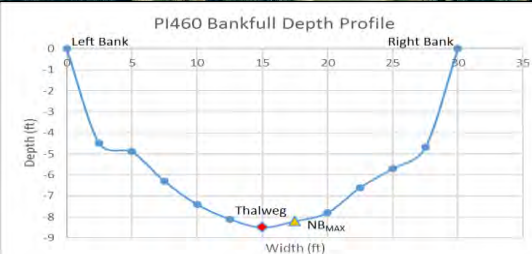
Charlie Creek			Severity Scale: 5.25-Moderate
Watershed: Peace River Subwatershed: Middle Charlie Creek Latitude: 27.45141 Longitude: -81.69399			County: Hardee Site Number: PI460 Reach Length: 81 ft. Landowner: Robertson Farms LLC

Risk Factor	Ranking	Score	
Pfankuch-Channel Stability:	Fair	1	
Channel Alteration:	None	0	
Bank Erosion:	Active	1	
BEHI:	Moderate (25.84)	0.5	
Local NPSP:	Obvious Sources	1.5	
Shoring Structures:	None	0	
Pipe Discharge:	None	0	
Water Odor:	Normal	0	
Fish Passage Barrier:	None	0	
RB: Riparian Buffer:	40 ft.	0.5	
LB: Riparian Buffer:	40 ft.	0.5	
RB: Floodplain Access:	Partial	0.25	
LB: Floodplain Access:	Full	0	
<b>Severity Scale:</b>		<b>5.25</b>	
Notes: 303d: NA			
Restoration Option 1

Additional Site Features
Stream Channel Woody Material: Moderate
Impoundments: None
Substrate Composition: Medium Sand
Bank Material: Sandy Clay
Near Bank Stress: Moderate
RB Landuse: Natural Forest, Pasture
LB Landuse: Natural Forest, Pasture

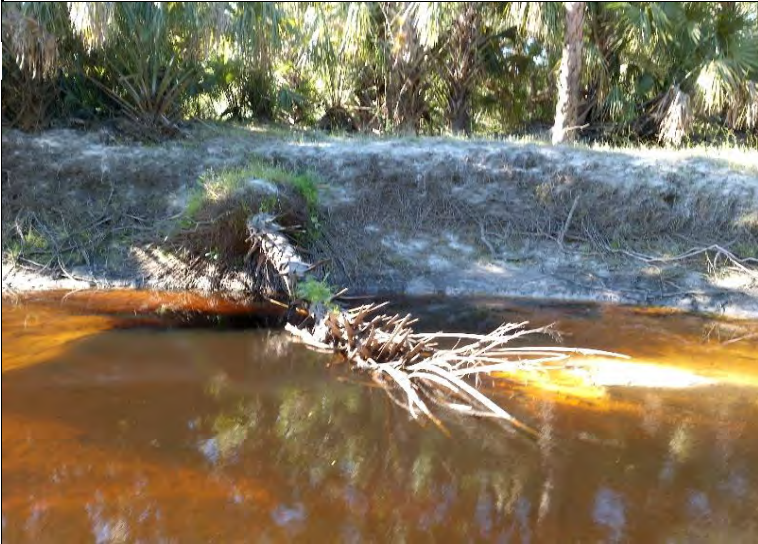
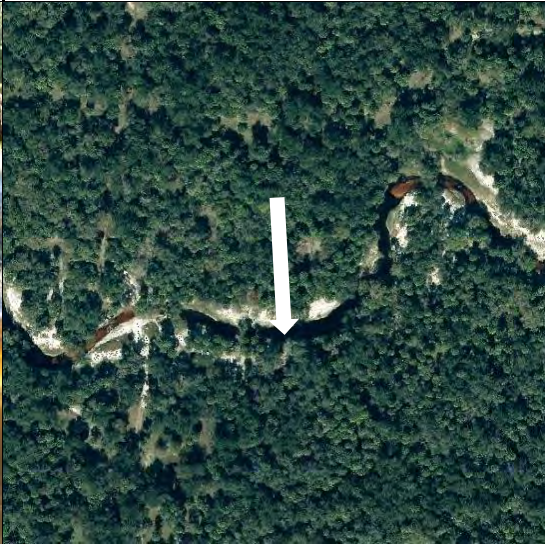
Charlie Creek			Severity Scale: 3.5-Low	
Watershed: Peace River Subwatershed: Middle Charlie Creek Latitude: 28.44074 Longitude: -81.72218			County: Hardee Site Number: PI461 Reach Length: 210 ft. Landowner: D H Ranch Inc.

<b>Risk Factor</b>	<b>Ranking</b>	<b>Score</b>	<b>*Depth Profile Not Recorded*</b>	
Pfankuch-Channel Stability:	Fair	1		
Channel Alteration:	None	0		
Bank Erosion:	Active	1		
BEHI:	High	1		
Local NPSP:	No Evidence	0		
Shoring Structures:	None	0	<b>Additional Site Features</b>	
Pipe Discharge:	None	0		
Water Odor:	Normal	0		Stream Channel Woody Material: NR
Fish Passage Barrier:	None	0		Impoundments: None
RB: Riparian Buffer:	60 ft	0.25		Substrate Composition: Medium Sand
LB: Riparian Buffer:	80 ft.	0.25		Bank Material: Sand
RB: Floodplain Access:	Full	0		Near Bank Stress: NR
LB: Floodplain Access:	Full	0		RB Landuse: Natural Forest, Pasture
<b>Severity Scale:</b>		<b>3.5</b>	LB Landuse: Natural Forest, Pasture

Notes: BEHI estimated; 303d: NA				
Restoration Option 1

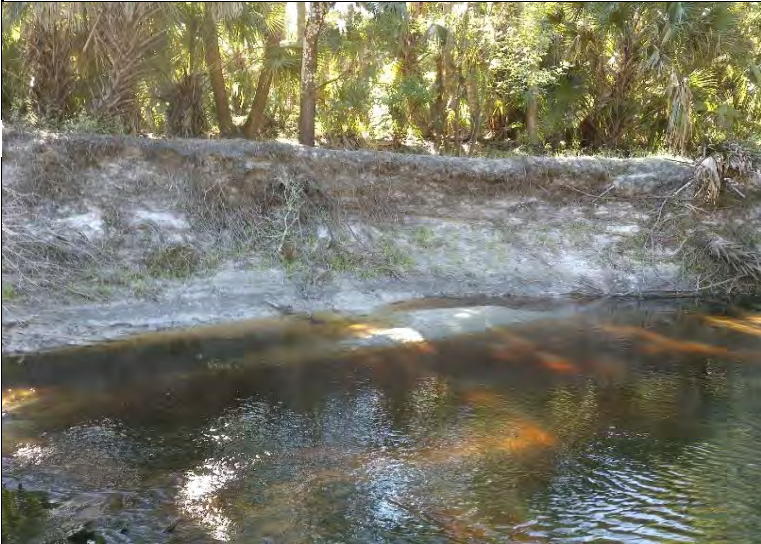
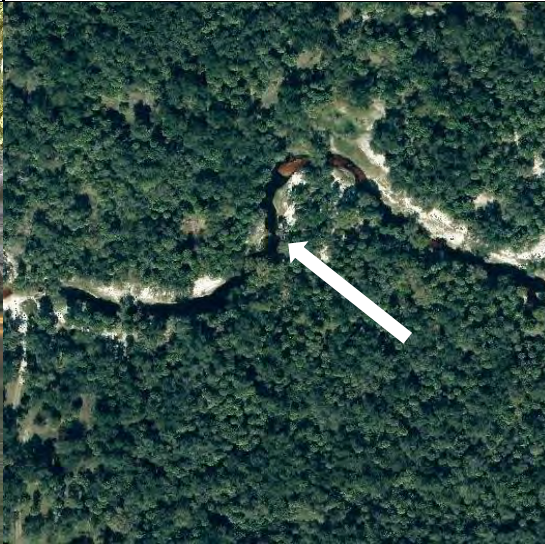
Charlie Creek			Severity Scale: 3.25-Low
Watershed: Peace River Subwatershed: Middle Charlie Creek Latitude: 27.4411 Longitude: -81.72198			County: Hardee Site Number: PI462 Reach Length: 82 ft. Landowner: D H Ranch Inc.

<b>Risk Factor</b>	<b>Ranking</b>	<b>Score</b>	<b>*Depth Profile Not Recorded*</b>
Pfankuch-Channel Stability:	Fair	1	
Channel Alteration:	None	0	
Bank Erosion:	Active	1	
BEHI:	High	1	
Local NPSP:	No Evidence	0	
Shoring Structures:	None	0	
Pipe Discharge:	None	0	<b>Additional Site Features</b>
Water Odor:	Normal	0	Stream Channel Woody Material: NR
Fish Passage Barrier:	None	0	Impoundments: None
RB: Riparian Buffer:	100 ft.	0	Substrate Composition: Medium Sand
LB: Riparian Buffer:	60 ft.	0.25	Bank Material: Sand
RB: Floodplain Access:	Full	0	Near Bank Stress: NR
LB: Floodplain Access:	Full	0	RB Landuse: Natural Forest
<b>Severity Scale:</b>		<b>3.25</b>	LB Landuse: Natural Forest

Notes: BEHI estimated; 303d: NA			
Restoration Option 1

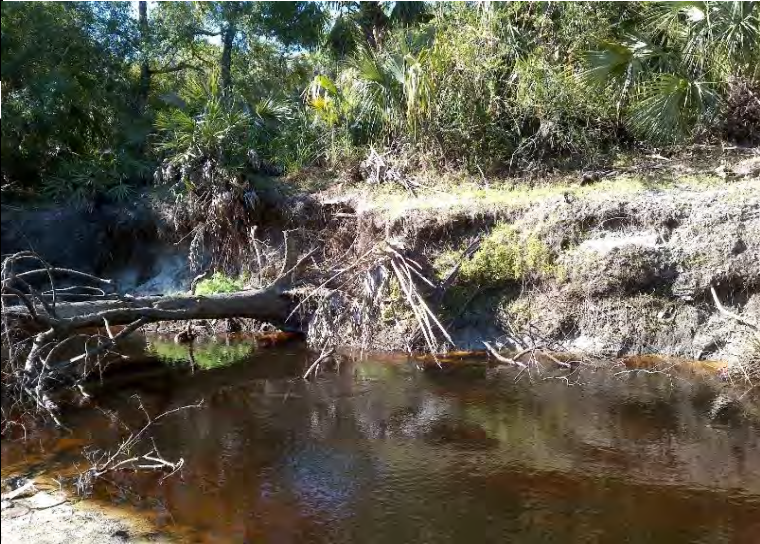
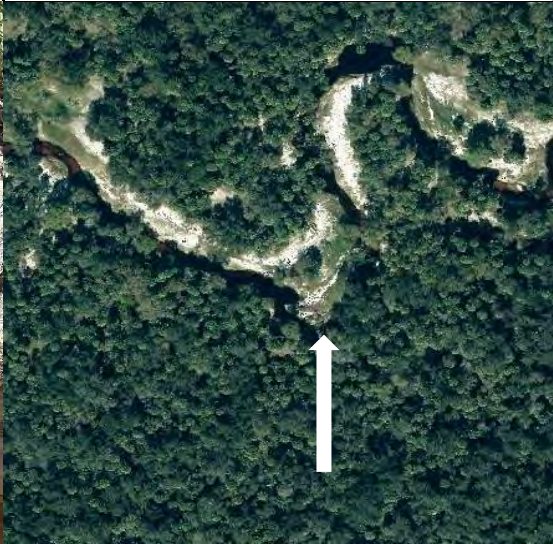
Charlie Creek			Severity Scale: 3.0-Low
Watershed: Peace River Subwatershed: Middle Charlie Creek Latitude: 27.440708 Longitude: -81.720396			County: Hardee Site Number: PI463 Reach Length: 99 ft. Landowner: D H Ranch Inc.

Risk Factor	Ranking	Score	*Depth Profile Not Recorded*
Pfankuch-Channel Stability:	Fair	1	
Channel Alteration:	None	0	
Bank Erosion:	Active	1	
BEHI:	High	1	
Local NPSP:	No Evidence	0	
Shoring Structures:	None	0	
Pipe Discharge:	None	0	Additional Site Features
Water Odor:	Normal	0	Stream Channel Woody Material: NR
Fish Passage Barrier:	None	0	Impoundments: None
RB: Riparian Buffer:	100 ft.	0	Substrate Composition: Medium Sand
LB: Riparian Buffer:	100 ft.	0	Bank Material: Sand
RB: Floodplain Access:	Full	0	Near Bank Stress: NR
LB: Floodplain Access:	Full	0	RB Landuse: Natural Forest
Severity Scale:		3.0	LB Landuse: Natural Forest
Notes: BEHI estimated; 303d: NA			
Restoration Option 1

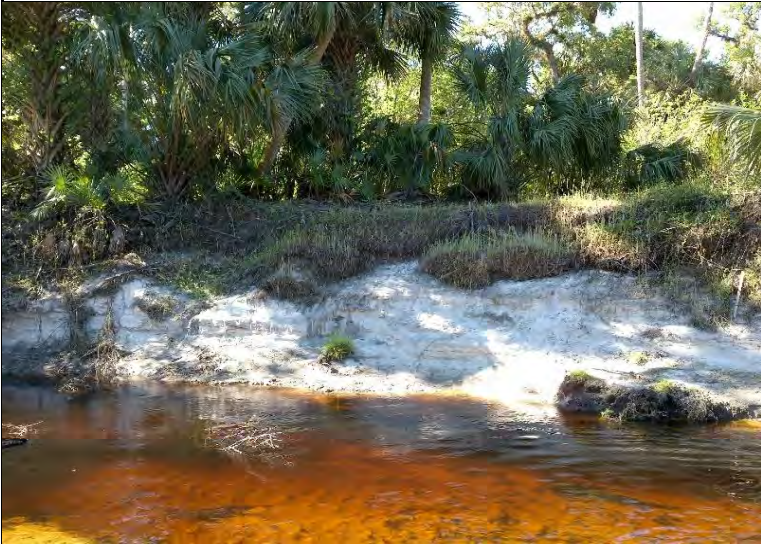
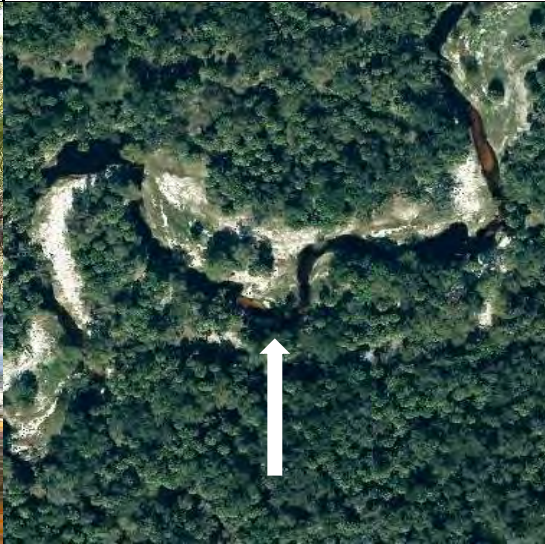
Charlie Creek			Severity Scale: 3.5-Low	
Watershed: Peace River Subwatershed: Middle Charlie Creek Latitude: 27.44143 Longitude: -81.71952			County: Hardee Site Number: PI464 Reach Length: 120 ft. Landowner: D H Ranch Inc.

<b>Risk Factor</b>	<b>Ranking</b>	<b>Score</b>	<b>*Depth Profile Not Recorded*</b>	
Pfankuch-Channel Stability:	Fair	1		
Channel Alteration:	None	0		
Bank Erosion:	Active	1		
BEHI:	High	1		
Local NPSP:	No Evidence	0		
Shoring Structures:	None	0	<b>Additional Site Features</b>	
Pipe Discharge:	None	0		
Water Odor:	Normal	0		Stream Channel Woody Material: NR
Fish Passage Barrier:	None	0		Impoundments: None
RB: Riparian Buffer:	100 ft.	0		Substrate Composition: Medium Sand
LB: Riparian Buffer:	60 ft.	0.25		Bank Material: Sand
RB: Floodplain Access:	Full	0		Near Bank Stress: NR
LB: Floodplain Access:	Partial	0.25		RB Landuse: Natural Forest
<b>Severity Scale:</b>		<b>3.5</b>	LB Landuse: Natural Forest

Notes: BEHI estimated; 303d: NA				
Restoration Option 1

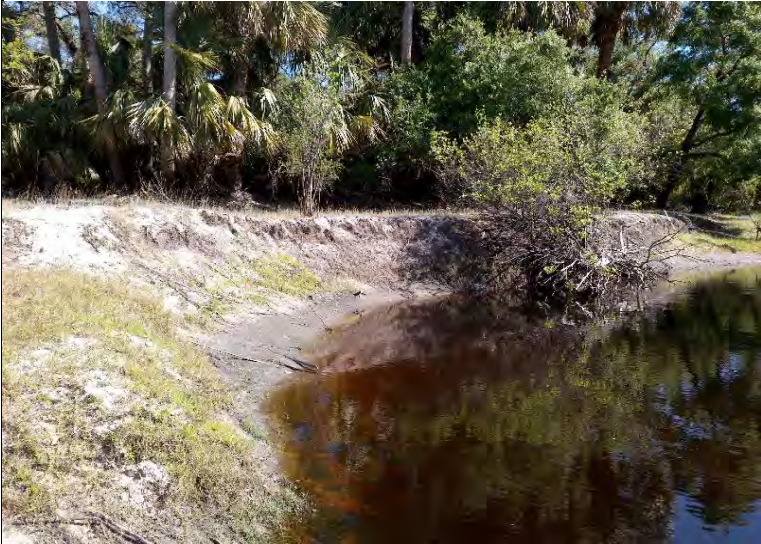
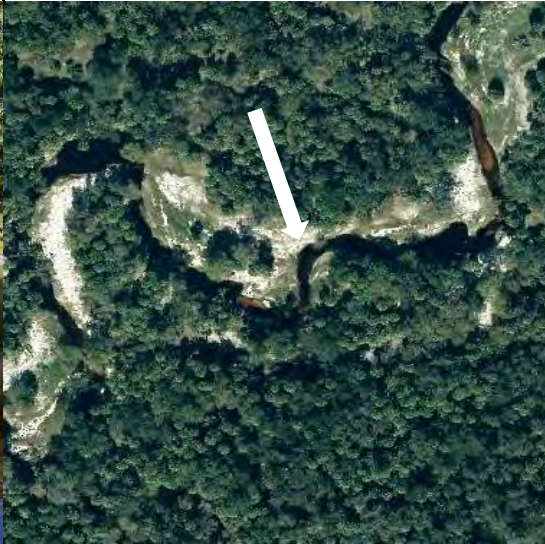
Charlie Creek			Severity Scale: 4.0-Low	
Watershed: Peace River Subwatershed: Middle Charlie Creek Latitude: 27.44155 Longitude: -81.71948			County: Hardee Site Number: PI465 Reach Length: 73 ft. Landowner: D H Ranch Inc.

<b>Risk Factor</b>	<b>Ranking</b>	<b>Score</b>	<b>*Depth Profile Not Recorded*</b>	
Pfankuch-Channel Stability:	Fair	1		
Channel Alteration:	None	0		
Bank Erosion:	Active	1		
BEHI:	Very High	1.5		
Local NPSP:	No Evidence	0		
Shoring Structures:	None	0	<b>Additional Site Features</b>	
Pipe Discharge:	None	0		
Water Odor:	Normal	0		Stream Channel Woody Material: NR
Fish Passage Barrier:	None	0		Impoundments: None
RB: Riparian Buffer:	40 ft.	0.5		Substrate Composition: Medium Sand
LB: Riparian Buffer:	100 ft.	0		Bank Material: Sand
RB: Floodplain Access:	Full	0		Near Bank Stress: NR
LB: Floodplain Access:	Full	0		RB Landuse: Natural Forest, Pasture
<b>Severity Scale:</b>		<b>4.0</b>		LB Landuse: Natural Forest

Notes: BEHI estimated; 303d: NA				
Restoration Option 1

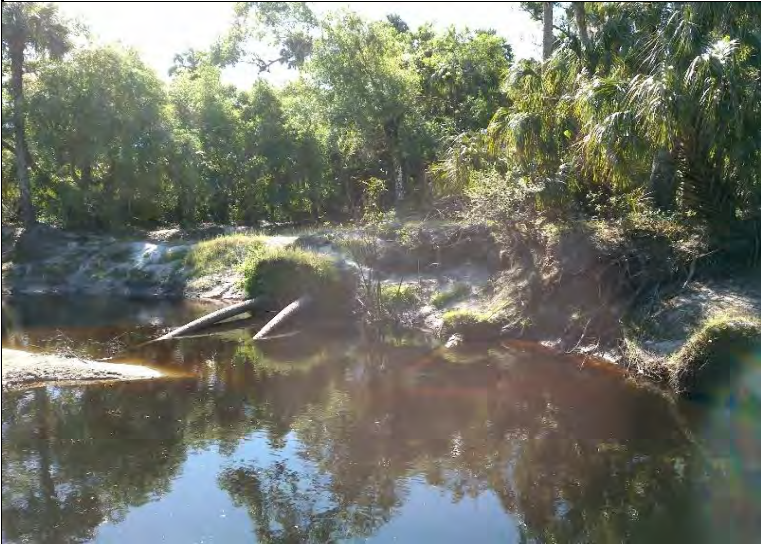
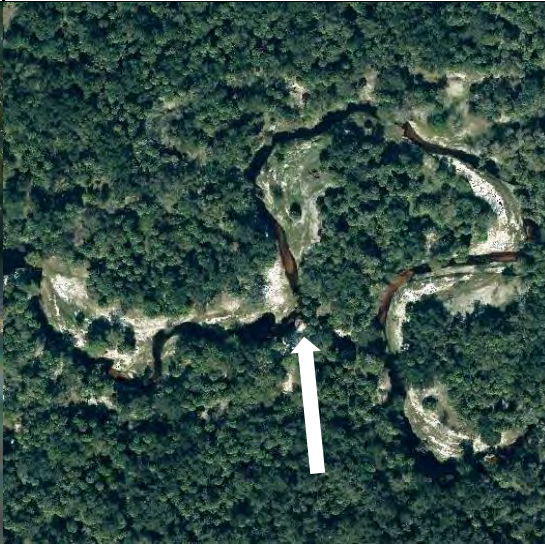
Charlie Creek			Severity Scale: 3.75-Low	
Watershed: Peace River Subwatershed: Middle Charlie Creek Latitude: 27.4416 Longitude: -81.71902			County: Hardee Site Number: PI466 Reach Length: 168 ft. Landowner: D H Ranch Inc.

<b>Risk Factor</b>	<b>Ranking</b>	<b>Score</b>	<b>*Depth Profile Not Recorded*</b>	
Pfankuch-Channel Stability:	Fair	1		
Channel Alteration:	None	0		
Bank Erosion:	Active	1		
BEHI:	Very High	1.5		
Local NPSP:	No Evidence	0		
Shoring Structures:	None	0	<b>Additional Site Features</b>	
Pipe Discharge:	None	0		
Water Odor:	Normal	0		Stream Channel Woody Material: NR
Fish Passage Barrier:	None	0		Impoundments: None
RB: Riparian Buffer:	100 ft.	0		Substrate Composition: Medium Sand
LB: Riparian Buffer:	80 ft.	0.25		Bank Material: Sand
RB: Floodplain Access:	Full	0		Near Bank Stress: NR
LB: Floodplain Access:	Full	0		RB Landuse: Natural Forest
<b>Severity Scale:</b>		<b>3.75</b>	LB Landuse: Natural Forest, Pasture

Notes: BEHI estimated; 303d: NA				
Restoration Option 1

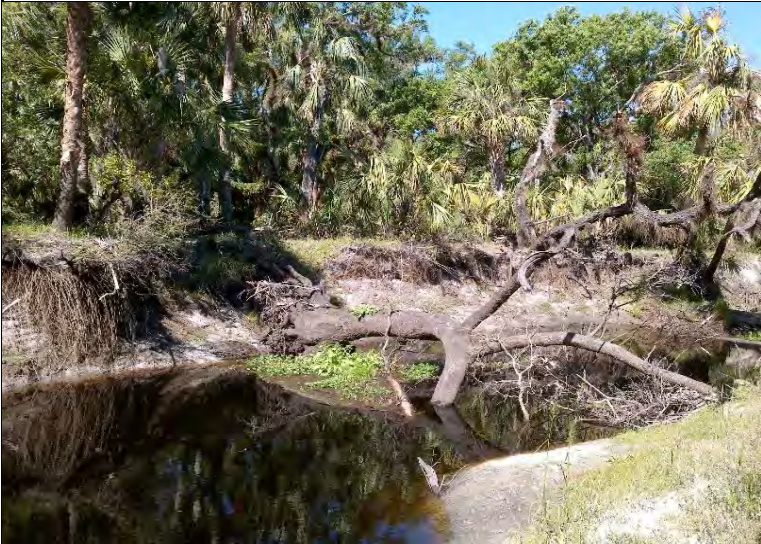
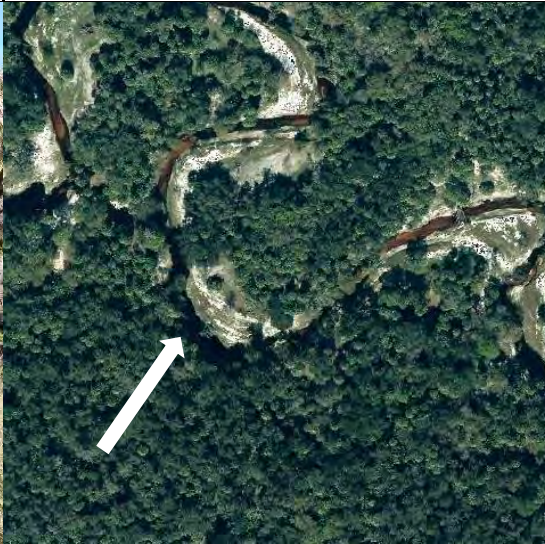
Charlie Creek			Severity Scale: 3.0-Low
Watershed: Peace River Subwatershed: Middle Charlie Creek Latitude: 27.440969 Longitude: -81.718062			County: Hardee Site Number: PI467 Reach Length: 340 ft. Landowner: D H Ranch Inc.

<b>Risk Factor</b>	<b>Ranking</b>	<b>Score</b>	<b>*Depth Profile Not Recorded*</b>
Pfankuch-Channel Stability:	Fair	1	
Channel Alteration:	None	0	
Bank Erosion:	Active	1	
BEHI:	High	1	
Local NPSP:	No Evidence	0	
Shoring Structures:	None	0	
Pipe Discharge:	None	0	<b>Additional Site Features</b>
Water Odor:	Normal	0	Stream Channel Woody Material: NR
Fish Passage Barrier:	None	0	Impoundments: None
RB: Riparian Buffer:	100 ft.	0	Substrate Composition: Medium Sand
LB: Riparian Buffer:	100 ft.	0	Bank Material: Sand
RB: Floodplain Access:	Full	0	Near Bank Stress: NR
LB: Floodplain Access:	Full	0	RB Landuse: Natural Forest
<b>Severity Scale:</b>		<b>3.0</b>	LB Landuse: Natural Forest

Notes: BEHI estimated; 303d: NA			
Restoration Option 1

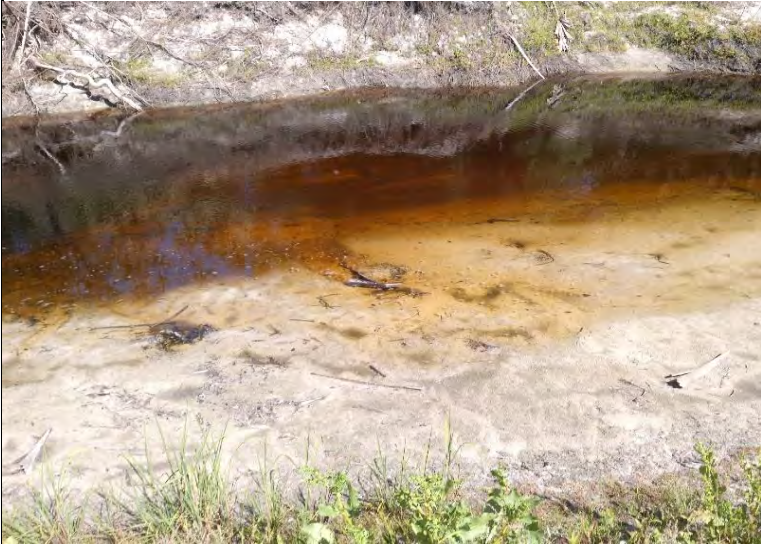
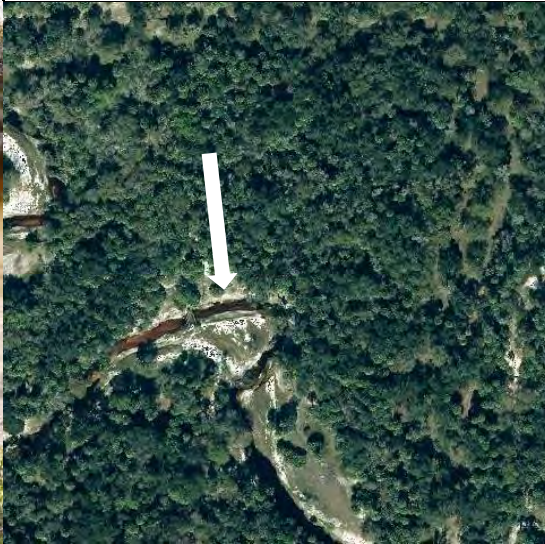
Charlie Creek			Severity Scale: 3.5-Low
Watershed: Peace River Subwatershed: Middle Charlie Creek Latitude: 27.44158 Longitude: -81.71671			County: Hardee Site Number: PI468 Reach Length: 71 ft. Landowner: D H Ranch Inc.

<b>Risk Factor</b>	<b>Ranking</b>	<b>Score</b>	<b>*Depth Profile Not Recorded*</b>
Pfankuch-Channel Stability:	Fair	1	
Channel Alteration:	None	0	
Bank Erosion:	Active	1	
BEHI:	High	1	
Local NPSP:	No Evidence	0	
Shoring Structures:	None	0	<b>Additional Site Features</b> Stream Channel Woody Material: Moderate Impoundments: None Substrate Composition: Sand Bank Material: Sand Near Bank Stress: High RB Landuse: Natural Forest LB Landuse: Natural Forest
Pipe Discharge:	None	0	
Water Odor:	Normal	0	
Fish Passage Barrier:	None	0	
RB: Riparian Buffer:	40 ft.	0.5	
LB: Riparian Buffer:	100 ft.	0	
RB: Floodplain Access:	Full	0	
LB: Floodplain Access:	Full	0	
<b>Severity Scale:</b>		<b>3.5</b>

Notes: BEHI estimated; 303d: NA			
Restoration Option 1

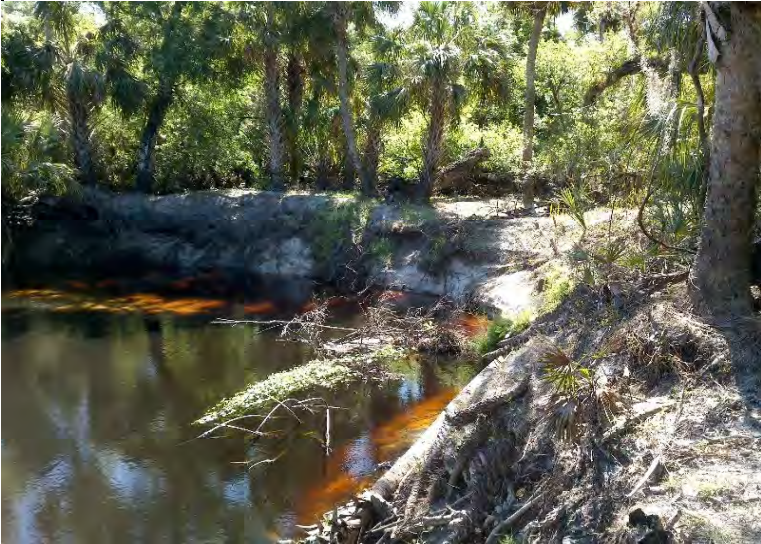
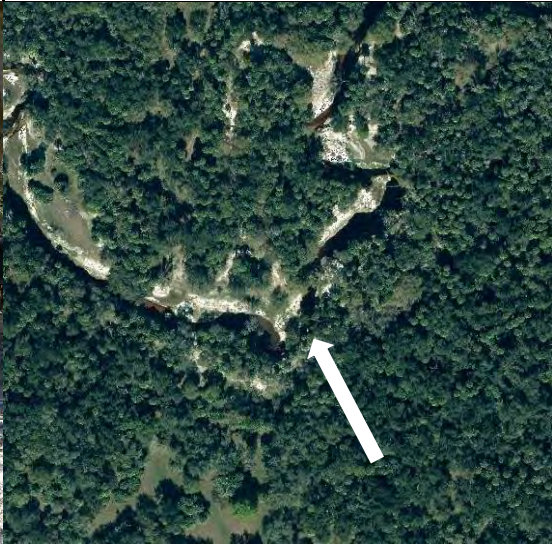
Charlie Creek			Severity Scale: 3.5-Low
Watershed: Peace River Subwatershed: Middle Charlie Creek Latitude: 27.44021 Longitude: -81.71519			County: Hardee Site Number: PI469 Reach Length: 224 ft. Landowner: D H Ranch Inc.

<b>Risk Factor</b>	<b>Ranking</b>	<b>Score</b>	<b>*Depth Profile Not Recorded*</b>
Pfankuch-Channel Stability:	Fair	1	
Channel Alteration:	None	0	
Bank Erosion:	Active	1	
BEHI:	High	1	
Local NPSP:	No Evidence	0	
Shoring Structures:	None	0	
Pipe Discharge:	None	0	<b>Additional Site Features</b>
Water Odor:	Normal	0	Stream Channel Woody Material: Extensive
Fish Passage Barrier:	None	0	Impoundments: None
RB: Riparian Buffer:	100 ft.	0	Substrate Composition: Sand
LB: Riparian Buffer:	60 ft.	0.25	Bank Material: Sand
RB: Floodplain Access:	Full	0	Near Bank Stress: Moderate
LB: Floodplain Access:	Partial	0.25	RB Landuse: Natural Forest
<b>Severity Scale:</b>		<b>3.5</b>	LB Landuse: Natural Forest

Notes: BEHI estimated; 303d: NA			
Restoration Option 1

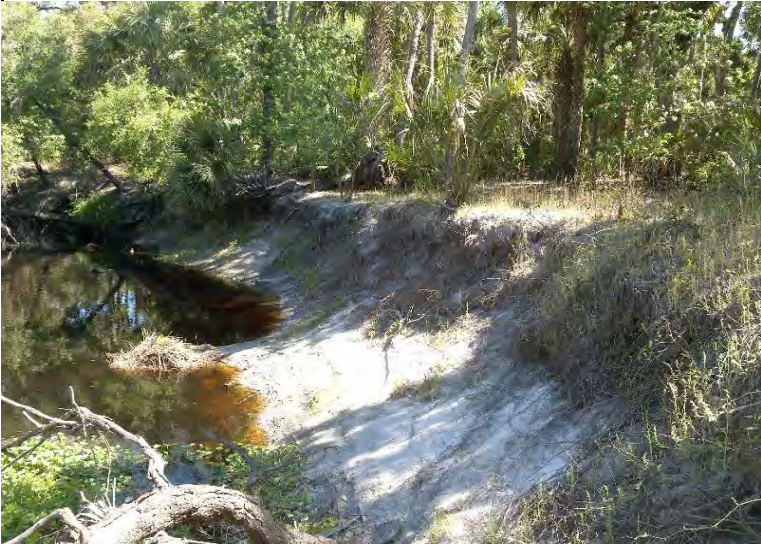
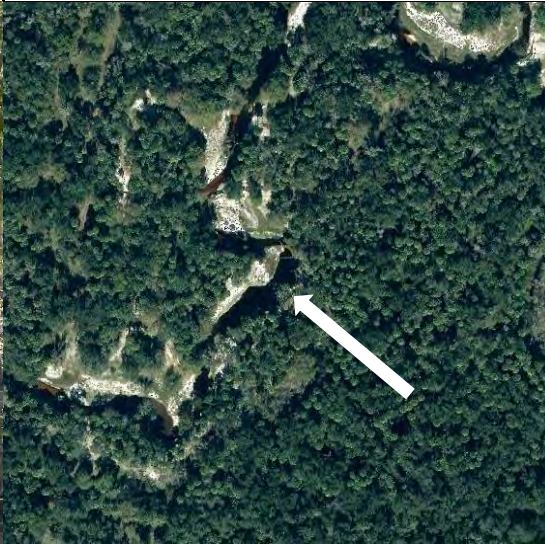
Charlie Creek			Severity Scale: 3.25-Low
Watershed: Peace River Subwatershed: Middle Charlie Creek Latitude: 27.44075 Longitude: -81.7145			County: Hardee Site Number: PI470 Reach Length: 148 ft. Landowner: D H Ranch Inc.

<b>Risk Factor</b>	<b>Ranking</b>	<b>Score</b>	<b>*Depth Profile Not Recorded*</b>
Pfankuch-Channel Stability:	Fair	1	
Channel Alteration:	None	0	
Bank Erosion:	Active	1	
BEHI:	High	1	
Local NPSP:	No Evidence	0	
Shoring Structures:	None	0	
Pipe Discharge:	None	0	<b>Additional Site Features</b>
Water Odor:	Normal	0	Stream Channel Woody Material: Extensive
Fish Passage Barrier:	None	0	Impoundments: None
RB: Riparian Buffer:	100 ft.	0	Substrate Composition: Sand
LB: Riparian Buffer:	60 ft.	0.25	Bank Material: Sand
RB: Floodplain Access:	Full	0	Near Bank Stress: Moderate
LB: Floodplain Access:	Full	0	RB Landuse: Natural Forest
<b>Severity Scale:</b>		<b>3.25</b>	LB Landuse: Natural Forest

Notes: BEHI estimated; 303d: NA			
Restoration Option 1

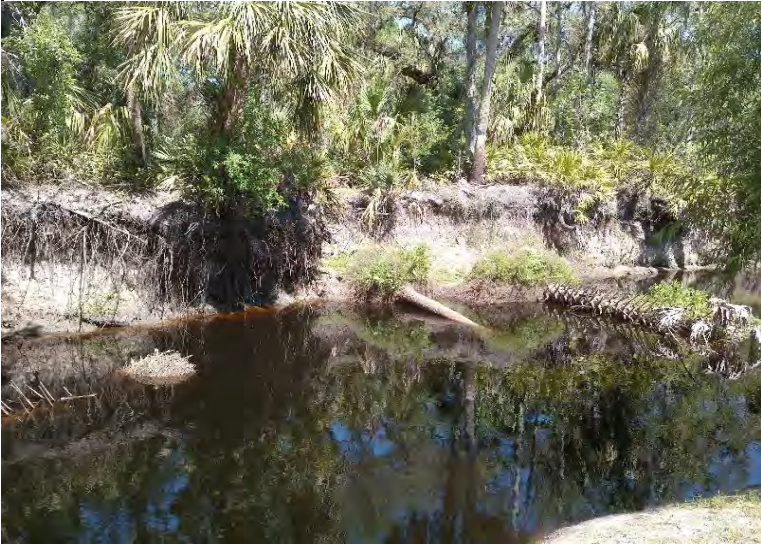
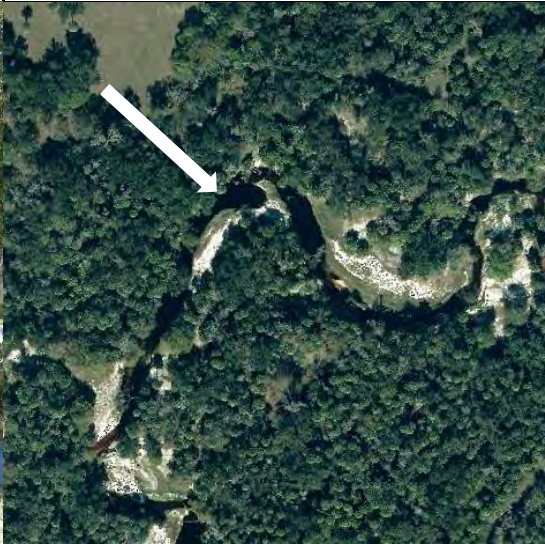
Charlie Creek			Severity Scale: 2.5-Low
Watershed: Peace River Subwatershed: Middle Charlie Creek Latitude: 27.44216 Longitude: -81.71436			County: Hardee Site Number: PI471 Reach Length: 181 ft. Landowner: D H Ranch Inc.*

<b>Risk Factor</b>	<b>Ranking</b>	<b>Score</b>	<b>*Depth Profile Not Recorded*</b>
Pfankuch-Channel Stability:	Fair	1	
Channel Alteration:	None	0	
Bank Erosion:	Active	1	
BEHI:	Moderate	0.5	
Local NPSP:	No Evidence	0	
Shoring Structures:	None	0	
Pipe Discharge:	None	0	<b>Additional Site Features</b>
Water Odor:	Normal	0	Stream Channel Woody Material: Moderate
Fish Passage Barrier:	None	0	Impoundments: None
RB: Riparian Buffer:	100 ft.	0	Substrate Composition: Sand
LB: Riparian Buffer:	100 ft.	0	Bank Material: Clay
RB: Floodplain Access:	Full	0	Near Bank Stress: Moderate
LB: Floodplain Access:	Full	0	RB Landuse: Natural Forest
<b>Severity Scale:</b>		<b>2.5</b>	LB Landuse: Natural Forest

Notes: BEHI estimated; 303d: NA; *Site also located on property owned by Square D Ranch LTD LLP			
Restoration Option 1
