# **Peace River and Withlacoochee River Threats Assessments and Fish Assemblage Monitoring**

**Final Report July 1, 2015 – June 30, 2019**

Submitted to Florida State Wildlife Grants Program  
August 1, 2019  
PID: 98462501284

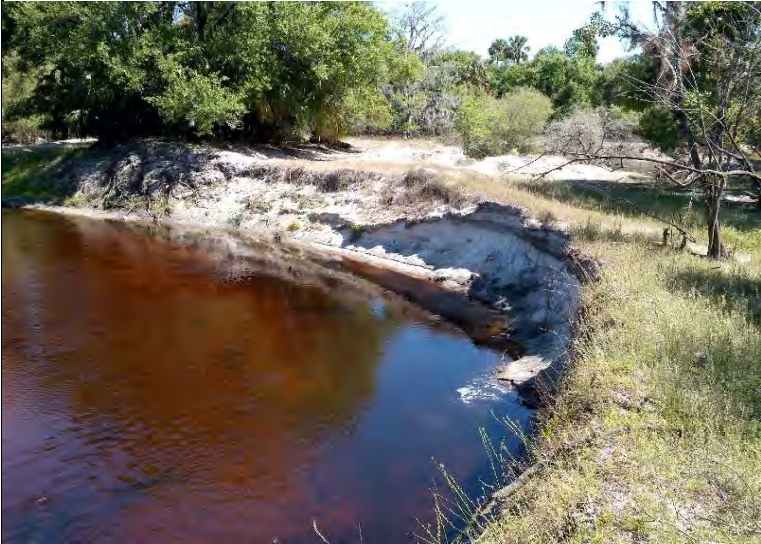
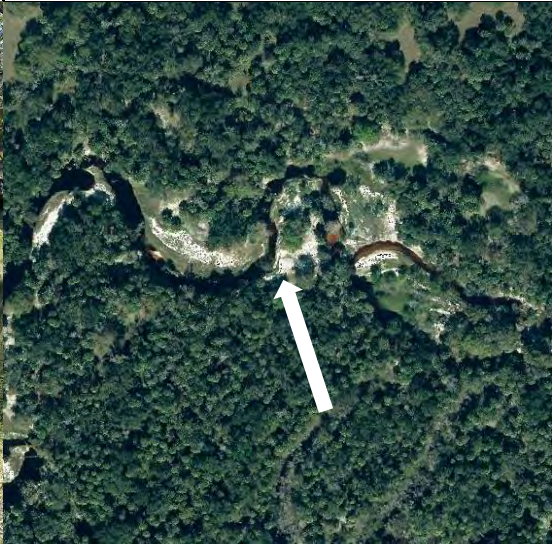
Charlie Creek			Severity Scale: 4.25-Moderate
Watershed: Peace River Subwatershed: Middle Charlie Creek Latitude: 27.44189 Longitude: -81.71315			County: Hardee Site Number: PI472 Reach Length: 68 ft. Landowner: D H Ranch Inc.

<b>Risk Factor</b>	<b>Ranking</b>	<b>Score</b>	<b>*Depth Profile Not Recorded*</b>
Pfankuch-Channel Stability:	Fair	1	
Channel Alteration:	None	0	
Bank Erosion:	Mass-wasting	1.5	
BEHI:	Very High	1.5	
Local NPSP:	No Evidence	0	
Shoring Structures:	None	0	
Pipe Discharge:	None	0	<b>Additional Site Features</b>
Water Odor:	Normal	0	Stream Channel Woody Material: Extensive
Fish Passage Barrier:	None	0	Impoundments: None
RB: Riparian Buffer:	100 ft.	0	Substrate Composition: Sand
LB: Riparian Buffer:	60 ft.	0.25	Bank Material: Sand
RB: Floodplain Access:	Full	0	Near Bank Stress: Very High
LB: Floodplain Access:	Full	0	RB Landuse: Natural Forest
<b>Severity Scale:</b>		<b>4.25</b>	LB Landuse: Natural Forest

Notes: BEHI estimated; 303d: NA			
Restoration Option 1

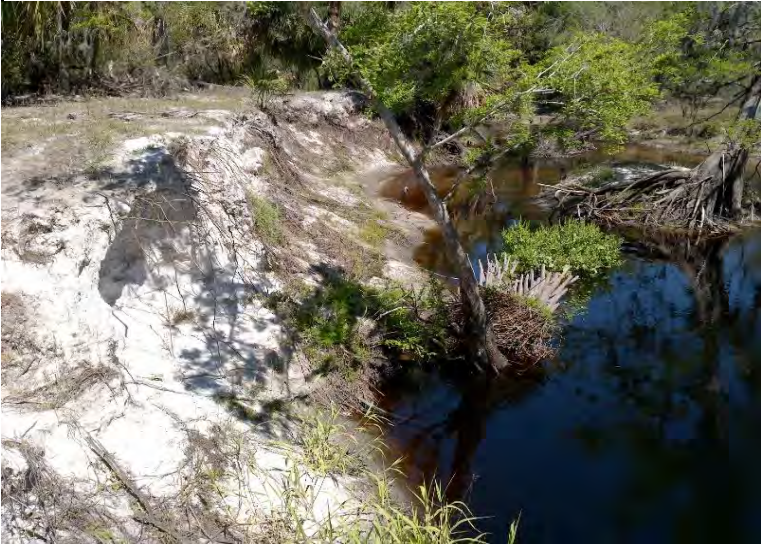
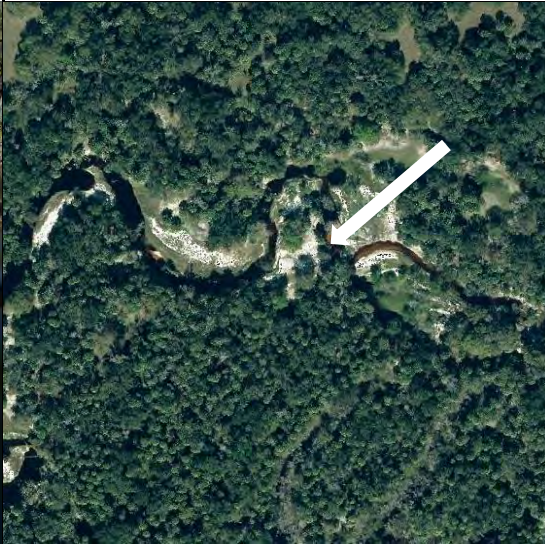
Charlie Creek			Severity Scale: 3.5-Low
Watershed: Peace River Subwatershed: Middle Charlie Creek Latitude: 27.44227 Longitude: -81.71284			County: Hardee Site Number: PI473 Reach Length: 78 ft. Landowner: D H Ranch Inc.

<b>Risk Factor</b>	<b>Ranking</b>	<b>Score</b>	<b>*Depth Profile Not Recorded*</b>
Pfankuch-Channel Stability:	Fair	1	
Channel Alteration:	None	0	
Bank Erosion:	Active	1	
BEHI:	High	1	
Local NPSP:	No Evidence	0	
Shoring Structures:	None	0	
Pipe Discharge:	None	0	<b>Additional Site Features</b>
Water Odor:	Normal	0	Stream Channel Woody Material: Numerous
Fish Passage Barrier:	None	0	Impoundments: None
RB: Riparian Buffer:	100 ft.	0	Substrate Composition: Sand
LB: Riparian Buffer:	40 ft.	0.5	Bank Material: Sand
RB: Floodplain Access:	Full	0	Near Bank Stress: Moderate
LB: Floodplain Access:	Full	0	RB Landuse: Natural Forest
<b>Severity Scale:</b>		<b>3.5</b>	LB Landuse: Natural Forest

Notes: BEHI estimated; 303d: NA			
Restoration Option 1

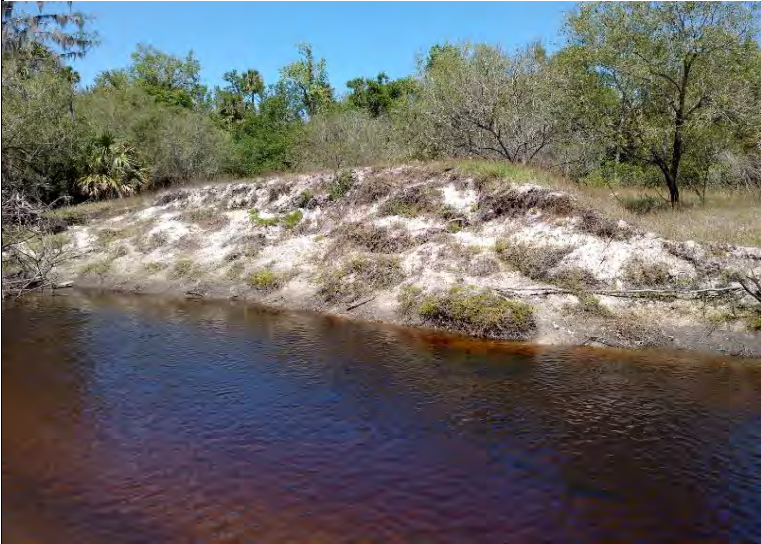
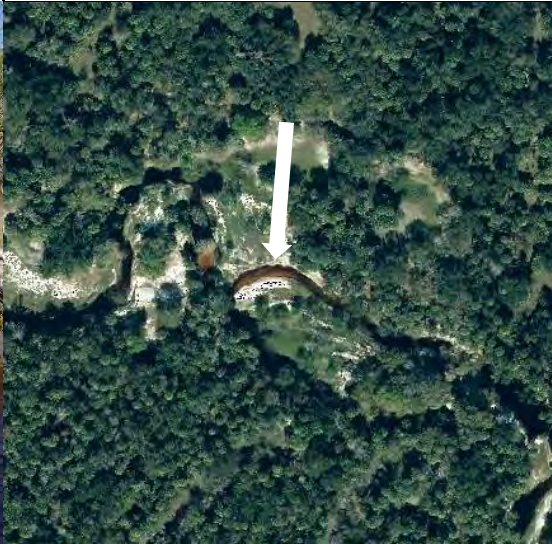
Charlie Creek			Severity Scale: 3.0-Low
Watershed: Peace River Subwatershed: Middle Charlie Creek Latitude: 27.44152 Longitude: -81.71283			County: Hardee Site Number: PI474 Reach Length: 71 ft. Landowner: D H Ranch Inc.

Risk Factor	Ranking	Score	*Depth Profile Not Recorded*
Pfankuch-Channel Stability:	Fair	1	
Channel Alteration:	None	0	
Bank Erosion:	Active	1	
BEHI:	High	1	
Local NPSP:	No Evidence	0	
Shoring Structures:	None	0	
Pipe Discharge:	None	0	Additional Site Features
Water Odor:	Normal	0	Stream Channel Woody Material: Moderate
Fish Passage Barrier:	None	0	Impoundments: None
RB: Riparian Buffer:	100 ft.	0	Substrate Composition: Sand
LB: Riparian Buffer:	100 ft.	0	Bank Material: Sand
RB: Floodplain Access:	Full	0	Near Bank Stress: High
LB: Floodplain Access:	Full	0	RB Landuse: Natural Forest
<b>Severity Scale:</b>		<b>3.0</b>	LB Landuse: Natural Forest
Notes: BEHI estimated; 303d: NA

Restoration Option 1

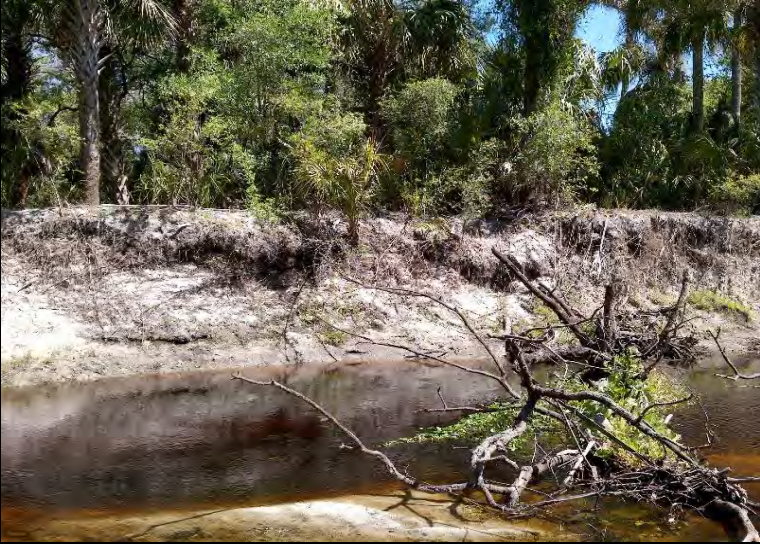
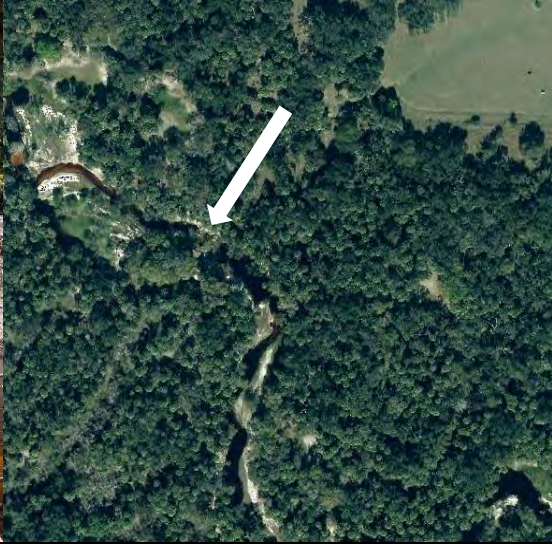
Charlie Creek			Severity Scale: 3.0-Low
Watershed: Peace River Subwatershed: Middle Charlie Creek Latitude: 27.4417 Longitude: -81.71179			County: Hardee Site Number: PI475 Reach Length: 180 ft. Landowner: D H Ranch Inc.

<b>Risk Factor</b>	<b>Ranking</b>	<b>Score</b>	<b>*Depth Profile Not Recorded*</b>
Pfankuch-Channel Stability:	Fair	1	
Channel Alteration:	None	0	
Bank Erosion:	Active	1	
BEHI:	Moderate	0.5	
Local NPSP:	No Evidence	0	
Shoring Structures:	None	0	
Pipe Discharge:	None	0	<b>Additional Site Features</b>
Water Odor:	Normal	0	Stream Channel Woody Material: Moderate
Fish Passage Barrier:	None	0	Impoundments: None
RB: Riparian Buffer:	100 ft.	0	Substrate Composition: Sand
LB: Riparian Buffer:	100 ft.	0	Bank Material: Sandy-clay
RB: Floodplain Access:	Partial	0.5	Near Bank Stress: Moderate
LB: Floodplain Access:	Full	0	RB Landuse: Natural Forest
<b>Severity Scale:</b>		<b>3.0</b>	LB Landuse: Natural Forest

Notes: BEHI estimated; 303d: NA			
Restoration Option 1

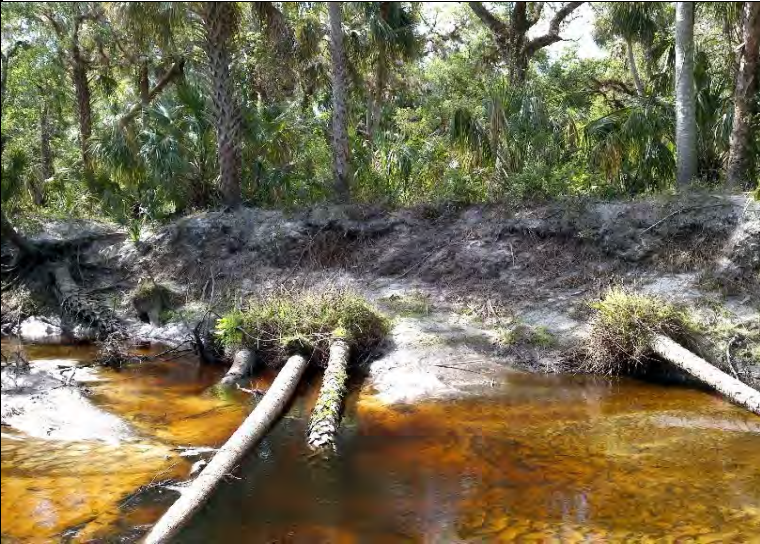
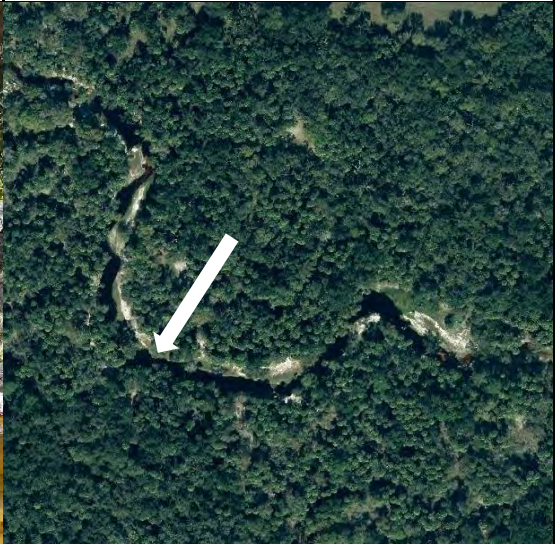
Charlie Creek			Severity Scale: 3.0-Low
Watershed: Peace River Subwatershed: Middle Charlie Creek Latitude: 27.44019 Longitude: 27.44019			County: Hardee Site Number: PI476 Reach Length: 95 ft. Landowner: D H Ranch Inc.

Risk Factor	Ranking	Score	*Depth Profile Not Recorded*
Pfankuch-Channel Stability:	Fair	1	
Channel Alteration:	None	0	
Bank Erosion:	Active	1	
BEHI:	Moderate	0.5	
Local NPSP:	No Evidence	0	
Shoring Structures:	None	0	
Pipe Discharge:	None	0	Additional Site Features
Water Odor:	Normal	0	Stream Channel Woody Material: Moderate
Fish Passage Barrier:	None	0	Impoundments: None
RB: Riparian Buffer:	100 ft.	0	Substrate Composition: Sand
LB: Riparian Buffer:	100 ft.	0	Bank Material: Sand
RB: Floodplain Access:	Full	0	Near Bank Stress: Low
LB: Floodplain Access:	Partial	0.5	RB Landuse: Natural Forest
<b>Severity Scale:</b>		<b>3.0</b>	LB Landuse: Natural Forest
Notes: BEHI estimated; 303d: NA

Restoration Option 1

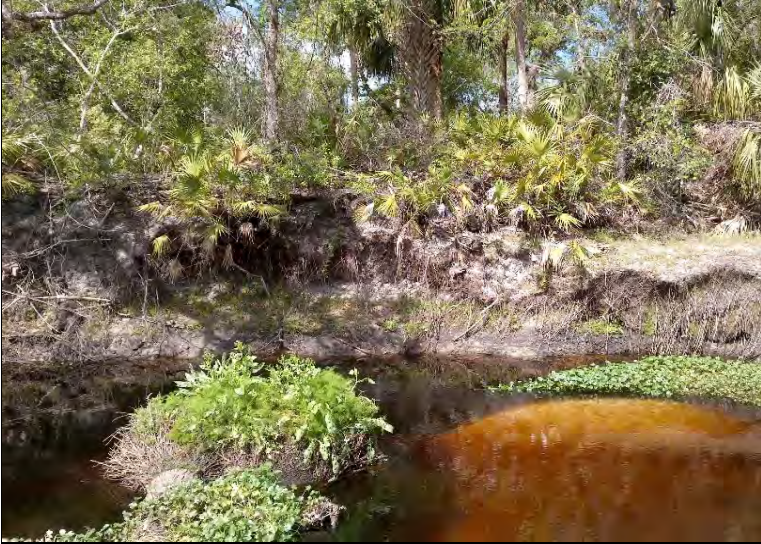
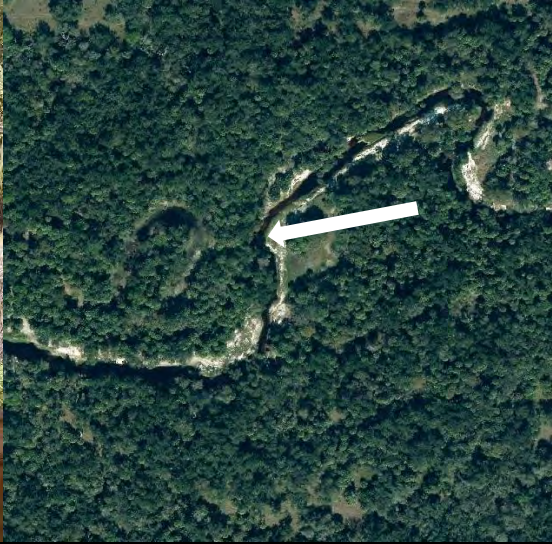
Charlie Creek			Severity Scale: 3.0-Low
Watershed: Peace River Subwatershed: Middle Charlie Creek Latitude: -81.70635 Longitude: 27.44069			County: Hardee Site Number: PI477 Reach Length: 77 ft. Landowner: D H Ranch Inc.

<b>Risk Factor</b>	<b>Ranking</b>	<b>Score</b>	<b>*Depth Profile Not Recorded*</b>
Pfankuch-Channel Stability:	Fair	1	
Channel Alteration:	None	0	
Bank Erosion:	Active	1	
BEHI:	Moderate	0.5	
Local NPSP:	No Evidence	0	
Shoring Structures:	None	0	
Pipe Discharge:	None	0	<b>Additional Site Features</b>
Water Odor:	Normal	0	Stream Channel Woody Material: Numerous
Fish Passage Barrier:	None	0	Impoundments: None
RB: Riparian Buffer:	100 ft.	0	Substrate Composition: Sand
LB: Riparian Buffer:	100 ft.	0	Bank Material: Sand
RB: Floodplain Access:	Partial	0.5	Near Bank Stress: High
LB: Floodplain Access:	Full	0	RB Landuse: Natural Forest
<b>Severity Scale:</b>		<b>3.0</b>	LB Landuse: Natural Forest

Notes: BEHI estimated; 303d: NA			
Restoration Option 1

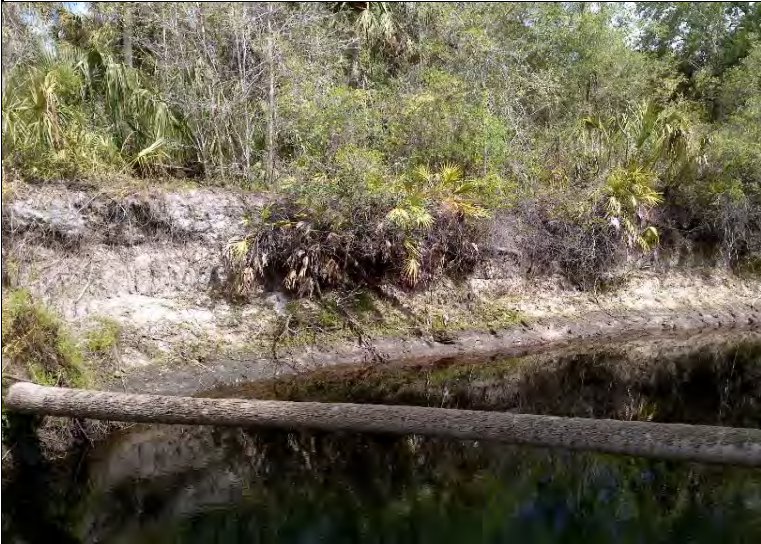
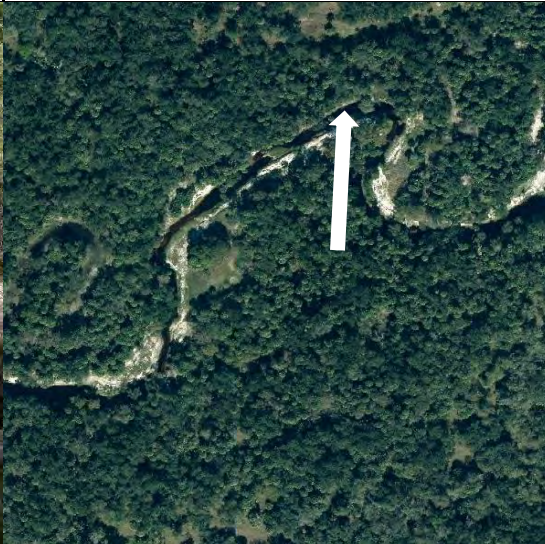
Charlie Creek			Severity Scale: 3.0-Low	
Watershed: Peace River Subwatershed: Middle Charlie Creek Latitude: -81.7054 Longitude: 27.44154			County: Hardee Site Number: PI478 Reach Length: 69 ft. Landowner: D H Ranch Inc.

<b>Risk Factor</b>	<b>Ranking</b>	<b>Score</b>	<b>*Depth Profile Not Recorded*</b>	
Pfankuch-Channel Stability:	Fair	1		
Channel Alteration:	None	0		
Bank Erosion:	Active	1		
BEHI:	Moderate	0.5		
Local NPSP:	No Evidence	0		
Shoring Structures:	None	0	<b>Additional Site Features</b>	
Pipe Discharge:	None	0		
Water Odor:	Normal	0		Stream Channel Woody Material: Numerous
Fish Passage Barrier:	None	0		Impoundments: None
RB: Riparian Buffer:	100 ft.	0		Substrate Composition: Sand
LB: Riparian Buffer:	100 ft.	0		Bank Material: Sand
RB: Floodplain Access:	Partial	0.5		Near Bank Stress: High
LB: Floodplain Access:	Full	0		RB Landuse: Natural Forest
<b>Severity Scale:</b>		<b>3.0</b>	LB Landuse: Natural Forest

Notes: BEHI estimated; 303d: NA				
Restoration Option 1

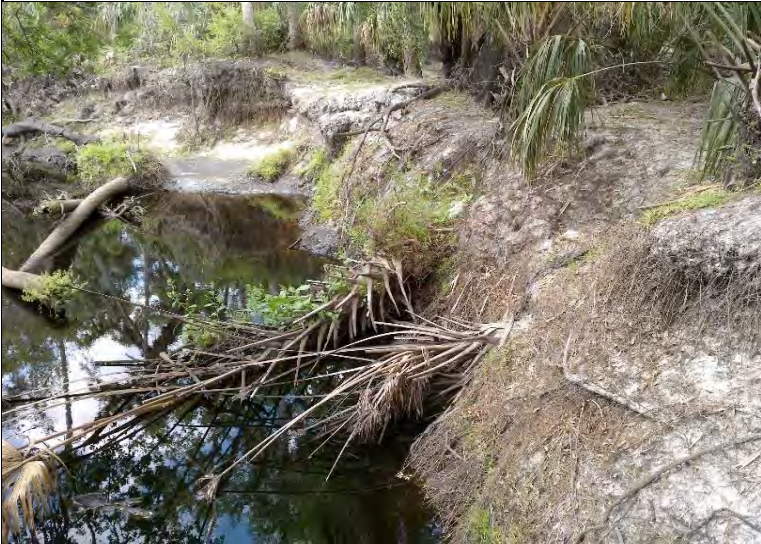
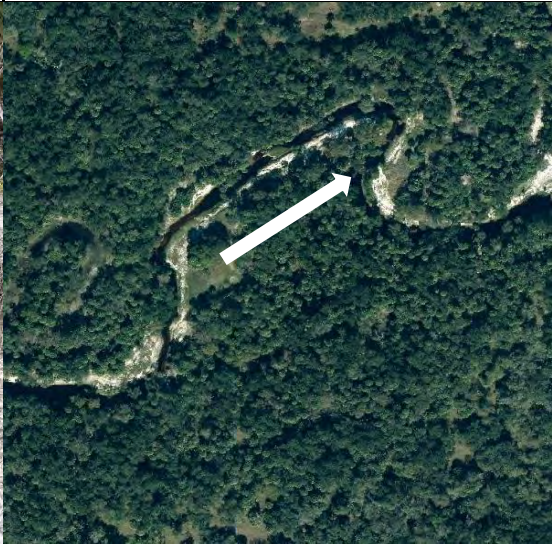
Charlie Creek			Severity Scale: 3.25-Low
Watershed: Peace River Subwatershed: Middle Charlie Creek Latitude: 27.44139 Longitude: -81.70535			County: Hardee Site Number: PI479 Reach Length: 115 ft. Landowner: D H Ranch Inc.

Risk Factor	Ranking	Score	*Depth Profile Not Recorded*
Pfankuch-Channel Stability:	Fair	1	
Channel Alteration:	None	0	
Bank Erosion:	Active	1	
BEHI:	High	1	
Local NPSP:	No Evidence	0	
Shoring Structures:	None	0	
Pipe Discharge:	None	0	Additional Site Features
Water Odor:	Normal	0	Stream Channel Woody Material: Extensive
Fish Passage Barrier:	None	0	Impoundments: None
RB: Riparian Buffer:	100 ft.	0	Substrate Composition: Medium Sand
LB: Riparian Buffer:	100 ft.	0	Bank Material: Sand
RB: Floodplain Access:	Full	0	Near Bank Stress: High
LB: Floodplain Access:	Partial	0.25	RB Landuse: Natural Forest
<b>Severity Scale:</b>		<b>3.25</b>	LB Landuse: Natural Forest
Notes: BEHI estimated; 303d: NA

Restoration Option 1

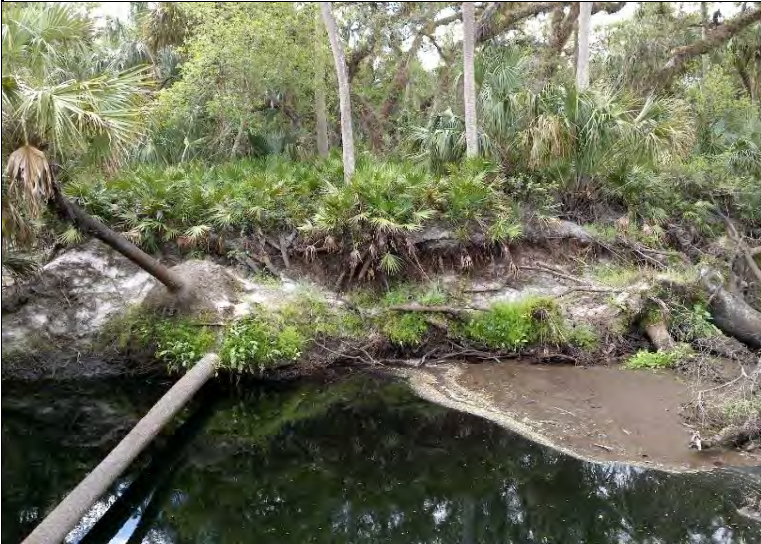
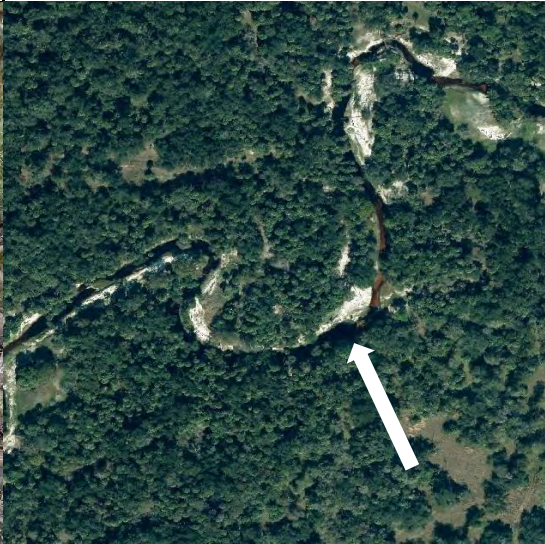
Charlie Creek			Severity Scale: 3.25-Low
Watershed: Peace River Subwatershed: Middle Charlie Creek Latitude: 27.44092 Longitude: -81.70472			County: Hardee Site Number: PI480 Reach Length: 210 ft. Landowner: D H Ranch Inc.

Risk Factor	Ranking	Score	*Depth Profile Not Recorded*
Pfankuch-Channel Stability:	Fair	1	
Channel Alteration:	None	0	
Bank Erosion:	Active	1	
BEHI:	High	1	
Local NPSP:	No Evidence	0	
Shoring Structures:	None	0	
Pipe Discharge:	None	0	Additional Site Features
Water Odor:	Normal	0	Stream Channel Woody Material: Dominating
Fish Passage Barrier:	None	0	Impoundments: Woody Material Jams
RB: Riparian Buffer:	100 ft.	0	Substrate Composition: Medium Sand
LB: Riparian Buffer:	100 ft.	0	Bank Material: Sand
RB: Floodplain Access:	Full	0	Near Bank Stress: Moderate
LB: Floodplain Access:	Partial	0.25	RB Landuse: Natural Forest
<b>Severity Scale:</b>		<b>3.25</b>	LB Landuse: Natural Forest

Notes: BEHI estimated; 303d: NA			
Restoration Option 1

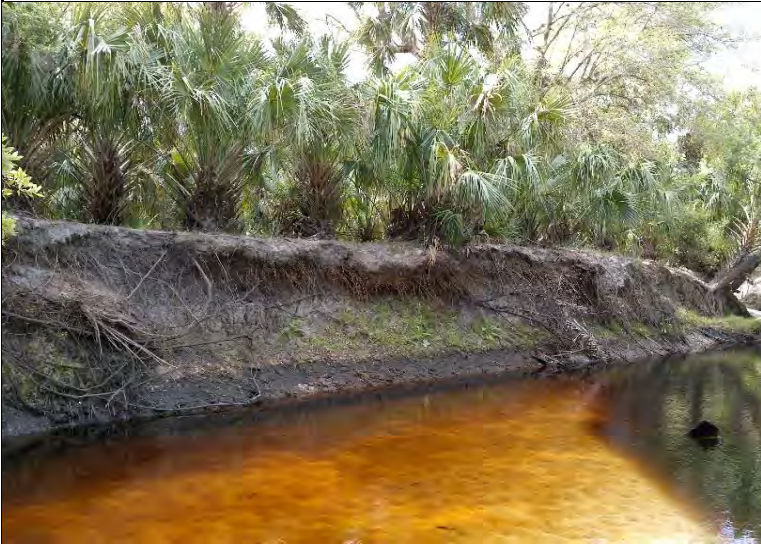
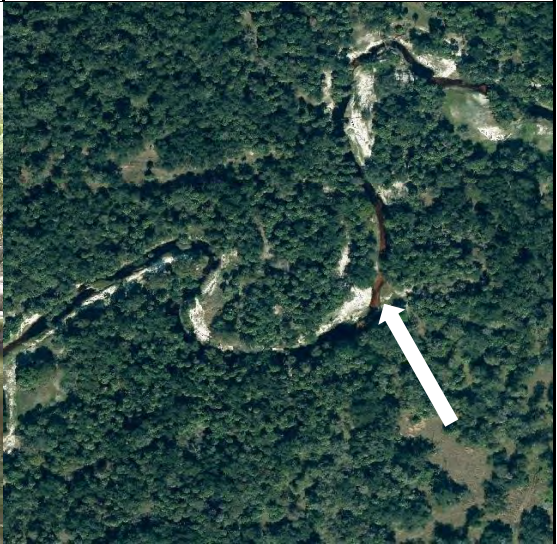
Charlie Creek			Severity Scale: 2.75-Low
Watershed: Peace River Subwatershed: Middle Charlie Creek Latitude: 27.44104 Longitude: -81.70436			County: Hardee Site Number: PI481 Reach Length: 125 ft. Landowner: D H Ranch Inc.

Risk Factor	Ranking	Score	*Depth Profile Not Recorded*
Pfankuch-Channel Stability:	Fair	1	
Channel Alteration:	None	0	
Bank Erosion:	Active	1	
BEHI:	Moderate	0.5	
Local NPSP:	No Evidence	0	
Shoring Structures:	None	0	
Pipe Discharge:	None	0	Additional Site Features
Water Odor:	Normal	0	Stream Channel Woody Material: Moderate
Fish Passage Barrier:	None	0	Impoundments: None
RB: Riparian Buffer:	100 ft.	0	Substrate Composition: Medium Sand
LB: Riparian Buffer:	100 ft.	0	Bank Material: Sandy Clay
RB: Floodplain Access:	Full	0	Near Bank Stress: High
LB: Floodplain Access:	Partial	0.25	RB Landuse: Natural Forest
<b>Severity Scale:</b>		<b>2.75</b>	LB Landuse: Natural Forest
Notes: BEHI estimated; 303d: NA

Restoration Option 1

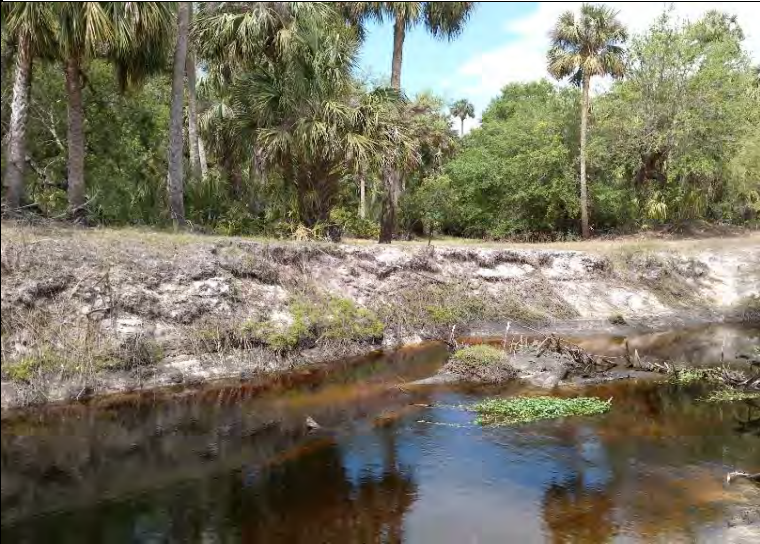
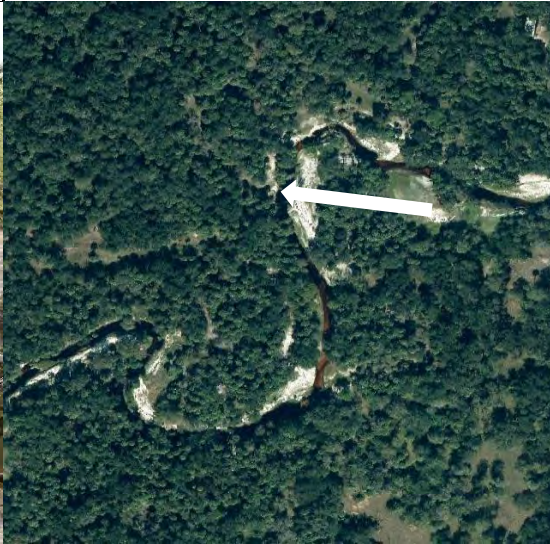
Charlie Creek			Severity Scale: 4.0-Low
Watershed: Peace River Subwatershed: Middle Charlie Creek Latitude: 27.44238 Longitude: -81.70411			County: Hardee Site Number: PI482 Reach Length: 80 ft. Landowner: D H Ranch Inc.*

Risk Factor	Ranking	Score	*Depth Profile Not Recorded*
Pfankuch-Channel Stability:	Fair	1	
Channel Alteration:	None	0	
Bank Erosion:	Mass-wasting	1.5	
BEHI:	High	1	
Local NPSP:	No Evidence	0	
Shoring Structures:	None	0	
Pipe Discharge:	None	0	Additional Site Features
Water Odor:	Normal	0	Stream Channel Woody Material: Numerous
Fish Passage Barrier:	None	0	Impoundments: Woody Material Jams
RB: Riparian Buffer:	40 ft.	0.5	Substrate Composition: Medium Sand
LB: Riparian Buffer:	100 ft.	0	Bank Material: Sand
RB: Floodplain Access:	Full	0	Near Bank Stress: Moderate
LB: Floodplain Access:	Full	0	RB Landuse: Natural Forest, Pasture
<b>Severity Scale:</b>		<b>4.0</b>	LB Landuse: Natural Forest

Notes: BEHI estimated; 303d: NA; *Site also located on property owned by Grass Valley Ranch Inc., fence across river			
Restoration Option 1

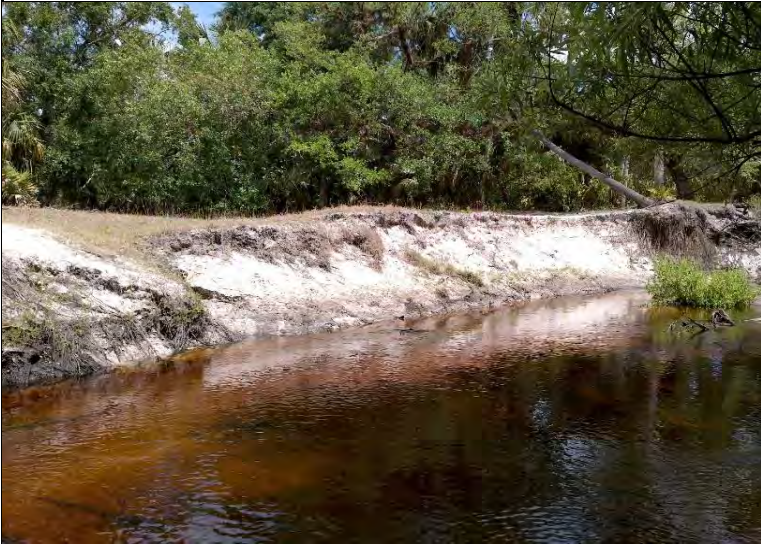
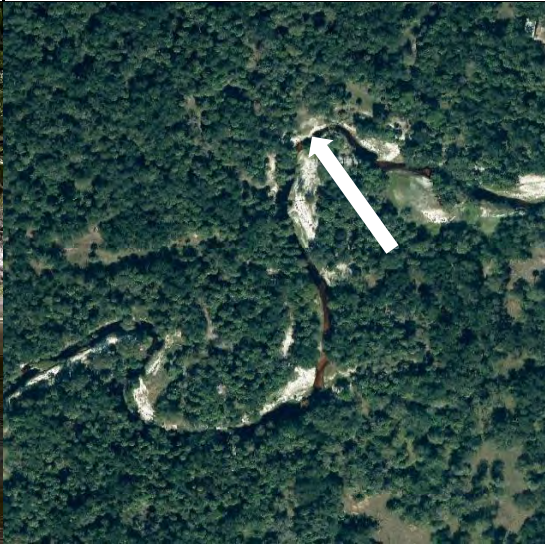
Charlie Creek			Severity Scale: 5.25-Moderate	
Watershed: Peace River Subwatershed: Middle Charlie Creek Latitude: 27.44283 Longitude: -81.70413			County: Hardee Site Number: PI483 Reach Length: 100 ft. Landowner: Grass Valley Ranch Inc.

<b>Risk Factor</b>	<b>Ranking</b>	<b>Score</b>	<b>*Depth Profile Not Recorded*</b>	
Pfankuch-Channel Stability:	Fair	1		
Channel Alteration:	None	0		
Bank Erosion:	Active	1		
BEHI:	Very High	1.5		
Local NPSP:	Moderate Potential	1		
Shoring Structures:	None	0	<b>Additional Site Features</b>	
Pipe Discharge:	None	0		
Water Odor:	Normal	0		Stream Channel Woody Material: Extensive
Fish Passage Barrier:	None	0		Impoundments: Woody Material Jams
RB: Riparian Buffer:	0 ft.	0.75		Substrate Composition: Medium Sand
LB: Riparian Buffer:	100 ft.	0		Bank Material: Sand
RB: Floodplain Access:	Full	0		Near Bank Stress: Moderate
LB: Floodplain Access:	Full	0	RB Landuse: Pasture, Natural Forest

<b>Severity Scale:</b>		<b>5.25</b>	LB Landuse: Natural Forest	
Notes: BEHI estimated; 303d: NA				
Restoration Option 1

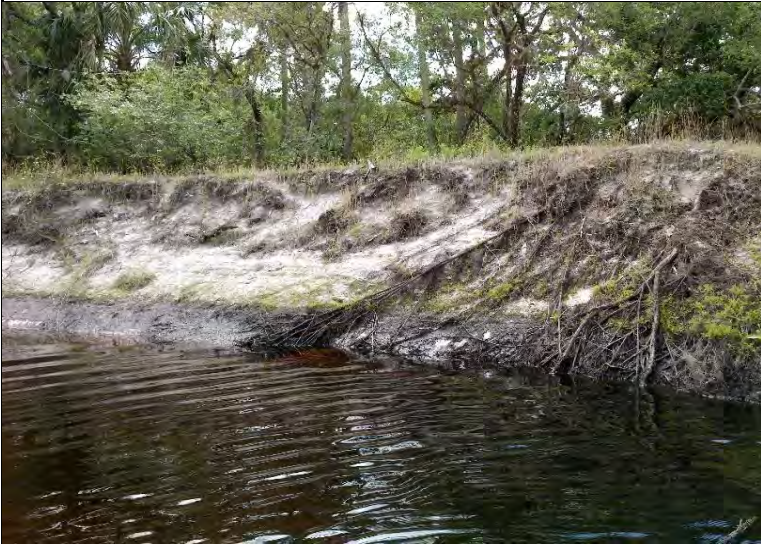
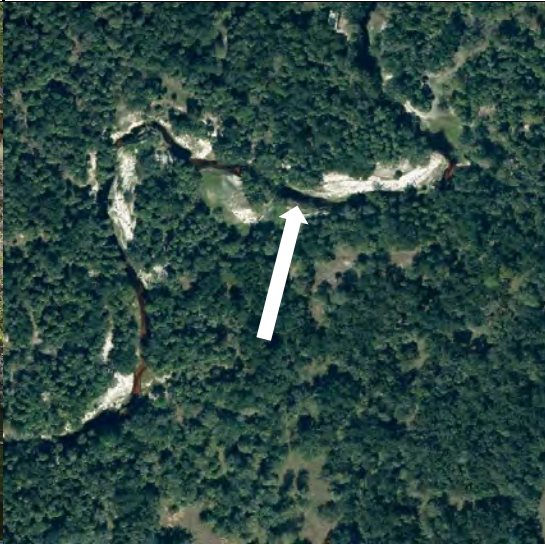
Charlie Creek			Severity Scale: 5.0-Moderate
Watershed: Peace River Subwatershed: Middle Charlie Creek Latitude: 27.44250 Longitude: -81.70283			County: Hardee Site Number: PI484 Reach Length: 75 ft. Landowner: Grass Valley Ranch Inc.

<b>Risk Factor</b>	<b>Ranking</b>	<b>Score</b>	<b>*Depth Profile Not Recorded*</b>
Pfankuch-Channel Stability:	Fair	1	
Channel Alteration:	None	0	
Bank Erosion:	Active	1	
BEHI:	High	1	
Local NPSP:	Moderate Potential	1	
Shoring Structures:	None	0	
Pipe Discharge:	None	0	<b>Additional Site Features</b>
Water Odor:	Normal	0	Stream Channel Woody Material: Infrequent
Fish Passage Barrier:	None	0	Impoundments: None
RB: Riparian Buffer:	60 ft.	0.25	Substrate Composition: Medium Sand
LB: Riparian Buffer:	40 ft.	0.5	Bank Material: Sand
RB: Floodplain Access:	Full	0	Near Bank Stress: High
LB: Floodplain Access:	Partial	0.25	RB Landuse: Natural Forest, Recreational
<b>Severity Scale:</b>		<b>5.0</b>	LB Landuse: Natural Forest, Pasture

Notes: BEHI estimated; 303d: NA			
Restoration Option 1

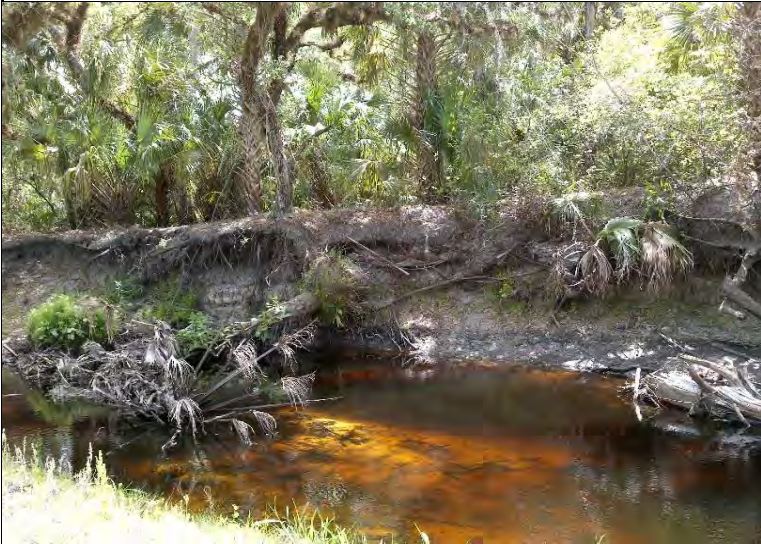
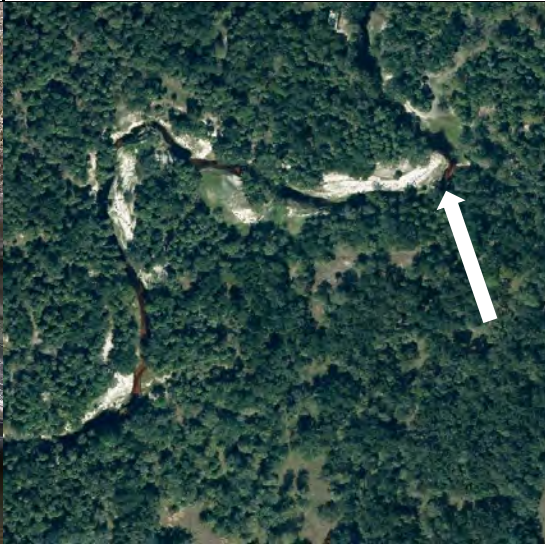
Charlie Creek			Severity Scale: 4.25-Moderate
Watershed: Peace River Subwatershed: Middle Charlie Creek Latitude: 27.44257 Longitude: -81.70235			County: Hardee Site Number: PI485 Reach Length: 160 ft. Landowner: Grass Valley Ranch Inc.

Risk Factor	Ranking	Score	*Depth Profile Not Recorded*
Pfankuch-Channel Stability:	Fair	1	
Channel Alteration:	None	0	
Bank Erosion:	Active	1	
BEHI:	Moderate	0.5	
Local NPSP:	Moderate Potential	1	
Shoring Structures:	None	0	
Pipe Discharge:	None	0	Additional Site Features
Water Odor:	Normal	0	Stream Channel Woody Material: Moderate
Fish Passage Barrier:	None	0	Impoundments: None
RB: Riparian Buffer:	40 ft.	0.5	Substrate Composition: Medium Sand
LB: Riparian Buffer:	100 ft.	0	Bank Material: Sandy Clay
RB: Floodplain Access:	Full	0	Near Bank Stress: Moderate
LB: Floodplain Access:	Partial	0.25	RB Landuse: Natural Forest
<b>Severity Scale:</b>		<b>4.25</b>	LB Landuse: Natural Forest, Recreation

Notes: BEHI estimated; 303d: NA			
Restoration Option 1

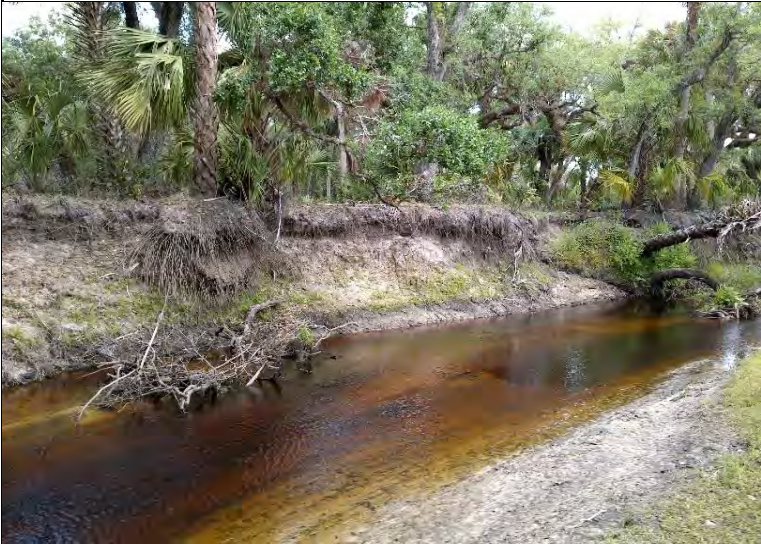
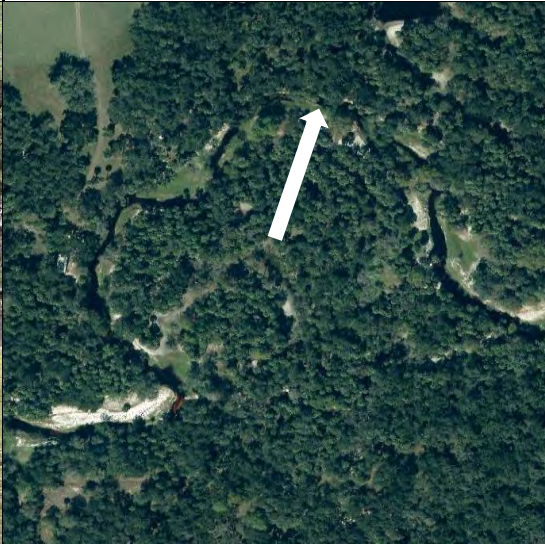
Charlie Creek			Severity Scale: 4.75-Moderate
Watershed: Peace River Subwatershed: Middle Charlie Creek Latitude: 27.44462 Longitude: -81.70151			County: Hardee Site Number: PI486 Reach Length: 335 ft. Landowner: Grass Valley Ranch Inc.

Risk Factor	Ranking	Score	*Depth Profile Not Recorded*
Pfankuch-Channel Stability:	Fair	1	
Channel Alteration:	None	0	
Bank Erosion:	Active	1	
BEHI:	High	1	
Local NPSP:	Obvious Sources	1.5	
Shoring Structures:	None	0	
Pipe Discharge:	None	0	Additional Site Features
Water Odor:	Normal	0	Stream Channel Woody Material: Numerous
Fish Passage Barrier:	None	0	Impoundments: None
RB: Riparian Buffer:	60 ft.	0.25	Substrate Composition: Medium Sand
LB: Riparian Buffer:	100 ft.	0	Bank Material: Sand
RB: Floodplain Access:	Full	0	Near Bank Stress: Moderate
LB: Floodplain Access:	Full	0	RB Landuse: Natural Forest, Pasture
<b>Severity Scale:</b>		<b>4.75</b>	LB Landuse: Natural Forest

Notes: BEHI estimated; 303d: NA			
Restoration Option 1

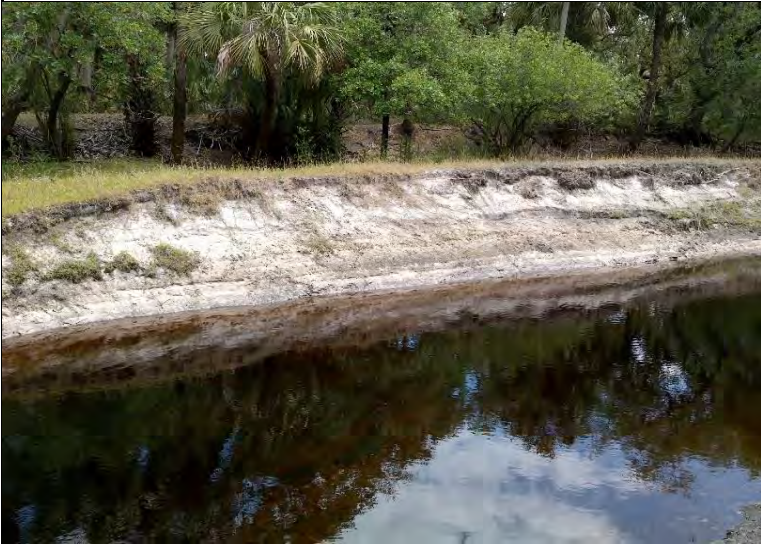
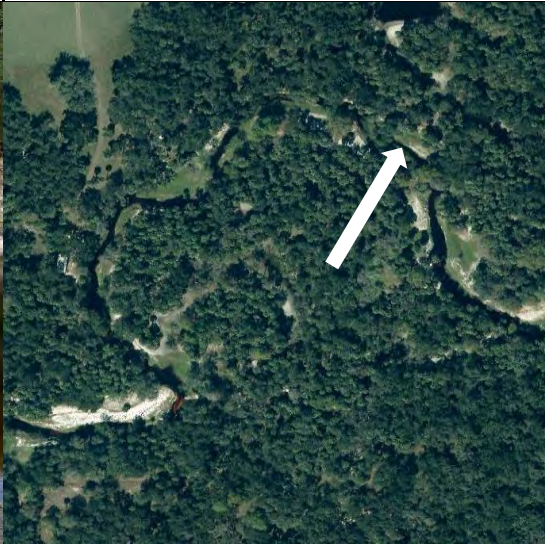
Charlie Creek			Severity Scale: 4.75-Moderate
Watershed: Peace River Subwatershed: Middle Charlie Creek Latitude: 27.44451 Longitude: -81.70042			County: Hardee Site Number: PI487 Reach Length: 63 ft. Landowner: Grass Valley Ranch Inc.

Risk Factor	Ranking	Score	*Depth Profile Not Recorded*
Pfankuch-Channel Stability:	Fair	1	
Channel Alteration:	None	0	
Bank Erosion:	Active	1	
BEHI:	High	1	
Local NPSP:	Obvious Sources	1.5	
Shoring Structures:	None	0	
Pipe Discharge:	None	0	Additional Site Features
Water Odor:	Normal	0	Stream Channel Woody Material: Moderate
Fish Passage Barrier:	None	0	Impoundments: None
RB: Riparian Buffer:	60 ft.	0.25	Substrate Composition: Medium Sand
LB: Riparian Buffer:	100 ft.	0	Bank Material: Sand
RB: Floodplain Access:	Full	0	Near Bank Stress: High
LB: Floodplain Access:	Full	0	RB Landuse: Natural Forest, Pasture
<b>Severity Scale:</b>		<b>4.75</b>	LB Landuse: Natural Forest

Notes: BEHI estimated; 303d: NA			
Restoration Option 1

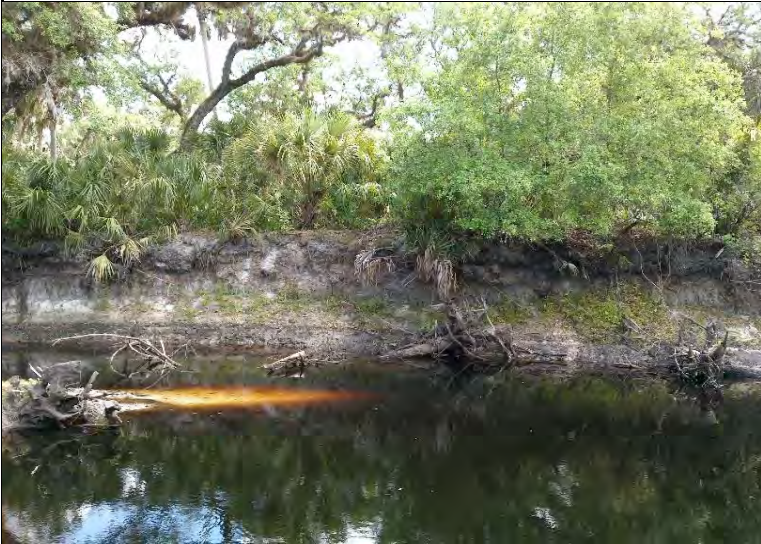
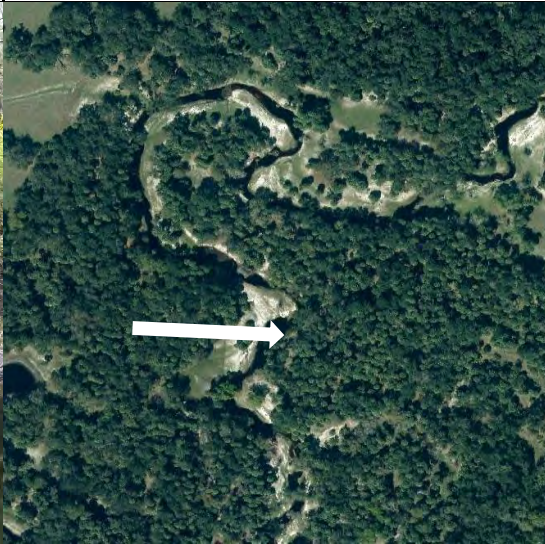
Charlie Creek			Severity Scale: 4.25-Moderate
Watershed: Peace River Subwatershed: Middle Charlie Creek Latitude: 27.44582 Longitude: -81.69868			County: Hardee Site Number: PI488 Reach Length: 135 ft. Landowner: Guy A. Willard (trustee)

Risk Factor	Ranking	Score	*Depth Profile Not Recorded*
Pfankuch-Channel Stability:	Fair	1	
Channel Alteration:	None	0	
Bank Erosion:	Active	1	
BEHI:	Moderate	0.5	
Local NPSP:	Obvious Sources	1.5	
Shoring Structures:	None	0	
Pipe Discharge:	None	0	Additional Site Features
Water Odor:	Normal	0	Stream Channel Woody Material: Numerous
Fish Passage Barrier:	None	0	Impoundments: None
RB: Riparian Buffer:	100 ft.	0	Substrate Composition: Medium Sand
LB: Riparian Buffer:	100 ft.	0	Bank Material: Sandy Clay
RB: Floodplain Access:	Full	0	Near Bank Stress: High
LB: Floodplain Access:	Partial	0.25	RB Landuse: Natural Forest
<b>Severity Scale:</b>		<b>4.25</b>	LB Landuse: Natural Forest

Notes: BEHI estimated; 303d: NA			
Restoration Option 1

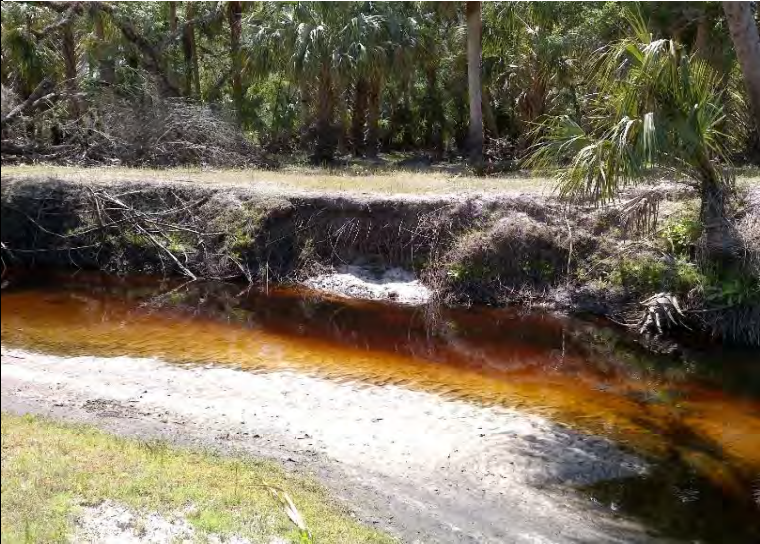
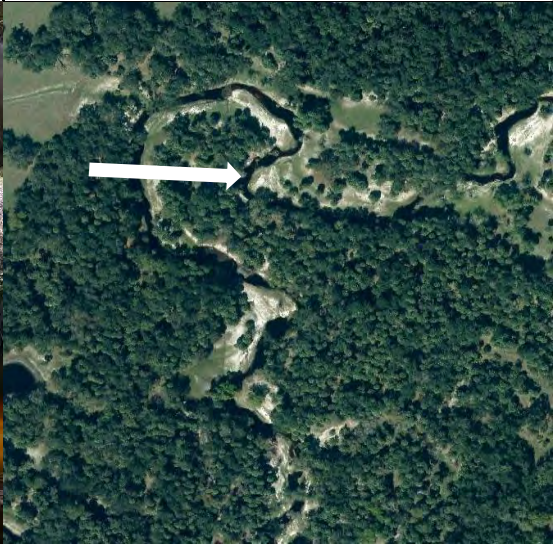
Charlie Creek			Severity Scale: 5.0-Moderate
Watershed: Peace River Subwatershed: Middle Charlie Creek Latitude: 27.44701 Longitude: -81.69861			County: Hardee Site Number: PI489 Reach Length: 110 ft. Landowner: Grass Valley Ranch Inc.

Risk Factor	Ranking	Score	*Depth Profile Not Recorded*
Pfankuch-Channel Stability:	Fair	1	
Channel Alteration:	None	0	
Bank Erosion:	Active	1	
BEHI:	Moderate	0.5	
Local NPSP:	Obvious Sources	1.5	
Shoring Structures:	None	0	
Pipe Discharge:	None	0	Additional Site Features
Water Odor:	Normal	0	Stream Channel Woody Material: Extensive
Fish Passage Barrier:	None	0	Impoundments: None
RB: Riparian Buffer:	40 ft.	0.5	Substrate Composition: Medium Sand
LB: Riparian Buffer:	40 ft.	0.5	Bank Material: Sand
RB: Floodplain Access:	Full	0	Near Bank Stress: High
LB: Floodplain Access:	Full	0	RB Landuse: Pasture, Natural Forest
<b>Severity Scale:</b>		<b>5.0</b>	LB Landuse: Natural Forest, Pasture

Notes: BEHI estimated; 303d: NA			
Restoration Option 1

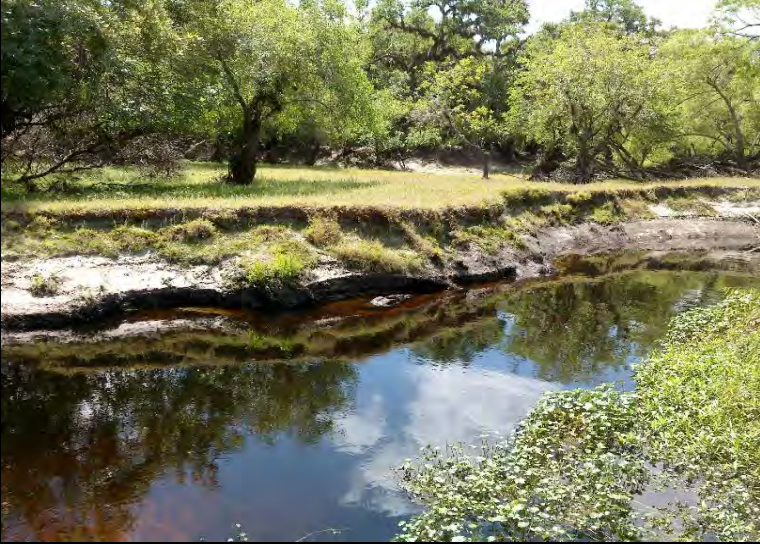
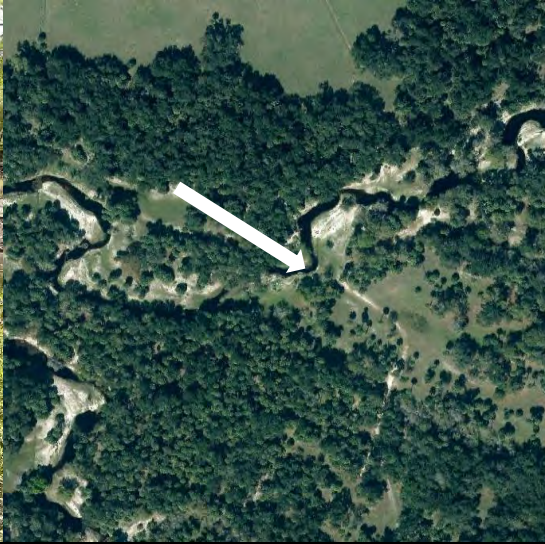
Charlie Creek			Severity Scale: 5.5-Moderate
Watershed: Peace River Subwatershed: Middle Charlie Creek Latitude: 27.44696 Longitude: -81.69723			County: Hardee Site Number: PI490 Reach Length: 125 ft. Landowner: Guy A. Willard (trustee)

Risk Factor	Ranking	Score	*Depth Profile Not Recorded*
Pfankuch-Channel Stability:	Fair	1	
Channel Alteration:	None	0	
Bank Erosion:	Mass-wasting	1.5	
BEHI:	High	1	
Local NPSP:	Obvious Sources	1.5	
Shoring Structures:	None	0	
Pipe Discharge:	None	0	Additional Site Features
Water Odor:	Normal	0	Stream Channel Woody Material: Infrequent
Fish Passage Barrier:	None	0	Impoundments: None
RB: Riparian Buffer:	100 ft.	0	Substrate Composition: Medium Sand
LB: Riparian Buffer:	40 ft.	0.5	Bank Material: Sand
RB: Floodplain Access:	Full	0	Near Bank Stress: High
LB: Floodplain Access:	Full	0	RB Landuse: Natural Forest
<b>Severity Scale:</b>		<b>5.5</b>	LB Landuse: Pasture, Natural Forest

Notes: BEHI estimated; 303d: NA			
Restoration Option 1

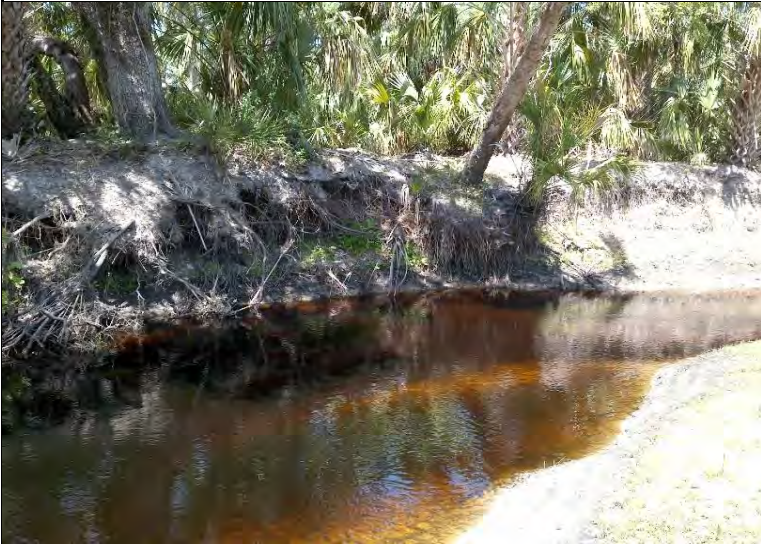
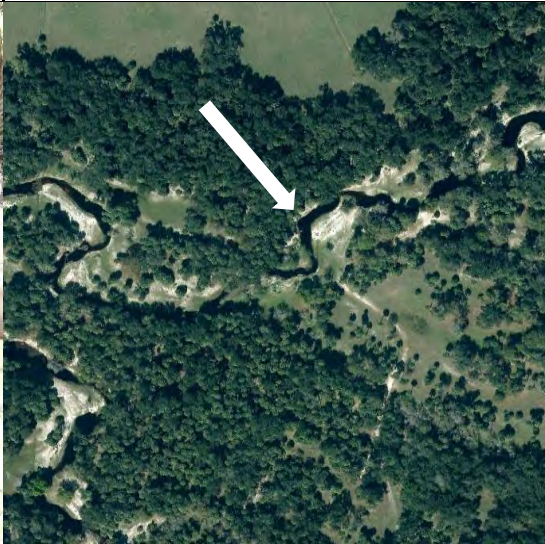
Charlie Creek			Severity Scale: 4.25-Moderate
Watershed: Peace River Subwatershed: Middle Charlie Creek Latitude: 27.44720 Longitude: -81.69710			County: Hardee Site Number: PI491 Reach Length: 100 ft. Landowner: Guy A. Willard (trustee)

Risk Factor	Ranking	Score	*Depth Profile Not Recorded*
Pfankuch-Channel Stability:	Fair	1	
Channel Alteration:	None	0	
Bank Erosion:	Active	1	
BEHI:	Moderate	0.5	
Local NPSP:	Obvious Sources	1.5	
Shoring Structures:	None	0	
Pipe Discharge:	None	0	Additional Site Features
Water Odor:	Normal	0	Stream Channel Woody Material: Infrequent
Fish Passage Barrier:	None	0	Impoundments: None
RB: Riparian Buffer:	100 ft.	0	Substrate Composition: Medium Sand
LB: Riparian Buffer:	60 ft.	0.25	Bank Material: Sand
RB: Floodplain Access:	Full	0	Near Bank Stress: High
LB: Floodplain Access:	Full	0	RB Landuse: Natural Forest
<b>Severity Scale:</b>		<b>4.25</b>	LB Landuse: Natural Forest, Pasture

Notes: BEHI estimated; 303d: NA			
Restoration Option 1

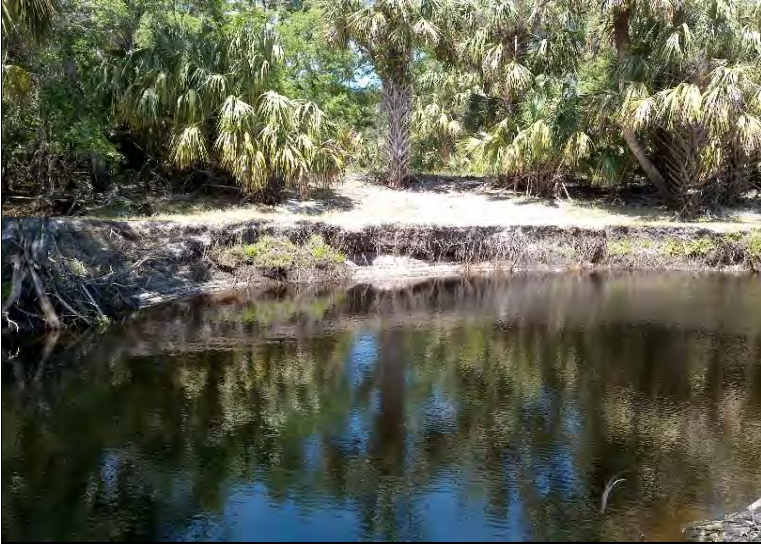
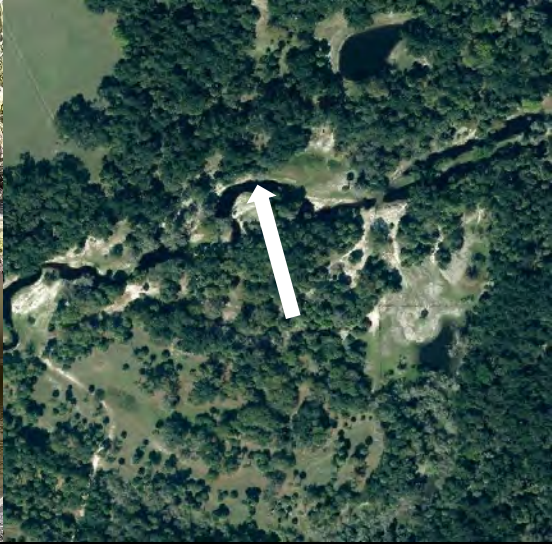
Charlie Creek			Severity Scale: 4.25-Moderate
Watershed: Peace River Subwatershed: Middle Charlie Creek Latitude: 27.44785 Longitude: -81.69567			County: Hardee Site Number: PI492 Reach Length: 130 ft. Landowner: Guy A. Willard (trustee)

<b>Risk Factor</b>	<b>Ranking</b>	<b>Score</b>	<b>*Depth Profile Not Recorded*</b>
Pfankuch-Channel Stability:	Fair	1	
Channel Alteration:	None	0	
Bank Erosion:	Active	1	
BEHI:	Moderate	0.5	
Local NPSP:	Obvious Sources	1.5	
Shoring Structures:	None	0	
Pipe Discharge:	None	0	<b>Additional Site Features</b>
Water Odor:	Normal	0	Stream Channel Woody Material: Moderate
Fish Passage Barrier:	None	0	Impoundments: None
RB: Riparian Buffer:	60 ft.	0.25	Substrate Composition: Medium Sand
LB: Riparian Buffer:	100 ft.	0	Bank Material: Sandy Clay
RB: Floodplain Access:	Full	0	Near Bank Stress: High
LB: Floodplain Access:	Full	0	RB Landuse: Natural Forest, Pasture
<b>Severity Scale: 4.25</b>			LB Landuse: Natural Forest

Notes: BEHI estimated; 303d: NA			
Restoration Option 1

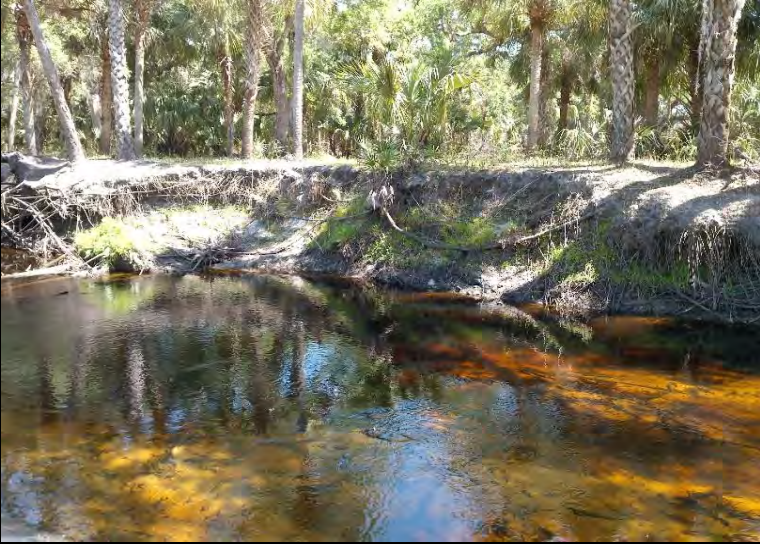
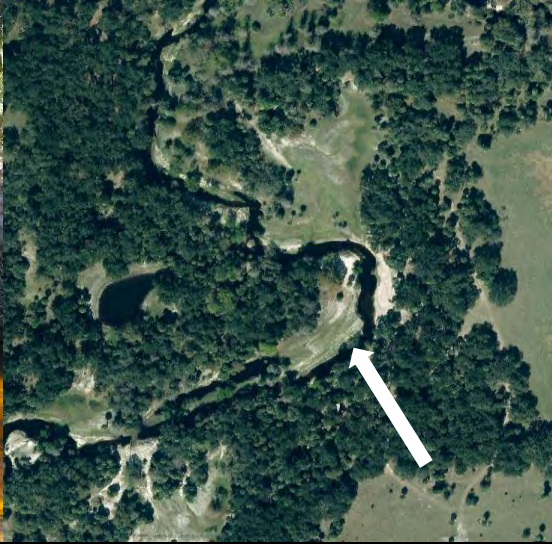
Charlie Creek			Severity Scale: 5.25-Moderate
Watershed: Peace River Subwatershed: Middle Charlie Creek Latitude: 27.44851 Longitude: -81.69332			County: Hardee Site Number: PI493 Reach Length: 100 ft. Landowner: Susan L. Alley & Others

<b>Risk Factor</b>	<b>Ranking</b>	<b>Score</b>	<b>*Depth Profile Not Recorded*</b>
Pfankuch-Channel Stability:	Fair	1	
Channel Alteration:	None	0	
Bank Erosion:	Active	1	
BEHI:	Moderate	0.5	
Local NPSP:	Obvious Sources	1.5	
Shoring Structures:	None	0	
Pipe Discharge:	None	0	<b>Additional Site Features</b>
Water Odor:	Normal	0	Stream Channel Woody Material: Extensive
Fish Passage Barrier:	None	0	Impoundments: None
RB: Riparian Buffer:	0 ft.	0.75	Substrate Composition: Medium Sand
LB: Riparian Buffer:	40 ft.	0.5	Bank Material: Sand
RB: Floodplain Access:	Full	0	Near Bank Stress: Moderate
LB: Floodplain Access:	Full	0	RB Landuse: Pasture
<b>Severity Scale:</b>		<b>5.25</b>	LB Landuse: Natural Forest, Pasture

Notes: BEHI estimated; 303d: NA			
Restoration Option 1
