# **Peace River and Withlacoochee River Threats Assessments and Fish Assemblage Monitoring**

**Final Report July 1, 2015 – June 30, 2019**

Submitted to Florida State Wildlife Grants Program  
August 1, 2019  
PID: 98462501284

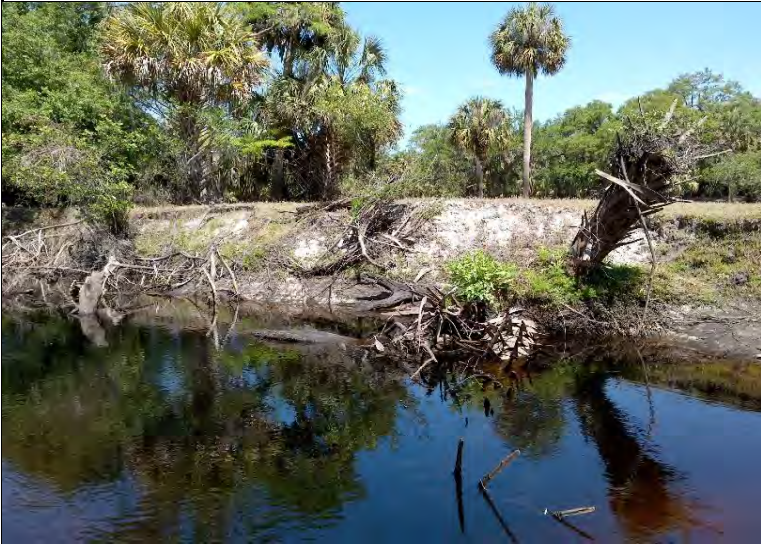
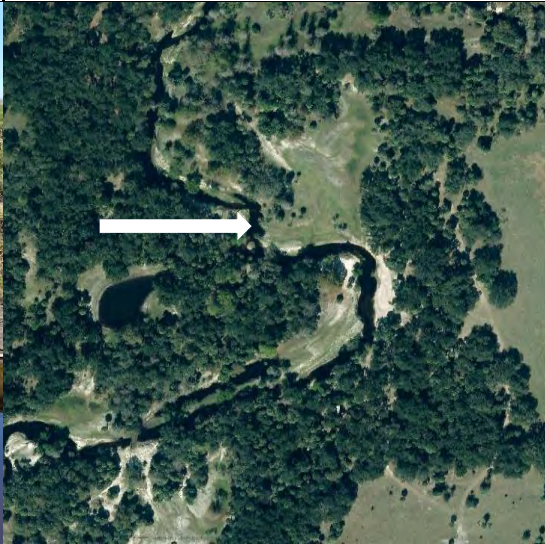
Charlie Creek			Severity Scale: 4.5-Moderate
Watershed: Peace River Subwatershed: Middle Charlie Creek Latitude: 27.44933 Longitude: -81.69396			County: Hardee Site Number: PI494 Reach Length: 95 ft. Landowner: Susan L. Alley & Others

Risk Factor	Ranking	Score	*Depth Profile Not Recorded*
Pfankuch-Channel Stability:	Fair	1	
Channel Alteration:	None	0	
Bank Erosion:	Active	1	
BEHI:	Moderate	0.5	
Local NPSP:	Obvious Sources	1.5	
Shoring Structures:	None	0	
Pipe Discharge:	None	0	Additional Site Features
Water Odor:	Normal	0	Stream Channel Woody Material: Numerous
Fish Passage Barrier:	None	0	Impoundments: None
RB: Riparian Buffer:	100 ft.	0	Substrate Composition: Medium Sand
LB: Riparian Buffer:	40 ft.	0.5	Bank Material: Sand
RB: Floodplain Access:	Full	0	Near Bank Stress: High
LB: Floodplain Access:	Full	0	RB Landuse: Natural Forest
<b>Severity Scale:</b>		<b>4.5</b>	LB Landuse: Pasture, Natural Forest

Notes: BEHI estimated; 303d: NA			
Restoration Option 1

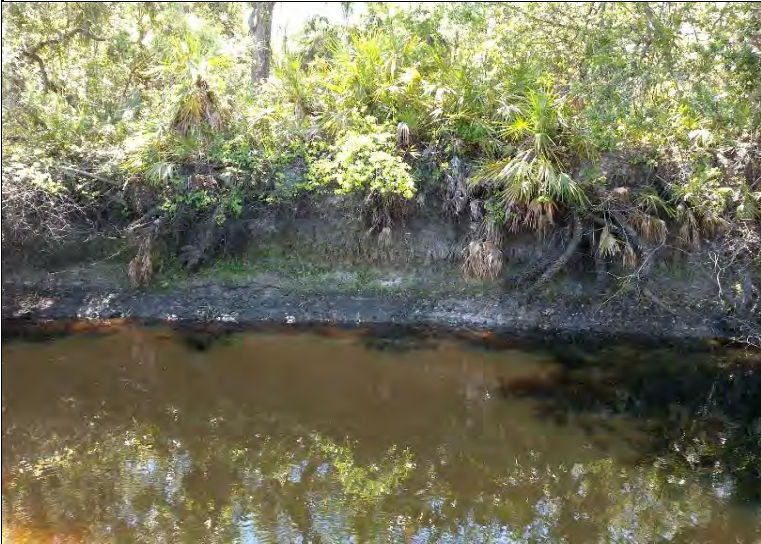
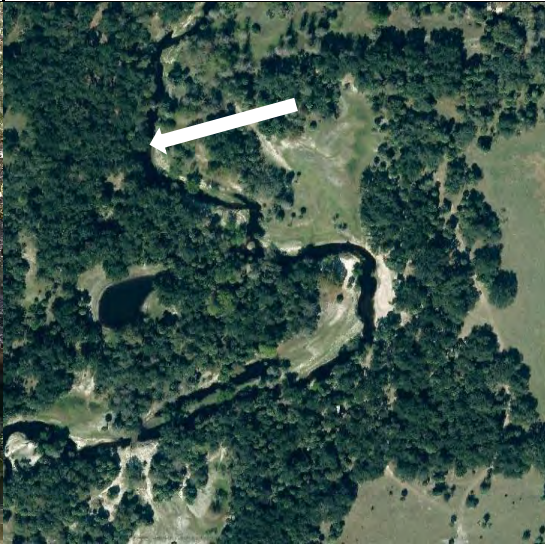
Charlie Creek			Severity Scale: 4.25-Moderate	
Watershed: Peace River Subwatershed: Middle Charlie Creek Latitude: 27.44981 Longitude: -81.69440			County: Hardee Site Number: PI495 Reach Length: 190 ft. Landowner: Susan L. Alley & Others

<b>Risk Factor</b>	<b>Ranking</b>	<b>Score</b>	<b>*Depth Profile Not Recorded*</b>	
Pfankuch-Channel Stability:	Fair	1		
Channel Alteration:	None	0		
Bank Erosion:	Active	1		
BEHI:	Moderate	0.5		
Local NPSP:	Obvious Sources	1.5		
Shoring Structures:	None	0	<b>Additional Site Features</b>	
Pipe Discharge:	None	0		
Water Odor:	Normal	0		Stream Channel Woody Material: Moderate
Fish Passage Barrier:	None	0		Impoundments: None
RB: Riparian Buffer:	100 ft.	0		Substrate Composition: Medium Sand
LB: Riparian Buffer:	60 ft.	0.25		Bank Material: Sandy Clay
RB: Floodplain Access:	Full	0		Near Bank Stress: High
LB: Floodplain Access:	Full	0		RB Landuse: Natural Forest

<b>Severity Scale:</b>		<b>4.25</b>	LB Landuse: Natural Forest, Pasture	
Notes: BEHI estimated; 303d: NA				
Restoration Option 1

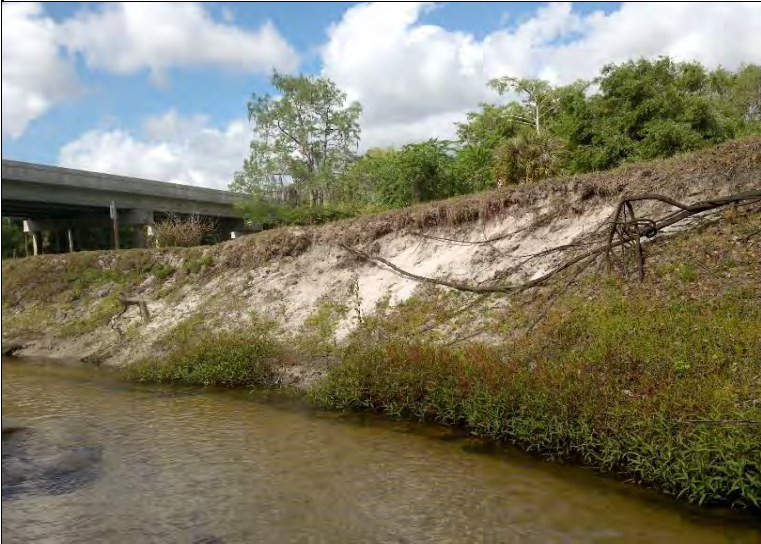
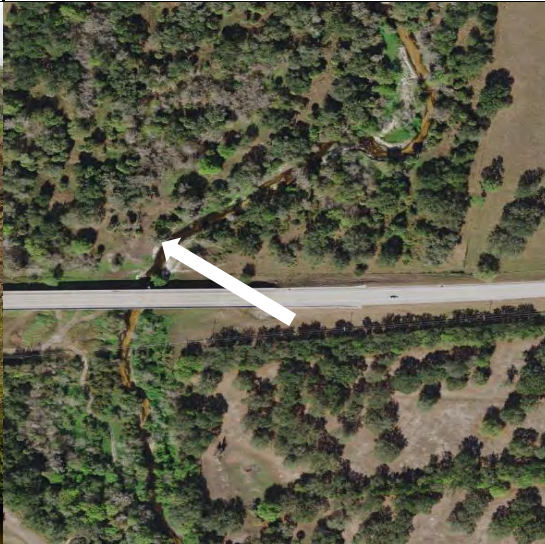
Horse Creek			Severity Scale: 7.0-Moderate	
Watershed: Peace River Subwatershed: Lower Horse Creek Latitude: 27.20001 Longitude: -81.98771			County: Desoto Site Number: PI496 Reach Length: 50 ft. Landowner: V C Hollingsworth SR

<b>Risk Factor</b>	<b>Ranking</b>	<b>Score</b>	<b>*Depth Profile Not Recorded*</b>	
Pfankuch-Channel Stability:	Poor	1.5		
Channel Alteration:	None	0		
Bank Erosion:	Active	1		
BEHI:	Very High	1.5		
Local NPSP:	Obvious Sources	1.5		
Shoring Structures:	None	0	<b>Additional Site Features</b>	
Pipe Discharge:	None	0		
Water Odor:	Normal	0		Stream Channel Woody Material: Infrequent
Fish Passage Barrier:	None	0		Impoundments: None
RB: Riparian Buffer:	0 ft.	0.75		Substrate Composition: Medium Sand
LB: Riparian Buffer:	40 ft.	0.5		Bank Material: Sand
RB: Floodplain Access:	Partial	0.25		Near Bank Stress: High
LB: Floodplain Access:	Full	0		RB Landuse: Pasture
<b>Severity Scale:</b>		<b>7.0</b>	LB Landuse: Natural Forest, Pasture

Notes: BEHI estimated; 303d: Impaired - Potable Water Supplies (BOD, DO)				
Restoration Option 1

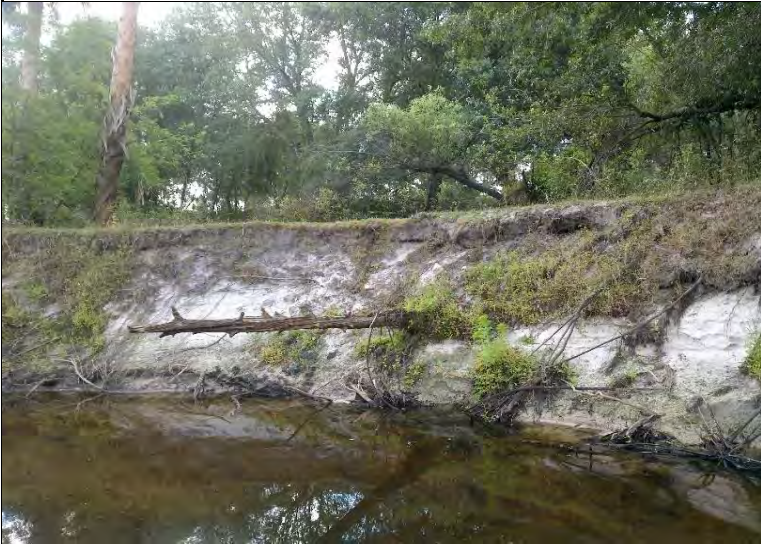
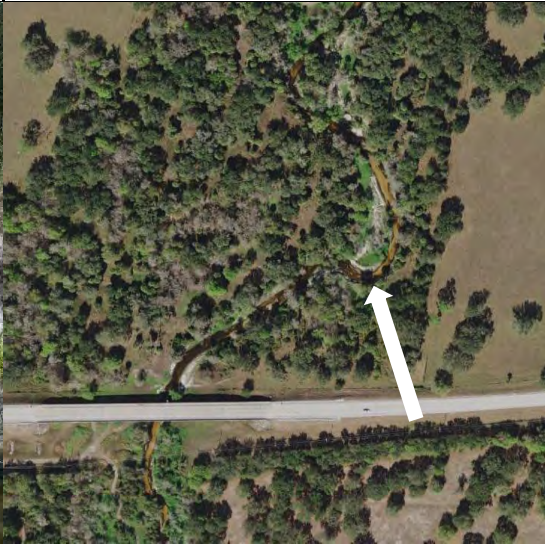
Horse Creek			Severity Scale: 6.25-Moderate
Watershed: Peace River Subwatershed: Lower Horse Creek Latitude: 27.20071 Longitude: -81.98651			County: Desoto Site Number: PI497 Reach Length: 150 ft. Landowner: V C Hollingsworth SR

<b>Risk Factor</b>	<b>Ranking</b>	<b>Score</b>	<b>*Depth Profile Not Recorded*</b>
Pfankuch-Channel Stability:	Poor	1.5	
Channel Alteration:	None	0	
Bank Erosion:	Active	1	
BEHI:	High	1	
Local NPSP:	Obvious Sources	1.5	
Shoring Structures:	None	0	
Pipe Discharge:	None	0	<b>Additional Site Features</b>
Water Odor:	Normal	0	Stream Channel Woody Material: Moderate
Fish Passage Barrier:	None	0	Impoundments: None
RB: Riparian Buffer:	40 ft.	0.5	Substrate Composition: Medium Sand
LB: Riparian Buffer:	40 ft.	0.5	Bank Material: Sand
RB: Floodplain Access:	Full	0	Near Bank Stress: High
LB: Floodplain Access:	Partial	0.25	RB Landuse: Natural Forest, Pasture
<b>Severity Scale:</b>		<b>6.25</b>	LB Landuse: Pasture, Natural Forest

Notes: BEHI estimated; 303d: Impaired - Potable Water Supplies (BOD, DO)			
Restoration Option 1

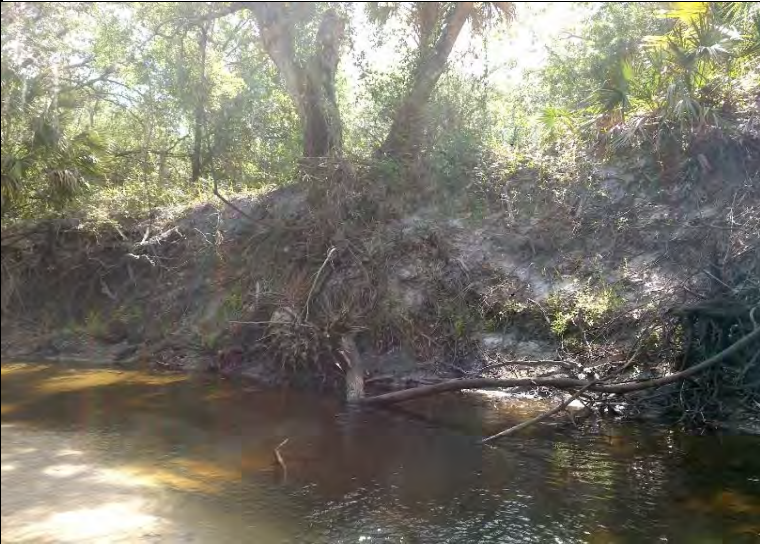
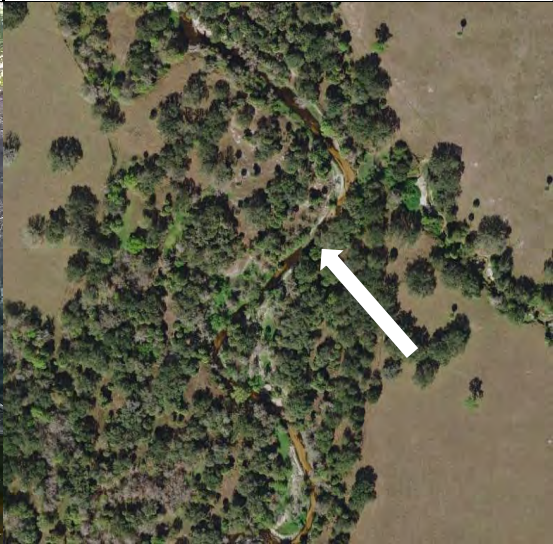
Horse Creek			Severity Scale: 5.25-Moderate
Watershed: Peace River Subwatershed: Lower Horse Creek Latitude: 27.20278 Longitude: -81.98621			County: Desoto Site Number: PI498 Reach Length: 60 ft. Landowner: V C Hollingsworth SR

Risk Factor	Ranking	Score	*Depth Profile Not Recorded*
Pfankuch-Channel Stability:	Poor	1.5	
Channel Alteration:	None	0	
Bank Erosion:	Active	1	
BEHI:	Moderate	0.5	
Local NPSP:	Obvious Sources	1.5	
Shoring Structures:	None	0	
Pipe Discharge:	None	0	Additional Site Features
Water Odor:	Normal	0	Stream Channel Woody Material: Moderate
Fish Passage Barrier:	None	0	Impoundments: None
RB: Riparian Buffer:	60 ft.	0.25	Substrate Composition: Medium Sand
LB: Riparian Buffer:	80 ft.	0.25	Bank Material: Sand
RB: Floodplain Access:	Full	0	Near Bank Stress: High
LB: Floodplain Access:	Partial	0.25	RB Landuse: Natural Forest, Pasture
<b>Severity Scale:</b>		<b>5.25</b>	LB Landuse: Natural Forest, Pasture

Notes: BEHI estimated; 303d: Impaired - Potable Water Supplies (BOD, DO)			
Restoration Option 1

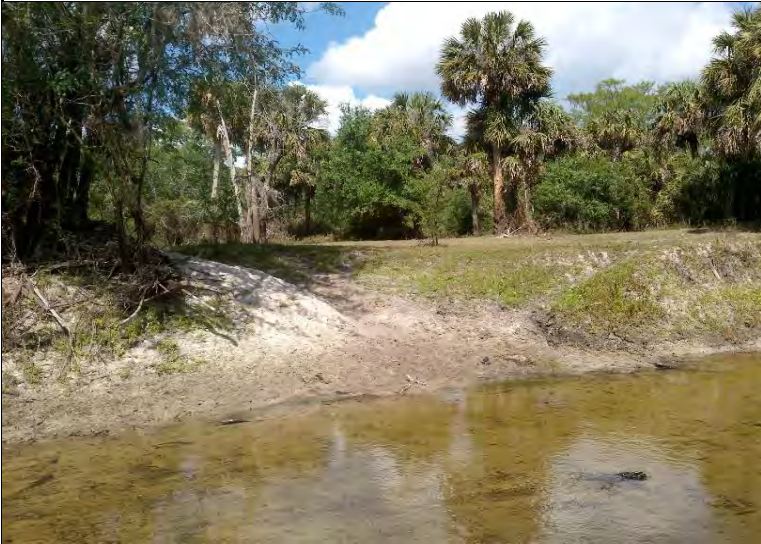
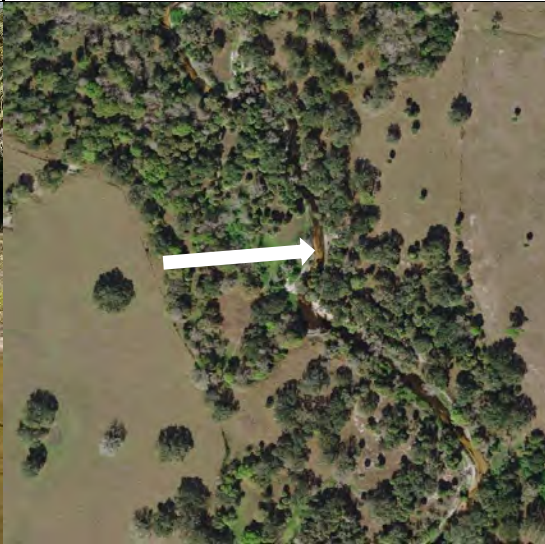
Horse Creek			Severity Scale: 7.25-Moderate	
Watershed: Peace River Subwatershed: Lower Horse Creek Latitude: 27.20480 Longitude: -81.98696			County: Desoto Site Number: PI499 Reach Length: 40 ft. Landowner: V C Hollingsworth SR

<b>Risk Factor</b>	<b>Ranking</b>	<b>Score</b>	<b>*Depth Profile Not Recorded*</b>	
Pfankuch-Channel Stability:	Poor	1.5		
Channel Alteration:	None	0		
Bank Erosion:	Active	1		
BEHI:	Very High	1.5		
Local NPSP:	Obvious Sources	1.5		
Shoring Structures:	None	0	<b>Additional Site Features</b>	
Pipe Discharge:	None	0		
Water Odor:	Normal	0		Stream Channel Woody Material: Infrequent
Fish Passage Barrier:	None	0		Impoundments: None
RB: Riparian Buffer:	0 ft.	0.75		Substrate Composition: Medium Sand
LB: Riparian Buffer:	0 ft.	0.75		Bank Material: Sand
RB: Floodplain Access:	Full	0		Near Bank Stress: Low
LB: Floodplain Access:	Partial	0.25		RB Landuse: Pasture
<b>Severity Scale:</b>		<b>7.25</b>	LB Landuse: Pasture, Natural Forest

Notes: BEHI estimated; 303d: Impaired - Potable Water Supplies (BOD, DO)				
Restoration Option 1

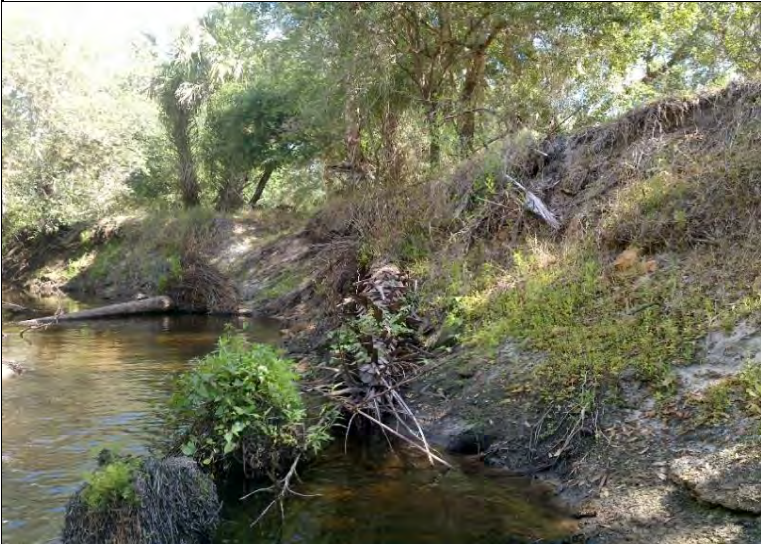
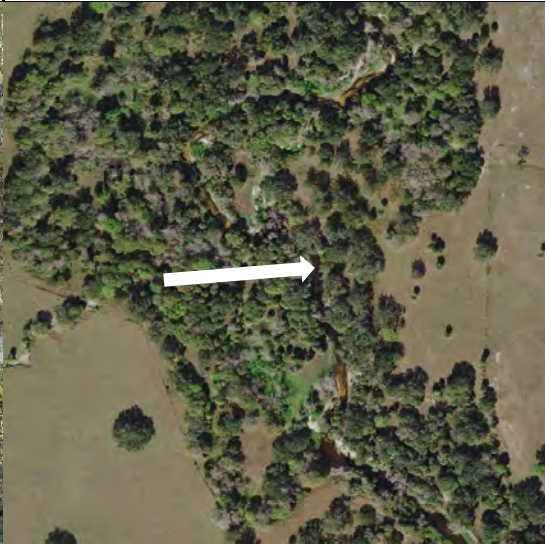
Horse Creek			Severity Scale: 5.75-Moderate
Watershed: Peace River Subwatershed: Lower Horse Creek Latitude: 27.20547 Longitude: -81.98715			County: Desoto Site Number: PI500 Reach Length: 70 ft. Landowner: V C Hollingsworth SR

<b>Risk Factor</b>	<b>Ranking</b>	<b>Score</b>	<b>*Depth Profile Not Recorded*</b>
Pfankuch-Channel Stability:	Poor	1.5	
Channel Alteration:	None	0	
Bank Erosion:	Active	1	
BEHI:	Moderate	0.5	
Local NPSP:	Obvious Sources	1.5	
Shoring Structures:	None	0	
Pipe Discharge:	None	0	<b>Additional Site Features</b>
Water Odor:	Normal	0	Stream Channel Woody Material: Moderate
Fish Passage Barrier:	None	0	Impoundments: None
RB: Riparian Buffer:	80 ft.	0.25	Substrate Composition: Medium Sand
LB: Riparian Buffer:	20 ft.	0.75	Bank Material: Medium Sand
RB: Floodplain Access:	Full	0	Near Bank Stress: High
LB: Floodplain Access:	Partial	0.25	RB Landuse: Pasture, Natural Forest
<b>Severity Scale:</b>		<b>5.75</b>	LB Landuse: Pasture, Natural Forest

Notes: BEHI estimated; 303d: Impaired - Potable Water Supplies (BOD, DO)			
Restoration Option 1

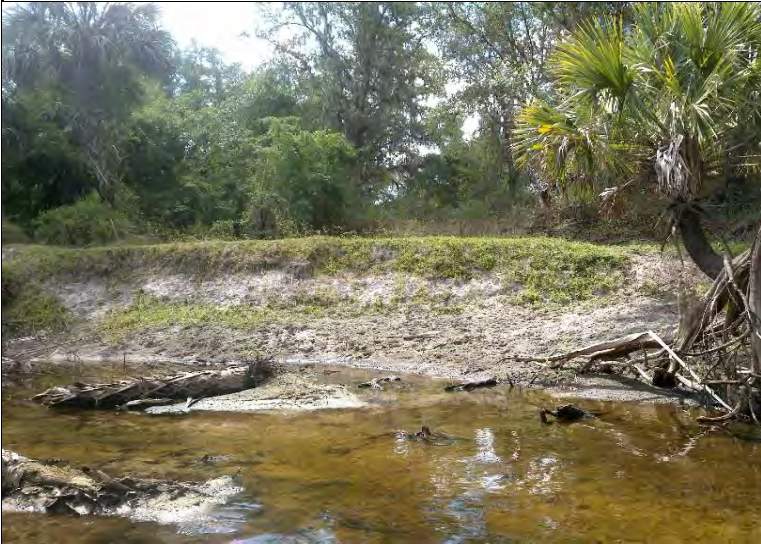
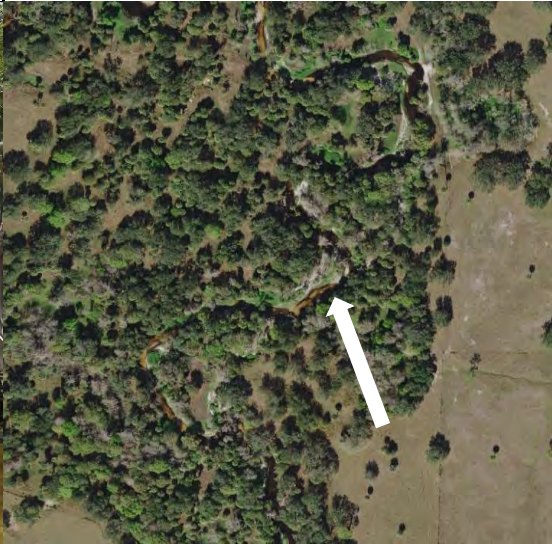
Horse Creek			Severity Scale: 6.0-Moderate
Watershed: Peace River Subwatershed: Lower Horse Creek Latitude: 27.20667 Longitude: -81.98714			County: Desoto Site Number: PI501 Reach Length: 250 ft. Landowner: V C Hollingsworth

Risk Factor	Ranking	Score	*Depth Profile Not Recorded*
Pfankuch-Channel Stability:	Poor	1.5	
Channel Alteration:	None	0	
Bank Erosion:	Active	1	
BEHI:	High	1	
Local NPSP:	Obvious Sources	1.5	
Shoring Structures:	None	0	
Pipe Discharge:	None	0	Additional Site Features
Water Odor:	Normal	0	Stream Channel Woody Material: Numerous
Fish Passage Barrier:	None	0	Impoundments: None
RB: Riparian Buffer:	40 ft.	0.5	Substrate Composition: Medium Sand
LB: Riparian Buffer:	60 ft.	0.25	Bank Material: Sand
RB: Floodplain Access:	Full	0	Near Bank Stress: Moderate
LB: Floodplain Access:	Partial	0.25	RB Landuse: Natural Forest, Pasture
<b>Severity Scale:</b>		<b>6.0</b>	LB Landuse: Natural Forest, Pasture

Notes: BEHI estimated; 303d: Impaired - Potable Water Supplies (BOD, DO)			
Restoration Option 1

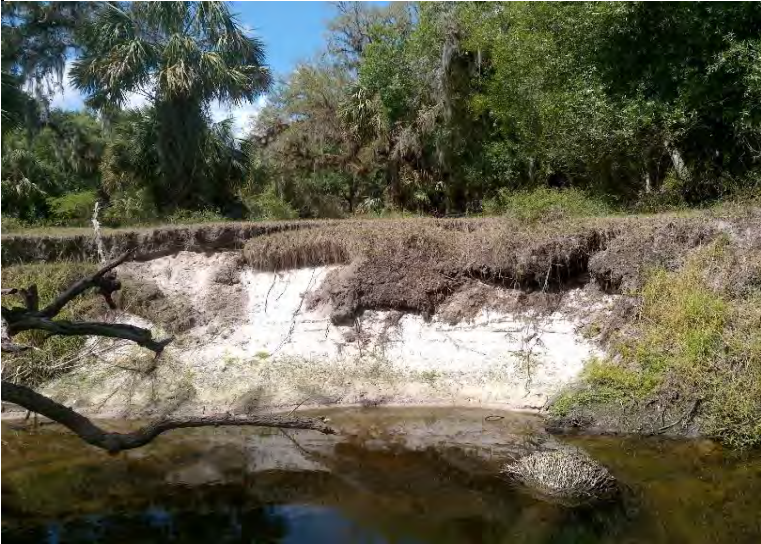
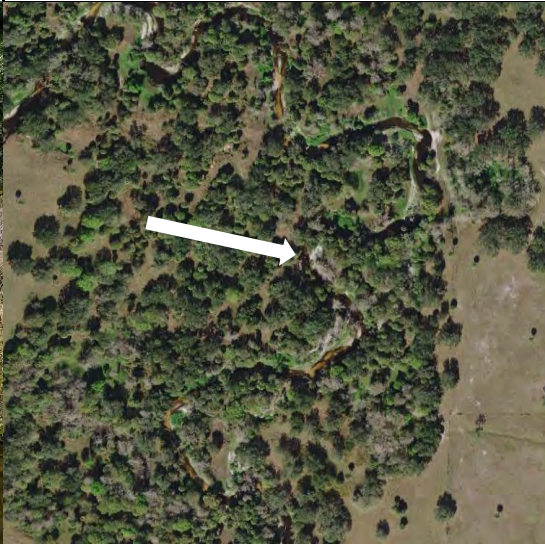
Horse Creek			Severity Scale: 6.75-Moderate
Watershed: Peace River Subwatershed: Lower Horse Creek Latitude: 27.20741 Longitude: -81.98699			County: Desoto Site Number: PI502 Reach Length: 150 ft. Landowner: V C Hollingsworth

<b>Risk Factor</b>	<b>Ranking</b>	<b>Score</b>	<b>*Depth Profile Not Recorded*</b>
Pfankuch-Channel Stability:	Poor	1.5	
Channel Alteration:	None	0	
Bank Erosion:	Mass-wasting	1.5	
BEHI:	High	1	
Local NPSP:	Obvious Sources	1.5	
Shoring Structures:	None	0	
Pipe Discharge:	None	0	<b>Additional Site Features</b>
Water Odor:	Normal	0	Stream Channel Woody Material: Numerous
Fish Passage Barrier:	None	0	Impoundments: None
RB: Riparian Buffer:	0 ft.	0.75	Substrate Composition: Medium Sand
LB: Riparian Buffer:	60 ft.	0.25	Bank Material: Sand
RB: Floodplain Access:	Partial	0.25	Near Bank Stress: High
LB: Floodplain Access:	Full	0	RB Landuse: Pasture, Natural Forest
<b>Severity Scale:</b>		<b>6.75</b>	LB Landuse: Natural Forest, Pasture

Notes: BEHI estimated; 303d: Impaired - Potable Water Supplies (BOD, DO)			
Restoration Option 1

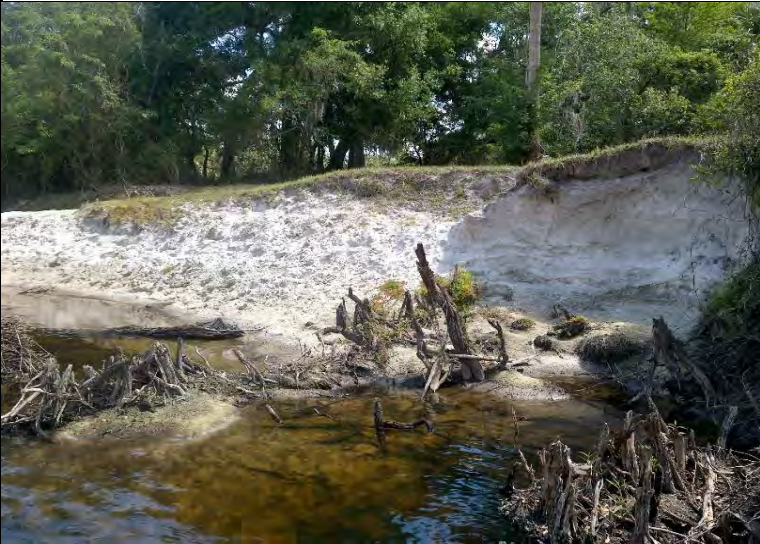
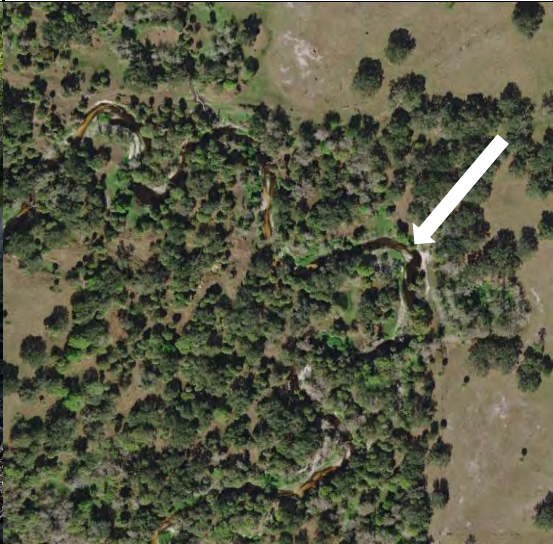
Horse Creek			Severity Scale: 7.0-Moderate
Watershed: Peace River Subwatershed: Lower Horse Creek Latitude: 27.20830 Longitude: -81.98616			County: Desoto Site Number: PI503 Reach Length: 140 ft. Landowner: V C Hollingsworth

Risk Factor	Ranking	Score	*Depth Profile Not Recorded*
Pfankuch-Channel Stability:	Poor	1.5	
Channel Alteration:	None	0	
Bank Erosion:	Mass-wasting	1.5	
BEHI:	Very High	1.5	
Local NPSP:	Obvious Sources	1.5	
Shoring Structures:	None	0	
Pipe Discharge:	None	0	Additional Site Features
Water Odor:	Normal	0	Stream Channel Woody Material: Moderate
Fish Passage Barrier:	None	0	Impoundments: None
RB: Riparian Buffer:	60 ft.	0.25	Substrate Composition: Medium Sand
LB: Riparian Buffer:	0 ft.	0.75	Bank Material: Sand
RB: Floodplain Access:	Full	0	Near Bank Stress: High
LB: Floodplain Access:	Full	0	RB Landuse: Natural Forest, Pasture
Severity Scale:		7.0	LB Landuse: Pasture, Natural Forest

Notes: BEHI estimated; 303d: Impaired - Potable Water Supplies (BOD, DO)			
Restoration Option 1

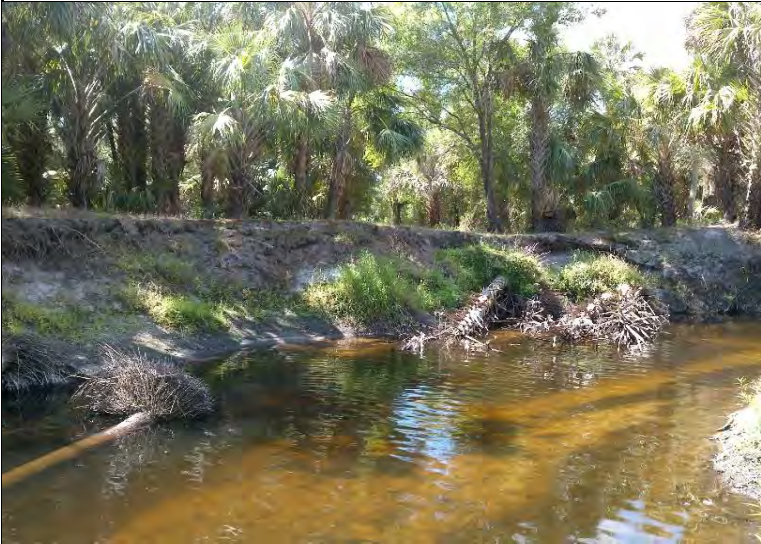
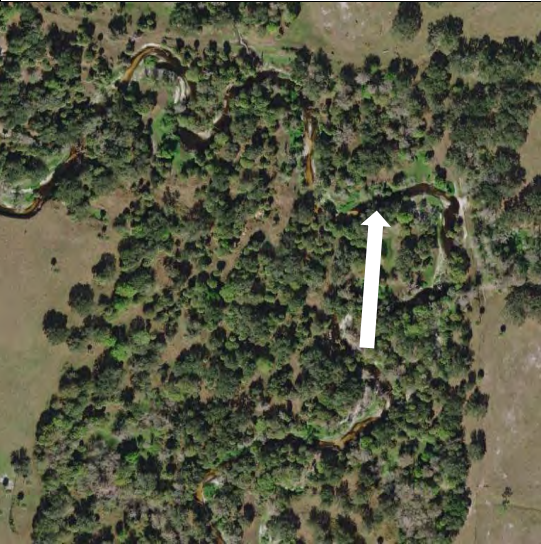
Horse Creek			Severity Scale: 6.0-Moderate	
Watershed: Peace River Subwatershed: Lower Horse Creek Latitude: 27.20838 Longitude: -81.98688			County: Desoto Site Number: PI504 Reach Length: 150 ft. Landowner: V C Hollingsworth

<b>Risk Factor</b>	<b>Ranking</b>	<b>Score</b>	<b>*Depth Profile Not Recorded*</b>	
Pfankuch-Channel Stability:	Poor	1.5		
Channel Alteration:	None	0		
Bank Erosion:	Active	1		
BEHI:	High	1		
Local NPSP:	Obvious Sources	1.5		
Shoring Structures:	None	0	<b>Additional Site Features</b>	
Pipe Discharge:	None	0		
Water Odor:	Normal	0		Stream Channel Woody Material: Numerous
Fish Passage Barrier:	None	0		Impoundments: None
RB: Riparian Buffer:	40 ft.	0.5		Substrate Composition: Medium Sand
LB: Riparian Buffer:	40 ft.	0.5		Bank Material: Sand
RB: Floodplain Access:	Full	0		Near Bank Stress: High
LB: Floodplain Access:	Full	0	RB Landuse: Natural Forest, Pasture	
<b>Severity Scale:</b>		<b>6.0</b>	LB Landuse: Natural Forest, Pasture

Notes: BEHI estimated; 303d: Impaired - Potable Water Supplies (BOD, DO)				
Restoration Option 1

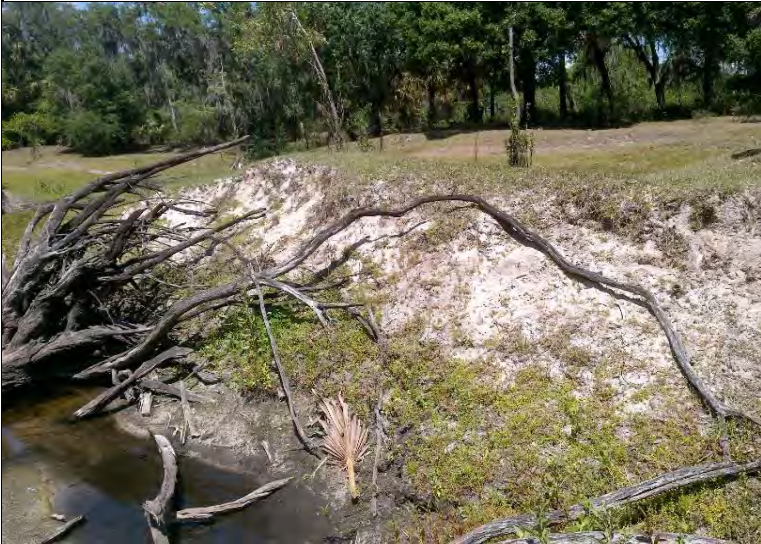
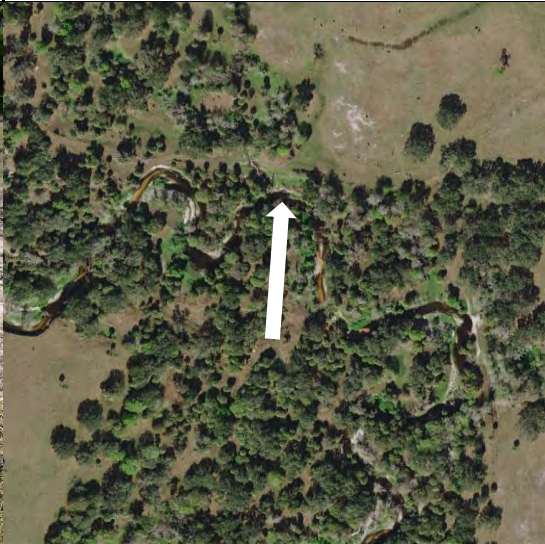
Horse Creek			Severity Scale: 5.5-Moderate
Watershed: Peace River Subwatershed: Lower Horse Creek Latitude: 27.20927 Longitude: -81.98734			County: Desoto Site Number: PI505 Reach Length: 90 ft. Landowner: V C Hollingsworth

<b>Risk Factor</b>	<b>Ranking</b>	<b>Score</b>	<b>*Depth Profile Not Recorded*</b>
Pfankuch-Channel Stability:	Poor	1.5	
Channel Alteration:	None	0	
Bank Erosion:	Active	1	
BEHI:	Moderate	0.5	
Local NPSP:	Obvious Sources	1.5	
Shoring Structures:	None	0	
Pipe Discharge:	None	0	<b>Additional Site Features</b>
Water Odor:	Normal	0	Stream Channel Woody Material: Extensive
Fish Passage Barrier:	None	0	Impoundments: None
RB: Riparian Buffer:	40 ft.	0.5	Substrate Composition: Medium Sand
LB: Riparian Buffer:	40 ft.	0.5	Bank Material: Sand
RB: Floodplain Access:	Full	0	Near Bank Stress: High
LB: Floodplain Access:	Full	0	RB Landuse: Natural Forest, Pasture
<b>Severity Scale:</b>		<b>5.5</b>	LB Landuse: Pasture, Natural Forest

Notes: BEHI estimated; 303d: Impaired - Potable Water Supplies (BOD, DO)			
Restoration Option 1

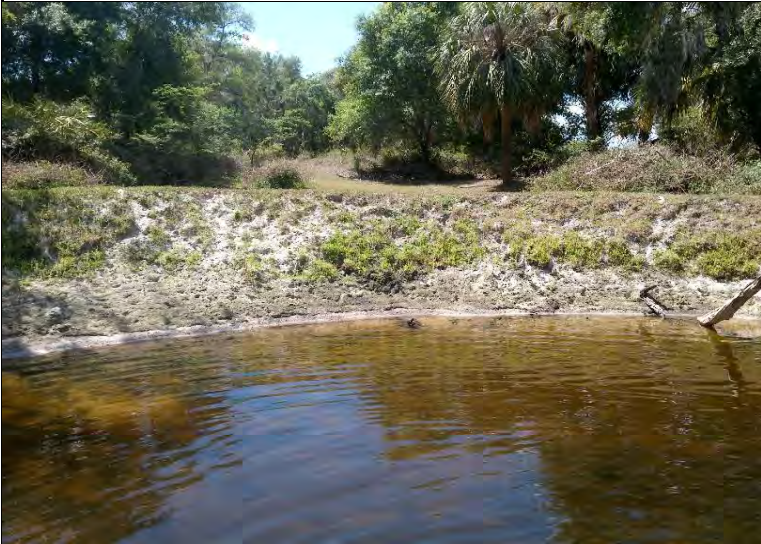
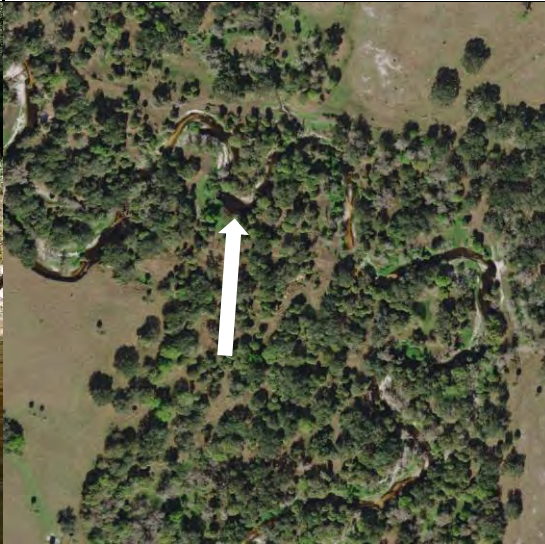
Horse Creek			Severity Scale: 5.25-Moderate
Watershed: Peace River Subwatershed: Lower Horse Creek Latitude: 27.20885 Longitude: -81.98814			County: Desoto Site Number: PI506 Reach Length: 70 ft. Landowner: V C Hollingsworth

<b>Risk Factor</b>	<b>Ranking</b>	<b>Score</b>	<b>*Depth Profile Not Recorded*</b>
Pfankuch-Channel Stability:	Poor	1.5	
Channel Alteration:	None	0	
Bank Erosion:	Active	1	
BEHI:	Moderate	0.5	
Local NPSP:	Obvious Sources	1.5	
Shoring Structures:	None	0	
Pipe Discharge:	None	0	<b>Additional Site Features</b>
Water Odor:	Normal	0	Stream Channel Woody Material: Infrequent
Fish Passage Barrier:	None	0	Impoundments: None
RB: Riparian Buffer:	0 ft.	0.75	Substrate Composition: Medium Sand
LB: Riparian Buffer:	100 ft.	0	Bank Material: Sand
RB: Floodplain Access:	Full	0	Near Bank Stress: Moderate
LB: Floodplain Access:	Full	0	RB Landuse: Pasture, Natural Forest
<b>Severity Scale: 5.25</b>			LB Landuse: Natural Forest

Notes: BEHI estimated; 303d: Impaired - Potable Water Supplies (BOD, DO)			
Restoration Option 1

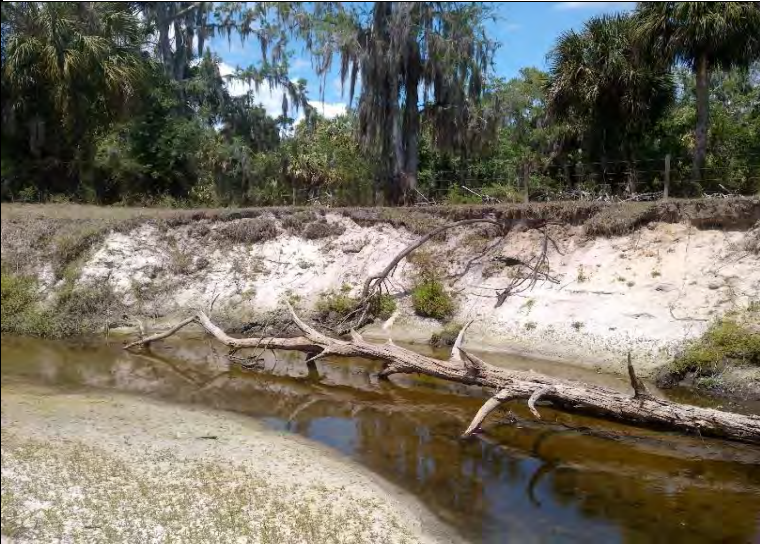
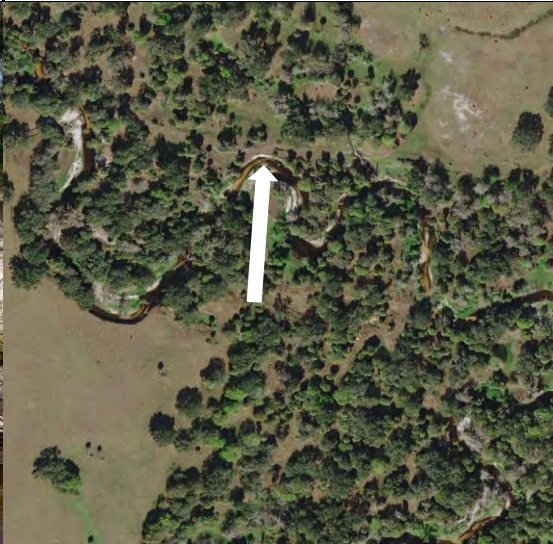
Horse Creek			Severity Scale: 6.25-Moderate
Watershed: Peace River Subwatershed: Lower Horse Creek Latitude: 27.20932 Longitude: -81.98815			County: Desoto Site Number: PI507 Reach Length: 125 ft. Landowner: V C Hollingsworth

Risk Factor	Ranking	Score	*Depth Profile Not Recorded*
Pfankuch-Channel Stability:	Poor	1.5	
Channel Alteration:	None	0	
Bank Erosion:	Mass-wasting	1.5	
BEHI:	High	1	
Local NPSP:	Obvious Sources	1.5	
Shoring Structures:	None	0	
Pipe Discharge:	None	0	Additional Site Features
Water Odor:	Normal	0	Stream Channel Woody Material: Moderate
Fish Passage Barrier:	None	0	Impoundments: None
RB: Riparian Buffer:	100 ft.	0	Substrate Composition: Medium Sand
LB: Riparian Buffer:	0 ft.	0.75	Bank Material: Sand
RB: Floodplain Access:	Full	0	Near Bank Stress: High
LB: Floodplain Access:	Full	0	RB Landuse: Natural Forest
<b>Severity Scale:</b>		<b>6.25</b>	LB Landuse: Pasture, Natural Forest

Notes: BEHI estimated; 303d: Impaired - Potable Water Supplies (BOD, DO)			
Restoration Option 1

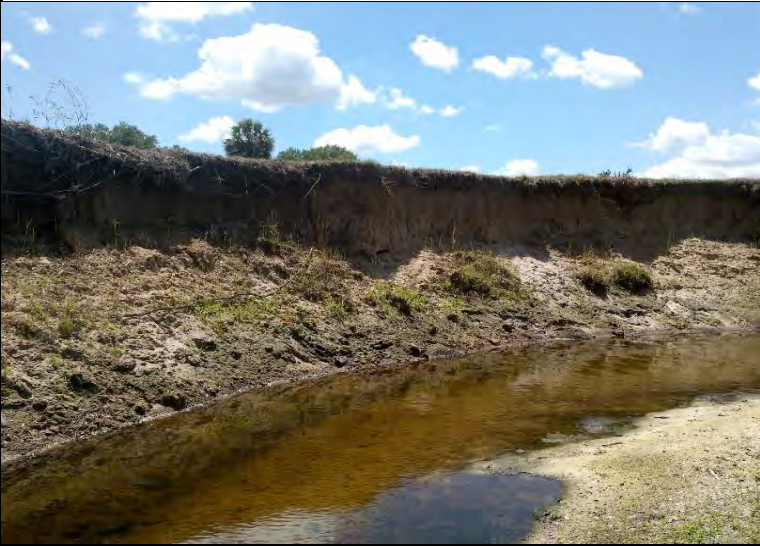
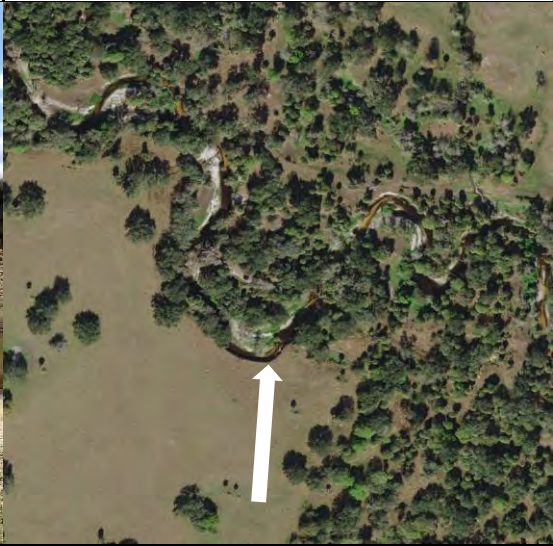
Horse Creek			Severity Scale: 7.5-High
Watershed: Peace River Subwatershed: Lower Horse Creek Latitude: 27.20876 Longitude: -81.98908			County: Desoto Site Number: PI508 Reach Length: 330 ft. Landowner: V C Hollingsworth

Risk Factor	Ranking	Score	*Depth Profile Not Recorded*
Pfankuch-Channel Stability:	Poor	1.5	
Channel Alteration:	None	0	
Bank Erosion:	Mass-wasting	1.5	
BEHI:	Very High	1.5	
Local NPSP:	Obvious Sources	1.5	
Shoring Structures:	None	0	
Pipe Discharge:	None	0	Additional Site Features
Water Odor:	Normal	0	Stream Channel Woody Material: Moderate
Fish Passage Barrier:	None	0	Impoundments: None
RB: Riparian Buffer:	0 ft.	0.75	Substrate Composition: Medium Sand
LB: Riparian Buffer:	40 ft.	0.5	Bank Material: Sandy Clay
RB: Floodplain Access:	Partial	0.25	Near Bank Stress: Moderate
LB: Floodplain Access:	Full	0	RB Landuse: Pasture
<b>Severity Scale:</b>		<b>7.5</b>	LB Landuse: Natural Forest, Pasture

Notes: BEHI estimated; 303d: Impaired - Potable Water Supplies (BOD, DO)			
Restoration Option 1

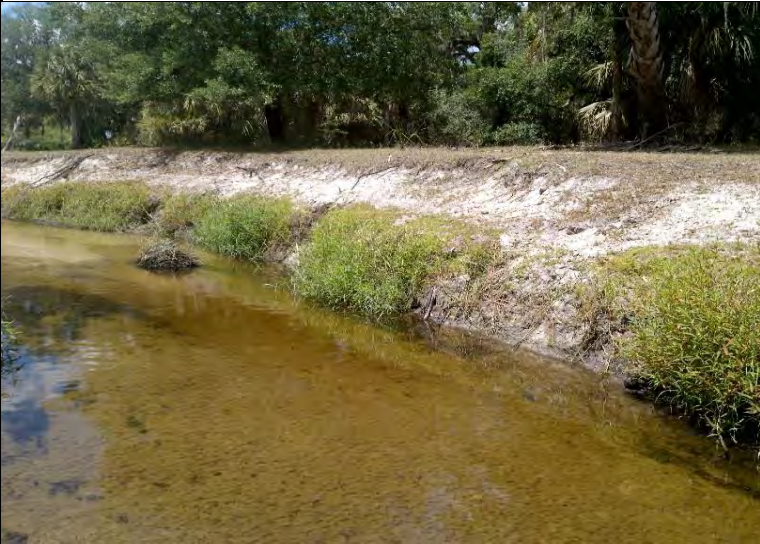
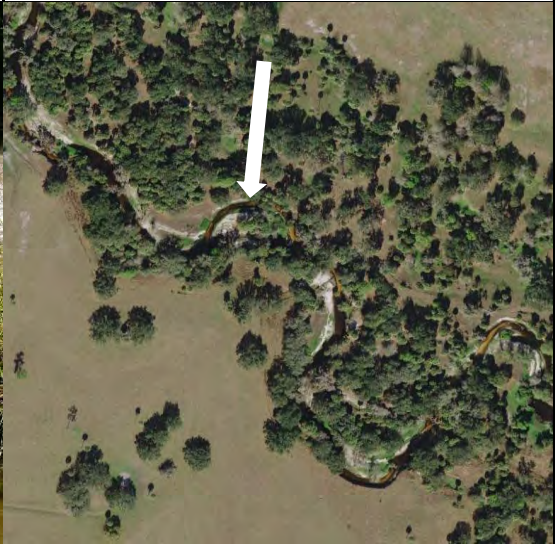
Horse Creek			Severity Scale: 5.75-Moderate
Watershed: Peace River Subwatershed: Lower Horse Creek Latitude: 27.21037 Longitude: -81.99043			County: Desoto Site Number: PI509 Reach Length: 85 ft. Landowner: V C Hollingsworth

Risk Factor	Ranking	Score	*Depth Profile Not Recorded*
Pfankuch-Channel Stability:	Poor	1.5	
Channel Alteration:	None	0	
Bank Erosion:	Active	1	
BEHI:	Moderate	0.5	
Local NPSP:	Obvious Sources	1.5	
Shoring Structures:	None	0	
Pipe Discharge:	None	0	Additional Site Features
Water Odor:	Normal	0	Stream Channel Woody Material: Moderate
Fish Passage Barrier:	None	0	Impoundments: None
RB: Riparian Buffer:	40 ft.	0.5	Substrate Composition: Medium Sand
LB: Riparian Buffer:	20 ft.	0.75	Bank Material: Sand
RB: Floodplain Access:	Full	0	Near Bank Stress: High
LB: Floodplain Access:	Full	0	RB Landuse: Natural Forest, Pasture
Severity Scale:		5.75	LB Landuse: Pasture, Natural Forest

Notes: BEHI estimated; 303d: Impaired - Potable Water Supplies (BOD, DO)			
Restoration Option 1

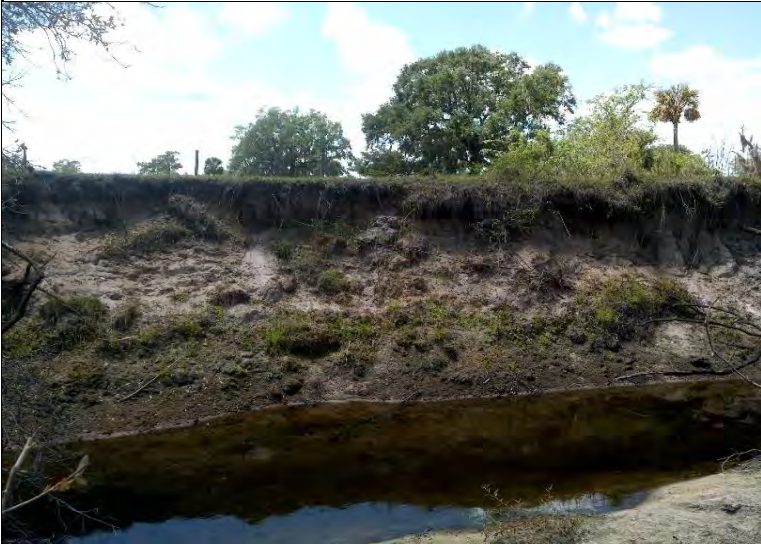
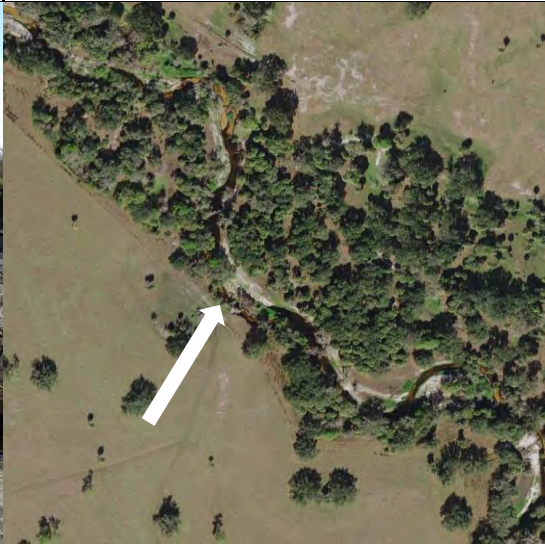
Horse Creek			Severity Scale: 7.5-High
Watershed: Peace River Subwatershed: Lower Horse Creek Latitude: 27.21068 Longitude: -81.99171			County: Desoto Site Number: PI510 Reach Length: 135 ft. Landowner: V C Hollingsworth

Risk Factor	Ranking	Score	*Depth Profile Not Recorded*
Pfankuch-Channel Stability:	Poor	1.5	
Channel Alteration:	None	0	
Bank Erosion:	Mass-wasting	1.5	
BEHI:	Very High	1.5	
Local NPSP:	Obvious Sources	1.5	
Shoring Structures:	None	0	
Pipe Discharge:	None	0	Additional Site Features
Water Odor:	Normal	0	Stream Channel Woody Material: Moderate
Fish Passage Barrier:	None	0	Impoundments: None
RB: Riparian Buffer:	0 ft.	0.75	Substrate Composition: Medium Sand
LB: Riparian Buffer:	40 ft.	0.5	Bank Material: Sand
RB: Floodplain Access:	Partial	0.25	Near Bank Stress: High
LB: Floodplain Access:	Full	0	RB Landuse: Pasture
<b>Severity Scale:</b>		<b>7.5</b>	LB Landuse: Pasture, Natural Forest

Notes: BEHI estimated; 303d: Impaired - Potable Water Supplies (BOD, DO)			
Restoration Option 1

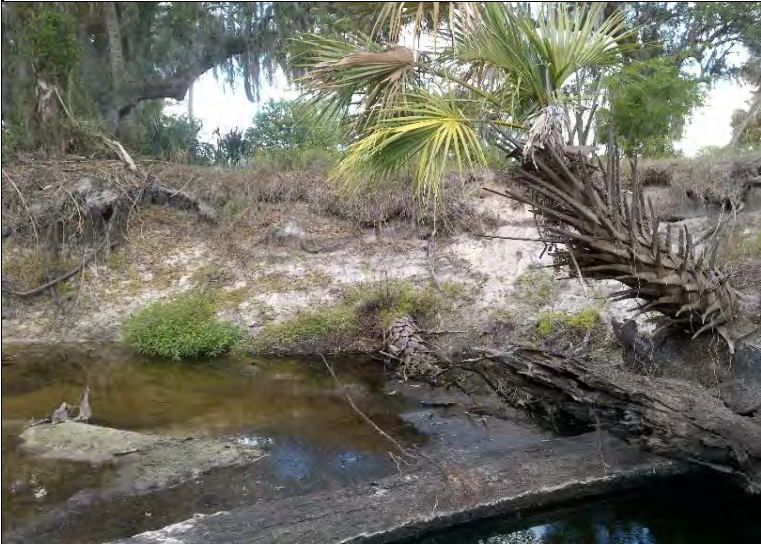
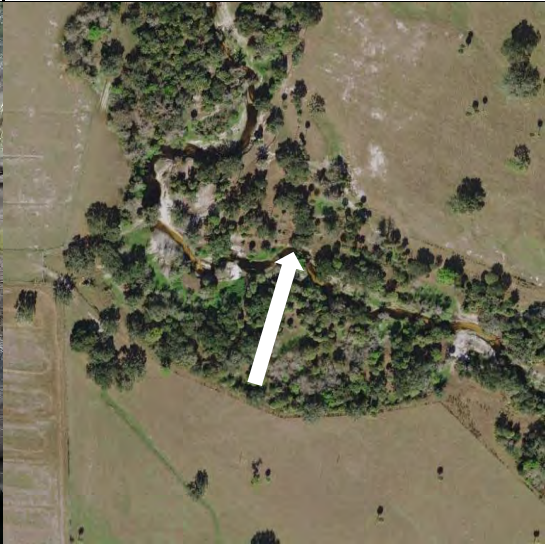
Horse Creek			Severity Scale: 6.0-Moderate
Watershed: Peace River Subwatershed: Lower Charlie Creek Latitude: 27.21068 Longitude: -81.99171			County: Desoto Site Number: PI511 Reach Length: 85 ft. Landowner: V C Hollingsworth

Risk Factor	Ranking	Score	*Depth Profile Not Recorded*
Pfankuch-Channel Stability:	Poor	1.5	
Channel Alteration:	None	0	
Bank Erosion:	Active	1	
BEHI:	High	1	
Local NPSP:	Obvious Sources	1.5	
Shoring Structures:	None	0	
Pipe Discharge:	None	0	Additional Site Features
Water Odor:	Normal	0	Stream Channel Woody Material: Extensive
Fish Passage Barrier:	None	0	Impoundments: None
RB: Riparian Buffer:	80 ft.	0.25	Substrate Composition: Medium Sand
LB: Riparian Buffer:	20 ft.	0.75	Bank Material: Sand
RB: Floodplain Access:	Full	0	Near Bank Stress: High
LB: Floodplain Access:	Full	0	RB Landuse: Natural Forest, Pasture
<b>Severity Scale:</b>		<b>6.0</b>	LB Landuse: Pasture, Natural Forest

Notes: BEHI estimated; 303d: Impaired - Potable Water Supplies (BOD, DO)			
Restoration Option 1

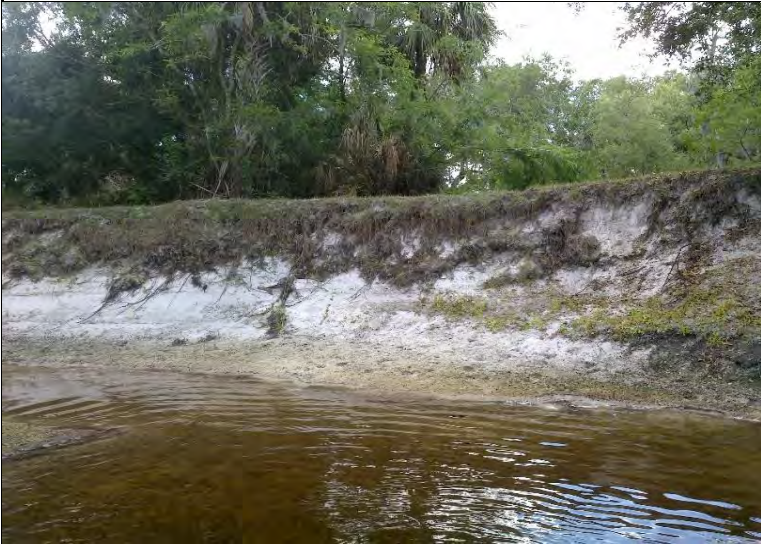
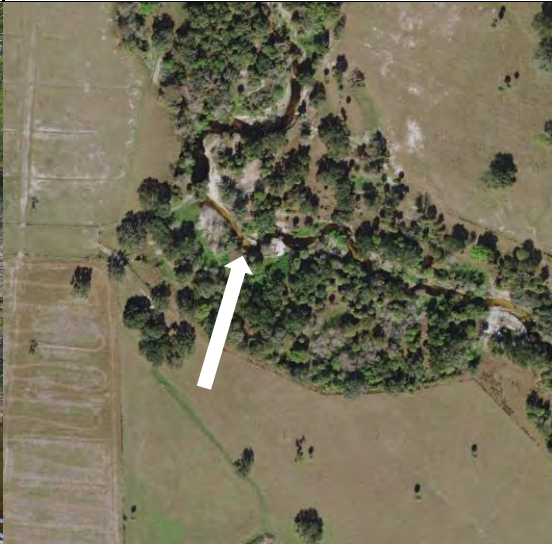
Horse Creek			Severity Scale: 6.25-Moderate
Watershed: Peace River Subwatershed: Lower Horse Creek Latitude: 27.21337 Longitude: -81.99566			County: Desoto Site Number: PI512 Reach Length: 75 ft. Landowner: V C Hollingsworth

Risk Factor	Ranking	Score	*Depth Profile Not Recorded*
Pfankuch-Channel Stability:	Poor	1.5	
Channel Alteration:	None	0	
Bank Erosion:	Active	1	
BEHI:	High	1	
Local NPSP:	Obvious Sources	1.5	
Shoring Structures:	None	0	
Pipe Discharge:	None	0	Additional Site Features
Water Odor:	Normal	0	Stream Channel Woody Material: Infrequent
Fish Passage Barrier:	None	0	Impoundments: None
RB: Riparian Buffer:	0 ft.	0.75	Substrate Composition: Medium Sand
LB: Riparian Buffer:	40 ft.	0.5	Bank Material: Sand
RB: Floodplain Access:	Full	0	Near Bank Stress: Moderate
LB: Floodplain Access:	Full	0	RB Landuse: Pasture
<b>Severity Scale:</b>		<b>6.25</b>	LB Landuse: Pasture, Natural Forest

Notes: BEHI estimated; 303d: Impaired - Potable Water Supplies (BOD, DO)			
Restoration Option 1

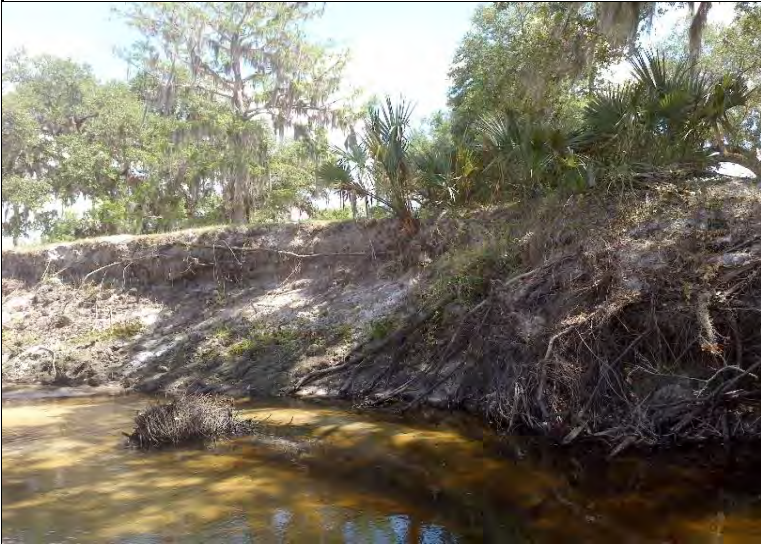
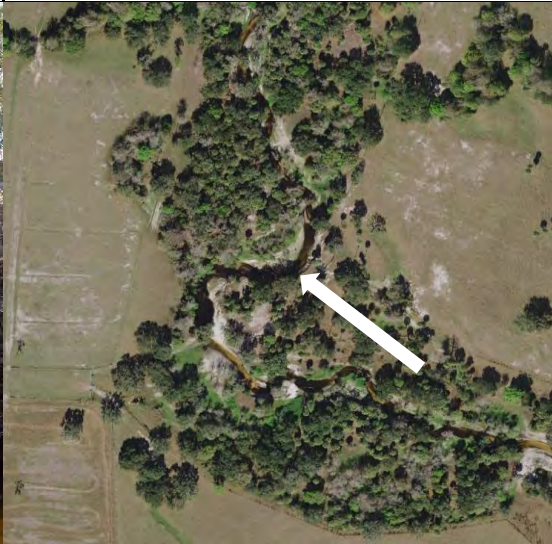
Horse Creek			Severity Scale: 7.0-Moderate
Watershed: Peace River Subwatershed: Lower Horse Creek Latitude: 27.21422 Longitude: -81.99580			County: Desoto Site Number: PI513 Reach Length: 180 ft. Landowner: V C Hollingsworth

Risk Factor	Ranking	Score	*Depth Profile Not Recorded*
Pfankuch-Channel Stability:	Poor	1.5	
Channel Alteration:	None	0	
Bank Erosion:	Mass-wasting	1.5	
BEHI:	Very High	1.5	
Local NPSP:	Obvious Sources	1.5	
Shoring Structures:	None	0	
Pipe Discharge:	None	0	Additional Site Features
Water Odor:	Normal	0	Stream Channel Woody Material: Numerous
Fish Passage Barrier:	None	0	Impoundments: None
RB: Riparian Buffer:	100 ft.	0	Substrate Composition: Medium Sand
LB: Riparian Buffer:	20 ft.	0.75	Bank Material: Sand
RB: Floodplain Access:	Full	0	Near Bank Stress: High
LB: Floodplain Access:	Partial	0.25	RB Landuse: Pasture, Natural Forest
<b>Severity Scale:</b>		<b>7.0</b>	LB Landuse: Natural Forest

Notes: BEHI estimated; 303d: Impaired - Potable Water Supplies (BOD, DO)			
Restoration Option 1

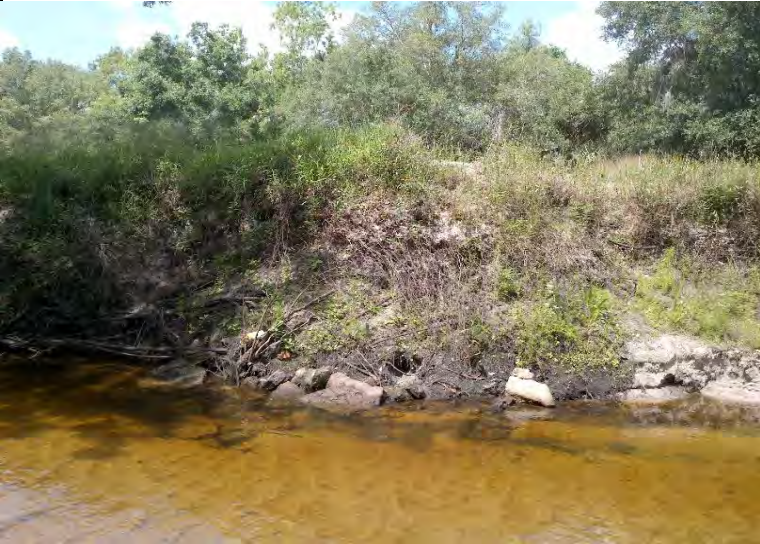
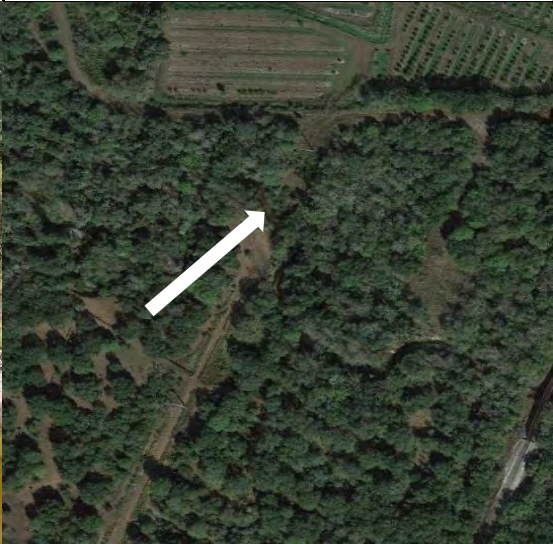
Joshua Creek			Severity Scale: 3.75-Low
Watershed: Peace River Subwatershed: Lower Joshua Creek Latitude: 27.16807 Longitude: -81.88316			County: De Soto Site Number: PI514 Reach Length: 60 ft. Landowner: Golden Ranch Farms LLC

Risk Factor	Ranking	Score	*Depth Profile Not Recorded*
Pfankuch-Channel Stability:	Good	0	
Channel Alteration:	None	0	
Bank Erosion:	Active	1	
BEHI:	Moderate	0.5	
Local NPSP:	No Evidence	0	
Shoring Structures:	Present	1.5	
Pipe Discharge:	None	0	Additional Site Features
Water Odor:	Normal	0	Stream Channel Woody Material: Infrequent
Fish Passage Barrier:	None	0	Impoundments: None
RB: Riparian Buffer:	100 ft.	0	Substrate Composition: Medium Sand
LB: Riparian Buffer:	0 ft.	0.75	Bank Material: Sand
RB: Floodplain Access:	Full	0	Near Bank Stress: Very High
LB: Floodplain Access:	Full	0	RB Landuse: Natural Forest
<b>Severity Scale:</b>		<b>3.75</b>	LB Landuse: Utilities
Notes: BEHI estimated; 303d: Impaired - Aquatic Life Harvesting (DO)

Restoration Option 1

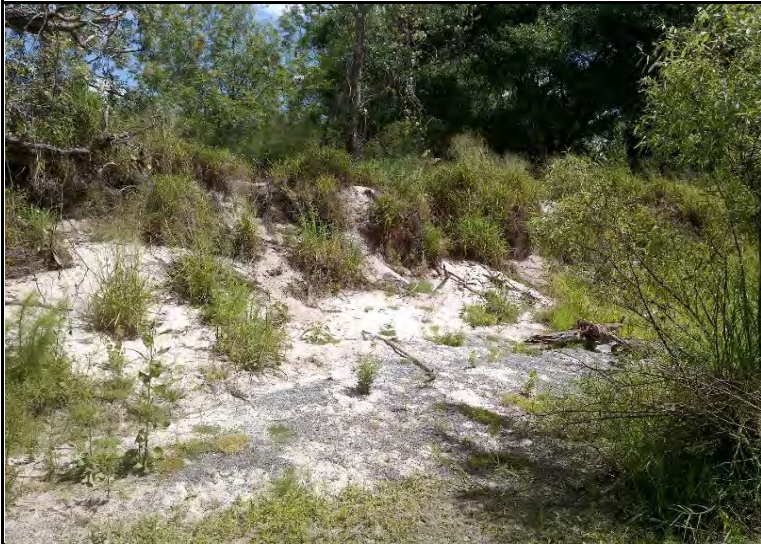
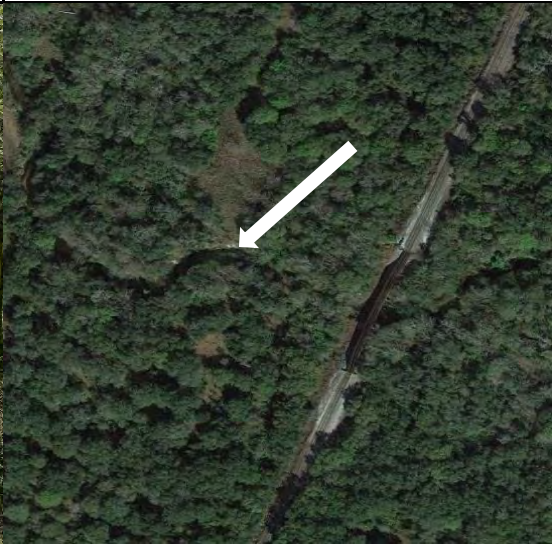
Joshua Creek			Severity Scale: 2.0-Low	
Watershed: Peace River Subwatershed: Lower Joshua Creek Latitude: 27.167577 Longitude: -81.882168			County: De Soto Site Number: PI515 Reach Length: 80 ft. Landowner: DD & TR Geraci

Risk Factor		Ranking	Score	*Depth Profile Not Recorded*
Pfankuch-Channel Stability:		Good	0	
Channel Alteration:		None	0	
Bank Erosion:		Active	1	
BEHI:		Moderate	0.5	
Local NPSP:		No Evidence	0	
Shoring Structures:		None	0	
Pipe Discharge:		None	0	Additional Site Features
Water Odor:		Normal	0	Stream Channel Woody Material: Moderate
Fish Passage Barrier:		None	0	Impoundments: None
RB: Riparian Buffer:		40 ft	0.5	Substrate Composition: Medium Sand
LB: Riparian Buffer:		100 ft	0	Bank Material: Sand
RB: Floodplain Access:		Full	0	Near Bank Stress: Low
LB: Floodplain Access:		Full	0	RB Landuse: Pasture, Natural Forest
Severity Scale:			2.0	LB Landuse: Natural Forest
Notes: BEHI estimated; 303d: Impaired - Aquatic Life Harvesting (DO)

Restoration Option 1
