# **Peace River and Withlacoochee River Threats Assessments and Fish Assemblage Monitoring**

**Final Report July 1, 2015 – June 30, 2019**

Submitted to Florida State Wildlife Grants Program  
August 1, 2019  
PID: 98462501284

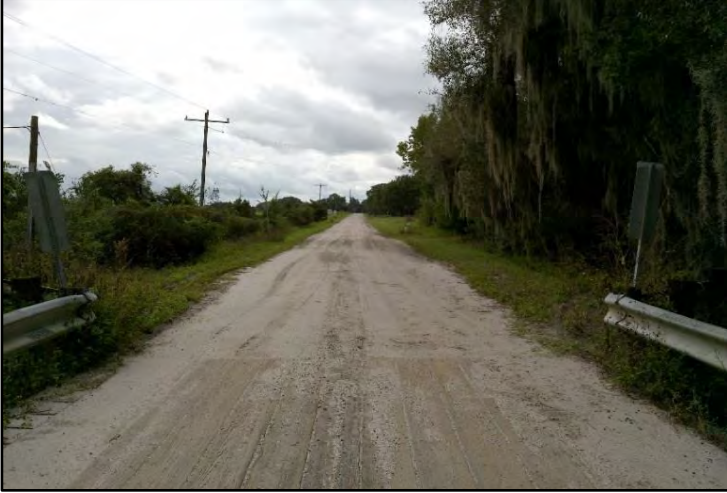
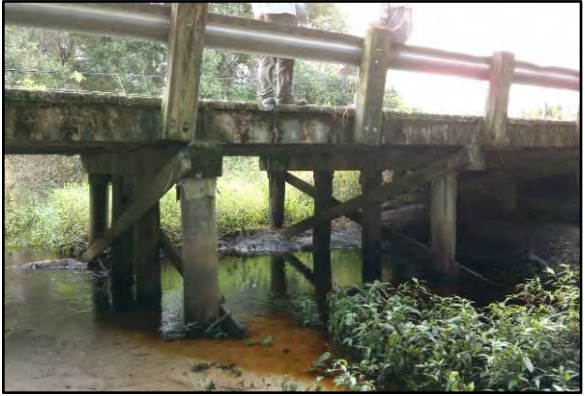
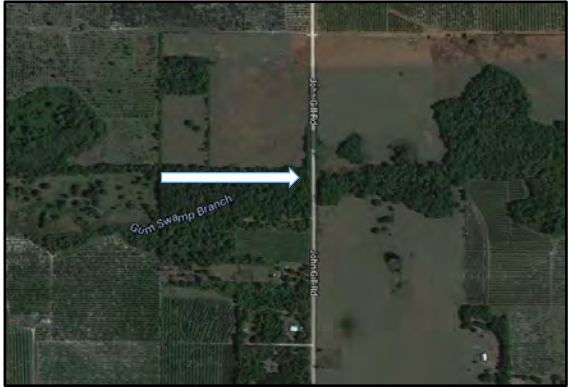
<p>Right Approach from Crossing Structure</p>

Gum Swamp Branch			Sediment Risk Index: 52-Low	
Watershed: Peace River Subwatershed: Upper Payne Creek Latitude: 27.601247 Longitude: -81.969113 Road Name: John Gill Rd.			County: Hardee Site Number: PU001 LULC: Cropland, pasture, tree crops & bottomland forest Landowner(s): Ronnie Albritton*

US Channel Morph	E	5		
DS Channel Morph	E	5		
DS Bank Alteration	Natural	5		
Upstream Skew Angle	< 5°	5		
Crossing fill condition	Vegetated	5		
Inlet/Outlet Condition	Sediment Islands	3		
Potential Eroded Vol.	> 40 c.y.	1		
Soil K Factor	≤ 0.20	5		
Approach Slope Mean	≤ 2.0%	5		
Road Approach Material	All Aggregate	5		
Upstream Rt Outlet	Vegetated	1		
Upstream Lt Outlet	Vegetated	1		
Upstream Rt Ditch	Vegetated	1		
Upstream Lt Ditch	Bare Soil	0		
Downstream Rt Outlet	Vegetated	1		
Downstream Lt Outlet	Vegetated	1

Downstream Rt Ditch	Vegetated	1		
Downstream Lt Ditch	Vegetated	1		
Improved Outlet Total	4	1		
Improved Ditches Total	3	0		
<b>SRI Total:</b>		<b>52</b>	<b>Additional Site Features</b> Crossing Type and Quantity: Bridge Crossing Material: Wood Culvert Outfall Drop: NA Fish Passage Barrier: Not Present Notes: Perched tributary flowing into Gum Swamp Branch from US left bank contributing high amounts of sediment. *Additional land owners: James & Betty Grunholzer.

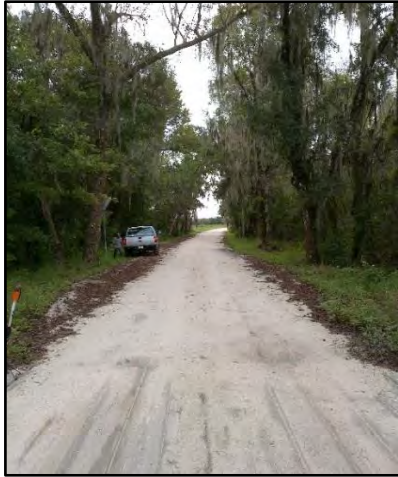
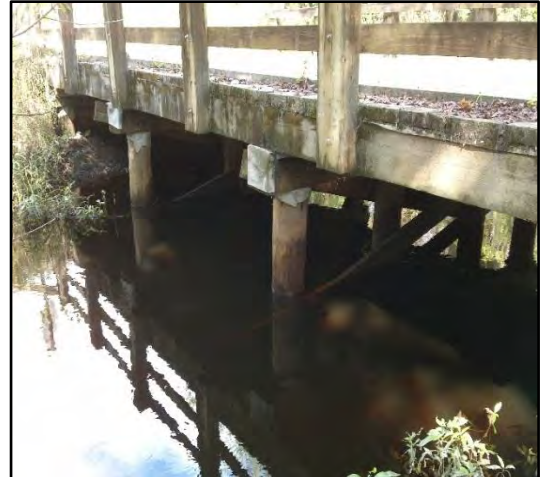
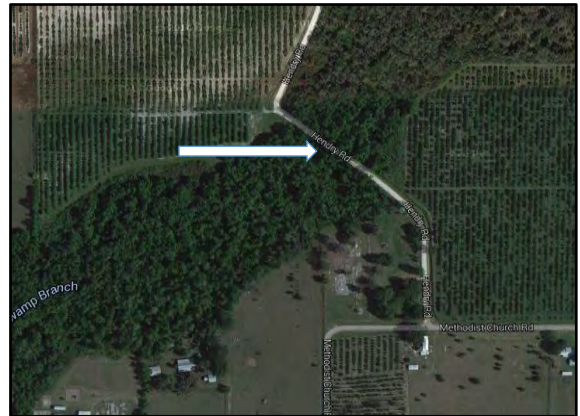
Right Approach from Crossing Structure

County: Hardee  
Site Number: PU002  
LULC: Cropland, pasture, tree crops & bottomland forest  
Landowner(s): Sean & Kathy Murphy\*

Risk Factor	Ranking	Score
US Channel Morph	E	5
DS Channel Morph	E	5
DS Bank Alteration	Natural	5
Upstream Skew Angle	<5°	5
Crossing fill condition	Vegetated	5
Inlet/Outlet Condition	No Impairment	5
Potential Eroded Vol.	≤ 21 c.y.	5
Soil K Factor	≤ 0.20	5
Approach Slope Mean	≤ 2.0%	5
Road Approach Material	All Aggregate	5
Upstream Rt Outlet	Vegetated	1
Upstream Lt Outlet	Vegetated	1
Upstream Rt Ditch	Vegetated	1
Upstream Lt Ditch	Vegetated	1
Downstream Rt Outlet	Vegetated	1
Downstream Lt Outlet	Vegetated	1
Downstream Rt Ditch	Vegetated	1
Downstream Lt Ditch	Vegetated	1
Improved Outlet Total	4	1
Improved Ditches Total	4	1
<b>SRI Total:</b>		<b>60</b>

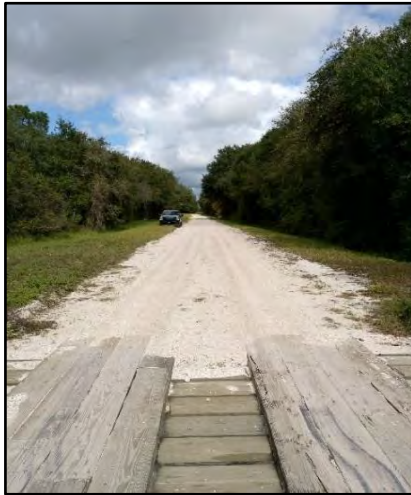
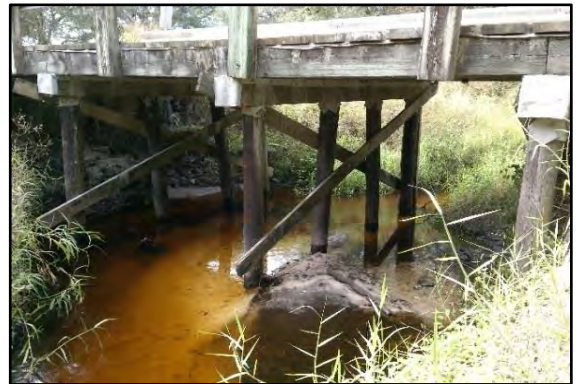
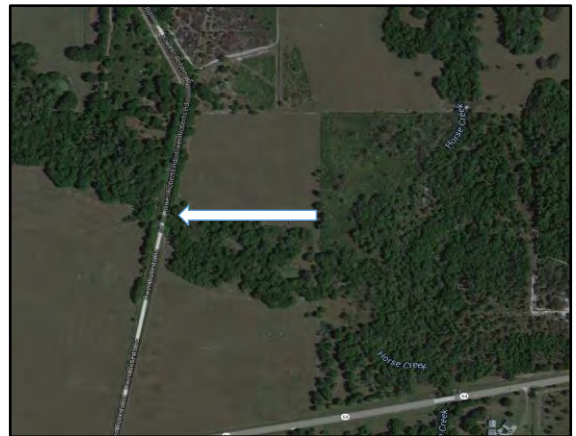
Left Approach from Crossing Structure

County: Hardee  
Site Number: PU003  
LULC: Bottomland forest, crops and pastureland & mixed rangeland  
Landowner(s): IMC Phosphates Co.

Risk Factor	Ranking	Score
US Channel Morph	C	5
DS Channel Morph	C	5
DS Bank Alteration	Minor or Partial	3
Upstream Skew Angle	< 5°	5
Crossing fill condition	Good/Vegetated	5
Inlet/Outlet Condition	Sediment/Scouring	3
Potential Eroded Vol.	< 21 c.y.	5
Soil K Factor	≤ 0.20	5
Approach Slope Mean	≤ 2.0%	5
Road Approach Material	All Aggregate	5
Upstream Rt Outlet	Vegetated	1
Upstream Lt Outlet	Vegetated	1
Upstream Rt Ditch	Vegetated	1
Upstream Lt Ditch	Vegetated	1
Downstream Rt Outlet	Vegetated	1
Downstream Lt Outlet	Vegetated	1
Downstream Rt Ditch	Vegetated	1
Downstream Lt Ditch	Vegetated	1
Improved Outlet Total	4	1
Improved Ditches Total	4	1
SRI Total:		56

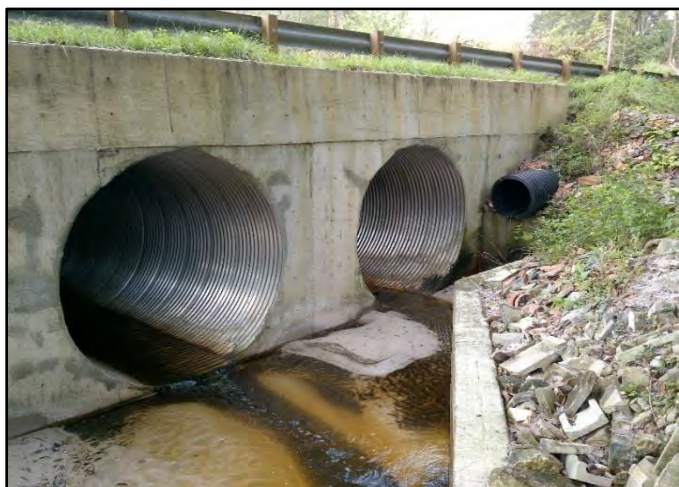
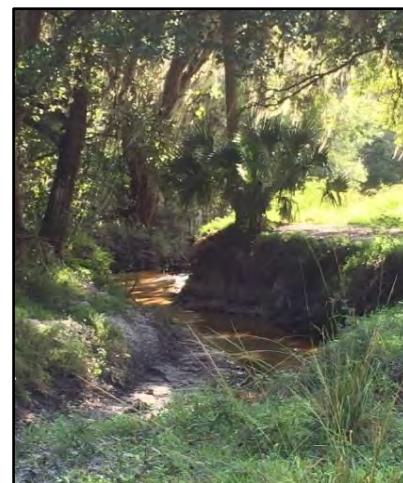
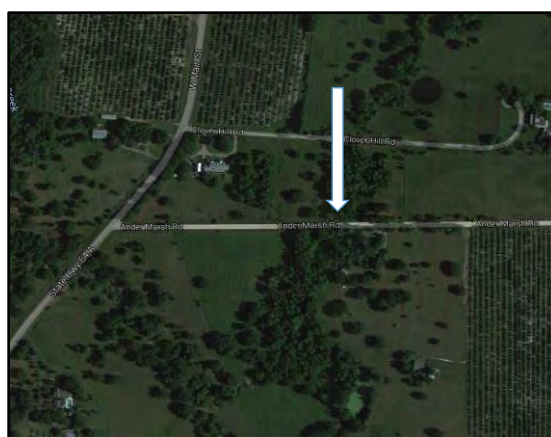
Crossing Structure: DS

County: Hardee  
Site Number: PU004  
LULC: Cropland, pastureland, low density residential & bottomland forest  
Landowner(s): David & Jane Durando\*

Risk Factor	Ranking	Score
US Channel Morph	E	5
DS Channel Morph	E	5
DS Bank Alteration	High	1
Upstream Skew Angle	<5°	5
Crossing fill condition	Fair/riprap	3
Inlet/Outlet Condition	Sediment/Scouring	3
Potential Eroded Vol.	< 21 c.y.	5
Soil K Factor	≤0.20	5
Approach Slope Mean	2.1% - 4.0%	3
Road Approach Material	All Aggregate	5
Upstream Rt Outlet	Vegetated	1
Upstream Lt Outlet	Vegetated	1
Upstream Rt Ditch	Vegetated	1
Upstream Lt Ditch	Vegetated	1
Downstream Rt Outlet	Riprap	1
Downstream Lt Outlet	Other	0
Downstream Rt Ditch	Vegetated	1
Downstream Lt Ditch	Vegetated	1
Improved Outlet Total	3	0
Improved Ditches Total	4	1
<b>SRI Total:</b>		<b>48</b>

Crossing Type and Quantity: Culvert (2)  
Crossing Material: Cor. metal & concrete  
Culvert Outfall Drop: 3 in.  
Fish Passage Barrier: Present  
Notes: Fish passage barrier caused by drop off from concrete pad; incised stream; cattle access, fencing DS. \*Additional land owners: B Carlton, K & D Oden

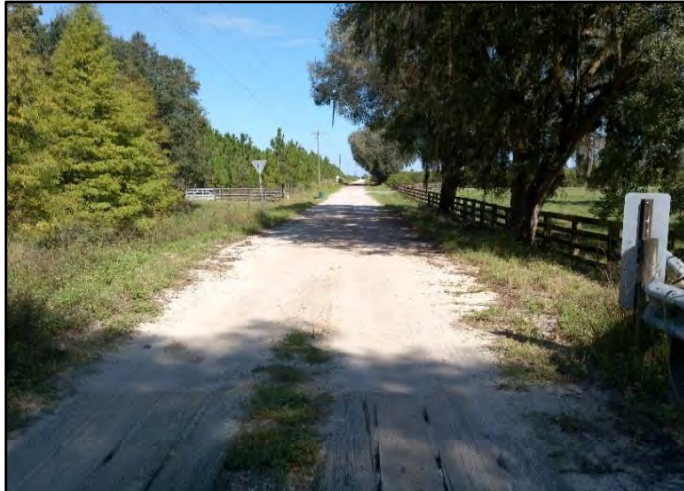
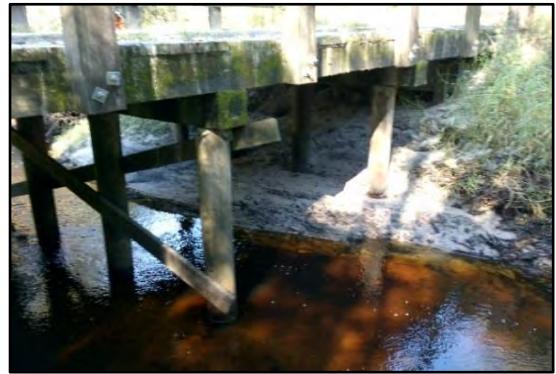
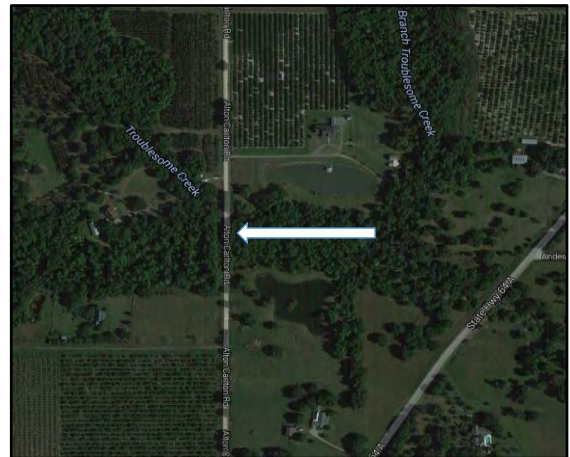
Left Approach from Crossing Structure

County: Hardee  
Site Number: PU005  
LULC: Tree crops, other open land & low density residential  
Landowner(s): ML & Carolyn Coker\*

Risk Factor	Ranking	Score
US Channel Morph	E	5
DS Channel Morph	C	5
DS Bank Alteration	High	1
Upstream Skew Angle	< 5°	5
Crossing fill condition	Fair	3
Inlet/Outlet Condition	Sediment/Scouring	3
Potential Eroded Vol.	> 40 c.y.	1
Soil K Factor	≤ 0.20	5
Approach Slope Mean	≤ 2.0%	5
Road Approach Material	Agg + Native Soil	3
Upstream Rt Outlet	Vegetated	1
Upstream Lt Outlet	Vegetated	1
Upstream Rt Ditch	Bare Soil	0
Upstream Lt Ditch	Bare Soil	0
Downstream Rt Outlet	Bare Soil	0
Downstream Lt Outlet	Bare Soil	0
Downstream Rt Ditch	Bare Soil	0
Downstream Lt Ditch	Vegetated	1
Improved Outlet Total	2	1
Improved Ditches Total	1	2
SRI Total:		42

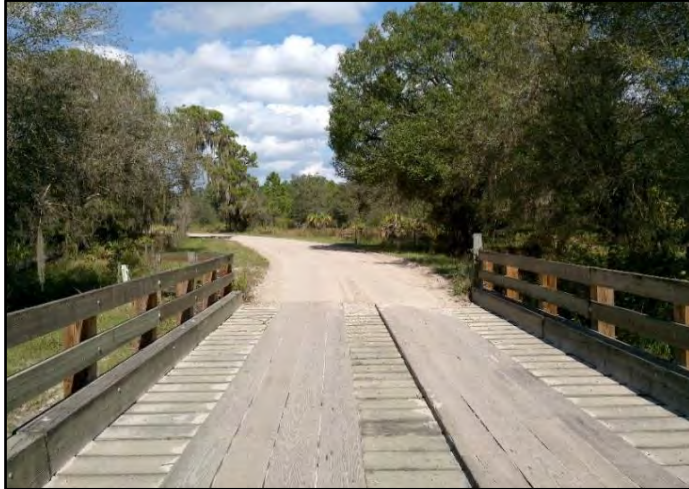
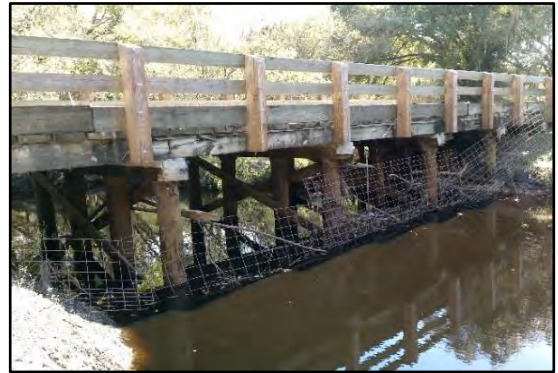
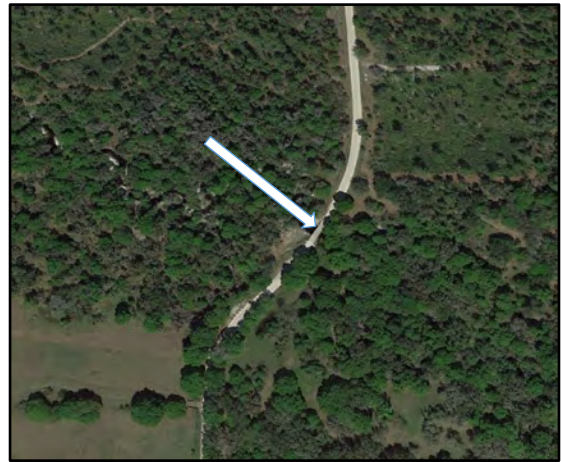
Right Approach from Crossing Structure

County: Hardee  
Site Number: PU006  
LULC: Pastureland, citrus groves  
Landowner(s): Citra Lee Partnership

Risk Factor	Ranking	Score
US Channel Morph	E	5
DS Channel Morph	E	5
DS Bank Alteration	High	1
Upstream Skew Angle	< 5°	5
Crossing fill condition	Good-Fair	4
Inlet/Outlet Condition	Sediment/Scouring	3
Potential Eroded Vol.	21-40 c.y.	3
Soil K Factor	≤ 0.20	5
Approach Slope Mean	≤ 2.0%	5
Road Approach Material	Agg + Native Soil	3
Upstream Rt Outlet	Vegetated	1
Upstream Lt Outlet	Bare Soil	0
Upstream Rt Ditch	Vegetated	1
Upstream Lt Ditch	Vegetated	1
Downstream Rt Outlet	Bare Soil	0
Downstream Lt Outlet	Vegetated	1
Downstream Rt Ditch	Vegetated	1
Downstream Lt Ditch	Vegetated	1
Improved Outlet Total	2	1
Improved Ditches Total	4	1
<b>SRI Total:</b>		<b>47</b>

Notes: Cattle access, potential fish passage barrier due to downstream fence and associated debris jam build up

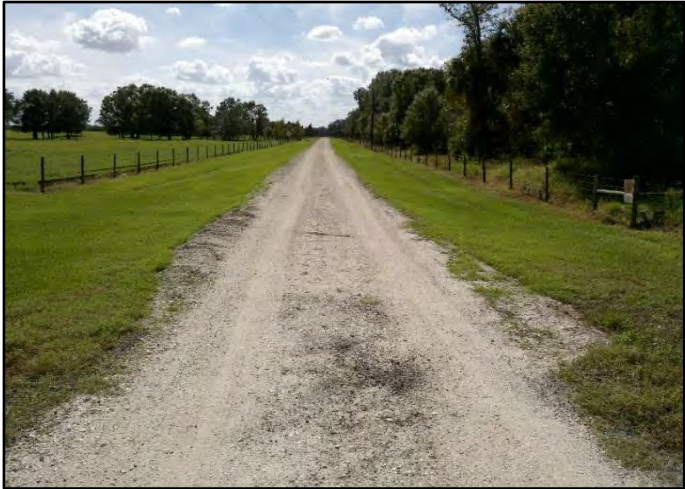
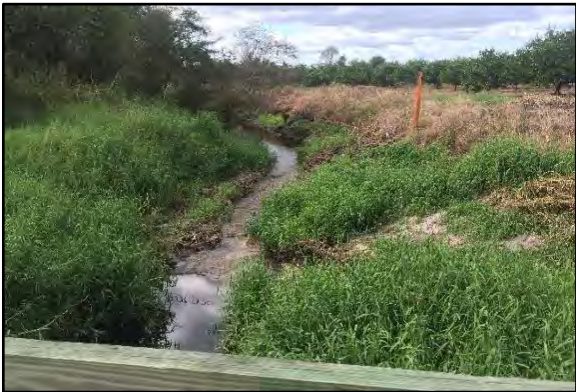
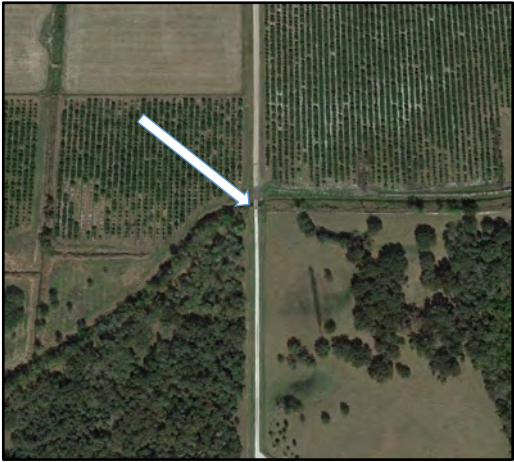
<p>Left Approach from Crossing Structure</p>

Mineral Branch			Sediment Risk Index: 47-Low	
Watershed: Peace River Subwatershed: Middle Charlie Creek Latitude: 27.454056 Longitude: -81.723300 Road Name: Mineral Branch Rd.			County: Hardee Site Number: PU007 LULC: Citrus groves, pastureland Landowner(s): Square D Ranch LTD LLP*

US Channel Morph	D	1		
DS Channel Morph	E	5		
DS Bank Alteration	High	1		
Upstream Skew Angle	< 5°	5		
Crossing fill condition	Good-Fair	4		
Inlet/Outlet Condition	Sediment/Scouring	3		
Potential Eroded Vol.	< 21 c.y.	5		
Soil K Factor	≤ 0.20	5		
Approach Slope Mean	≤ 2.0%	5		
Road Approach Material	All Aggregate	5		
Upstream Rt Outlet	Vegetated	1		
Upstream Lt Outlet	Synthetic	1		
Upstream Rt Ditch	Vegetated	1		
Upstream Lt Ditch	Vegetated	1		
Downstream Rt Outlet	Bare Soil	0		
Downstream Lt Outlet	Vegetated	1

Downstream Rt Ditch	Vegetated	1		
Downstream Lt Ditch	Vegetated	1		
Improved Outlet Total	3	0		
Improved Ditches Total	4	1		
SRI Total:		47	Additional Site Features	
			Crossing Type and Quantity: Bridge	
			Crossing Material: Wood	
			Culvert Outfall Drop: NA	
			Fish Passage Barrier: Not Present	
			Notes: *Additional land owners: The Carleton Group LLC, Dixie Belle Groves Partnership

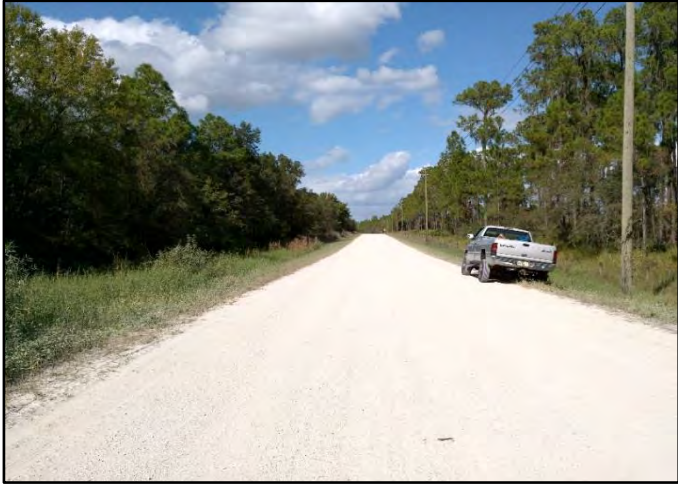
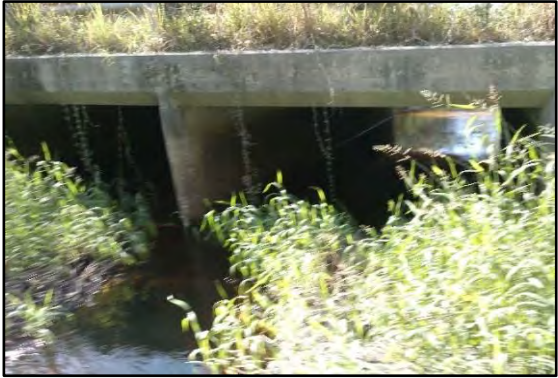
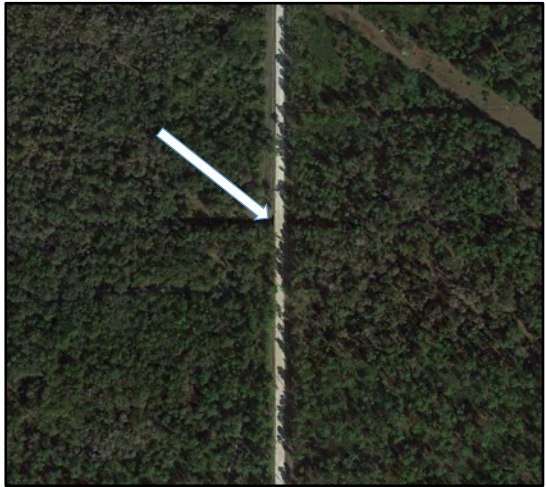
<p>Right Approach from Crossing Structure</p>

Old Town Creek			Sediment Risk Index: 56-Low	
Watershed: Peace River Subwatershed: Charlie Creek Headwaters Latitude: 27.6310 Longitude: -81.620490 Road Name: Old Town Creek Rd.			County: Hardee Site Number: PU008 LULC: Natural Forest, Pasture Land Owner(s): Crews Groves Inc, 660 LLC

US Channel Morph	DA	3		
DS Channel Morph	E	5		
DS Bank Alteration	Natural	5		
Upstream Skew Angle	< 5°	5		
Crossing fill condition	Good/Vegetated	5		
Inlet/Outlet Condition	Sediment/Scouring	3		
Potential Eroded Vol.	< 21 c.y.	5		
Soil K Factor	≤ 0.20	5		
Approach Slope Mean	≤ 2.0%	5		
Road Approach Material	All Aggregate	5		
Upstream Rt Outlet	Vegetated	1		
Upstream Lt Outlet	Vegetated	1		
Upstream Rt Ditch	Vegetated	1		
Upstream Lt Ditch	Vegetated	1		
Downstream Rt Outlet	Vegetated	1

Downstream Lt Outlet	Vegetated	1		
Downstream Rt Ditch	Vegetated	1		
Downstream Lt Ditch	Vegetated	1		
Improved Outlet Total	4	1		
Improved Ditches Total	4	1		
<b>SRI Total:</b>		<b>56</b>	<b>Additional Site Features</b> Crossing Type and Quantity: Culvert (3) Crossing Material: Concrete Culvert Outfall Drop: 0 in. Fish Passage Barrier: Not Present Notes: Paved as of 11/1/2016; Open box culvert

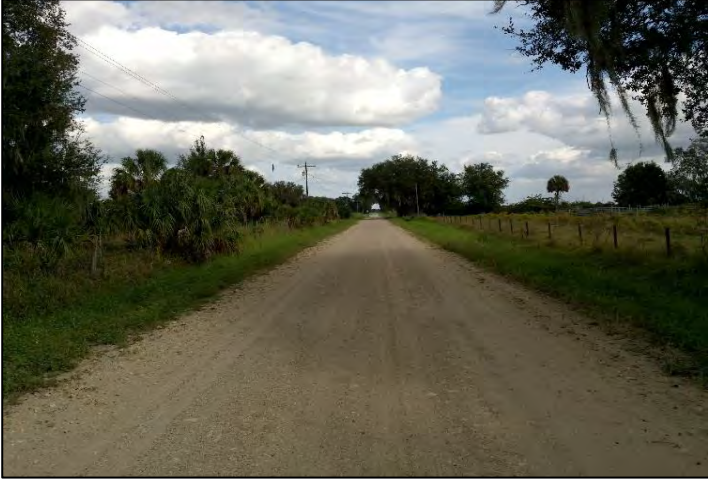
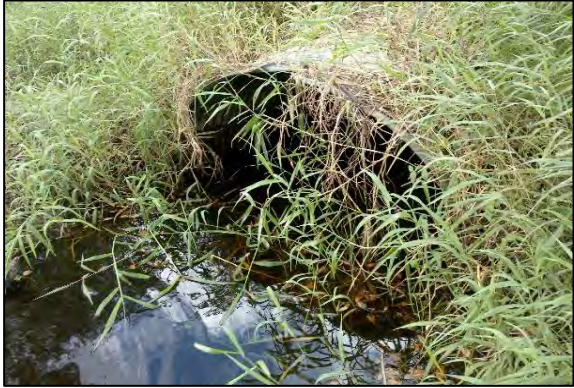
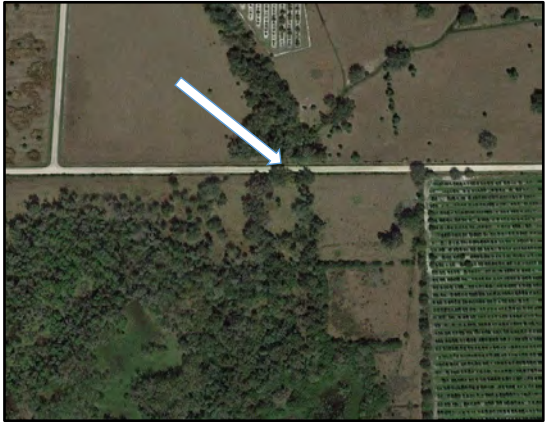
<p>Left Approach from Crossing Structure</p>

Unnamed Tributary			Sediment Risk Index: 52-Low	
Watershed: Peace River Subwatershed: Buckhorn Creek Latitude: 27.529672 Longitude: -81.716465 Road Name: Collin Poucher Rd.			County: Hardee Site Number: PU009 LULC: Pastureland, citrus groves Landowner(s): Barlow Family Partnership*

US Channel Morph	C	5		
DS Channel Morph	C	5		
DS Bank Alteration	High	1		
Upstream Skew Angle	< 5°	5		
Crossing fill condition	Good/Vegetated	5		
Inlet/Outlet Condition	No Impairment	5		
Potential Eroded Vol.	< 21 c.y.	5		
Soil K Factor	≤ 0.20	5		
Approach Slope Mean	≤ 2.0%	5		
Road Approach Material	All Aggregate	5		
Upstream Rt Outlet	Bare Soil	0		
Upstream Lt Outlet	Vegetated	1		
Upstream Rt Ditch	Vegetated	1		
Upstream Lt Ditch	Vegetated	1		
Downstream Rt Outlet	Bare Soil	0		
Downstream Lt Outlet	Bare Soil	0

Downstream Rt Ditch	Vegetated	1		
Downstream Lt Ditch	Bare Soil	0		
Improved Outlet Total	1	2		
Improved Ditches Total	3	0		
SRI Total:		52	<b>Additional Site Features</b> Crossing Type and Quantity: Culvert (1) Crossing Material: Corrugated metal Culvert Outfall Drop: 0 in. Fish Passage Barrier: Not Present Notes: Cattle access. *Additional land owners: Durrance & Whidden Properties LLC

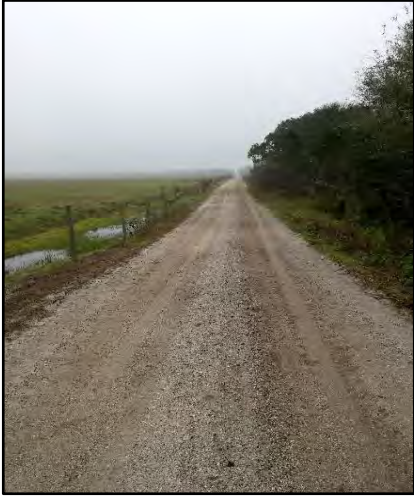
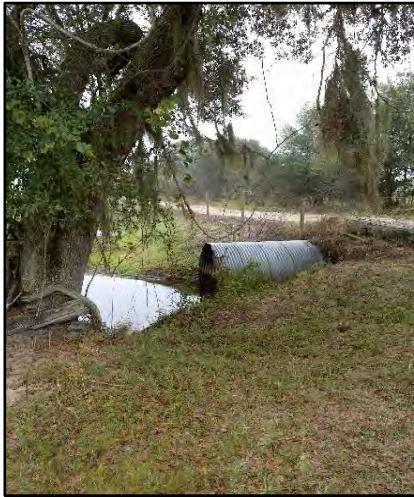
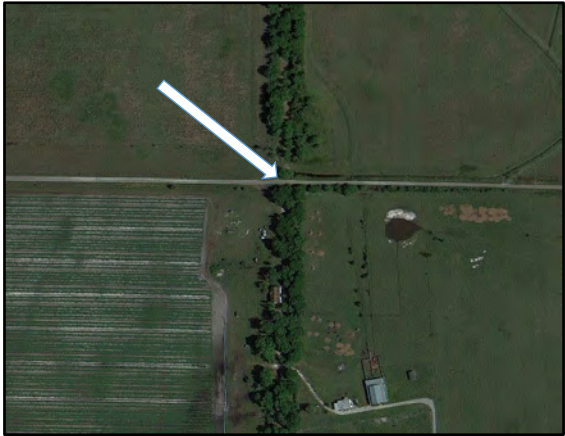
Left Approach from Crossing Structure			Crossing Structure: US	
Risk Factor	Ranking	Score

Unnamed Tributary			Sediment Risk Index: 50-Low	
Watershed: Peace River Subwatershed: Lower Prairie Creek Latitude: 27.005428 Longitude: -81.935606 Road Name: Live Oak Blvd.			County: Charlotte Site Number: PU010 LULC: Pasture  Land Owner(s): Zachariah P Zacharia*

US Channel Morph	C	5		
DS Channel Morph	Ponded	1		
DS Bank Alteration	Minor/Partial	3		
Upstream Skew Angle	<5°	5		
Crossing fill condition	Fair	3		
Inlet/Outlet Condition	Sediment/Scouring	3		
Potential Eroded Vol.	< 21 c.y.	5		
Soil K Factor	≤0.20	5		
Approach Slope Mean	≤2.0%	5		
Road Approach Material	All aggregate	5		
Upstream Rt Outlet	Vegetated	1		
Upstream Lt Outlet	Vegetated	1		
Upstream Rt Ditch	Vegetated	1		
Upstream Lt Ditch	Vegetated	1		
Downstream Rt Outlet	Vegetated	1		
Downstream Lt Outlet	Vegetated	1		
Downstream Rt Ditch	Vegetated	1

Downstream Lt Ditch	Vegetated	1		
Improved Outlet Total	4	1		
Improved Ditches Total	4	1		
SRI Total:		50	Additional Site Features	
			Crossing Type and Quantity: Culvert (1)	
			Crossing Material: Corrugated Metal	
			Culvert Outfall Drop: 0 in.	
			Fish Passage Barrier: Not Present	
			Notes: Culvert is perched at road crossing; *Additional land owners: Zemel Family Ventures LLC, Hudson Hammocks LLC, & JMH-TR

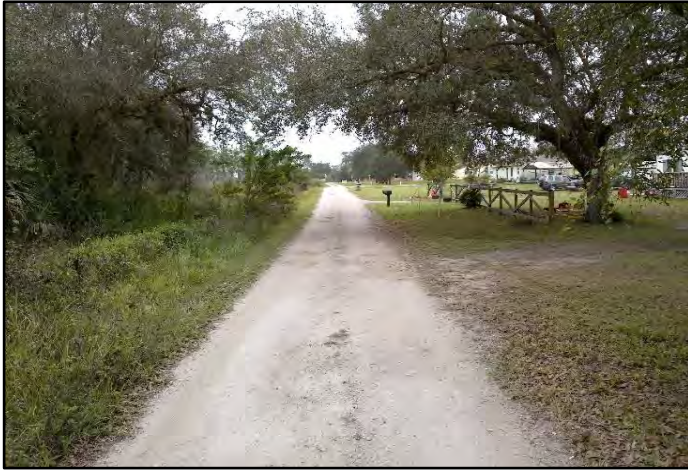
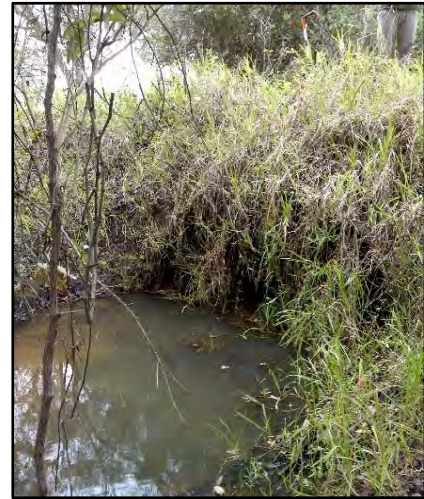
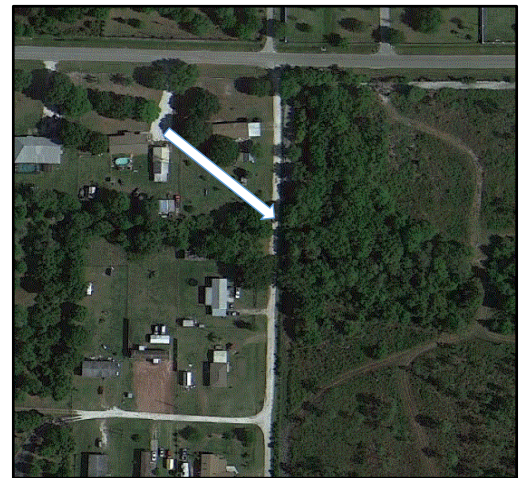
Right Approach from Crossing Structure

County: Desoto  
Site Number: PU011  
LULC: Natural Forest, Low Density Housing  
Land Owner(s): Juanita & Winfred Gibbs\*

Risk Factor	Ranking	Score
US Channel Morph	C	5
DS Channel Morph	C	5
DS Bank Alteration	Natural	5
Upstream Skew Angle	5° to 30°	3
Crossing fill condition	Good	5
Inlet/Outlet Condition	Scouring	4
Potential Eroded Vol.	< 21 c.y.	5
Soil K Factor	≤0.20	5
Approach Slope Mean	≤2.0%	5
Road Approach Material	All aggregate	5
Upstream Rt Outlet	Vegetated	1
Upstream Lt Outlet	Vegetated	1
Upstream Rt Ditch	Vegetated	1
Upstream Lt Ditch	Vegetated	1
Downstream Rt Outlet	Vegetated	1
Downstream Lt Outlet	Vegetated	1
Downstream Rt Ditch	Vegetated	1
Downstream Lt Ditch	Vegetated	1
Improved Outlet Total	4	1
Improved Ditches Total	4	1
<b>SRI Total:</b>		<b>57</b>

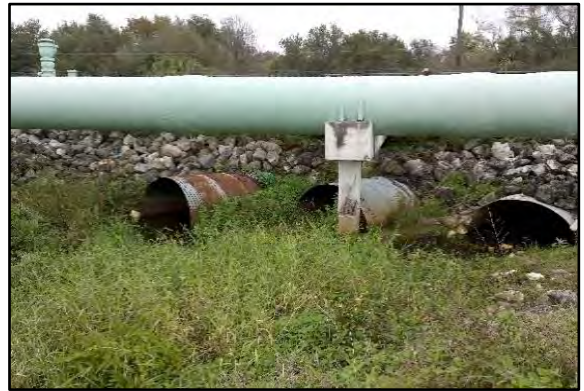
<table><tr><th>Risk Factor</th><th>Ranking</th><th>Score</th></tr><tr><td>Channel Alteration:</td><td>None</td><td>0</td></tr></table>

Notes: Discharging from city water supply reservoir.  
Riprap present in stream. \*Peace River Manasota  
Regional Water Supply Authority

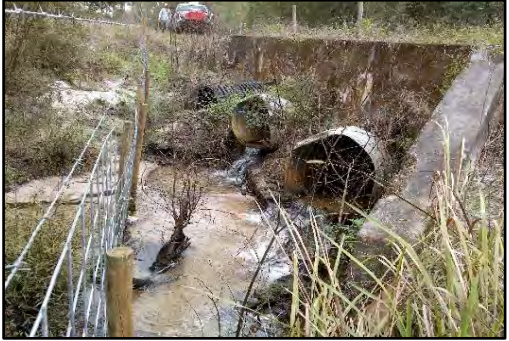
<p>Crossing Structure: DS</p>	
Risk Factor	Ranking	Score

Downstream Rt Ditch	Vegetated	1		
Downstream Lt Ditch	Vegetated	1		
Improved Outlet Total	3	0	<b>Additional Site Features</b> Crossing Type and Quantity: Culvert (4) Crossing Material: Corr. Metal, Synthetic Culvert Outfall Drop: 2 ft. Fish Passage Barrier: Present Notes: Cement headwall with 2 corrugated metal and 2 synthetic culverts underneath. *Additional land owners: Arcadia Ranch Properties LLC	
Improved Ditches Total	4	1		
<b>SRI Total:</b>		54

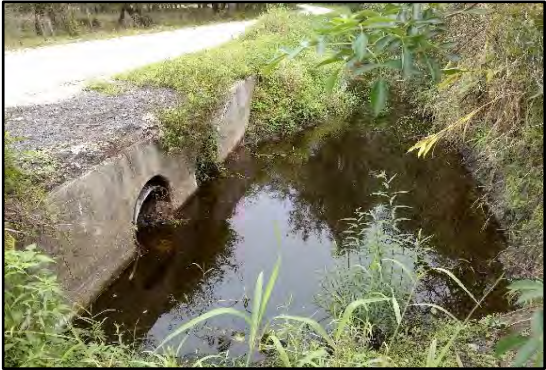
<p>Crossing Structure: US</p>	
Risk Factor	Ranking	Score

Downstream Rt Ditch	Bare Soil	0		
Downstream Lt Ditch	Vegetated	1		
Improved Outlet Total	4	1		
Improved Ditches Total	3	0		
SRI Total:		46	<b>Additional Site Features</b> Crossing Type and Quantity: Culvert (2) Crossing Material: Corrugated Metal, Concrete Culvert Outfall Drop: 8 in. Fish Passage Barrier: Present Notes: Culverts rusted, upstream section of stream is a channelized road ditch. Left Approach has a negative slope.

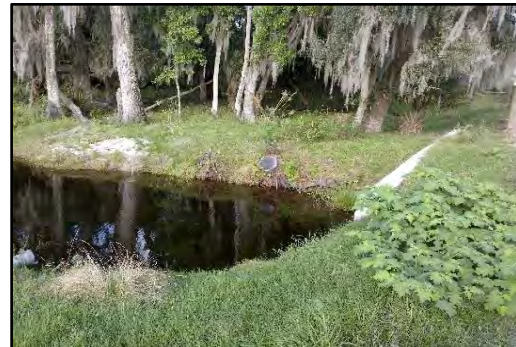
Crossing Structure: DS

Notes: Road turns into private drive. Fence blocking view of crossing structure. \*Additional land owners: Martha & Thomas Trust Taylor

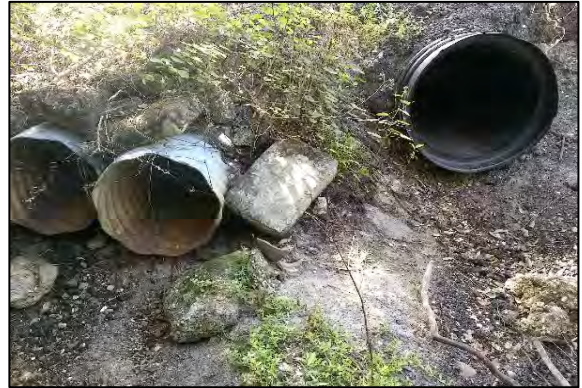
Crossing Structure: DS

Crossing Type and Quantity: Culvert (4)  
Crossing Material: Corrugated Metal (3), PVC (1)  
Culvert Outfall Drop: 0 in.  
Fish Passage Barrier: Not Present  
Notes: No water flowing in 3 of 4 culverts, \*Additional land owners: SISK JEFFREY & DEANA

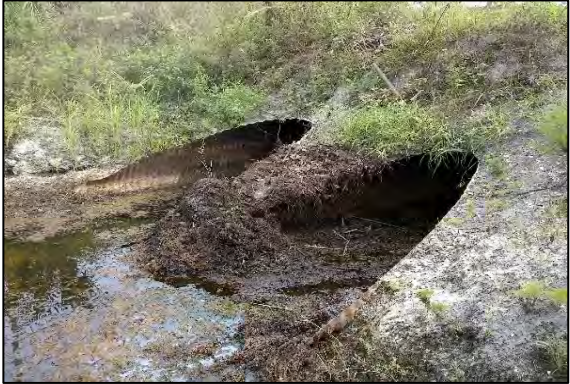
<p>Crossing Structure: US</p>	
Risk Factor	Ranking	Score

Downstream Rt Ditch	Vegetated	1		
Downstream Lt Ditch	Vegetated	1		
Improved Outlet Total	4	1		
Improved Ditches Total	4	1		
SRI Total:		48	<b>Additional Site Features</b> Crossing Type and Quantity: Culvert (2) Crossing Material: Corrugated Metal Culvert Outfall Drop: 0 in. Fish Passage Barrier: Not Present Notes: Slightly pooled at crossing

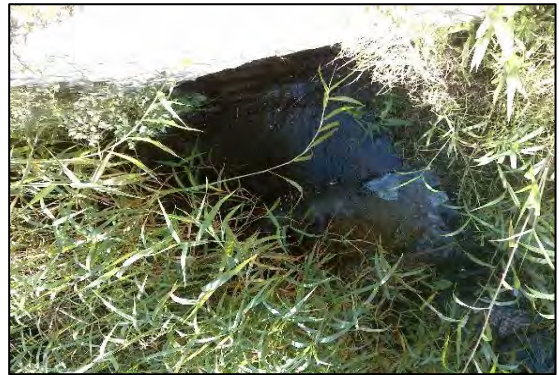
Crossing Structure: DS

Notes: Pasture - no riparian vegetation, \*Additional land owners: HARDEE COUNTY INDUSTRIAL

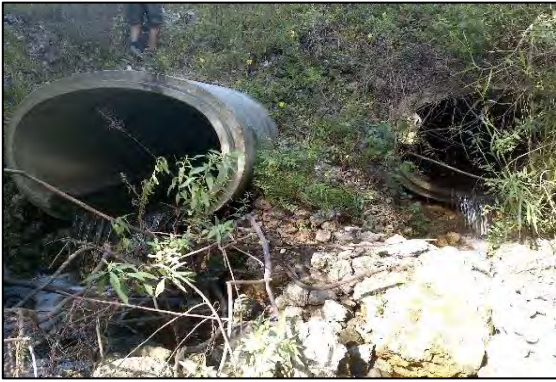
<p>Crossing Structure: DS</p>	
<b>Risk Factor</b>	<b>Ranking</b>	<b>Score</b>

Downstream Rt Ditch	Vegetated	1		
Downstream Lt Ditch	Vegetated	1		
Improved Outlet Total	4	1		
Improved Ditches Total	4	1	Crossing Type and Quantity: Culvert (2)	
<b>SRI Total:</b> 48			Crossing Material: Concrete	
			Culvert Outfall Drop: 2 ft.	
			Fish Passage Barrier: Present	
			Notes: Riprap barrier downstream of crossing

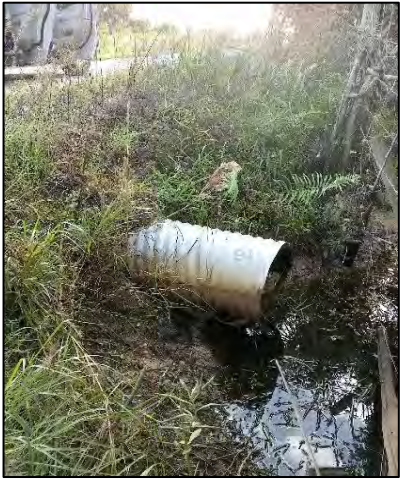
Downstream Lt Ditch	Vegetated	1		
Improved Outlet Total	4	1		
Improved Ditches Total	4	1		
SRI Total:		58	<b>Additonal Site Features</b> Crossing Type and Quantity: Culvert (1) Crossing Material: Corrugated Metal Culvert Outfall Drop: 3 in. Fish Passage Barrier: Present Notes: Stream not flowing; Pasture upstream

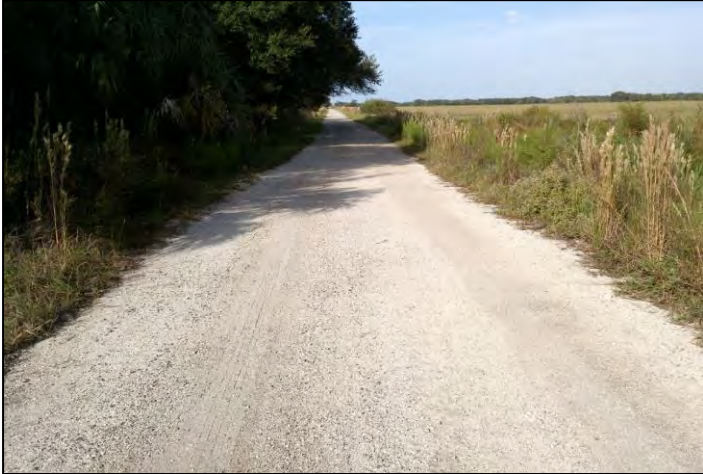
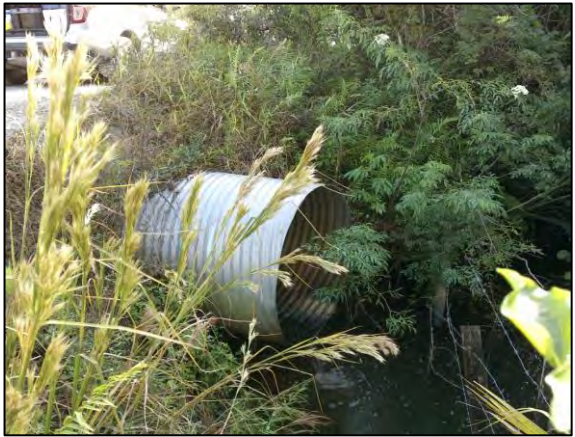
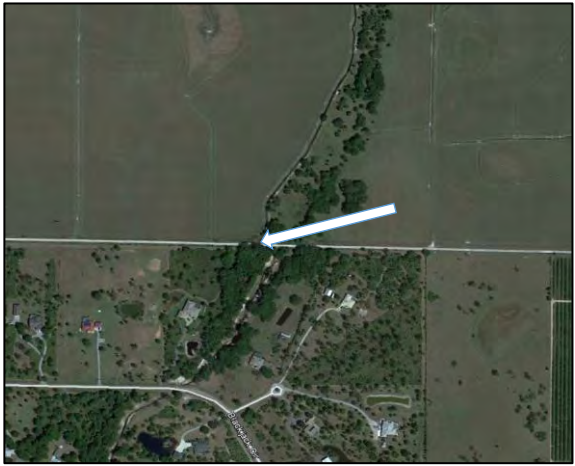
Unnamed Tributary			Sediment Risk Index: 43-Moderate
Watershed: Peace River Subwatershed: Lower Prairie Creek Latitude: 27.00497 Longitude: -81.910367 Road Name: Live Oak Rd.			County: Charlotte Site Number: PU026 LULC: Pasture, Low Density Residential Land Owner(s): HUDSON HAMMOCKS & JMH-TR*

US Channel Morph	Ponded	1	
DS Channel Morph	Ponded	1	
DS Bank Alteration	Partial	3	
Upstream Skew Angle	>30°	1	
Crossing fill condition	Vegated/Fair	4	
Inlet/Outlet Condition	Sediment/Scouring	3	
Potential Eroded Vol.	< 21 c.y.	5	
Soil K Factor	≤0.20	5	
Approach Slope Mean	≤2.0%	5	
Road Approach Material	All Aggregate	5	
Upstream Rt Outlet	Vegated	1	
Upstream Lt Outlet	Vegated	1	
Upstream Rt Ditch	Vegated	1	
Upstream Lt Ditch	Vegated	1	
Downstream Rt Outlet	Vegated	1	
Downstream Lt Outlet	Vegated	1

Downstream Rt Ditch	Vegated	1	
Downstream Lt Ditch	Vegated	1	
Improved Outlet Total	4	1	
Improved Ditches Total	4	1	
<b>SRI Total:</b>		<b>43</b>	<b>Additonal Site Features</b> Crossing Type and Quantity: Culvert (1) Crossing Material: Corrugated Metal Culvert Outfall Drop: 1 ft. Fish Passage Barrier: Present Notes: Channelized upstream of crossing; Sharp 90° bend towards culvert; Barb wire fence downstream of culvert, * Additional land owners: PRAIRIE CREEK WEST POA INC

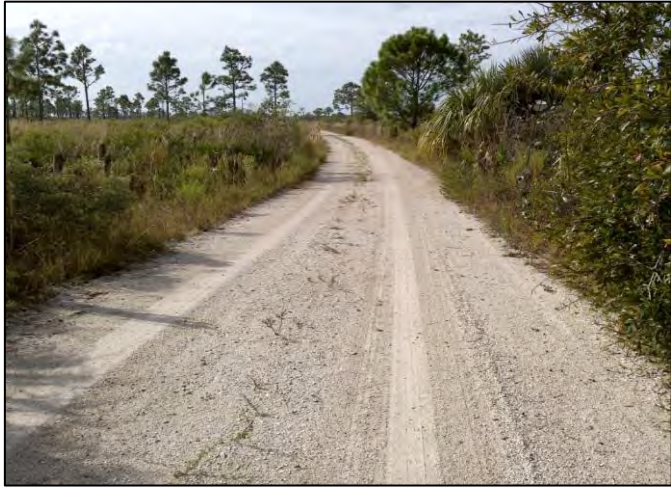
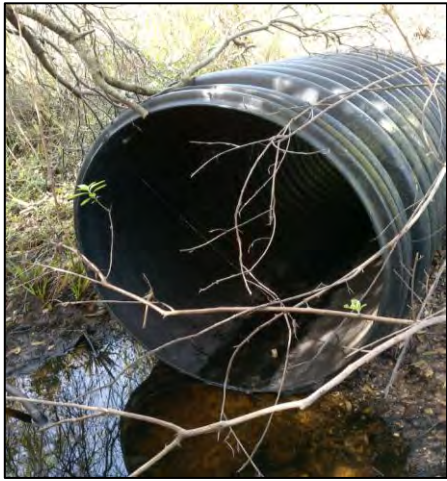
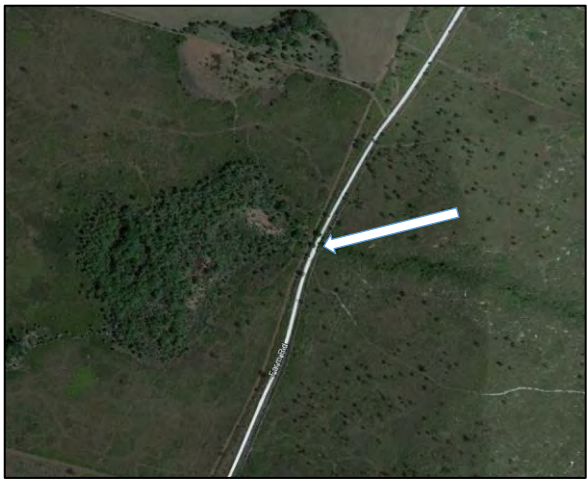
Unnamed Tributary			Sediment Risk Index: 60-Low	
Watershed: Peace River Subwatershed: Lower Prairie Creek Latitude: 27.012643 Longitude: -81.890356 Road Name: Farm Rd.			County: Charlotte Site Number: PU027 LULC: Wetland, Prairie  Land Owner(s): CHARLOTTE COUNTY

US Channel Morph	Wetland	5		
DS Channel Morph	E	5		
DS Bank Alteration	Natural	5		
Upstream Skew Angle	<5°	5		
Crossing fill condition	Vegetated	5		
Inlet/Outlet Condition	No Impairment	5		
Potential Eroded Vol.	< 21 c.y.	5		
Soil K Factor	≤0.20	5		
Approach Slope Mean	≤2.0%	5		
Road Approach Material	All Aggregate	5		
Upstream Rt Outlet	Vegetated	1		
Upstream Lt Outlet	Vegetated	1		
Upstream Rt Ditch	Vegetated	1		
Upstream Lt Ditch	Vegetated	1		
Downstream Rt Outlet	Vegetated	1		
Downstream Lt Outlet	Vegetated	1		
Downstream Rt Ditch	Vegetated	1

Downstream Lt Ditch	Vegetated	1		
Improved Outlet Total	4	1		
Improved Ditches Total	4	1		
<b>SRI Total:</b>		<b>60</b>	<b>Additonal Site Features</b> Crossing Type and Quantity: Culvert (1) Crossing Material: PVC Culvert Outfall Drop: 0 in. Fish Passage Barrier: Not Present Notes: Prairie Creek Preserve

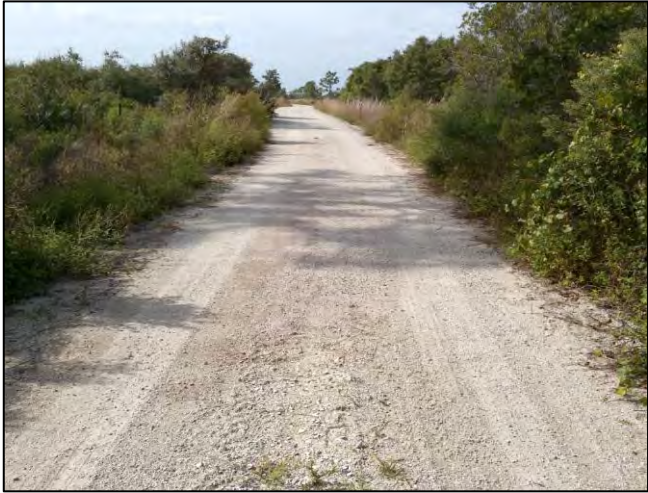
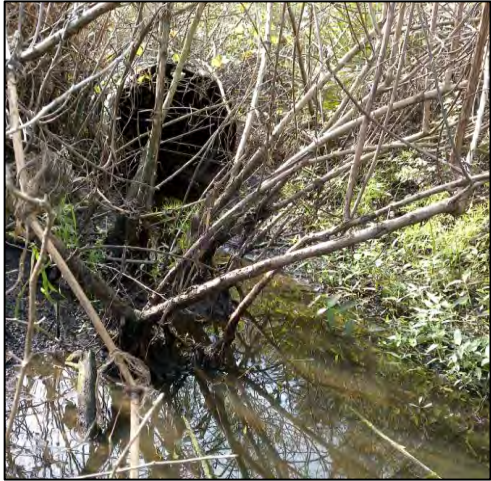
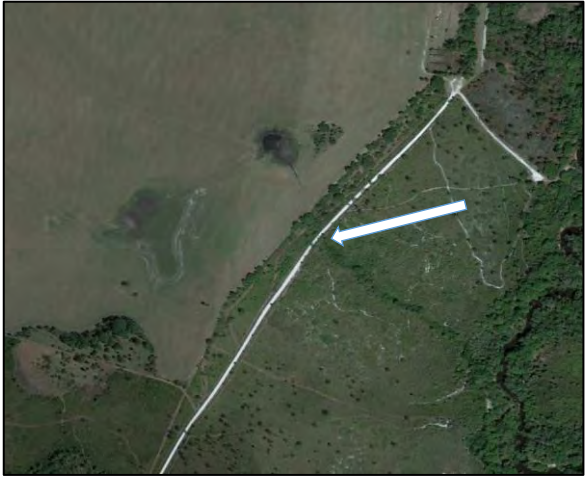
Unnamed Tributary			Sediment Risk Index: 60-Low	
Watershed: Peace River Subwatershed: Lower Prairie Creek Latitude: 27.016723 Longitude: -81.887703 Road Name: Farm Rd.			County: Charlotte Site Number: PU028 LULC: Pasture, Prairie  Land Owner(s): CHARLOTTE COUNTY

US Channel Morph	E	5		
DS Channel Morph	E	5		
DS Bank Alteration	Natural	5		
Upstream Skew Angle	<5°	5		
Crossing fill condition	Good/Vegetated	5		
Inlet/Outlet Condition	No Impairment	5		
Potential Eroded Vol.	< 21 c.y.	5		
Soil K Factor	≤0.20	5		
Approach Slope Mean	≤2.0%	5		
Road Approach Material	All Aggregate	5		
Upstream Rt Outlet	Vegetated	1		
Upstream Lt Outlet	Vegetated	1		
Upstream Rt Ditch	Vegetated	1		
Upstream Lt Ditch	Vegetated	1		
Downstream Rt Outlet	Vegetated	1		
Downstream Lt Outlet	Vegetated	1		
Downstream Rt Ditch	Vegetated	1

Downstream Lt Ditch	Vegetated	1		
Improved Outlet Total	4	1		
Improved Ditches Total	4	1		
<b>SRI Total:</b>		<b>60</b>	<b>Additional Site Features</b> Crossing Type and Quantity: Culvert (1) Crossing Material: PVC Culvert Outfall Drop: 0 in. Fish Passage Barrier: Present Notes: Prairie Creek Preserve

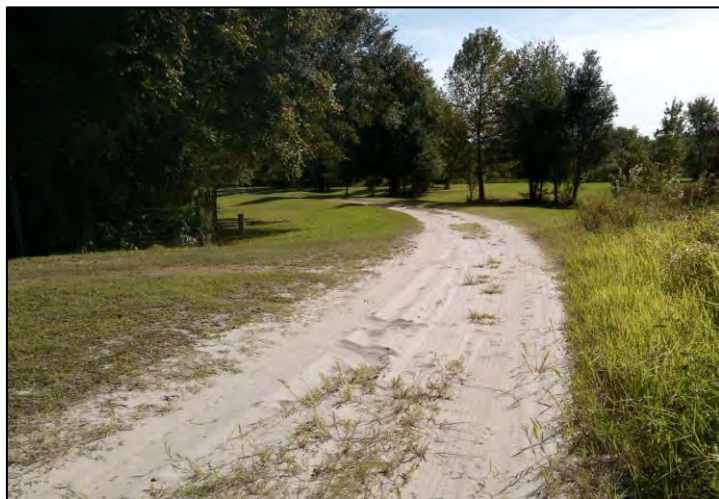
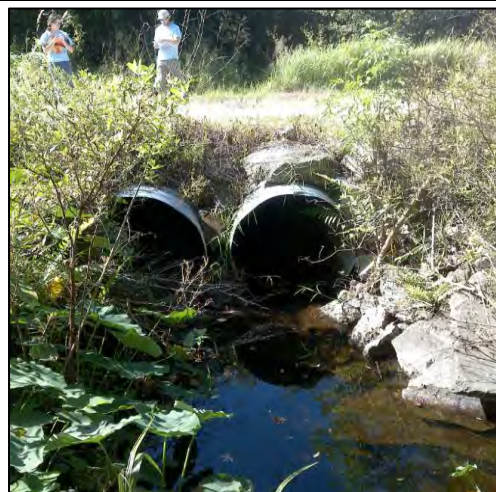
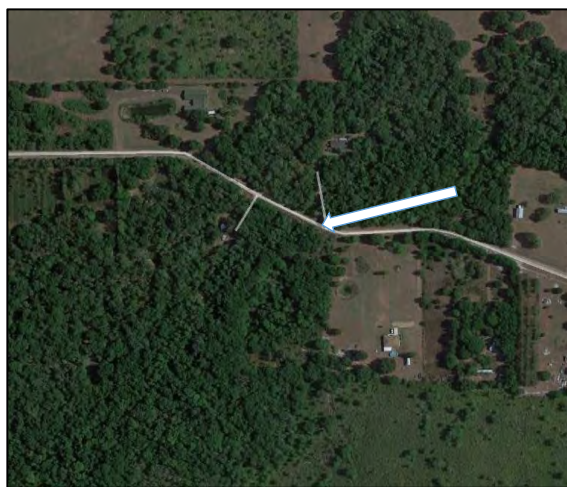
County: Hardee  
Site Number: PU029  
LULC: Natural Forest, Low Density Residential  
Land Owner(s): Barnes Sandra L R\*

Risk Factor	Ranking	Score
US Channel Morph	E	5
DS Channel Morph	E	5
DS Bank Alteration	Natural	5
Upstream Skew Angle	5° to 30°	3
Crossing fill condition	Vegetated/Riprap	4
Inlet/Outlet Condition	Sediment/Scouring	3
Potential Eroded Vol.	> 40 c.y.	1
Soil K Factor	≤0.20	5
Approach Slope Mean	≤2.0%	5
Road Approach Material	All Sand/Clay	3
Upstream Rt Outlet	Vegetated	1
Upstream Lt Outlet	Vegetated	1
Upstream Rt Ditch	Vegetated	1
Upstream Lt Ditch	Vegetated	1
Downstream Rt Outlet	Vegetated	1
Downstream Lt Outlet	Vegetated	1
Downstream Rt Ditch	Vegetated	1
Downstream Lt Ditch	Vegetated	1
Improved Outlet Total	4	1
Improved Ditches Total	4	1
SRI Total:		49

Crossing Type and Quantity: Culvert (2)  
Crossing Material: Corrugated Metal  
Culvert Outfall Drop: 1.3 ft.  
Fish Passage Barrier: Present  
Notes: Riprap/concrete blocks downstream of culverts; Lightly used road, grass in middle of road and sides, \*Additional land owners: Voris Leon & Rose E

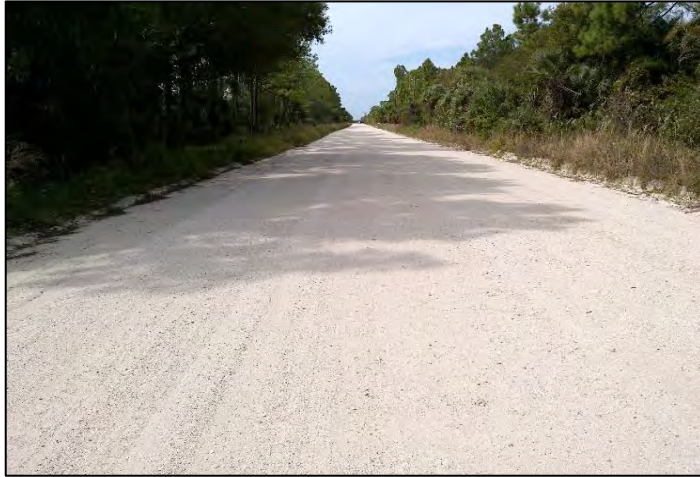
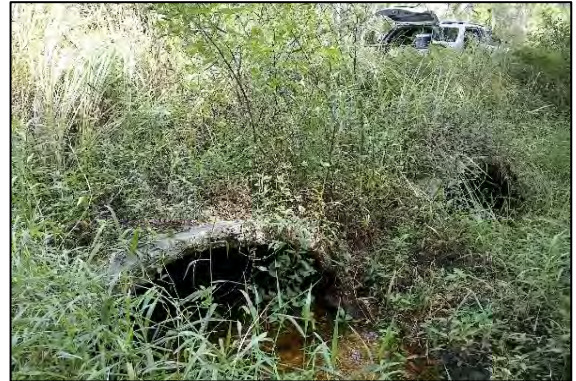
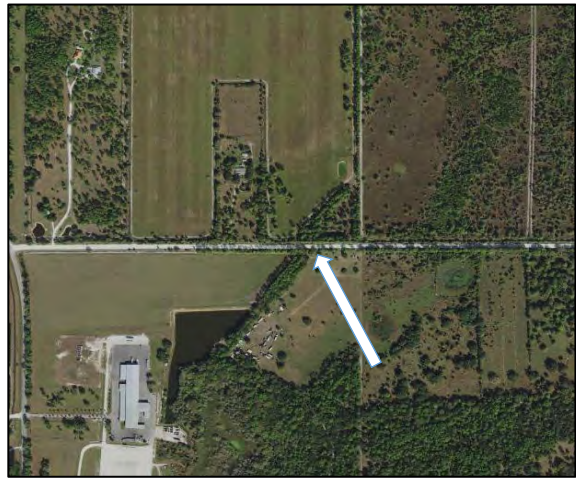
Risk Factor	Ranking	Score
US Channel Morph	Ponded	1
DS Channel Morph	Ponded	1
DS Bank Alteration	High	1
Upstream Skew Angle	<5°	5
Crossing fill condition	Vegetated	5
Inlet/Outlet Condition	Sediment/Scouring	3
Potential Eroded Vol.	> 40 c.y.	1
Soil K Factor	≤0.20	5
Approach Slope Mean	≤2.0%	5
Road Approach Material	All Aggregate	5
Upstream Rt Outlet	Vegetated	1
Upstream Lt Outlet	Vegetated	1
Upstream Rt Ditch	Bare Soil	0
Upstream Lt Ditch	Bare Soil	0
Downstream Rt Outlet	Vegetated	1
Downstream Lt Outlet	Vegetated	1
Downstream Rt Ditch	Bare Soil	0
Downstream Lt Ditch	Bare Soil	0
Improved Outlet Total	4	1
Improved Ditches Total	0	1
<b>SRI Total:</b>		<b>38</b>

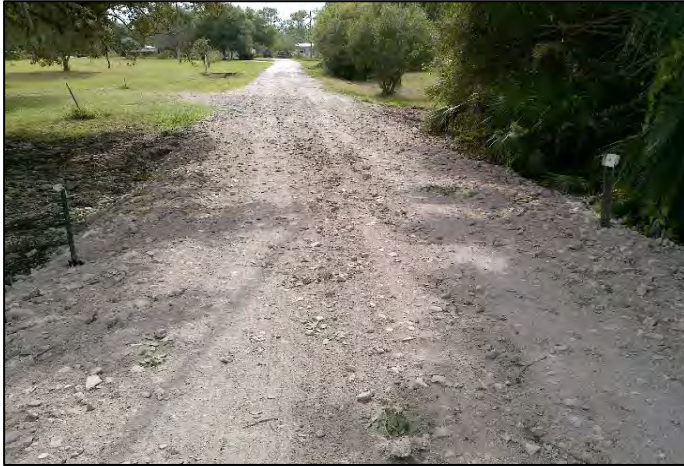
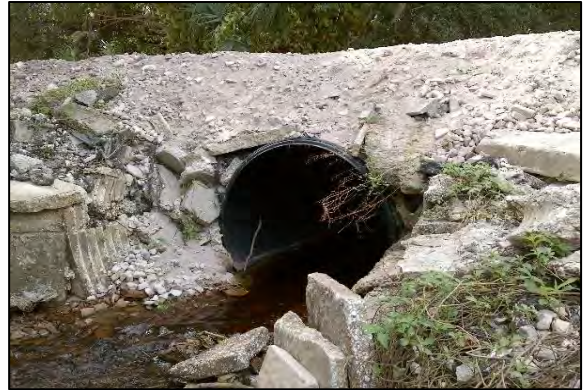
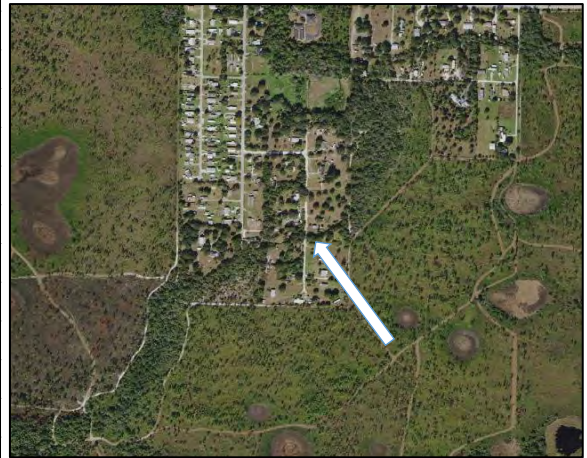
County: Desoto  
Site Number: PU031  
LULC: Low Density Residential  
Land Owner(s): MEYER MARY OLIVE\*

Risk Factor	Ranking	Score
US Channel Morph	G	1
DS Channel Morph	G	1
DS Bank Alteration	High	1
Upstream Skew Angle	<5°	5
Crossing fill condition	Poor	1
Inlet/Outlet Condition	Sediment/Scouring	3
Potential Eroded Vol.	> 40 c.y.	1
Soil K Factor	≤0.20	5
Approach Slope Mean	≤2.0%	5
Road Approach Material	All Native Soil	1
Upstream Rt Outlet	Bare Soil	0
Upstream Lt Outlet	Bare Soil	0
Upstream Rt Ditch	Bare Soil	0
Upstream Lt Ditch	Bare Soil	0
Downstream Rt Outlet	Bare Soil	0
Downstream Lt Outlet	Bare Soil	0
Downstream Rt Ditch	Vegetated	1
Downstream Lt Ditch	Bare Soil	0
Improved Outlet Total	0	1
Improved Ditches Total	1	2
<b>SRI Total:</b>		<b>28</b>

Notes: Generally unsafe crossing - no guard rail

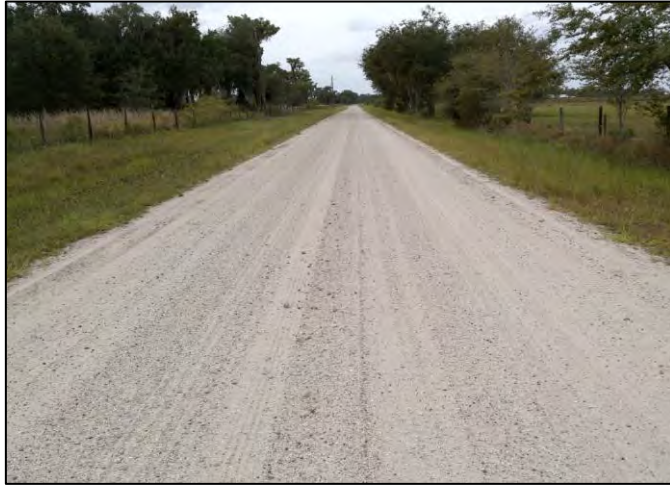
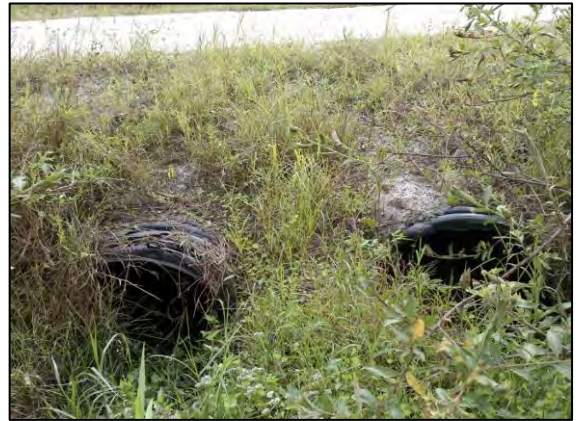
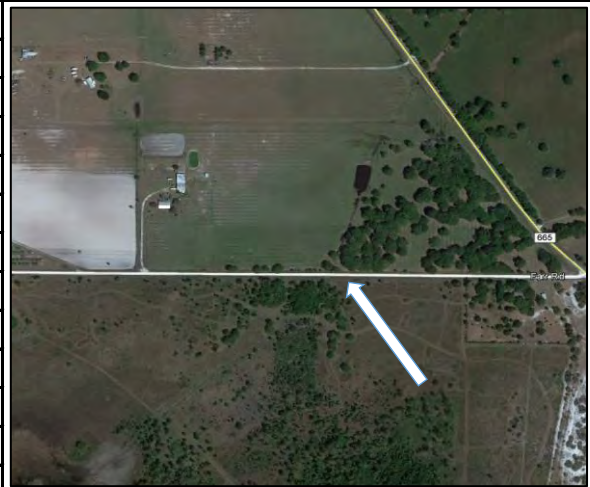
Risk Factor	Ranking	Score
US Channel Morph	Wetland	5
DS Channel Morph	C	5
DS Bank Alteration	Minor	3
Upstream Skew Angle	<5°	5
Crossing fill condition	Vegetated	5
Inlet/Outlet Condition	No Impairment	5
Potential Eroded Vol.	21-40 c.y.	3
Soil K Factor	≤0.20	5
Approach Slope Mean	≤2.0%	5
Road Approach Material	All Aggregate	5
Upstream Rt Outlet	Vegetated	1
Upstream Lt Outlet	Vegetated	1
Upstream Rt Ditch	Vegetated	1
Upstream Lt Ditch	Vegetated	1
Downstream Rt Outlet	Vegetated	1
Downstream Lt Outlet	Vegetated	1
Downstream Rt Ditch	Vegetated	1
Downstream Lt Ditch	Vegetated	1
Improved Outlet Total	4	1
Improved Ditches Total	4	1
<b>SRI Total:</b>		<b>56</b>
