# **Peace River and Withlacoochee River Threats Assessments and Fish Assemblage Monitoring**

**Final Report July 1, 2015 – June 30, 2019**

Submitted to Florida State Wildlife Grants Program  
August 1, 2019  
PID: 98462501284

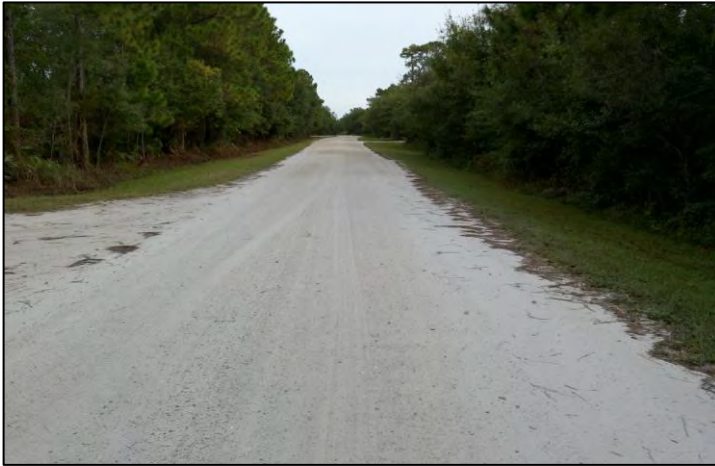
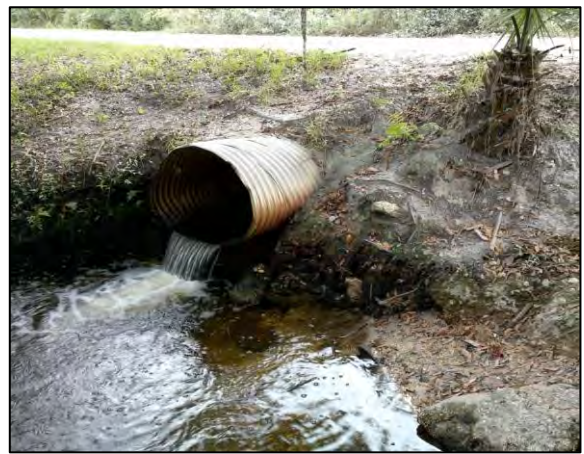
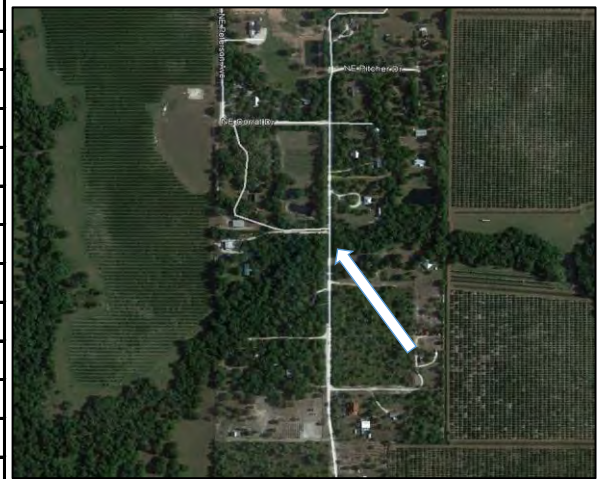
County: Desoto  
Site Number: PU033  
LULC: Low Density Residential, Citrus Groves  
Land Owner(s): COBBAN WILLIAM FRANKLIN\*

Risk Factor	Ranking	Score
US Channel Morph	E	5
DS Channel Morph	Ponded	1
DS Bank Alteration	Minor	3
Upstream Skew Angle	5° to 30°	3
Crossing fill condition	Fair	3
Inlet/Outlet Condition	Sediment/Scouring	3
Potential Eroded Vol.	< 21 c.y.	5
Soil K Factor	≤0.20	5
Approach Slope Mean	≤2.0%	5
Road Approach Material	All Aggregate	5
Upstream Rt Outlet	Vegetated	1
Upstream Lt Outlet	Vegetated	1
Upstream Rt Ditch	Vegetated	1
Upstream Lt Ditch	Vegetated	1
Downstream Rt Outlet	Vegetated	1
Downstream Lt Outlet	Bare Soil	0
Downstream Rt Ditch	Vegetated	1
Downstream Lt Ditch	Vegetated	1
Improved Outlet Total	3	0
Improved Ditches Total	4	1
<b>SRI Total:</b>		<b>46</b>

Notes: Two roads measured on right approach,  
\*Additional land owners: CONNER RONNIE ESTATE

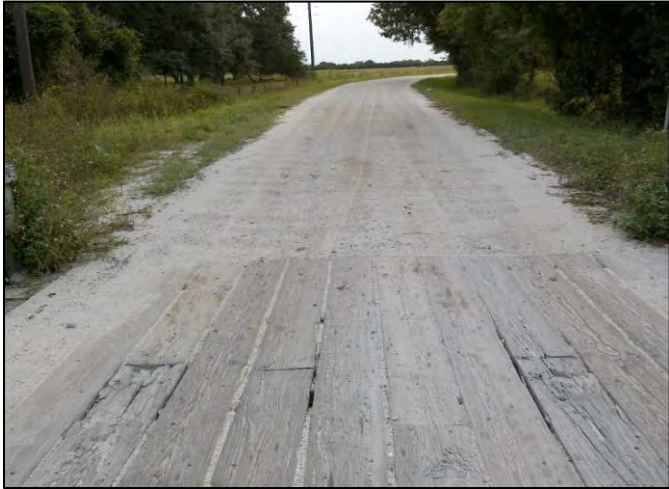
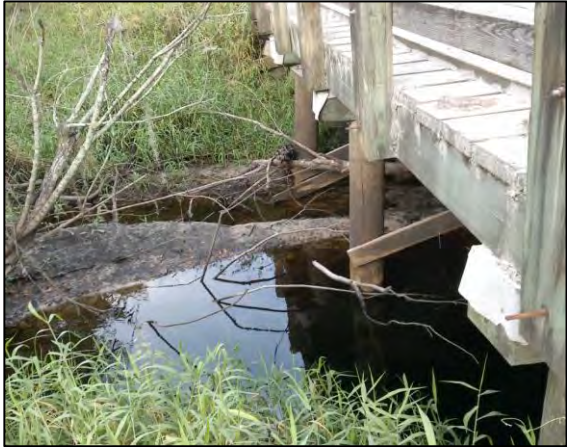
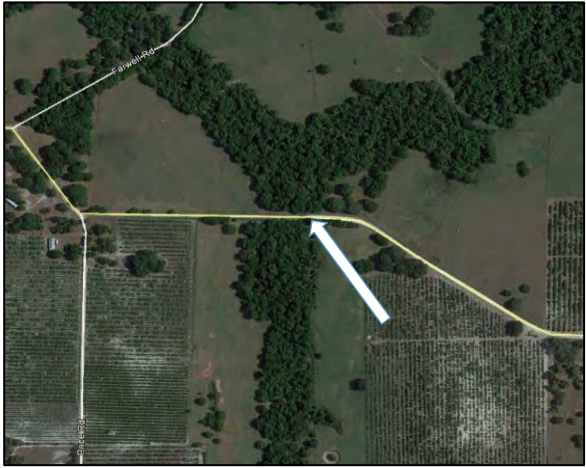
Unnamed Tributary			Sediment Risk Index: 50-Low	
Watershed: Peace River Subwatershed: Fish Branch Latitude: 27.357052 Longitude: -81.727610 Road Name: Fish Branch Rd.			County: Hardee Site Number: PU034 LULC: Natural Forest, Pasture, Citrus Groves Land Owner(s): WILBURN CARL M & BETTY*

US Channel Morph	E	5		
DS Channel Morph	Ponded	1		
DS Bank Alteration	Natural	5		
Upstream Skew Angle	<5°	5		
Crossing fill condition	Good	5		
Inlet/Outlet Condition	Sediment/Scouring	3		
Potential Eroded Vol.	> 40 c.y.	1		
Soil K Factor	≤0.20	5		
Approach Slope Mean	≤2.0%	5		
Road Approach Material	All Aggregate	5		
Upstream Rt Outlet	Vegetated	1		
Upstream Lt Outlet	Vegetated	1		
Upstream Rt Ditch	Vegetated	1		
Upstream Lt Ditch	Vegetated	1		
Downstream Rt Outlet	Vegetated	1		
Downstream Lt Outlet	Vegetated	1

Downstream Rt Ditch	Vegetated	1		
Downstream Lt Ditch	Vegetated	1		
Improved Outlet Total	4	1		
Improved Ditches Total	4	1		
SRI Total:		50	Additional Site Features	
			Crossing Type and Quantity: Bridge (1)	
			Crossing Material: Wood	
			Culvert Outfall Drop: NA	
			Fish Passage Barrier: Not Present	
			Notes: *Additional land owners: MERCER WILLIAM PAT TRUSTEE

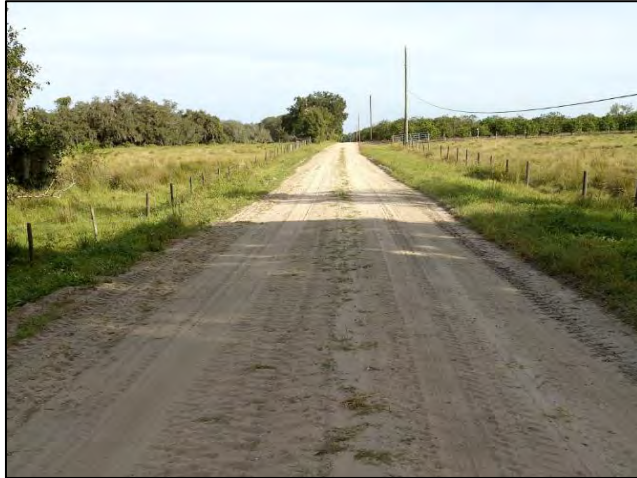
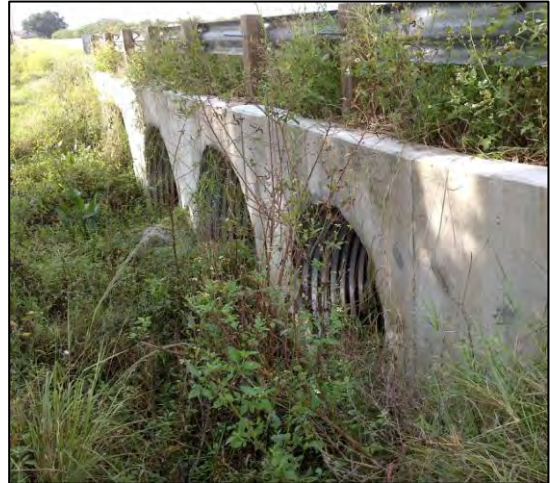
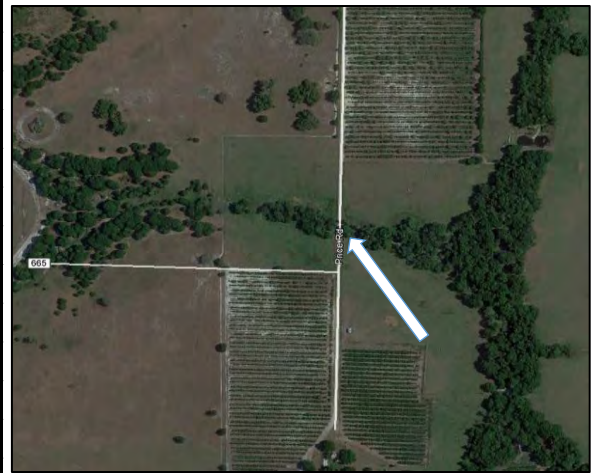
County: Hardee  
Site Number: PU035  
LULC: Pasture, Citrus Groves, Natural Forest  
Land Owner(s): WILBURN CARL M & BETTY

Risk Factor	Ranking	Score
US Channel Morph	E	5
DS Channel Morph	E	5
DS Bank Alteration	High	1
Upstream Skew Angle	>30°	1
Crossing fill condition	Vegetated	5
Inlet/Outlet Condition	Blocked	1
Potential Eroded Vol.	> 40 c.y.	1
Soil K Factor	≤0.20	5
Approach Slope Mean	≤2.0%	5
Road Approach Material	All Native Soil	1
Upstream Rt Outlet	Vegetated	1
Upstream Lt Outlet	Vegetated	1
Upstream Rt Ditch	Vegetated	1
Upstream Lt Ditch	Vegetated	1
Downstream Rt Outlet	Vegetated	1
Downstream Lt Outlet	Vegetated	1
Downstream Rt Ditch	Bare Soil	0
Downstream Lt Ditch	Bare Soil	0
Improved Outlet Total	4	1
Improved Ditches Total	2	1
<b>SRI Total:</b>		<b>38</b>

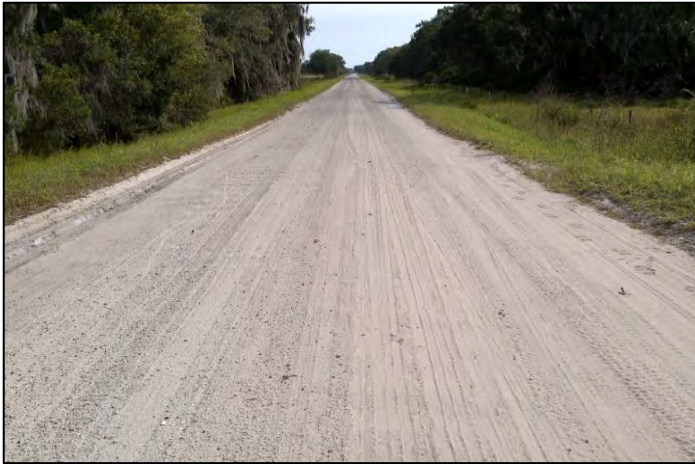
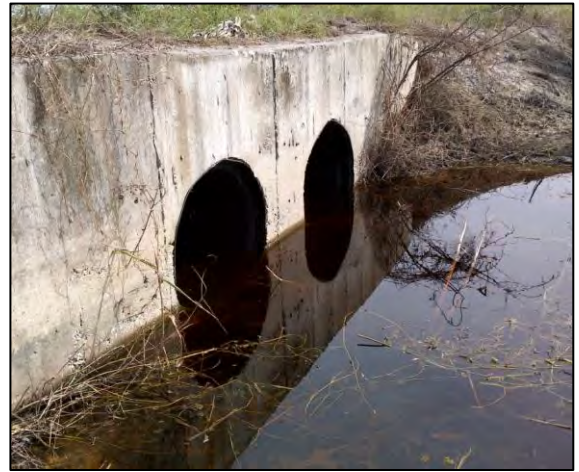
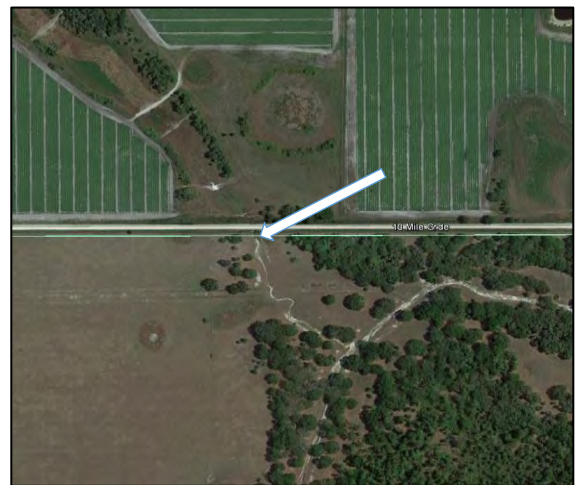
County: Hardee/Desoto  
Site Number: PU036  
LULC: Pasture, wetland  
Land Owner(s): SKIPPER CATTLE & CITRUS

Risk Factor	Ranking	Score
US Channel Morph	Wetland	5
DS Channel Morph	E	5
DS Bank Alteration	Minor	3
Upstream Skew Angle	>30°	1
Crossing fill condition	Vegetated	5
Inlet/Outlet Condition	Sediment/Scouring	3
Potential Eroded Vol.	> 40 c.y.	1
Soil K Factor	≤0.20	5
Approach Slope Mean	≤2.0%	5
Road Approach Material	All Aggregate	5
Upstream Rt Outlet	Vegetated	1
Upstream Lt Outlet	Vegetated	1
Upstream Rt Ditch	Vegetated	1
Upstream Lt Ditch	Vegetated	1
Downstream Rt Outlet	Bare Soil	0
Downstream Lt Outlet	Bare Soil	0
Downstream Rt Ditch	Vegetated	1
Downstream Lt Ditch	Vegetated	1
Improved Outlet Total	2	1
Improved Ditches Total	4	1
<b>SRI Total:</b>		<b>46</b>

Crossing Type and Quantity: Culvert (2)  
Crossing Material: PVC/Concrete  
Culvert Outfall Drop: 0 in.  
Fish Passage Barrier: Not Present  
Notes: Pasture upstream and downstream

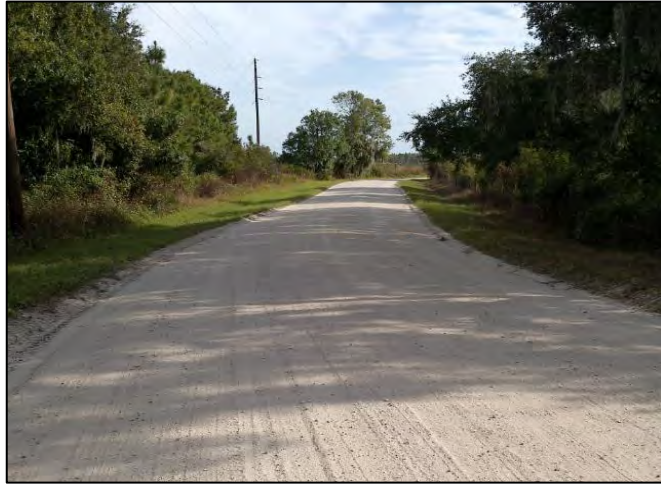
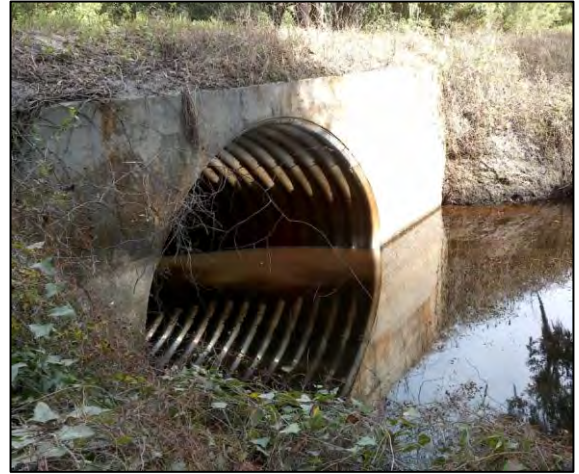
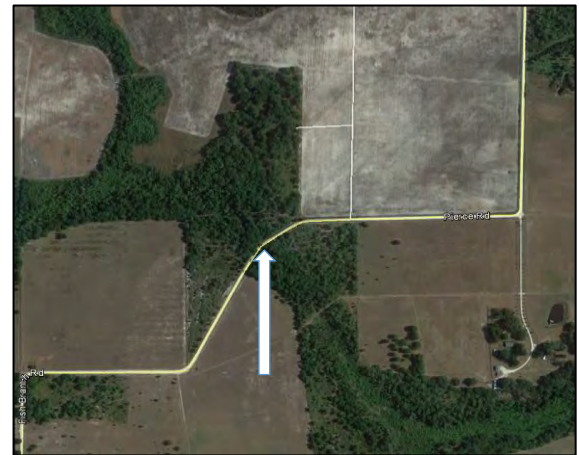
County: Hardee  
Site Number: PU037  
LULC: Natural Forest, Pasture  
Land Owner(s): WELLS LAWRENCE B & CYNTHIA L

Risk Factor	Ranking	Score
US Channel Morph	Ponded	1
DS Channel Morph	Ponded	1
DS Bank Alteration	Natural	5
Upstream Skew Angle	<5°	5
Crossing fill condition	Good/Vegetated	5
Inlet/Outlet Condition	Sediment/Scouring	3
Potential Eroded Vol.	> 40 c.y.	1
Soil K Factor	≤0.20	5
Approach Slope Mean	≤2.0%	5
Road Approach Material	All Aggregate	5
Upstream Rt Outlet	Vegetated	1
Upstream Lt Outlet	Vegetated	1
Upstream Rt Ditch	Bare Soil	0
Upstream Lt Ditch	Bare Soil	0
Downstream Rt Outlet	Vegetated	1
Downstream Lt Outlet	Vegetated	1
Downstream Rt Ditch	Vegetated	1
Downstream Lt Ditch	Vegetated	1
Improved Outlet Total	4	1
Improved Ditches Total	2	1
<b>SRI Total:</b>		<b>44</b>

Crossing Type and Quantity: Culvert (1)  
Crossing Material: Corrugated Metal/Concrete  
Culvert Outfall Drop: 0 in.  
Fish Passage Barrier: Not Present  
Notes: Deep ponds on both sides of crossing

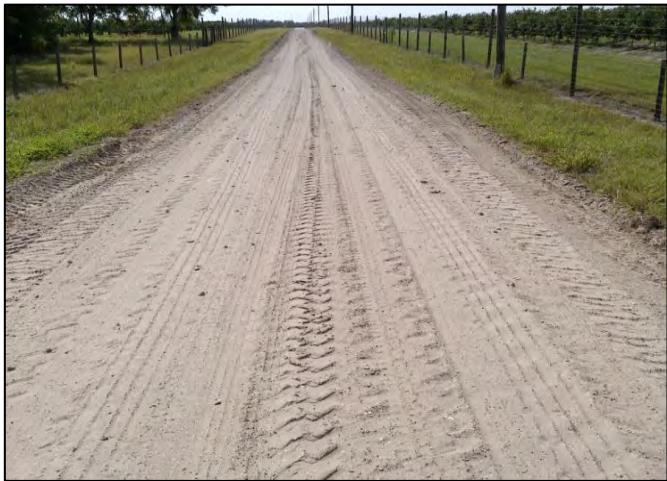
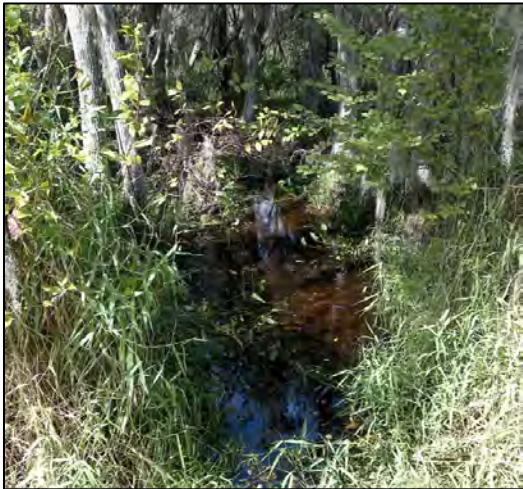
Unnamed Tributary			Sediment Risk Index: 58-Low	
Watershed: Peace River Subwatershed: Lower Charlie Creek Latitude: 27.406414 Longitude: -81.755684 Road Name: Paulsen Dr.			County: Hardee Site Number: PU038 LULC: Citrus groves, Pasture, Natural Forest Land Owner(s): TWENTY-TWENTY GROVES*

Left Approach from Crossing Structure			DS from crossing structure	
Risk Factor	Ranking	Score		
US Channel Morph	Wetland	5		
DS Channel Morph	Wetland	5		
DS Bank Alteration	Natural	5		
Upstream Skew Angle	<5°	5		
Crossing fill condition	Good	5		
Inlet/Outlet Condition	No Impairment	5		
Potential Eroded Vol.	< 21 c.y.	5		
Soil K Factor	≤0.20	5		
Approach Slope Mean	≤2.0%	5		
Road Approach Material	Sandy Aggregate	3		
Upstream Rt Outlet	Vegetated	1		
Upstream Lt Outlet	Vegetated	1		
Upstream Rt Ditch	Vegetated	1		
Upstream Lt Ditch	Vegetated	1		
Downstream Rt Outlet	Vegetated	1		
Downstream Lt Outlet	Vegetated	1

Downstream Rt Ditch	Vegetated	1		
Downstream Lt Ditch	Vegetated	1		
Improved Outlet Total	4	1		
Improved Ditches Total	4	1		
<b>SRI Total:</b>		<b>58</b>

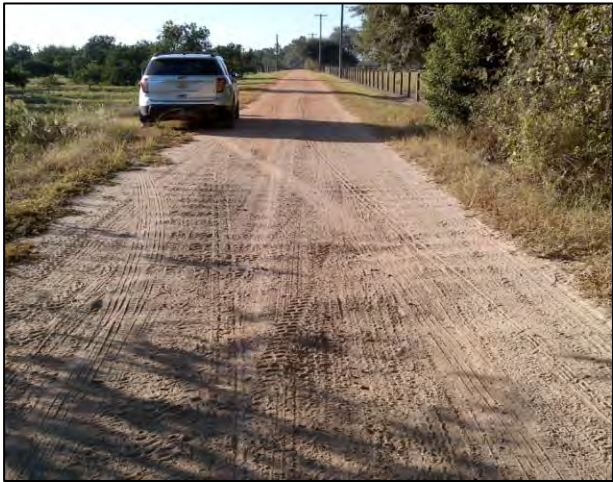
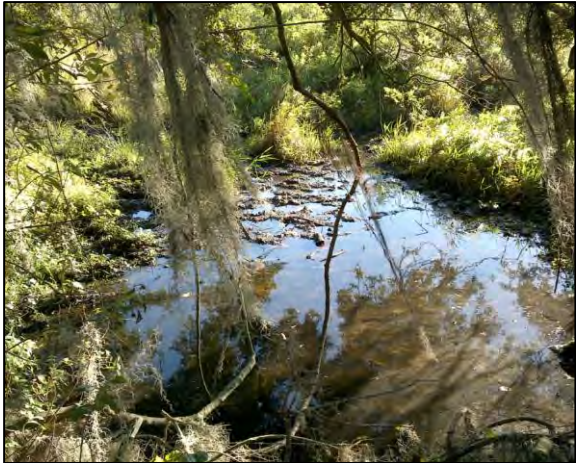
Unnamed Tributary			Sediment Risk Index: 52-Low	
Watershed: Peace River Subwatershed: Lake Garfield Latitude: 27.846418 Longitude: -81.72773 Road Name: Barush Rd.			County: Polk Site Number: PU039 LULC: Pasture, Citrus groves Land Owner(s): CREWS PHILIP F*

Downstream Lt Ditch	Vegetated	1		
Improved Outlet Total	4	1		
Improved Ditches Total	4	1		
SRI Total:		52	Additional Site Features	
			Crossing Type and Quantity: Culvert (2)	
			Crossing Material: Corrugated Metal	
			Culvert Outfall Drop: 0 in.	
			Fish Passage Barrier: Not Present	
			Notes: Crossing structure blocked by barb wire upstream and downstream; Channel alteration - cattle prints in stream, no riparian in areas/bank erosion,	
			*Additional land owner: CREWS SANDRA

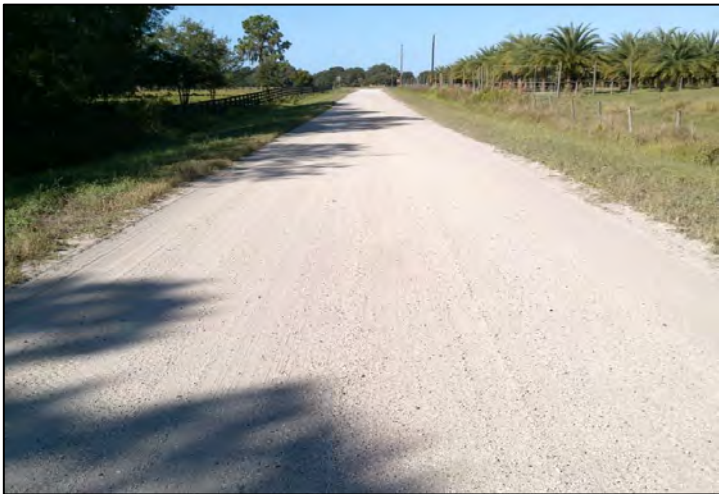
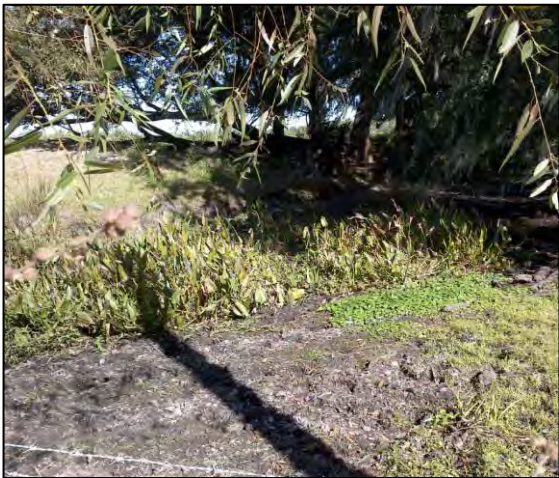
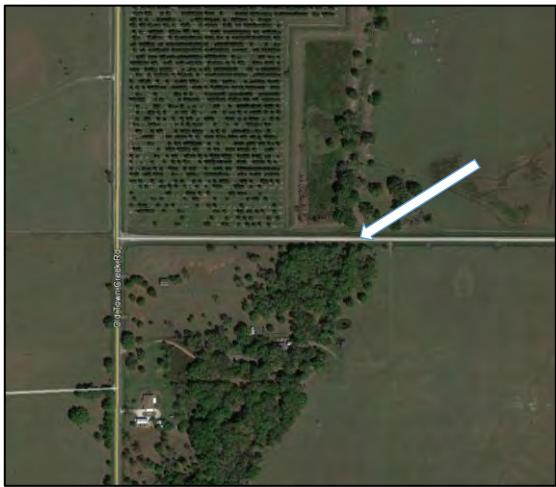
Unnamed Tributary			Sediment Risk Index: 50-Low	
Watershed: Peace River Subwatershed: Charlie Creek Headwaters Latitude: 27.617569 Longitude: -81.617688 Road Name: Mel Smith Rd.			County: Hardee Site Number: PU040 LULC: Pasture, Citrus groves, Natural Forest Land Owner(s): CREWS GROVES INC*

Downstream Rt Ditch	Vegetated	1		
Downstream Lt Ditch	Vegetated	1		
Improved Outlet Total	4	1		
Improved Ditches Total	4	1	Notes: Cattle degrading banks; Tree branches blocking inlet, *Additional land owners: DE LA CRUZ PABLO MOLINA	
SRI Total:		50

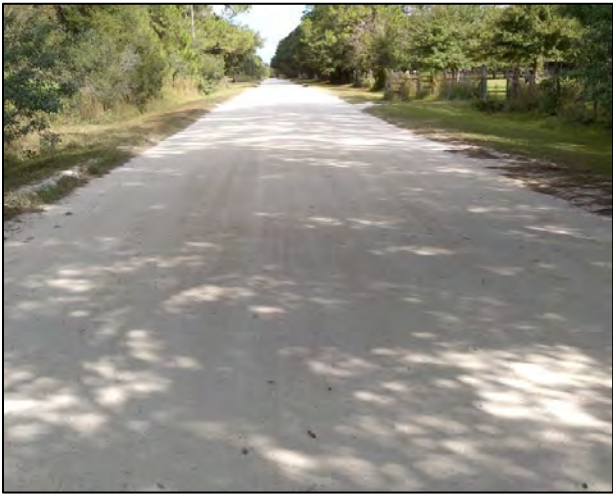
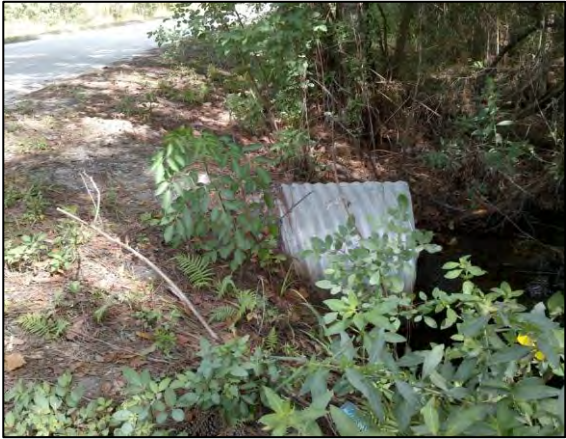
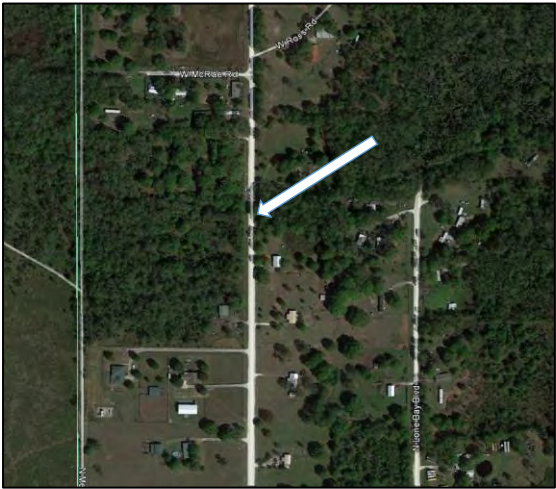
Unnamed Tributary			Sediment Risk Index: 52-Low	
Watershed: Peace River Subwatershed: Bee Branch - Charlie Creek Latitude: 27.599101 Longitude: -81.561388 Road Name: N Ruth Rd.			County: Highlands Site Number: PU042 LULC: Low Density Residential, Natural Forest Land Owner(s): IGLESIAS CARIDAD LOPEZ

<b>Additional Site Features</b> Crossing Type and Quantity: Culvert (1) Crossing Material: Corrugated Metal Culvert Outfall Drop: 0 in. Fish Passage Barrier: Not Present Notes: Crossing fill not well vegetated

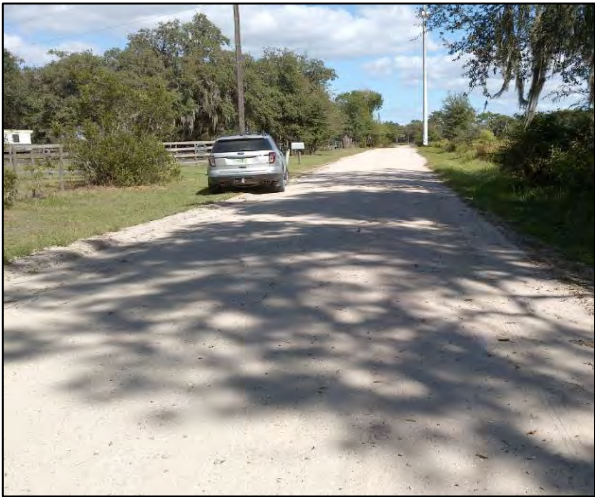
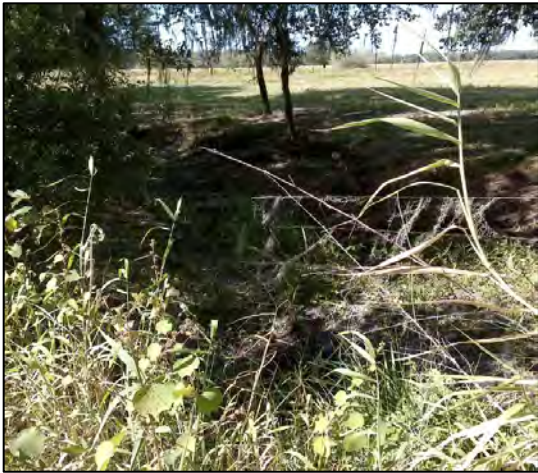
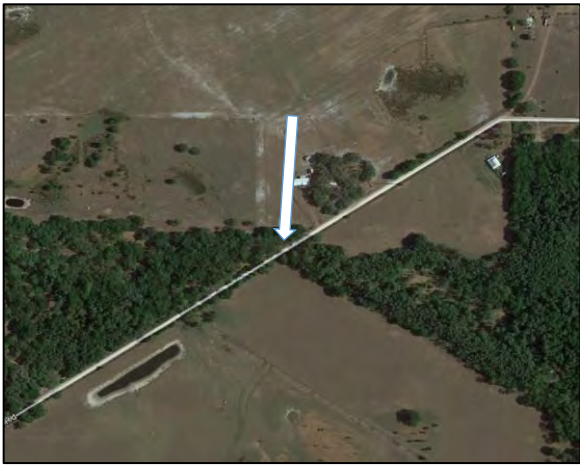
Unnamed Tributary			Sediment Risk Index: 56-Low	
Watershed: Peace River Subwatershed: Middle Charlie Creek Latitude: 27.462676 Longitude: -81.65670 Road Name: Davis Ranch Rd.			County: Hardee Site Number: PU045 LULC: Pasture, Natural Forest Land Owner(s): WIDENER LACY ALLEN*

Downstream Lt Ditch	Vegetated	1		
Improved Outlet Total	4	1	Additional Site Features	
Improved Ditches Total	4	1	Crossing Type and Quantity: Culvert (1)	
SRI Total: 56			Crossing Material: Corrugated Metal	
			Culvert Outfall Drop: 0 in.	
			Fish Passage Barrier: Not Present	
			Notes: Stream not flowing at survey; Cattle in streambed, *Additional land owners: WARNIMONT NANCY L AS TRUSTEE

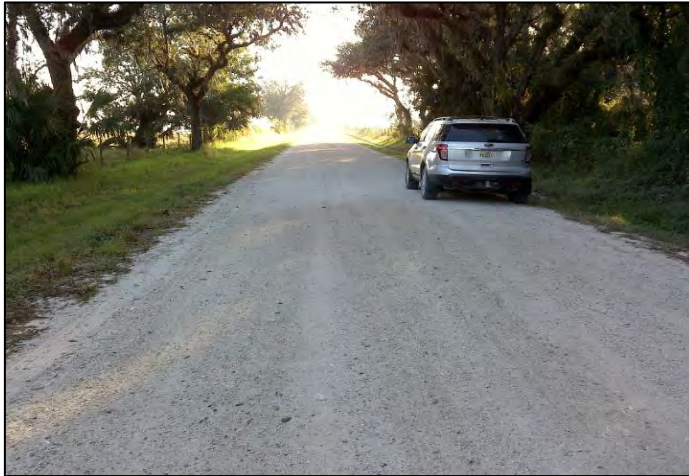
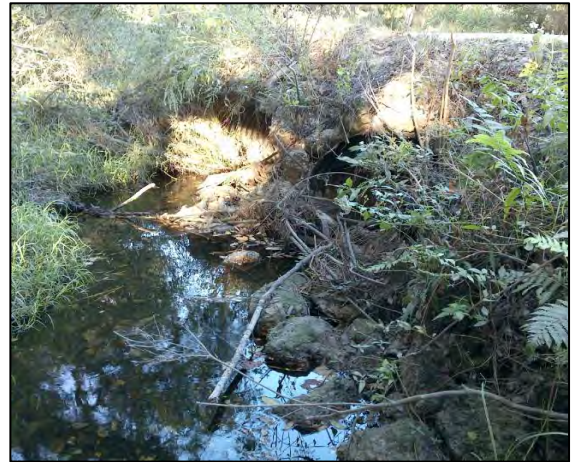
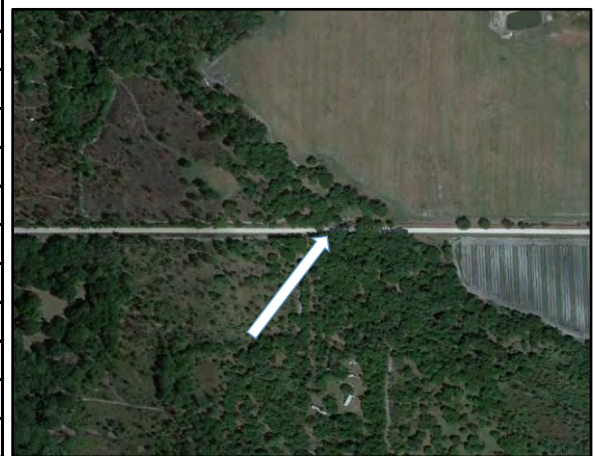
County: Hardee  
Site Number: PU047  
LULC: Pasture, Natural Forest  
Land Owner(s): LIMESTONE RANCH LLC

Notes: Cattle watering hole downstream of crossing, cow patties in stream; Barb wire fence across downstream channel - potential for blockage

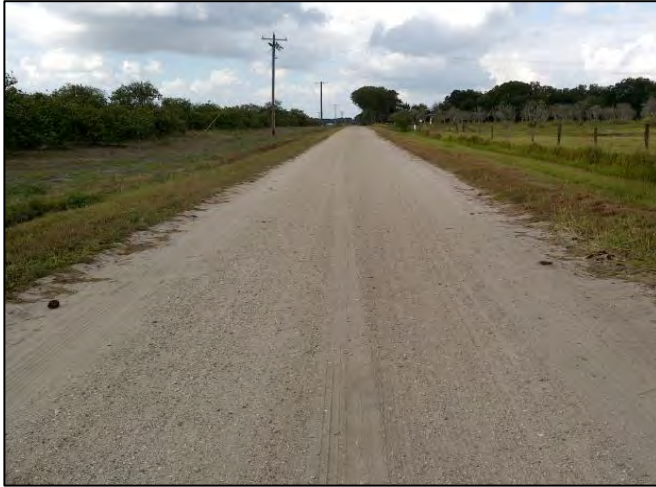
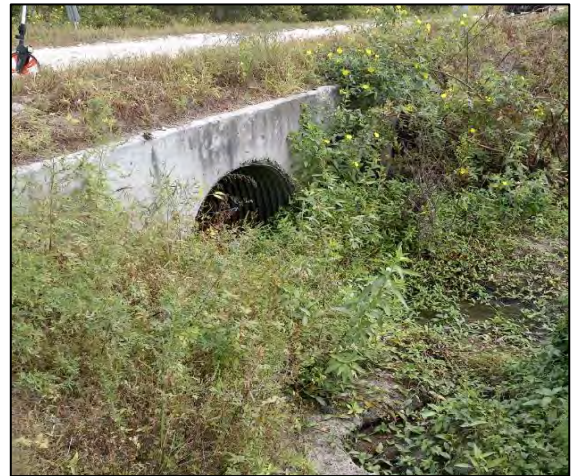
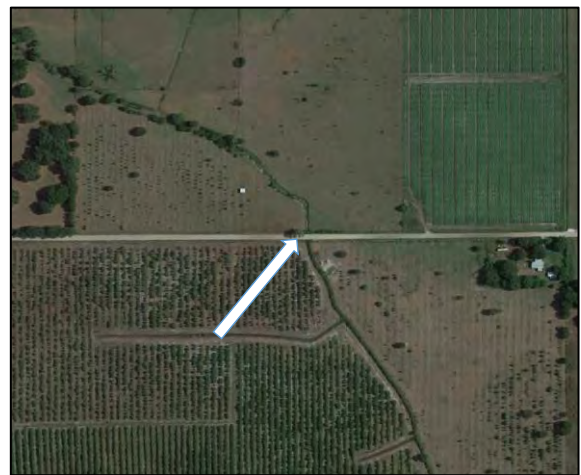
County: Hardee  
Site Number: PU049  
LULC: Citrus Groves, Pasture  
Land Owner(s): SKITKA DANNY\*

Crossing Type and Quantity: Culvert (3)  
Crossing Material: Corrugated Metal  
Culvert Outfall Drop: 0 in.  
Fish Passage Barrier: Not Present  
Notes: Berm upstream and downstream on pasture and citrus groves, \*Additional land owners: WILBURN CARL M & BETTY A

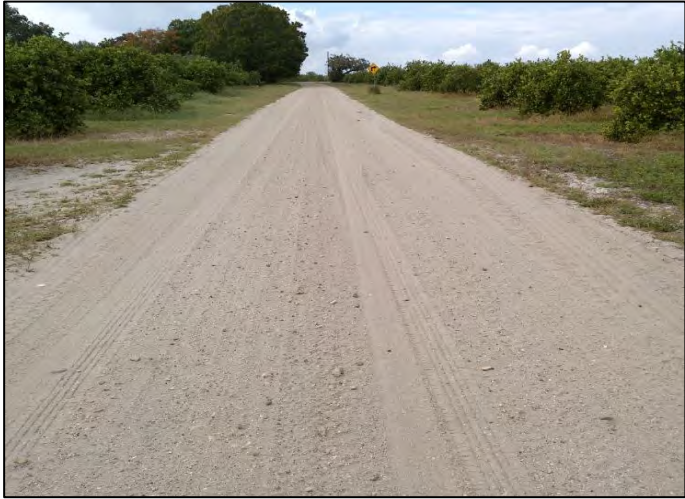
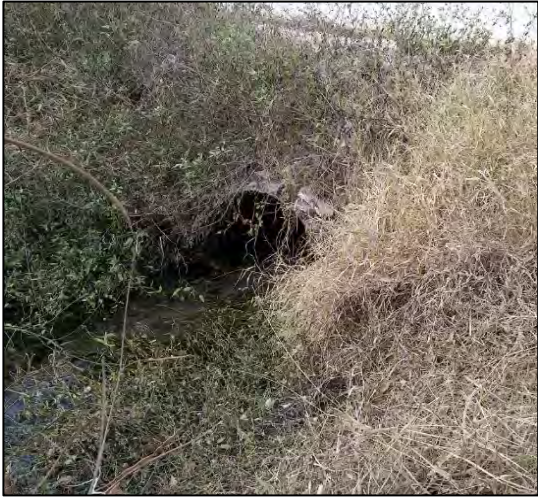
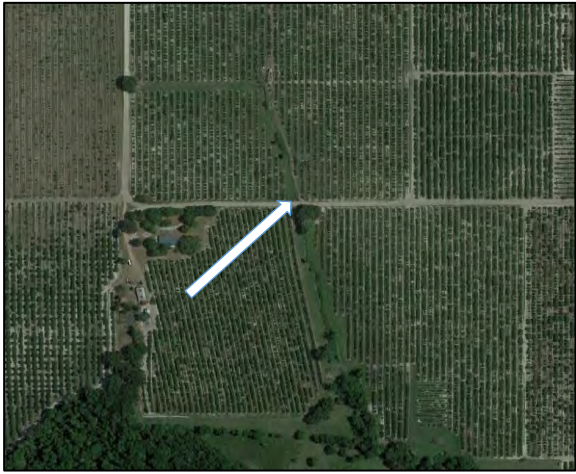
Unnamed Tributary			Sediment Risk Index: 42-Moderate	
Watershed: Peace River Subwatershed: Buckhorn Creek Latitude: 27.54436 Longitude: -81.675998 Road Name: Rest Haven Rd.			County: Hardee Site Number: PU051 LULC: Citrus Groves  Land Owner(s): T C PRESCOTT LLC

US Channel Morph	E	5		
DS Channel Morph	E	5		
DS Bank Alteration	High	1		
Upstream Skew Angle	5° to 30°	3		
Crossing fill condition	Riprap	3		
Inlet/Outlet Condition	Sediment/Scouring	3		
Potential Eroded Vol.	> 40 c.y.	1		
Soil K Factor	≤0.20	5		
Approach Slope Mean	≤2.0%	5		
Road Approach Material	Sandy Aggregate	3		
Upstream Rt Outlet	Bare Soil	0		
Upstream Lt Outlet	Bare Soil	0		
Upstream Rt Ditch	Vegetated	1		
Upstream Lt Ditch	Vegetated	1		
Downstream Rt Outlet	Vegetated	1		
Downstream Lt Outlet	Bare Soil	0		
Downstream Rt Ditch	Vegetated	1

Downstream Lt Ditch	Vegetated	1		
Improved Outlet Total	1	2		
Improved Ditches Total	4	1		
<b>SRI Total:</b>		42

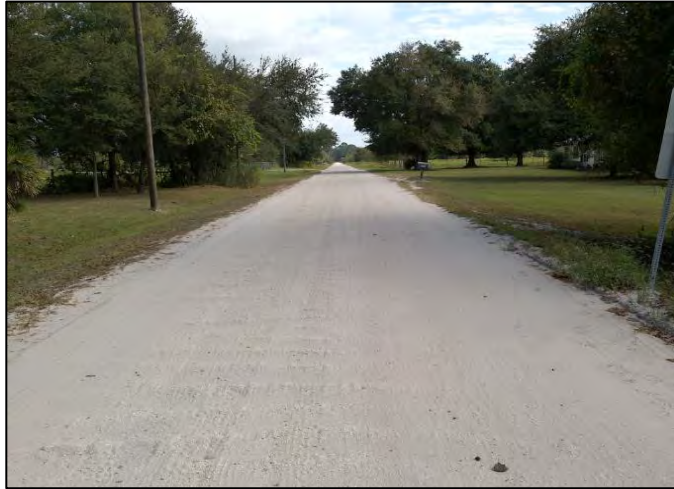
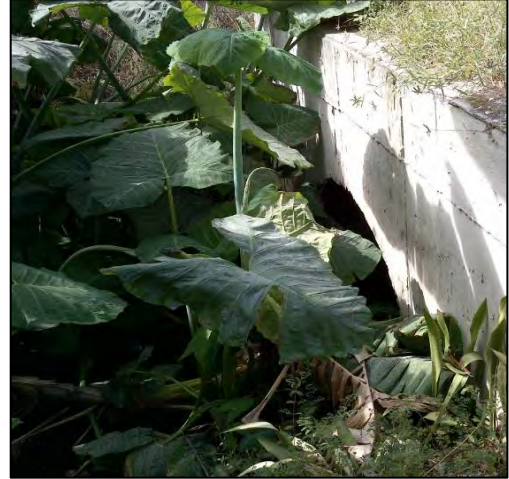
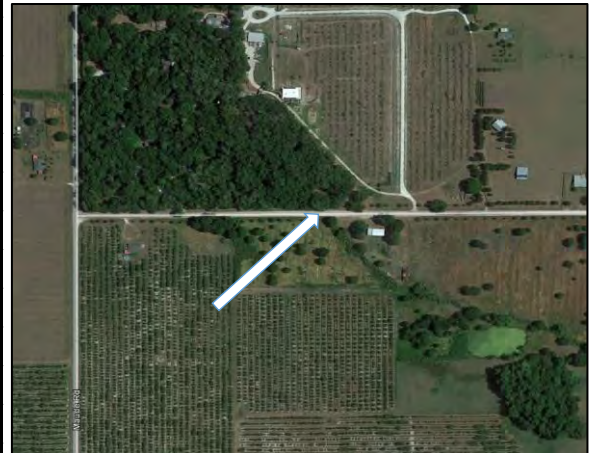
County: Hardee  
Site Number: PU052  
LULC: Natural Forest, Citrus Groves, Pasture  
Land Owner(s): NEECE MELBA\*

Risk Factor	Ranking	Score
US Channel Morph	G	1
DS Channel Morph	G	1
DS Bank Alteration	Natural	5
Upstream Skew Angle	5° to 30°	3
Crossing fill condition	Fair	3
Inlet/Outlet Condition	Sediment/Scouring	3
Potential Eroded Vol.	< 21 c.y.	5
Soil K Factor	≤0.20	5
Approach Slope Mean	≤2.0%	5
Road Approach Material	All Aggregate	5
Upstream Rt Outlet	Bare Soil	0
Upstream Lt Outlet	Vegetated	1
Upstream Rt Ditch	Vegetated	1
Upstream Lt Ditch	Vegetated	1
Downstream Rt Outlet	Riprap	1
Downstream Lt Outlet	Bare Soil	0
Downstream Rt Ditch	Vegetated	1
Downstream Lt Ditch	Vegetated	1
Improved Outlet Total	2	1
Improved Ditches Total	4	1
<b>SRI Total:</b>		<b>44</b>

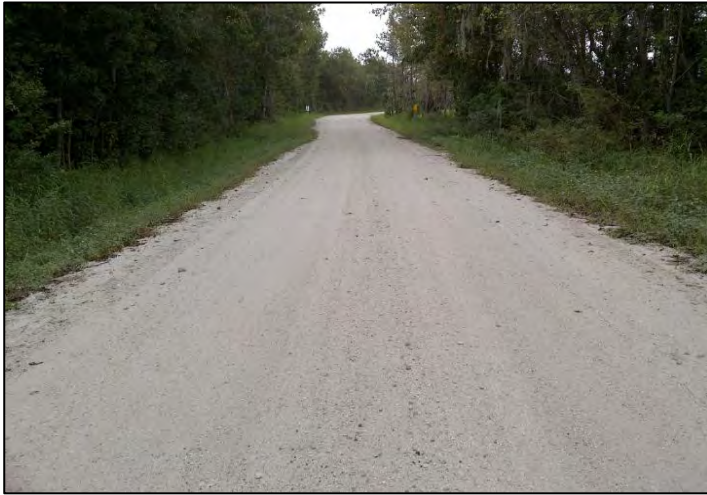
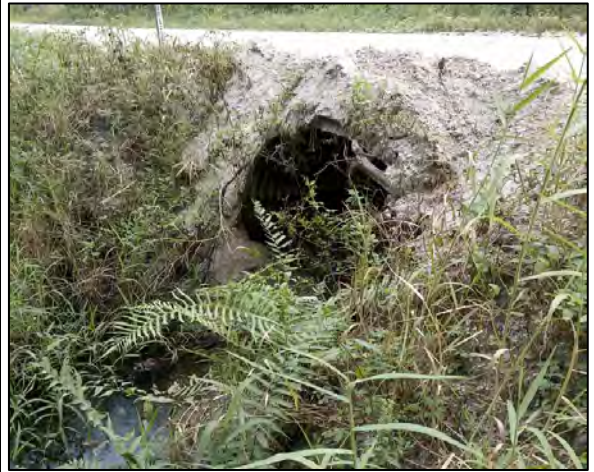
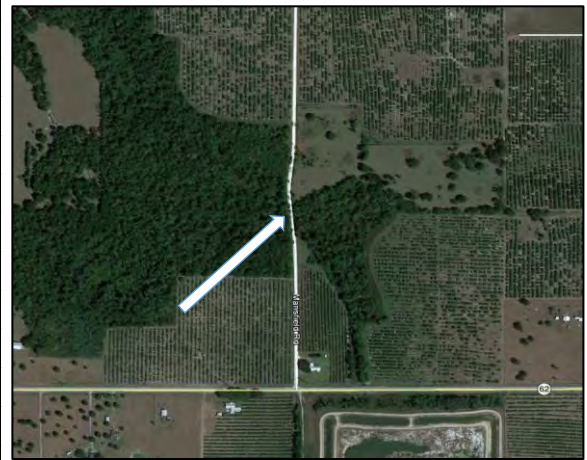
County: Hardee  
Site Number: PU053  
LULC: Natural Forest, Citrus Groves  
Land Owner(s): MOSAIC FERTILIZER LLC

Risk Factor	Ranking	Score
US Channel Morph	E	5
DS Channel Morph	E	5
DS Bank Alteration	Natural	5
Upstream Skew Angle	5° to 30°	3
Crossing fill condition	Poor/Bare Soil	1
Inlet/Outlet Condition	Sediment/Scouring	3
Potential Eroded Vol.	21-40 c.y.	3
Soil K Factor	≤0.20	5
Approach Slope Mean	≤2.0%	5
Road Approach Material	All Aggregate	5
Upstream Rt Outlet	Vegetated	1
Upstream Lt Outlet	Vegetated	1
Upstream Rt Ditch	Vegetated	1
Upstream Lt Ditch	Vegetated	1
Downstream Rt Outlet	Vegetated	1
Downstream Lt Outlet	Vegetated	1
Downstream Rt Ditch	Vegetated	1
Downstream Lt Ditch	Vegetated	1
Improved Outlet Total	4	1
Improved Ditches Total	4	1
<b>SRI Total:</b>		<b>50</b>

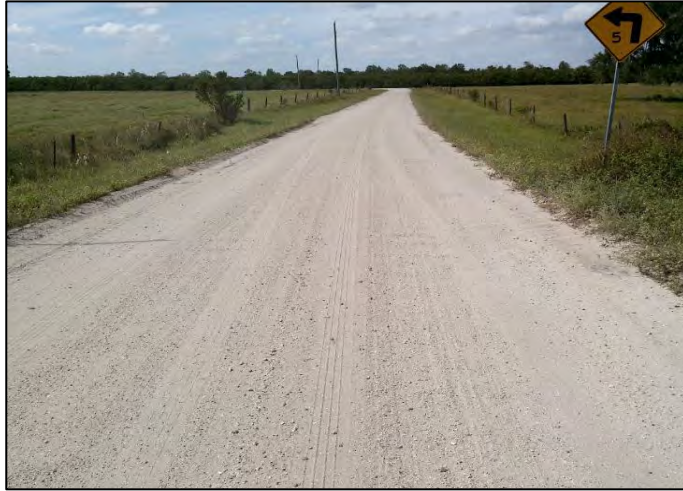
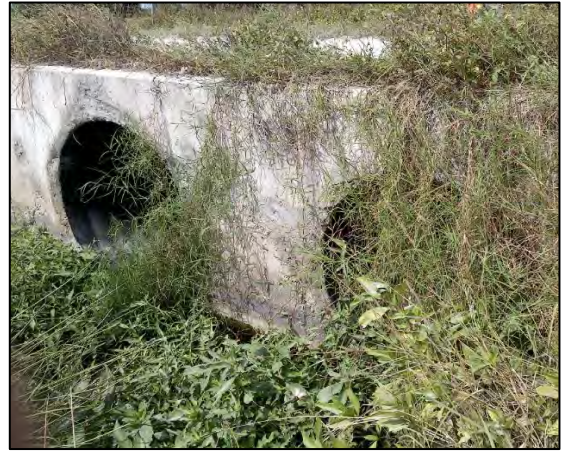
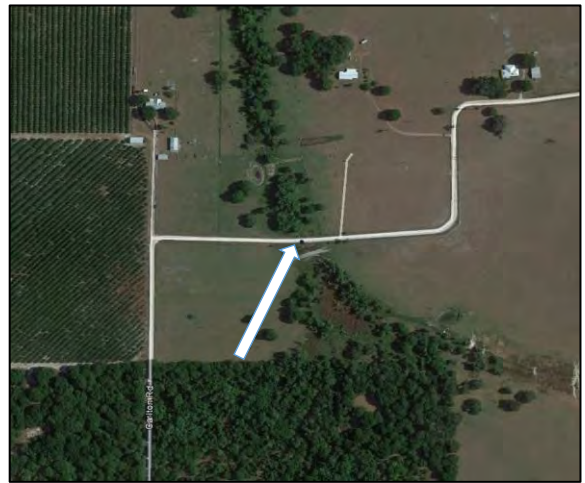
County: Hardee  
Site Number: PU054  
LULC: Pasture, Citrus Groves, Natural Forest, Wetland  
Land Owner(s): RAFTER C RANCH INC\*

Risk Factor	Ranking	Score
US Channel Morph	Wetland	5
DS Channel Morph	E	5
DS Bank Alteration	Minor/Partial	3
Upstream Skew Angle	<5°	5
Crossing fill condition	Good/Vegetated	5
Inlet/Outlet Condition	Sediment/Scouring	3
Potential Eroded Vol.	21-40 c.y.	3
Soil K Factor	≤0.20	5
Approach Slope Mean	≤2.0%	5
Road Approach Material	All Aggregate	5
Upstream Rt Outlet	Vegetated	1
Upstream Lt Outlet	Vegetated	1
Upstream Rt Ditch	Vegetated	1
Upstream Lt Ditch	Vegetated	1
Downstream Rt Outlet	Vegetated	1
Downstream Lt Outlet	Vegetated	1
Downstream Rt Ditch	Vegetated	1
Downstream Lt Ditch	Vegetated	1
Improved Outlet Total	4	1
Improved Ditches Total	4	1
<b>SRI Total:</b>		<b>54</b>

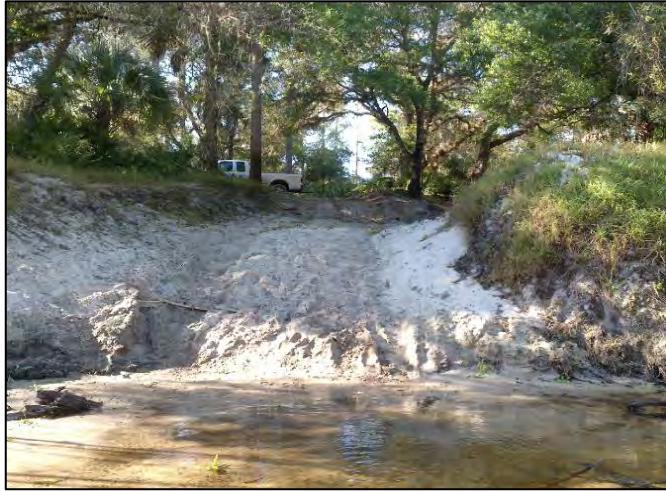
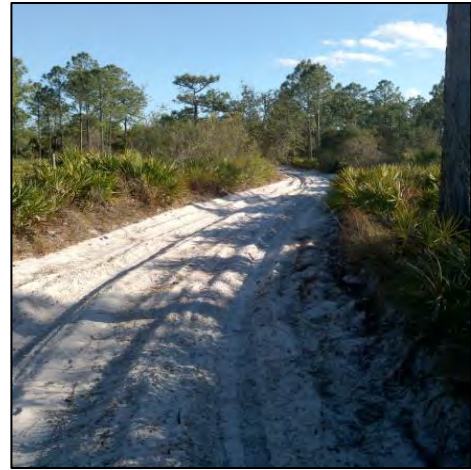
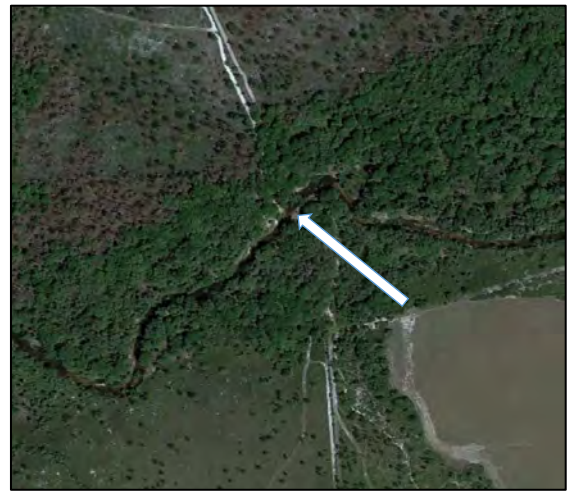
Risk Factor	Ranking	Score
US Channel Morph	Ponded	1
DS Channel Morph	E	5
DS Bank Alteration	Natural	5
Upstream Skew Angle	<5°	5
Crossing fill condition	Good/Vegetated	5
Inlet/Outlet Condition	Sediment/Scouring	3
Potential Eroded Vol.	21-40 c.y.	3
Soil K Factor	0.21 to 0.40	3
Approach Slope Mean	>4.0%	1
Road Approach Material	All Native Soil	1
Upstream Rt Outlet	Bare Soil	0
Upstream Lt Outlet	Bare Soil	0
Upstream Rt Ditch	Bare Soil	0
Upstream Lt Ditch	Bare Soil	0
Downstream Rt Outlet	Bare Soil	0
Downstream Lt Outlet	Bare Soil	0
Downstream Rt Ditch	Bare Soil	0
Downstream Lt Ditch	Bare Soil	0
Improved Outlet Total	0	1
Improved Ditches Total	0	1
<b>SRI Total:</b>		<b>34</b>

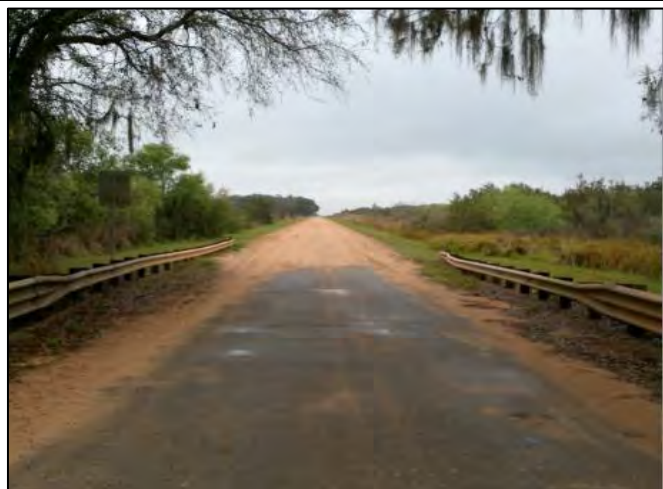
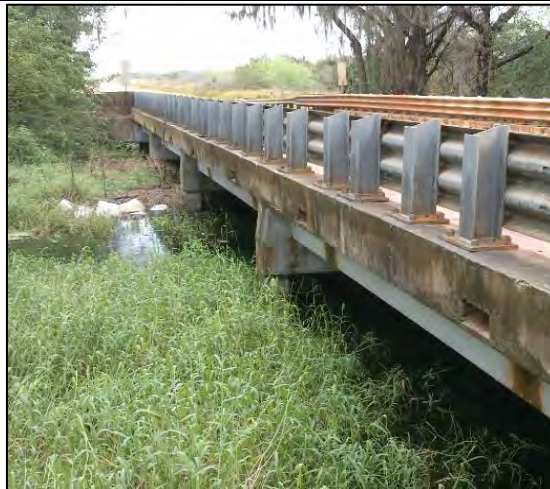
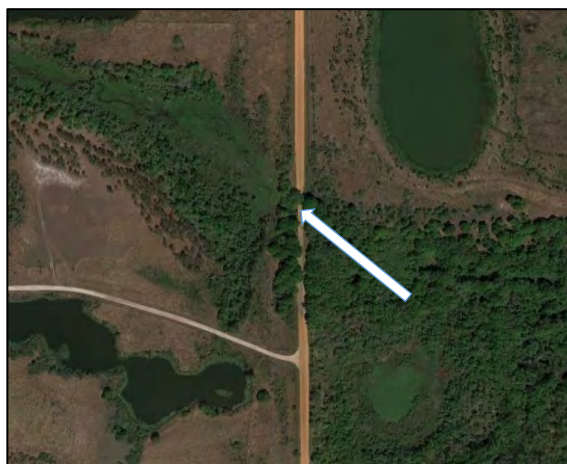
County: Polk  
Site Number: PU056  
LULC: Historic Phosphate Mining, Wetland, Natural Forest  
Land Owner(s):US AGRI CHEMICALS CORP\*

Risk Factor	Ranking	Score
US Channel Morph	DA	3
DS Channel Morph	DA	3
DS Bank Alteration	Natural	5
Upstream Skew Angle	<5°	5
Crossing fill condition	Fair	3
Inlet/Outlet Condition	Sediment/Scouring	3
Potential Eroded Vol.	> 40 c.y.	1
Soil K Factor	≤0.20	5
Approach Slope Mean	2.1% to 4.0%	3
Road Approach Material	All Native Soil	1
Upstream Rt Outlet	Vegetated	1
Upstream Lt Outlet	Vegetated	1
Upstream Rt Ditch	Vegetated	1
Upstream Lt Ditch	Vegetated	1
Downstream Rt Outlet	Vegetated	1
Downstream Lt Outlet	Vegetated	1
Downstream Rt Ditch	Vegetated	1
Downstream Lt Ditch	Vegetated	1
Improved Outlet Total	4	1
Improved Ditches Total	4	1
<b>SRI Total:</b>		<b>42</b>

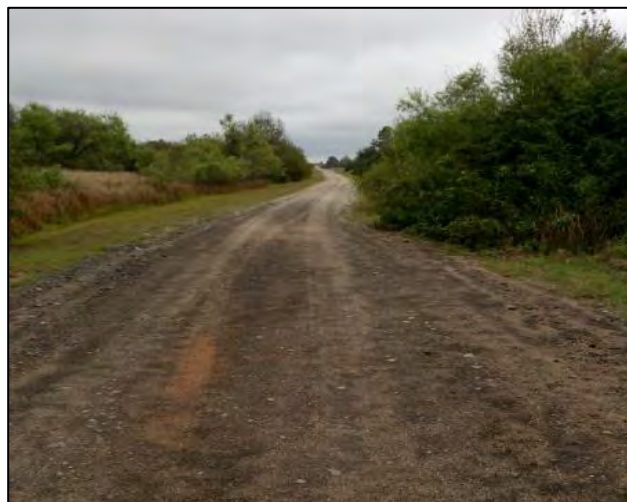
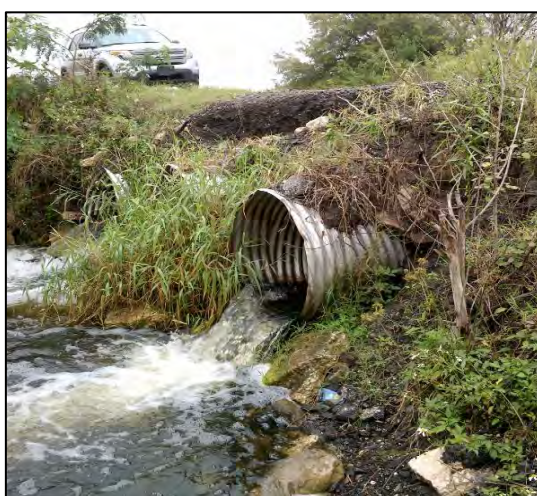
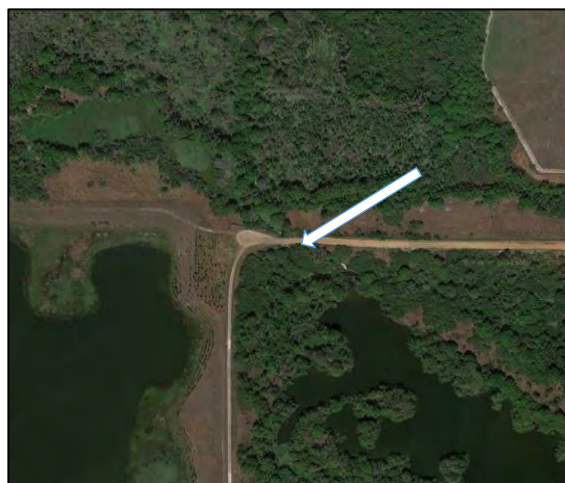
Risk Factor	Ranking	Score
US Channel Morph	Ponded	1
DS Channel Morph	C	5
DS Bank Alteration	High	1
Upstream Skew Angle	>30°	1
Crossing fill condition	Riprap/Poor	2
Inlet/Outlet Condition	Sediment/Scouring	3
Potential Eroded Vol.	21-40 c.y.	3
Soil K Factor	≤0.20	5
Approach Slope Mean	≤2.0%	5
Road Approach Material	Aggregate/Native Soil	3
Upstream Rt Outlet	Vegetated	1
Upstream Lt Outlet	Bare Soil	0
Upstream Rt Ditch	Vegetated	1
Upstream Lt Ditch	Bare Soil	0
Downstream Rt Outlet	Bare Soil	0
Downstream Lt Outlet	Bare Soil	0
Downstream Rt Ditch	Vegetated	1
Downstream Lt Ditch	Vegetated	1
Improved Outlet Total	1	2
Improved Ditches Total	3	0
<b>SRI Total:</b>		<b>35</b>

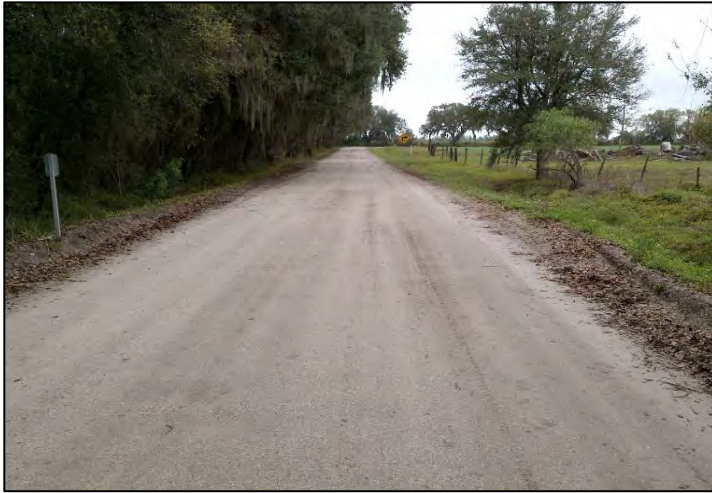
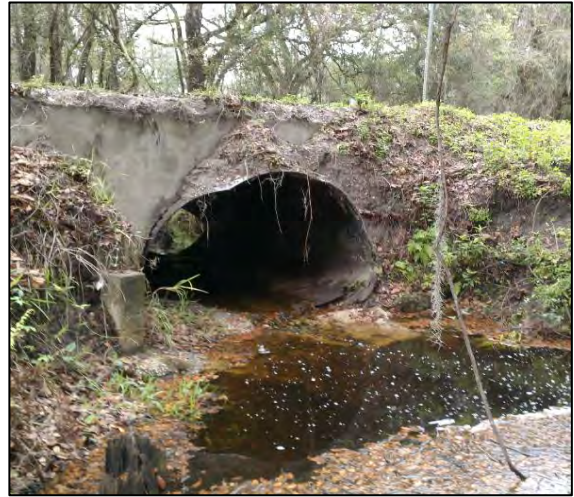
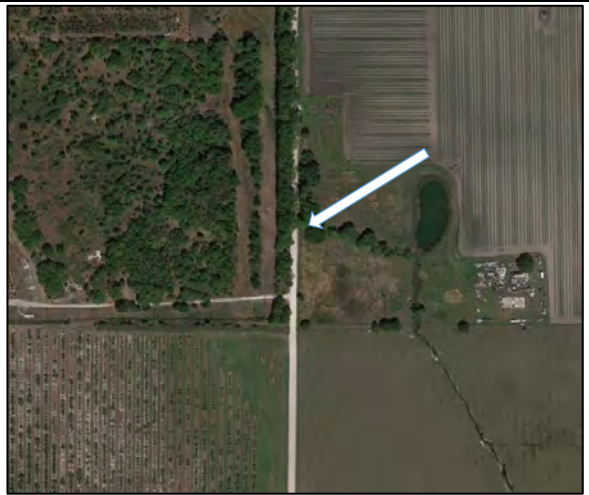
County: Hardee  
Site Number: PU058  
LULC: Natural Forest, Citrus Groves, Pasture  
Land Owner(s): WOODARD VANCE J\*

Risk Factor	Ranking	Score
US Channel Morph	E	5
DS Channel Morph	E	5
DS Bank Alteration	Natural	5
Upstream Skew Angle	5° to 30°	2
Crossing fill condition	Fair	3
Inlet/Outlet Condition	Sediment/Scouring	3
Potential Eroded Vol.	21-40 c.y.	3
Soil K Factor	≤0.20	5
Approach Slope Mean	≤2.0%	5
Road Approach Material	All Aggregate	5
Upstream Rt Outlet	Vegetated	1
Upstream Lt Outlet	Vegetated	1
Upstream Rt Ditch	Vegetated	1
Upstream Lt Ditch	Vegetated	1
Downstream Rt Outlet	Vegetated	1
Downstream Lt Outlet	Vegetated	1
Downstream Rt Ditch	Vegetated	1
Downstream Lt Ditch	Vegetated	1
Improved Outlet Total	4	1
Improved Ditches Total	4	1
<b>SRI Total:</b>		<b>51</b>

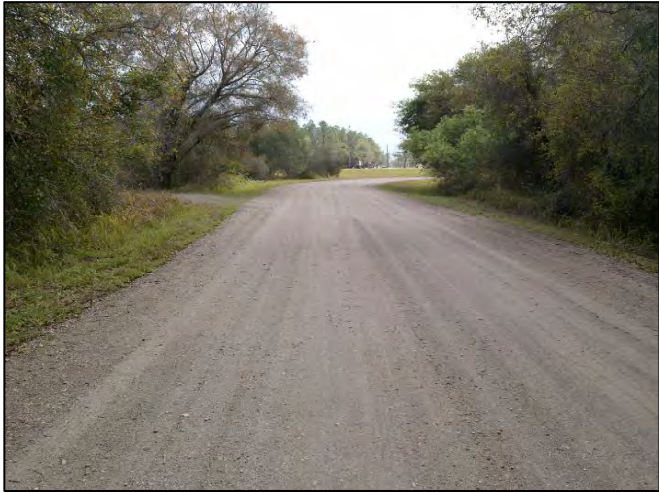
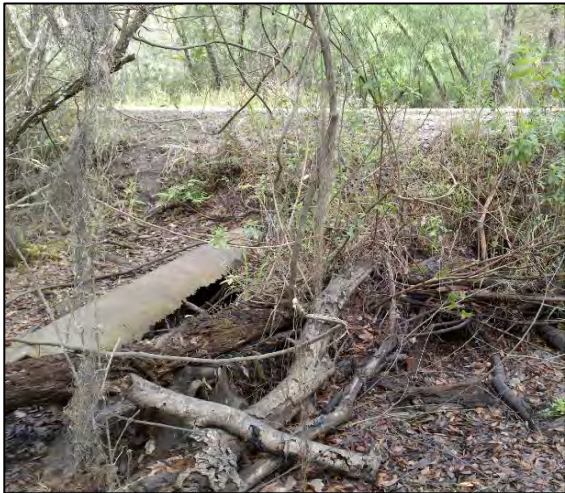
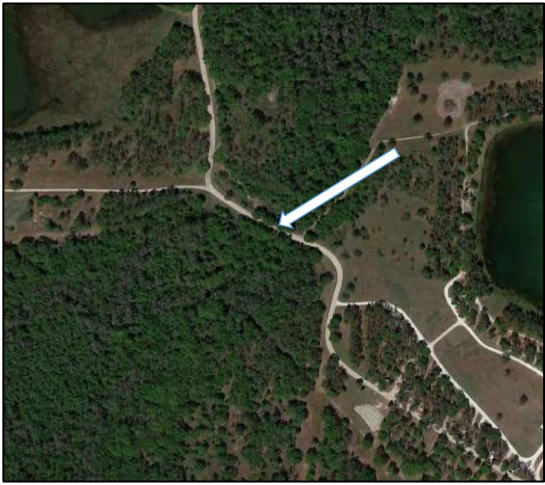
Unnamed Tributary			Sediment Risk Index: 50-Low	
Watershed: Peace River Subwatershed: Upper Payne Creek Latitude: 27.63119 Longitude: -81.97923 Road Name: John Gill Rd.			County: Hardee Site Number: PU059 LULC: Natural Forest  Land Owner(s): HARDEE COUNTY

US Channel Morph	Ponded	1		
DS Channel Morph	C	5		
DS Bank Alteration	Natural	5		
Upstream Skew Angle	<5°	5		
Crossing fill condition	Vegetated	5		
Inlet/Outlet Condition	Blocked	1		
Potential Eroded Vol.	21-40 c.y.	3		
Soil K Factor	≤0.20	5		
Approach Slope Mean	≤2.0%	5		
Road Approach Material	All Aggregate	5		
Upstream Rt Outlet	Vegetated	1		
Upstream Lt Outlet	Vegetated	1		
Upstream Rt Ditch	Vegetated	1		
Upstream Lt Ditch	Vegetated	1		
Downstream Rt Outlet	Vegetated	1		
Downstream Lt Outlet	Vegetated	1		
Downstream Rt Ditch	Vegetated	1

Downstream Lt Ditch	Vegetated	1		
Improved Outlet Total	4	1		
Improved Ditches Total	4	1	Crossing Type and Quantity: Culvert (4)	
<b>SRI Total:</b> 50			Crossing Material: Metal	
			Culvert Outfall Drop: 0 in.	
			Fish Passage Barrier: Not Present	
			Notes: Hardee Lakes County Park; Two roads included in left approach
