# **Peace River and Withlacoochee River Threats Assessments and Fish Assemblage Monitoring**

**Final Report July 1, 2015 – June 30, 2019**

Submitted to Florida State Wildlife Grants Program  
August 1, 2019  
PID: 98462501284

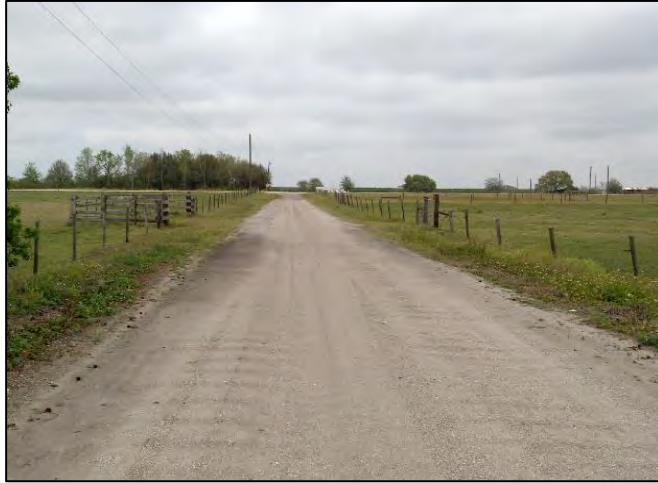
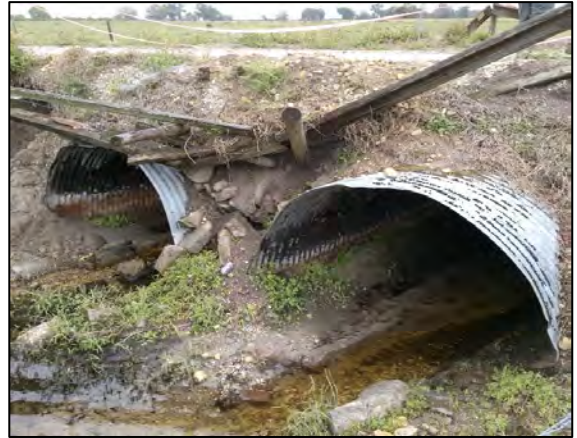
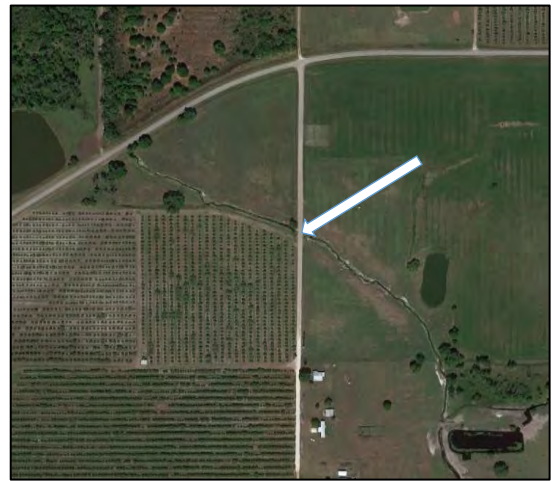
County: Hardee  
Site Number: PU060  
LULC: Pasture, Citrus Groves  
Land Owner(s): BEST GLENDA\*

Risk Factor	Ranking	Score
US Channel Morph	F	1
DS Channel Morph	F	1
DS Bank Alteration	High	1
Upstream Skew Angle	5° to 30°	3
Crossing fill condition	Fair/Riprap	3
Inlet/Outlet Condition	Sediment/Scouring	3
Potential Eroded Vol.	< 21 c.y.	5
Soil K Factor	≤0.20	5
Approach Slope Mean	≤2.0%	5
Road Approach Material	All Aggregate	5
Upstream Rt Outlet	Vegetated	1
Upstream Lt Outlet	Vegetated	1
Upstream Rt Ditch	Vegetated	1
Upstream Lt Ditch	Vegetated	1
Downstream Rt Outlet	Bare Soil	0
Downstream Lt Outlet	Vegetated	1
Downstream Rt Ditch	Vegetated	1
Downstream Lt Ditch	Vegetated	1
Improved Outlet Total	3	0
Improved Ditches Total	4	1
<b>SRI Total:</b>		<b>40</b>

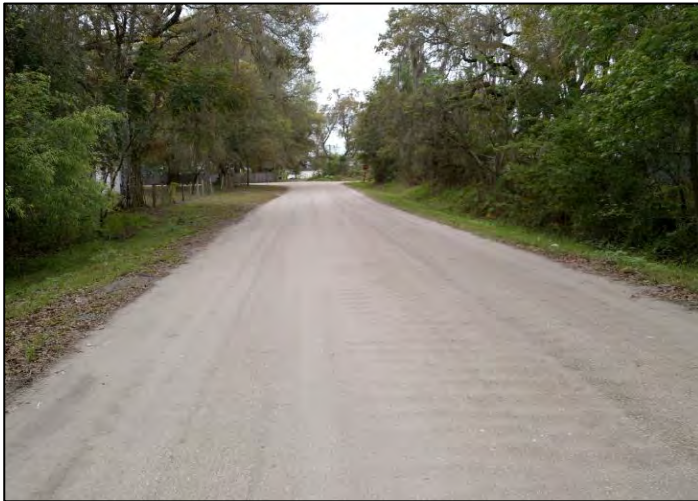
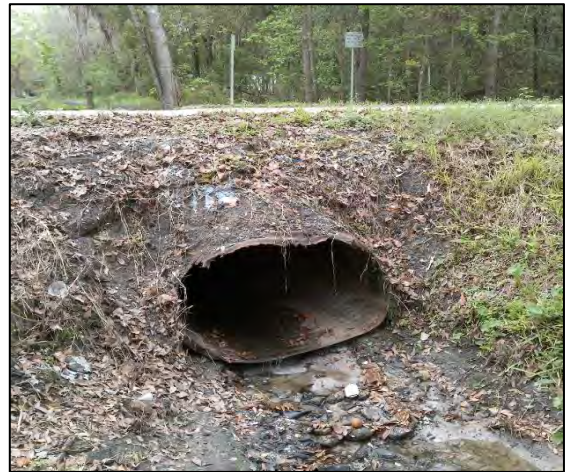
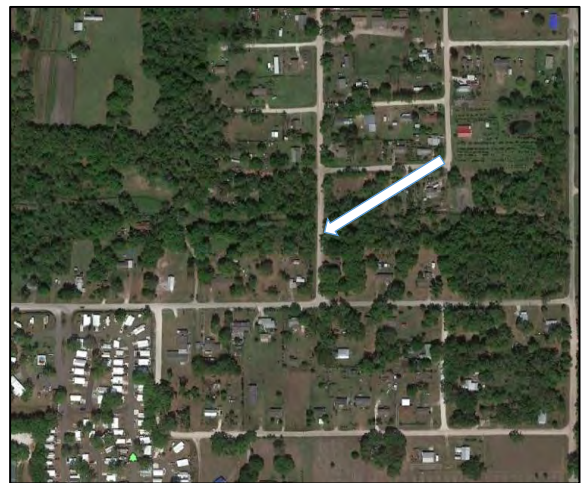
Risk Factor	Ranking	Score
US Channel Morph	G	1
DS Channel Morph	G	1
DS Bank Alteration	High	1
Upstream Skew Angle	<5°	5
Crossing fill condition	Fair	3
Inlet/Outlet Condition	Sediment/Scouring	3
Potential Eroded Vol.	< 21 c.y.	5
Soil K Factor	≤0.20	5
Approach Slope Mean	≤2.0%	5
Road Approach Material	All Aggregate	5
Upstream Rt Outlet	Bare Soil	0
Upstream Lt Outlet	Vegetated	1
Upstream Rt Ditch	Vegetated	1
Upstream Lt Ditch	Vegetated	1
Downstream Rt Outlet	Vegetated	1
Downstream Lt Outlet	Vegetated	1
Downstream Rt Ditch	Vegetated	1
Downstream Lt Ditch	Vegetated	1
Improved Outlet Total	3	0
Improved Ditches Total	4	1
<b>SRI Total:</b>		<b>42</b>

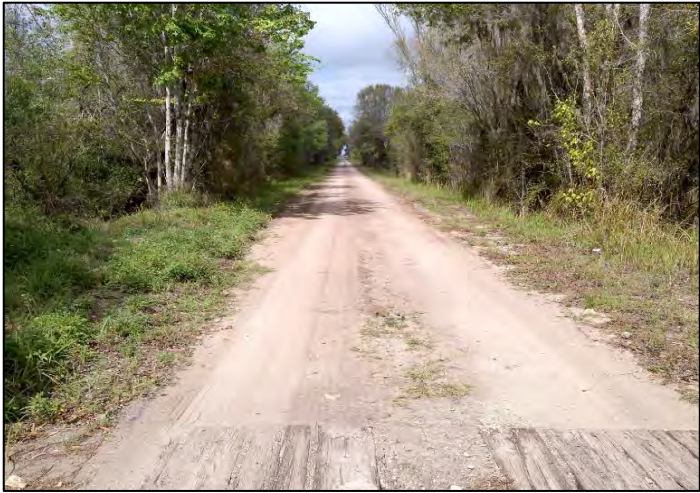
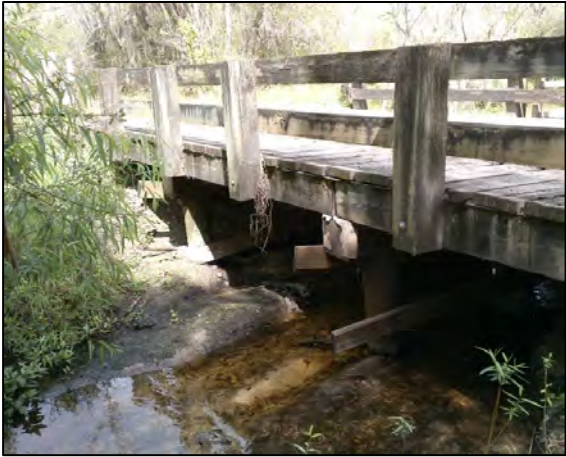
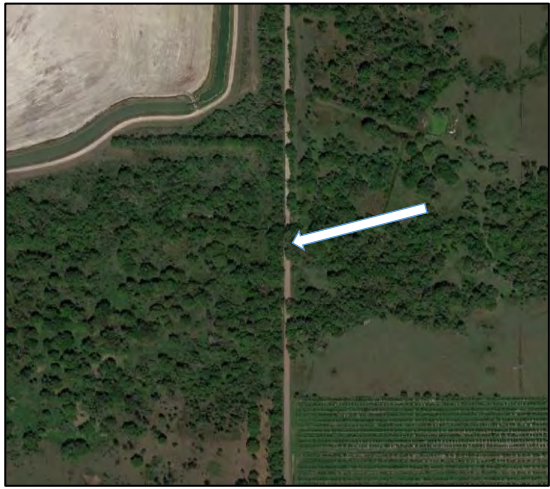
Little Charlie Creek			Sediment Risk Index: 50-Low	
Watershed: Peace River Subwatershed: Little Charlie Creek Latitude: 27.62716 Longitude: -81.72779 Road Name: Locklar Rd.			County: Hardee Site Number: PU062 LULC: Natural Forest, Citrus Groves, Phosphate Mining Land Owner(s): SEANSA LLC*

US Channel Morph	C	5		
DS Channel Morph	C	5		
DS Bank Alteration	Natural	5		
Upstream Skew Angle	<5°	5		
Crossing fill condition	Good/Vegetated	5		
Inlet/Outlet Condition	Sediment/Scouring	3		
Potential Eroded Vol.	> 40 c.y.	1		
Soil K Factor	≤0.20	5		
Approach Slope Mean	≤2.0%	5		
Road Approach Material	All Native Soil	1		
Upstream Rt Outlet	Vegetated	1		
Upstream Lt Outlet	Vegetated	1		
Upstream Rt Ditch	Vegetated	1		
Upstream Lt Ditch	Vegetated	1		
Downstream Rt Outlet	Vegetated	1		
Downstream Lt Outlet	Vegetated	1

Downstream Rt Ditch	Vegetated	1		
Downstream Lt Ditch	Vegetated	1		
Improved Outlet Total	4	1		
Improved Ditches Total	4	1		
SRI Total:		50	Additional Site Features	
			Crossing Type and Quantity: Bridge (1)	
			Crossing Material: Wood/Concrete	
			Culvert Outfall Drop: NA	
			Fish Passage Barrier: Not Present	
			Notes: Fence across stream under bridge - debris jam potential; USGS gaging station at crossing, *Additional land owners: MOSAIC FERTILIZER LLC

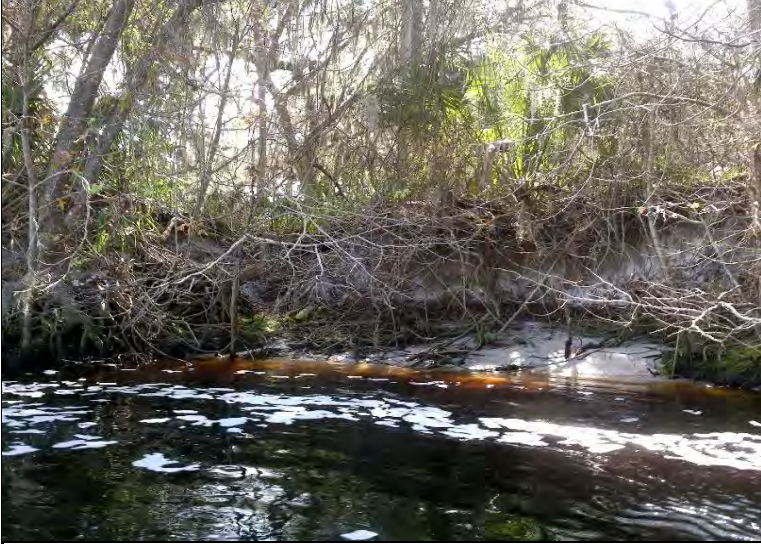
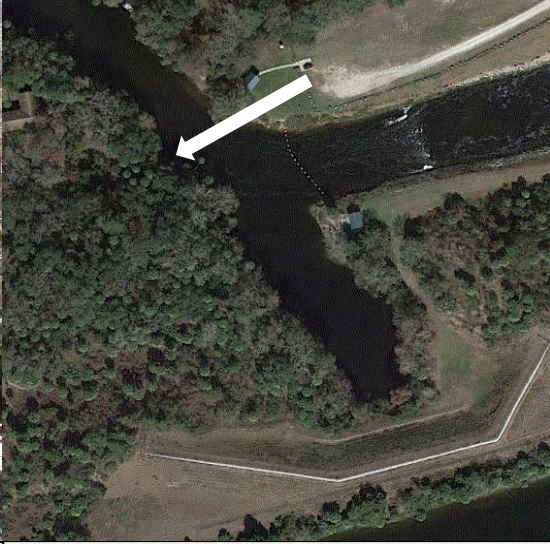
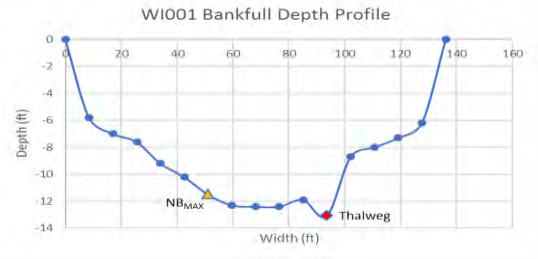
Withlacoochee River			Severity Scale: 3.25-Low
Watershed: Withlacoochee River Subwatershed: West Lake Rousseau (Barge Canal) Latitude: 29.020844 Longitude: -82.639861			County: Citrus Site Number: WI001 Reach Length: 25 ft. Landowner: Michael Collins

Pfankuch-Channel Stability:	Good	0	
Channel Alteration:	Historic	0.5	
Bank Erosion:	Active	0.5	
BEHI:	High (30.14)	1	
Local NPSP:	Slight Potential	0.5	
Shoring Structures:	None	0	
Pipe Discharge:	None	0	
Water Odor:	Normal	0	
Fish Passage Barrier:	None	0	
RB: Riparian Buffer:	30 ft.	0.5	
LB: Riparian Buffer:	100 ft.	0	
RB: Floodplain Access:	Full	0	
LB: Floodplain Access:	Partial	0.25	
<b>Severity Scale:</b>		<b>3.25</b>	
			Additional Site Features
			Stream Channel Woody Material: Moderate
			Impoundments: Manmade (Lake Rousseau)
			Substrate Composition: Medium Sand
			Bank Material: Sand
			Near Bank Stress: Low

RB Landuse: Recreation, Natural Forest
			LB Landuse: Natural Forest, Residential
Notes: Unpaved road beside dam on right bank w/recreational access; Discharge from dam released at 90 degree angle to stream channel on left bank at site; 303d: Impaired - DO and Benthic Macroinvertebrates Bioassessments			
Restoration Option 1

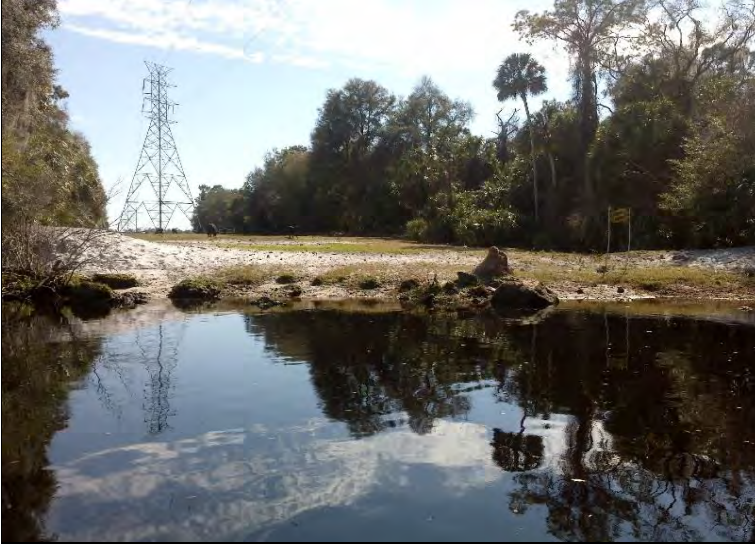
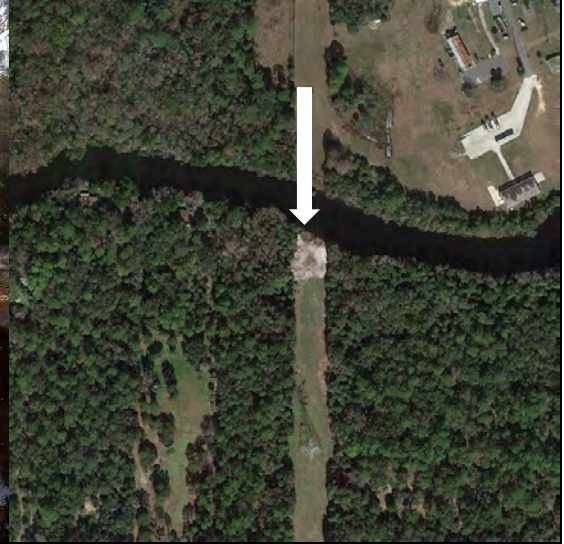
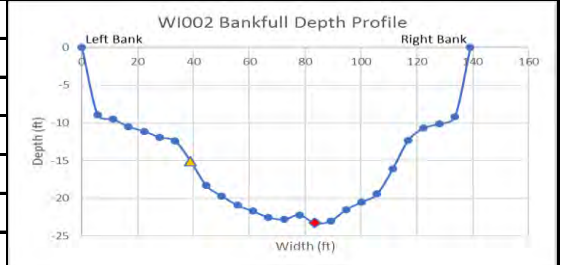
Risk Factor	Ranking	Score
Pfankuch-Channel Stability:	Good	0
Channel Alteration:	None	0
Bank Erosion:	Active	1
BEHI:	High (33.33)	1
Local NPSP:	Obvious Sources	1.5
Shoring Structures:	None	0
Pipe Discharge:	None	0
Water Odor:	Normal	0
Fish Passage Barrier:	None	0
RB: Riparian Buffer:	0 ft.	0.75
LB: Riparian Buffer:	0 ft.	0.75
RB: Floodplain Access:	Full	0
LB: Floodplain Access:	Full	0
Severity Scale:		5.0

Stream Channel Woody Material: Infrequent
Impoundments: None
Substrate Composition: Medium Sand
Bank Material: Sand
Near Bank Stress: Low
RB Landuse: Utilities
LB Landuse: Pasture

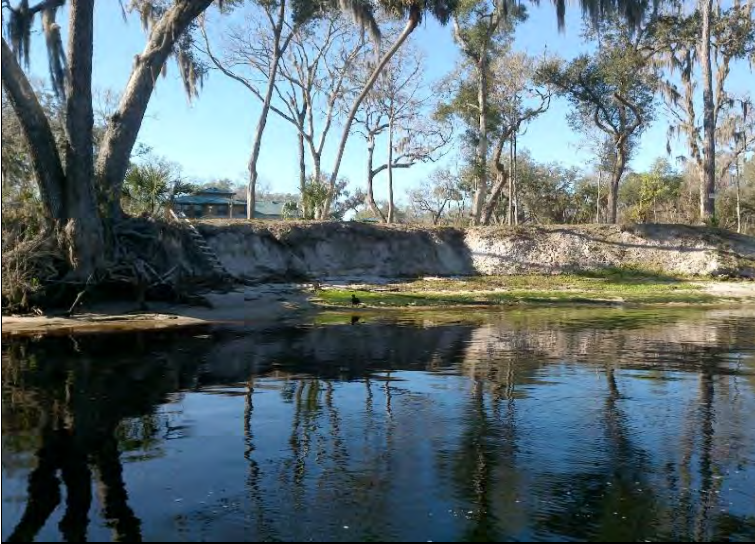
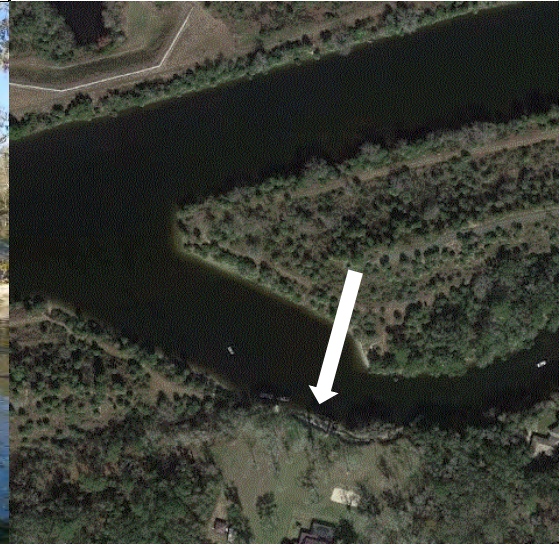
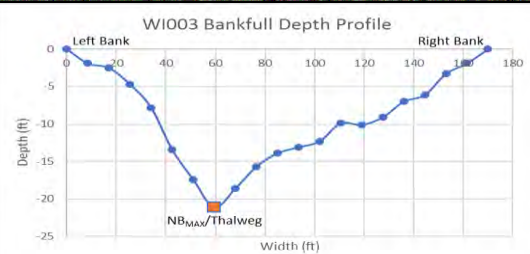
Risk Factor	Ranking	Score
Pfankuch-Channel Stability:	Good	0
Channel Alteration:	None	0
Bank Erosion:	Mass-wasting	1.5
BEHI:	High (36.06)	1
Local NPSP:	Slight Potential	0.5
Shoring Structures:	None	0
Pipe Discharge:	None	0
Water Odor:	Normal	0
Fish Passage Barrier:	None	0
RB: Riparian Buffer:	100 ft.	0
LB: Riparian Buffer:	0 ft.	0.75
RB: Floodplain Access:	Partial	0.25
LB: Floodplain Access:	Partial	0.25
<b>Severity Scale:</b>		<b>4.25</b>

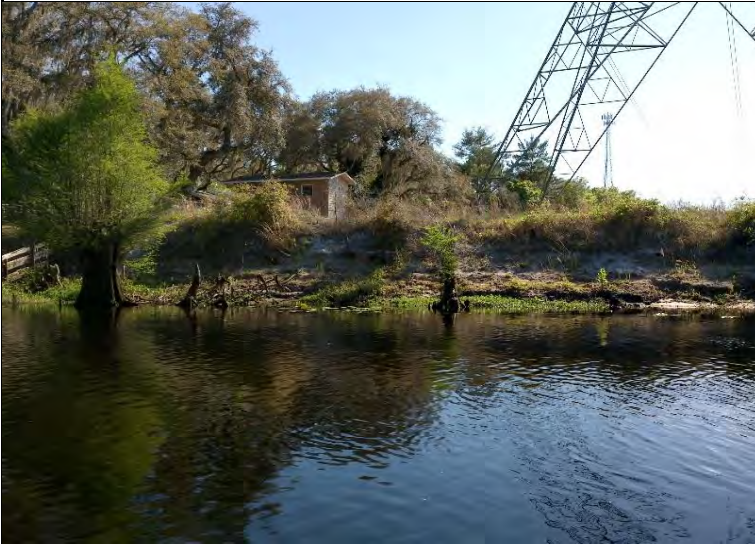
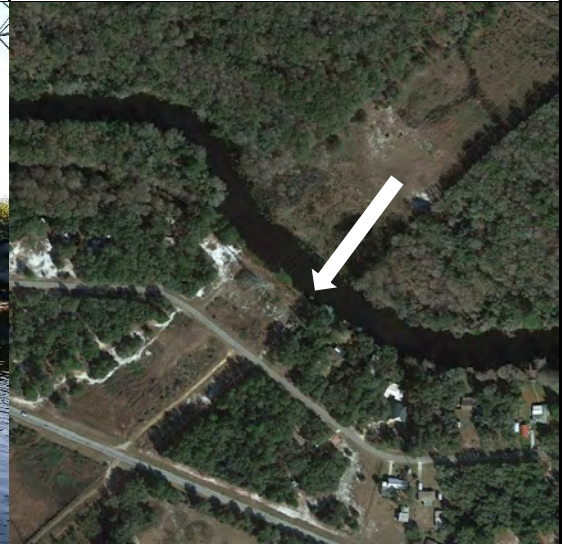
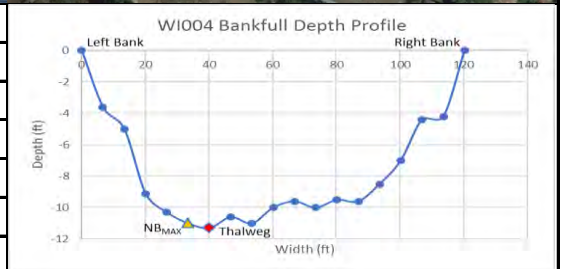
County: Citrus  
Site Number: WI004  
Reach Length: 217 ft.  
Landowner: Duke Energy Florida Inc.

Risk Factor	Ranking	Score
Pfankuch-Channel Stability:	Good	0
Channel Alteration:	None	0
Bank Erosion:	Active	1
BEHI:	Moderate (23.30)	0.5
Local NPSP:	No Evidence	0
Shoring Structures:	None	0
Pipe Discharge:	None	0
Water Odor:	Normal	0
Fish Passage Barrier:	None	0
RB: Riparian Buffer:	100 ft.	0
LB: Riparian Buffer:	100 ft.	0
RB: Floodplain Access:	Full	0
LB: Floodplain Access:	Full	0

Additional Site Features
Stream Channel Woody Material: Infrequent
Impoundments: None
Substrate Composition: Medium Sand
Bank Material: Sand
Near Bank Stress: High
RB Landuse: Utilities
LB Landuse: Utilities, Residential

**Severity Scale: 1.5**

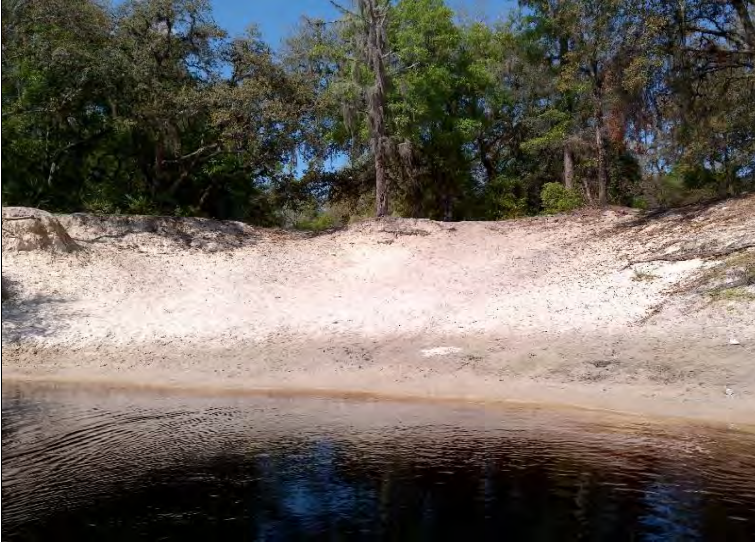
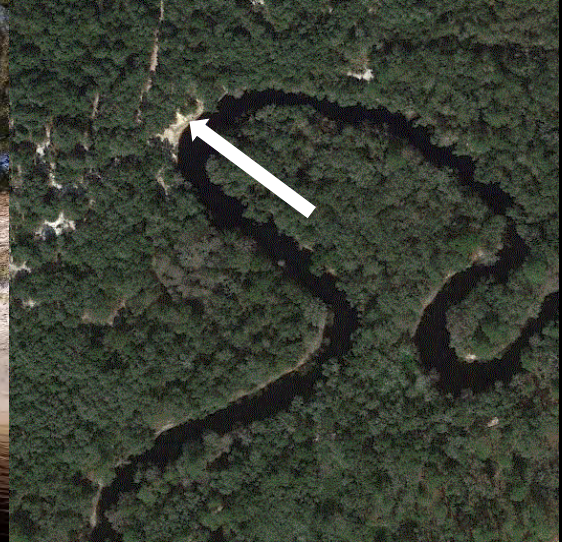
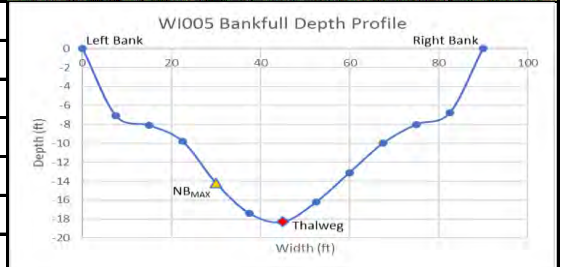
Risk Factor	Ranking	Score
Pfankuch-Channel Stability:	Good	0
Channel Alteration:	None	0
Bank Erosion:	Active	1
BEHI:	High (36.49)	1
Local NPSP:	Slight Potential	0.5
Shoring Structures:	None	0
Pipe Discharge:	None	0
Water Odor:	Normal	0
Fish Passage Barrier:	None	0
RB: Riparian Buffer:	100 ft.	0
LB: Riparian Buffer:	40 ft.	0.5
RB: Floodplain Access:	Full	0
LB: Floodplain Access:	Partial	0.25
<b>Severity Scale:</b>		<b>3.25</b>

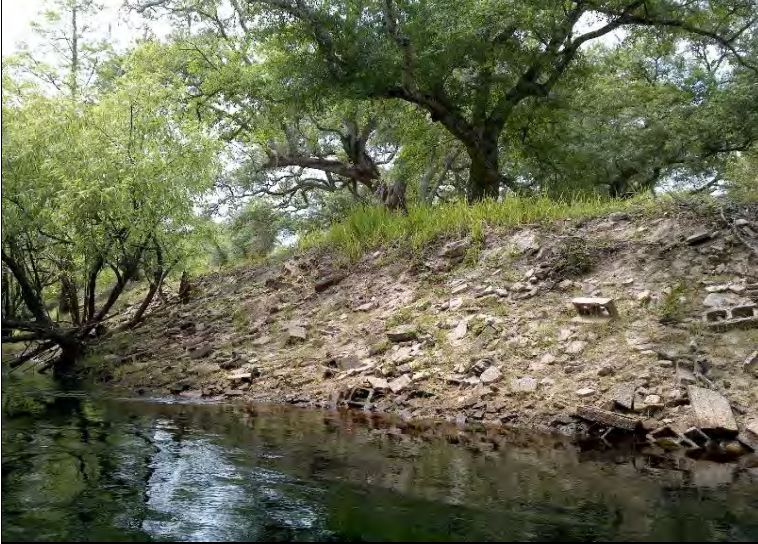
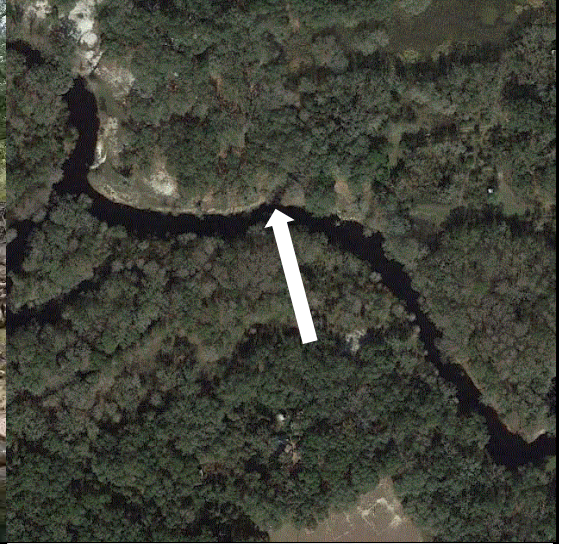
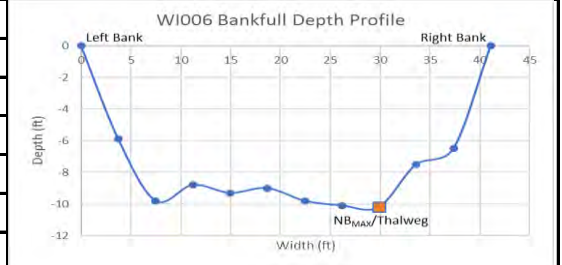
Risk Factor	Ranking	Score
Pfankuch-Channel Stability:	Good	0
Channel Alteration:	None	0
Bank Erosion:	Active	1
BEHI:	Moderate (26.50)	0.5
Local NPSP:	Slight Potential	0.5
Shoring Structures:	Present	1.5
Pipe Discharge:	None	0
Water Odor:	Normal	0
Fish Passage Barrier:	None	0
RB: Riparian Buffer:	40 ft.	0.5
LB: Riparian Buffer:	100 ft.	0
RB: Floodplain Access:	Full	0
LB: Floodplain Access:	Full	0
Severity Scale:		4.0

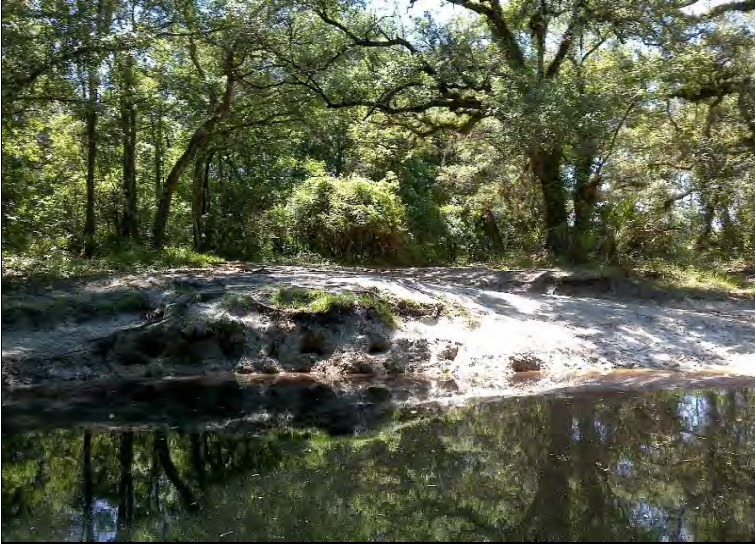
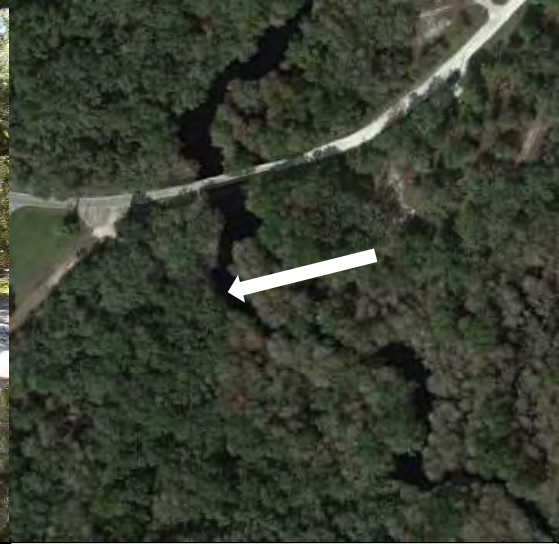
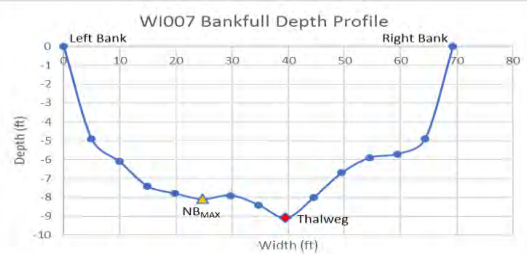
County: Pasco  
Site Number: WI007  
Reach Length: 45 ft.  
Landowner: SWFWMD

Risk Factor	Ranking	Score
Pfankuch-Channel Stability:	Good	0
Channel Alteration:	None	0
Bank Erosion:	Active	1
BEHI:	High (36.51)	1
Local NPSP:	Slight Potential	0.5
Shoring Structures:	None	0
Pipe Discharge:	None	0
Water Odor:	Normal	0
Fish Passage Barrier:	None	0
RB: Riparian Buffer:	100 ft.	0
LB: Riparian Buffer:	0 ft.	0.75
RB: Floodplain Access:	Full	0
LB: Floodplain Access:	Full	0
Severity Scale:		3.25

Stream Channel Woody Material: Infrequent  
Impoundments: None  
Substrate Composition: Medium Sand  
Bank Material: Sand  
Near Bank Stress: Low  
RB Landuse: Natural Forest  
LB Landuse: Recreation, Natural Forest

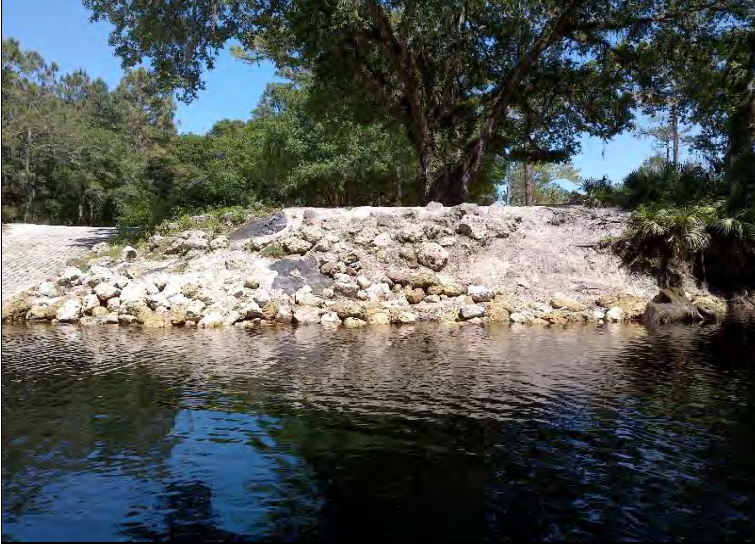
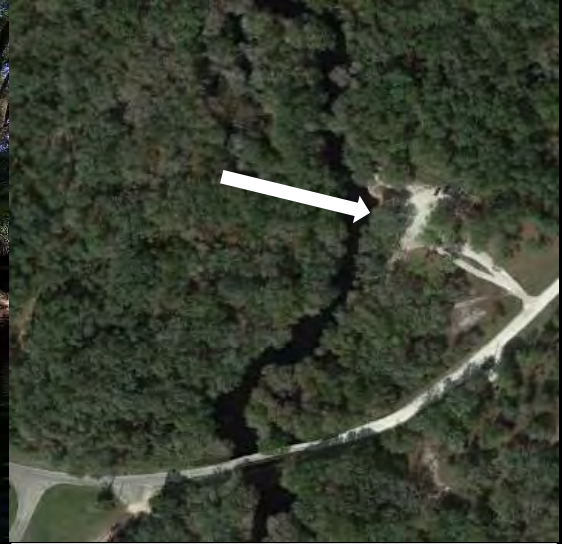
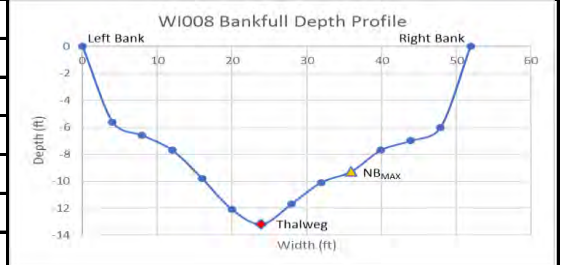
Risk Factor	Ranking	Score
Pfankuch-Channel Stability:	Good	0
Channel Alteration:	None	0
Bank Erosion:	Active	1
BEHI:	High (36.55)	1
Local NPSP:	Slight Potential	0.5
Shoring Structures:	Present	1.5
Pipe Discharge:	None	0
Water Odor:	Normal	0
Fish Passage Barrier:	None	0
RB: Riparian Buffer:	0 ft.	0.75
LB: Riparian Buffer:	100 ft.	0
RB: Floodplain Access:	Full	0
LB: Floodplain Access:	Full	0
<b>Severity Scale:</b>		<b>4.75</b>

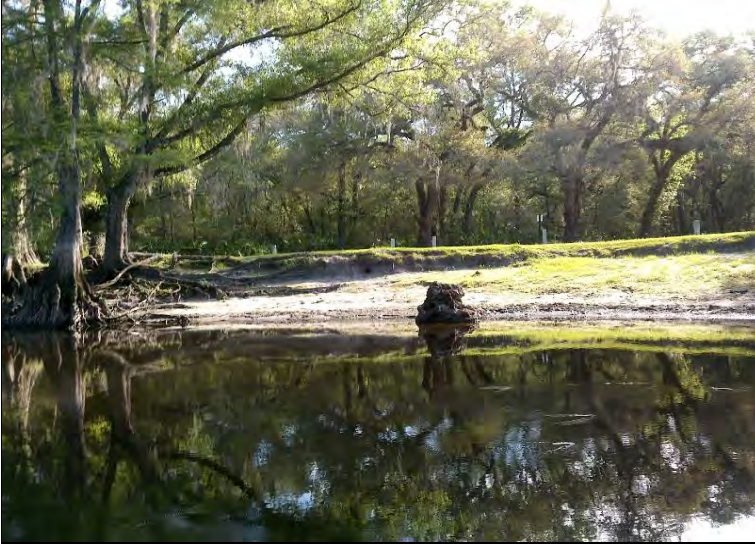
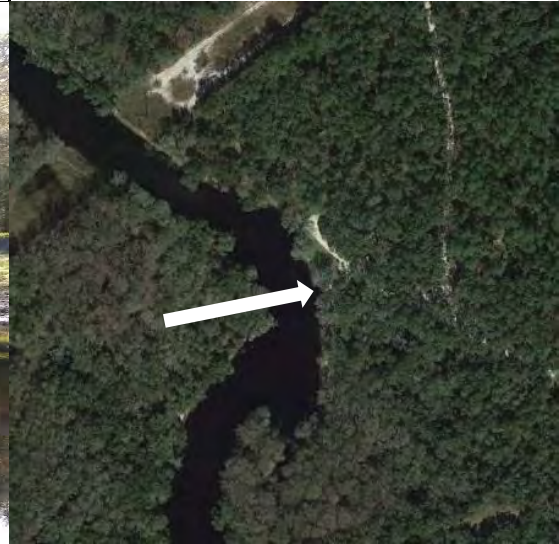
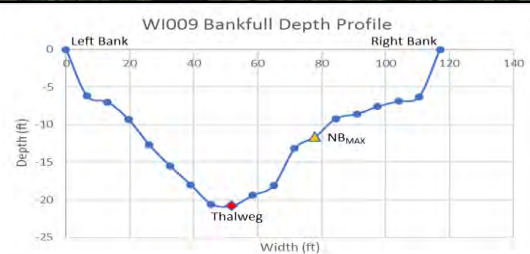
Risk Factor	Ranking	Score
Pfankuch-Channel Stability:	Good	0
Channel Alteration:	None	0
Bank Erosion:	Active	1
BEHI:	Moderate (25.06)	0.5
Local NPSP:	Slight Potential	0.5
Shoring Structures:	None	0
Pipe Discharge:	None	0
Water Odor:	Normal	0
Fish Passage Barrier:	None	0
RB: Riparian Buffer:	0 ft.	0.75
LB: Riparian Buffer:	100 ft.	0
RB: Floodplain Access:	Full	0
LB: Floodplain Access:	Full	0
<b>Severity Scale:</b>		<b>2.75</b>

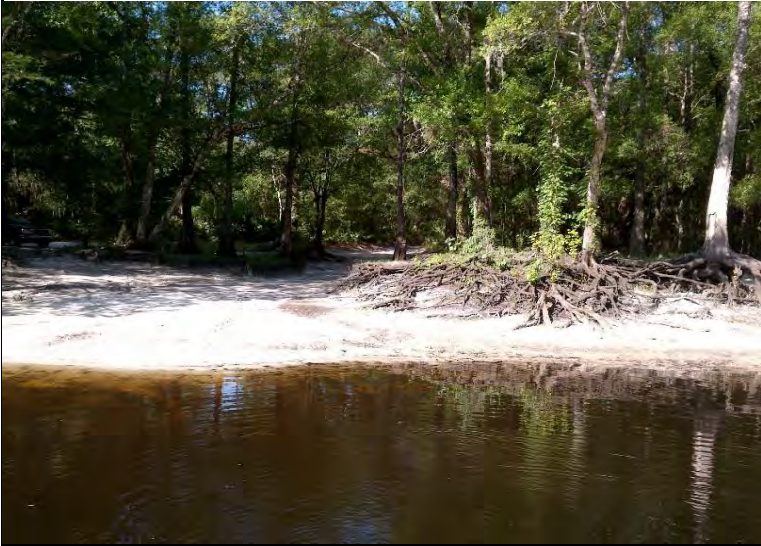
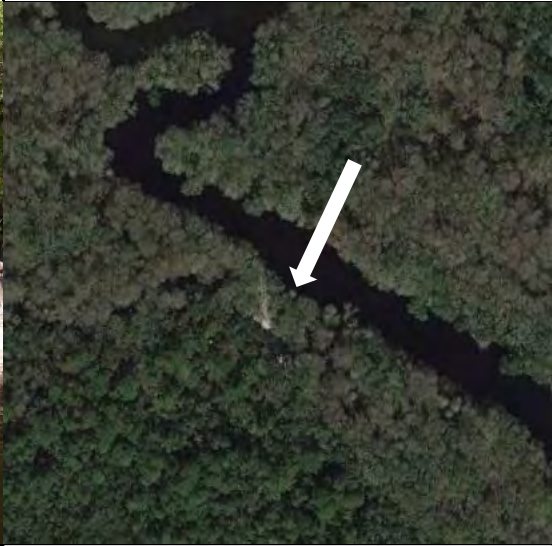
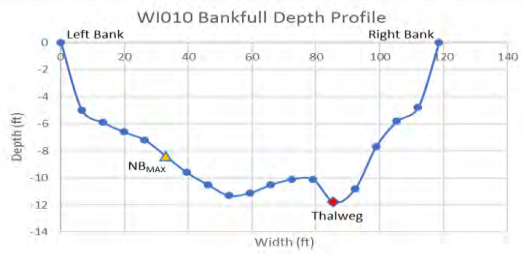
Withlacoochee River			Severity Scale: 3.0-Low	
Watershed: Withlacoochee River Subwatershed: Silver Lake Latitude: 28.59762 Longitude: -82.22670			County: Hernando Site Number: WI010 Reach Length: 85 ft. Landowner: DEP Div. of State Lands*

Pfankuch-Channel Stability:	Good	0		
Channel Alteration:	None	0	<b>Additional Site Features</b> Stream Channel Woody Material: Infrequent Impoundments: None Substrate Composition: Medium Sand Bank Material: Sand Near Bank Stress: Low RB Landuse: Natural Forest LB Landuse: Natural Forest, Recreation	
Bank Erosion:	Active	1		
BEHI:	Moderate (28.43)	0.5		
Local NPSP:	Moderate Potential	1		
Shoring Structures:	None	0		
Pipe Discharge:	None	0		
Water Odor:	Normal	0		
Fish Passage Barrier:	None	0		
RB: Riparian Buffer:	100 ft.	0		
LB: Riparian Buffer:	40 ft.	0.5		
RB: Floodplain Access:	Full	0		
LB: Floodplain Access:	Full	0

<b>Severity Scale:</b>		<b>3.0</b>		
Notes: *TIITF; Sediment input from unpaved access road; 303d: Impaired - DO and mercury in fish tissues				
Restoration Option 2 or 3

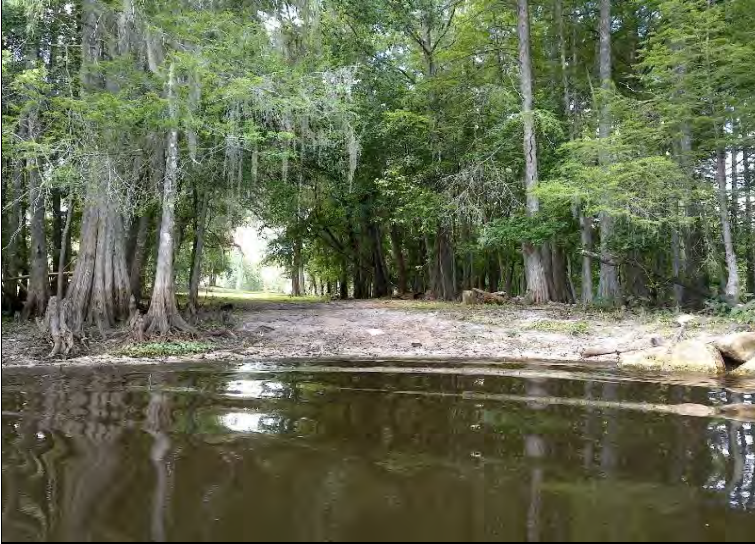
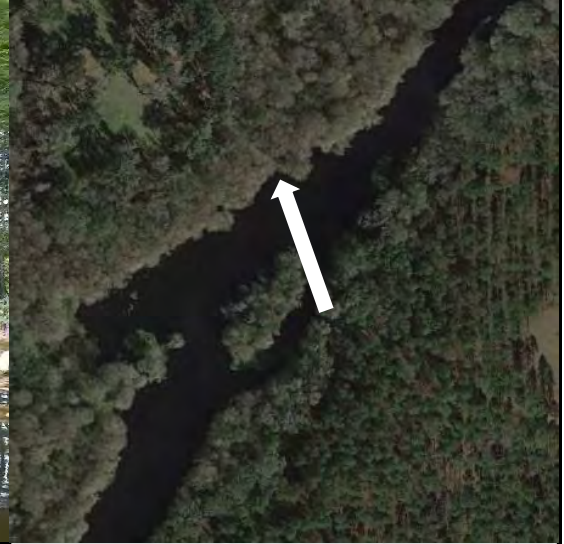
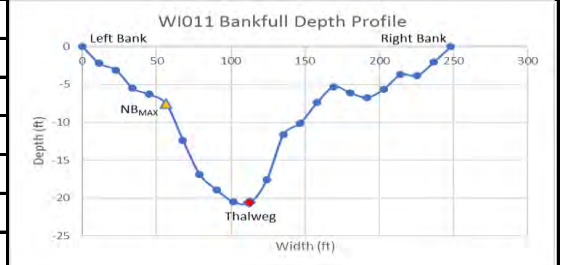
Risk Factor	Ranking	Score
Pfankuch-Channel Stability:	Good	0
Channel Alteration:	None	0
Bank Erosion:	Active	1
BEHI:	High (38.83)	1
Local NPSP:	Obvious Sources	1.5
Shoring Structures:	None	0
Pipe Discharge:	None	0
Water Odor:	Normal	0
Fish Passage Barrier:	None	0
RB: Riparian Buffer:	100 ft.	0
LB: Riparian Buffer:	0 ft.	0.75
RB: Floodplain Access:	Full	0
LB: Floodplain Access:	Full	0
Severity Scale:		4.25

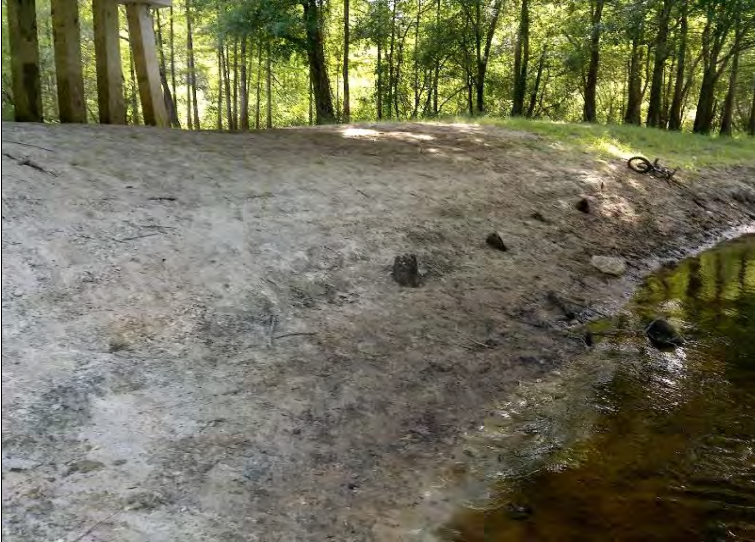
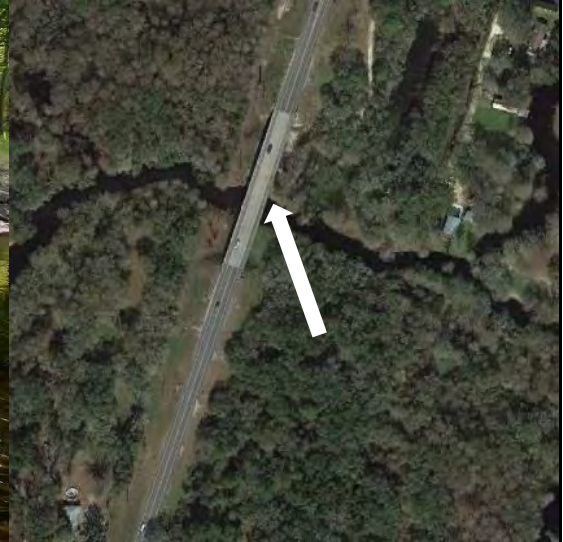
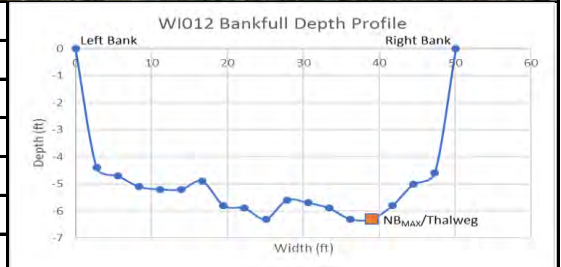
Risk Factor	Ranking	Score
Pfankuch-Channel Stability:	Good	0
Channel Alteration:	Historic	0.5
Bank Erosion:	Active	1
BEHI:	High (36.93)	1
Local NPSP:	Obvious Sources	1.5
Shoring Structures:	None	0
Pipe Discharge:	None	0
Water Odor:	Normal	0
Fish Passage Barrier:	None	0
RB: Riparian Buffer:	0 ft.	0.75
LB: Riparian Buffer:	40 ft.	0.5
RB: Floodplain Access:	Full	0
LB: Floodplain Access:	Full	0
<b>Severity Scale:</b>		<b>5.25</b>

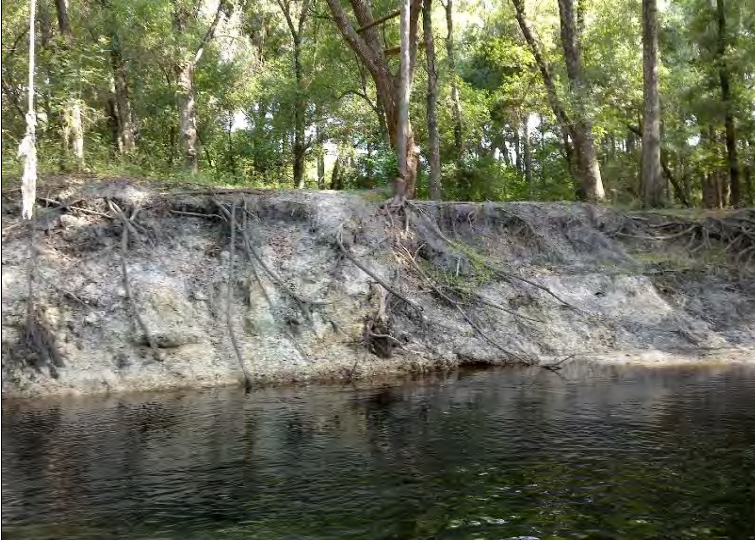
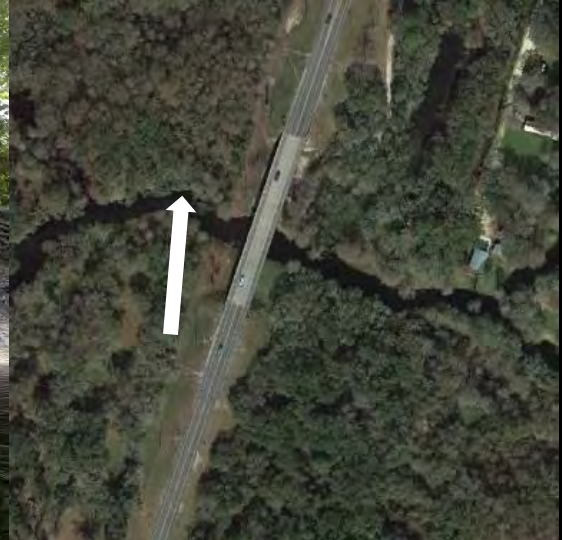
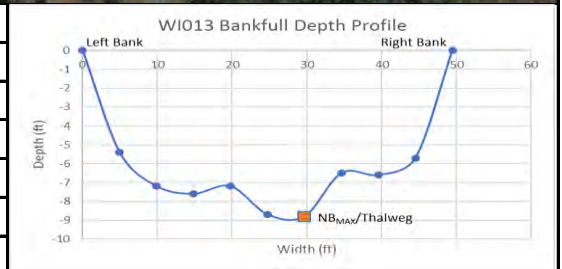
Risk Factor	Ranking	Score
Pfankuch-Channel Stability:	Good	0
Channel Alteration:	None	0
Bank Erosion:	Active	1
BEHI:	Moderate (26.45)	0.5
Local NPSP:	Moderate Potential	1
Shoring Structures:	None	0
Pipe Discharge:	None	0
Water Odor:	Normal	0
Fish Passage Barrier:	None	0
RB: Riparian Buffer:	100 ft.	0
LB: Riparian Buffer:	100 ft.	0
RB: Floodplain Access:	Partial	0.25
LB: Floodplain Access:	Full	0
<b>Severity Scale:</b>		<b>2.75</b>

Additional Site Features
Stream Channel Woody Material: Moderate
Impoundments: None
Substrate Composition: Medium Sand
Bank Material: Sand
Near Bank Stress: Moderate
RB Landuse: Natural Forest, Recreation
LB Landuse: Natural Forest

Notes: Rope swing/swimming hole; 303d: Impaired - DO and mercury in fish tissues

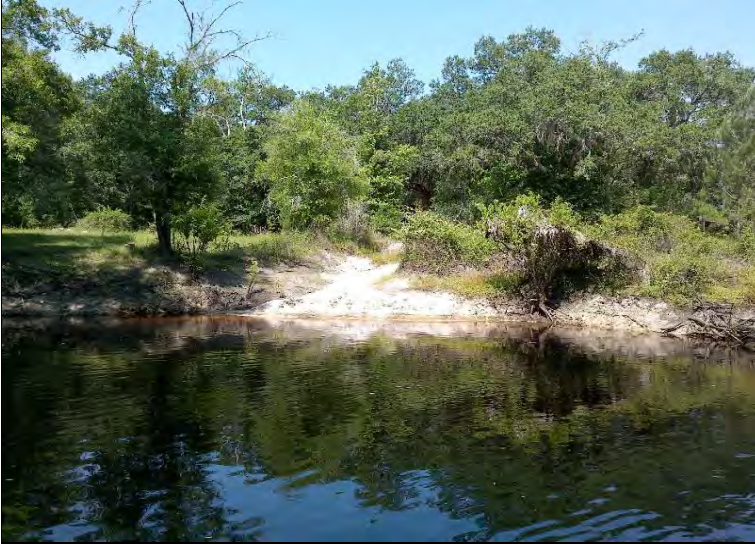
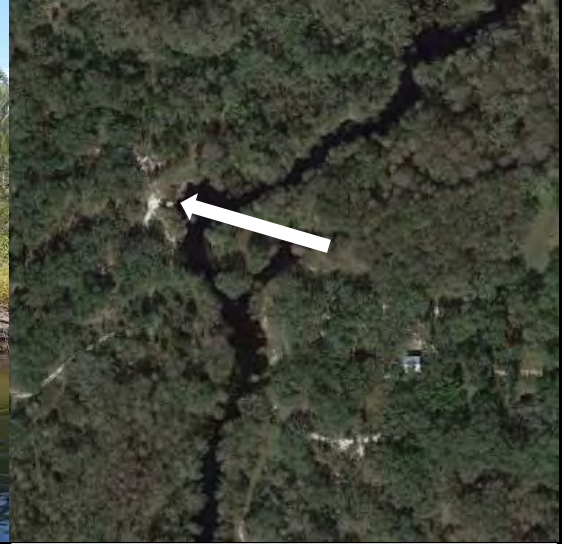
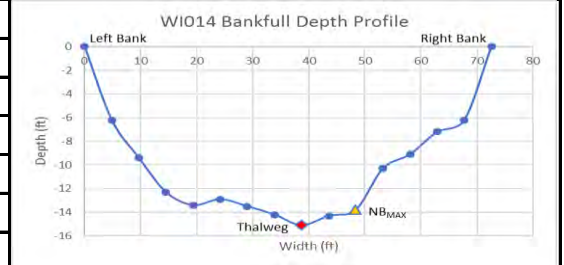
County: Hernando  
Site Number: WI014  
Reach Length: 25 ft.  
Landowner: Larry J. Davis

Risk Factor	Ranking	Score
Pfankuch-Channel Stability:	Good	0
Channel Alteration:	None	0
Bank Erosion:	Active	1
BEHI:	High (33.19)	1
Local NPSP:	Obvious Sources	1.5
Shoring Structures:	None	0
Pipe Discharge:	None	0
Water Odor:	Normal	0
Fish Passage Barrier:	None	0
RB: Riparian Buffer:	40 ft.	0.5
LB: Riparian Buffer:	100 ft.	0
RB: Floodplain Access:	Partial	0.25
LB: Floodplain Access:	Full	0
<b>Severity Scale:</b>		<b>4.25</b>

Stream Channel Woody Material: Moderate  
Impoundments: None  
Substrate Composition: Medium Sand  
Bank Material: Sand  
Near Bank Stress: Moderate  
RB Landuse: Natural Forest, Recreation  
LB Landuse: Natural Forest

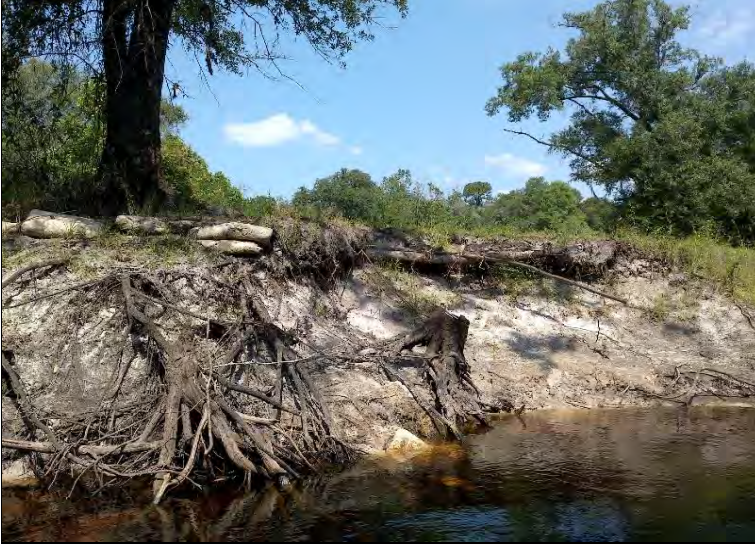
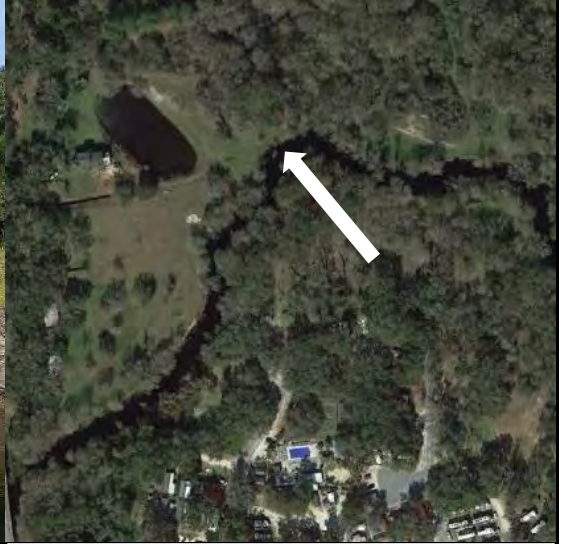
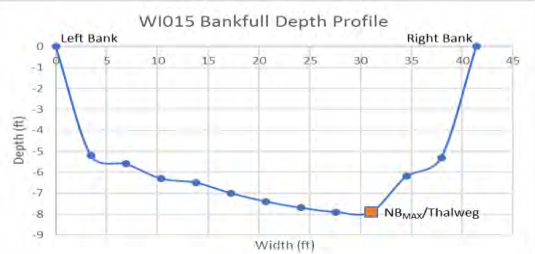
Reach Length: 35 ft.

Risk Factor	Ranking	Score
Pfankuch-Channel Stability:	Good	0
Channel Alteration:	None	0
Bank Erosion:	Active	1
BEHI:	Moderate (26.08)	0.5
Local NPSP:	No Evidence	0
Shoring Structures:	Present	1.5
Pipe Discharge:	None	0
Water Odor:	Normal	0
Fish Passage Barrier:	None	0
RB: Riparian Buffer:	0 ft.	0.75
LB: Riparian Buffer:	100 ft.	0
RB: Floodplain Access:	Full	0
LB: Floodplain Access:	Full	0

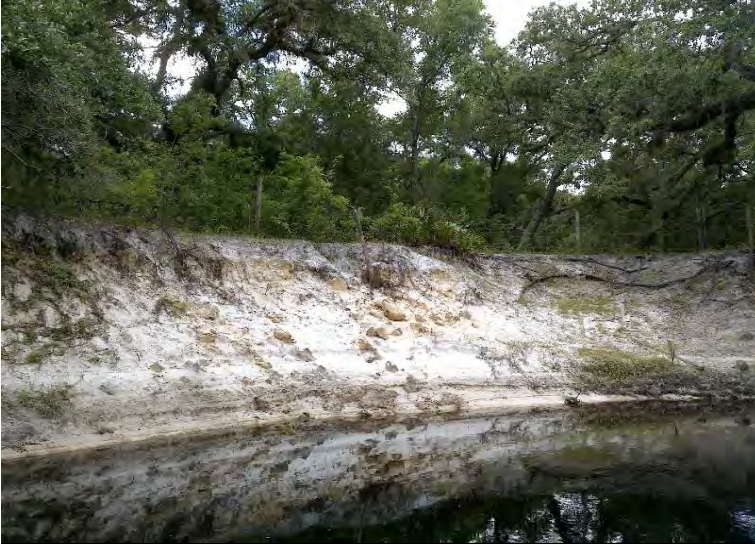
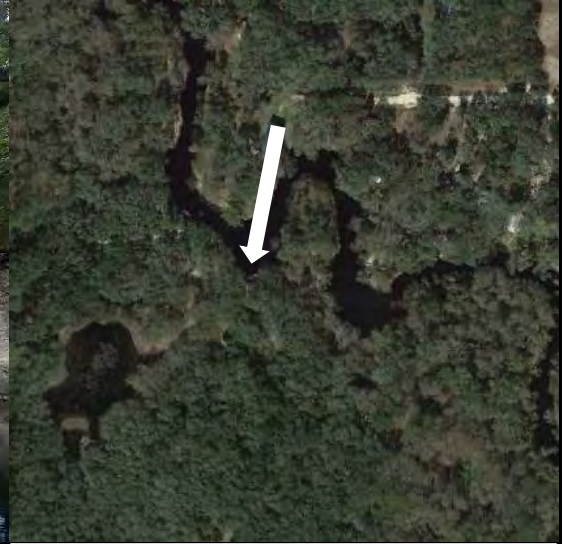
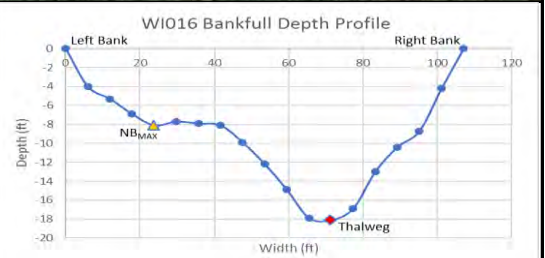
Reach Length: 100 ft.

Risk Factor	Ranking	Score
Pfankuch-Channel Stability:	Good	0
Channel Alteration:	None	0
Bank Erosion:	Active	1
BEHI:	High (33.41)	1
Local NPSP:	Slight Potential	0.5
Shoring Structures:	None	0
Pipe Discharge:	None	0
Water Odor:	Normal	0
Fish Passage Barrier:	None	0
RB: Riparian Buffer:	40 ft.	0.5
LB: Riparian Buffer:	60 ft.	0.25
RB: Floodplain Access:	Partial	0.25
LB: Floodplain Access:	Partial	0.25
<b>Severity Scale:</b>		<b>3.75</b>

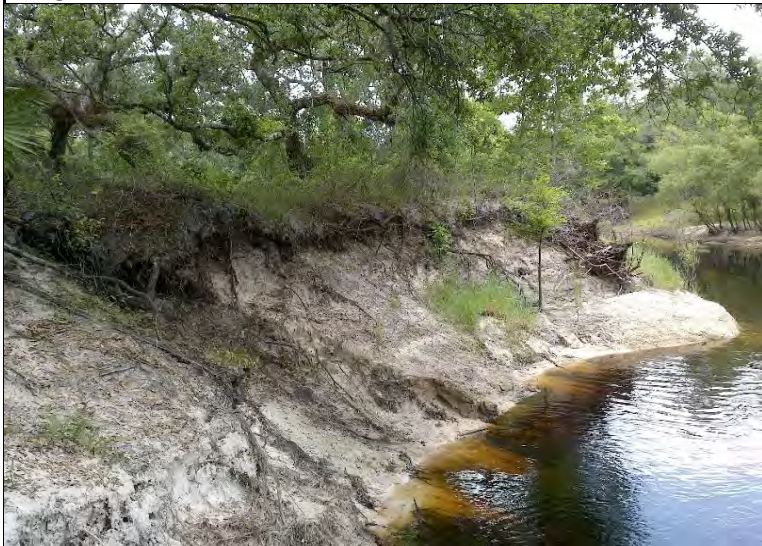
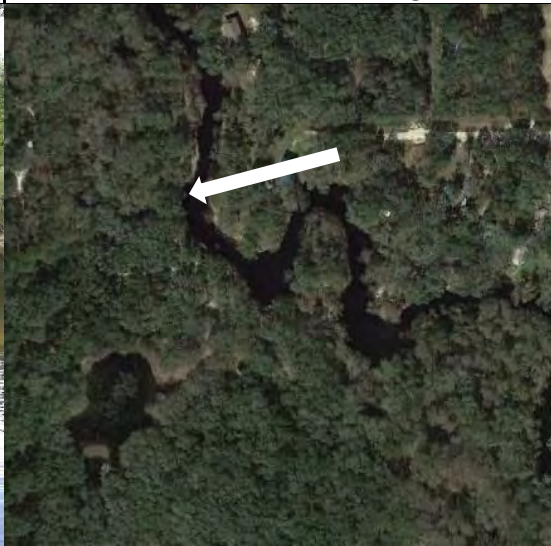
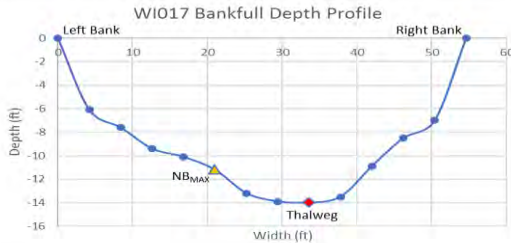
Withlacoochee River			Severity Scale: 2.25-Low																													
Watershed: Withlacoochee River Subwatershed: Devil's Creek Latitude: 28.49285 Longitude: -82.20367			County: Hernando Site Number: WI017 Reach Length: 60 ft. Landowner: Paul E. & Reeta M. Elgland

<p>Left Bank</p> <p>Right Bank</p> <p>Thalweg</p> <p>NB<sub>MAX</sub></p>		Width (ft)	Depth (ft)	0	0	5	-6	10	-8	15	-9	20	-10	25	-11	30	-12	35	-13	40	-12	45	-10	50	-8	55	-6	60	0
Width (ft)	Depth (ft)																															
0	0																															
5	-6																															
10	-8																															
15	-9																															
20	-10																															
25	-11																															
30	-12																															
35	-13																															
40	-12																															
45	-10																															
50	-8																															
55	-6																															
60	0																															
Pfankuch-Channel Stability:	Good	0																														
Channel Alteration:	None	0																														
Bank Erosion:	Active	1																														
BEHI:	Moderate	0.5																														
Local NPSP:	No Evidence	0																														
Shoring Structures:	None	0																														
Pipe Discharge:	None	0																														
Water Odor:	Normal	0																														
Fish Passage Barrier:	None	0																														
RB: Riparian Buffer:	40 ft.	0.5																														
LB: Riparian Buffer:	100 ft.	0																														
RB: Floodplain Access:	Full	0																														
LB: Floodplain Access:	Partial	0.25																														
Severity Scale:		2.25	Additional Site Features																													
			Stream Channel Woody Material: Infrequent																													
			Impoundments: None																													
			Substrate Composition: Medium Sand																													
			Bank Material: Sand																													
			Near Bank Stress: Low																													
			RB Landuse: Natural Forest																													
			LB Landuse: Natural Forest, Residential																													
Notes: 303d: Impaired - DO and mercury in fish tissues																																
Restoration Option 1

Restoration Option 1

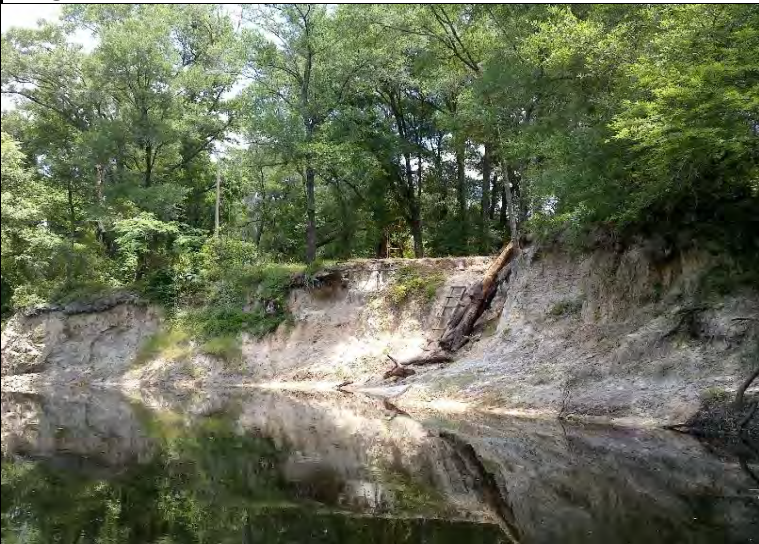
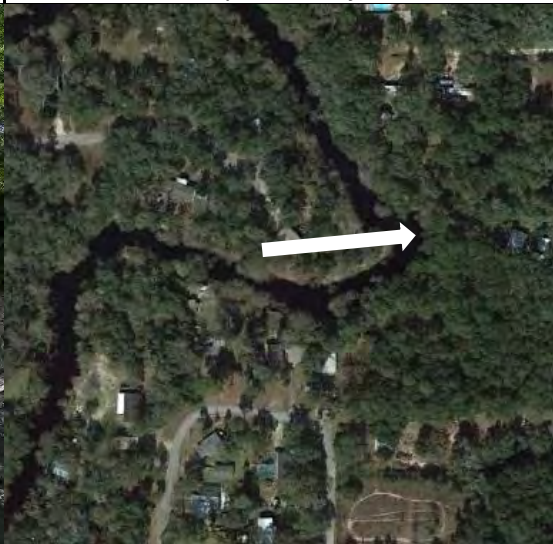
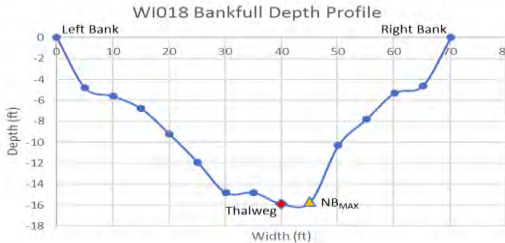
Withlacoochee River			Severity Scale: 4.0-Low	
Watershed: Withlacoochee River			County: Hernando	
Subwatershed: Devil's Creek			Site Number: WI018	
Latitude: 28.49939			Reach Length: 70 ft	
Longitude: -82.19907			Landowner: Emory R. & Marjorie Waddle

Pfankuch-Channel Stability:	Good	0		
Channel Alteration:	None	0		
Bank Erosion:	Mass-wasting	1.5		
BEHI:	Very High (44.48)	1.5		
Local NPSP:	No Evidence	0		
Shoring Structures:	None	0		
Pipe Discharge:	None	0		
Water Odor:	Normal	0		
Fish Passage Barrier:	None	0		
RB: Riparian Buffer:	60 ft.	0.25	Additional Site Features	
LB: Riparian Buffer:	40 ft.	0.5	Stream Channel Woody Material: Moderate	
RB: Floodplain Access:	Partial	0.25	Impoundments: None	
LB: Floodplain Access:	Full	0	Substrate Composition: Medium Sand	
Severity Scale: 4.0			Bank Material: Sand	
			Near Bank Stress: Moderate	
			RB Landuse: Residential, Natural Forest

LB Landuse: Natural Forest, Residential	
Notes: 303d: Impaired - DO and mercury in fish tissues				
Restoration Option 1
