# **Peace River and Withlacoochee River Threats Assessments and Fish Assemblage Monitoring**

**Final Report July 1, 2015 – June 30, 2019**

Submitted to Florida State Wildlife Grants Program  
August 1, 2019  
PID: 98462501284

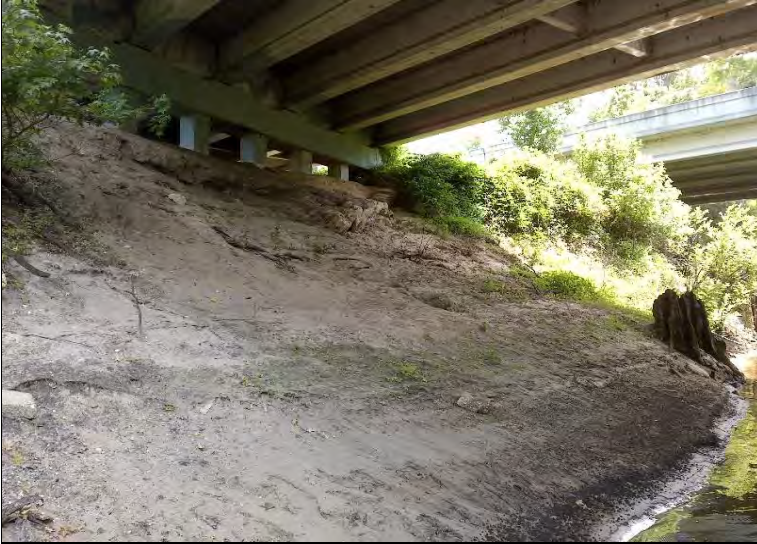
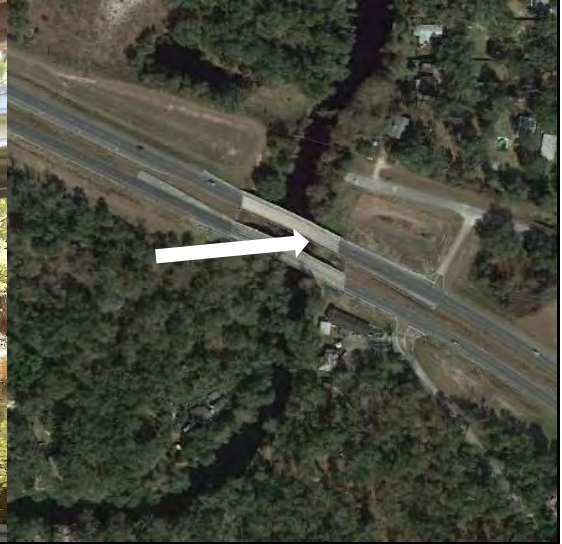
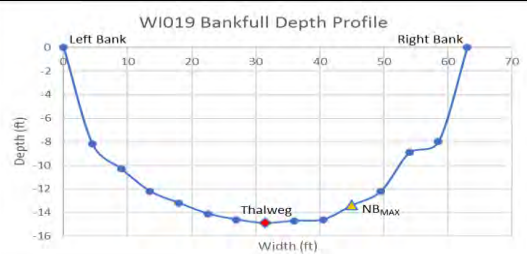
Reach Length: 16 ft.

Risk Factor	Ranking	Score
Pfankuch-Channel Stability:	Good	0
Channel Alteration:	Historic	0.5
Bank Erosion:	Active	1
BEHI:	High (37.52)	1
Local NPSP:	Obvious Sources	1.5
Shoring Structures:	Present	1.5
Pipe Discharge:	None	0
Water Odor:	Normal	0
Fish Passage Barrier:	None	0
RB: Riparian Buffer:	0 ft.	0.75
LB: Riparian Buffer:	0 ft.	0.75
RB: Floodplain Access:	Partial	0.25
LB: Floodplain Access:	Partial	0.25
<b>Severity Scale:</b>		<b>7.5</b>

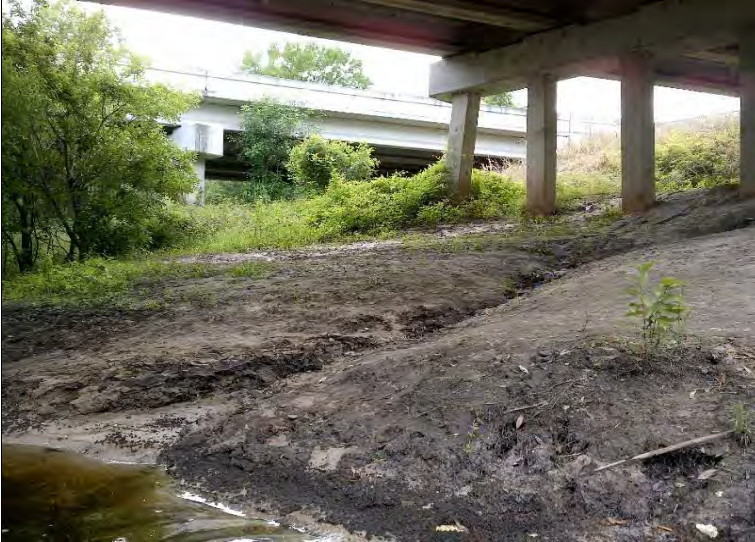
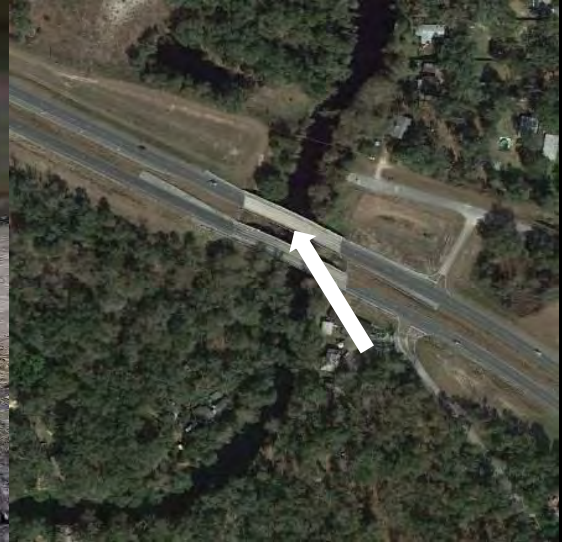
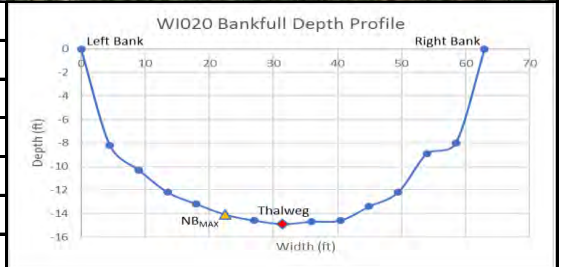
Reach Length: 16 ft.

Risk Factor	Ranking	Score
Pfankuch-Channel Stability:	Good	0
Channel Alteration:	Historic	0.5
Bank Erosion:	Active	1
BEHI:	High (32.84)	1
Local NPSP:	Obvious Sources	1.5
Shoring Structures:	Present	1.5
Pipe Discharge:	None	0
Water Odor:	Normal	0
Fish Passage Barrier:	None	0
RB: Riparian Buffer:	0 ft.	0.75
LB: Riparian Buffer:	0 ft.	0.75
RB: Floodplain Access:	Partial	0.25
LB: Floodplain Access:	Partial	0.25
<b>Severity Scale:</b>		<b>7.5</b>

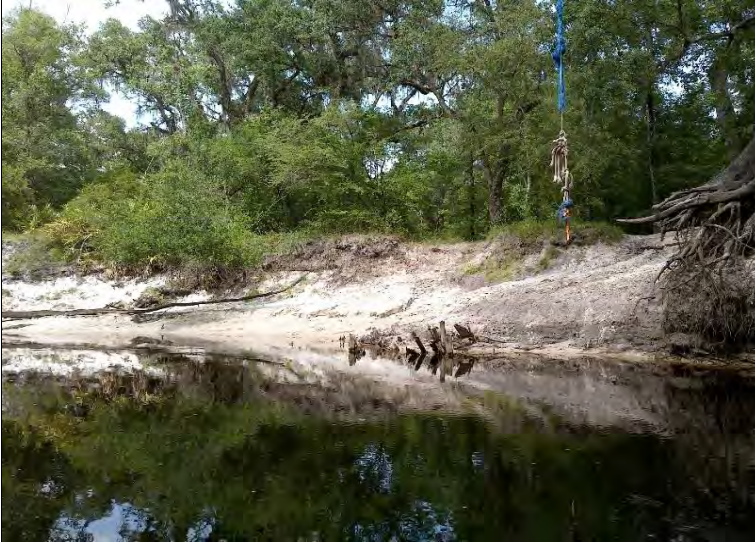
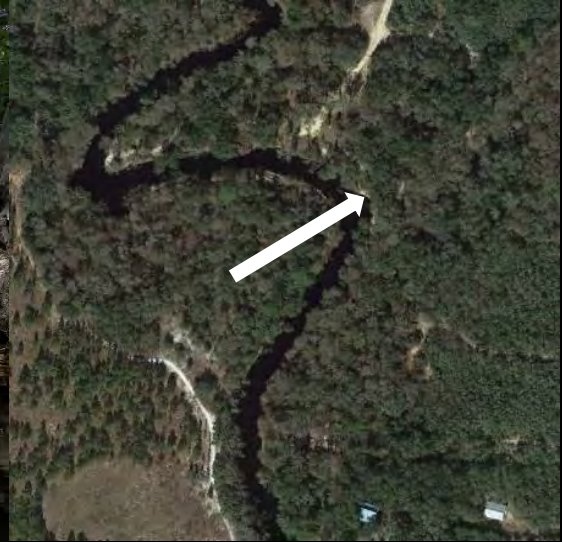
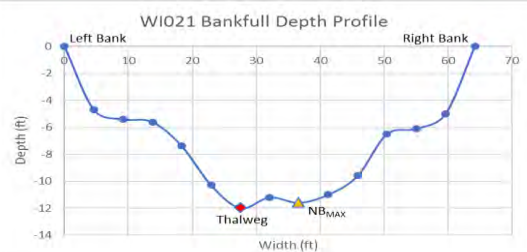
Reach Length: 100 ft.

Risk Factor	Ranking	Score
Pfankuch-Channel Stability:	Good	0
Channel Alteration:	None	0
Bank Erosion:	Active	1
BEHI:	High (33.65)	1
Local NPSP:	Obvious Sources	1.5
Shoring Structures:	None	0
Pipe Discharge:	None	0
Water Odor:	Normal	0
Fish Passage Barrier:	None	0
RB: Riparian Buffer:	40 ft.	0.5
LB: Riparian Buffer:	100 ft.	0
RB: Floodplain Access:	Full	0
LB: Floodplain Access:	Partial	0.25
<b>Severity Scale:</b>		<b>4.25</b>

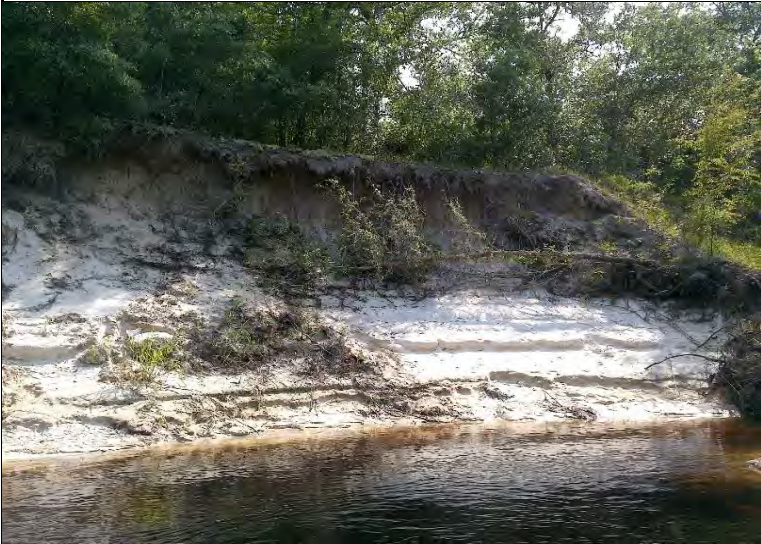
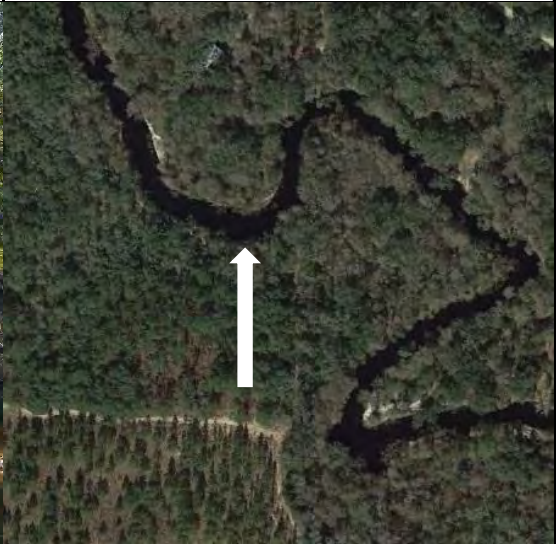
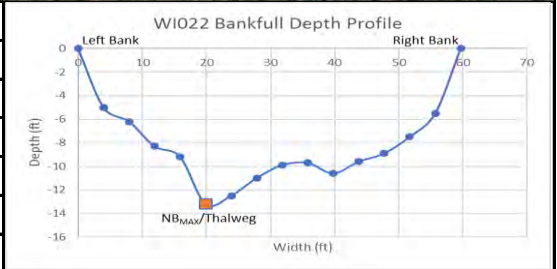
Withlacoochee River			Severity Scale: 2.25-Low	
Watershed: Withlacoochee River Subwatershed: Devil's Creek Latitude: 28.54908 Longitude: -82.20045			County: Hernando Site Number: WI022 Reach Length: 30 ft. Landowner: DEP Div. of State Lands

Risk Factor	Ranking	Score		
Pfankuch-Channel Stability:	Good	0		
Channel Alteration:	None	0		
Bank Erosion:	Active	1		
BEHI:	High (36.61)	1		
Local NPSP:	No Evidence	0		
Shoring Structures:	None	0		
Pipe Discharge:	None	0		
Water Odor:	Normal	0		
Fish Passage Barrier:	None	0		
RB: Riparian Buffer:	100 ft.	0		
LB: Riparian Buffer:	100 ft.	0		
RB: Floodplain Access:	Full	0		
LB: Floodplain Access:	Partial	0.25		
Severity Scale:		2.25		
Notes: 303d: Impaired - DO and mercury in fish tissues				
Restoration Option 1

Additional Site Features	
Stream Channel Woody Material: Moderate	
Impoundments: None	
Substrate Composition: Medium Sand	
Bank Material: Sand	
Near Bank Stress: High	
RB Landuse: Natural Forest	
LB Landuse: Natural Forest

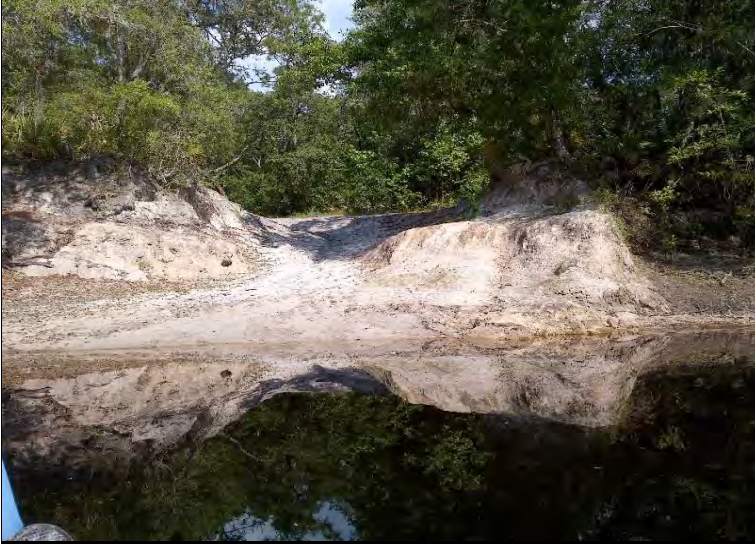
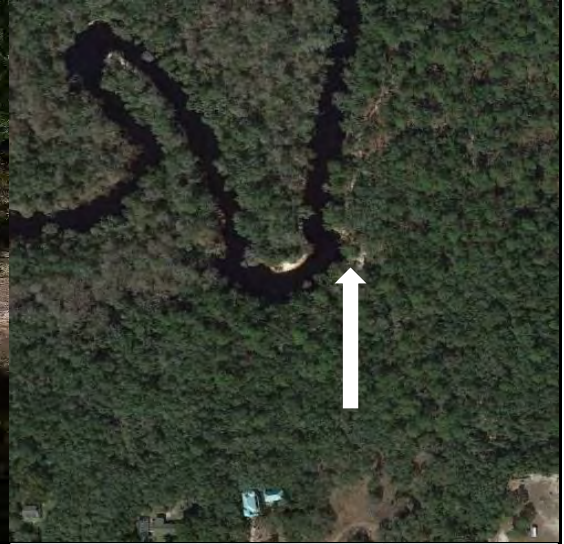
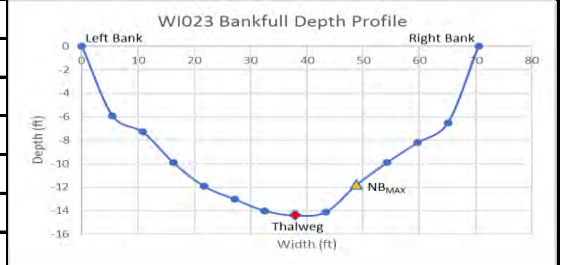
Reach Length: 30 ft.

Risk Factor	Ranking	Score
Pfankuch-Channel Stability:	Good	0
Channel Alteration:	None	0
Bank Erosion:	Active	1
BEHI:	High (37.80)	1
Local NPSP:	Obvious Sources	1.5
Shoring Structures:	None	0
Pipe Discharge:	None	0
Water Odor:	Normal	0
Fish Passage Barrier:	None	0
RB: Riparian Buffer:	60 ft.	0.25
LB: Riparian Buffer:	100 ft.	0
RB: Floodplain Access:	Partial	0.25
LB: Floodplain Access:	Full	0
Severity Scale:		4.0

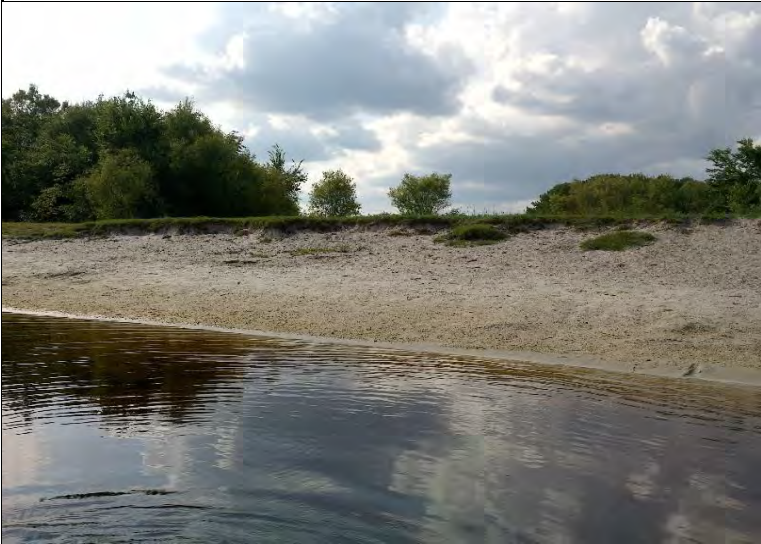
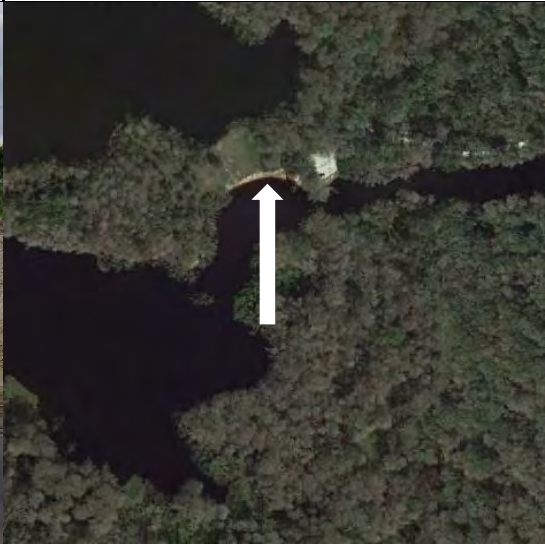
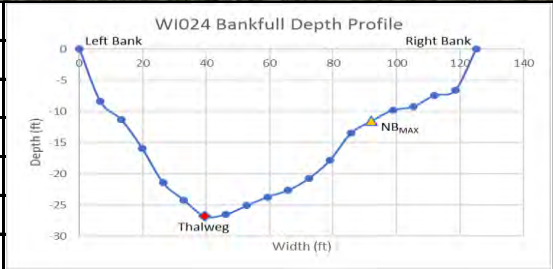
Withlacoochee River			Severity Scale: 3.0-Low
Watershed: Withlacoochee River Subwatershed: Silver Lake Latitude: 28.57208 Longitude: -82.20734			County: Sumter Site Number: WI024 Reach Length: 150 ft. Landowner: DEP Div. of State Lands

Risk Factor	Ranking	Score	
Pfankuch-Channel Stability:	Good	0	
Channel Alteration:	None	0	
Bank Erosion:	Active	1	
BEHI:	High (38.49)	1	
Local NPSP:	Slight Potential	0.5	
Shoring Structures:	None	0	
Pipe Discharge:	None	0	
Water Odor:	Normal	0	
Fish Passage Barrier:	None	0	
RB: Riparian Buffer:	40 ft.	0.5	
LB: Riparian Buffer:	100 ft.	0	
RB: Floodplain Access:	Full	0	
LB: Floodplain Access:	Full	0	
Severity Scale:		3.0	
Notes: Bank next to boat ramp used for loading/unloading passengers; Downstream of site has sediment build up and makes boat passage difficult at low flow; 303d: Impaired - DO and mercury in fish tissues			
Restoration Option 1

Additional Site Features
Stream Channel Woody Material: Moderate
Impoundments: None
Substrate Composition: Medium Sand
Bank Material: Sand
Near Bank Stress: Low
RB Landuse: Recreation, Natural Forest
LB Landuse: Natural Forest

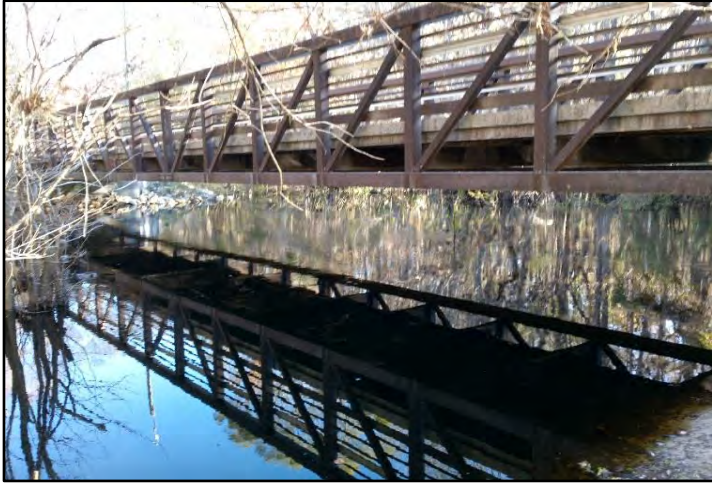
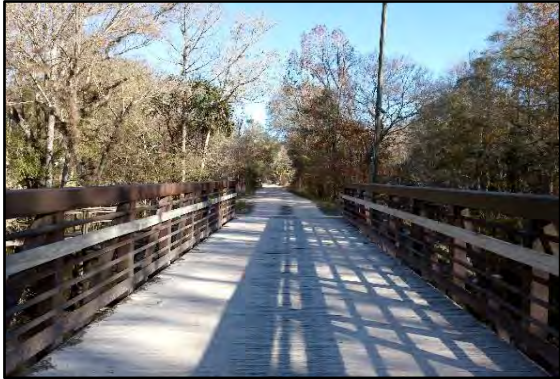
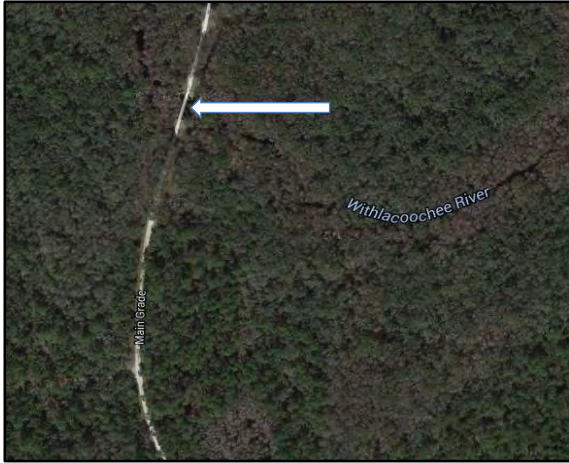
Withlacoochee River			Sediment Risk Index: 57-Low	
Watershed: Withlacoochee River Subwatershed: Pony Creek Latitude: 28.32578 Longitude: -81.93182 Road Name: Main Grade Rd.			County: Polk Site Number: WU001 LULC: Natural Forest Land Owner(s): SWFWMD

US Channel Morph	Wetland	5		
DS Channel Morph	Wetland	5		
DS Bank Alteration	Natural	5		
Upstream Skew Angle	< 5°	5		
Crossing fill condition	Vegetated/Rip-rap	4		
Inlet/Outlet Condition	No Impairment	5		
Potential Eroded Vol.	< 21 c.y.	5		
Soil K Factor	0.21-0.40	3		
Approach Slope Mean	< 2%	5		
Road Approach Material	All Aggregate	5		
Upstream Rt Outlet	Vegetated/Rip-rap	1		
Upstream Lt Outlet	Vegetated/Rip-rap	1		
Upstream Rt Ditch	Vegetated	1		
Upstream Lt Ditch	Vegetated	1		
Downstream Rt Outlet	Vegetated/Rip-rap	1		
Downstream Lt Outlet	Vegetated/Rip-rap	1

Downstream Rt Ditch	Vegetated	1		
Downstream Lt Ditch	Vegetated	1		
Improved Outlet Total	4	1		
Improved Ditches Total	4	1		
SRI Total:		57	Additional Site Features Crossing Type and Quantity: Bridge Crossing Material: Wood/Metal Culvert Outfall Drop: NA Fish Passage Barrier: Not Present Notes: Fill is a combination of riprap and vegetation

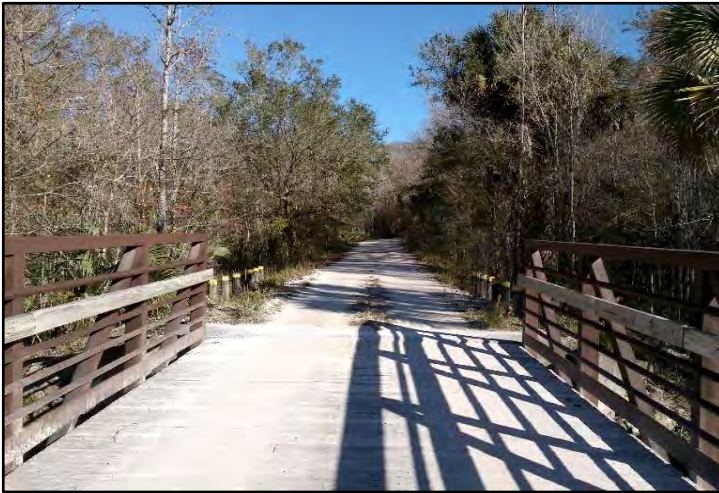
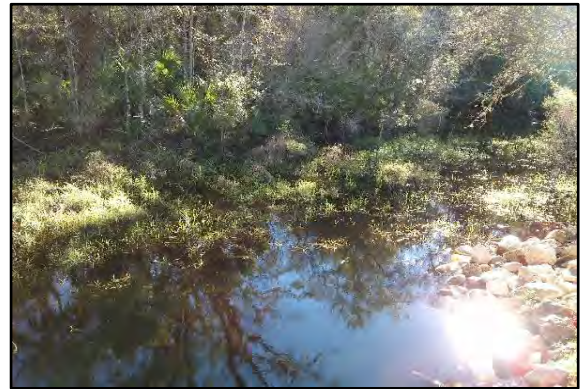
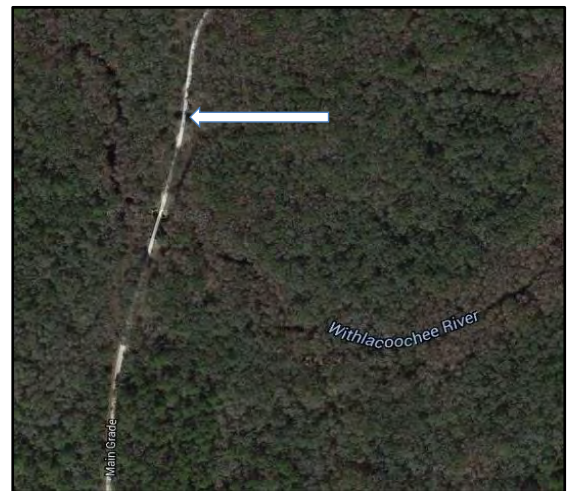
County: Polk  
 Site Number: WU002  
 LULC: Natural Forest  
 Land Owner(s): SWFWMD

Risk Factor	Ranking	Score
US Channel Morph	Wetland	5
DS Channel Morph	Wetland	5
DS Bank Alteration	Natural	5
Upstream Skew Angle	< 5°	5
Crossing fill condition	Vegetated/Rip-rap	4
Inlet/Outlet Condition	No Impairment	5
Potential Eroded Vol.	< 21 c.y.	5
Soil K Factor	0.21-0.40	3
Approach Slope Mean	< 2%	5
Road Approach Material	All Aggregate	5
Upstream Rt Outlet	Vegetated/Rip-rap	1
Upstream Lt Outlet	Vegetated/Rip-rap	1
Upstream Rt Ditch	Vegetated	1
Upstream Lt Ditch	Vegetated	1
Downstream Rt Outlet	Vegetated	1
Downstream Lt Outlet	Vegetated	1
Downstream Rt Ditch	Vegetated	1
Downstream Lt Ditch	Vegetated	1
Improved Outlet Total	4	1
Improved Ditches Total	4	1
SRI Total:		57

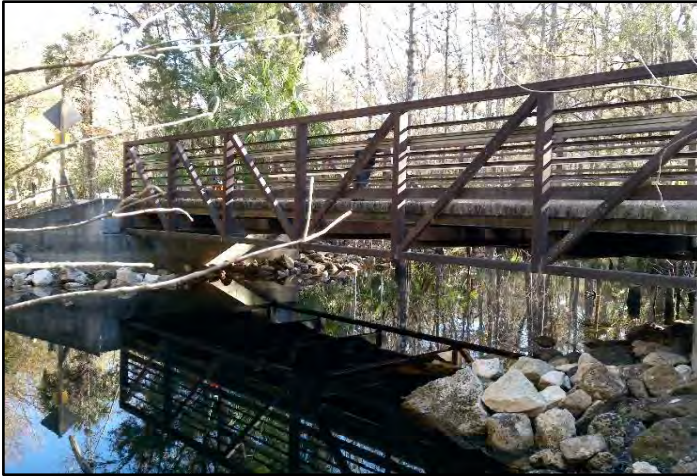
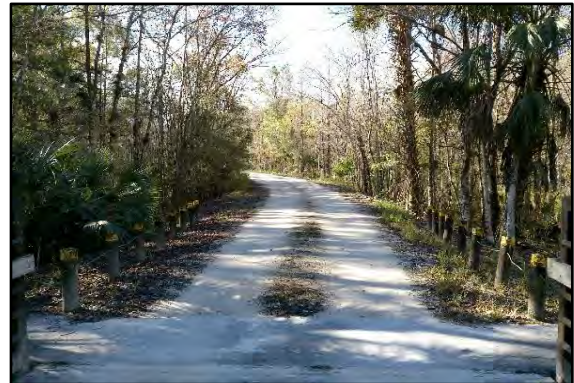
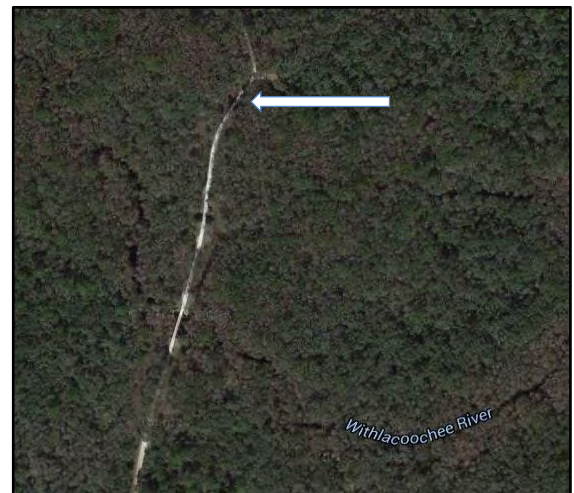
County: Polk  
Site Number: WU003  
LULC: Natural Forest  
Land Owner(s): SWFWMD

Risk Factor	Ranking	Score
US Channel Morph	Wetland	5
DS Channel Morph	Wetland	5
DS Bank Alteration	Natural	5
Upstream Skew Angle	< 5°	5
Crossing fill condition	Fair/Rip-rap	3
Inlet/Outlet Condition	No Impairment	5
Potential Eroded Vol.	< 21 c.y.	5
Soil K Factor	0.21-0.40	3
Approach Slope Mean	< 2%	5
Road Approach Material	All Aggregate	5
Upstream Rt Outlet	Vegetated	1
Upstream Lt Outlet	Vegetated	1
Upstream Rt Ditch	Vegetated	1
Upstream Lt Ditch	Vegetated	1
Downstream Rt Outlet	Vegetated	1
Downstream Lt Outlet	Vegetated	1
Downstream Rt Ditch	Vegetated	1
Downstream Lt Ditch	Vegetated	1
Improved Outlet Total	4	1
Improved Ditches Total	4	1
SRI Total:		56

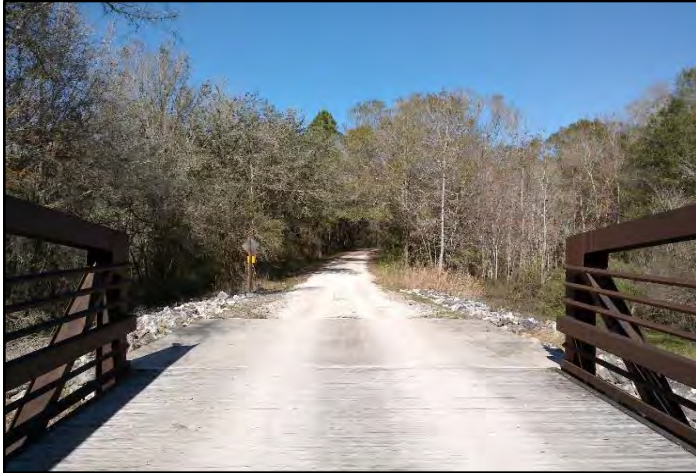
County: Sumter  
Site Number: WU004  
LULC: Natural Forest  
Land Owner(s): SWFWMD

Risk Factor	Ranking	Score
US Channel Morph	DA	3
DS Channel Morph	DA	3
DS Bank Alteration	Natural	5
Upstream Skew Angle	<5°	5
Crossing fill condition	Fair/Riprap	3
Inlet/Outlet Condition	No Impairment	5
Potential Eroded Vol.	< 21 c.y.	5
Soil K Factor	0.21-0.40	3
Approach Slope Mean	<2°	5
Road Approach Material	All aggregate	5
Upstream Rt Outlet	Vegetated	1
Upstream Lt Outlet	Vegetated	1
Upstream Rt Ditch	Vegetated	1
Upstream Lt Ditch	Vegetated	1
Downstream Rt Outlet	Vegetated	1
Downstream Lt Outlet	Vegetated	1
Downstream Rt Ditch	Vegetated	1
Downstream Lt Ditch	Vegetated	1
Improved Outlet Total	4	1
Improved Ditches Total	4	1
<b>SRI Total:</b>		<b>52</b>

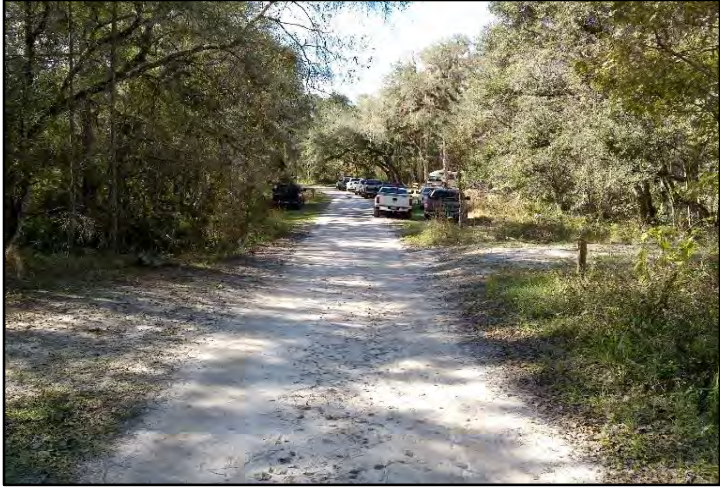
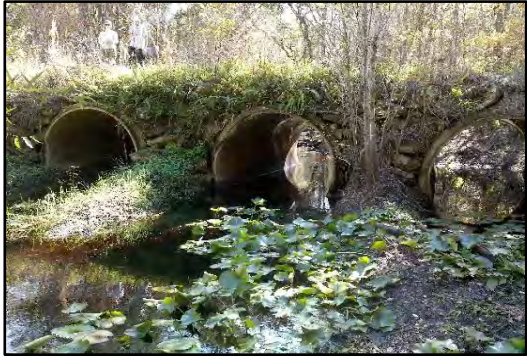
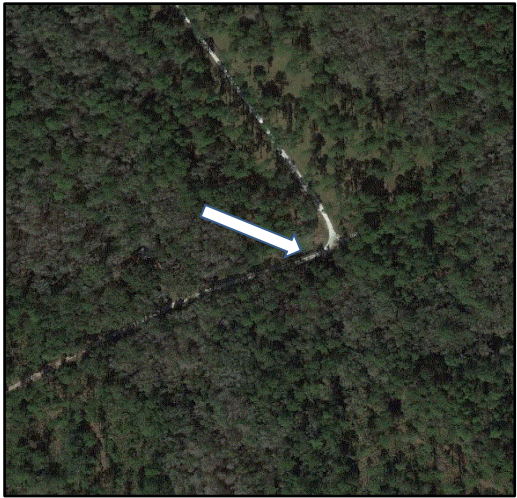
Gator Creek			Sediment Risk Index: 46-Low	
Watershed: Withlacoochee River Subwatershed: Gator Creek Latitude: 28.277276 Longitude: -82.031084 Road Name: Colt Creek State Park-Unnamed road			County: Polk Site Number: WU005 LULC: Natural forest  Land Owner(s): SWFWMD

US Channel Morph	C	5		
DS Channel Morph	Ponded	1		
DS Bank Alteration	High	1		
Upstream Skew Angle	5°-30°	3		
Crossing fill condition	Good/Vegetated	5		
Inlet/Outlet Condition	Sediment Islands/Scouring	3		
Potential Eroded Vol.	< 21 c.y.	5		
Soil K Factor	≤ 0.20	5		
Approach Slope Mean	<2°	5		
Road Approach Material	All aggregate	5		
Upstream Rt Outlet	Vegetated	1		
Upstream Lt Outlet	Vegetated	1		
Upstream Rt Ditch	Vegetated	1		
Upstream Lt Ditch	Vegetated	1		
Downstream Rt Outlet	Vegetated	1		
Downstream Lt Outlet	Vegetated	1		
Downstream Rt Ditch	Bare Soil	0

Downstream Lt Ditch	Vegetated	1		
Improved Outlet Total	4	1		
Improved Ditches Total	3	0		
<b>SRI Total:</b>		<b>46</b>	<b>Additional Site Features</b>	
			Crossing Type and Quantity: Culvert, 4	
			Crossing Material: Reinforced Concrete	
			Culvert Outfall Drop: 0"	
			Fish Passage Barrier: Not Present	
			Notes: Both ditches on right approach appear to feed into a wetland, not the creek. The left bank has a high berm up and downstream.

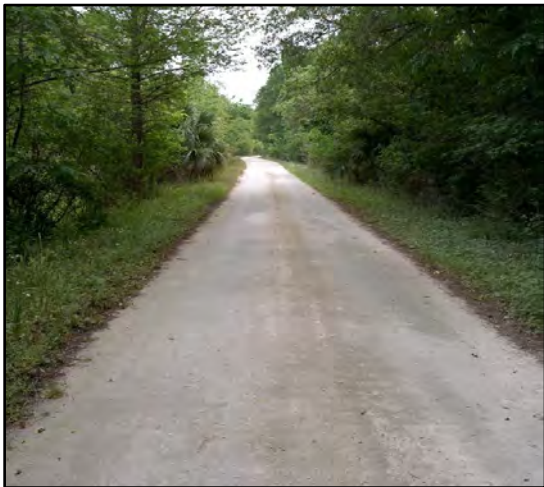
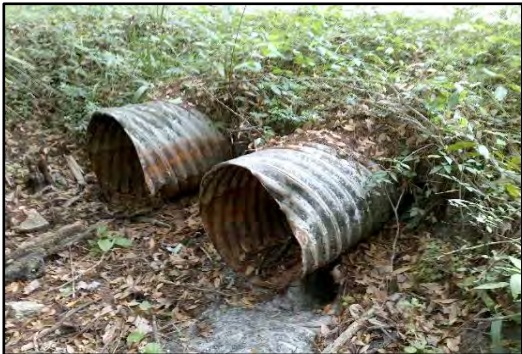
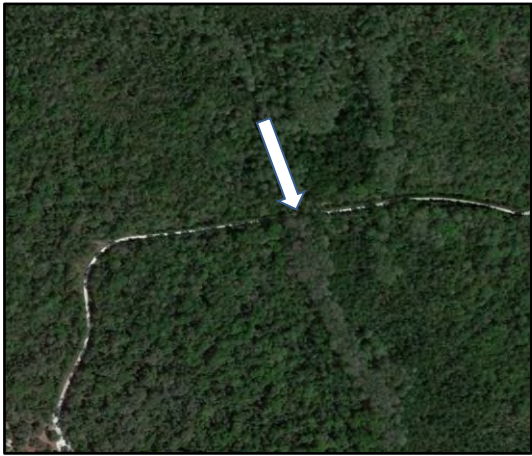
Unnamed Tributary			Sediment Risk Index: 60-Low	
Watershed: Withlacoochee River Subwatershed: Jumper Creek Swamp Latitude: 28.75838 Longitude: -82.16146 Road Name: Unnamed road			County: Sumter Site Number: WU008 LULC: Natural forest  Land Owner(s): WITHLACOOCHEE STATE FOREST

US Channel Morph	Wetland	5		
DS Channel Morph	Wetland	5		
DS Bank Alteration	Natural	5		
Upstream Skew Angle	<5°	5		
Crossing fill condition	Good/Vegetated	5		
Inlet/Outlet Condition	No Impairment	5		
Potential Eroded Vol.	< 21 c.y.	5		
Soil K Factor	≤ 0.20	5		
Approach Slope Mean	<2°	5		
Road Approach Material	All aggregate	5		
Upstream Rt Outlet	Vegetated	1		
Upstream Lt Outlet	Vegetated	1		
Upstream Rt Ditch	Vegetated	1		
Upstream Lt Ditch	Vegetated	1		
Downstream Rt Outlet	Vegetated	1		
Downstream Lt Outlet	Vegetated	1

Downstream Rt Ditch	Vegetated	1		
Downstream Lt Ditch	Vegetated	1		
Improved Outlet Total	4	1		
Improved Ditches Total	4	1		
<b>SRI Total:</b>		<b>60</b>	<b>Additional Site Features</b> Crossing Type and Quantity: Culvert, 2 Crossing Material: Corrugated Metal Culvert Outfall Drop: 12" Fish Passage Barrier: Present Notes:

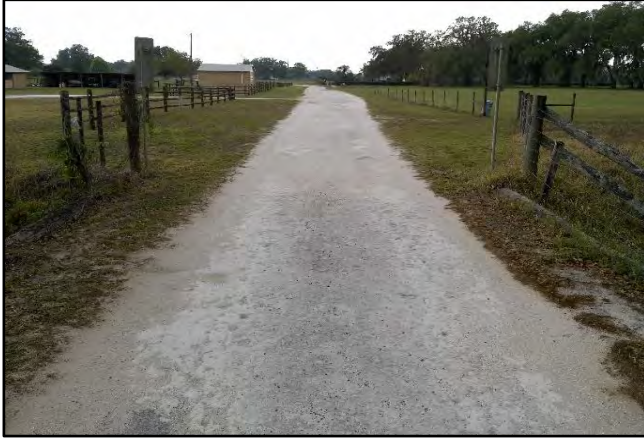
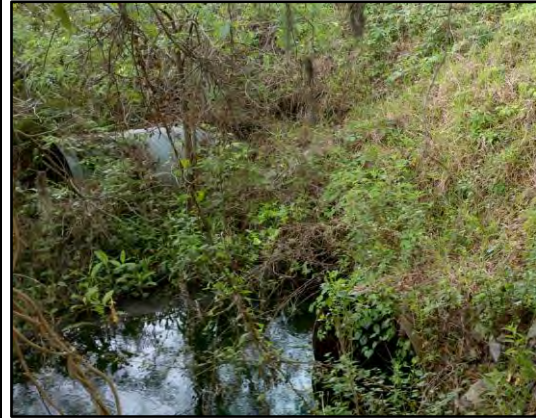
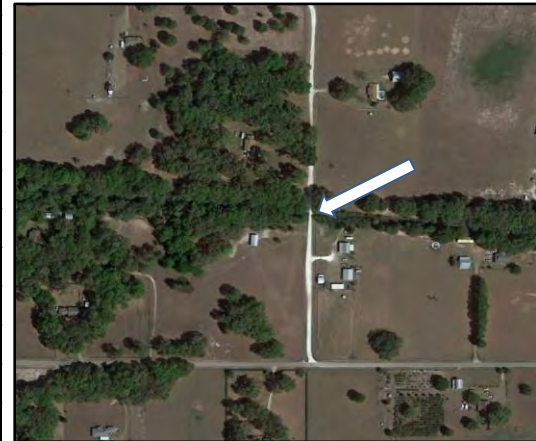
County: Sumter  
Site Number: WU009  
LULC: Residential, Natural forest  
Land Owner(s): GALLET YVES P & LISA C\*

Risk Factor	Ranking	Score
US Channel Morph	C	5
DS Channel Morph	C	5
DS Bank Alteration	High	1
Upstream Skew Angle	5°-30°	3
Crossing fill condition	Good/Vegetated	5
Inlet/Outlet Condition	Sediment/Scouring	3
Potential Eroded Vol.	< 21 c.y.	5
Soil K Factor	≤ 0.20	5
Approach Slope Mean	<2°	5
Road Approach Material	All Aggregate	5
Upstream Rt Outlet	Vegetated	1
Upstream Lt Outlet	Vegetated	1
Upstream Rt Ditch	Vegetated	1
Upstream Lt Ditch	Vegetated	1
Downstream Rt Outlet	Vegetated	1
Downstream Lt Outlet	Vegetated	1
Downstream Rt Ditch	Vegetated	1
Downstream Lt Ditch	Vegetated	1
Improved Outlet Total	4	1
Improved Ditches Total	4	1
<b>SRI Total:</b>		<b>52</b>

Crossing Type and Quantity: Culvert, 3  
Crossing Material: Corrugated Metal  
Culvert Outfall Drop: 0 in.  
Fish Passage Barrier: Not Present  
Notes: \*Additional land owners: PRICE WILLIAM T, CAUSEY JOE S & KAREN K, NESSELROTTE TRINA & KEITH

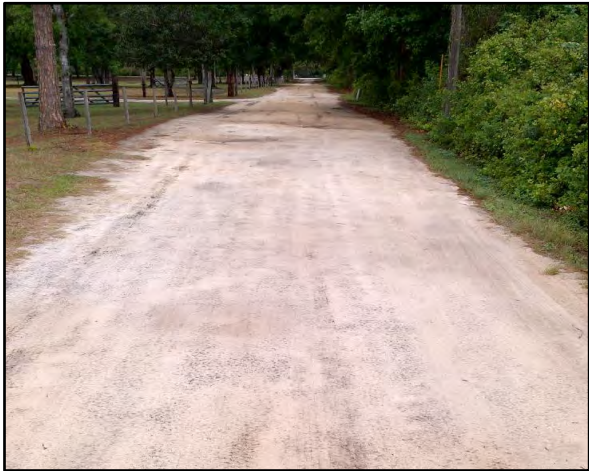
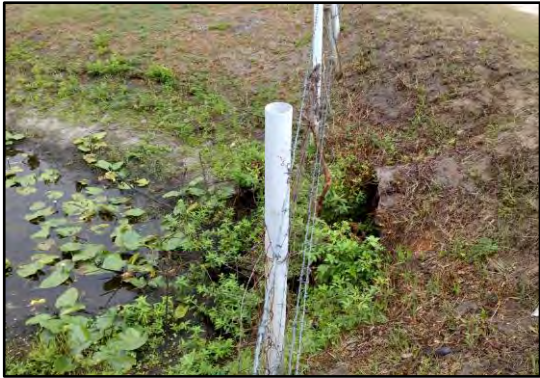
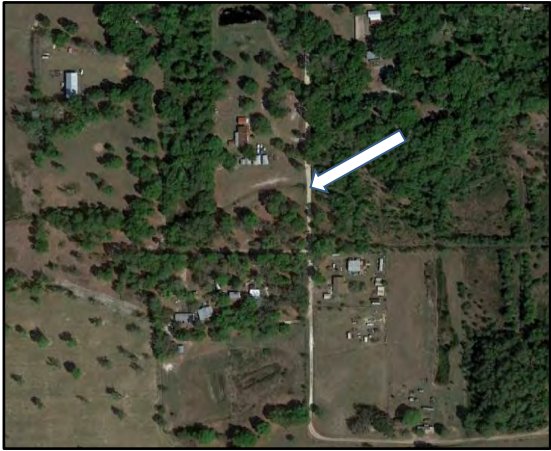
Unnamed Tributary			Sediment Risk Index: 45-Moderate	
Watershed: Withlacoochee River Subwatershed: Walled Sink Ditch Latitude: 28.65404 Longitude: -81.94587 Road Name: Sunridge Rd			County: Lake Site Number: WU012 LULC: Residential, pasture Land Owner(s): RODGERS BENJAMIN T*

US Channel Morph	Ponded	1		
DS Channel Morph	Wetland	5		
DS Bank Alteration	Natural	5		
Upstream Skew Angle	<5°	5		
Crossing fill condition	Fair/Rip-rap	3		
Inlet/Outlet Condition	Sediment/Scouring	4		
Potential Eroded Vol.	21-40 c.y.	3		
Soil K Factor	≤ 0.20	5		
Approach Slope Mean	<2°	5		
Road Approach Material	Native soil	1		
Upstream Rt Outlet	bare soil	0		
Upstream Lt Outlet	bare soil	0		
Upstream Rt Ditch	Vegetated	1		
Upstream Lt Ditch	Vegetated	1		
Downstream Rt Outlet	Vegetated	1		
Downstream Lt Outlet	Vegetated	1

Downstream Rt Ditch	Vegetated	1		
Downstream Lt Ditch	Vegetated	1		
Improved Outlet Total	2	1		
Improved Ditches Total	4	1		
<b>SRI Total:</b>		<b>45</b>	<b>Additional Site Features</b> Crossing Type and Quantity: Culvert, 1 Crossing Material: Corrugated Metal Culvert Outfall Drop: 0 in. Fish Passage Barrier: Not Present Notes: *Additional land owners: CAPSHAW NANCY A LIFE ESTATE

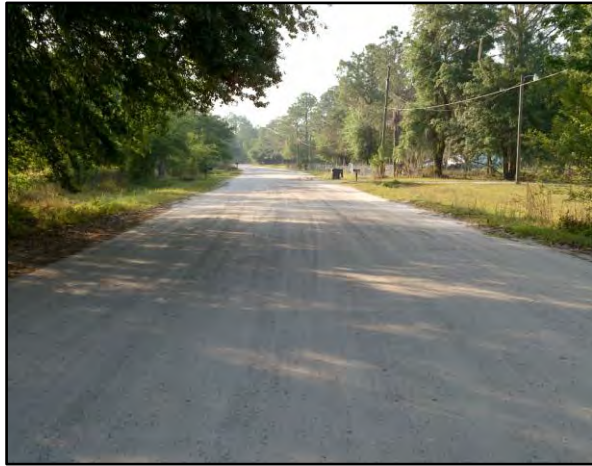
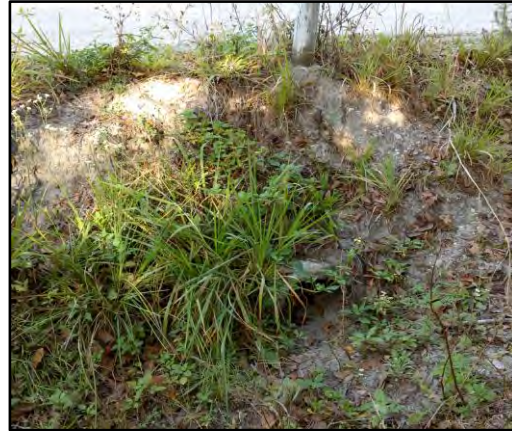
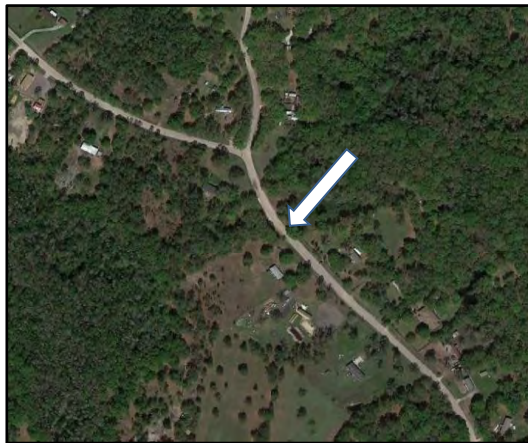
Land Owner(s): XAYASONGKHAM BOUNMA\*

Risk Factor	Ranking	Score
US Channel Morph	G	1
DS Channel Morph	G	1
DS Bank Alteration	High	1
Upstream Skew Angle	>30°	1
Crossing fill condition	Fair/Rip-rap	4
Inlet/Outlet Condition	Sediment/Scouring	3
Potential Eroded Vol.	>40 c.y.	1
Soil K Factor	≤ 0.20	5
Approach Slope Mean	<2°	5
Road Approach Material	All Aggregate	5
Upstream Rt Outlet	Vegetated	1
Upstream Lt Outlet	Vegetated	1
Upstream Rt Ditch	Vegetated	1
Upstream Lt Ditch	Vegetated	1
Downstream Rt Outlet	Vegetated	1
Downstream Lt Outlet	Vegetated	1
Downstream Rt Ditch	Vegetated	1
Downstream Lt Ditch	bare soil	0
Improved Outlet Total	4	1
Improved Ditches Total	3	0
<b>SRI Total:</b>		<b>35</b>

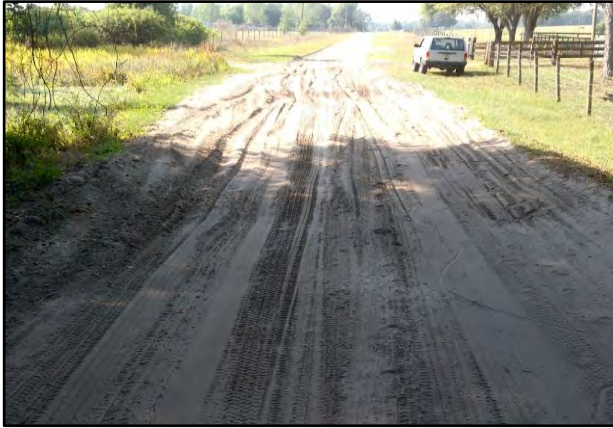
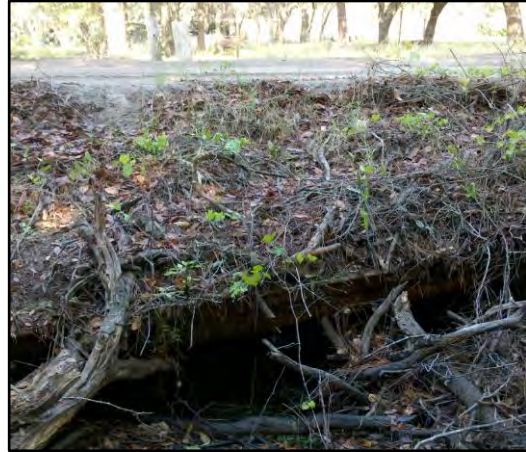
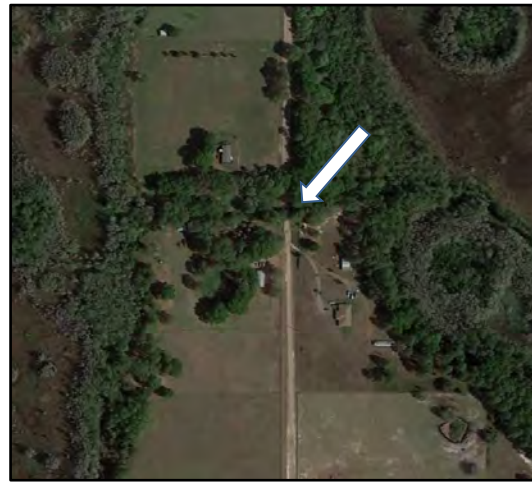
County: Lake  
Site Number: WU015  
LULC: Residential, natural forest  
Land Owner(s): HILLARY MATTHEW B\*

Risk Factor	Ranking	Score
US Channel Morph	Wetland	5
DS Channel Morph	F	1
DS Bank Alteration	Minor or Partial	3
Upstream Skew Angle	5°-30°	3
Crossing fill condition	Fair/Rip-rap	3
Inlet/Outlet Condition	Sediment/Scouring	4
Potential Eroded Vol.	21-40 c.y.	3
Soil K Factor	≤ 0.20	5
Approach Slope Mean	<2°	5
Road Approach Material	Native soil	1
Upstream Rt Outlet	Vegetated	1
Upstream Lt Outlet	Vegetated	1
Upstream Rt Ditch	Vegetated	1
Upstream Lt Ditch	Vegetated	1
Downstream Rt Outlet	Vegetated	1
Downstream Lt Outlet	Vegetated	1
Downstream Rt Ditch	Vegetated	1
Downstream Lt Ditch	Vegetated	1
Improved Outlet Total	4	1
Improved Ditches Total	4	1
<b>SRI Total:</b>		<b>43</b>

Crossing Type and Quantity: Culvert, 2  
Crossing Material: Corrugated Metal  
Culvert Outfall Drop: 0 in.  
Fish Passage Barrier: Not Present  
Notes: Channelized creek, \*Additional land owners: CURTIS WILMONT D JR & GLORIA

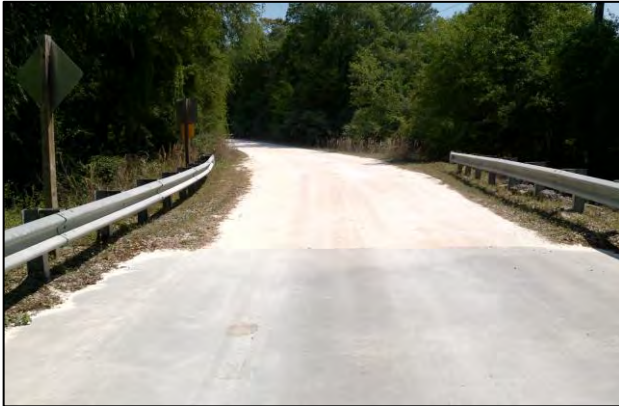
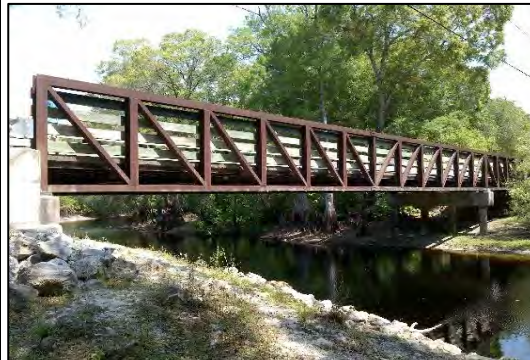
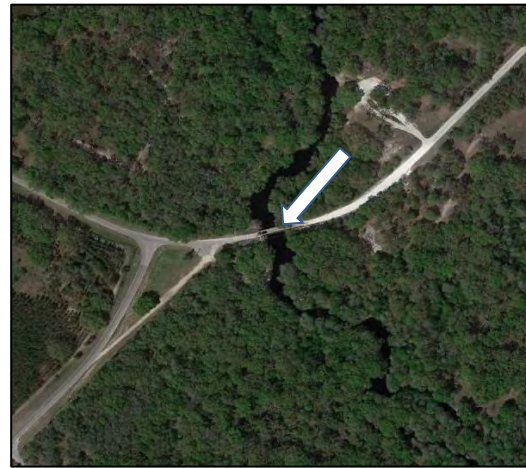
County: Pasco  
Site Number: WU017  
LULC: Natural forest  
Land Owner(s): SWFWMD

Risk Factor	Ranking	Score
US Channel Morph	E	5
DS Channel Morph	E	5
DS Bank Alteration	Natural	5
Upstream Skew Angle	<5°	5
Crossing fill condition	Fair/Rip-rap	3
Inlet/Outlet Condition	No Impairment	5
Potential Eroded Vol.	< 21 c.y.	5
Soil K Factor	≤ 0.20	5
Approach Slope Mean	<2°	5
Road Approach Material	All aggregate	5
Upstream Rt Outlet	Vegetated	1
Upstream Lt Outlet	*NA	1
Upstream Rt Ditch	Vegetated	1
Upstream Lt Ditch	*NA	1
Downstream Rt Outlet	Vegetated	1
Downstream Lt Outlet	*NA	1
Downstream Rt Ditch	Vegetated	1
Downstream Lt Ditch	*NA	1
Improved Outlet Total	4	1
Improved Ditches Total	4	1
<b>SRI Total:</b>		<b>58</b>

Crossing Type and Quantity: Bridge  
Crossing Material: Reinforced Concrete  
Culvert Outfall Drop: 0 in.  
Fish Passage Barrier: Not Present  
Notes: Left approach was paved

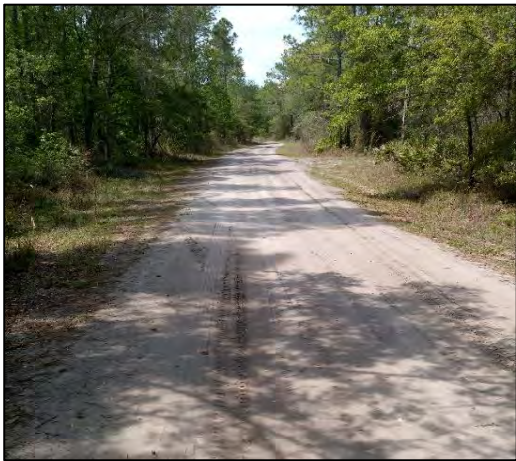
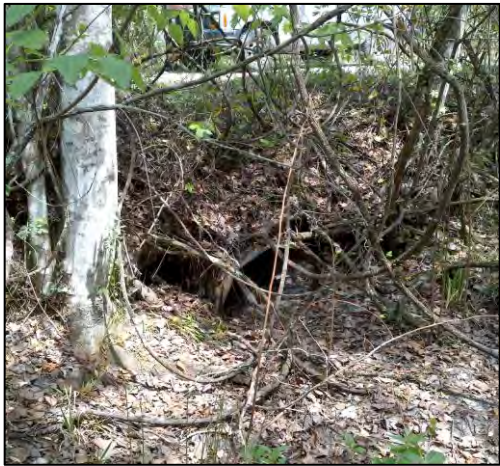
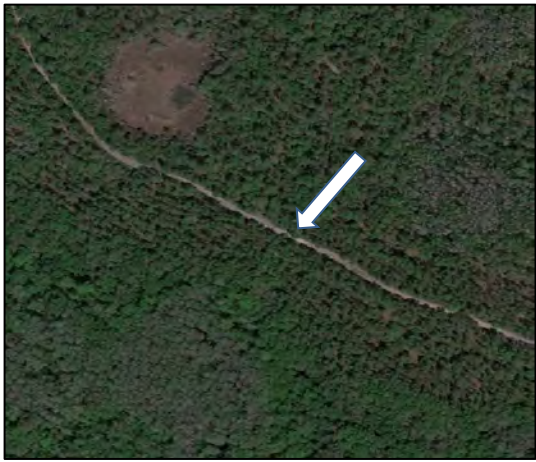
Unnamed Tributary			Sediment Risk Index: 52-Low	
Watershed: Withlacoochee River Subwatershed: Lower Little Withlacoochee River Latitude: 28.53447 Longitude: -82.10075 Road Name: Boggey Rd			County: Sumter Site Number: WU018 LULC: Natural forest  Land Owner(s): WITHLACOOCHEE STATE FOREST

US Channel Morph	E	5		
DS Channel Morph	E	5		
DS Bank Alteration	Natural	5		
Upstream Skew Angle	<5°	5		
Crossing fill condition	Good/Vegetated	5		
Inlet/Outlet Condition	Sediment/Scouring	3		
Potential Eroded Vol.	21-40 c.y.	3		
Soil K Factor	≤ 0.20	5		
Approach Slope Mean	<2°	5		
Road Approach Material	Native soil	1		
Upstream Rt Outlet	Vegetated	1		
Upstream Lt Outlet	Vegetated	1		
Upstream Rt Ditch	Vegetated	1		<b>Additional Site Features</b>
Upstream Lt Ditch	Vegetated	1		Crossing Type and Quantity: Culvert, 1

Downstream Rt Outlet	Vegetated	1		Crossing Material: Corrugated Metal
Downstream Lt Outlet	Vegetated	1		Culvert Outfall Drop: 0 in.
Downstream Rt Ditch	Vegetated	1		Fish Passage Barrier: Not Present
Downstream Lt Ditch	Vegetated	1		Notes: Concrete pad on top of crossing
Improved Outlet Total	4	1		
Improved Ditches Total	4	1		
<b>SRI Total:</b>		<b>52</b>

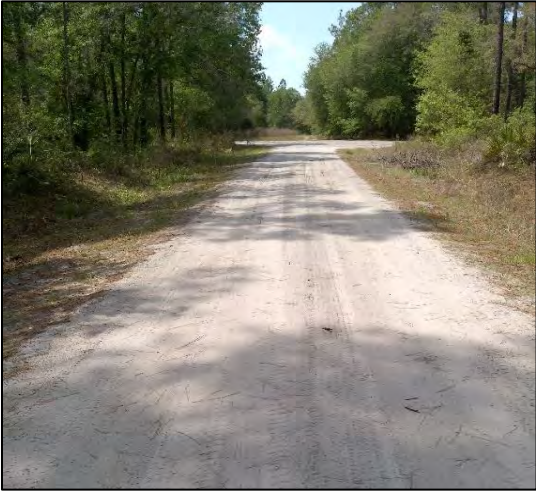
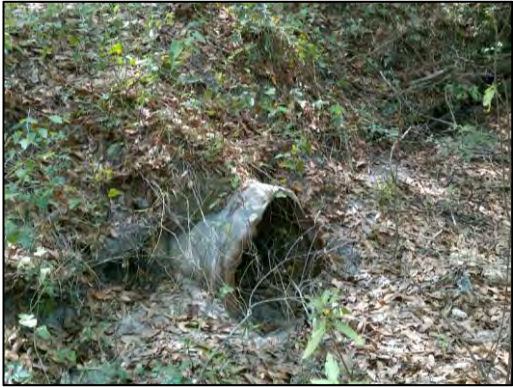
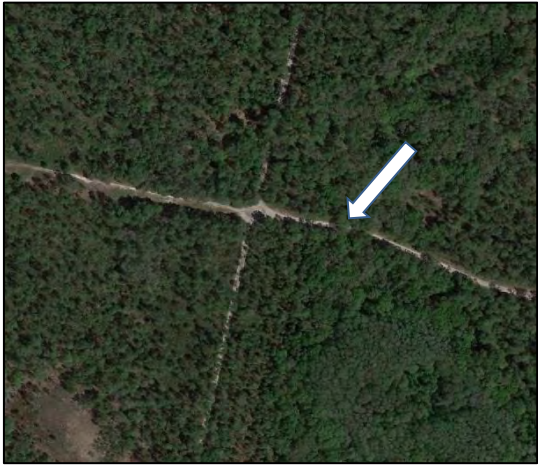
Unnamed Tributary			Sediment Risk Index: 54-Low	
Watershed: Withlacoochee River Subwatershed: Lower Little Withlacoochee River Latitude: 28.54872 Longitude: -82.11501 Road Name: Boggey Rd			County: Sumter Site Number: WU019 LULC: Natural forest  Land Owner(s): WITHLACOOCHEE STATE FOREST

US Channel Morph	C	5		
DS Channel Morph	C	5		
DS Bank Alteration	Natural	5		
Upstream Skew Angle	<5°	5		
Crossing fill condition	Good/Vegetated	5		
Inlet/Outlet Condition	No Impairment	5		
Potential Eroded Vol.	21-40 c.y.	3		
Soil K Factor	≤ 0.20	5		
Approach Slope Mean	<2°	5		
Road Approach Material	Native soil	1		
Upstream Rt Outlet	Vegetated	1		
Upstream Lt Outlet	Vegetated	1		
Upstream Rt Ditch	Vegetated	1		
Upstream Lt Ditch	Vegetated	1		
Downstream Rt Outlet	Vegetated	1		
Downstream Lt Outlet	Vegetated	1

Downstream Rt Ditch	Vegetated	1		
Downstream Lt Ditch	Vegetated	1		
Improved Outlet Total	4	1		
Improved Ditches Total	4	1		
<b>SRI Total:</b>		<b>54</b>	<b>Additonal Site Features</b> Crossing Type and Quantity: Culvert, 2 Crossing Material: Corrugated Metal Culvert Outfall Drop: 0 in. Fish Passage Barrier: Not Present Notes:

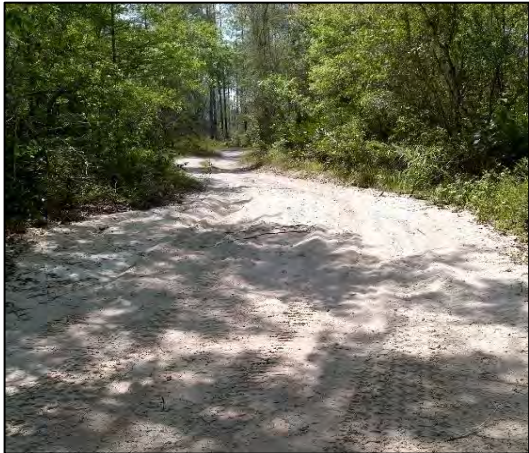
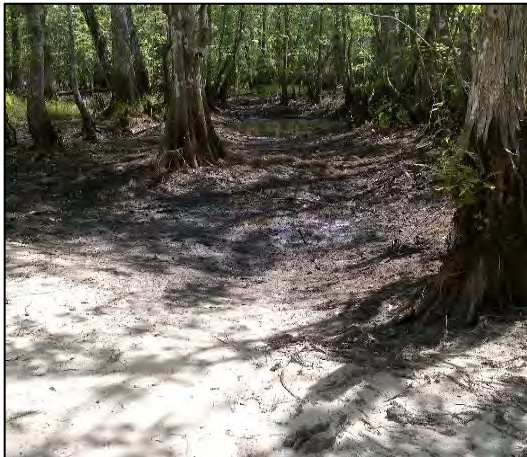
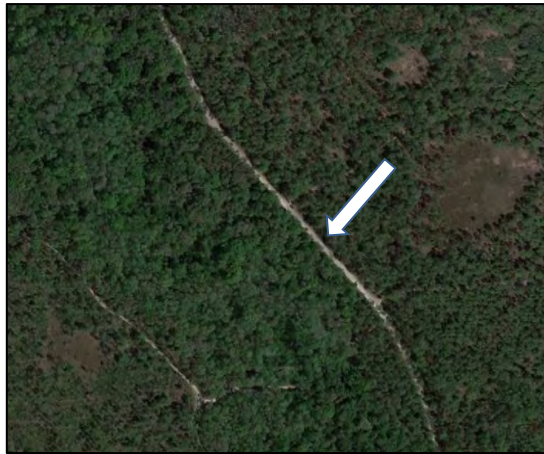
Unnamed Tributary			Sediment Risk Index: 42-Moderate
Watershed: Withlacoochee River Subwatershed: Lower Little Withlacoochee River Latitude: 28.54064 Longitude: -82.10728 Road Name: Boggey Rd			County: Sumter Site Number: WU020 LULC: Natural forest  Land Owner(s): WITHLACOOCHEE STATE FOREST

US Channel Morph	E	5	
DS Channel Morph	E	5	
DS Bank Alteration	Natural	5	
Upstream Skew Angle	<5°	5	
Crossing fill condition	Poor, Bare Soil	1	
Inlet/Outlet Condition	No Impairment	5	
Potential Eroded Vol.	21-40 c.y.	3	
Soil K Factor	≤ 0.20	5	
Approach Slope Mean	<2°	5	
Road Approach Material	Native soil	1	
Upstream Rt Outlet	bare soil	0	
Upstream Lt Outlet	bare soil	0	
Upstream Rt Ditch	bare soil	0	
Upstream Lt Ditch	bare soil	0	
Downstream Rt Outlet	bare soil	0	
Downstream Lt Outlet	bare soil	0

Downstream Rt Ditch	bare soil	0	
Downstream Lt Ditch	bare soil	0	
Improved Outlet Total	0	1	
Improved Ditches Total	0	1	
<b>SRI Total:</b>		<b>42</b>	<b>Additional Site Features</b> Crossing Type and Quantity: Ford Crossing Material: NA Culvert Outfall Drop: NA Fish Passage Barrier: Not Present Notes:

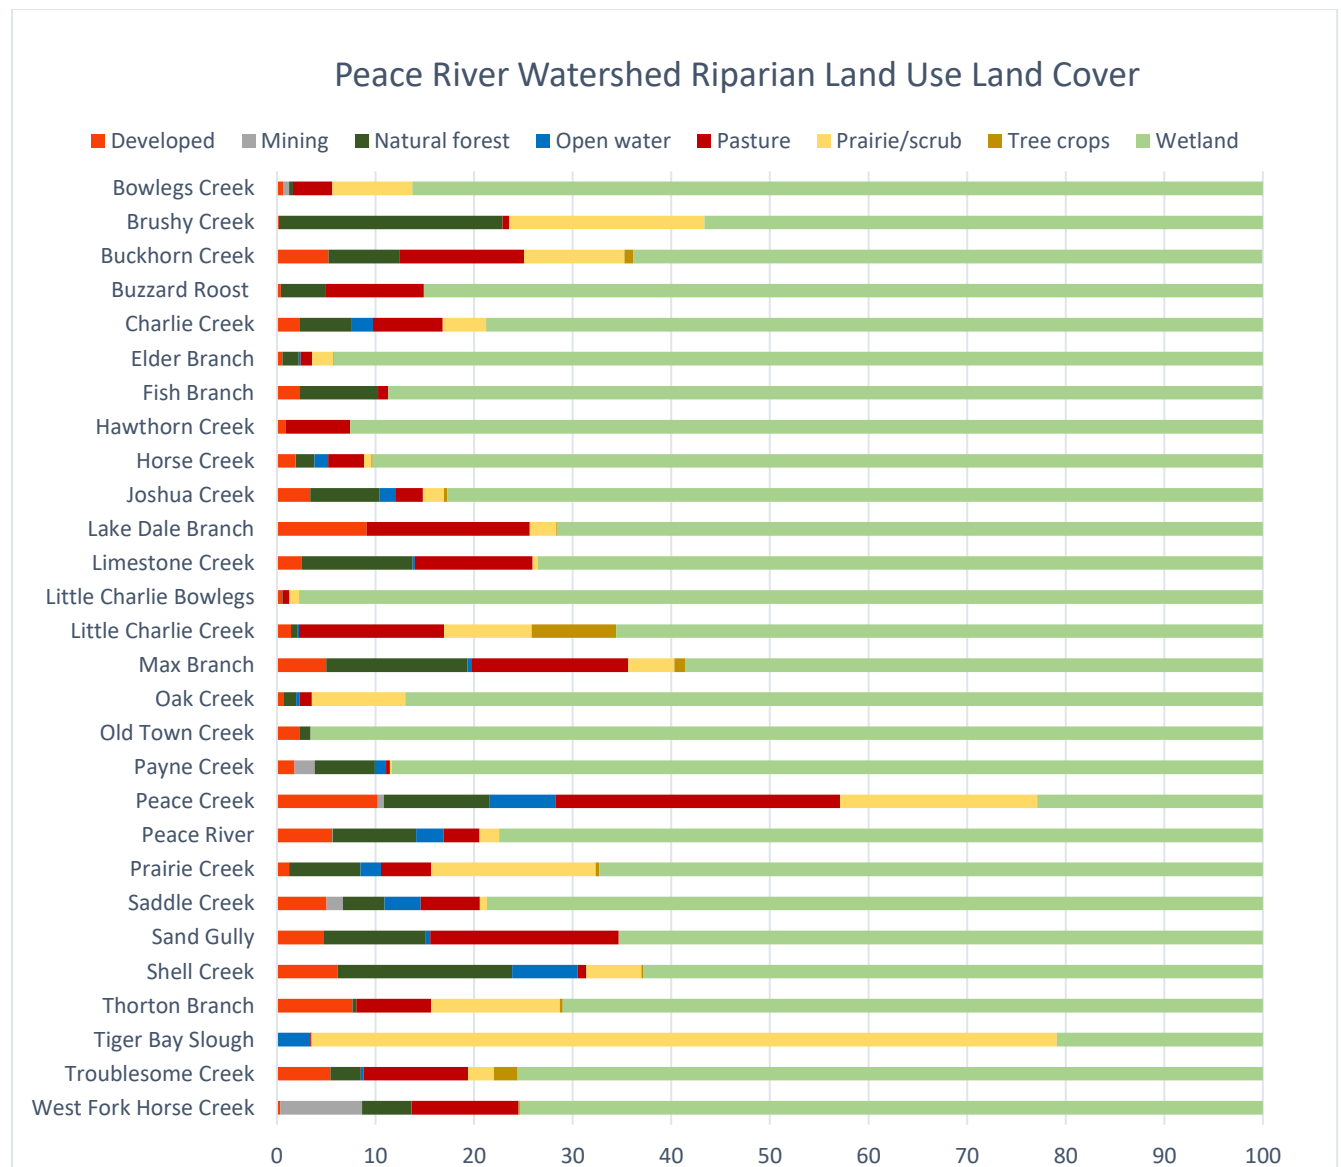
Figure E1. Land use land cover within riparian buffers for assessed streams in the Peace River Watershed.

The riparian LULC results for the main stem of the Peace River and major tributaries (N = 28) are shown in Figure E1. The dominant LULC for most streams was wetlands, with an average of 74.1% for all streams assessed in the Peace River Watershed. Developed areas comprised a small amount of the riparian LULC, averaging 3.1%. Peace Creek had the highest level of development (10.2%) within the riparian LULC. Pasture lands were the primary LULC of interest due to their negative impacts including streambank erosion, riparian zone degradation, and nonpoint source pollution. Percent pasture ranged from 0 to 28.9% and averaged 7.3% of the LULC in riparian buffers. Peace Creek had the highest percent pasture (28.9%) within the riparian LULC of any stream in the Peace River Watershed. This figure is alarmingly high since, in comparison, the Peace River riparian LULC contained 3.6% pasture and we identified 278 impairment sites (74,454 feet) in the 103.7 miles assessed during the threats-assessment project. Additionally, of the 28 streams assessed for riparian LULC within the Peace River Watershed, 60.7% of the streams had a higher percent pasture than the Peace River. This indicates that many of the non-navigable tributaries have numerous impairments.
