# **Peace River and Withlacoochee River Threats Assessments and Fish Assemblage Monitoring**

**Final Report July 1, 2015 – June 30, 2019**

Submitted to Florida State Wildlife Grants Program  
August 1, 2019  
PID: 98462501284

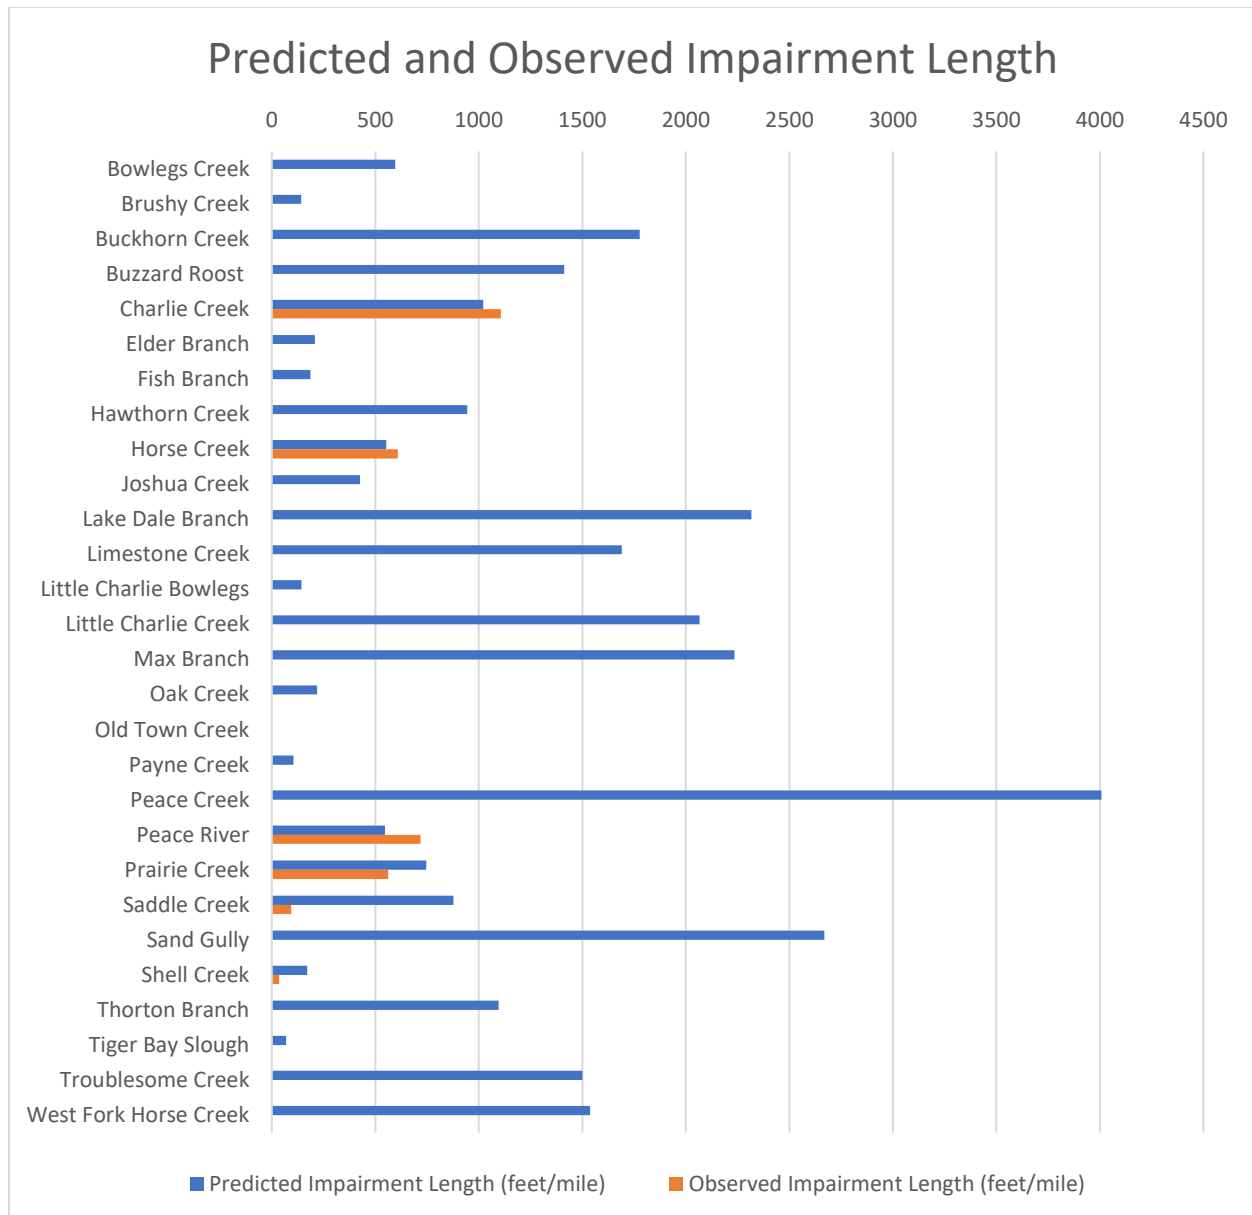
Figure E2. Predicted and observed impairment length per mile for assessed streams in the Peace River Watershed.

the best relationship with impairment site length (i.e., highest  $R^2$  values). Using the regression analysis best fit line equation, we extrapolated or predicted the impairment site length per mile for all target streams (Figure E2). The predicted impairment length per mile generally agreed with visual assessments of riparian imagery and collected or observed data (Figure E2). It should be noted, when comparing predicted and observed data, that entire stream lengths were only surveyed in a few cases (e.g., Peace River, Saddle Creek), due to navigability. Therefore, we only included observed results when a significant portion of the stream was assessed in the field. This was done since land uses often change between the upper and lower reaches of a stream, and inclusion of incomplete data may cause discrepancies between observed and predicted results, which may be misleading.

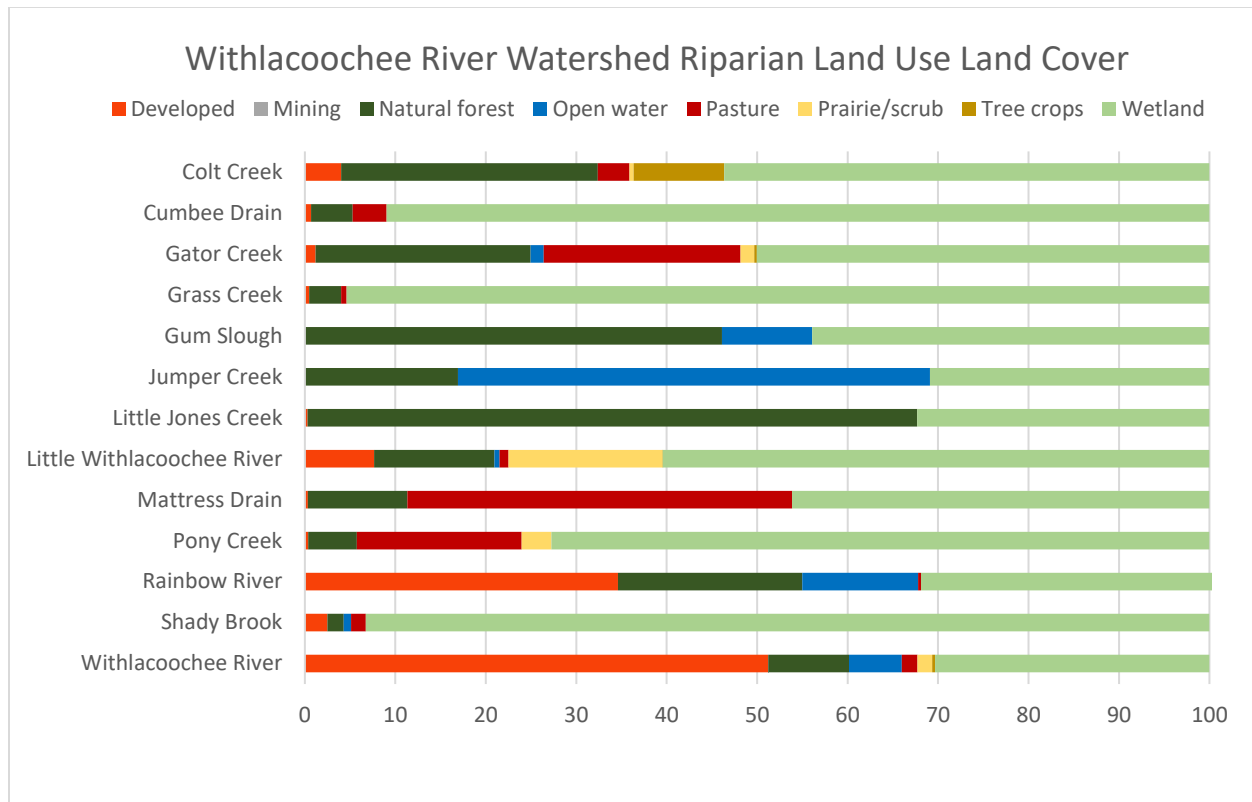
Figure E3. Land use land cover within riparian buffers for assessed streams in the Withlacoochee River Watershed.

Watershed with an average of 7.9%. The most developed waterbodies were the Withlacoochee River (51.2%) and Rainbow River (34.6%). The high level of development in riparian buffers of Rainbow River has resulted in loss of floodplain connectivity and increased nutrients from fertilizer runoff and septic systems leaks. Percent pasture ranged from 0 to 42.5% and averaged 7.3% for all LULC in riparian buffers, which was very similar to the Peace River Watershed. Mattress Drain had the highest percent pasture (42.5%) within the riparian LULC for all streams assessed.

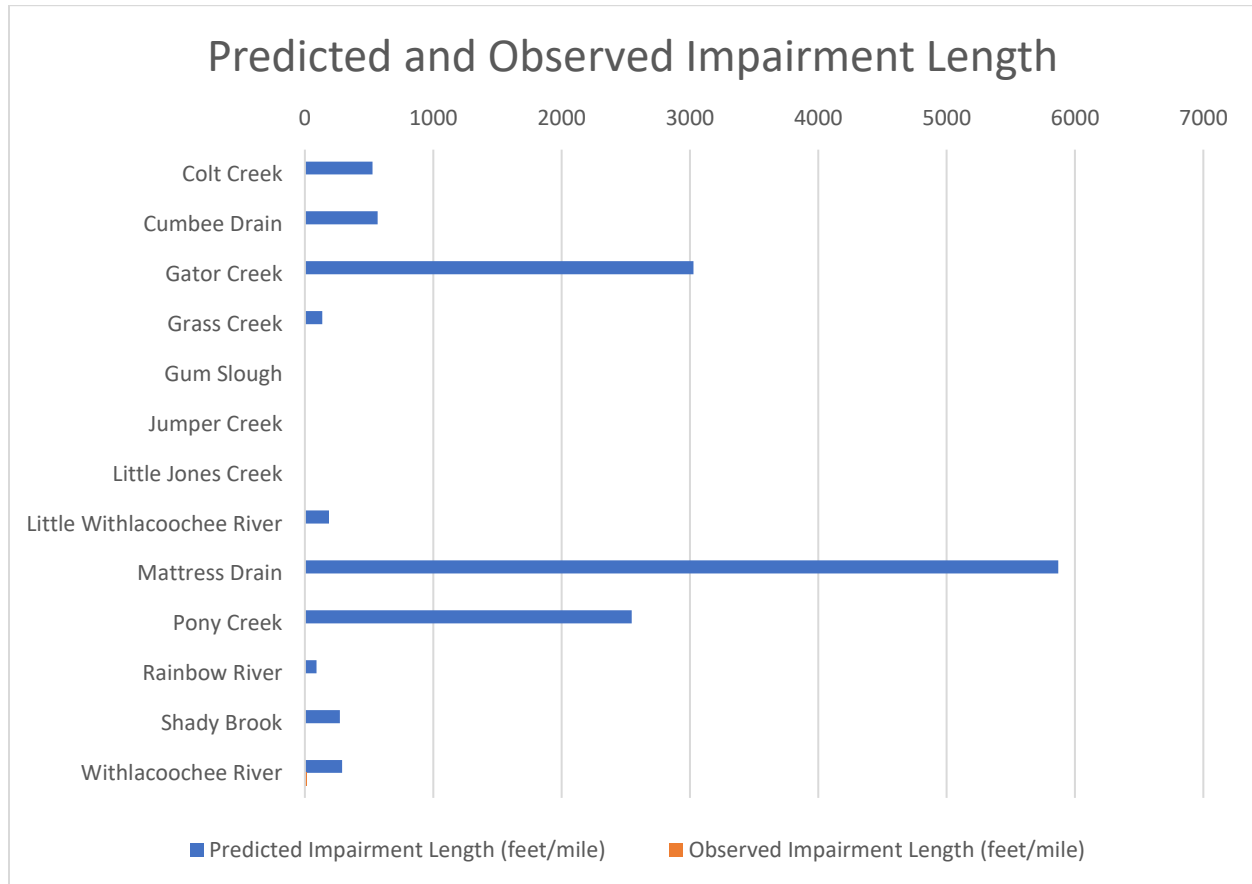
Figure E4. Predicted and observed impairment length per mile for assessed streams in the Withlacoochee River Watershed. Note: observed results were included for Jumper Creek (0 feet/mile), Little Withlacoochee River (0 feet/mile), Rainbow River (0 feet/mile), and Withlacoochee River (16.8 feet/mile).
