Tampa Shoreline Restoration Initiative

[*Shoreline Restoration Masterplan*]

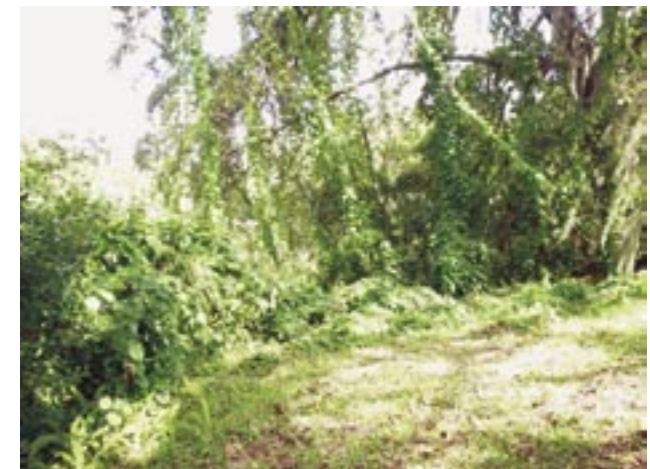
The 22nd Street Park shoreline consists primarily of a freshwater marsh buffer. Several large laurel oaks (*Quercus laurifolia*) and cabbage palms (*Sabal palmetto*) provide canopy along the shoreline, but the cover is not dense enough to classify the entire shoreline as a riparian forest. This system contains approximately 35% cover of nuisance species including: air potato (*Dioscorea bulbifera*), Brazilian pepper (*Schinus terebinthifolius*) and creeping ox-eye (*Vedelia trilobata*). Leather fern (*Acrostichum sp.*) was observed along the waterward edge of this system and, due to the steep slope, is isolated from the surrounding nuisance species. The water level is appropriate, but the shoreline has severely eroded. Due to the steep slope, the extent of the wetland species is limited to the base of the slope, and upland species have colonized the top of the bank. The shoreline provides some habitat for wading birds, amphibians and fish.

Figure 2: Air potato vine and Brazilian pepper along the 22nd Street Park shoreline.

Short Term: Volunteers to remove the nuisance species, in particular, the air potato vine and Brazilian pepper shown in figure 2.

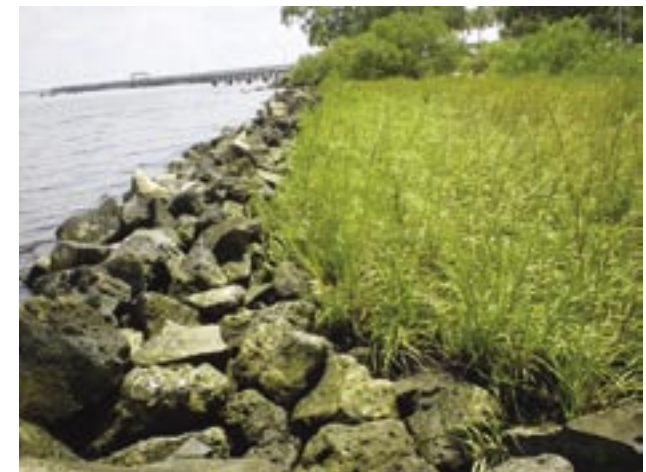
It is evident that a majority of the Ballast Point shoreline has successfully been restored. The entire shoreline has been faced with rip-rap, and vegetation has been planted or colonized in all areas; with the exception of the wall adjacent to the boat ramp and dock (figure 4). A lagoon area has been created through the installation of rip-rap approximately 20 feet waterward of the seawall. This area includes several native species including: smooth cordgrass (*Spartina alterniflora*) and red mangroves (*Rhizophora mangle*). The remaining shoreline has been colonized by red, black and white mangroves (*Avicennia germinans* and *Languncularia racemosa*), and saltbush (*Baccharis halimifolia*). The southern point was not part of the original restoration and contains approximately 10% cover by Brazilian pepper (*Schinus terebinthifolius*). It is anticipated that the overall shoreline provides habitat for wading birds, fish, amphibians and invertebrates.

Figure 4: Rip-rap and vegetation along the Ballast Point Park shoreline.

Long Term: Pursue funding in conjunction with the City of Tampa and/or SWFWMD to restore the southern point of the park including Brazilian pepper removal, rip-rap installation and restoration using native plantings.

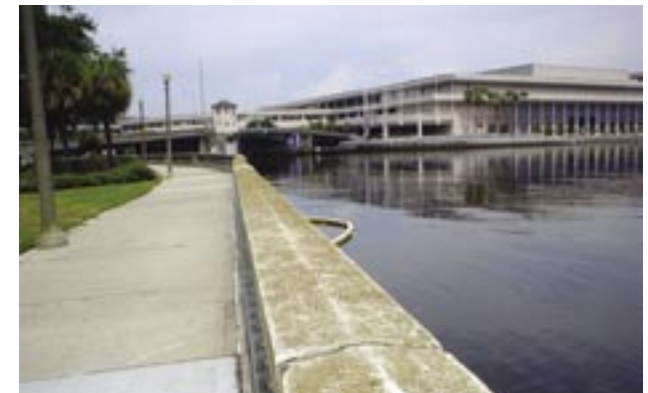
Seawall makes up the entire Bayshore Blvd. Linear Park shoreline (figure 7). The adjoining upland area consists of a concrete footpath and a narrow vegetated buffer that separates the footpath from a busy roadway. This park does not contain any natural area and provides no obvious wildlife support. Finger piers are adjacent to a majority of the shoreline and may preclude the placement of rip-rap along the wall. Litter observed within this park was found floating in the water and therefore would be difficult to retrieve. This park has a low exotic removal rating due to the absence of vegetation, but could benefit from enhancing the shoreline through the placement of rip-rap or reef material waterward of the existing seawall to create habitat for wading birds and fish. Further enhancement would be difficult due to the limited park area. Overall, the habitat quality for the seawall is minimal.

Figure 7: Concrete footpath and vegetated buffer along Bayshore Blvd. Linear Park.

Long Term: 1) Pursue funding in conjunction with the City of Tampa and/or SWFMWD to install rip-rap waterward of the seawall in applicable areas. 2) Pursue funding in conjunction with Tampa Bay Watch for seawall enhancement such as oyster reefs.

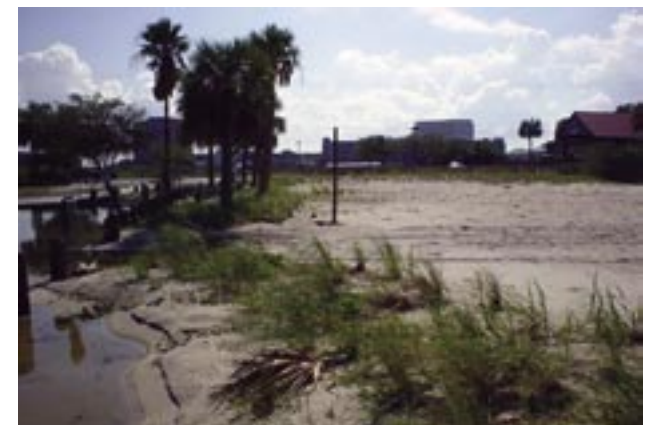
The Ben T. Davis Park shoreline consists primarily of a hardened shoreline with both rip-rap and seawall. The park area includes a public beach, concession stand, parking area and a long access roadway, which is used for recreational fishing along the waterward side of the road. The beach area is isolated but contains a small, vegetated area including both sea oats (*Uniola paniculata*) and railroad vine (*Ipomoea brasiliensis*) (figure 9). The beach area is immediately adjacent to a large commercial building and the park's parking area.

Figure 9: Sea oats and railroad vine along the Ben T. Davis Park shoreline.

Long Term: 1) Large scale restoration is needed for stabilization and beach erosion. 2) Pursue funding in conjunction with the City of Tampa and/or SWFMWD to place rip-rap along the section of seawall waterward of the concession stand.

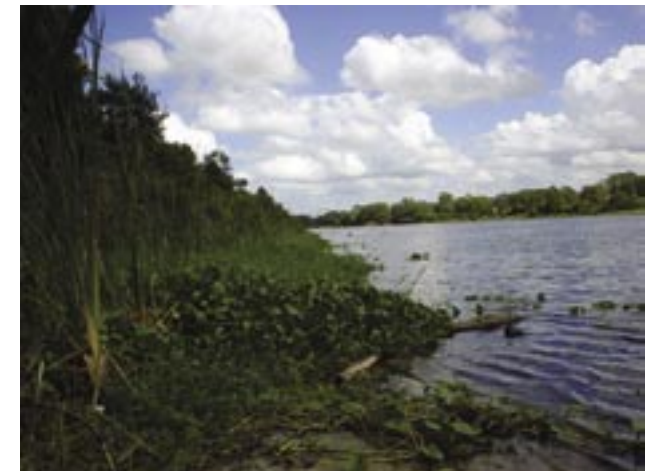
Figure 11: Exotics along the Blackwater Hammock Park shoreline.

Long Term: 1) Pursue funding for Phase 2 of restoration with City of Tampa. 2) Pursue funding, in conjunction with the City of Tampa and/or SWFWMD, for the creation of a freshwater marsh focusing on the south section of the property where upland restoration has previously occurred, along with the incorporation of a boardwalk feature similar in design to that at Lowry Park.

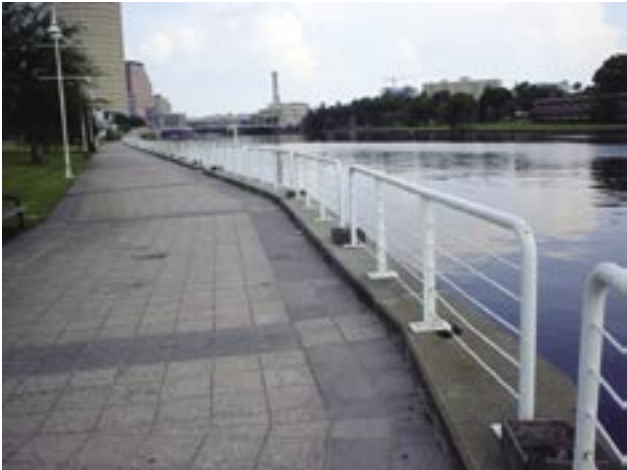
The entire Curtis Hixon Park shoreline is sea-walled (figure 14). In addition, the area will be undergoing major reconstruction which, at this time, plans indicate that the shoreline will remain the same. The park is located adjacent to the Hillsborough River as an upland urban park. This shoreline provides no significant habitat value for wildlife that would be found utilizing the adjacent river. The assessment area immediately upland of the seawall is a wide concrete pedestrian path. In addition, the park and river are located in a highly urbanized area. The adjacent upland park is maintained as a grassed area with scattered oaks. The park is highly visible and in an urban area with high usage. Therefore, it would be highly beneficial to restore the shoreline by installing rip-rap or reef material along the seawall. Similar plans have been considered by the City of Seattle in the Terminal 46 Area (Landscape Northwest 2004).

Figure 14: The seawall along Curtis Hixon Park's shoreline.

- Short Term:** Determine if existing plans for reconstruction could incorporate unique shoreline features such as habitat shelves.
- Long Term:** Pursue funding in conjunction with the City of Tampa, SWFMWD, and or Tampa Bay Watch to install rip-rap, habitat shelves, or reef balls adjacent to the wall to serve as a demonstration project.

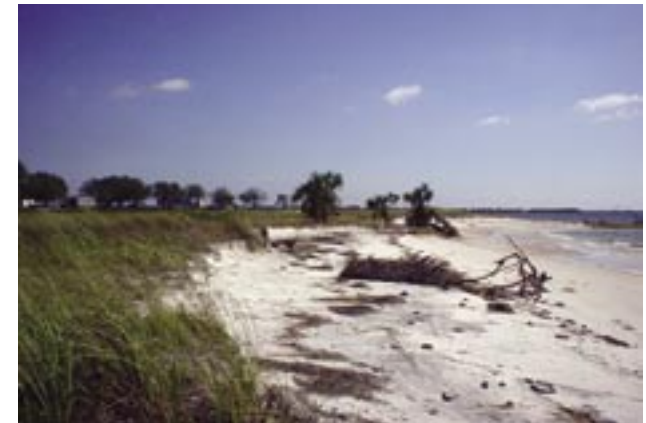
The Cypress Point Park shoreline is a diverse mixture of habitats including: mangrove fringe, coastal dunes and coastal shrub. Although this park is narrow, the shoreline provides a significant amount of natural habitat and wildlife support. The coastal dune system contains several native species including: sea-oats (*Uniola paniculata*), cucumber leaved sunflower (*Helianthus angustifolius*), sand cord grass (*Spartina bakeri*), love grass (*Eragrostis sp.*), railroad vine (*Ipomea brasiliensis*) and fingergrass (*Eustachys petraea*) (figure 16). The dune system experienced some erosion during the 2004 hurricane season, creating several steep ledges. The coastal shrub system also contains a variety of native species including: finger grass, buttonwood (*Conocarpus erectus*), seashore elder (*Iva imbricata*), and black and white mangroves (*Languncularia racemosa* and *Avicennia germinans*). The coastal shrub blends into and becomes a pure mangrove fringe on the western edge of the park. This mangrove fringe contains a healthy stand of red (*Rhizophora mangle*), black and white mangrove fringe, which are diverse in both species and size distribution. Saltgrass (*Distichlis spicata*) forms a dense cover waterward of the fringe within the shallow areas. This combination of habitats provides wildlife support for fish, wading and shore birds, amphibians and invertebrates. The hydrology is normal for this type of system and is supporting appropriate vegetation.

Figure 16: Native species along the Cypress Point Park shoreline.

Short Term/Long Term: Utilize volunteers to monitor the site for litter, and nuisance and exotic species to ensure the site is maintained in its current state.

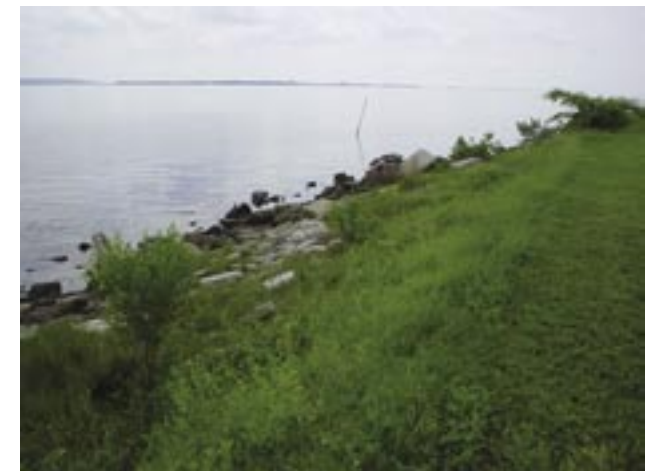
The Davis Island Park shoreline is a combination of seawall and rip-rap. Vegetation has begun to naturally recruit within the rip-rap shoreline. Native species observed include: black, white and red mangroves (*Avicennia germinans*, *Laguncularia racemosa*, *Rhizophora mangle*), saltbush (*Baccharis halimifolia*). Nuisance species, including creeping ox-eye (*Wedelia trilobata*), Brazilian pepper (*Schinus terebinthifolius*), and the less dominant mimosa (*Acacia julibrissin*) have also colonized the shoreline (figure 19). The rip-rap has been placed along the peninsular portion of the shoreline, and the adjacent upland consists of maintained grass; therefore, providing little supporting habitat. The rest of the shoreline is hardened by seawall, and the adjacent upland is also maintained grass. Both shorelines are influenced by the bay, which allows for movement and provides supporting habitat for species that may utilize the rip-rap areas. The seawall provides no obvious wildlife support.

Figure 19: Nuisance species along the Davis Island Park shoreline.

Long Term: Install rip-rap or reef ball structures waterward of the seawall, and plant native coastal vegetation along the shoreline.

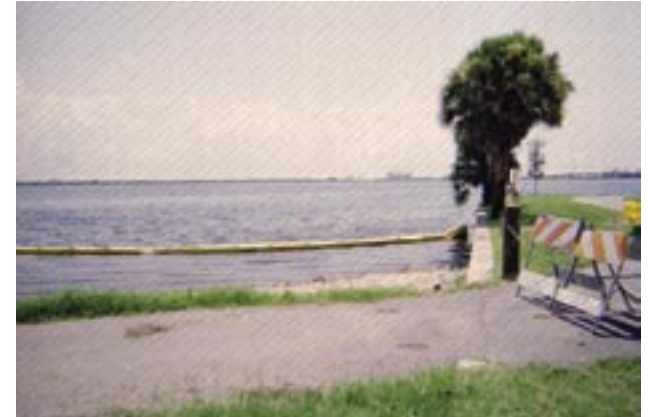
At the time of the inspection, the shoreline was being actively restored; therefore, the standard assessment could not be utilized. It appears that the shoreline is being restored in accordance with the included SWIM plans. Prior to the construction activities, the shoreline was a combination of natural vegetation and poured concrete. The vegetated portion of the shoreline was minimal and contained Brazilian pepper (*Schinus terebinthifolius*) and red, black and white mangroves (*Rhizophora mangle*, *Avicennia germinans*, and *Languncularia racemosa*). The remaining shoreline was covered with concrete; therefore, was devoid of vegetation.

The upland portion of the park is maintained lawn with a pedestrian path. The shoreline is adjacent to the bay, which allows for wildlife movement and provides supporting habitat. This park was not given an exotic removal score because the shoreline is in the process of being restored (figures 21 and 22).

Figure 21: Restoration work being done in DeSoto Park.

Short Term: Restoration activities are currently underway.

Long Term: Volunteers will be needed for ongoing maintenance.

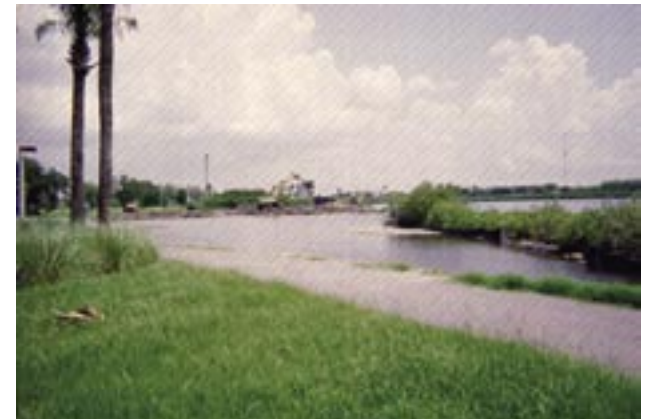
Figure 22: Upland portion of DeSoto Park.

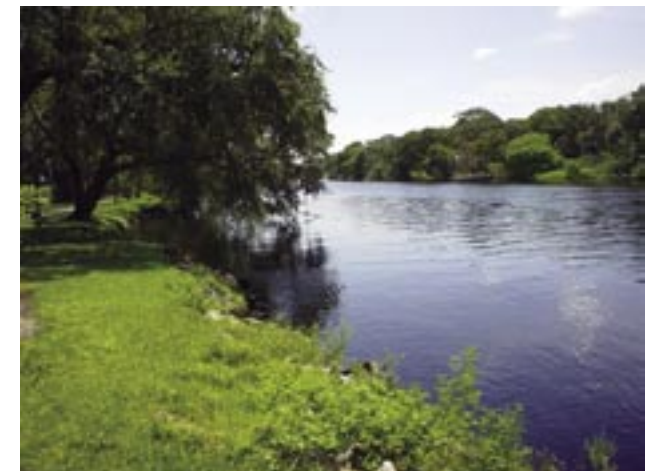
The Epps Park shoreline consists primarily of an oligohaline riparian buffer with scattered lengths of rip-rap (figure 23). This system consists of a variety of native species including: cypress (*Taxodium distichum*), laurel oak (*Quercus laurifolia*), leather fern (*Acrostichum sp.*), sand cord grass (*Spartina bakeri*), maidencane (*Panicum hemitomon*), wax myrtle (*Myrica cerifera*), needle rush (*Juncus roemerianus*) and arrowhead (*Sagittaria sp.*). Nuisance species along the shoreline include: torpedo grass (*Panicum repens*), creeping ox-eye (*Wedelia trilobata*) and cattails (*Typha sp.*). The entire shoreline is rip-rapped but the vegetation is covering all but the most waterward rocks.

Figure 23: Epps Park's shoreline showing riparian buffer with scattered rip-rap.

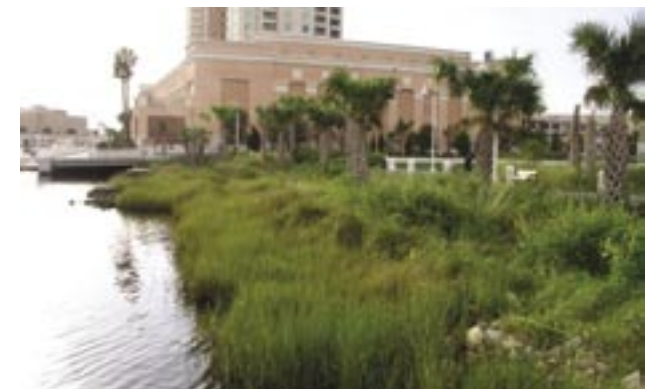
The Ft. Brooke Cotanchobee Park shoreline has been hardened by a seawall and rip-rap. The rip-rap portion of the park shows evidence of restoration planting and natural recruitment that has resulted in a vegetated shoreline. A diversity of native species occurs along this portion (figure 25) of the shoreline including: smooth cordgrass (*Spartina alterniflora*), false-willow (*Baccharis angustifolia*), and black and white mangroves (*Avicennia germinans* and *Languncularia racemosa*). No exotic species were observed along the shoreline. In addition, a row of sand cord grass (*Spartina bakeri*) appears to have been planted along the entire shoreline at the top of slope. The seawall is a small part of the shoreline and is associated with a large concrete pier. Overall, the shoreline provides habitat for fish, wading birds, and invertebrates. The bay allows water movement in and out of the site and provides supporting habitat for fish and wading birds. The adjacent park is primarily comprised of paved sidewalks and planters and is located in the middle of an urban area. The park is narrow and located next to a heavily used roadway. The park has benefited from restoration activities. The installation of rip-rap and native plants has greatly increased the habitat value of this shoreline.

Figure 25: Native species along the Ft. Brooke Cotanchobee Park shoreline.

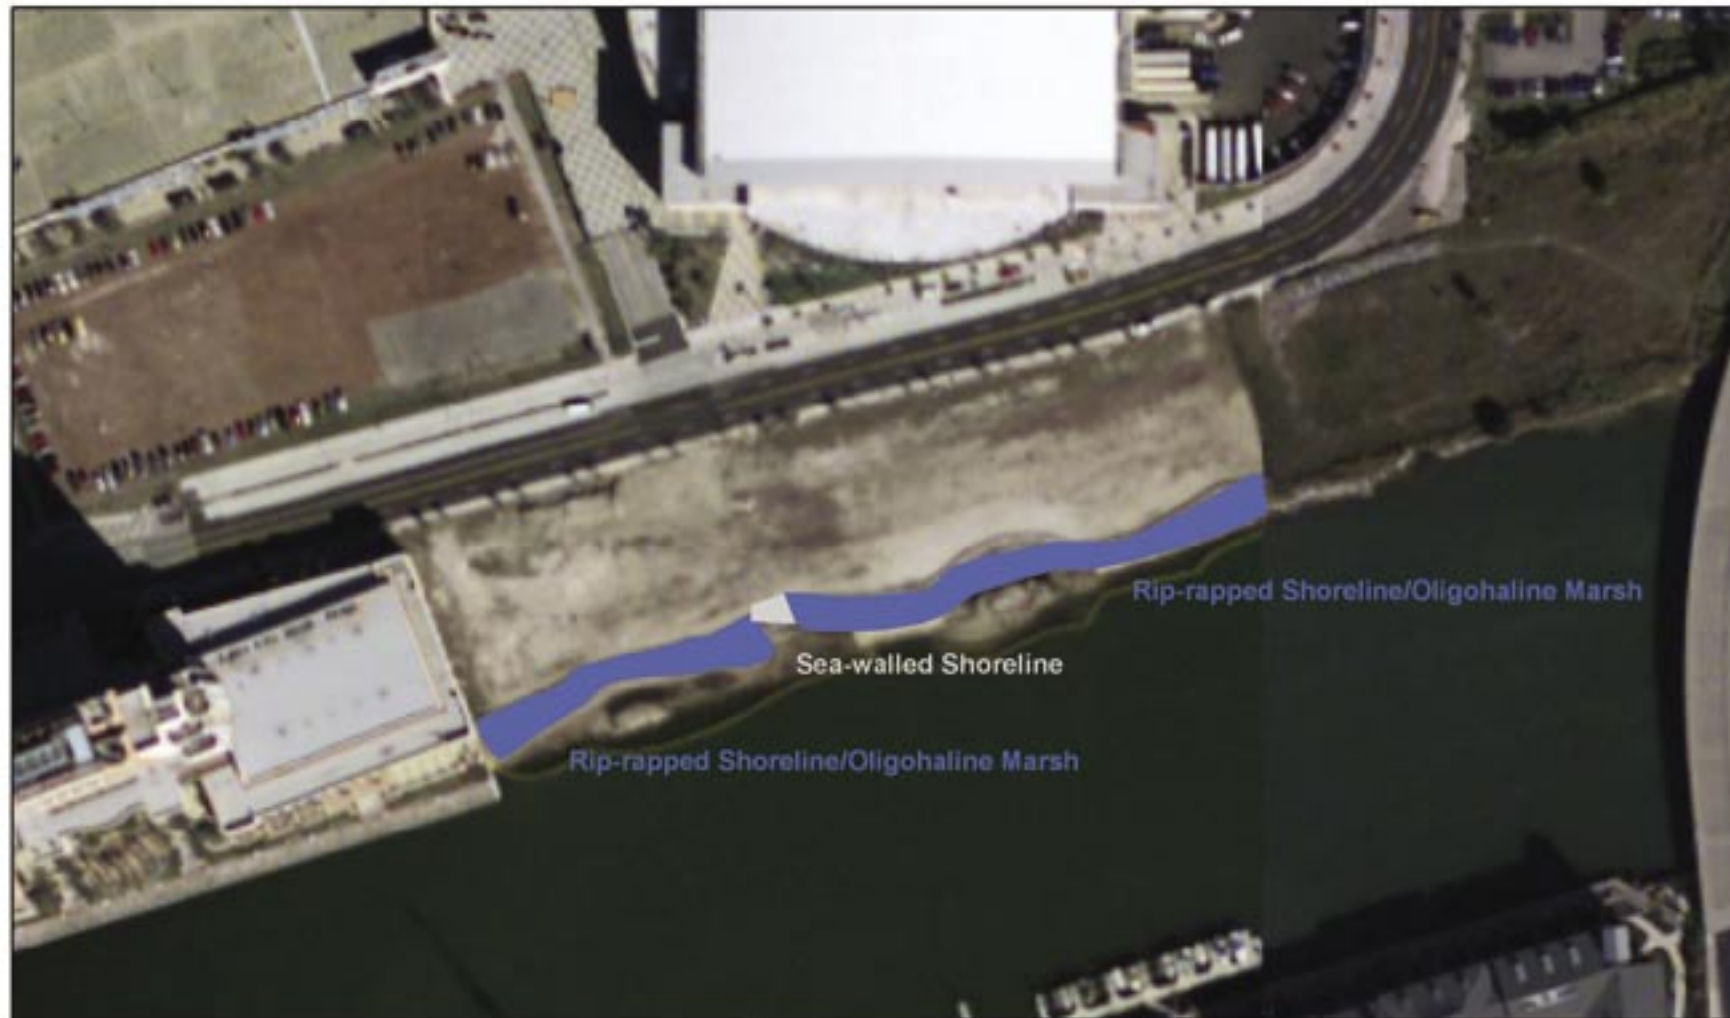
Figure 26: Existing shoreline condition of Ft. Brooke Cotanchobee Park.

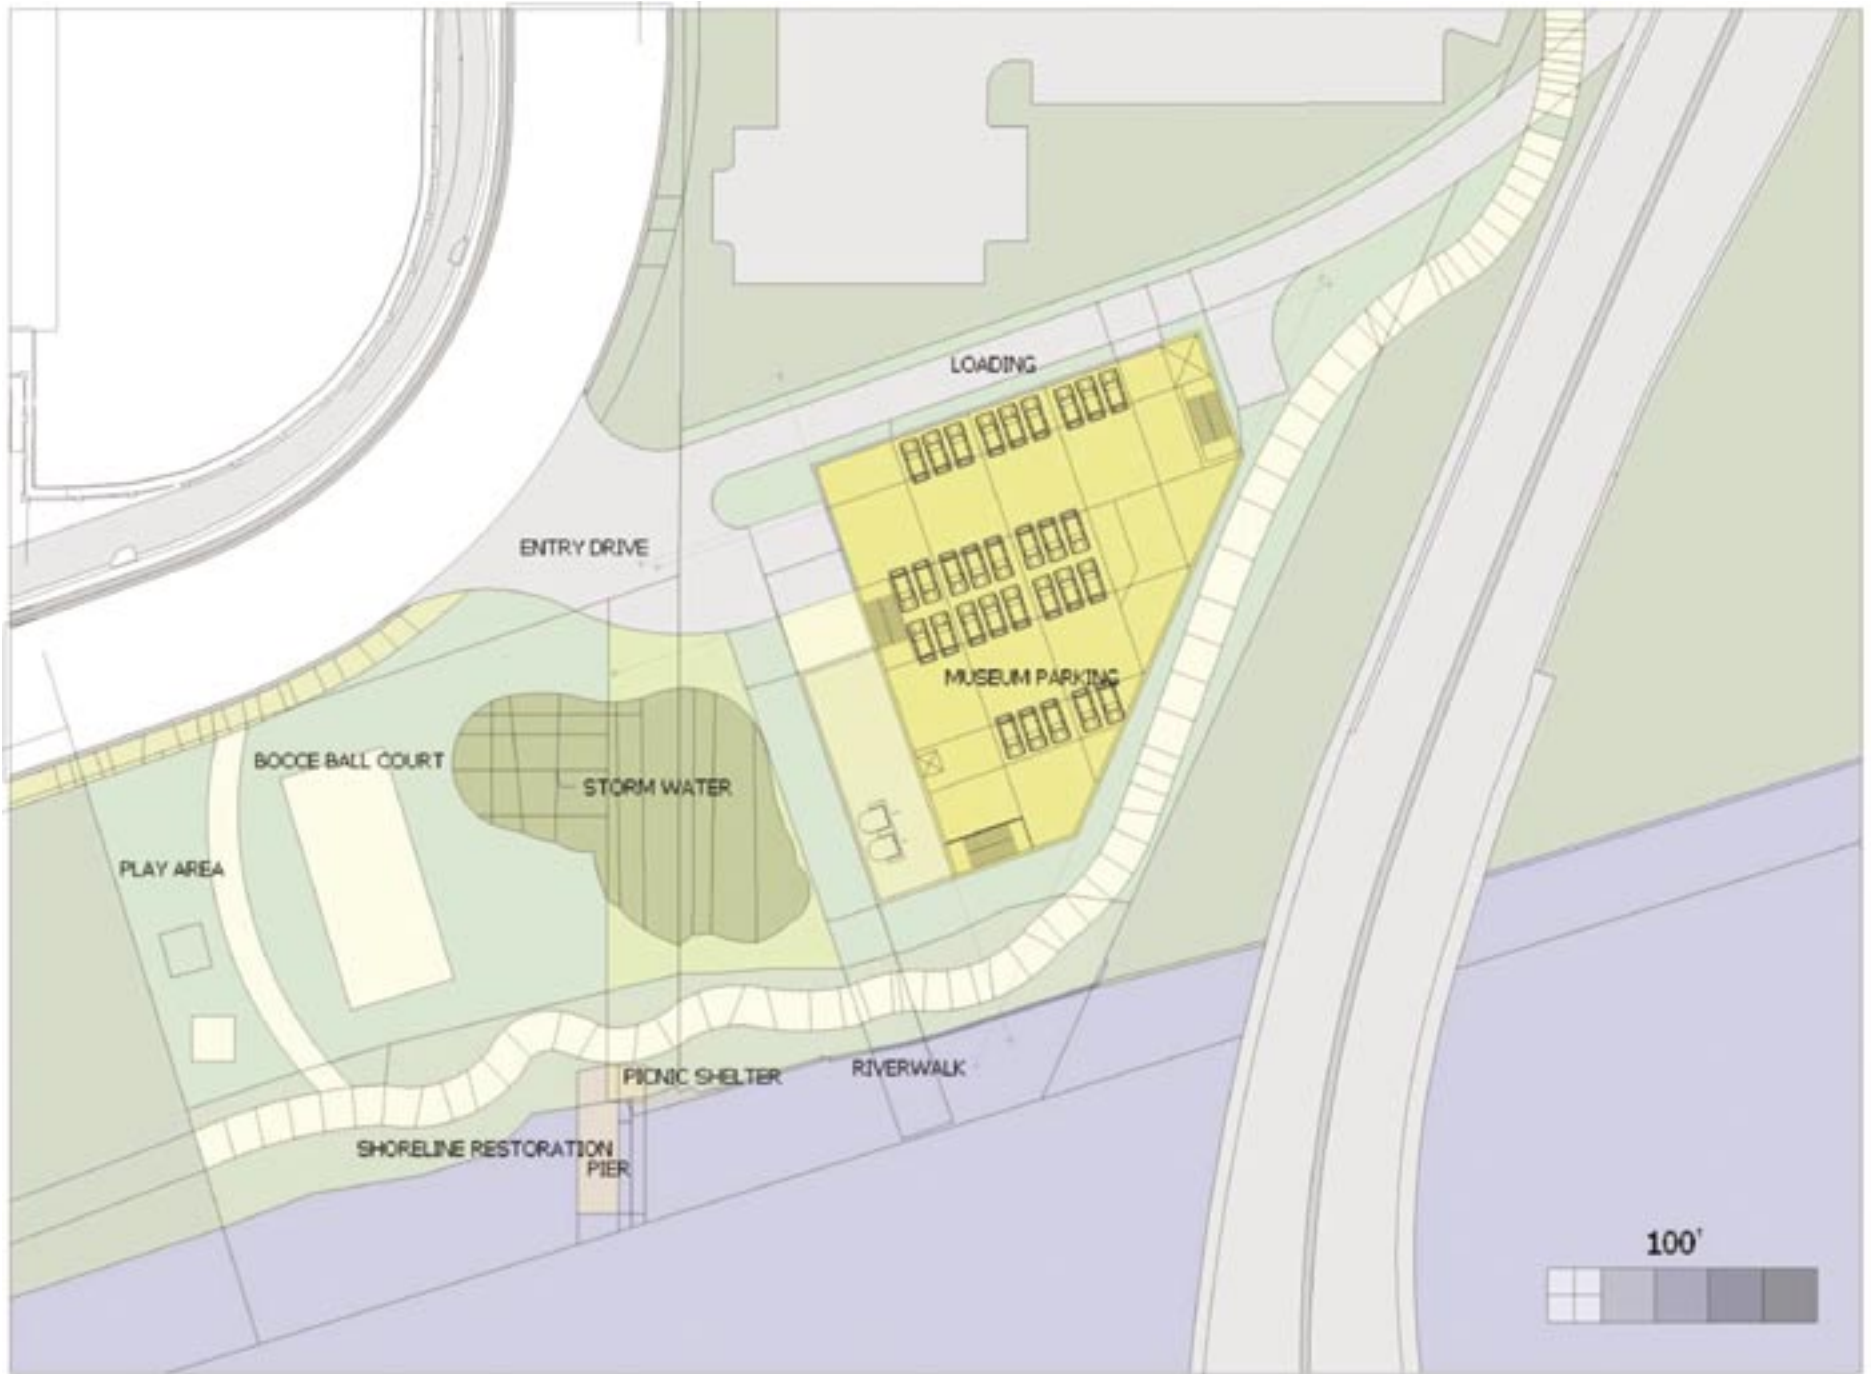
The City of Tampa has completed Phase 1 and Phase 2 (November 2001) of restoration which converted hardened shoreline to vegetated shoreline and altered the slope. \$100,000 was provided by the City of Tampa in kind, and SWFWMD provided \$50,000 (figure 27). As part of the restoration, Tampa Bay Watch installed 5,000 smooth cord grass (*Spartina alterniflora*) plugs.

Figure 27: Phase 2 of shoreline restoration for Ft. Brooke Cotanchobee Park.

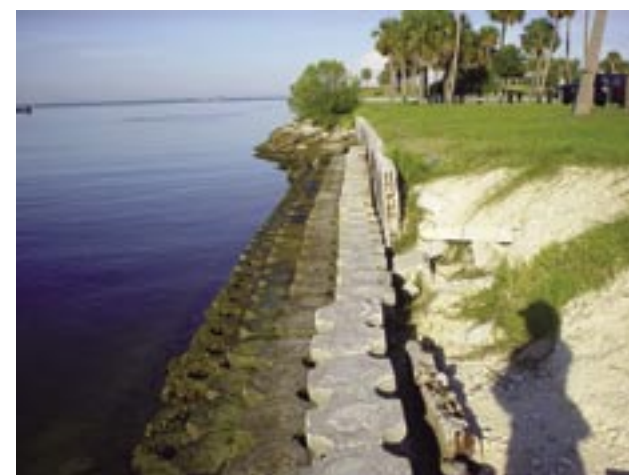
Portions of the Gandy Park shoreline were previously restored through a cooperative project with the SWIM program and the City of Tampa. The majority of the shoreline was historically sea-walled, but now consists primarily of a mangrove fringe. The western end of the park consists of a steep rip-rap and "mac block" shoreline for shoreline protection of the Gandy Bridge approach (figure 28). This area has very little vegetative cover due to the hardened shoreline and higher wave energy due to boat wakes and wave exposure from the open bay. Vegetation along the shoreline includes: black mangroves (*Avicennia germinans*), saltbush (*Baccharis halimifolia*) and morning-glory (*Ipomea brasiliensis*). The majority of the shoreline is a dense, healthy mangrove fringe. Remnant portions of the seawall, which were cut or breached, still exist in several areas—the breaches allow for tidal exchange with the bay. The mangrove fringe contains a variety of native species including: red, white, and black mangroves, saltbush and flat-topped goldenrod (*Euthamia minor*). On the landward edge of the fringe, scattered cabbage palms (*Sabal palmetto*) and laurel oaks (*Quercus laurifolia*) occur. Approximately 20% of the fringe has been recolonized by exotic/nuisance vegetation including mimosa (*Acacia sp.*) and Brazilian pepper (*Schinus terebinthifolius*). Within the mangrove fringe is a small, tidally influenced, open water area. The mangrove fringe is healthy and diverse in size and species. The exotics appear to be limited primarily to the landward edge of the fringe.

Figure 28: Mac block shoreline along the Gandy Bridge approach.

Short Term: 1) Use volunteers to remove Brazilian pepper along mangrove fringe. 2) Volunteers needed for annual bay cleanup.

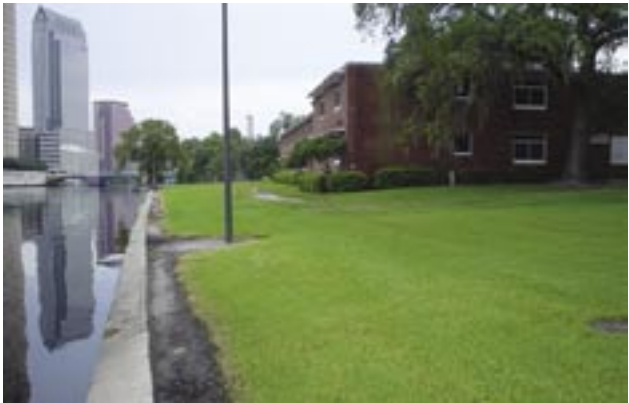
Seawall makes up the entire Henry B. Plant Park shoreline (figure 31). The adjoining upland area is a maintained lawn adjacent to housing for the University of Tampa. The seawall does not provide any obvious wildlife support, and precludes the river from influencing the adjacent upland system. The upland assessment area contains some scattered oaks, and may provide some supporting habitat for wading birds. This park has a low exotic removal priority rating due to the absence of exotic vegetation, but could benefit from enhancing the shoreline through the placement of rip-rap waterward of the existing seawall to create habitat for wading birds and fish. The habitat quality rating for the seawall is minimal.

Figure 31: Sea-walled shoreline in Henry B. Plant Park.

Long Term: Pursue funding in conjunction with the City of Tampa and/or SWFMWD to install rip-rap or reef material waterward of the seawall. If possible, the wall should be removed, the slope regraded to a more gradual incline, rip-rap installed, and native plants installed.

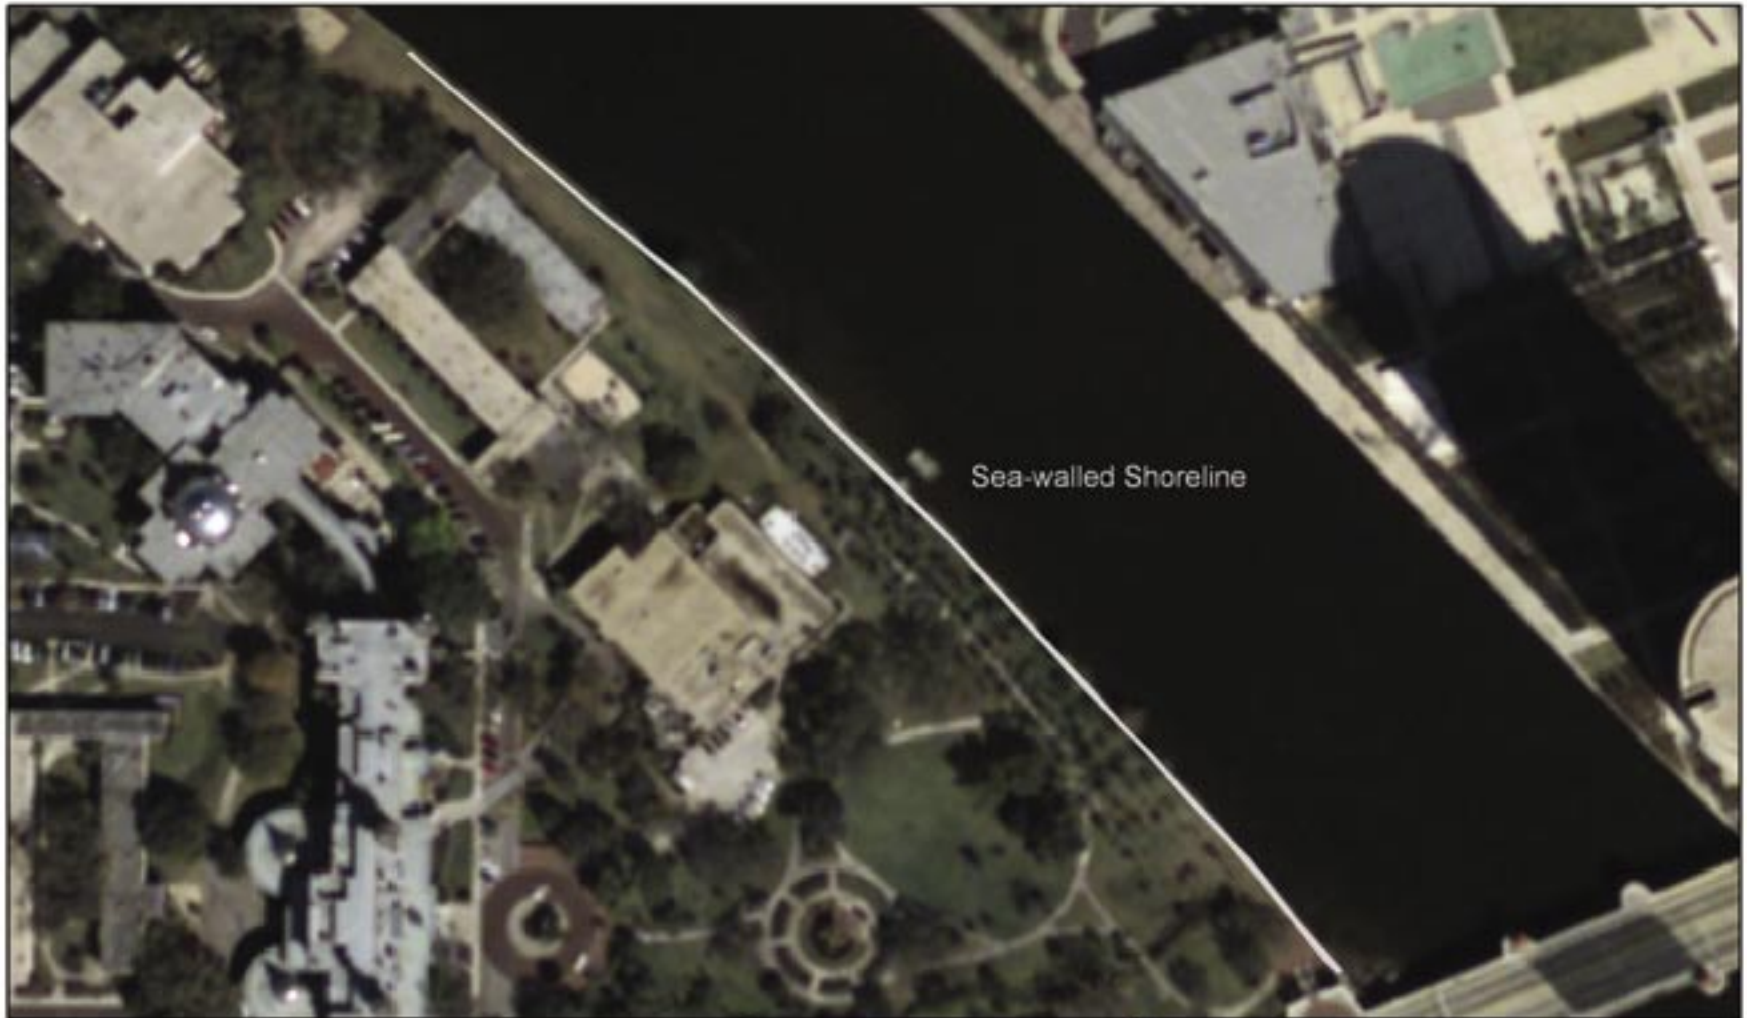
Figure 32: Existing shoreline condition of Henry B. Plant Park.

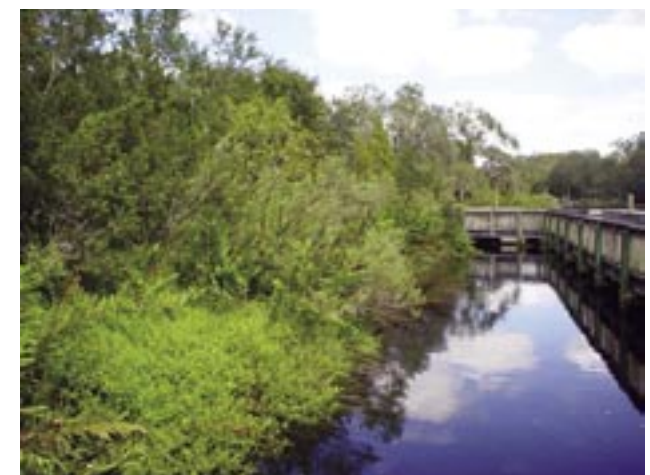
The Lowry Park shoreline consists primarily of a restored oligohaline riparian buffer (figure 33). This system consists of a variety of native species including: leather fern (*Acrostichum sp.*), wax myrtle (*Myrica cerifera*), bulrush (*Scirpus sp.*), saltbush (*Baccharis halimifolia*), sand cord grass (*Spartina bakeri*), cypress (*Taxodium distichum*), red maple (*Acer rubrum*) and several other beneficial species. Within the marsh habitat, approximately 20% of the cover consisted of exotic or invasive species including torpedo grass (*Panicum repens*) and cattails (*Typha sp.*). Adjacent to the seawall and rip-rap, the percent cover of cattails (*Typha sp.*) was approximately 15%. Overall, the native species are large and dominant and it does not appear that the exotic species are becoming a nuisance. The slope of the shoreline is shallow and there is no evidence of litter.

Figure 33: Oligohaline riparian buffer at Lowry Park.

Short Term: 1) At this time exotic species are not a problem, and the park should be monitored to ensure that there is no further spread of nuisance species. 2) Stakeholder agencies partner with the City of Tampa in funding Phase 2 of shoreline restoration.

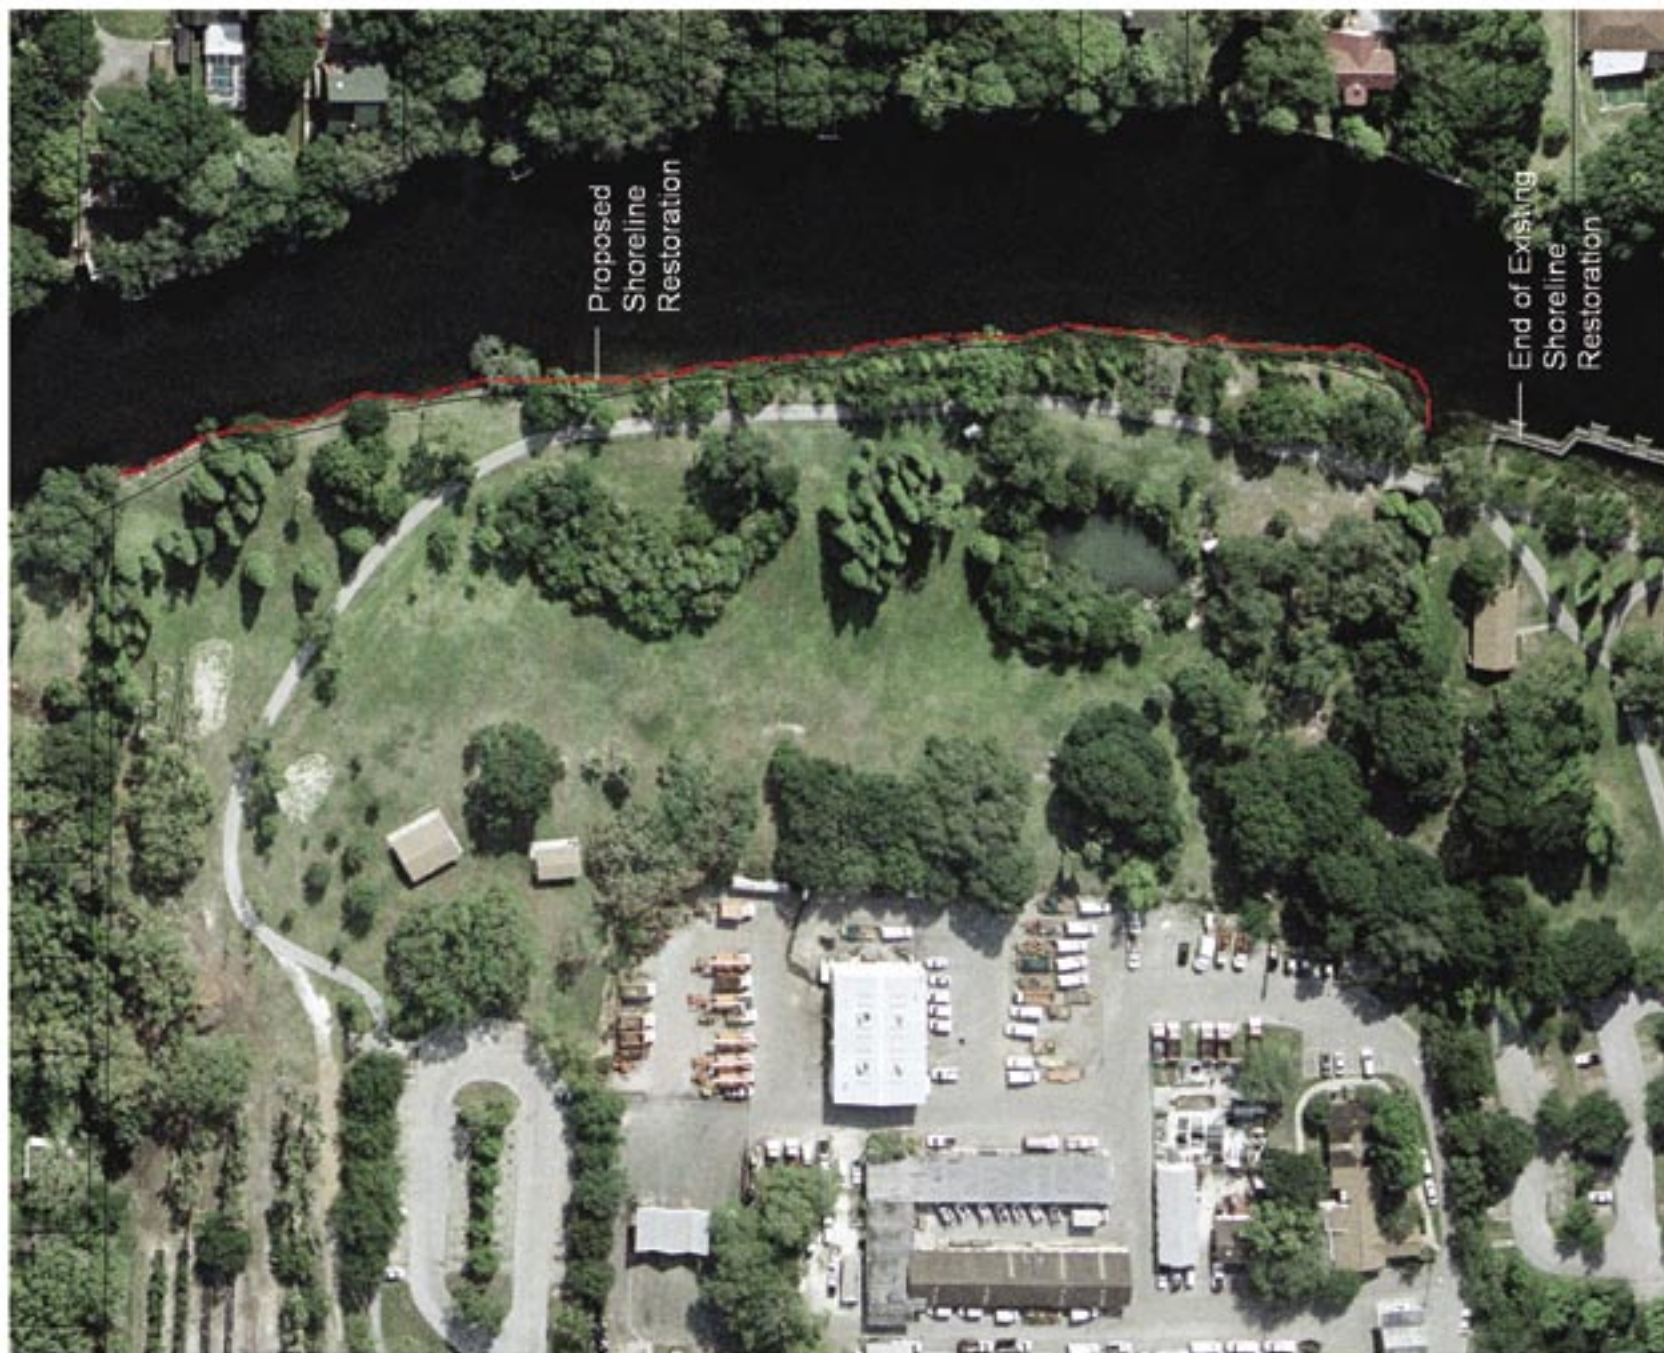
Lowry Park Shoreline Restoration

The City of Tampa has identified Phase 2 of restoration as a high priority (figure 35).

Figure 35: Phase 2 of the City of Tampa's restoration plan for Lowry Park.

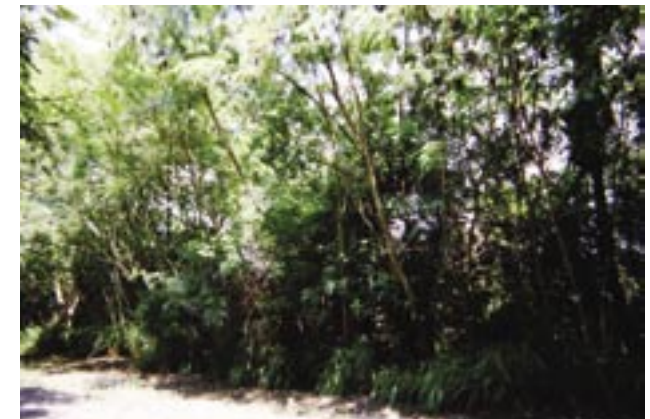
The McKay Bay Nature Park shoreline can be broken into two polygons. A large portion of the shoreline is a healthy, wide mangrove fringe (figure 36). The remaining shoreline is riverine forest that contains 40% nuisance species. The shoreline is narrow and adjacent to a narrow access road that runs between the park and a recycling plant. The shoreline is very steep and the vegetation is stratified. *Mimosa* (*Albizia julibrissin*) occurs on the landward edge of the fringe. Within the fringe is a mixture of mimosa and Brazilian pepper (*Schinus terebinthifolius*), and red and white mangroves (*Rhizophora mangle* and *Languncularia racemosa*) occur on the waterward edge. This habitat is adjacent to the bay, which allows for movement in and out of the system. It is anticipated that this shoreline supports wading birds, fish, and invertebrate species. Due to the close proximity of the recycling plant, there is little supporting habitat landward of the fringe. Overall, due to the low level of nuisance species cover (2%) within this system, it has a low exotic removal priority rating.

Figure 36: Shoreline of McKay Bay Nature Park.

Long Term: Pursue funding in conjunction with the City of Tampa and/or SWFMWD to stabilize the shoreline and replant with native vegetation.

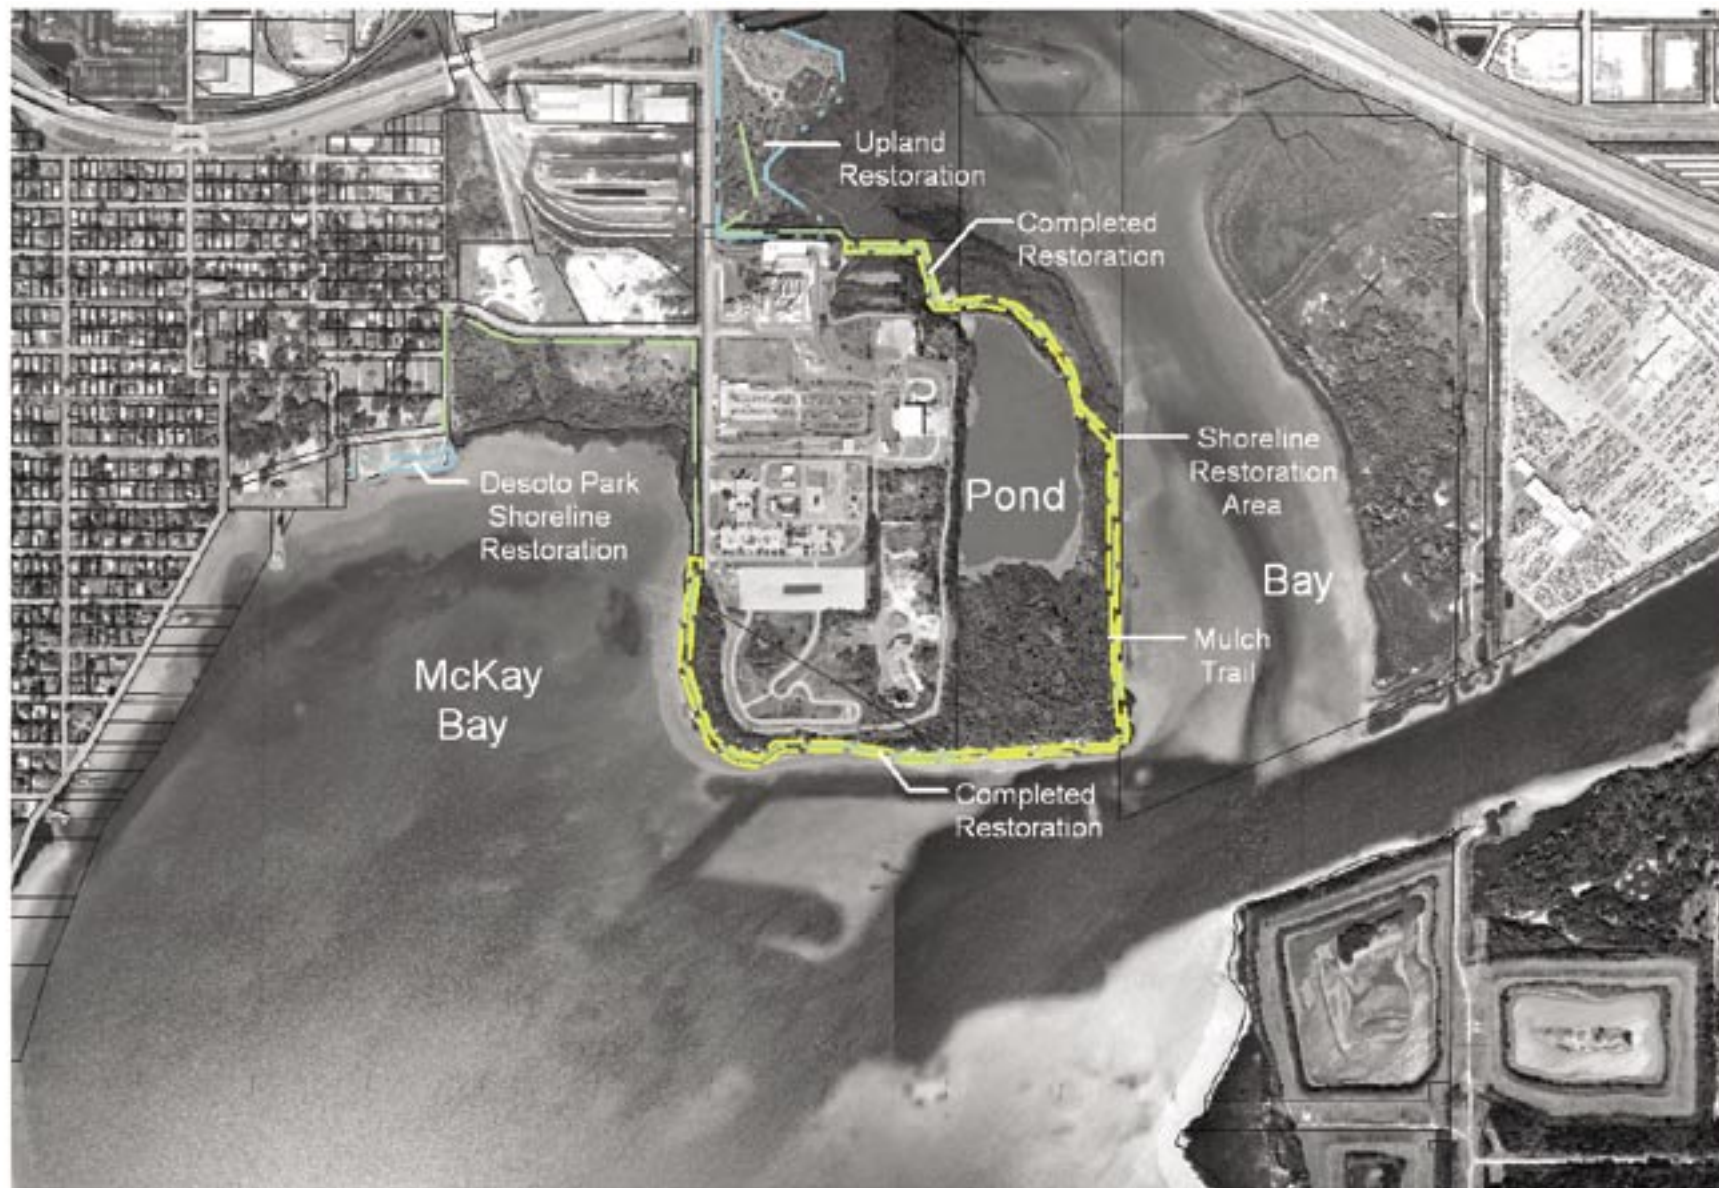
CONCEPTUAL PLAN
FIGURE 1

A complete management plan was developed for McKay Bay Nature Park in 1995 with cooperation from many stakeholders (figure 38). In addition, the Tampa Bay Estuary Program awarded Tampa Audubon with a minigrant for exotic removal.

Figure 38: Restoration Plan for McKay Bay Nature Park.

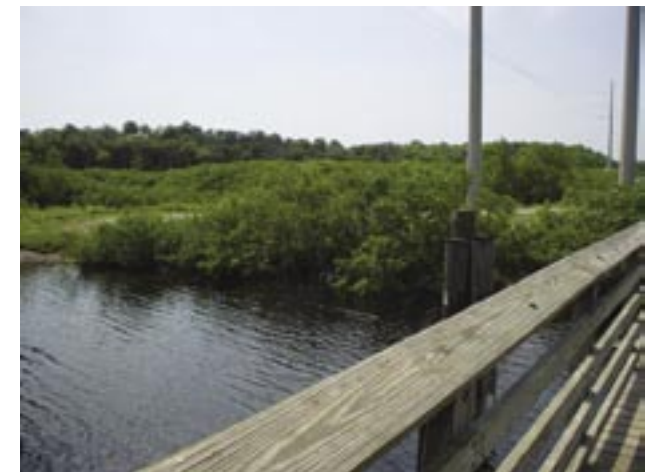
The McKay Bay Bike Trail Park was assessed as a substitution for Palm River Park, which is not located on the river. McKay Bay Bike Trail is located on McKay Bay directly outside the mouth of the Palm River (figure 39). The entire shoreline is a mangrove fringe containing both red and white mangroves (*Rhizophora mangle* and *Languncularia racemosa*) along the waterward edge of the fringe. The fringe contains approximately 50% exotic species, 40% of which is mimosa (*Albizia julibrissin*). The mimosa is limited to the landward edge of the fringe. The shoreline is steep and there are signs of erosion.

Figure 39: The shoreline of Palm River Park.

Long Term: Pursue funding in conjunction with the City of Tampa and/or SWFMWD to stabilize the shoreline with rip-rap, and replant with native vegetation.
