Tampa Shoreline Restoration Initiative

[*Shoreline Restoration Masterplan*]

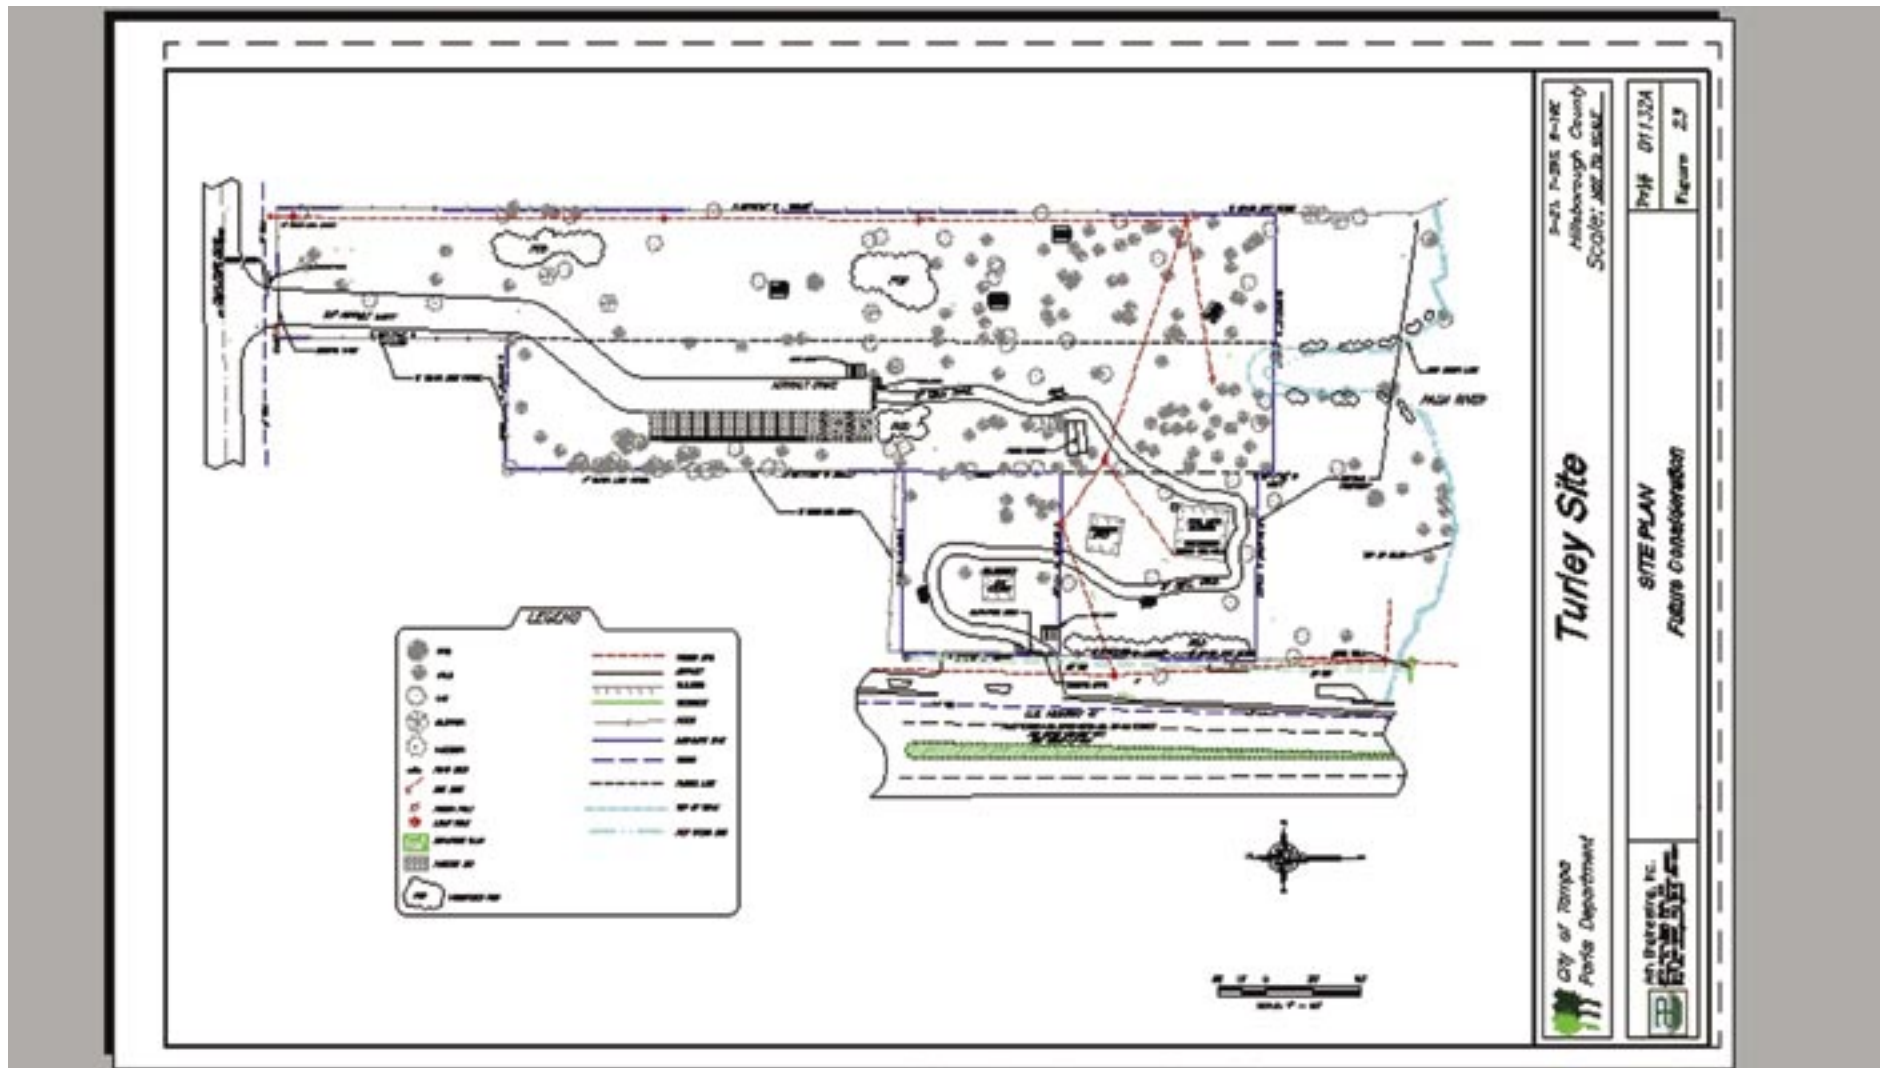
Tampa Bay Watch and other stakeholder agencies have formed a management committee for the management of Palm River. The planting scheme is shown in figure 41.

Figure 41: Existing planting scheme for Palm River Park.

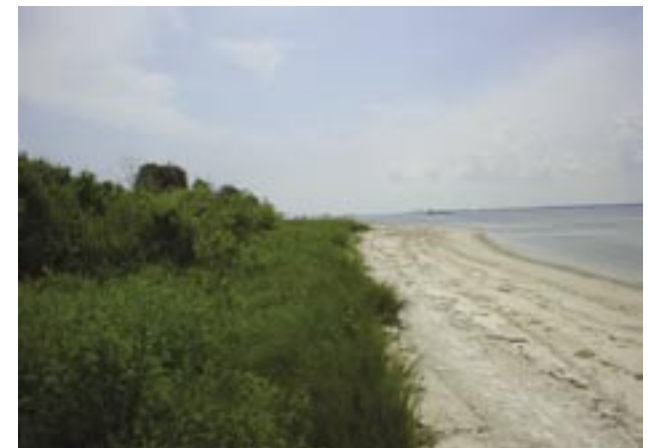
Overall, this shoreline is healthy and the previous restoration project has been highly successful (figure 42). The upland park is maintained to facilitate use by the public but still provides some supporting habitat. The water level is appropriate in the various community types. All of the habitat types at Picnic Island are rated as optimal except the costal shrub portion which has a moderate rating. The exotic removal priority rating for this park is low due to the level of exotic species.

Figure 42: A healthy shoreline at Picnic Island Park due to a successful restoration project.

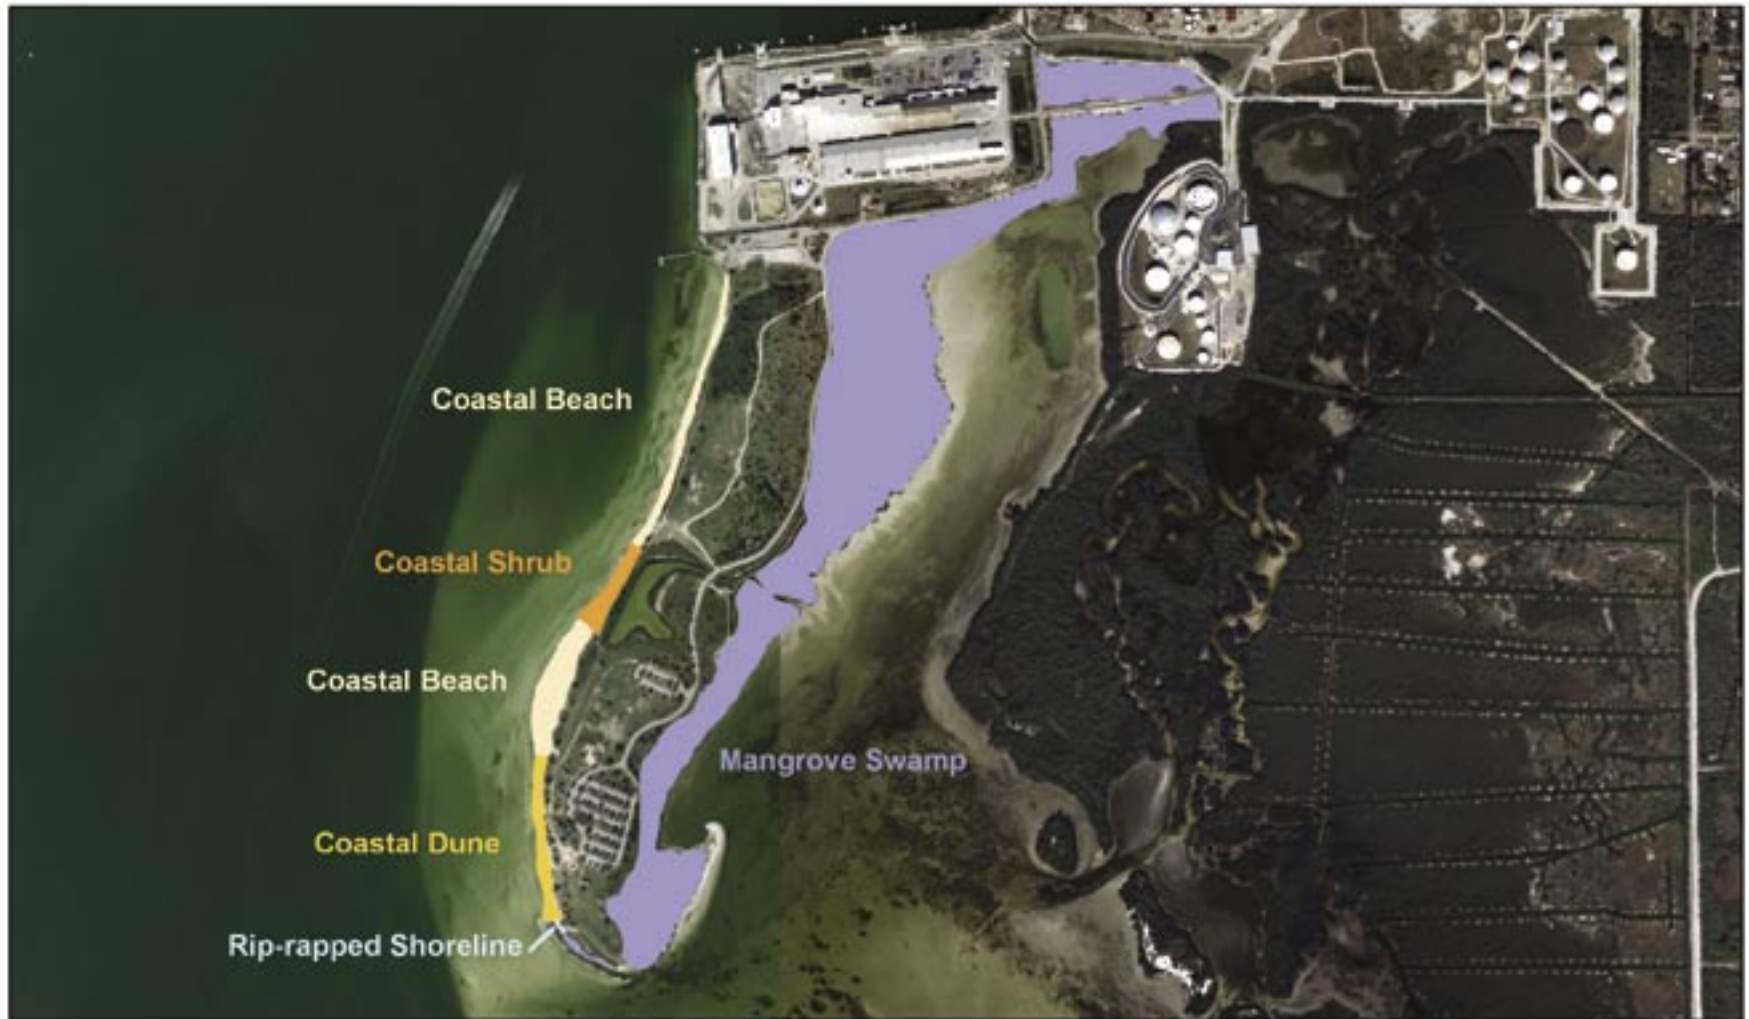
Figure 43: Existing shoreline condition of Picnic Island Park.

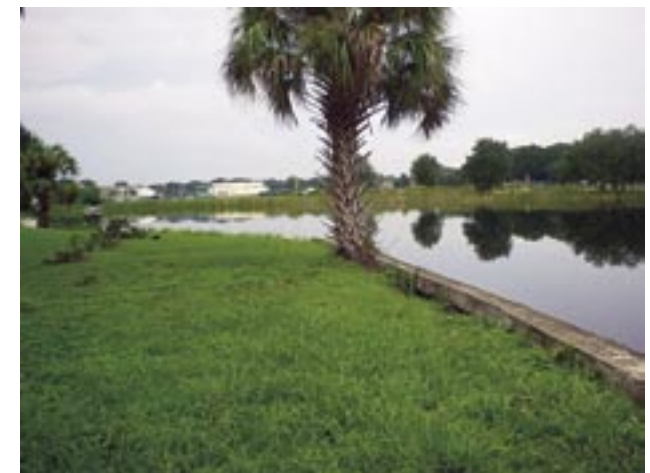
The Reed Property shoreline consists of a mixture of freshwater marsh, seawall and rip-rapped shoreline (figure 44). The seawall has been compromised in several areas and has caused erosion to occur landward of the wall. Due to recent heavy rain events, water has pooled landward of the wall. Vegetation within this area is limited to the uplands landward of the wall and includes: laurel oaks (*Quercus laurifolia*), bahia and St. Augustine grass (*Paspalum notatum* and *Stenotaphrum secundatum*). A portion of the seawall is rip-rapped, and some cattails (*Typha sp.*) are growing waterward of the rocks. The freshwater marsh is primarily covered by nuisance and/or exotic species including: cattails (*Typha sp.*), Brazilian pepper (*Schinus terebinthifolius*) and the less dominant creeping ox-eye (*Wedelia trilobata*). It is anticipated that the shoreline provides some habitat for fish, amphibians and wading birds. The river level was normal for this time of the year, and is supporting the plant species within this habitat. However, the seawall is precluding the water from influencing the entire shoreline. The shoreline is eroding behind the seawall and along a portion of the freshwater marsh.

Figure 44: Reed Property's mixed shoreline.

Long Term: 1) Use volunteers to remove exotic species and ongoing maintenance once construction is complete. 2) Monitoring of shoreline condition once restoration is complete.

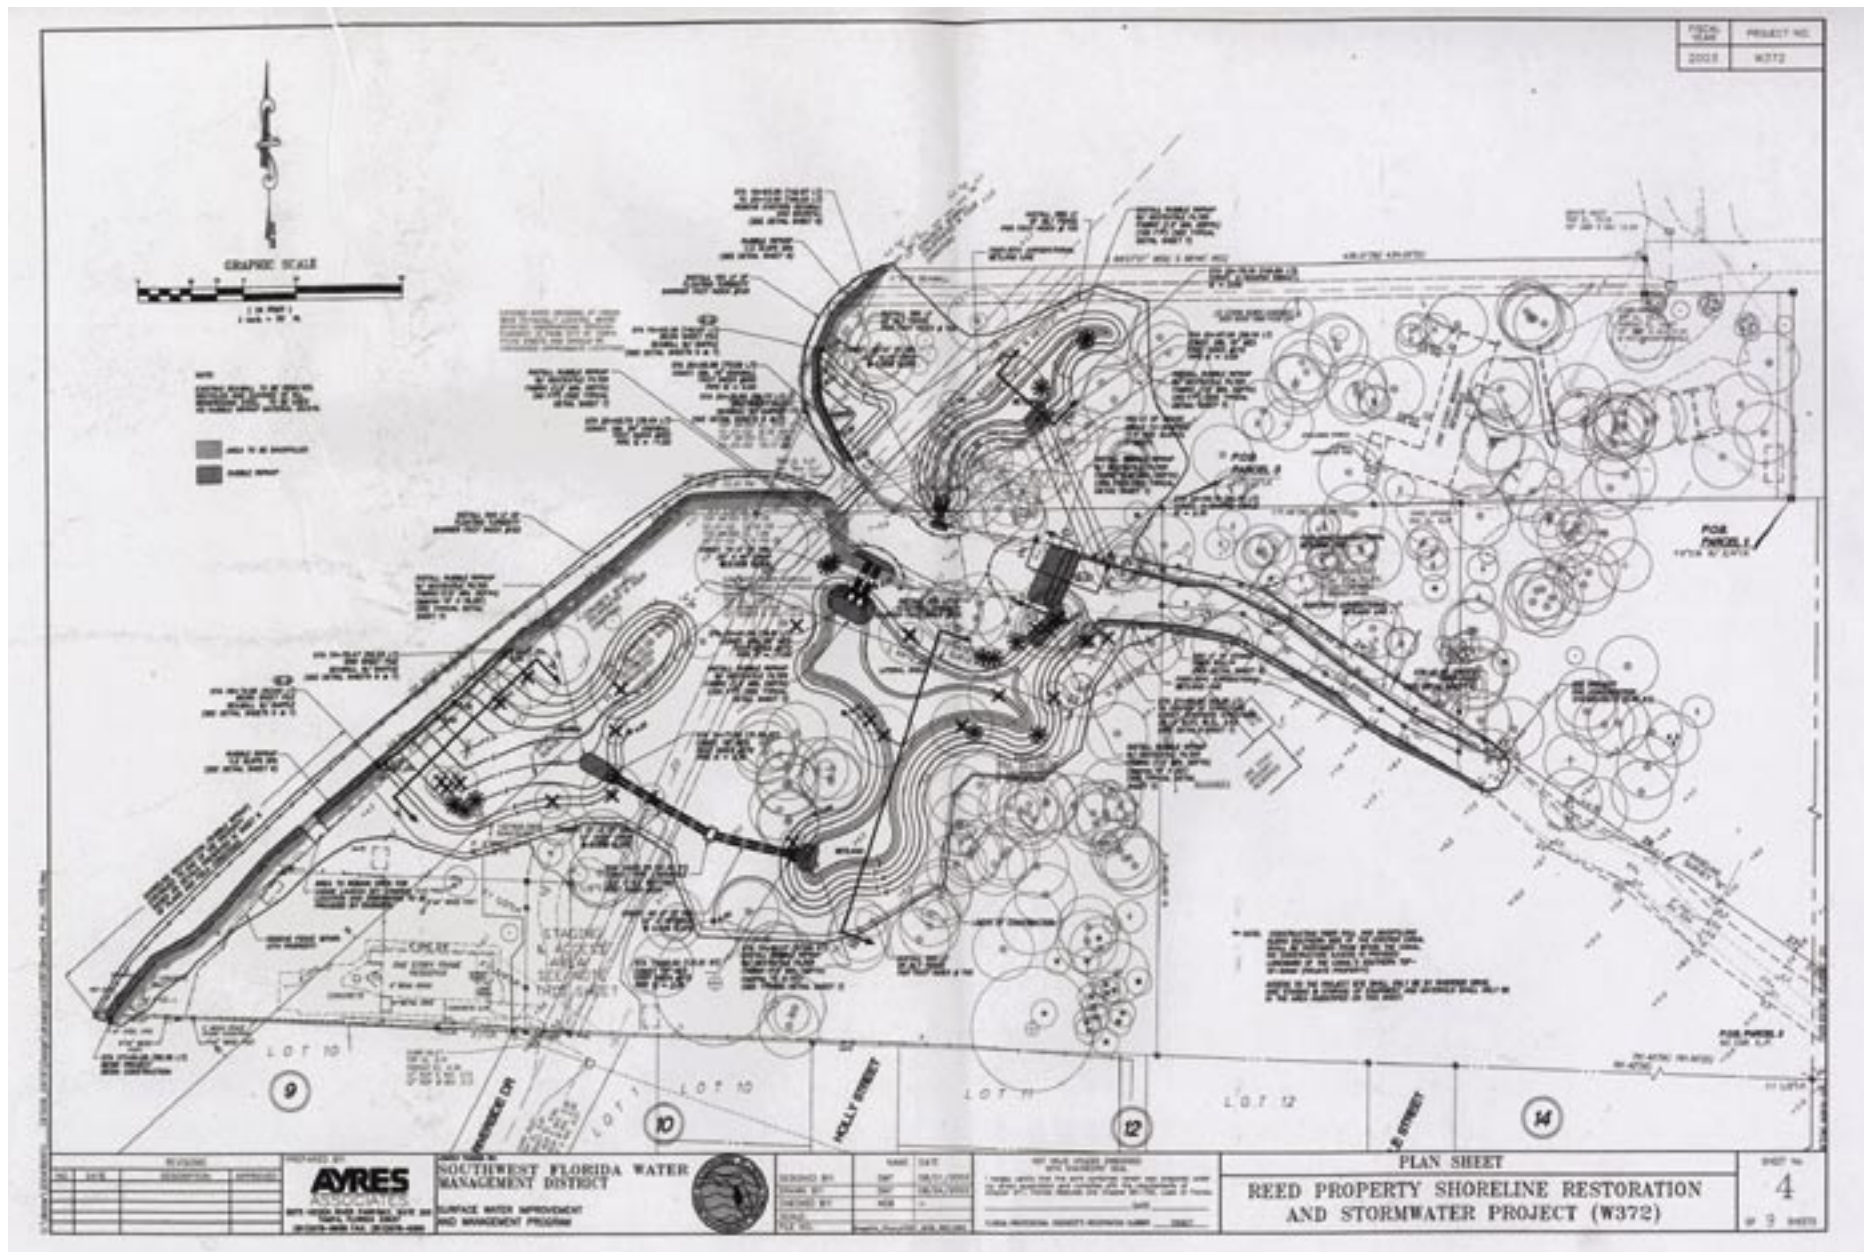
The City of Tampa has design and construction plans for the site which are completed (figure 46). SWFWMD invested \$500,000 in the restoration, and the City of Tampa funded \$30,000. When the project is complete, 100% of the shoreline will be restored.

Figure 46: Design and construction plans for Reed Property.

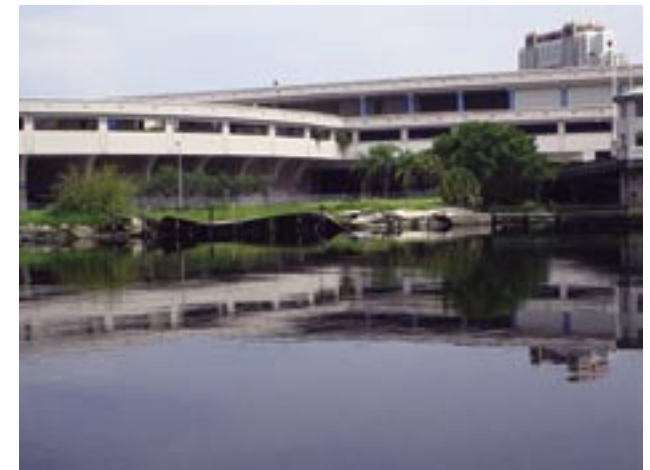
The entire Ribbon of Green Park shoreline is rip-rapped with concrete rubble (figure 47). The park is located adjacent to the Hillsborough River and is an upland urban park. Brazilian pepper (*Schinus terebinthifolius*) has begun to colonize the shoreline and covers approximately 2% of the entire shoreline. The shoreline provides some habitat for fish, wading birds and amphibians. The adjacent upland is narrow and contains maintained lawn. The adjacent river provides supporting habitat and allows for wildlife movement. However, the park is located in a highly urban area and is adjacent to a high volume roadway, and therefore, provides little to no wildlife support to species that may utilize the shoreline. The hydrology is influenced both by the tide and river flow. A master plan has been developed for the site which includes a wetland restoration component. Alternative forms of shoreline stabilization (such as reticulated concrete block mats) could be used to allow more vegetation to grow along the shoreline.

Figure 47: Rip-rapped shoreline with concrete rubble at Ribbon of Green Park.

Long Term: 1) Monitoring of wetland restoration. 2) Volunteers for litter and exotic removal.

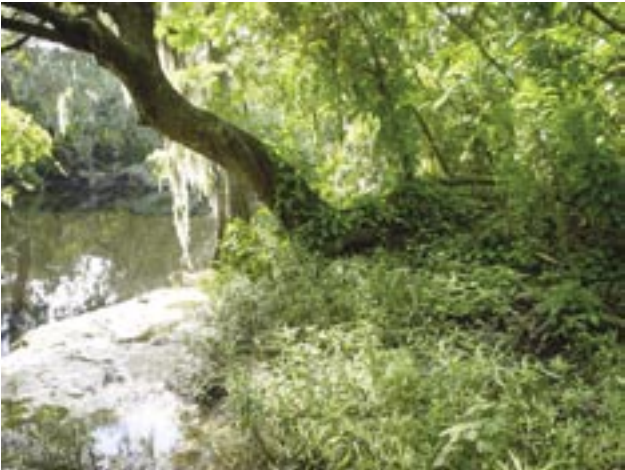
The Rivercove Park shoreline consists primarily of a forested riparian buffer. The canopy consists primarily of laurel oaks (*Quercus laurifolia*) and cabbage palms (*Sabal palmetto*) (figure 50). Native vegetation within the system includes: leather fern (*Acrostichum sp.*) and corkwood (*Stillingia aquatica*). Nuisance species within this site include: air potato (*Dioscorea bulbifera*) and wild taro (*Colocasia esculenta*). Due to the severe slope of the landward fringe of the system, the river is not able to influence the top of the bank. Therefore, there is encroachment by weedy upland species including: Caesar weed (*Urena lobata*), bahia grass (*Paspalum notatum*), and common beggarticks (*Bidens alba*). Overall, the shoreline is severely eroded and limited in the amount of habitat it provides for fish, wading birds and amphibians.

Figure 50: The canopy of Rivercove Park.

Long Term: Stakeholder agencies pursue funding to stabilize and enhance the shoreline with riparian and oligohaline species.

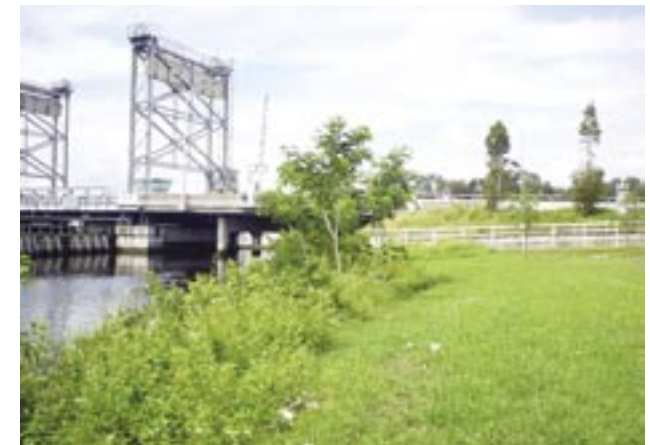
The Rivercrest Park shoreline consists of a freshwater marsh shoreline. A majority of the shoreline has been restored and rip-rap has been placed waterward of the shoreline to create a protected lagoon area. This system consists of a variety of native species including: bulrush (*Scirpus sp.*), saltbush (*Baccharis halimifolia*), needle rush (*Juncus roemerianus*) and maidencane (*Panicum hemitomon*). Although these areas have been restored, there is a large amount of nuisance species encroachment from the adjacent upland including: Brazilian pepper (*Schinus terebinthifolius*), creeping ox-eye (*Wedelia trilobata*), torpedo grass (*Panicum repens*) and St. Augustine grass (*Stenotaphrum secundatum*). Areas that have not been restored have a natural shallow shoreline but contain a large percentage of nuisance species including: paragrass (*Brachiaria mutica*), creeping ox-eye, Brazilian pepper, cowpea (*Vigna luteola*) and mimosa (*Acacia sp.*) (figure 52).

Although a portion of this park has been restored, it has a high exotic removal priority rating due to the large percentage of nuisance species encroaching from the landward edge. It is recommended that the exotics species be cleared from this area and the landward edge be replanted to avoid further encroachment.

Figure 52: Nuisance species along unrestored shoreline at Rivercrest Park.

Long Term: Pursue funding in conjunction with the City of Tampa and/or SWFWMD to replant the landward edge with native vegetation and complete restoration of the shoreline.

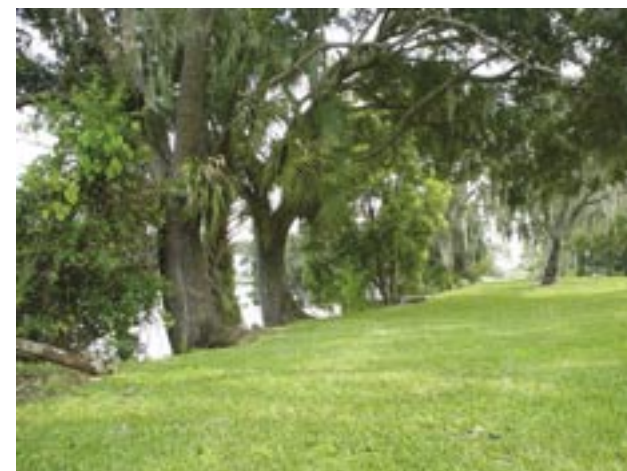
The Riverside Garden Park shoreline consists of a mixture of freshwater marsh, riverine forest and hardened shoreline (seawall and rip-rap). Several large laurel oaks (*Quercus laurifolia*) and cabbage palms (*Sabal palmetto*) provide canopy along the shoreline, but the cover is not high enough to classify the entire shoreline as a riverine forest (figure 56). The shoreline consists primarily of a freshwater marsh with intermittent laurel oak and cabbage palm hammock. This freshwater marsh system contains a moderate percentage (25%) of nuisance species including: paragrass (*Brachiaria mutica*), cattails (*Typha sp.*), and torpedo grass (*Panicum repens*). Similar species were observed within the riverine forest but also included Brazilian pepper (*Schinus terebinthifolius*). Native species found within this system include: laurel oak (*Quercus laurifolia*), cabbage palm (*Sabal palmetto*) and American elm (*Fraxinus Americana*). The seawall is composed of eroded aluminum that has detached from the shoreline allowing water to get landward of the wall; although no native wetland species have encroached the area. In several areas, the upland grass is being mowed down to the water's edge precluding native vegetative growth.

Figure 56: The canopy along Riverside Garden Park's shoreline.

Long Term: 1) Monitoring of restoration. Volunteers to provide ongoing exotic removal.

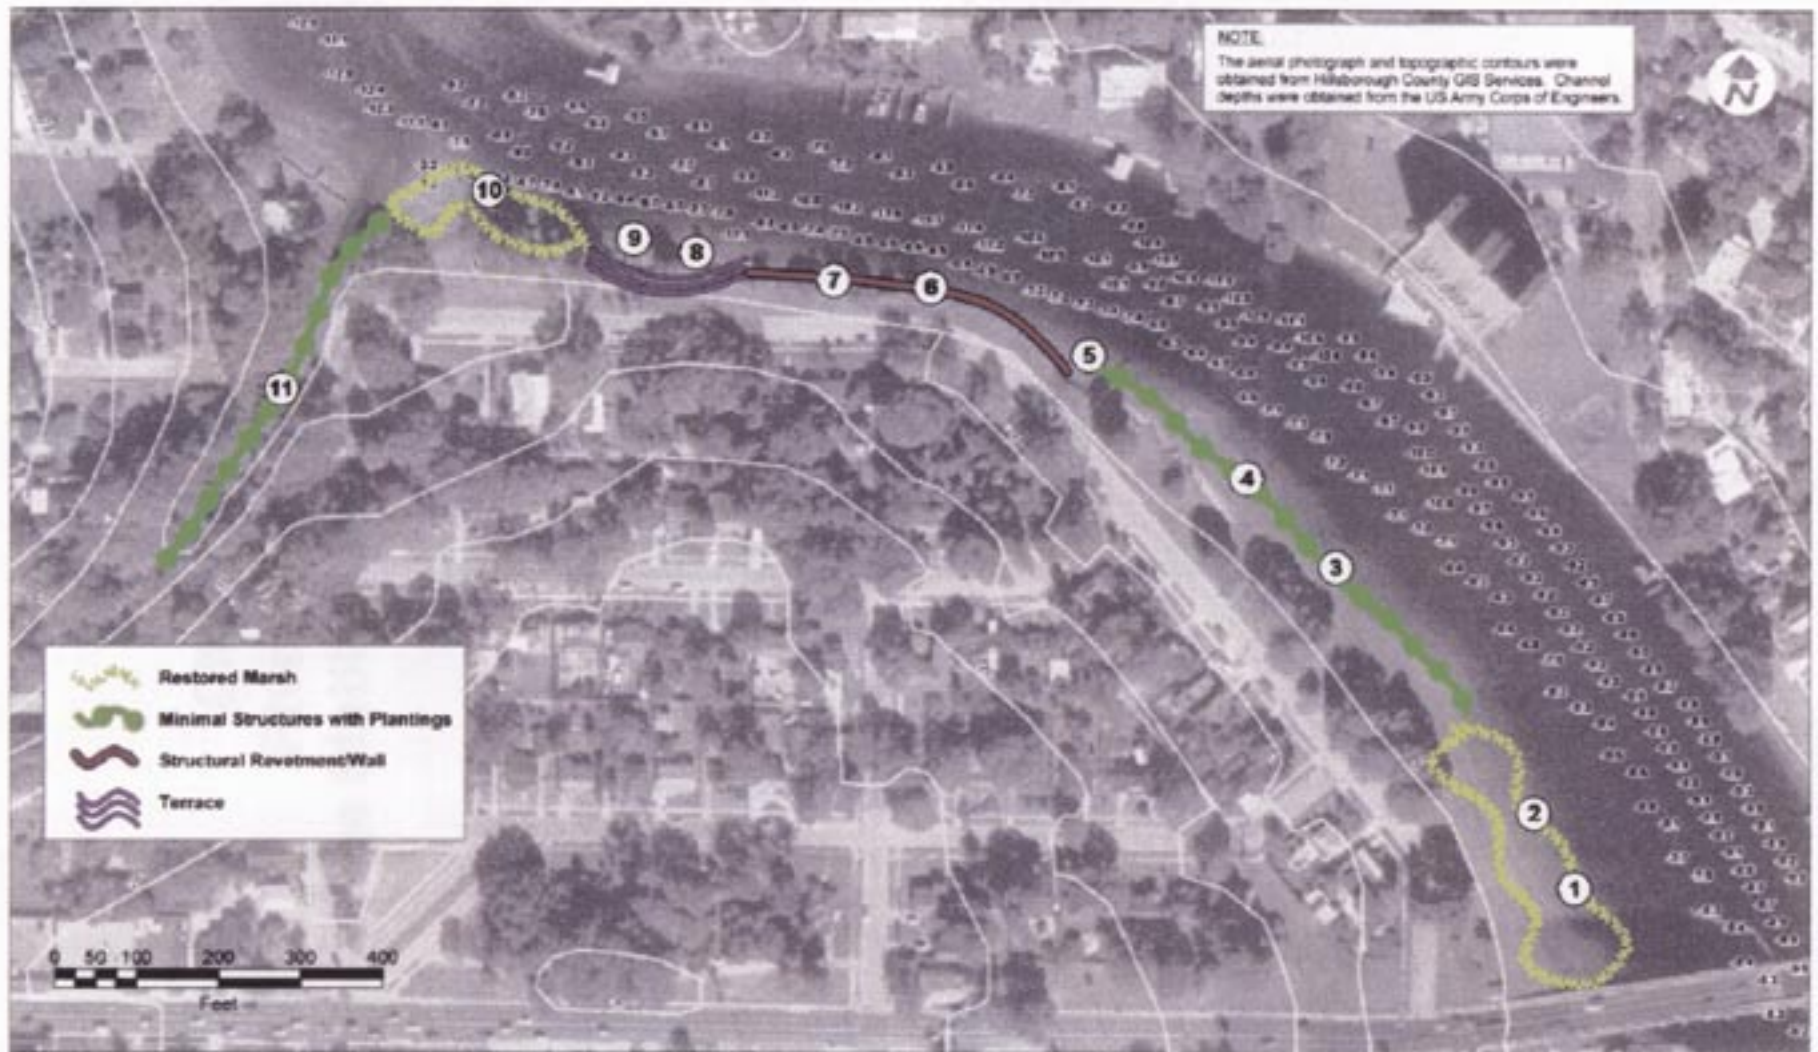
Rivergarden Park Shoreline Stabilization and Restoration

Conceptual plans to restore 2,500 linear feet with funding from the SWIM program (figure 58).

Figure 58: Conceptual plans to restore 2,500 linear feet of Riverside Garden Park shoreline with funding from the SWIM program.

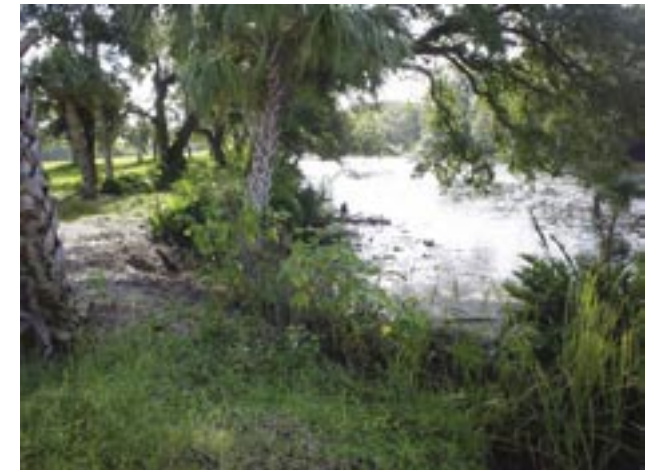
The River Tower Park shoreline consists primarily of an oligohaline marsh with scattered canopy (figure 59). Several large laurel oaks (*Quercus laurifolia*) and cabbage palms (*Sabal palmetto*) provide canopy along the shoreline, but the cover is not high enough to classify the entire shoreline as a riverine forest. This system contained approximately 20% cover of nuisance species including: air potato (*Dioscorea bulbifera*), Brazilian pepper (*Schinus terebinthifolius*) and the less dominant cattails (*Typha sp.*). Beneficial native species appear to be located at the water's edge and include leather fern (*Acrostichum sp.*) and bulrush (*Scirpus sp.*). Other species include: common beggartick (*Bidens alba*), Caesar weed (*Urena lobata*) and St. Augustine grass (*Stenotaphrum secundatum*). Overall, the shoreline is steep and severely eroding. The water level is normal for this time of year but is not reaching the entire shoreline due to the steep slope created by the erosion.

Figure 59: River Tower Park shoreline and canopy.

Long Term: 1) Monitor restoration. 2) Volunteer ongoing exotic removal and maintenance.

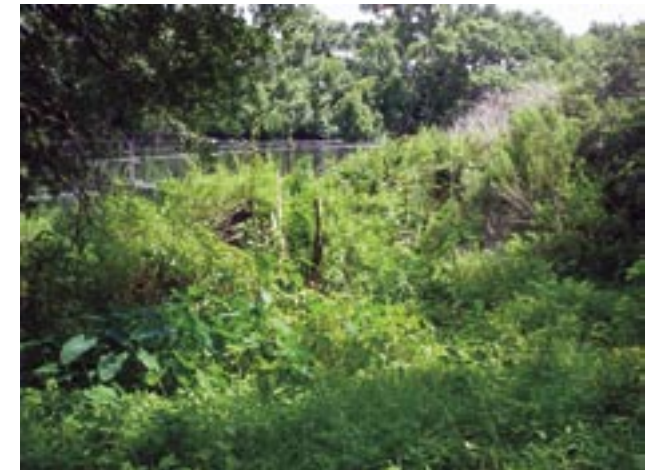
The Rowlett Park shoreline consists primarily of an oligohaline marsh and riparian buffer with some scattered tree cover (figure 61). This shoreline consists of a variety of native species including: Carolina willow (*Salix caroliniana*), laurel oak (*Quercus laurifolia*), cabbage palm (*Sabal palmetto*), leather fern (*Acrostichum* sp) and elderberry (*Sambucus canadensis*). Approximately 45% of this site consists of nuisance species including air potato (*Dioscorea bulbifera*), cattails (*Typha* sp.) and creeping ox-eye (*Wedelia trilobata*). In addition, there is some encroachment of less dominant nuisance species including Caesar weed (*Urena lobata*) and white beggar-ticks (*Bidens pilosa*). The shoreline width varies between 20 to 100 feet wide and has a shallow slope.

Figure 61: Oligohaline marsh and riparian buffer of Rowlett Park.

Long Term: Pursue funding in cooperation with stakeholder agencies to enhance oligohaline marsh which is a priority of the Tampa Bay Estuary.

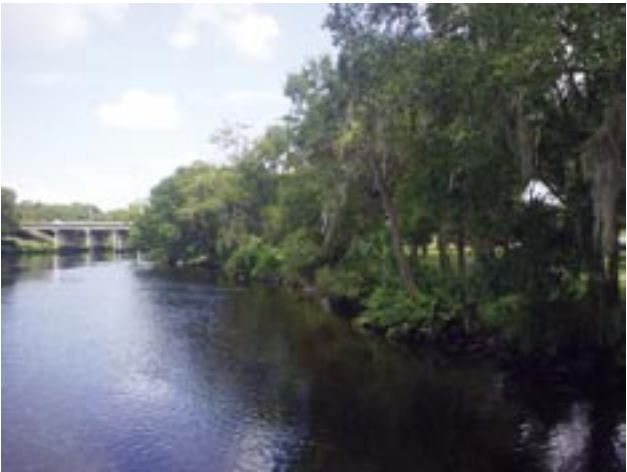
The Sulphur Springs Park shoreline consists primarily of an oligohaline fringe and riparian forest buffer adjacent to the rip-rap shoreline (figure 63). Several large laurel oaks and cabbage palms provide canopy along the shoreline. The slope of the shoreline is medium to steep. This system consists of a variety of native species including: leather fern (*Acrostichum sp.*), laurel oaks (*Quercus laurifolia*) and cabbage palms (*Sabal palmetto*). Approximately 15 percent of the shoreline is covered with nuisance species, including air potato (*Dioscorea bulbifera*) and barnyard grass (*Echinochloa sp.*). The air potato cover is high in some areas and completely covers the native vegetation. Overall, the shoreline is rip-rapped but herbaceous vegetation has covered all but the most waterward rocks.

Figure 63: Sulphur Springs Park shoreline.

- Short Term:** Volunteers to remove the nuisance species in particular the air potato vine.
- Long Term:** Pursue funding in conjunction with stakeholder agencies for creation of oligohaline marsh on the south section of the property with incorporation of a boardwalk feature similar in design to that at Lowry Park.

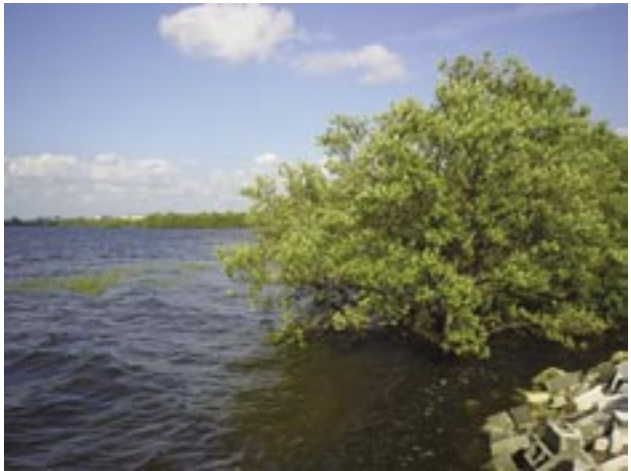
The Tappan Park shoreline is a diverse and healthy mangrove fringe (figure 65). No nuisance or exotic species were observed within the fringe. The fringe included red, white and black mangroves (*Rhizophora mangle*, *Languncularia racemosa* and *Avicennia germinans*) and is diverse both in species composition and size distribution. Immediately upland of the mangrove fringe is a large, tidally influenced saltern area. This site was recently restored through a cooperative project between the City of Tampa and SWFWMD/SWIM and no nuisance or exotic vegetation was observed. The fringing estuarine area provides habitat for wading birds, amphibians, fish and invertebrates. The adjacent saltern area and the bay provide suitable wildlife support for species that may utilize the fringe. The park is located within a residential area, and is located next to a road.

Figure 65: Mangrove fringe along Tappan Park's shoreline.

Short Term: This park has been restored and no additional work is needed. Volunteers could conduct inspections of the park, at least annually, to ensure that no exotic or nuisance vegetation recolonizes the site and that litter is removed.

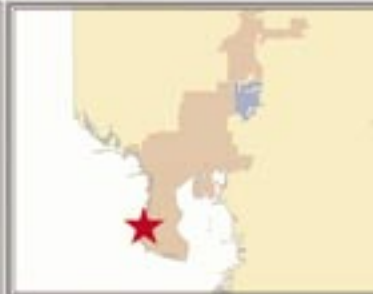
Figure 66: Existing shoreline condition of Tappan Park.

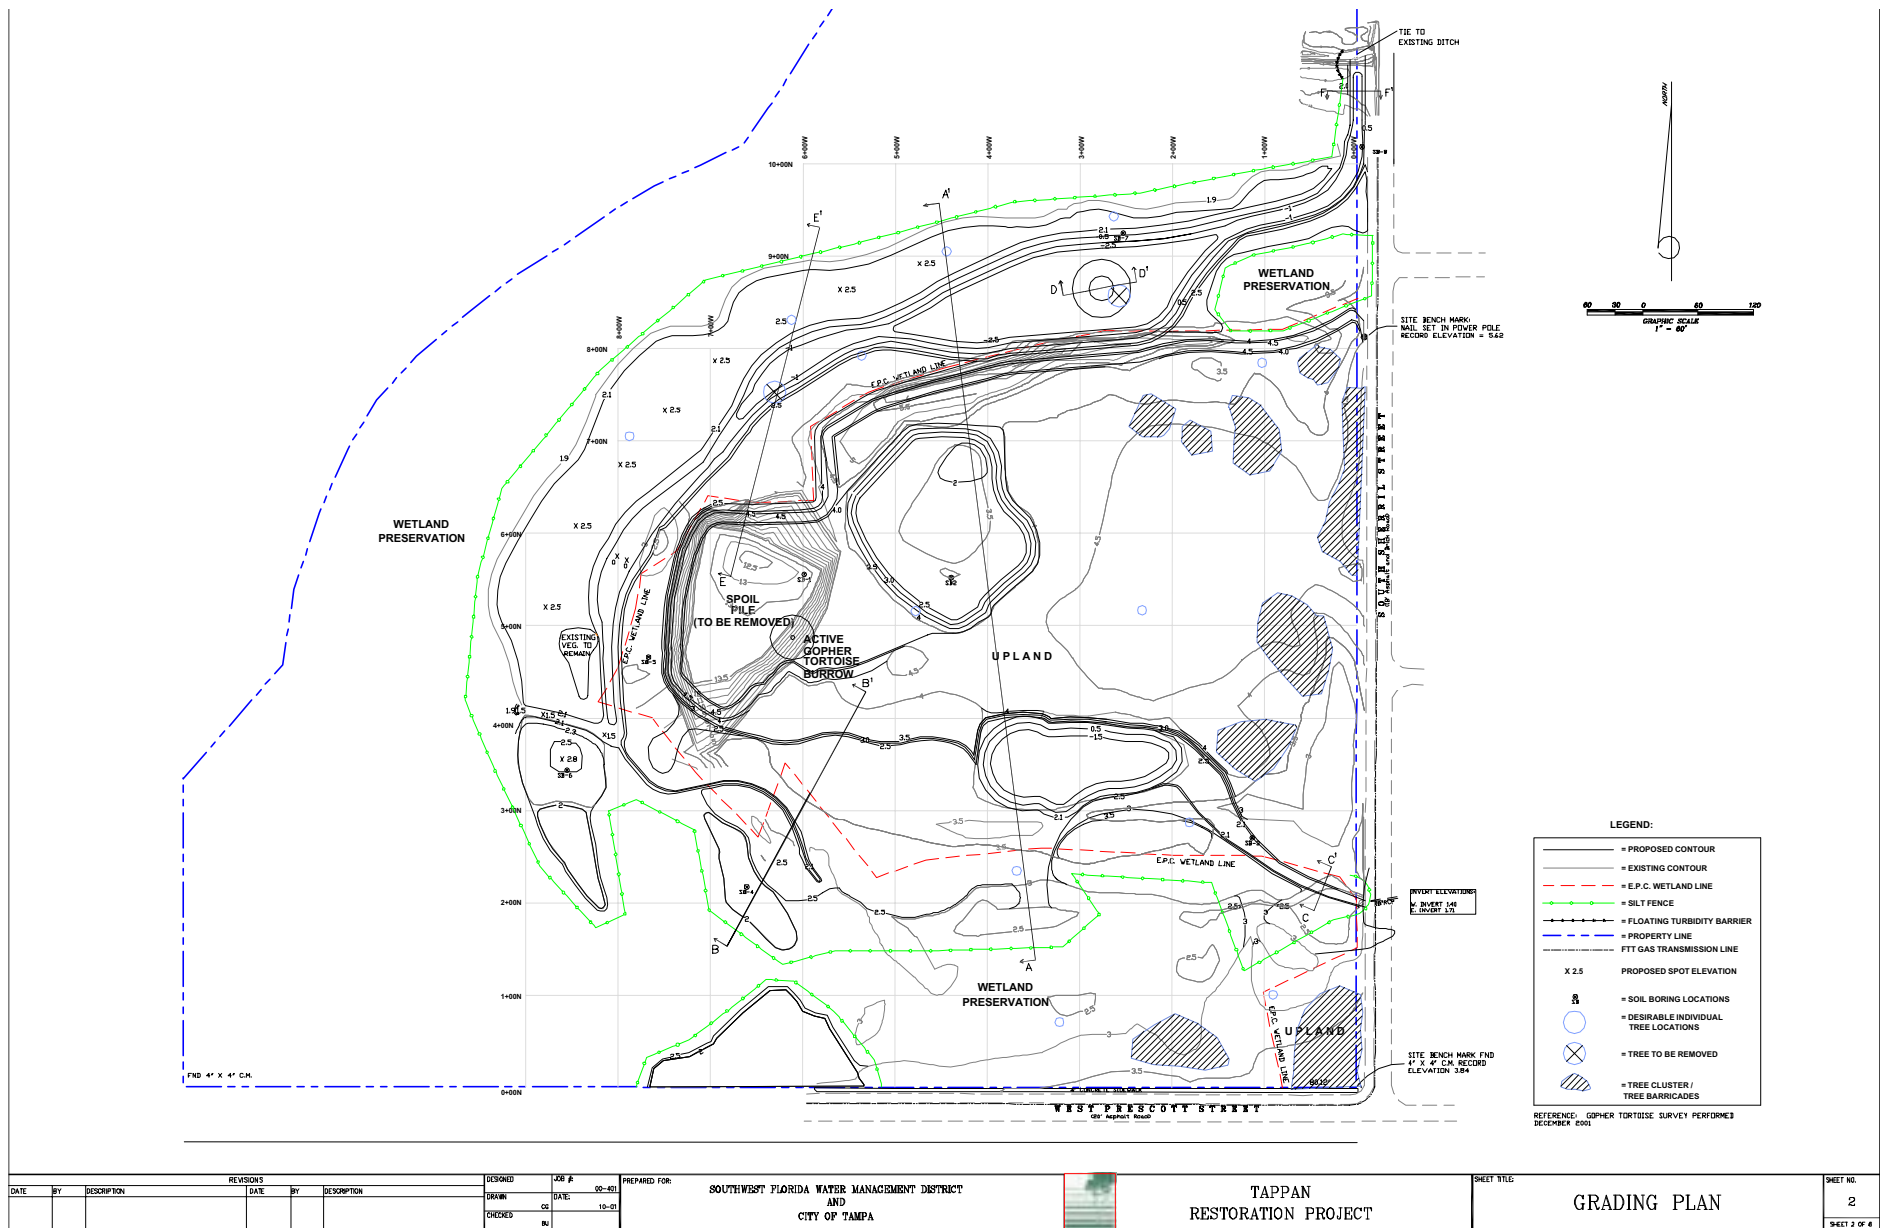
A restoration project funded by SWFWMD was completed in 2002. Total funding for the project was \$260,000 plus \$10,000 from the City of Tampa (figure 67).

Figure 67: Restoration plan for Tappan Park.

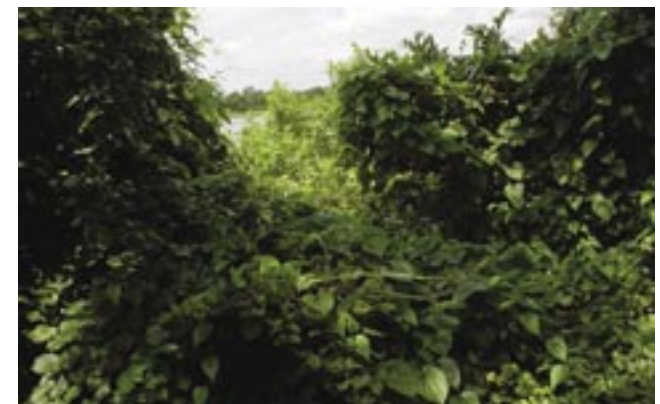
The Temple Crest Center Park shoreline consists predominantly of a mixture of freshwater marsh and riverine forest. Several large laurel oaks (*Quercus laurifolia*) and cabbage palms (*Sabal palmetto*) provide canopy along the shoreline, but the cover is not high enough to classify the entire shoreline as a riverine forest. The shoreline consists primarily of a freshwater marsh with intermittent laurel oak and cabbage palm hammock. This system contained a large percentage of nuisance species including: air potato (*Dioscorea bulbifera*), Brazilian pepper (*Schinus terebinthifolius*), paragrass (*Brachiaria mutica*) and creeping ox-eye (*Wedelia trilobata*) (figure 68). Native species found within this system included: dayflower (*Commelina sp.*), beauty berry (*Callicarpa americana*) and wax myrtle (*Myrica cerifera*). There is evidence of encroachment by upland species including: common beggarticks (*Bidens alba*), dog fennel (*Eupatorium capillifolium*) and scarlet milkweed (*Asclepias curassavica*). The shoreline is gradual in most places with the exception of a small seawall surrounding a drainage pipe.

Figure 68: Nuisance species along the shoreline of Temple Crest Center Park.

Long Term: Pursue funding in conjunction with stakeholder agencies to restore freshwater marsh species and riparian canopy species.

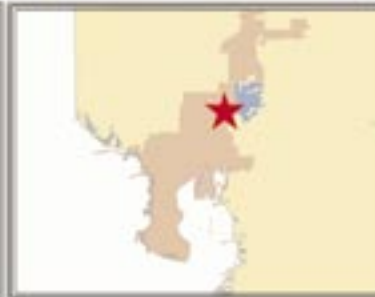
Figure 69: Existing shoreline condition of Temple Crest Center Park.

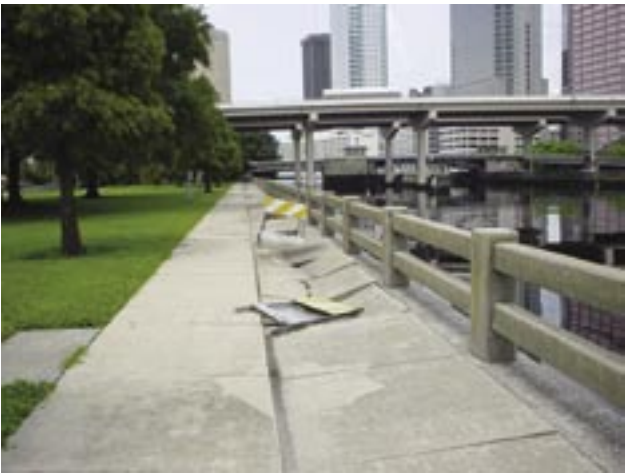
Seawall makes up the entire Tony Jannus Park shoreline (figure 70). The adjoining upland area consists of a concrete footpath and a narrow, vegetated buffer that separates the footpath from a high volume roadway. This park does not contain any natural area and provides no obvious wildlife support. Litter observed within this park was found floating in the water, and therefore, would be difficult to retrieve. This park has a low exotic removal priority rating due to the absence of vegetation, but could benefit from enhancing the shoreline through the placement of rip-rap or reef material waterward of the existing seawall to create habitat for wading birds and fish. Further enhancement would be difficult due to the limited park area.

Figure 70: The seawall along the Tony Jannus Park shoreline.

- Short Term:** Use volunteers to occasionally pick up litter along the path.
- Long Term:** Pursue funding in conjunction with the City of Tampa and/or SWFMWD to install rip-rap or reef material waterward of the seawall.

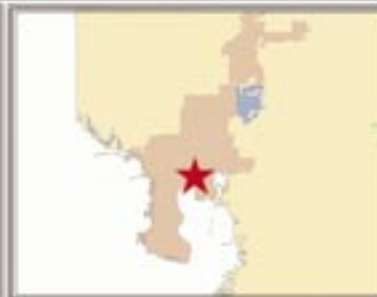
Figure 71: Existing shoreline condition of Tony Jannus Park.

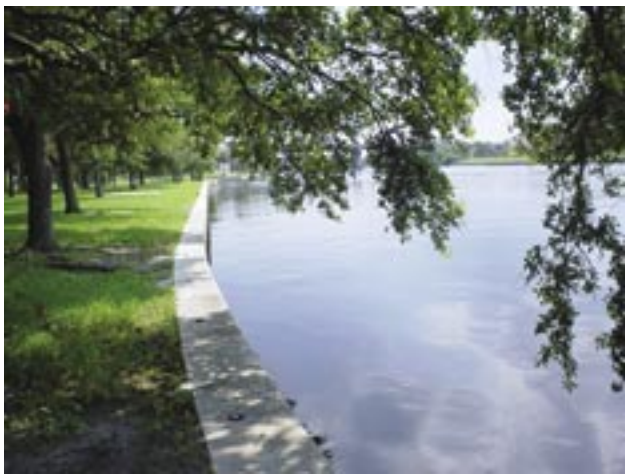
The entire Water Works Park shoreline is seawall; therefore, there is no vegetation within the assessment area. The area immediately upland of the shoreline is a maintained grassed area with scattered laurel oaks (*Quercus laurifolia*) and cabbage palms (*Sabal palmetto*) (figure 72). The seawall provides no wildlife support, and precludes the adjacent upland from being influenced by the river. In addition, the upland provides very little wildlife support. There is a small isolated spring within the park but it is not within the assessment area and contains a large percentage of exotic species.

Figure 72: The Water Works Park shoreline.

- Short Term:** Exotic and litter monitoring and removal by volunteers.
- Long Term:** Pursue funding in conjunction with stakeholder agencies to install rip-rap or reef material waterward of the seawall.

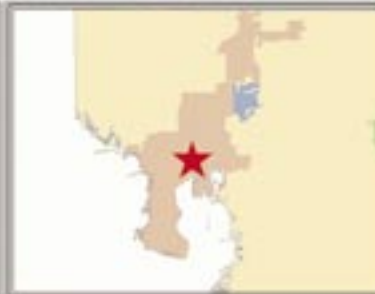
Figure 73: Existing shoreline condition of Water Works Park.
