RECOMMENDED PROJECTS

Department of Public Works
Engineering Division
Stormwater Management
Section

DELANEY CREEK AREA
STORMWATER MANAGEMENT
MASTER PLAN
SEPTEMBER 2000

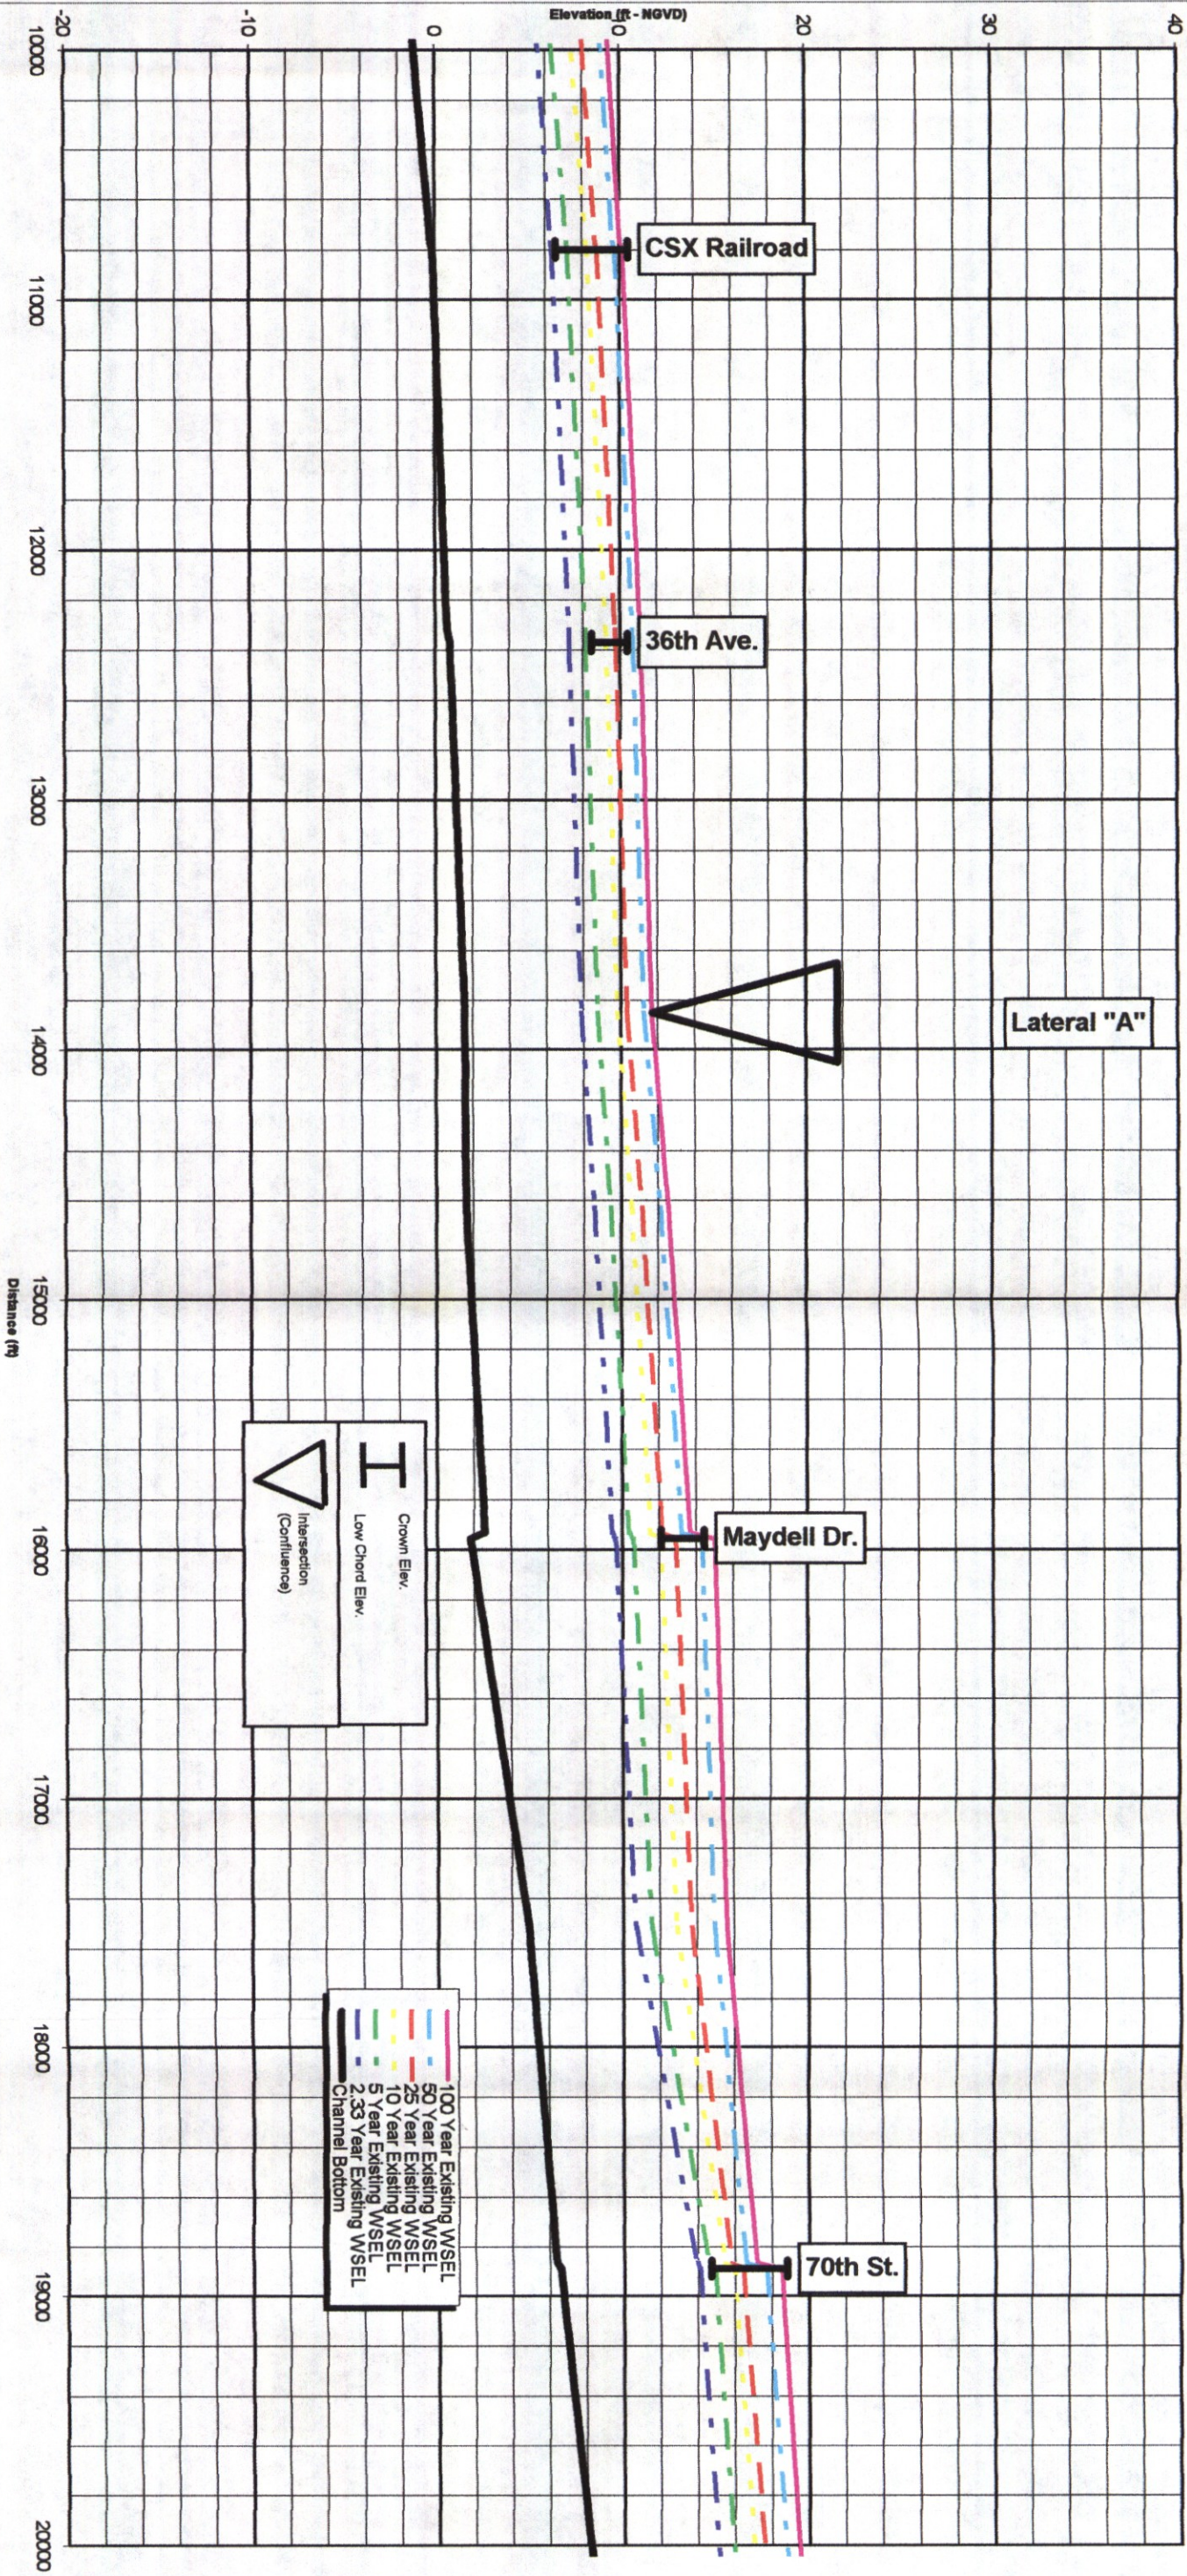
Exhibit 6-1b

Existing Condition Model
Delaney Creek Sub-watershed/ Main Channel
Sheet 2 of 8

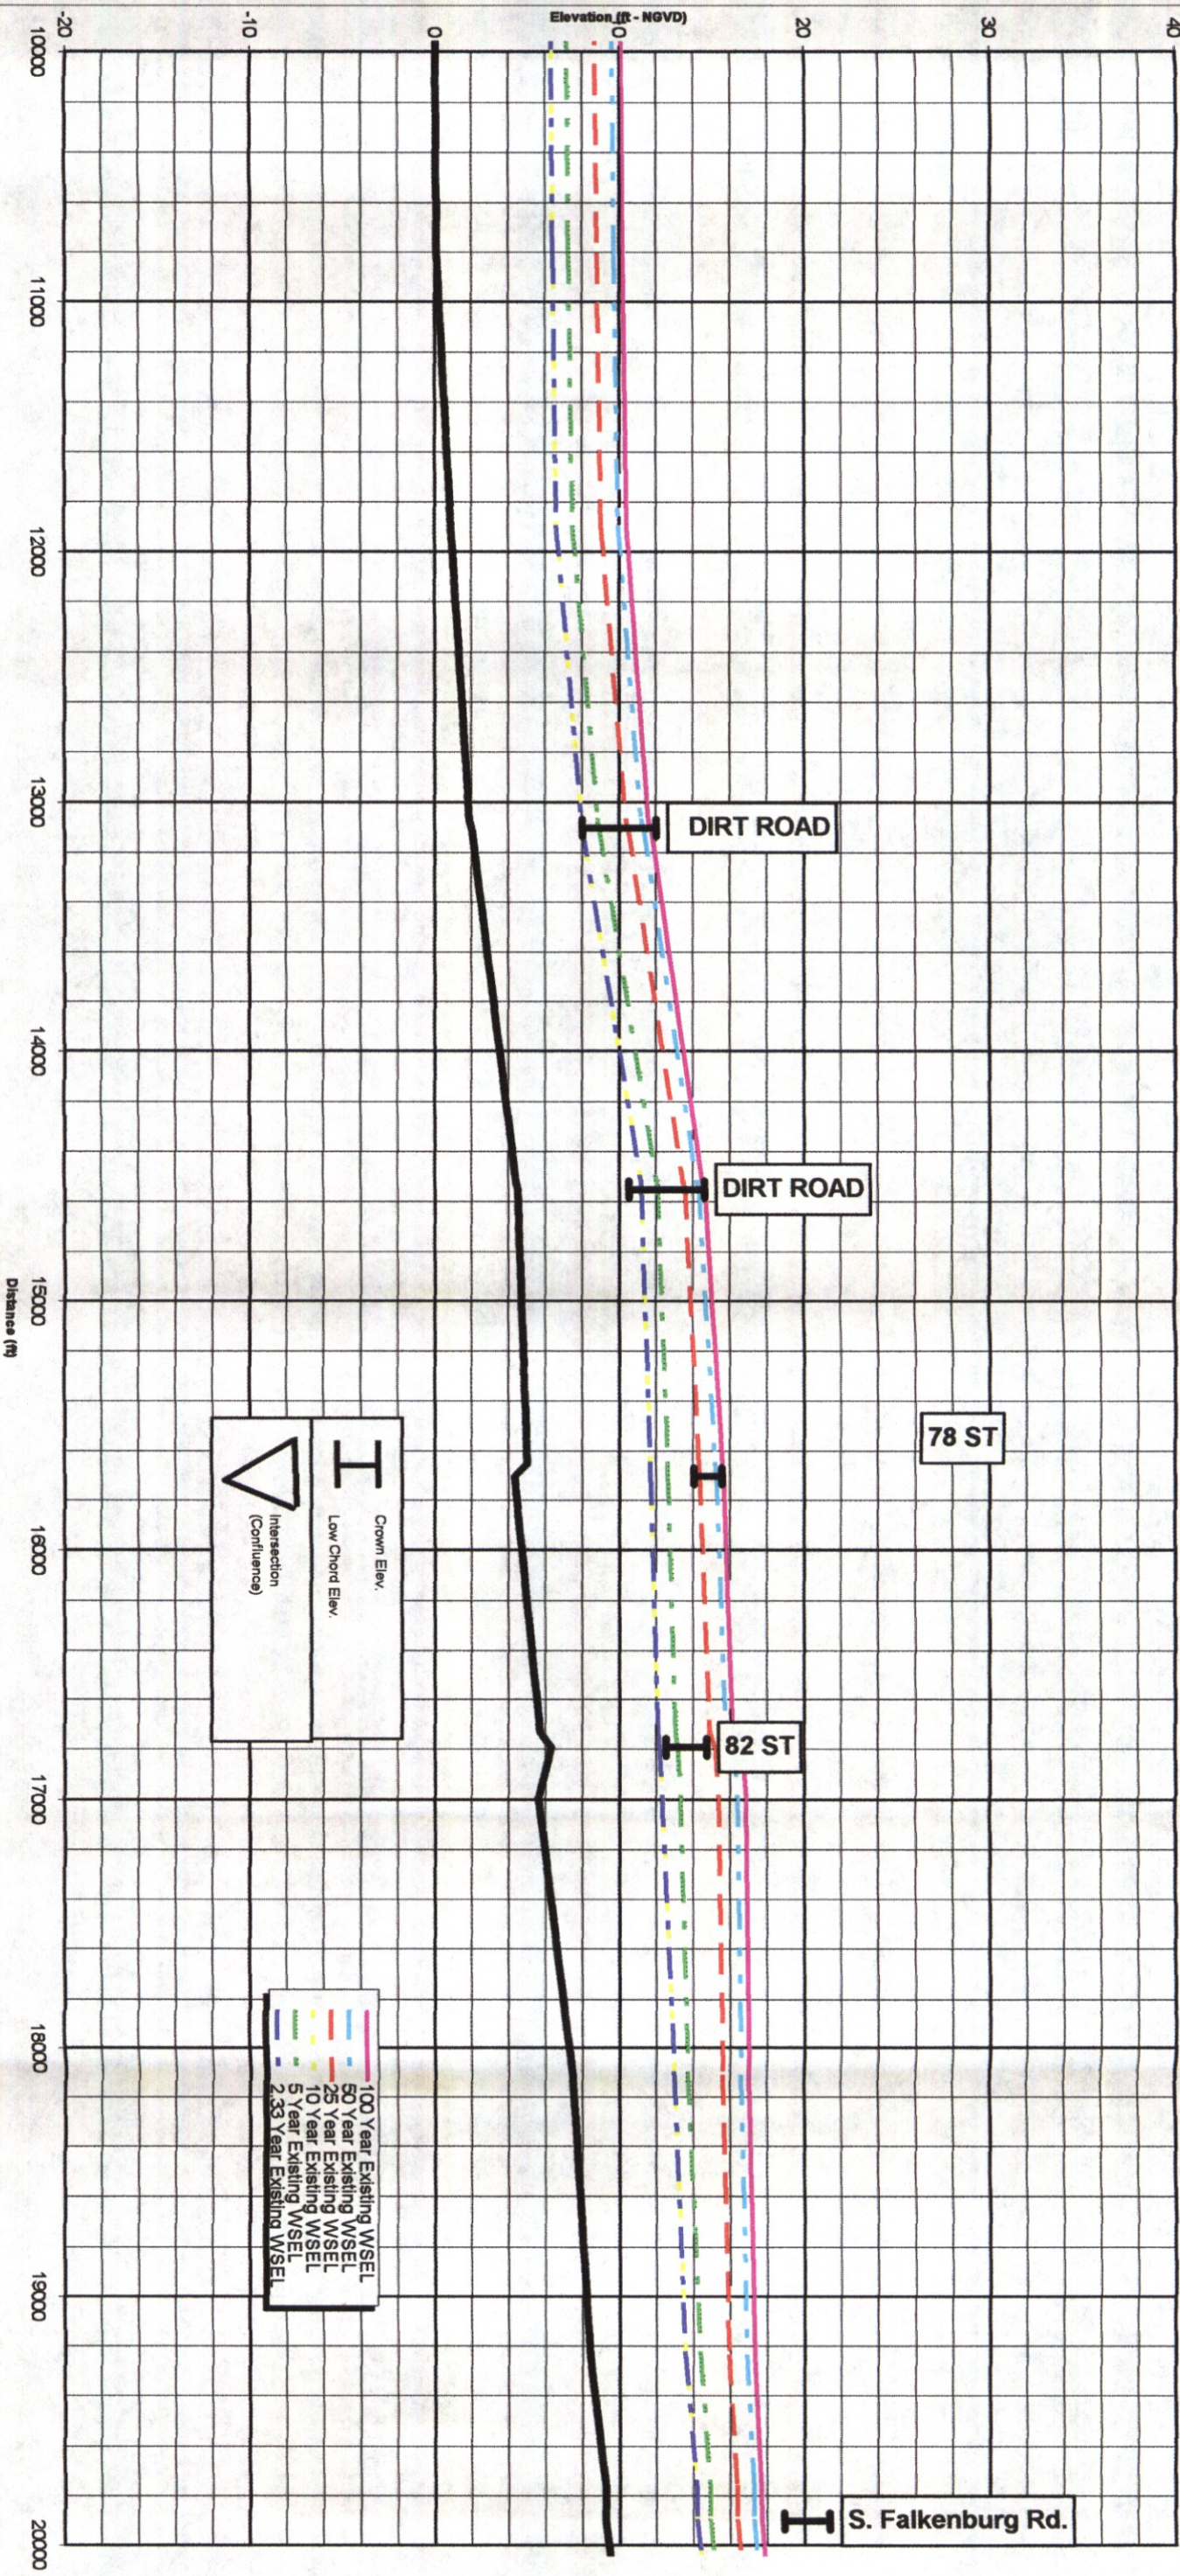
Exhibit 6-3b

Existing Condition Model
North Archie Creek Sub-watershed/ Main Channel
Sheet 2 of
