**MEMORANDUM**

**SUBJECT: Proposed minimum and guidance levels for Halfmoon Lake in  
Hillsborough County, Florida**

## **Halfmoon Lake**

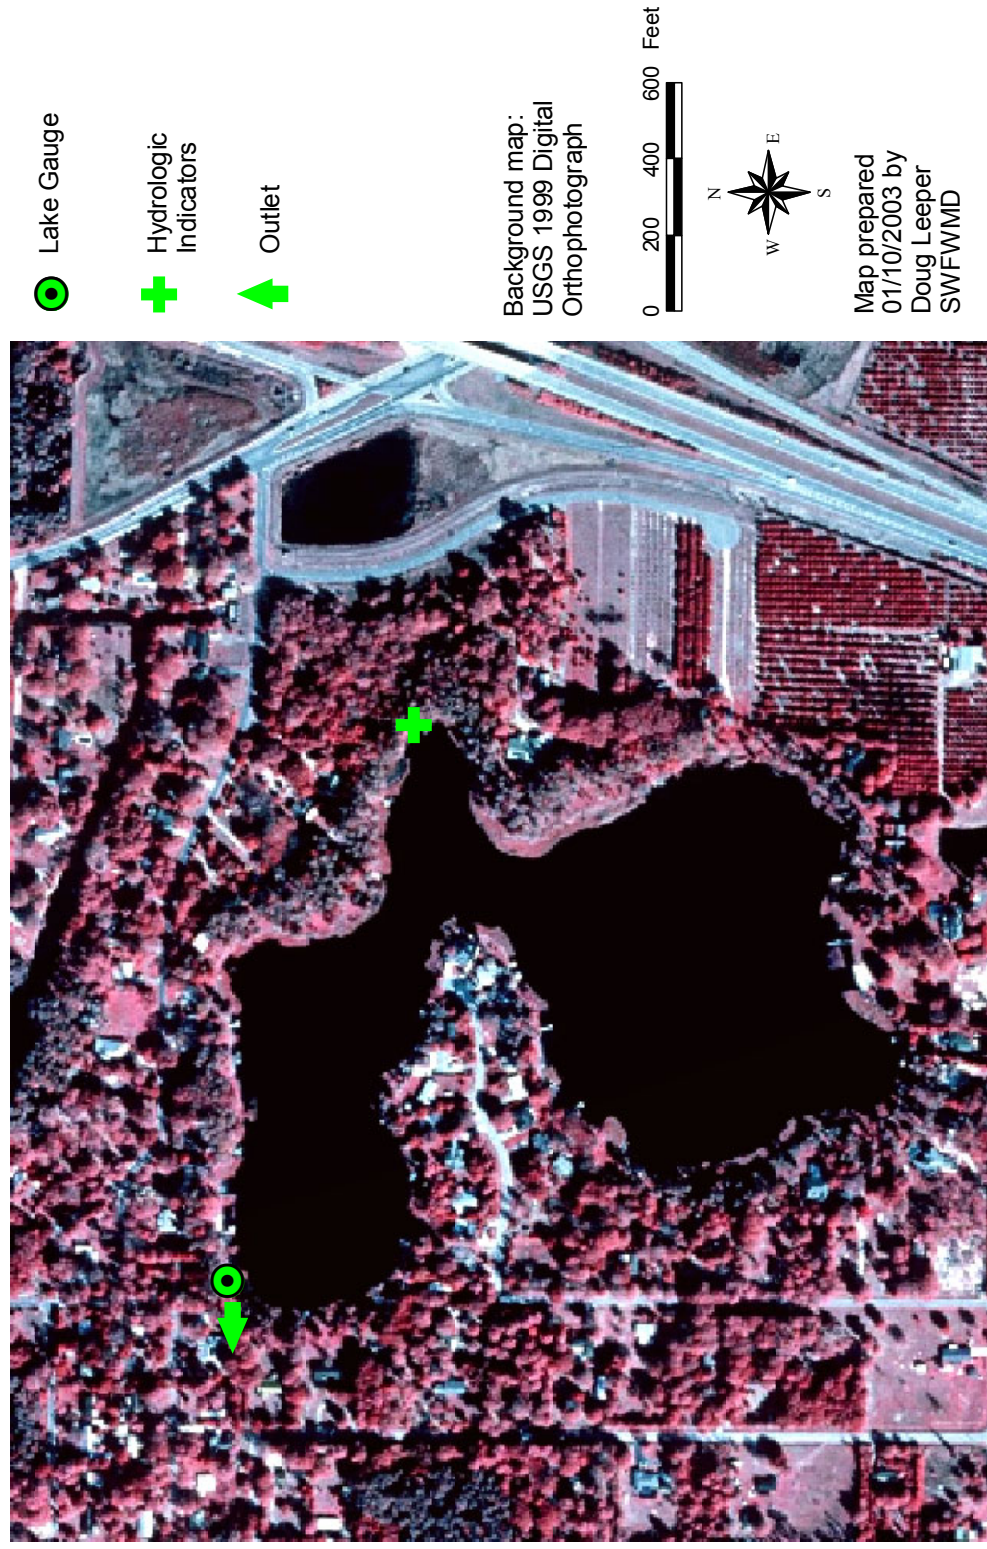
**Figure Halfmoon-2. Location of District lake gauge, outlet and site where hydrologic indicators were measured at Halfmoon Lake in Hillsborough County, Florida.**

The Normal Pool elevation was established using cypress trees within the swamp occurring along the northeastern shore of the lake (Tables Halfmoon-3 and Halfmoon-4, Figure Halfmoon-2). The low floor slab elevation, extent of structural alteration and the control point elevation were determined using available one-foot contour interval aerial maps and field survey data (Tables Halfmoon-3 and Halfmoon-5, Figure Halfmoon-6). The Normal Pool elevation is above the control point, so the lake is considered to be Structurally Altered.

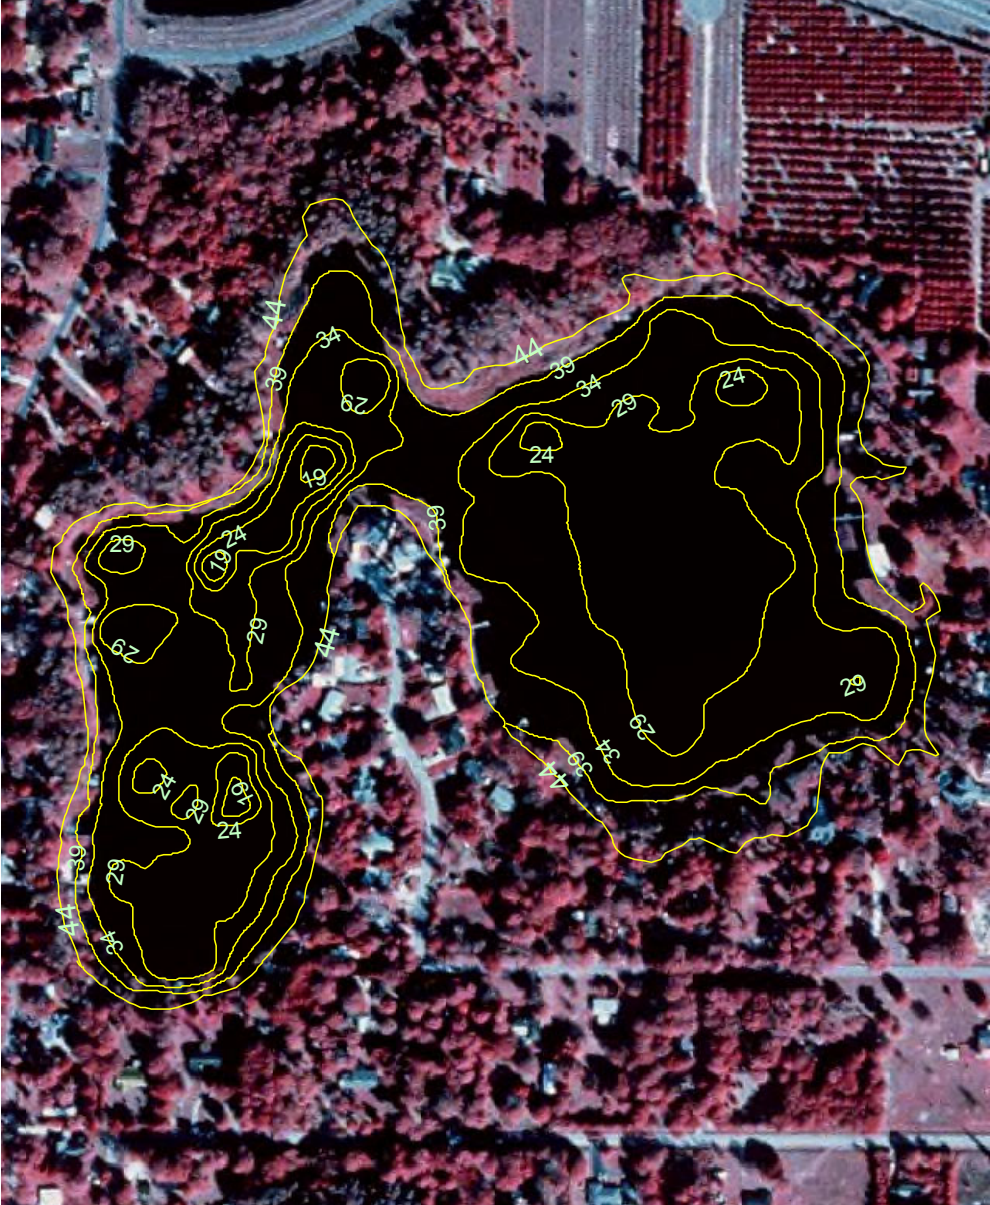
Figure Halfmoon-3. Five-foot contour lines within the Halfmoon Lake basin, Hillsborough County, Florida. Values shown are elevations, in feet, relative to the National Geodetic Vertical Datum of 1929.

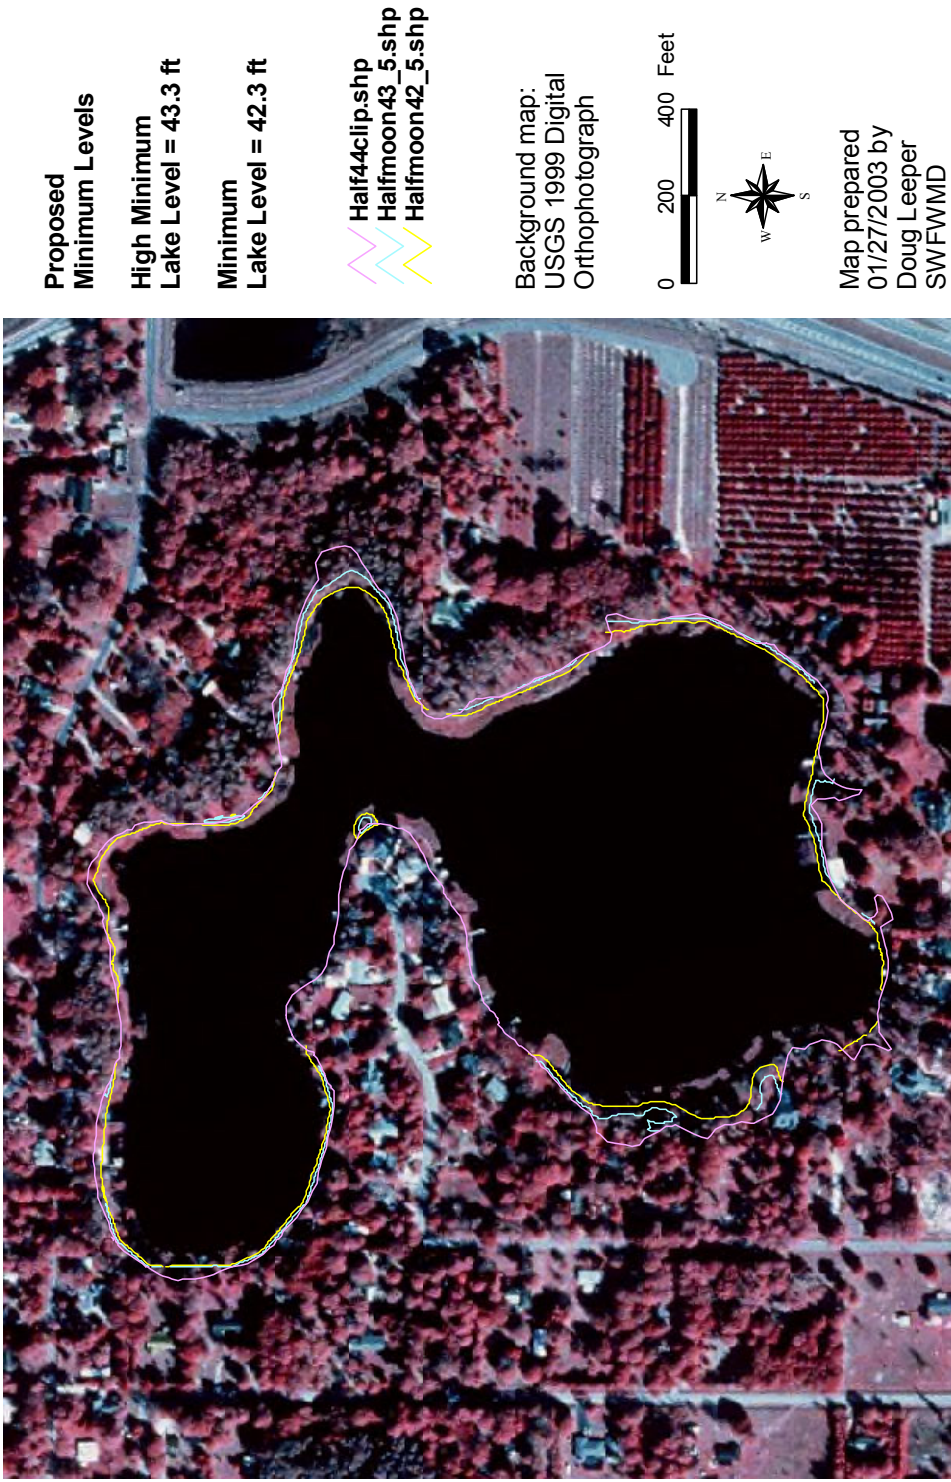
**Figure Halfmoon-4. Approximate location of the proposed Minimum Lake Level (yellow), the proposed High Minimum Lake Level (blue) and a line at an elevation 44 feet above the National Geodetic Vertical Datum of 1929 (fuchsia) within the Halfmoon Lake basin in Hillsborough County, Florida.**

Proposed Minimum and Guidance Levels were developed for Halfmoon Lake using the methodology for Category 2 Lakes described in current District rules (Chapter 40D-8, Florida Administrative Code; see also SWFWMD 1999). Proposed levels, along with lake surface area values for each level are listed in Table Halfmoon-2. The locations of the proposed minimum levels within the lake basin are shown in Figure Halfmoon-4.

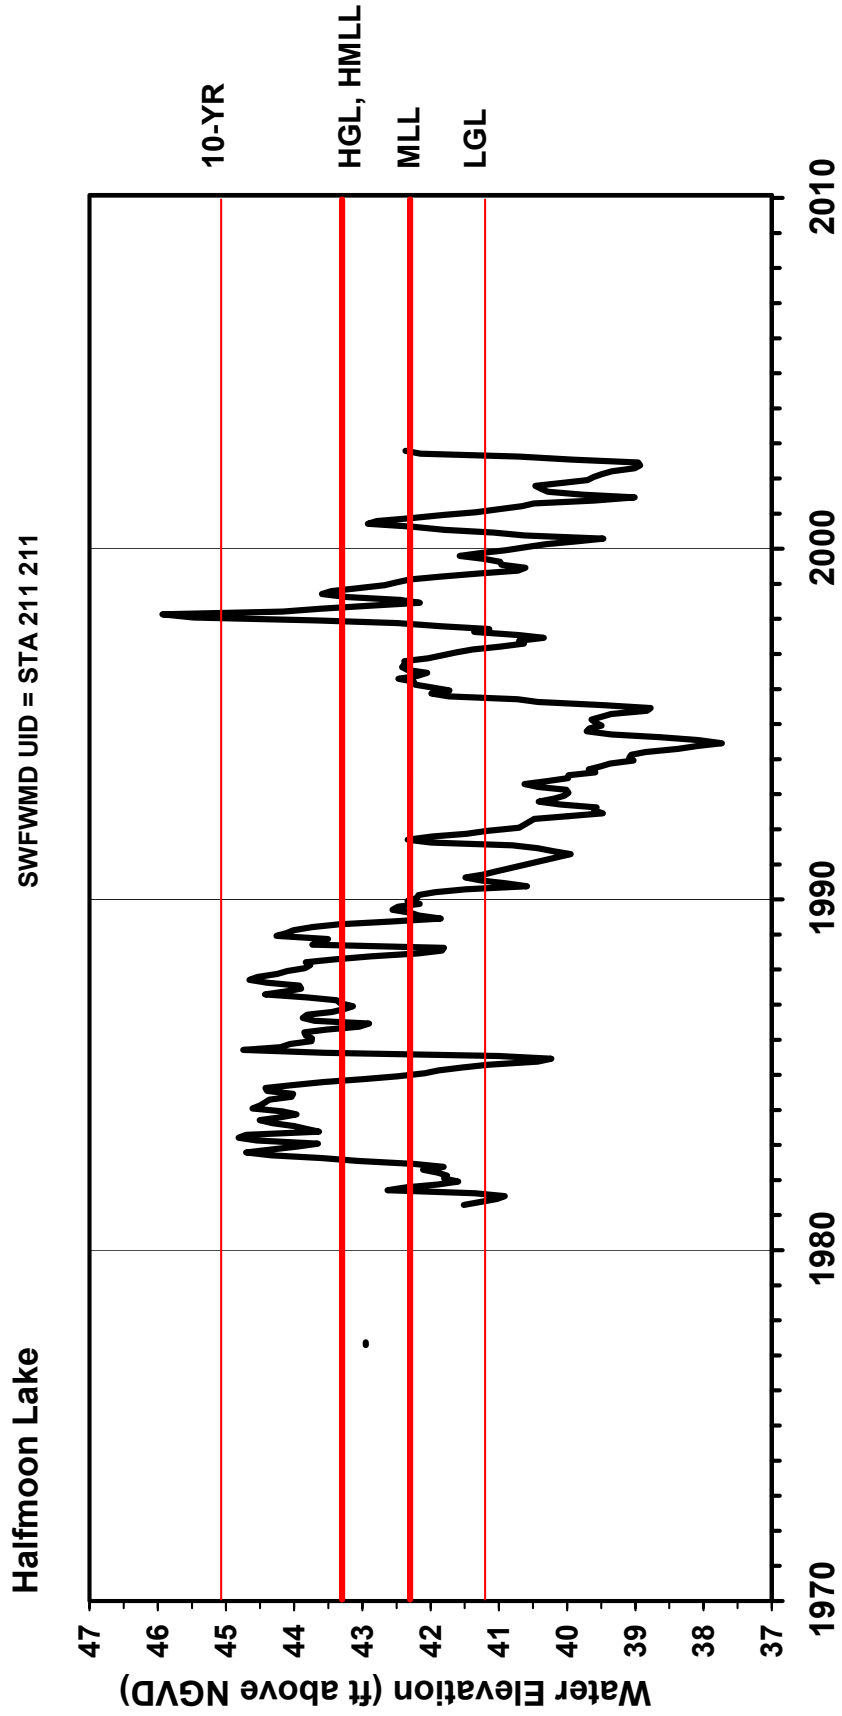
Figure Halfmoon-5. Mean monthly surface water elevation, and proposed guidance and minimum levels for Halfmoon Lake in Hillsborough County, Florida. Proposed levels include the Ten Year Flood Guidance Level (10-YR), High Guidance Level (HGL), Low Guidance Level (LGL), High Minimum Lake Level (HMLL), and Minimum Lake Level (MLL).

Hydrologic data are available for Halfmoon Lake (District Universal ID Number STA 211 211) from April 1981 (a single record from April 1977 is also available) through the present date (Figure Halfmoon-5). These data cannot be classified as Historic or Current data; a new structure was installed at the lake in spring 1998, so less than four years of data reflecting current conditions are available.

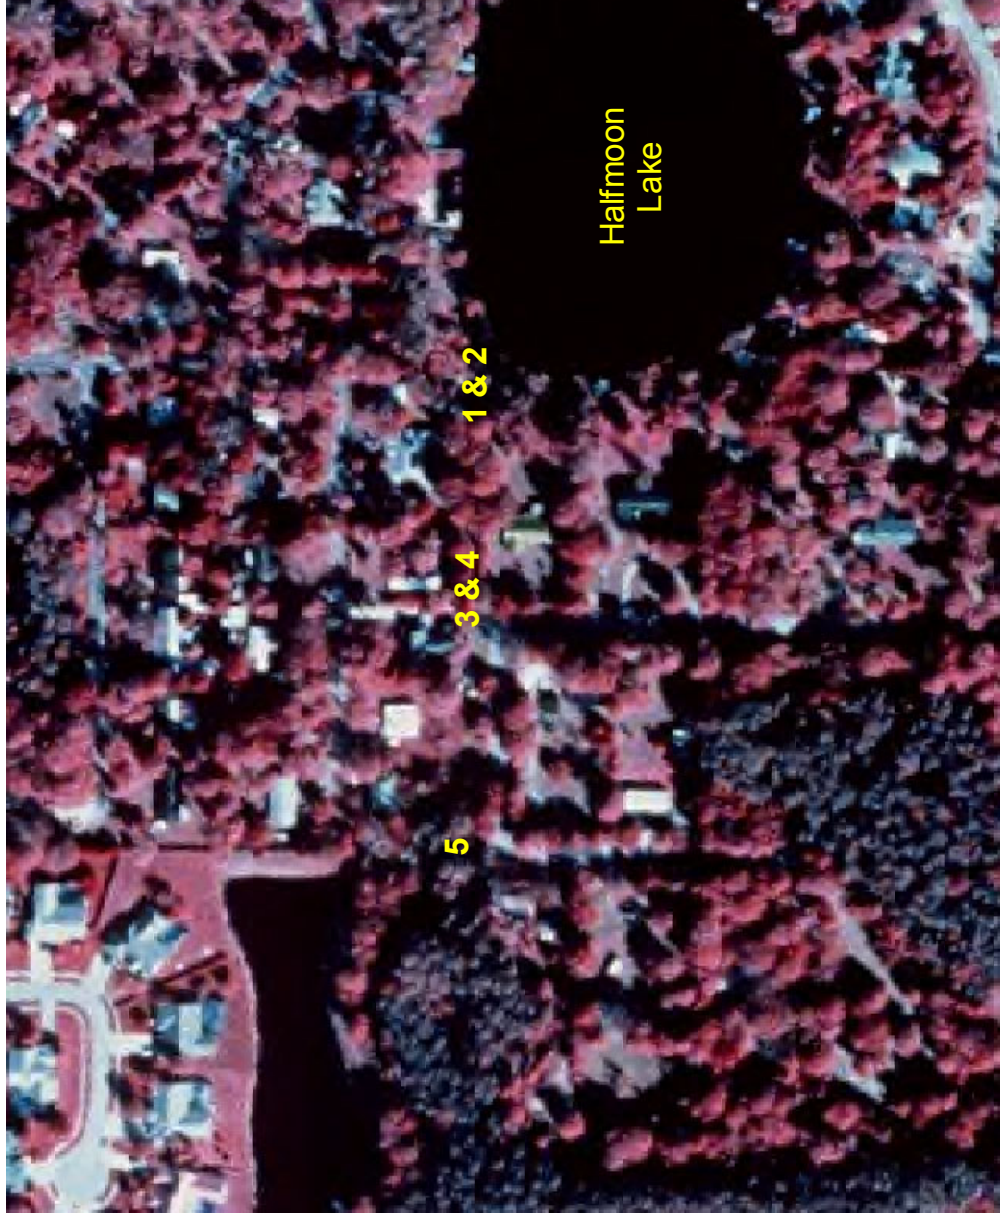
**Figure Halfmoon-6. Outlet conveyance system for Halfmoon Lake in Hillsborough County, Florida. Numbered sited are described in table Halfmoon-5.**

**Table Halfmoon-5. Summary of structural alteration and control point elevation information for Halfmoon Lake in Hillsborough County, Florida. Numbers correspond to those shown in Figure Halfmoon-6.**

<b>No.</b>	<b>Description</b>	<b>Elevation (feet above NGVD)</b>
1	Control point; three slots (one 18" x 18" and two 12" x 18") cut into concrete drop inlet structure. Bottom elevations for three slots = 43.29, 43.31 and 43.32 ft above NGVD.	43.3
2	Invert at east end of 18" reinforced concrete pipe connected to drop inlet structure (No. 1 above)	42.62
3	Invert at west end of 18" reinforced concrete pipe (No. 2 above) that is connected to a second concrete drop inlet structure	41.83
4	Invert at east end of 18" reinforced concrete pipe connected to concrete drop inlet structure	41.83
5	Invert at west end of 18" reinforced concrete pipe	41.04
