MEMORANDUM

**FROM: Doug Leeper, Senior Environmental Scientist
Resource Conservation and Development Department
Southwest Florida Water Management District**

**SUBJECT: Proposed minimum and guidance levels for Strawberry (North
Crystal) Lake in Hillsborough County, Florida**

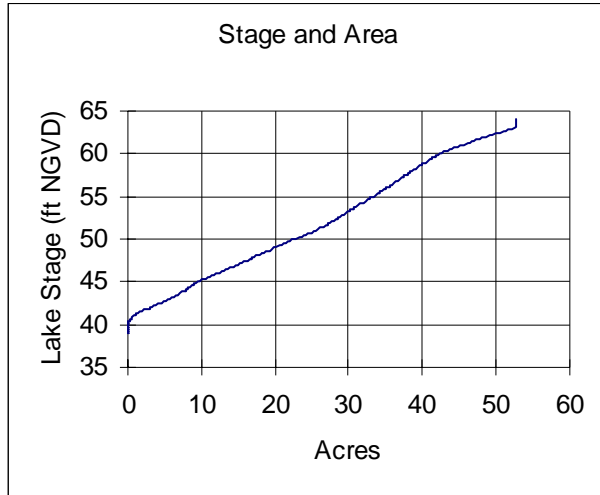
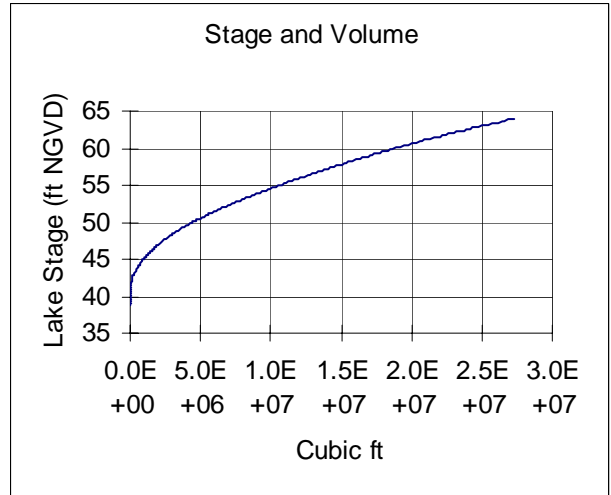
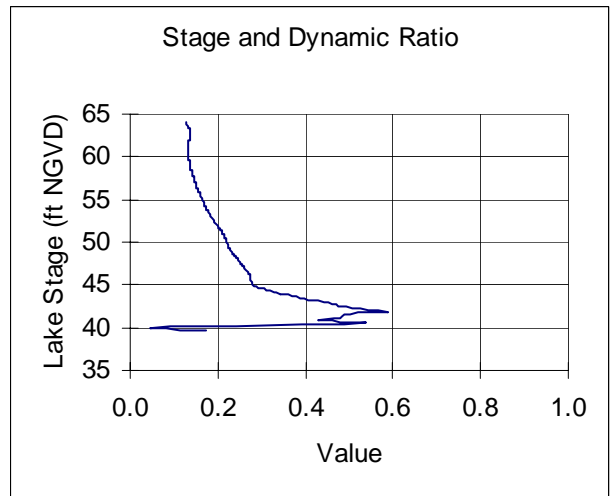
Figure 8. Surface area, volume, mean depth, dynamic ratio (basin slope), potential herbaceous wetland area, and area available for colonization by aquatic macrophytes versus lake stage for Strawberry (North Crystal) Lake in Hillsborough County, Florida.

Dock-Use, Basin Connectivity, Aesthetics, and Species Richness Standards were evaluated for minimum levels development (Table 3). The Dock-Use Standard was established at 59.3 ft above NGVD, based on the elevation of sediments at the end of 90% of the 10 docks at the lake (56.2 ft above NGVD, Table 5), a clearance value of 2 ft based on use of powerboats in the lake, and the difference between the Reference Lake Water Regime 5090 for the northern Tampa Bay area (1.1 ft). The Connectivity Standard was established at 58.1 ft above NGVD, based on the elevation that ensures connectivity among the two major sub-basins of the lake (55 ft), a two-foot clearance value for use of powerboats on the lake, and the Reference Lake Water Regime 5090 for the northern Tampa Bay area (1.1 ft). The Aesthetic-Standard for the lake was established at the Low Guidance Level elevation of 58.0 ft above NGVD. The Species Richness Standard was established at 55.6 ft above NGVD, based on limiting reduction in lake surface area to less than a 15% decrease in the area at the Historic P50 elevation. Mixing and Recreation/Ski Standards were not developed, based on the small size and morphology of the lake basin. Review of changes in potential herbaceous wetland area associated with change in lake stage, and potential change in area available for aquatic macrophyte colonization did not indicate that use of any of the identified standards would be inappropriate for minimum levels development (Figure 8).
