Appendix I - Potential Forested Freshwater Wetland Restoration Sites for the CHSJS CCMP

Table 1. Priority Ranking of Potential Forested Freshwater Restoration Sites

Figure 1. Potential Forested Freshwater Wetland Restoration Sites

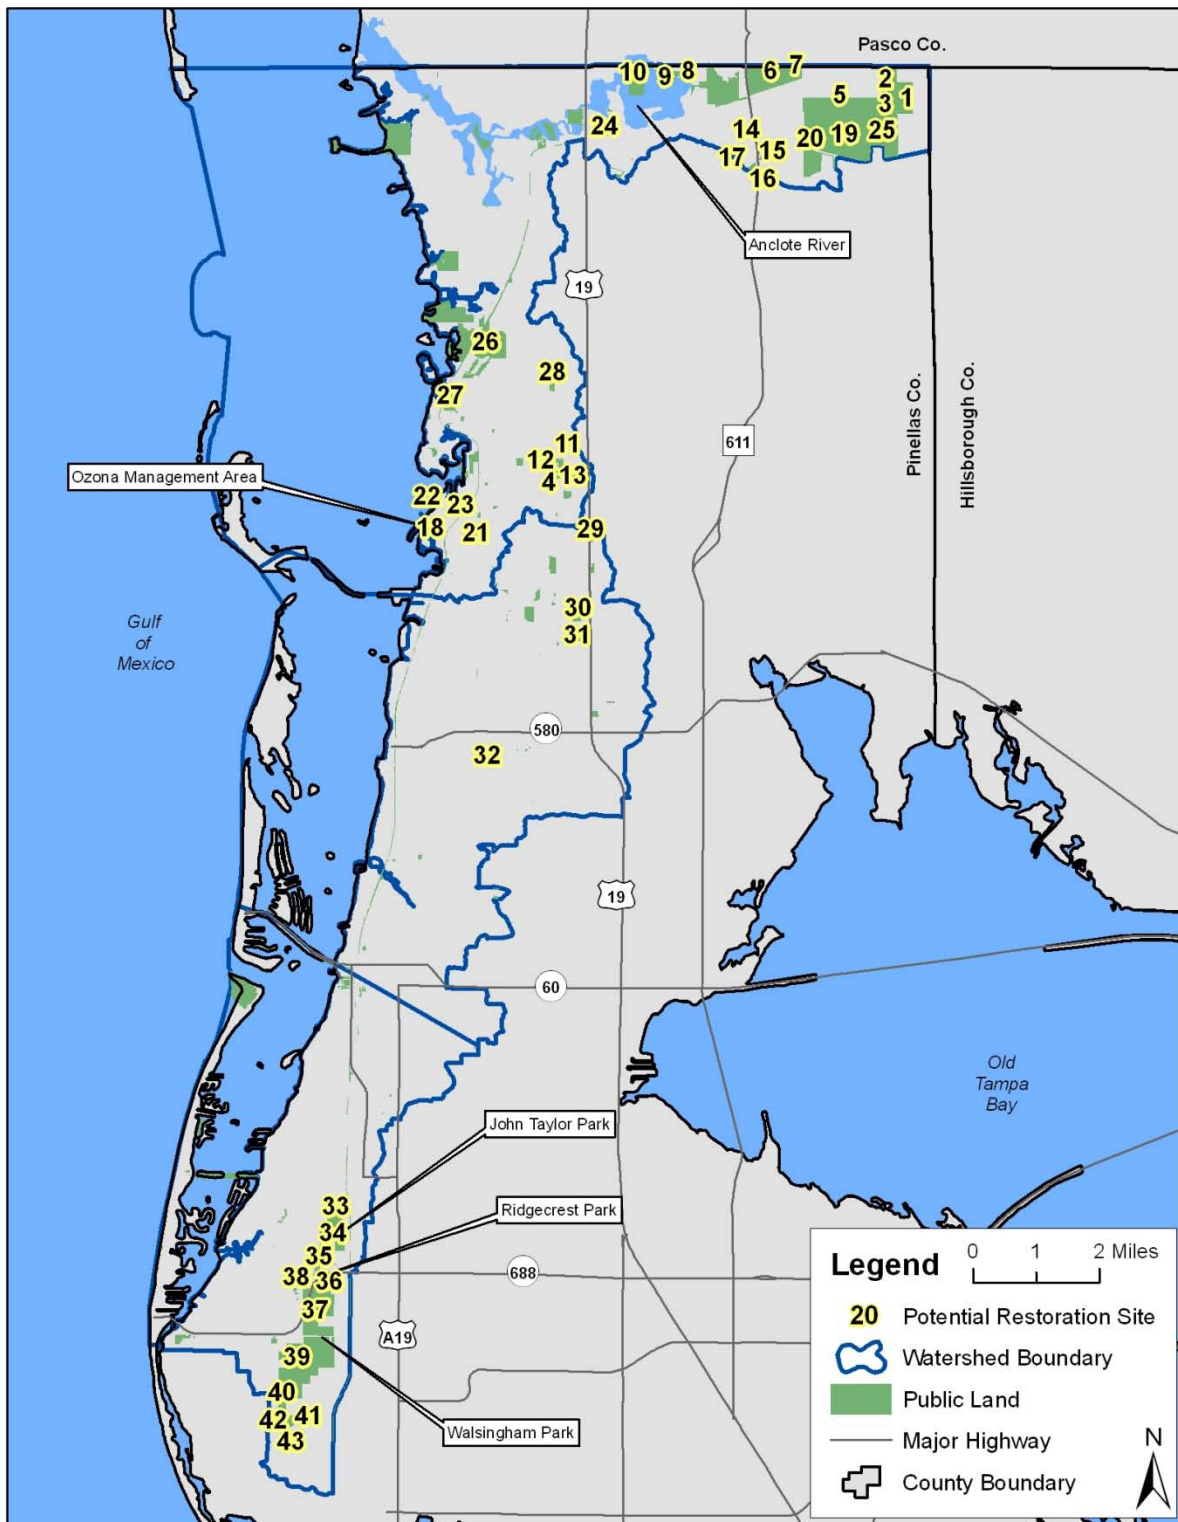
A total of 1,058 acres of historical forested freshwater wetlands on public lands were identified as potential opportunities for restoration, enhancement, or preservation. The methods used to identify potential sites are detailed below and the sites themselves are listed in Table 1 and all 43 potential sites are mapped in Figure 1. Individual maps of the 43 potential sites are attached.

through 28, in the Clearwater Harbor North Watershed include Map ID numbers 29 through 32, and in the Clearwater Harbor South Watershed include Map ID numbers 33 – 43. Figure 1 maps the location of the sites by Map ID.

Potential wetland restoration sites were prioritized after exclusionary criteria were applied. Table 1 lists the sites by Map ID and their respective priority ranking. Sites with a total value of 3, 4, or 5 are shaded gray. Sites located in the St. Joseph Sound Watershed include Map ID numbers 1
