# Turkey Creek

# **Study Area**

Turkey Creek, located in eastern Hillsborough County Florida, was sampled upstream for Durant Road was assessed on 5/31/2016. Turkey Creek discharges into the Alafia River. The watershed surrounding Turkey Creek is dominated by Residential (25.0%), Reclaimed Lands (20.8%), Agricultural (27.9%), and Natural (15.7%) land use. The Landscape Development Intensity Index of the watershed is 5.35.

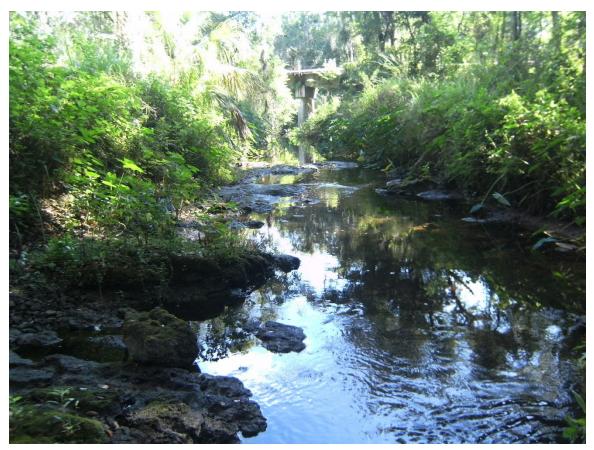
Figure 2 Overview photograph of the Turkey Creek at Durant Road sample site

Turkey Creek at Durant Road received a Habitat Assessment score of 130. The primary habitat components scored in the optimal category for Substrate Availability, Substrate Diversity and Habitat Smothering. Suboptimal scores were observed for Water Velocity. The secondary habitat components showed suboptimal scores for artificial channelization. The left bank scored in the suboptimal range for Riparian Buffer Width and Riparian Zone Vegetation Quality and scored marginal for Bank Stability. The right bank scored higher than the left bank with optimal scores for Riparian Buffer Zone Width, Bank Stability and Riparian Zone Vegetation Quality.

During the Rapid Periphyton Survey, periphyton was observed in 31 of the 99 individual grab samples performed with 13 being ranked 4-6. The average canopy cover in the 100 meter region was 75.5%. The Secchi Disk Depth was measured as 0.3 meters visible on bottom at the 50 meter mark. The average water depth at the time of the assessment was 0.3 meters.

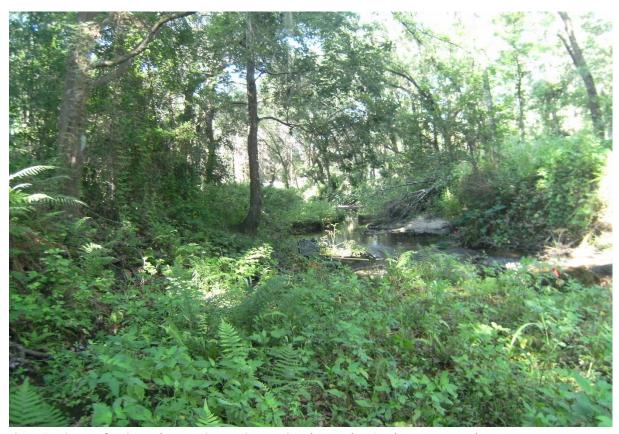
The Linear Vegetation Survey identified 3 species rooted in the water at the time of the assessment. The majority of these species (2) are non-native, invasive species shown in bold in Table 1. The remaining 1 species are native to this region. None of the three species were identified as dominant species in the regions of the Linear Vegetation Survey. The vegetation community along this sample

location showed evidence of frequent disturbance resulting in the dominance by pioneering species. There were a total of 9 species observations in the 100 meter study area. The mean Coefficient of Conservatism (CoC) metric for the study area was 0.64 and the % FLEPPC metric for the study area was 66.66%. Both of these metrics do not meet the FDEP thresholds of > 2.5 for Mean CoC and < 25% for % FLEPPC.

Figure 3. Mixture of native and non-native species growing along Turkey Creek at Durant Road
